A9 Dualling Dalraddy to Slochd

Stage 2 Scheme Assessment

Appendix A10.1

Hydromorphology Assessment

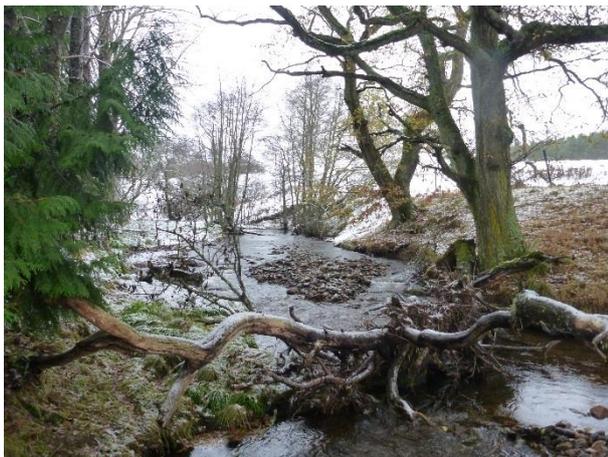
P1040399 – View upstream of large woody debris dam and evidence of incision (NGR 2852 8091)

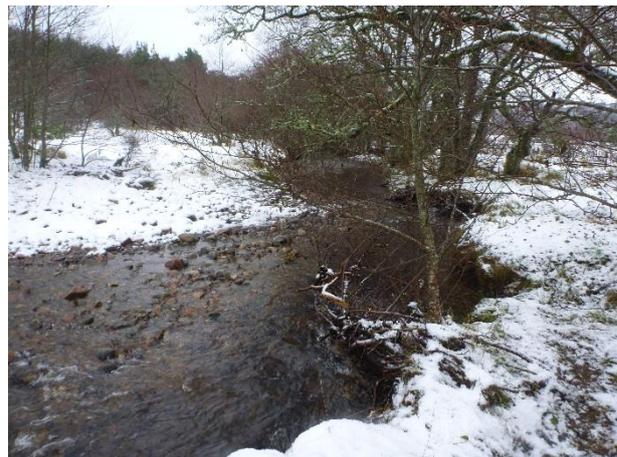
P1040405 – View downstream; eroding outer bank on the right and shallow gravel bar on the inside indicating a lateral adjustment (NGR 2852 8091)

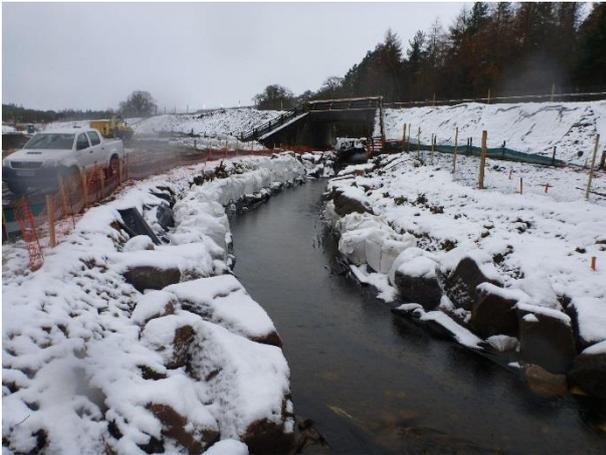
P1040416 – View upstream towards existing A9 crossing; the channel had been lined artificially with rip-rap and boulder protection as part of the ongoing construction works (NGR 2855 8092)

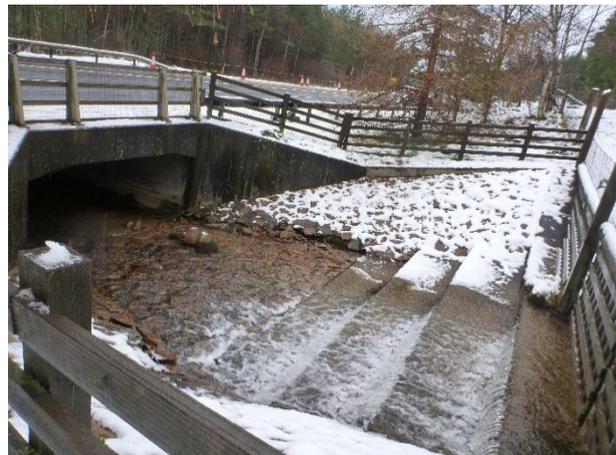
P1040419 – View of existing A9 crossing with concrete stepped cascade leading into culvert (NGR 2857 8095)

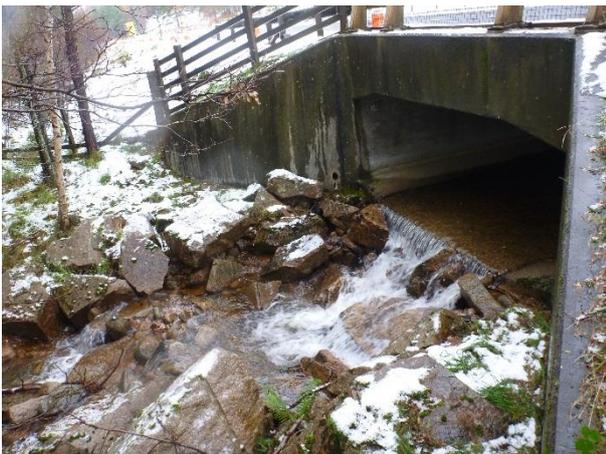
P1040425 – View of culvert outlet with signs of incision downstream and the invert was perched above the channel bed (NGR 2857 8095)

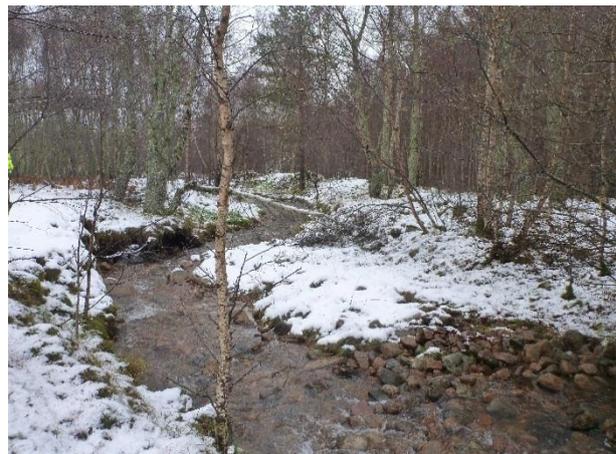
P1040434 – View downstream showing sinuous planform with some evidence of minor lateral adjustment (NGR 2858 8095)

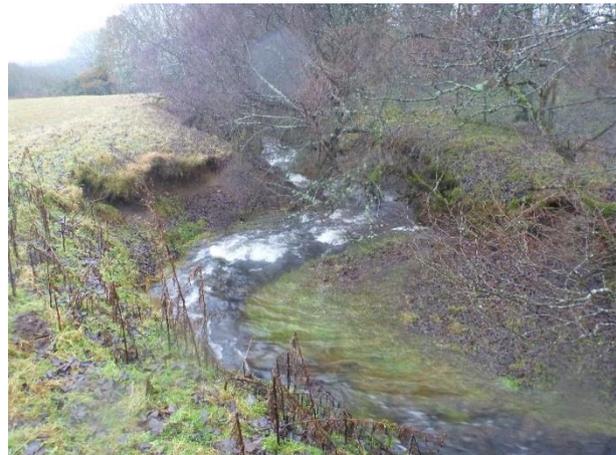
P1040514 – View downstream of wooded gorge, with landslips and bank erosion visible on the left; gravel bar on the RHB (inside bank) (NGR 2864 8102)

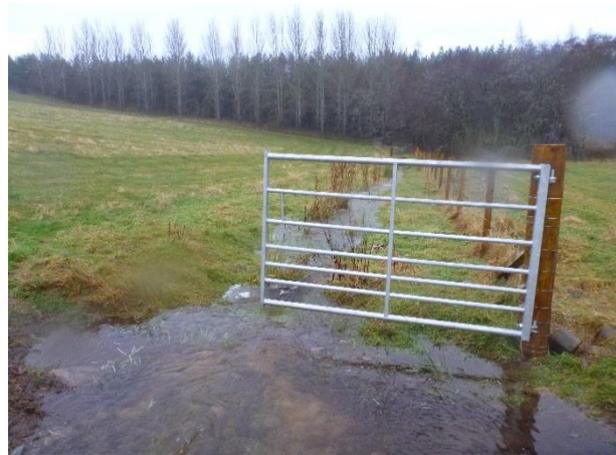
P1040500 – View downstream of straightened course following the field boundary (NGR 2866 7102)

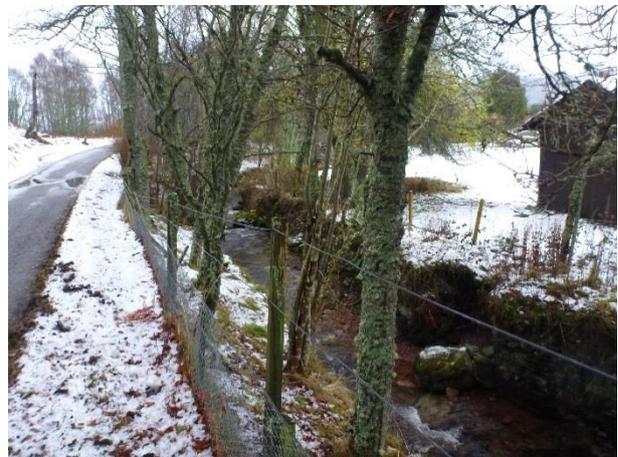
P1040449 – View downstream towards existing A9 crossing; the channel here has been channelised and bank protected around residential properties (NGR 2881 8107)

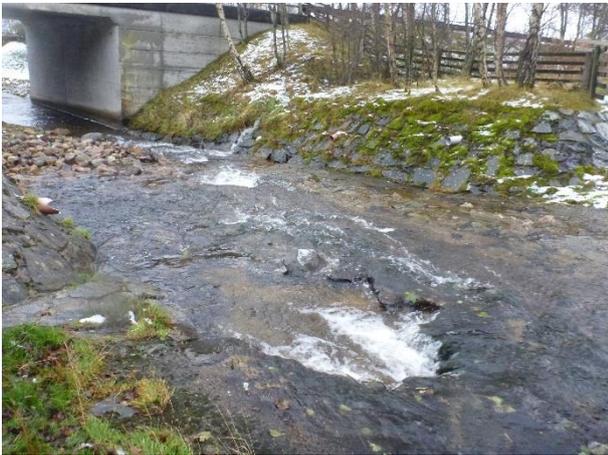
Because of these constraints the channel had been modified and straightened, including installation of concrete bed and bank protection (some of which had become damaged, see P1040468 below). There were few signs of fluvial erosion. However there were a number of side bars underneath the crossings which were probably formed when coarser material from upstream has been transferred through and deposited where the gradient was less and the channel was wider. From the observations made the channel appears to be narrowing through the preferential deposition of coarse material, however this may be localised underneath these crossings.

P1040468 – Collapse concrete/cobble bed leading towards the existing A9 crossing (NGR 2884 8106)

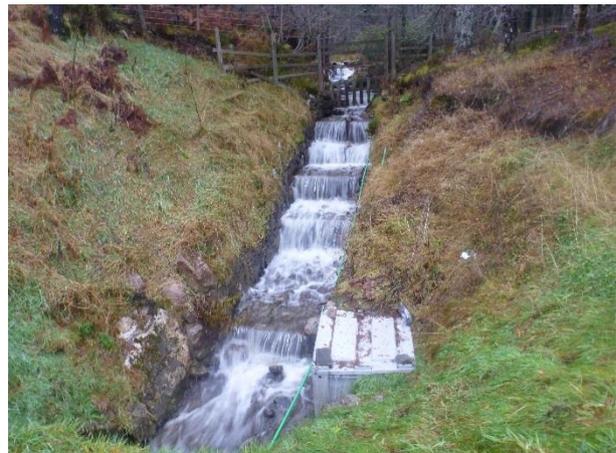
P1040794 – Artificial concrete steps leading into existing A9 crossing (NGR 2902 8164)

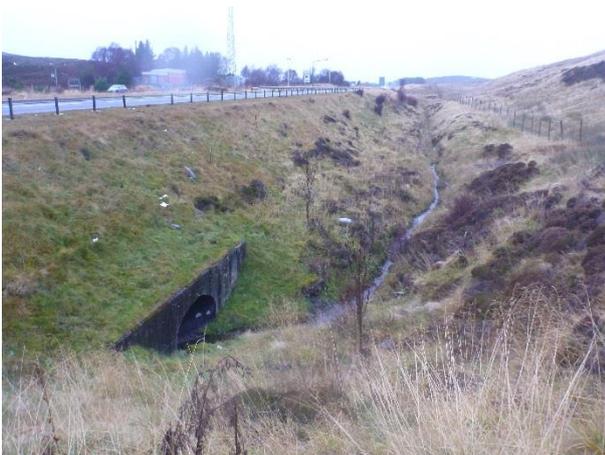
P1040955 – The channel has been realigned and constrained into a narrow artificial valley through a series of culverts (NGR 2836 8256)

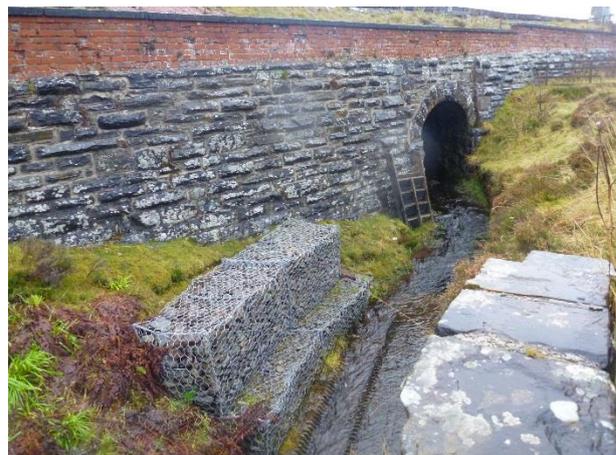
P1040970 – Channel between the railway and A9 was lined with gabion and stone wall protection through two culverts (NGR 2837 8254)

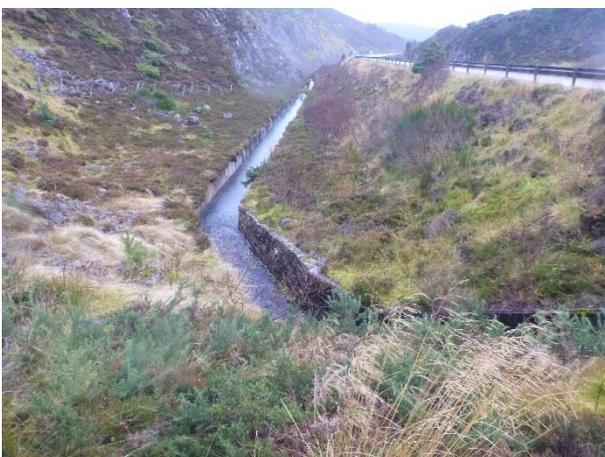
P1040973 – Downstream of the A9 the channel was contained within a concrete lined uniform channel with a very steep gradient (NGR 2838 8253)

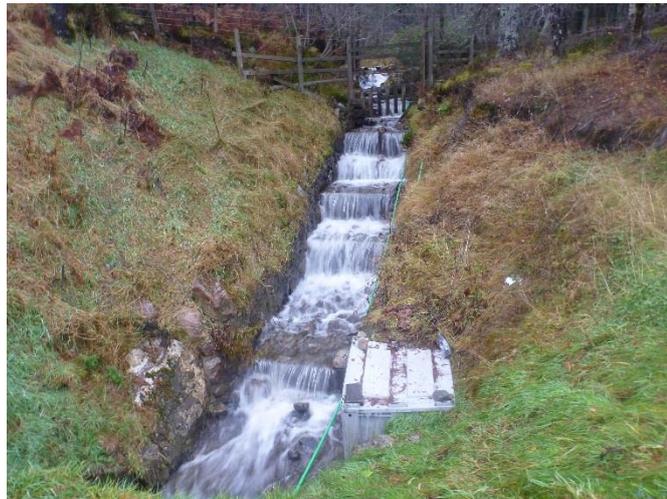
Figure 6-1 Existing cascade at Southern Avie Lochan Burn (P1040794)
