FORTH REPLACEMENT CROSSING

**AIR QUALITY MONITORING REPORT
 JULY 2013**

REP-00129-00

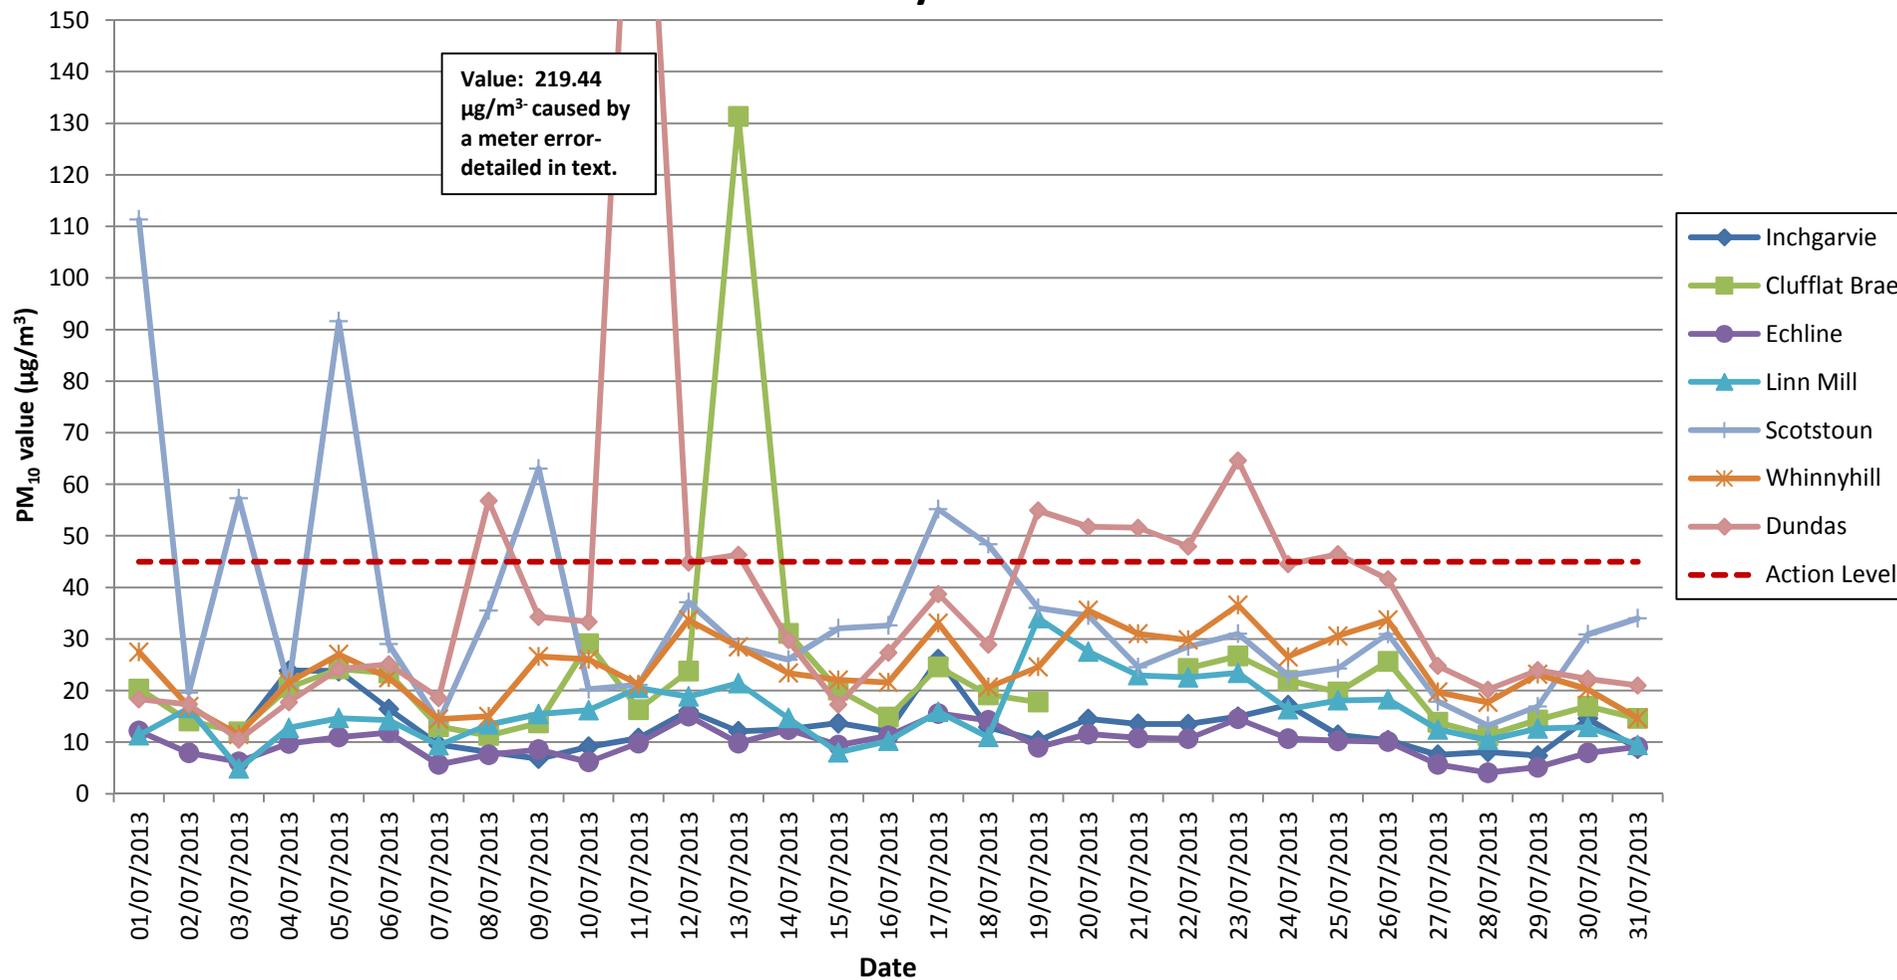
Particulate Matter (PM10) Results for all Monitoring Locations

3.1.1. Light scatter results for July 2013 have been presented in a monthly chart; this can be found in Appendix A. Results show that the PM₁₀ levels were largely below threshold levels and generally followed the same pattern across the site. During July there were 15 days on which exceedances of the threshold occurred. These exceedances occurred at Scotstoun, Dundas and Clufflat. However, only those exceedances occurring at Scotstoun are thought to be related to construction works. Table 2 lists the locations at which the exceedances occurred on these dates. The dust log (section 3.4 and Appendix D) provides further details with regard to the conditions and the actions taken as a result of each exceedance.

- 3.1.2.** The results at Dundas are not considered to be related to construction. The meter at Dundas is particularly sensitive to foggy, misty and hazy conditions (see 2.2). Foggy conditions were observed and recorded on 8, 13, 19 to 23 and 25 July, with high humidity levels recorded at the light scatter meters located at Clufflat and Inchgarvie on these dates, in addition to nearby weather stations noting foggy conditions on these dates. With regard to the exceedance on 11 July, there was an error with the device at 3:55 pm and the results were unrealistically high (5 minute average greater than 15,000 μ g/m³). However, as the cause is uncertain, the data has not been excluded, though it is not considered to be related to construction works.

- 3.1.3.** The exceedance at Clufflat on 13 July was caused by a period of high particulate levels in the late afternoon and early evening. No works were being undertaken on this day (Saturday) and winds were not such that wind-blown dust could have affected this location (as recorded at weather stations across the site). It is, therefore, thought that the exceedance was caused by local, non-construction related factors.

- 3.1.4.** The exceedances at Scotstoun on 1, 3, 5, 9, 17 and 18 July appear to be localised events. It is likely that the results for this monitor were affected by dust associated with vehicle movements at the site entrances close to this monitoring location and also further affected by dust associated with the adjacent road. A road sweeper is in operation at this location which reduces the dust levels associated with the road, whilst a bowser works full time on dust suppression in the south network areas to dampen down all areas of site, including the site entrances. Where required, an additional bowser was deployed in the south network areas. On several of the dates on which exceedances occurred, strong winds were also noted. Windy conditions were found to influence the recorded PM₁₀ results; in such instances, mitigation measures were deployed as far as reasonably practicable.

- 3.1.5.** During periods of high dust levels, the environmental department were notified by trigger alerts and there was close liaison with the works manager and section head of the south networks area to ensure that mitigation was in place.
- 3.1.6.** The PM₁₀ results have also been compared to the daily mean results obtained from the TEOM air quality monitoring stations located in Newton, Rosyth, Broxburn, Queensferry Road, Edinburgh and St Leonards, Edinburgh (an urban background site). The TEOM at Newton was installed by West Lothian Council, facilitated by FCBC, during May 2012. The comparison between the light scatter and TEOM results demonstrates that both sets of results generally follow the same pattern at similar levels, indicating that the pattern observed throughout July was largely due to regional changes in air quality, with the exceptions as discussed above.

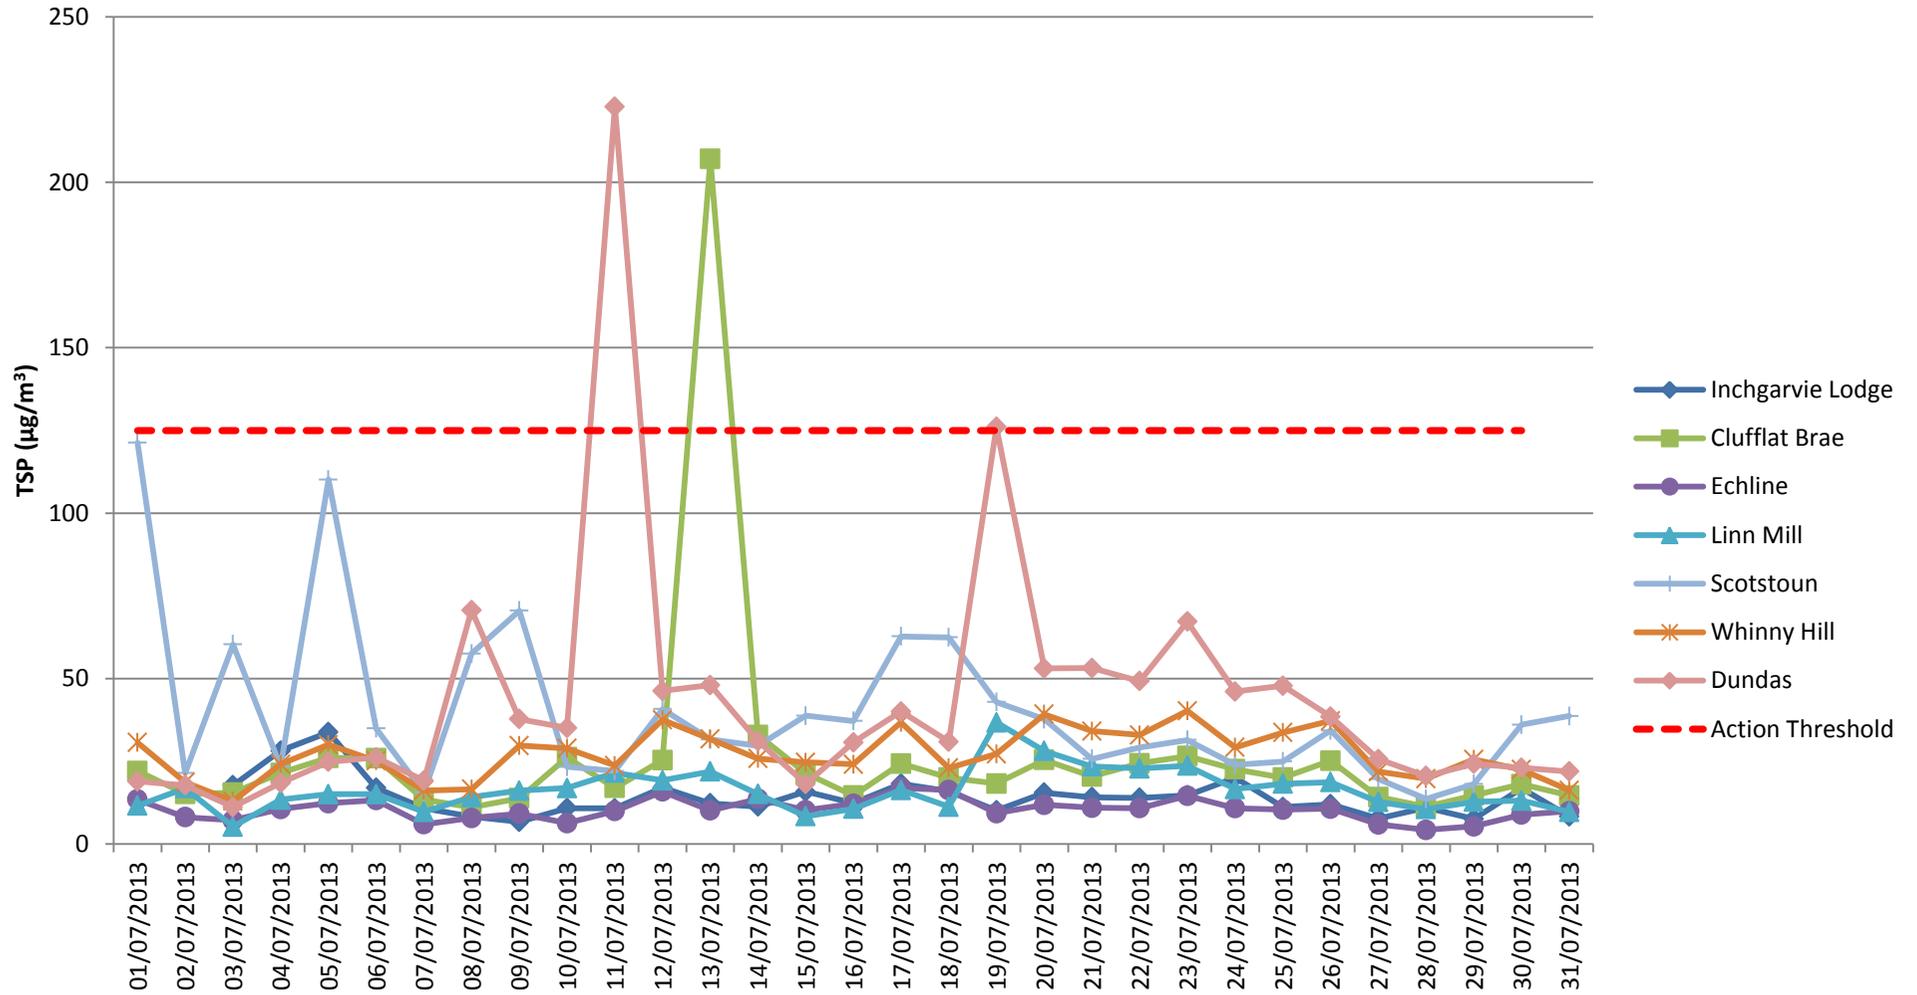
Total Suspended Particles (TSP) Results July 2013

- 3.2.1.** The TSP results for July 2013 have been presented in a monthly chart; this can be found in Appendix B. The TSP levels at monitoring locations during July were generally low and all within the threshold level, with the exception of 11 and 19 July at Dundas and 13 July at Clufflat. These exceedances were related to device error and foggy conditions at Dundas and a localised event that is not considered to be related to construction works at Clufflat (Table 3), as discussed in relation to the high PM₁₀ levels noted above (see 3.1). All locations were mostly found to follow a similar pattern across the site, demonstrating that in general the levels were influenced by regional changes in TSP levels, rather than construction works, with some exceptions relating to the PM₁₀ levels discussed in section 3.1.

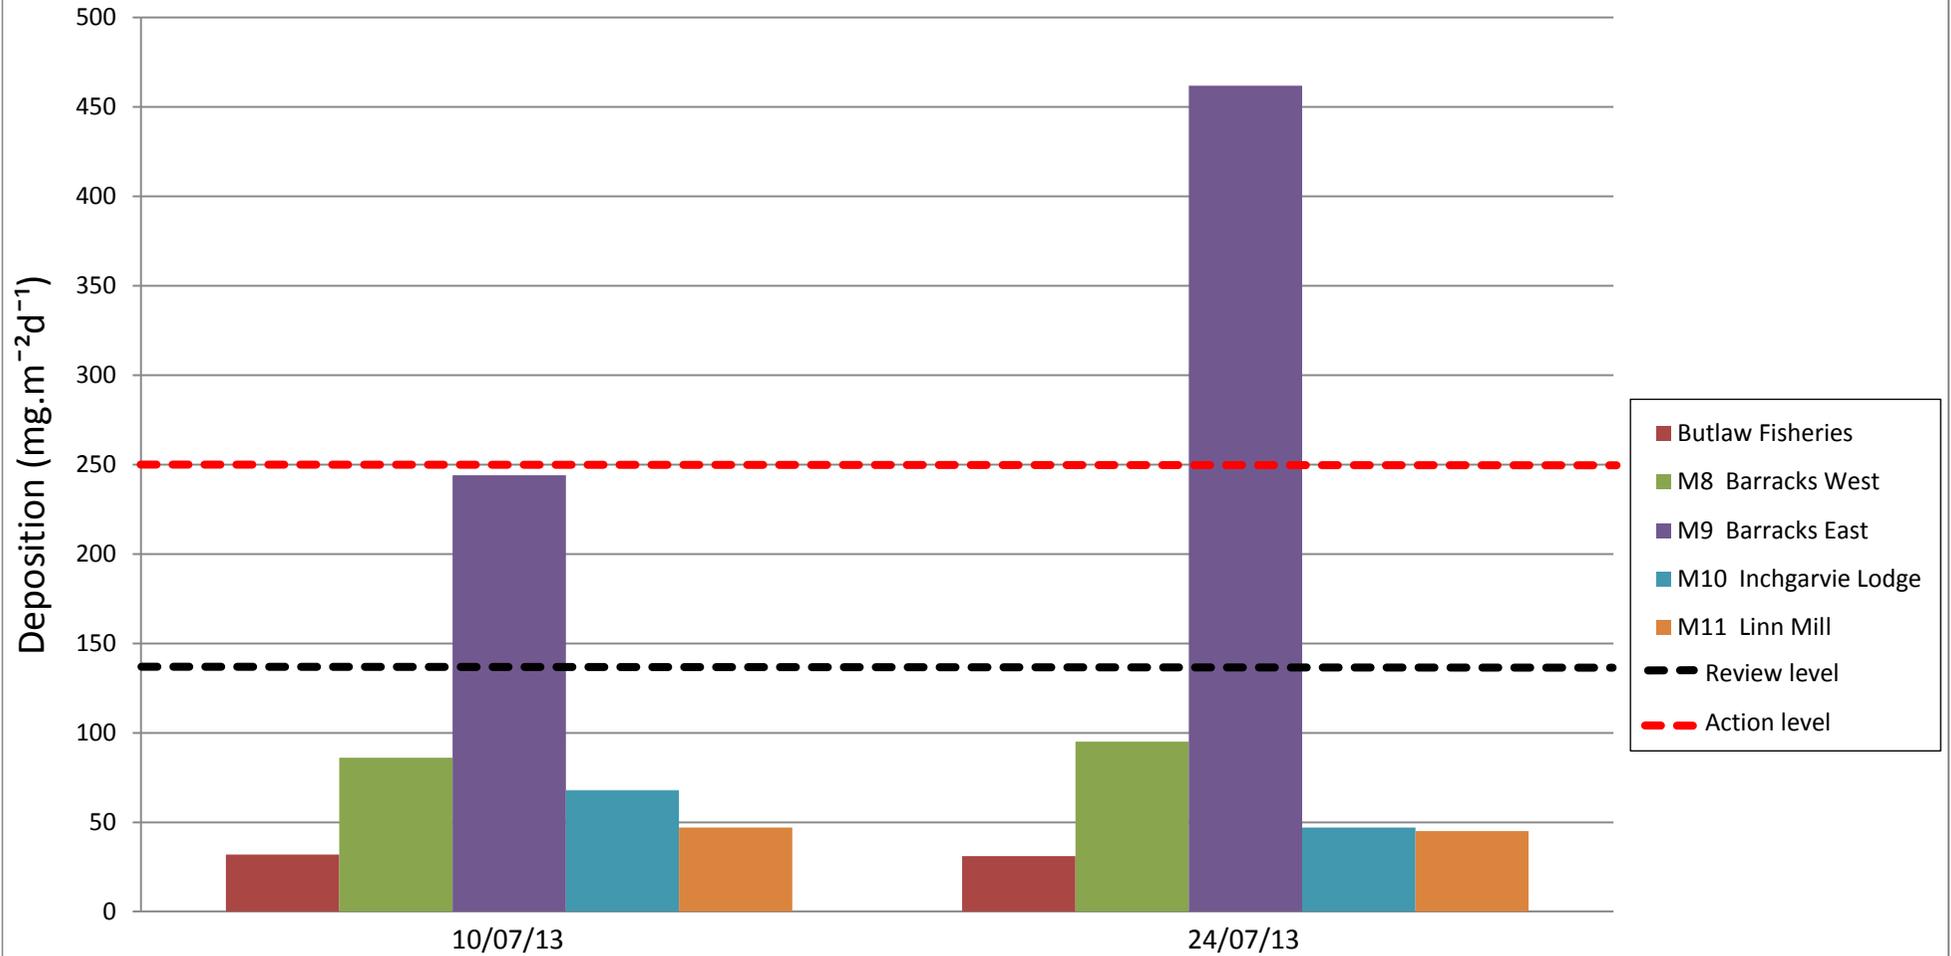
Frisbee Dust Deposition Results: Group 1
Locations: M7 Butlaw Fisheries, M8 Barracks West, M9 Barracks East, M10 Inchgarvie Lodge and M11 Linn Mill

- 3.3.7.** The exceedance of the review level at Newton is not considered to be related to construction works. On-going building works at the property are immediately adjacent to the Frisbee gauge and, therefore, are thought to have contributed to the levels recorded at this location.
- 3.3.8.** The exceedance of the review threshold for the period ending 10 July, and the exceedance of the action threshold for the period ending 24 July at Barracks East are thought to have been caused by vehicles turning immediately adjacent to the Frisbee gauge and the deposition of material close by for the Society Road embankment works. However, this appears to be a localised exceedance as the results at Barracks West (located within 100 meters of Barrack East) show no high results. It should also be noted that there are no sensitive receptors in the immediate vicinity of the Barracks East gauge.

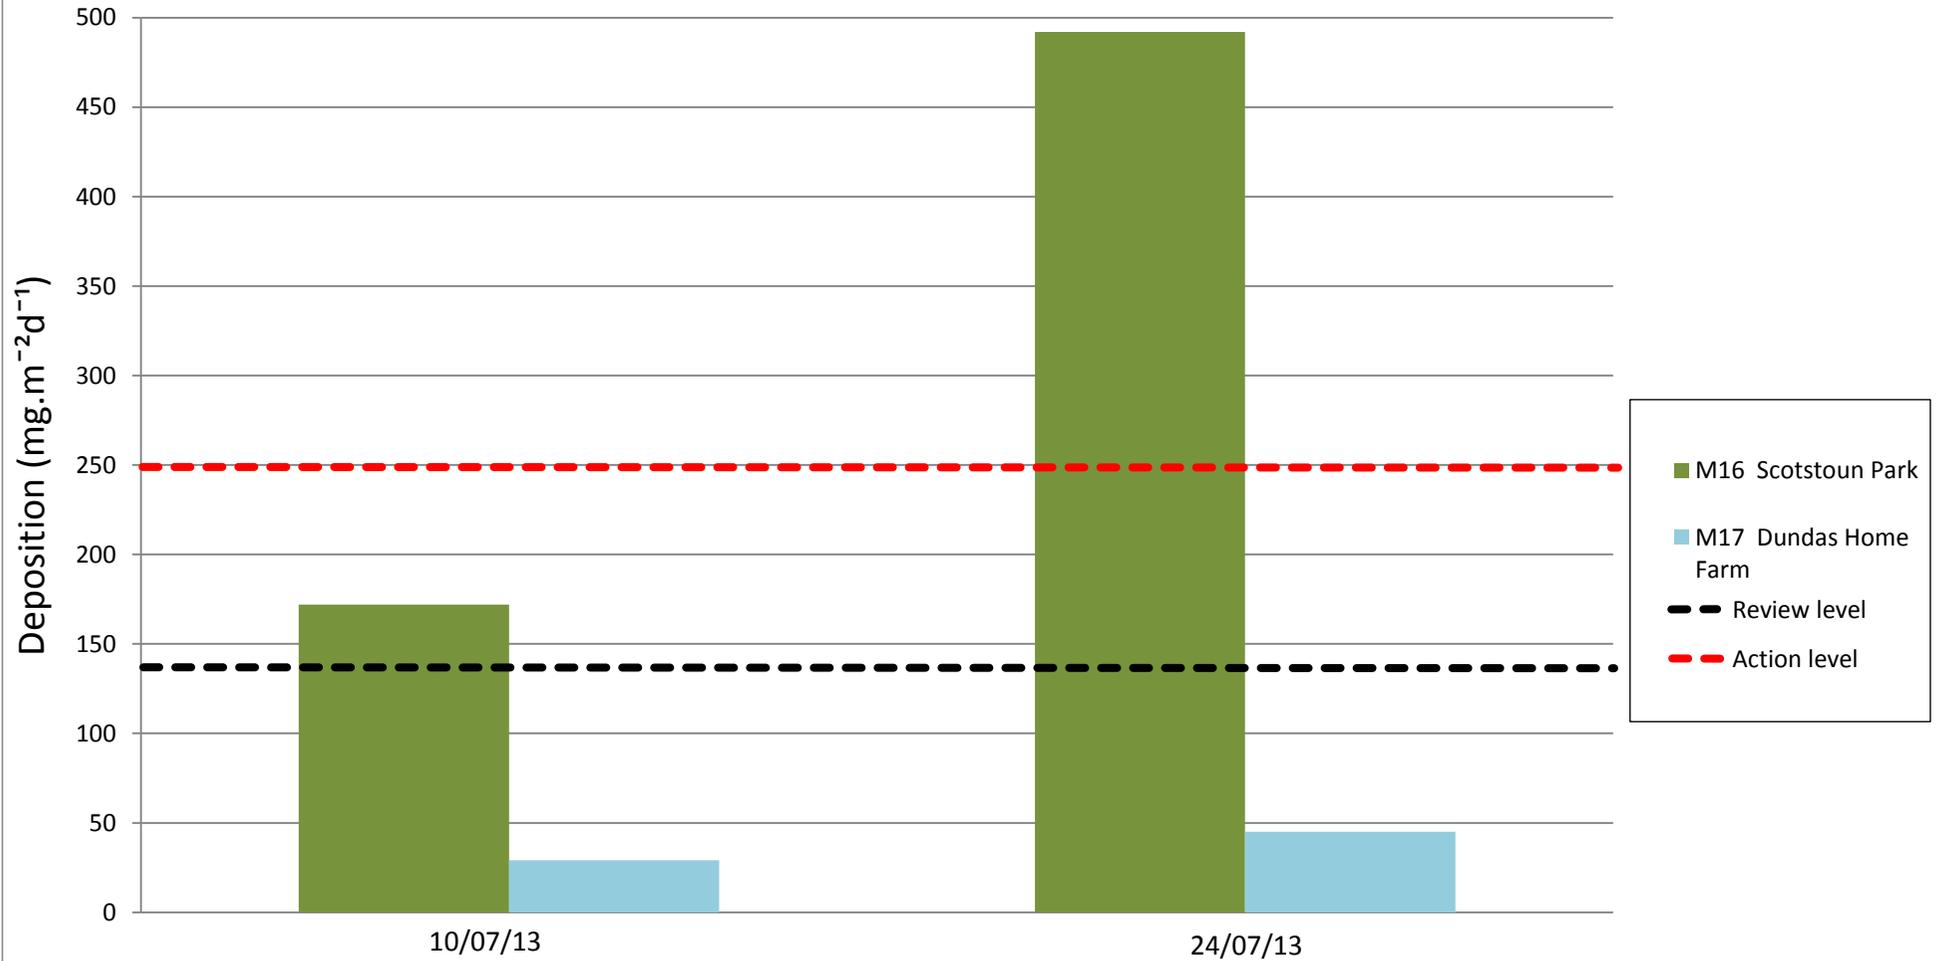
Frisbee Dust Deposition Results: Group 3

3.3.5. With regard to the exceedances at Scotstoun, appropriate reviews of the works in the area, the potential of works to have affected dust levels and any mitigation measures in place were undertaken. It is possible that these were caused by construction works due to the dust observed during some inspections and the particulate matter levels recorded by the light scatter meter at Scotstoun. Additional mitigation measures were therefore put in place (refer to 3.1.4).

3.3.6. However, it should be noted that the samples collected were found to be contaminated with vegetation from mature trees above the gauge and animal particles. Therefore, the exceedances are not considered to be entirely related construction works. The laboratory responsible for testing the dust samples have confirmed that, during summer months, there is likely to be an increase in the amount of vegetation and animal

particles collected in the samples. As the Frisbee gauge does not discriminate on particle type, this can lead to 'false' increased results.
