Project **FORTH REPLACEMENT CROSSING**

AIR QUALITY MONITORING REPORT
SEPTEMBER 2013

Document number
REP-00137-00

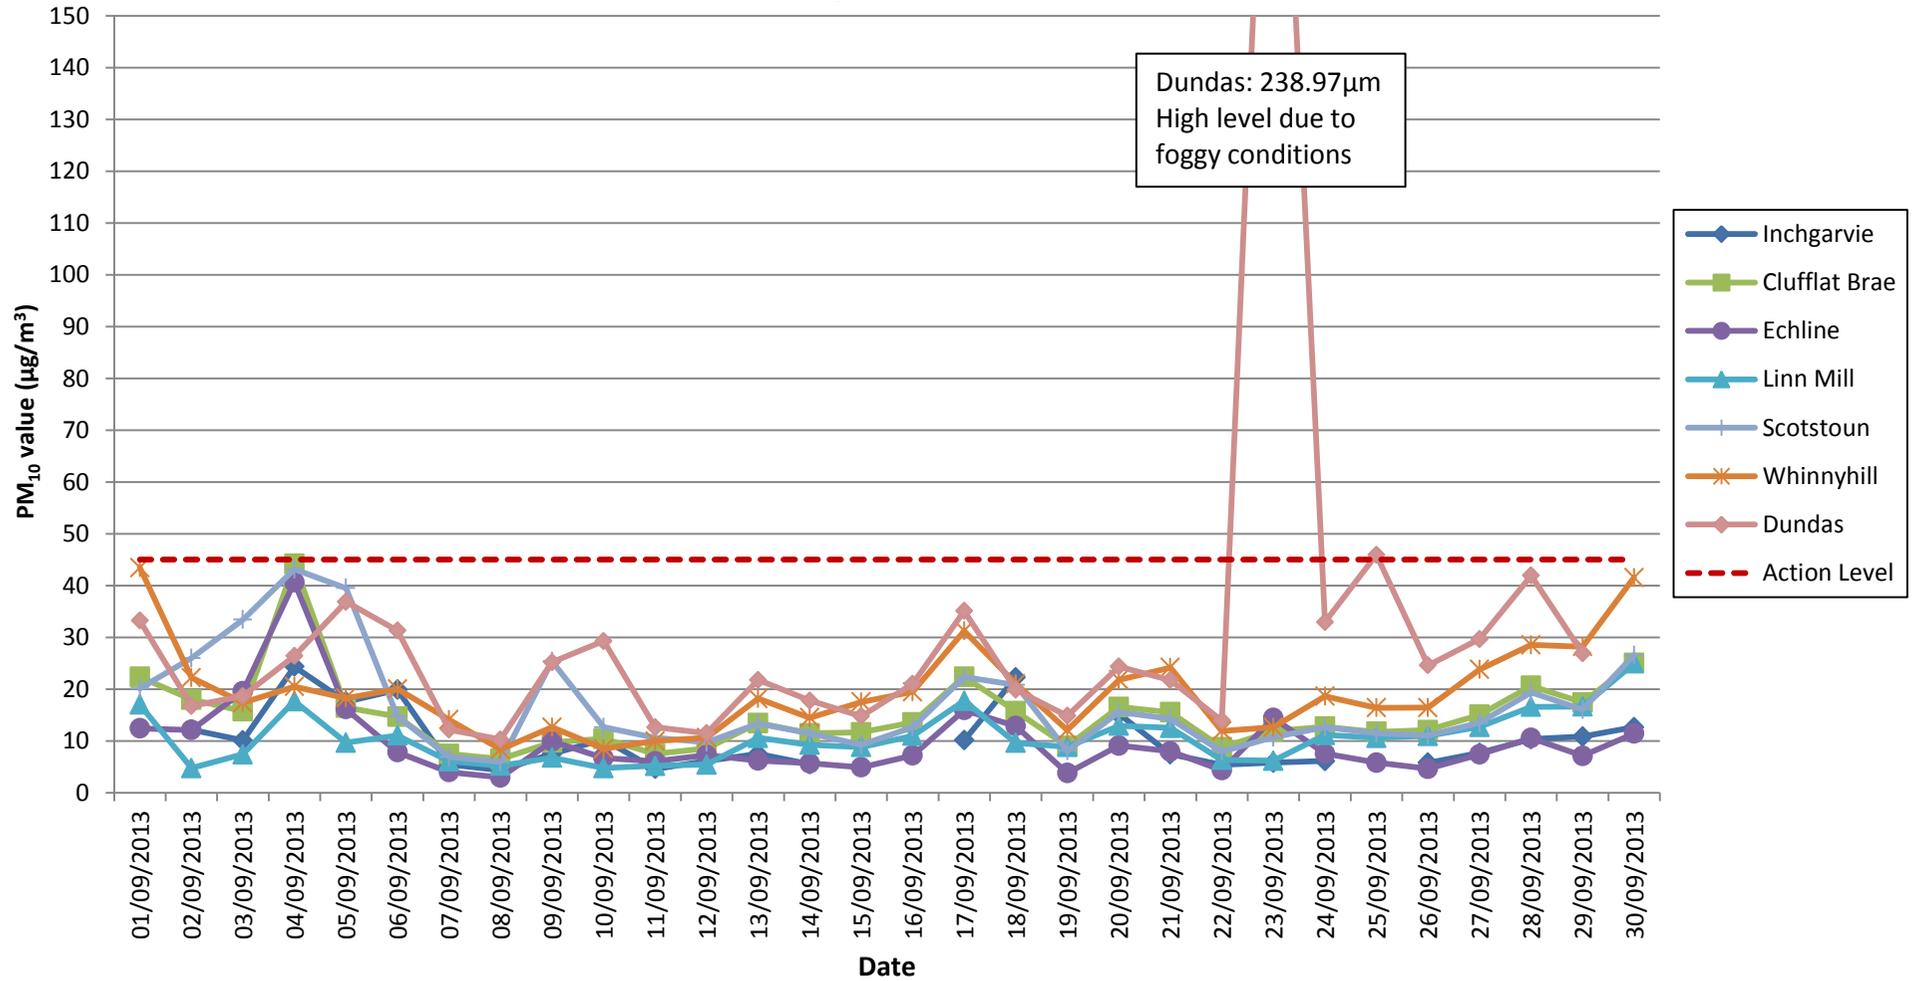
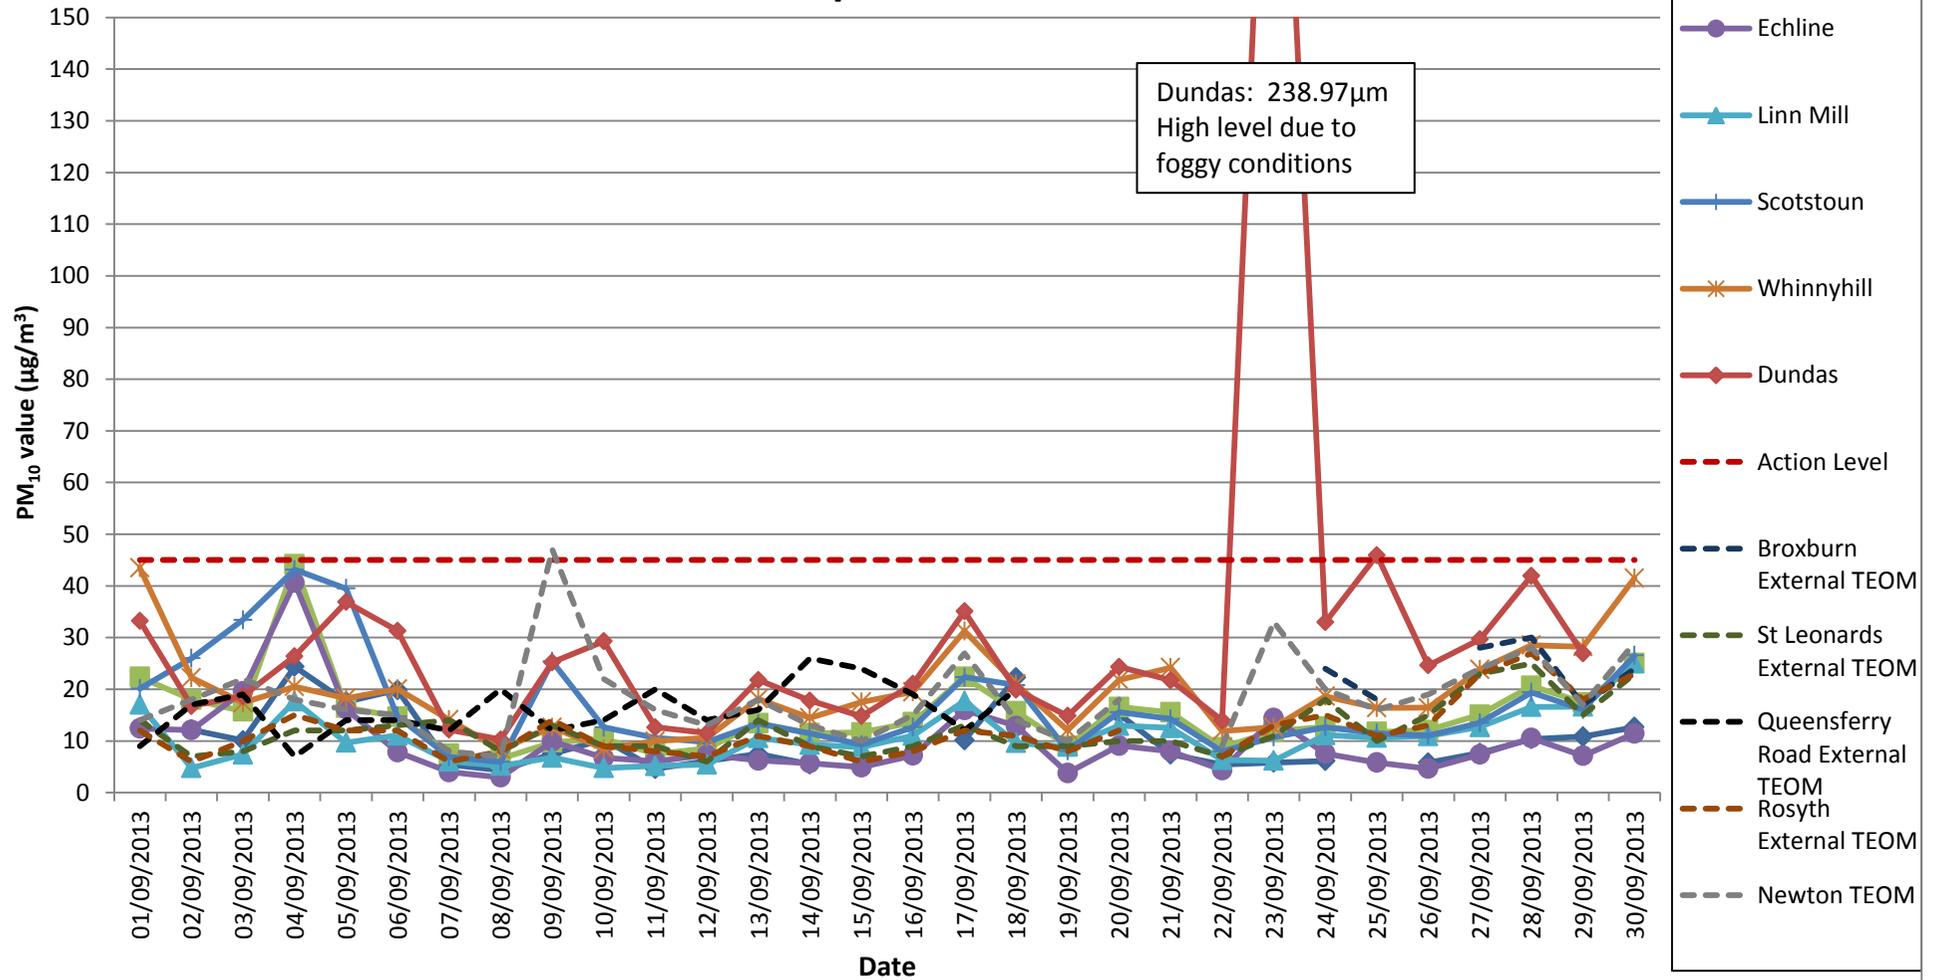
Particulate Matter (PM10) Results for all Monitoring Locations

3.1.1. Light scatter results for September 2013 have been presented in a monthly chart; this can be found in Appendix A. Results show that the PM₁₀ levels were below threshold levels and generally followed the same pattern across the site, with the exception of two days at Dundas. However, no September exceedances are thought to be related to construction works.

Date	Monitoring Location	Notable conditions
23/09/13	Dundas	Damp conditions on site
25/09/13	Dundas	Damp conditions on site – low level cloud and drizzle

3.1.3. The results at Dundas are not considered to be related to construction. The meter at Dundas is particularly sensitive to foggy, misty and hazy conditions (see 2.2) and therefore it is likely that the results were affected by the damp conditions. On 23 September, an error appeared to occur between 5.20pm and 5.25pm, which caused unrealistically high levels (greater than 50,000µg). With regard to the exceedance on 25 September, high levels were noted between 12.30am and 4.15am, indicating that foggy conditions during the night, as recorded at local weather stations, may have caused the exceedance.

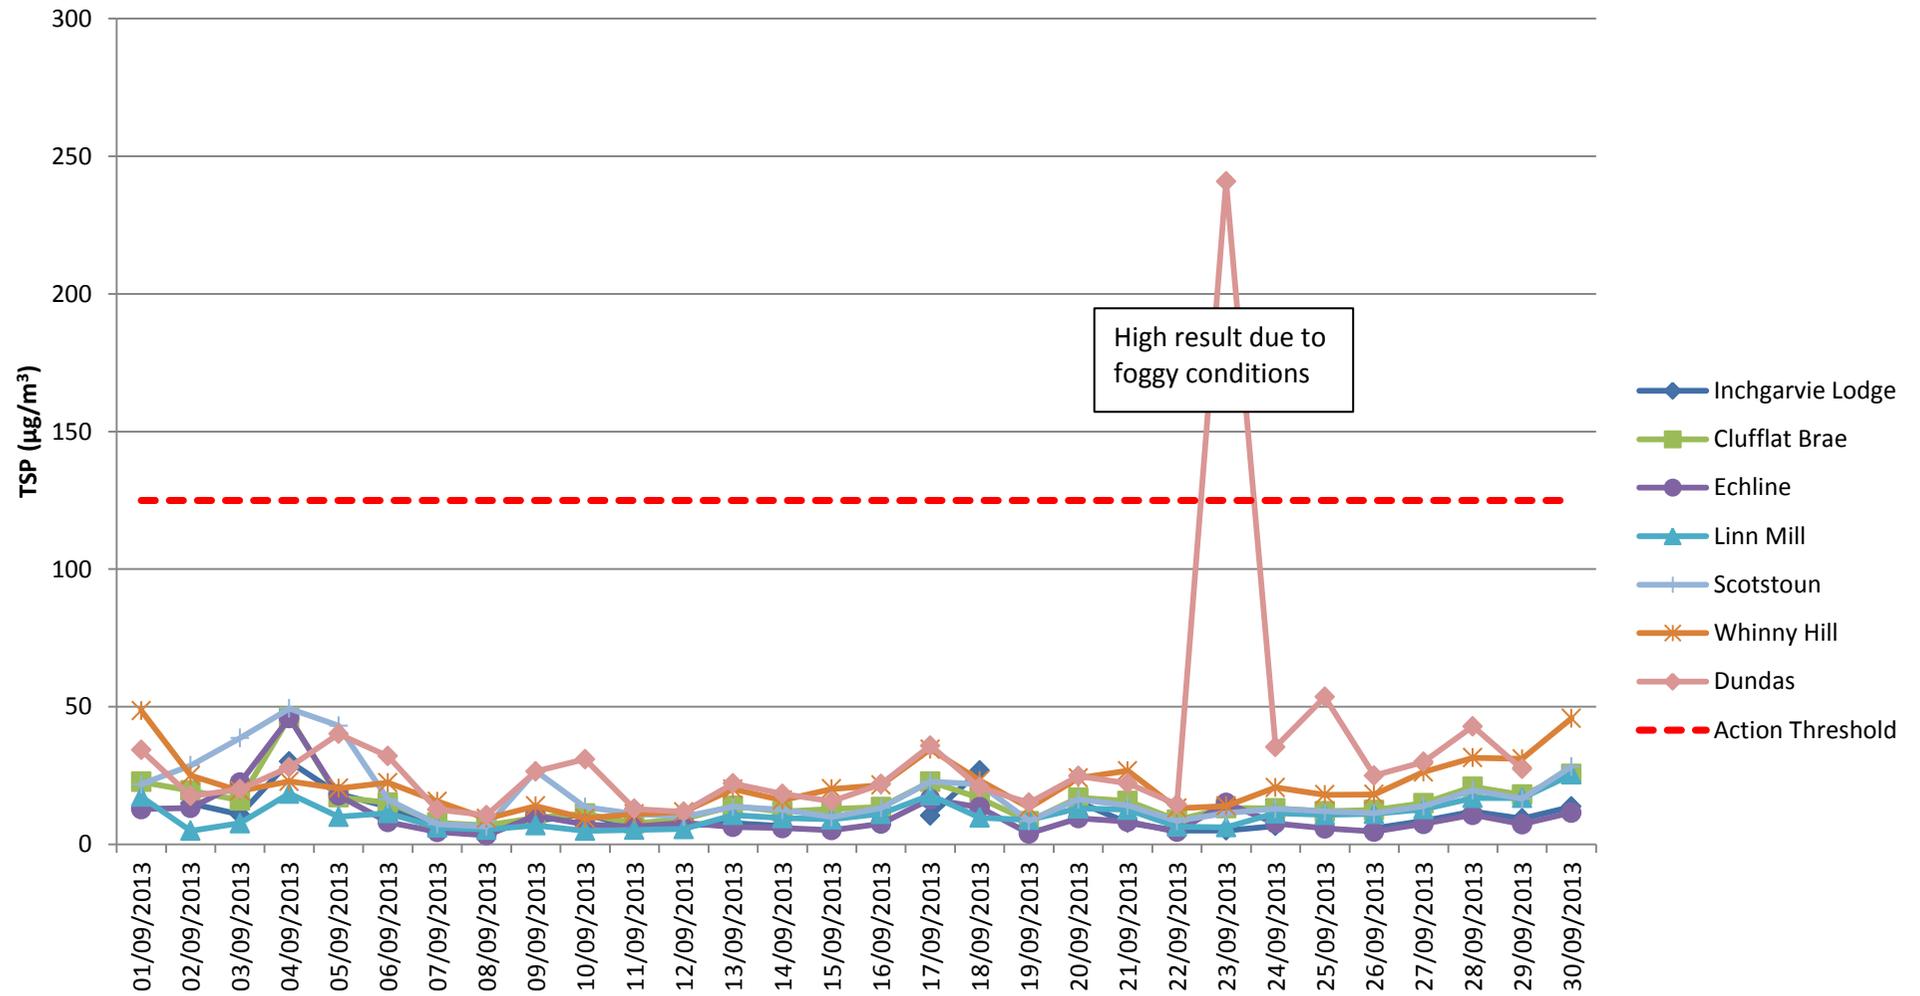
Total Suspended Particles (TSP) Results September 2013

3.2.1. The TSP results for September 2013 have been presented in a monthly chart; this can be found in Appendix B. The TSP levels at monitoring locations during September were generally low and all within the threshold level, with the exception of 23 September at Dundas. This exceedance was related to an error with the device that is likely to relate to the weather conditions on this date (Table 3), as discussed in relation to the high PM₁₀ levels noted above (see 3.1). No exceedances were, therefore, found to occur as a result of construction activities. All locations were mostly found to follow a similar pattern across the site,

Date	Monitoring Location	Notable conditions
23/09/13	Dundas	Damp conditions

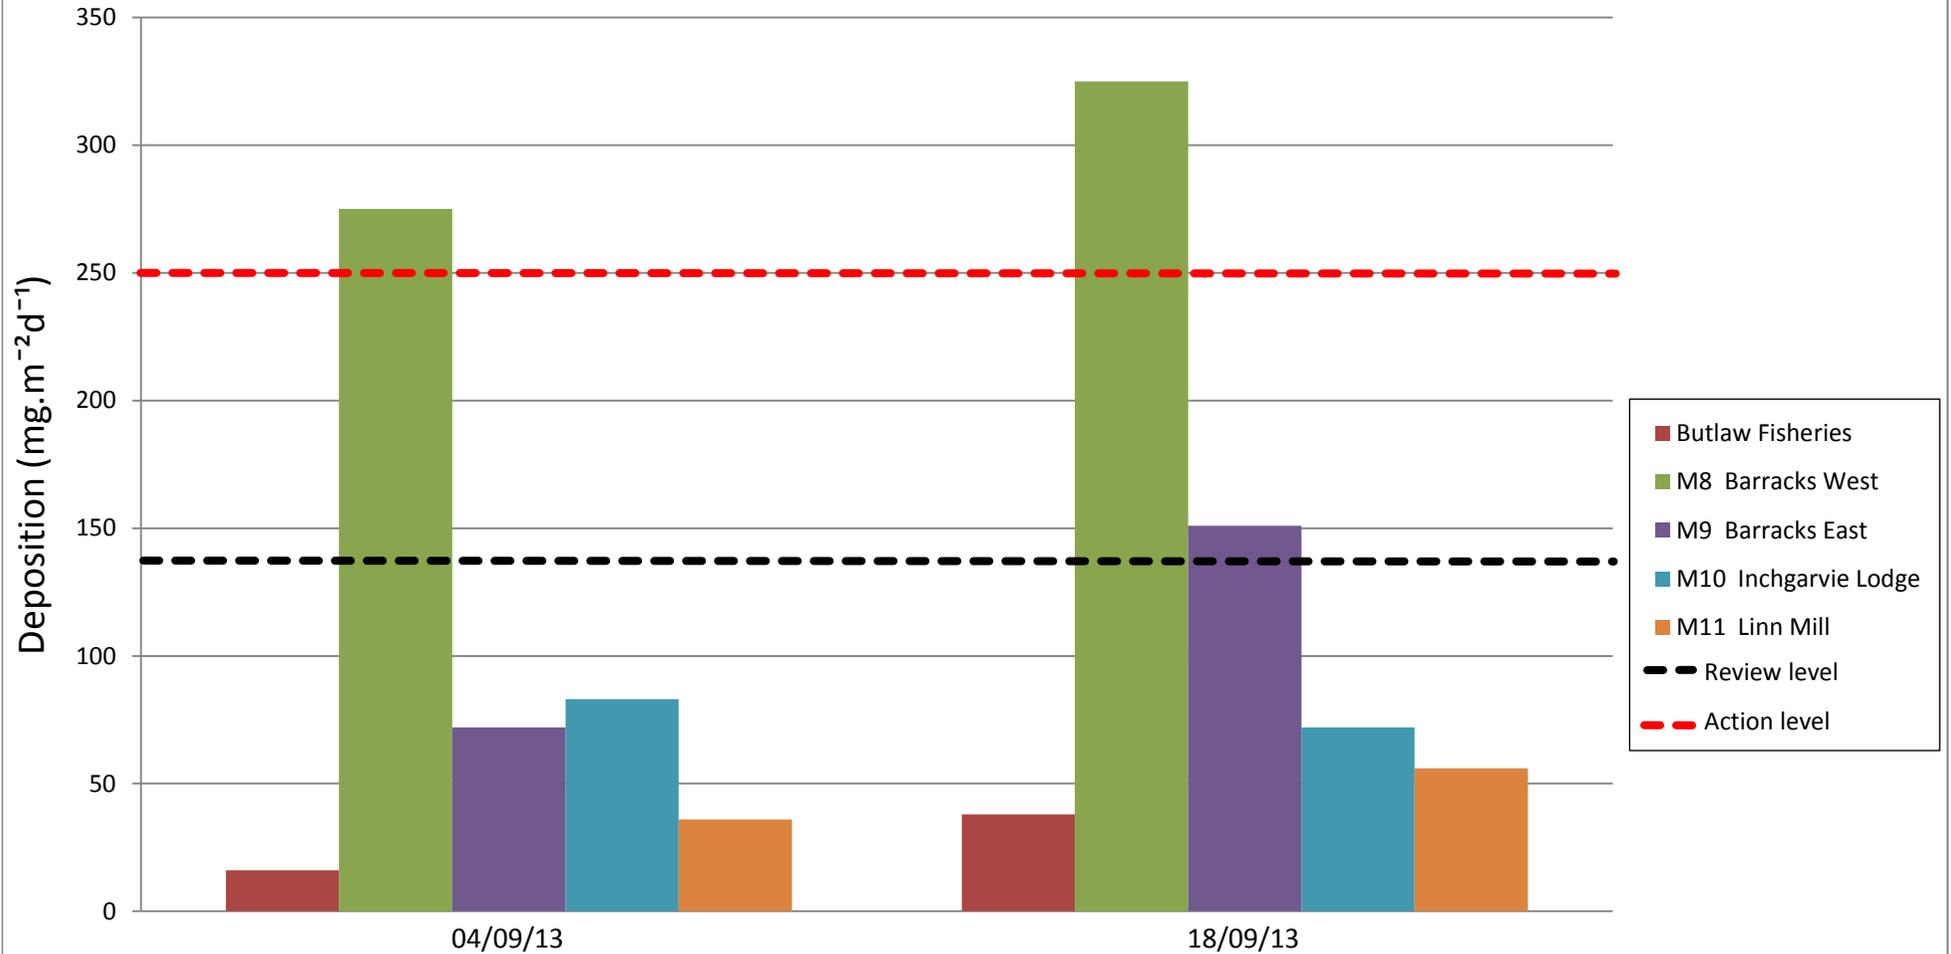
Frisbee Dust Deposition Results: Group 1
Locations: M7 Butlaw Fisheries, M8 Barracks West, M9 Barracks East, M10 Inchgarvie Lodge and M11 Linn Mill

Fortnight ending	Threshold Exceeded	Monitoring Location	Notable conditions at time of collection
04/09/13	Review	Scotstoun	Particles of vegetation in sample as located underneath trees
	Action	Barracks West	No notable conditions
18/09/13	Review	Barracks East	Located in vehicle turning area
		Springfield	Located underneath vegetation that is beginning to fall
		Scotstoun	Located underneath vegetation that is beginning to fall
	Action	Barracks West	No notable conditions

3.3.6. With regard to the exceedances at Barracks West, no notable conditions were found that could have caused such high dust levels at this location. The Barracks West gauge is located in an area where no viaducts works were undertaken during September. Whilst it is possible that the on-going works at Society Road may have partially influenced the result, it should be noted that the results from nearby monitors, located closer to residential properties, indicated lower levels of dust deposition for this period, with no exceedances of the thresholds. However, due to the high results at this location, the programme of works for the immediate area is being reviewed for any dust generating activities and to ensure that appropriate mitigation is in place where necessary.
