FORTH REPLACEMENT CROSSING

**AIR QUALITY MONITORING REPORT
 SEPTEMBER 2014**

REP -00199-00

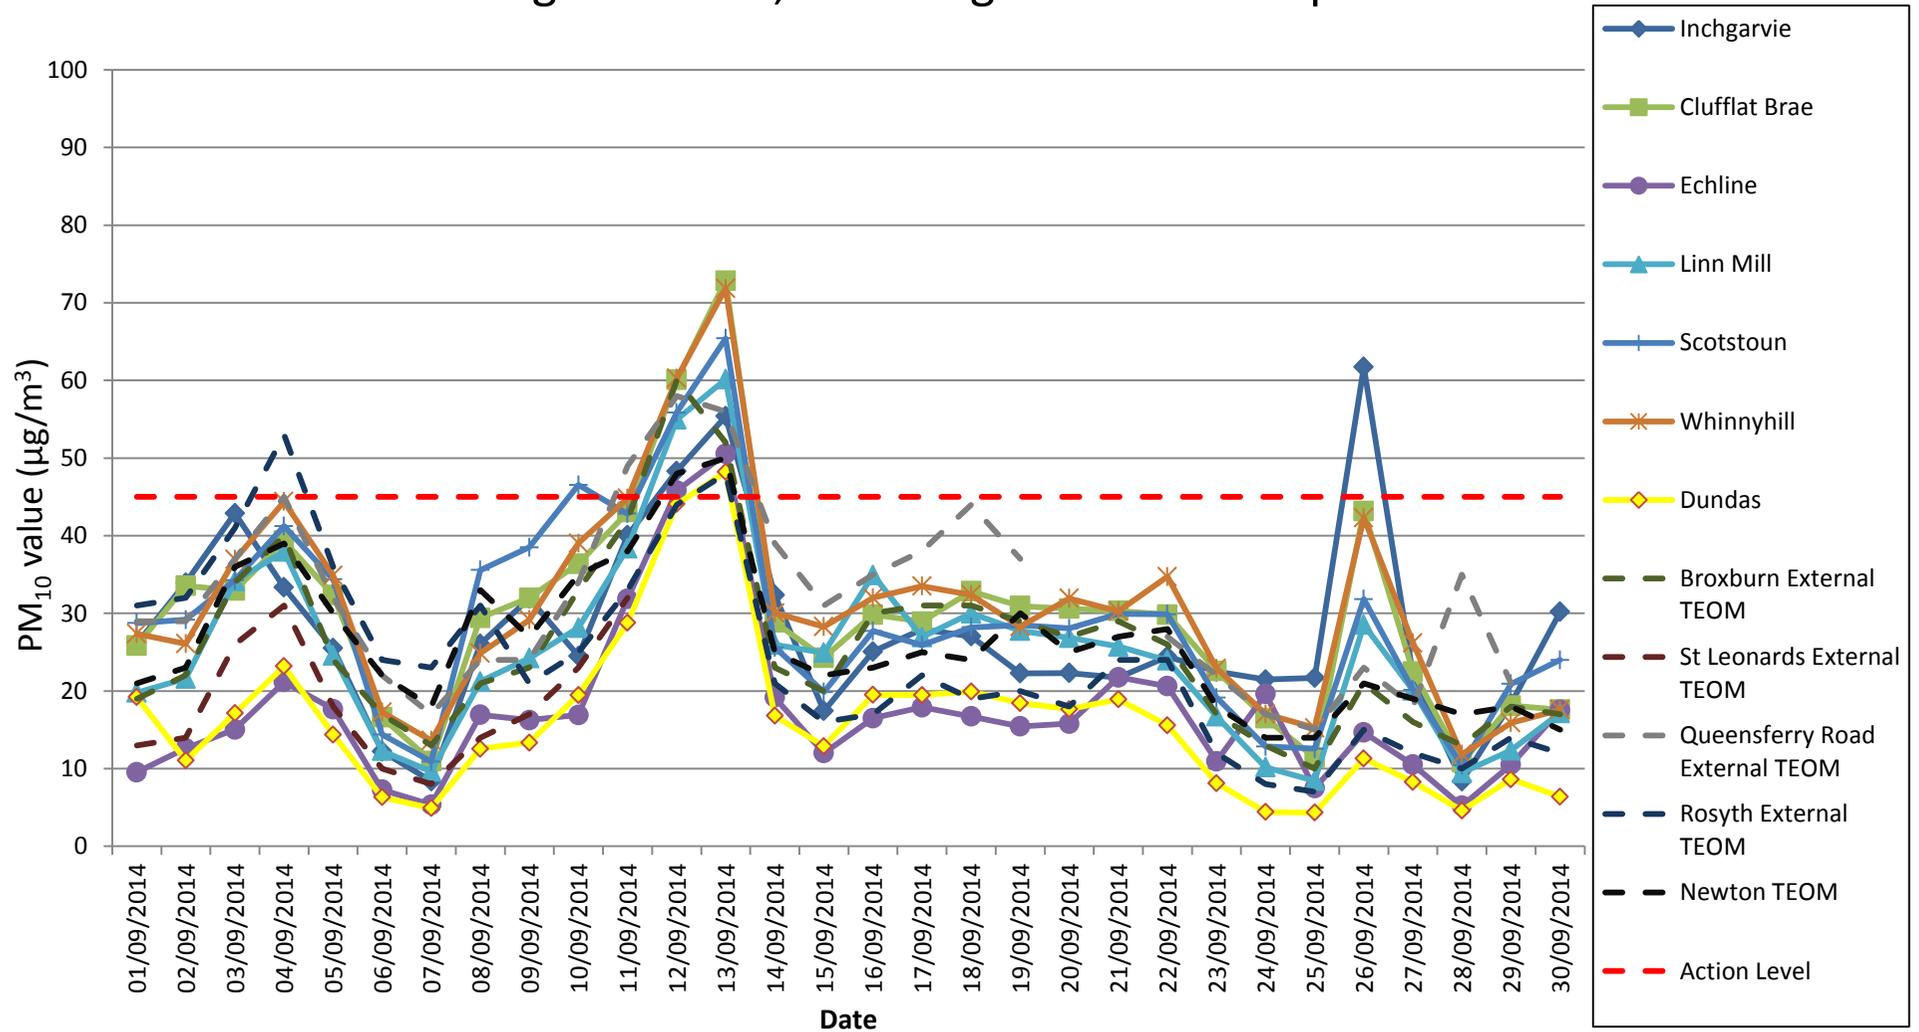
Air Quality Monitoring: Particulate Matter (PM10) Results for all Monitoring Locations, including TEOM data September 2014

3.1.1. Light scatter results for September 2014 have been presented in a monthly chart; this can be found in Appendix A. Results show that the PM₁₀ levels were below threshold levels throughout the month with the exception of two periods. All monitors registered values over the threshold on the 12th and/or 13th September and Inchgarvie registered levels above the threshold on the 26th September. All the monitors follow the same general pattern throughout the month.

3.1.2. It was noted that foggy conditions occurred on 4th-5th, 10th-13th and 26th September. All monitors saw increases in PM₁₀ levels during these dates. For

the exceedances of the action level, a review of the works in each of the areas, weather conditions, and the mitigation measures in place was undertaken. The fact that all seven monitors showed the same pattern would suggest that a regional event affected the levels across the whole area rather than the increases being related to works activities in one specific area affecting only a few monitors. In this case it is concluded that fog caused all the exceedances (see section 2.2) as the dates coincide and all monitors show increases at these times.

- 3.1.3.** The PM₁₀ results have also been compared to the daily mean results obtained from the TEOM air quality monitoring stations located in Newton, Rosyth, and Broxburn, and from the TEOM FDMS stations located at Queensferry Road, Edinburgh and St Leonards, Edinburgh (an urban background site). The TEOM at Newton was installed by West Lothian Council, facilitated by FCBC, during May 2012. The comparison between the light scatter and TEOM results demonstrates that both sets of results generally follow the same pattern at similar levels, indicating that the pattern observed throughout September was largely driven by regional changes in air quality.

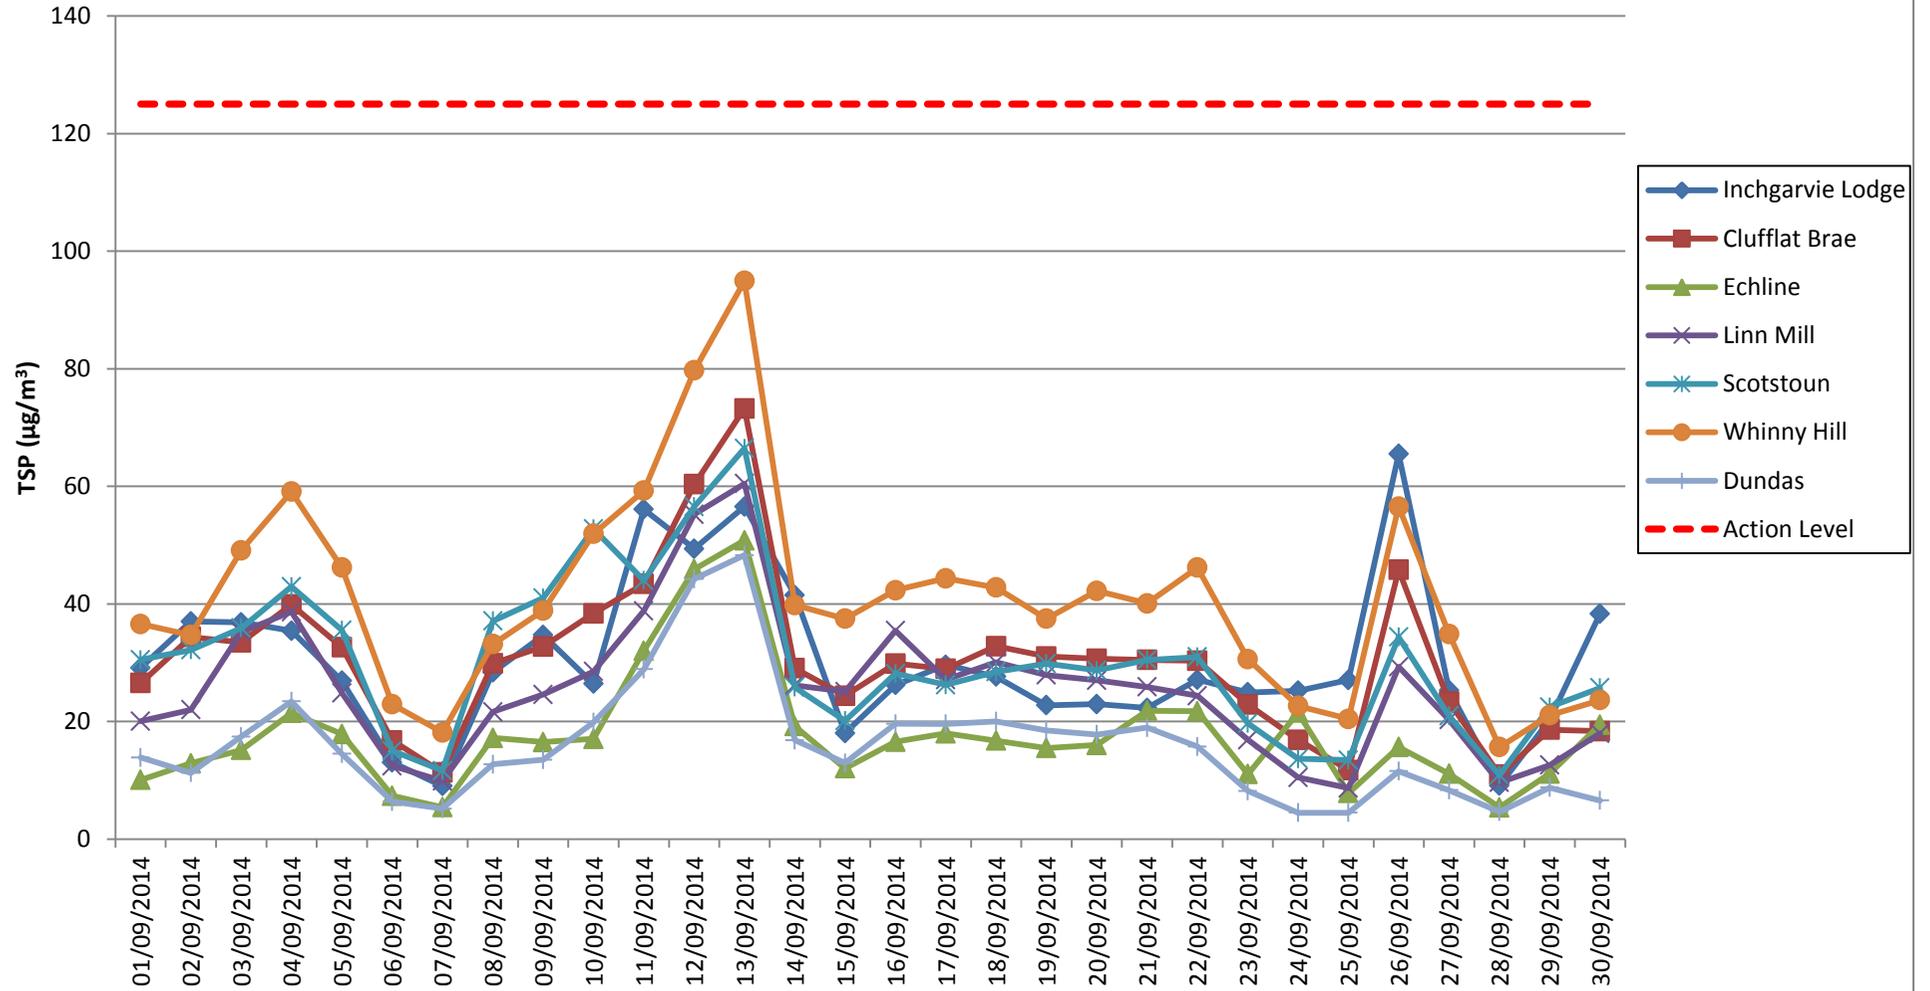
Total Suspended Particles (TSP) Results September 2014

- 3.2.1.** The TSP results for September 2014 have been presented in a monthly chart; this can be found in Appendix B. The TSP levels at monitoring locations during September were found to be low and all within the threshold level. All locations across the site were mostly found to follow a similar pattern, demonstrating that, in general, the levels were influenced by regional changes in TSP levels, rather than construction works.

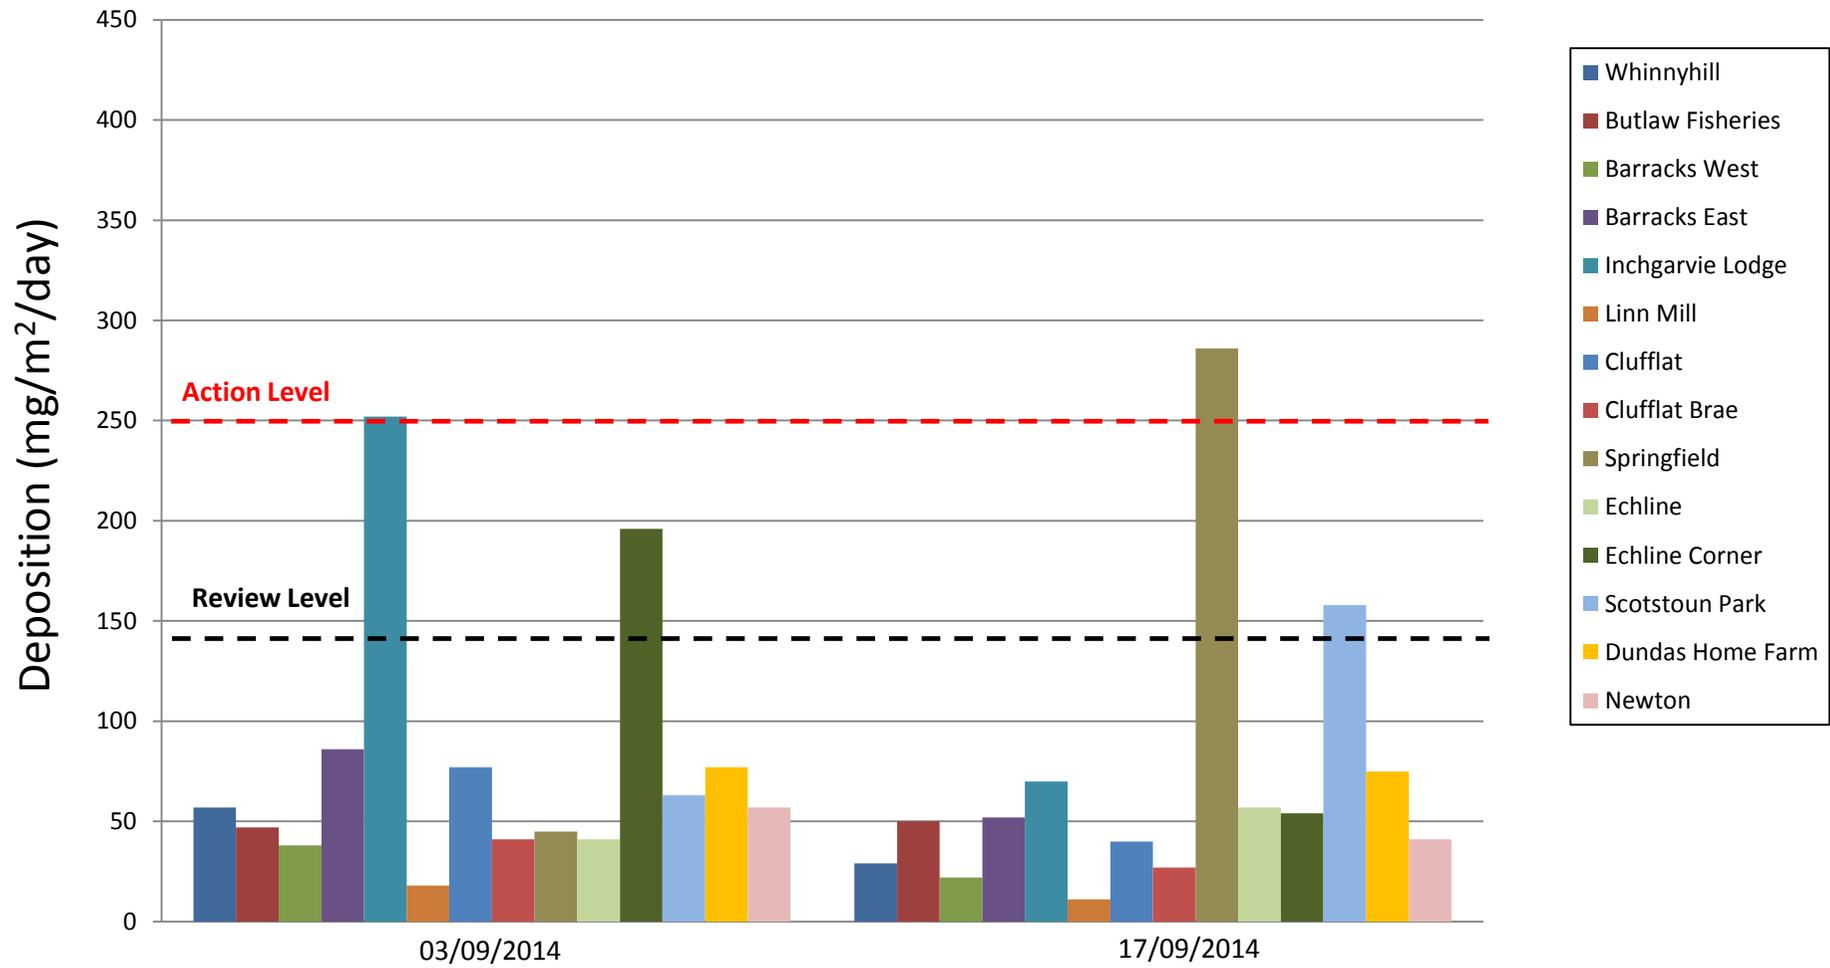
Frisbee Dust Deposition Results: September 2014

- 3.3.2.** The site action level for the dust deposition rate has been set at 250 mg/m²/day. Exceedances of this level are treated as a potential incident and a review of the works in the vicinity of the site is instigated. A lower site review level has been set at 140 mg/m²/day. Where concentrations exceed the lower review threshold the site works are reviewed to ensure good practice is implemented; it is essentially a warning that additional controls may be required.
- 3.3.3.** During September there were two exceedances of the site review level and two exceedance of action level (see Table 2).

- 3.3.5.** With regards to the exceedance of the action level at Inchgarvie Lodge for the fortnight concluding 3rd September, a review into works undertaken in the vicinity was carried out. Brickwork cladding was taking place on the newly installed wall to the rear of Inchgarvie Lodge, in immediate proximity to the gauge (within 10m). It should be noted that site works do not usually occur at this location and the wall construction is a short-term activity. This means that during this period the gauge was essentially within the construction site. A review of the works in the area, weather conditions, and the mitigation measures in place was undertaken. Considering all the factors, the proximity of the work is believed to be responsible for the exceedance. Three other gauges (Clufflat, Clufflat Brae & Barracks East) are located within 150m of the Inchgarvie Lodge gauge, all of which registered low readings during the same period. It is concluded that while brickwork cladding activities caused the exceedance at the Inchgarvie Frisbee gauge, mitigation was in place which limited the increase in dust to the immediate area and prevented it from migrating off site. Work on the wall concluded during the next period and a return to low dust deposition levels was observed.

- 3.3.6.** During the period ending 3rd September the Echline Corner Frisbee registered levels above the review level. This is an additional temporary Frisbee that was put in place after a dust incident during April. It has been positioned within the construction site and provides information regarding dust levels generated on-site. A review of the works was undertaken and it was found that although

construction activities that could give rise to dust took place in the area during this period, mitigation was in place to prevent dust migrating off-site. The Echline gauge, which is located within 200m from the Echline Corner Frisbee gauge, registered very low levels during the same period suggesting that the levels of dust at source on site were above review level but mitigation has prevented dust migrating off-site.

3.3.7. With regards to the exceedance of the action level at Springfield for the fortnight concluding 17th September, a review into works undertaken in the vicinity was carried out. However, during the period in question no construction activities that would be likely to give rise to dust took place in close proximity to the area. The excavations being undertaken to the north of the A904 are located 500m to the south-west. Four other Frisbee gauges are situated within 500m of the Springfield Frisbee (Clufflat, Clufflat Brae, Echline and Inchgarvie Lodge), all of which showed very low levels during this period. These factors would indicate that the exceedance at this location was not related to FCBC works. Similar construction activities were ongoing throughout the entire month and low levels of dust deposition were measured for the previous period at all monitors within proximity of the work with the exception of Inchgarvie (see section 3.3.6) , further suggesting that the exceedance was not related to FCBC construction factors. However, considering the elevated levels in consecutive months FCBC will continue to conduct increased inspections in the vicinity.

3.3.8. With regard to the exceedance of the review level at Scotstoun for the fortnight concluding 17th September, a further review into works undertaken in the vicinity took place. However, during the period in question no construction activities that would be likely to give rise to dust took place in proximity to the meter. The Scotstoun light scatter meter registered levels well below the action level for both TSP and PM₁₀ during this period, with one exception (see section 3.1.2). Activities in the area were monitored more closely during September due to elevated levels during August. No construction related incidents were noted in the area during September. These factors would indicate that the exceedance at this location was not related to FCBC works. However,

considering the elevated levels FCBC will continue to conduct increased inspections in the vicinity to ensure adequate dust suppression measures are in place if required.
