2. Existing Conditions

- 2.1.1 This section of the report provides a description of the existing A77 within the limits of the A77 Maybole Bypass Study Area and the land to the north of Maybole encompassed by each of the three bypass corridors.
- 2.1.2 The A77 Route Action Plan² (RAP) contained a detailed assessment of the geometric standards along the A77, including the length of the trunk road within the study area of this assessment.

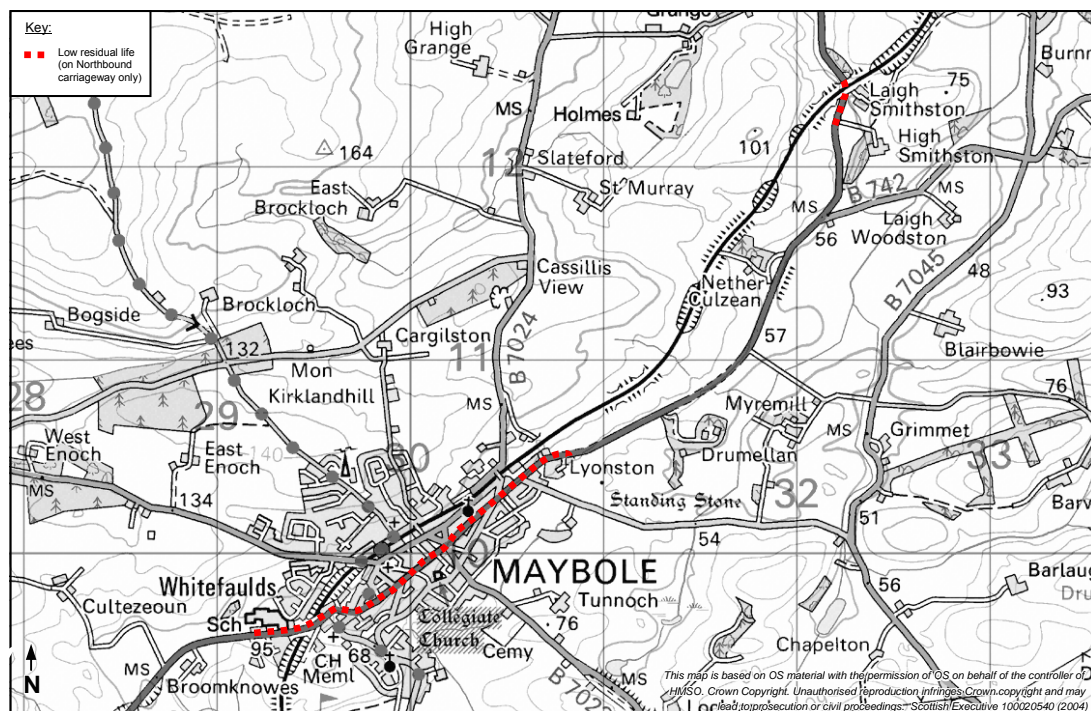
Figure 2.1 – Pavement Condition – Areas of Low Residual Life

2.3.30 The Deflectograph data shows that a significant proportion of the pavement is exhibiting high deflections, i.e. 33% of the route shows deflections >300 microns. The deflections are variable and high in both left and right wheel paths of the northbound lane. Areas of high deflection and areas approaching critical condition, i.e. <5 years residual life are shown in Table 2.3. Areas of low residual life are also indicated in Figure 2.1.

Direction	Locations
High Deflections	NB	<ul style="list-style-type: none"> Wellhome to Dalchomie Broomknowes to Lyonstone Farm High Smithston Bridge to High Smithston access
Low Residual Life	NB	<ul style="list-style-type: none"> Carrick Academy to Lyonstone Farm High Smithston Bridge to High Smithston access

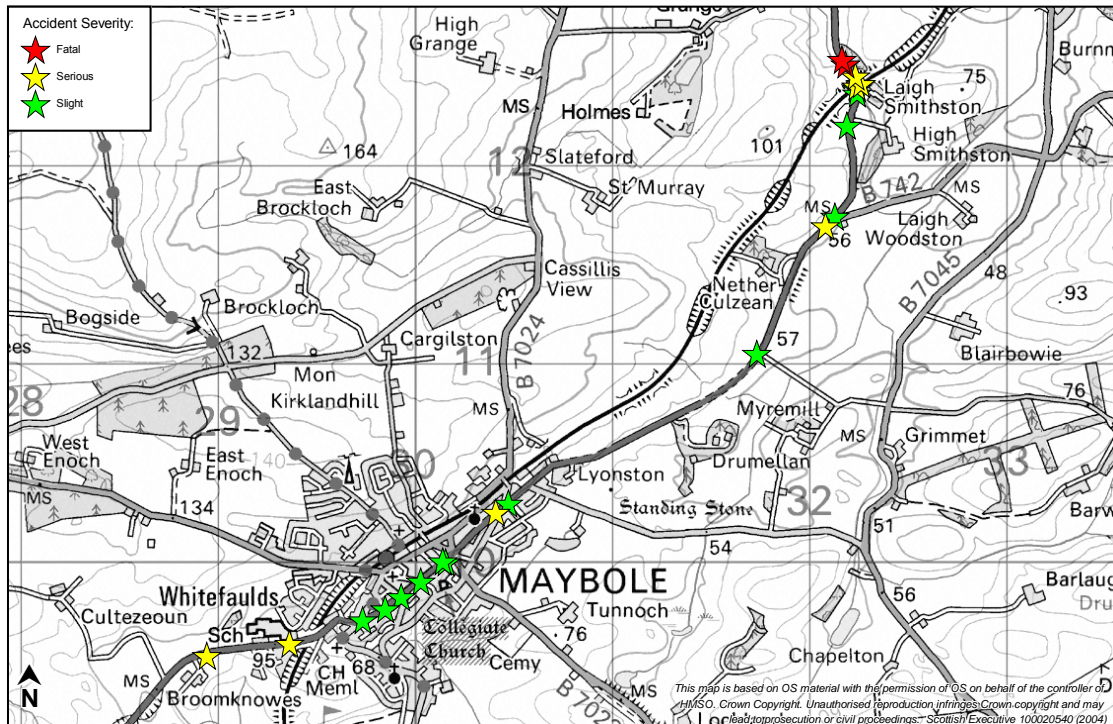
Figure 2.2 – Accident Location and Severity (Jan 1999 – Dec 2003)

- 2.3.32 Accident data was obtained for the section of the A77 being studied for the five year period between January 1999 and December 2003 from the Scottish Executive (now Transport Scotland). The location and severity of accidents in the vicinity of Maybole is shown in Figure 2.2. For details of accident rates and comparable national averages, refer to Section 6 of this report.

- 2.3.33 The accident rate through the town centre is lower than the comparable national average, however it is understood that there is a high 'perceived accident' risk arising from the volume of traffic passing through the historic and narrow streets. This accident risk does not appear to be fully realised (in terms of recorded accidents).

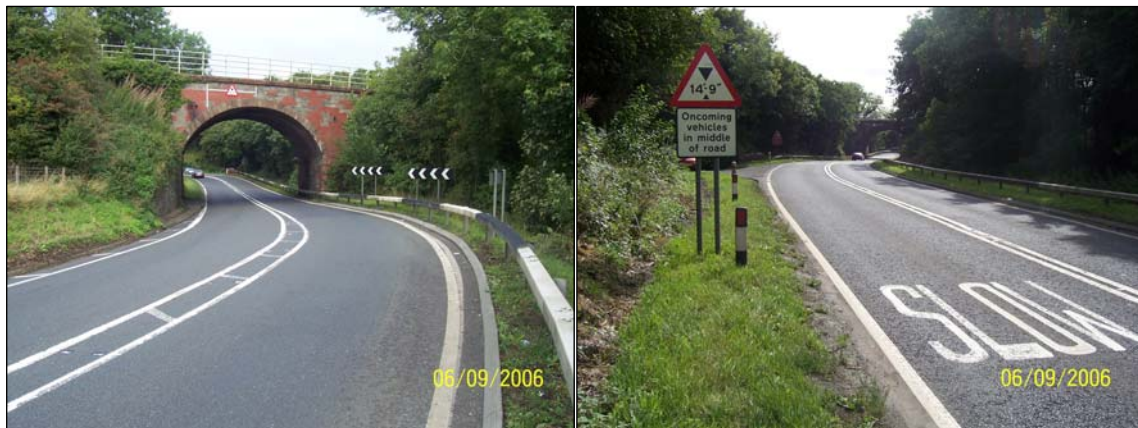
Figure 2.3 – Existing A77 at Smithston Bridge (northbound and southbound)

- 2.3.34 There is an accident cluster at Smithston Bridge which is located in the north-east of the Figure 2.2 where the railway passes over the A77 road. At this location the accident rate is considerably higher than the comparable national average. The arch shown in Figure 2.3 is the most western of the three arch structure at Smithston Railway Bridge.

- 2.3.35 The existing geometry on approach to, and through, the Smithston Bridge appears to be sub-standard: consisting of a right hand bend with radius of approximately 200 metres, then a left hand bend through Smithston Bridge with radius down to approximately 120 metres. There is also a 150 metre right hand radius approximately 200 metres north of Smithston Bridge.

- 2.3.36 The sub-standard geometry is coincident with limited forward visibility and a narrow cross section through the railway arch. This has led to a number of accidents at this location in recent times.
