# Inclusive Kerbs Study

Phase 3

November 2023

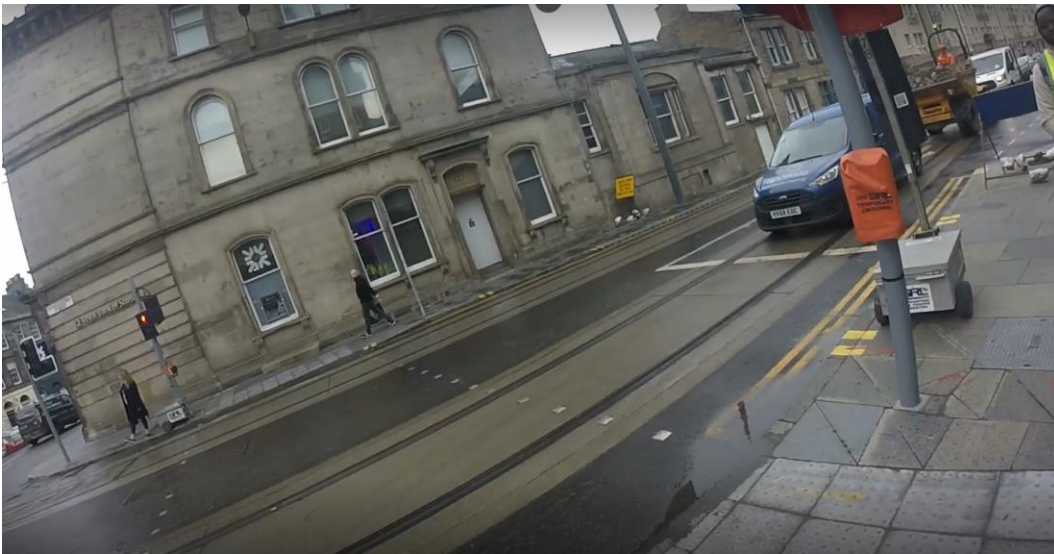
**Figure 4-1: Controlled crossing with tactile paving at Constitution Street**

They were also able to identify the newly installed tram track while crossing the carriageway. The participant was able to detect the crossing point and the Pedestrian Demand Unit (PDU) from the footway with the use of the tactile paving, as shown in Figure 4-1.

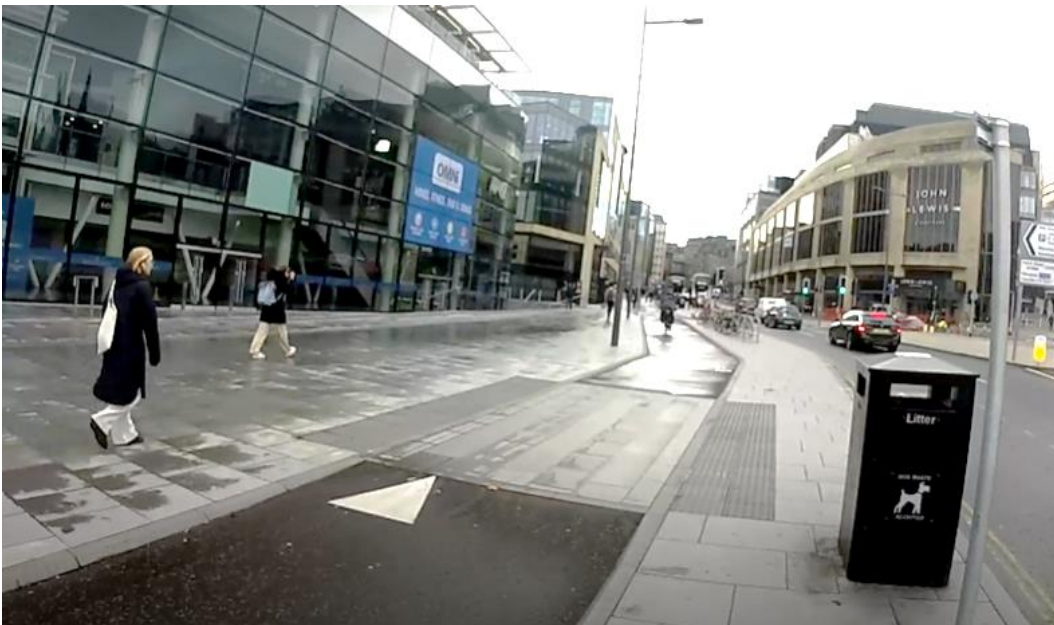
**Figure 4-2: Cycleway crossing at Picardy Place**

The participant reported relying on people to guide or help on occasions when crossing cycleways. During the site visit at Picardy Place, they noted that it was impossible to tell when they were approaching the cycleway from the footway, see Figure 4-2. They reported that the tactile paving was not providing any detectable difference to the participant using the cane at that location.

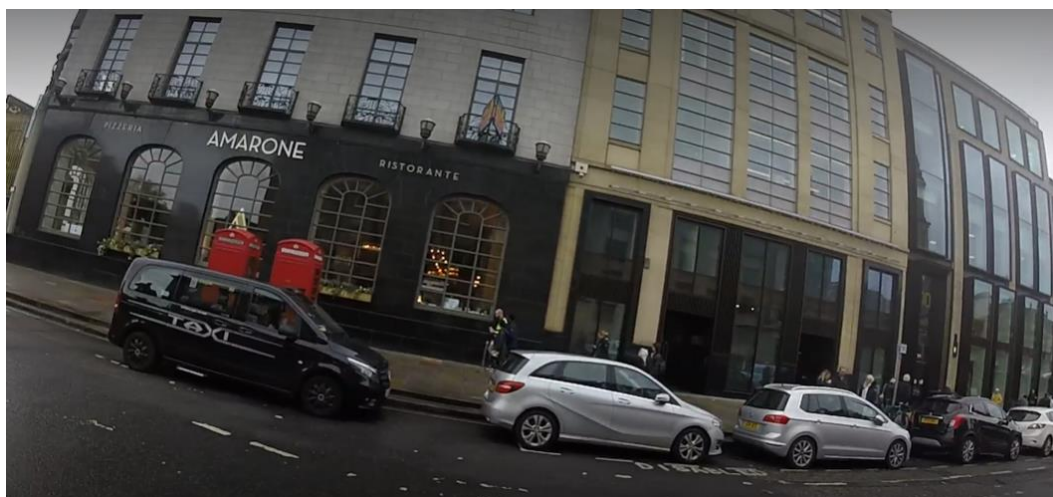
**Figure 4-3: Kerbs of varying height at disabled on-street parking**

The participant made observations regarding kerb height during the site visit to George Street. It was evident that the conspicuous double kerbs of varying height were present at the disabled on-street parking markings as shown in Figure 4-3. This area is understood to be constructed pre-2010 and the Designing Streets policy. Other participants observed that these older disabled parking areas were too narrow for safe use as a wheelchair was forced to approach from the roadside where little separation from traffic was available. This was considered hazardous for disabled users. However, it was noted the kerbs present at the bus stop at this site were good for pedestrians and wheelchairs.

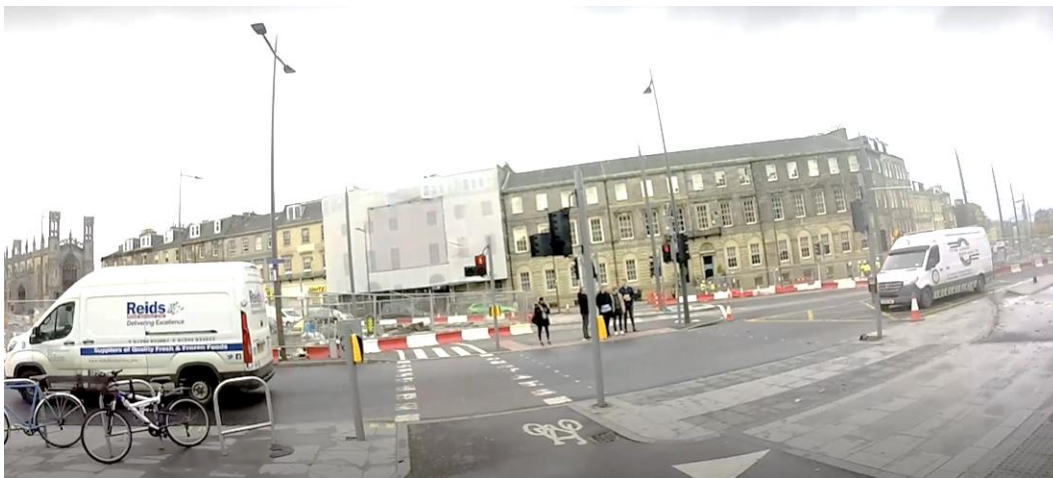
**Figure 4-4: Road and cycleway markings noted as unclear**

Another issue raised by this participant was the inconsistencies in road markings during the site visit at Picardy Place. It was demonstrated that the cycleway crossed the carriageway with some inconsistencies in the road markings. For instance, the painted cycle picture is only in one part of the cycleway junction, as shown in Figure 4-4. They noted these inconsistencies were present where the cycleways are connecting with the carriageway and that the intended directionality was unclear, presenting a substantial hazard of collision with vehicle traffic and other cyclists. It was also observed that footway obstructions by cycle parking facilities were potentially hazardous on small buffer areas between the carriageway and cycleway, as shown in Figure 4-4.

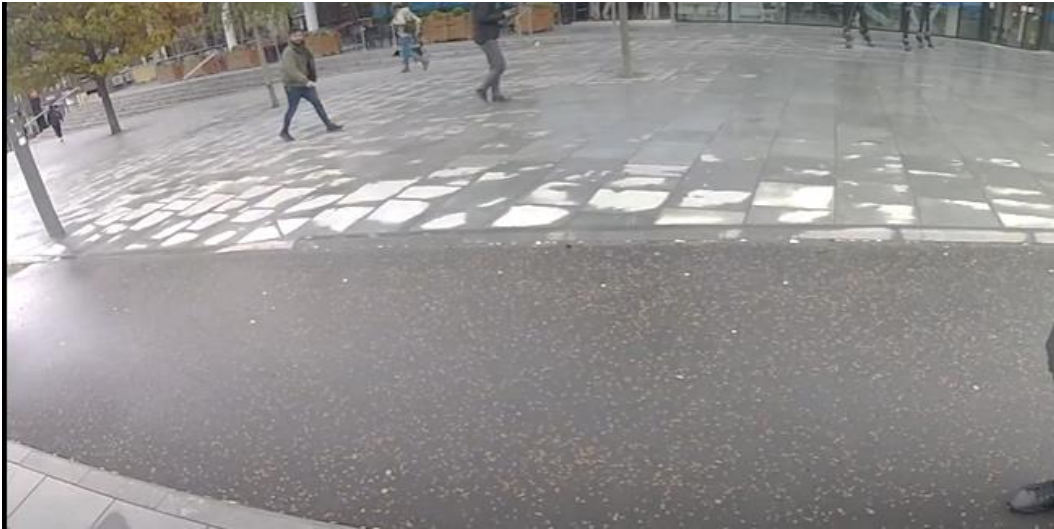
**Figure 4-5: Contrast in colour between footway and cycleway**

Some observations were made regarding the road surface colour during the site visit at Picardy Place. The contrast in colour between the footway, carriageway and tram surfaces was described as good by the participant. In addition, the kerb stones developed increased contrast in colour when wet but the contrast was also reduced where the wet surface darkened. Similarly, the participant noted the contrast in the colour of the footway and the cycleways as shown in Figure 4-5.

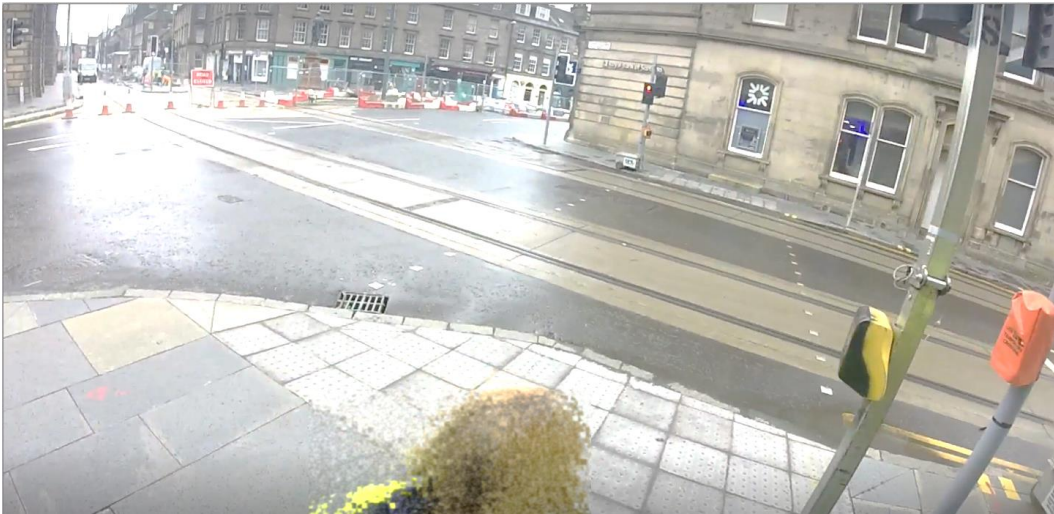
**Figure 4-6: Constitution Street controlled crossing point**

During the site visit at Constitution Street using the temporary controlled crossing at the signalised junction, Participant 5 noted that the kerb height and the sloping towards the carriageway between the road and the footway at the traffic junction, as shown in Figure 4-6: Constitution Street controlled crossing point could cause the wheelchair to tip over if there was a stabiliser on the wheelchair.

From observation and listening to the feedback from the participant a key problem for wheelchair users as it relates to the kerbing arrangements is the drop height more than the shape. Figure 4-6 also clearly shows the difficulty in assessing the kerb height on the other side of the road. These could be measured as this is the determining factor on whether they will be able to traverse them without tipping over.

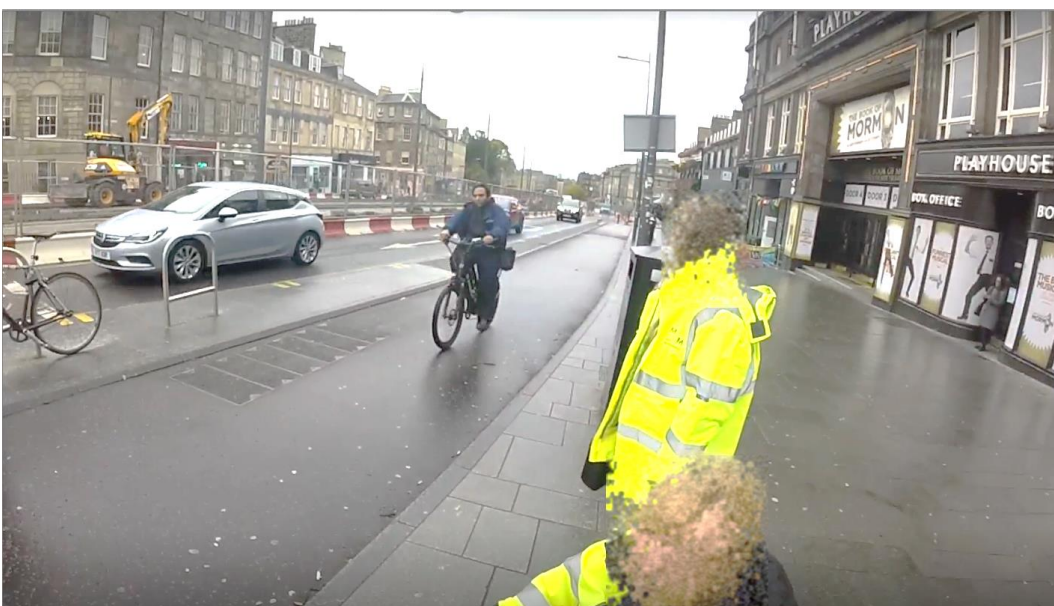
**Figure 4-7: Electric cyclist approaching at speed**

This participant was not comfortable with crossing the cycleway during the site visit at Picardy Place. It was evident that they were unable to hear approaching cyclists and considered them a significant hazard while crossing the cycleway, as shown in Figure 4-7 by a passing electric cyclist.

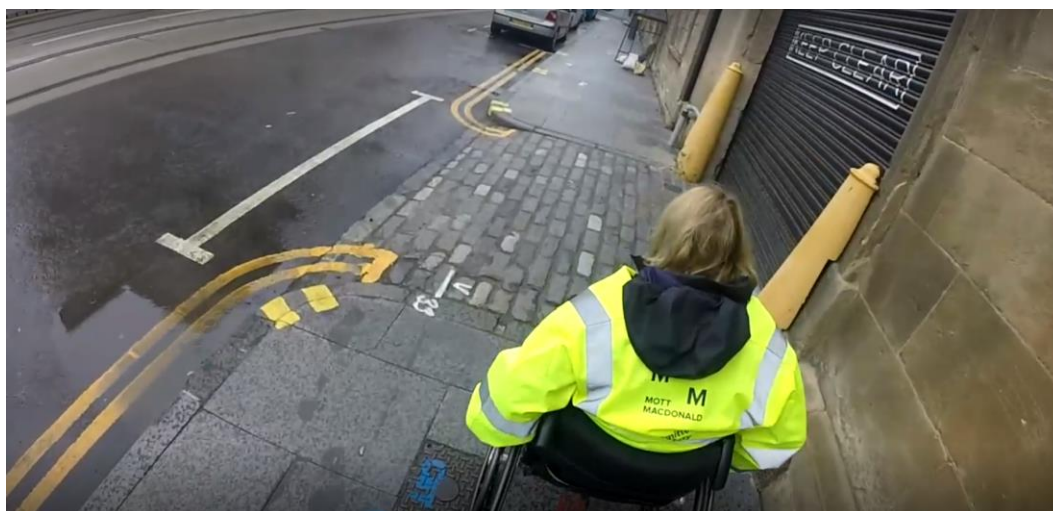
**Figure 4-8: Constitution Street, cobbled entranceway**

Some kerbs on the non-managed area of the Constitution Street site were considered to be hazardous by the participant. For example, a cobbled footway section for a private access caused painful vibration of the wheelchair and was difficult to traverse as shown in Figure 4-8.

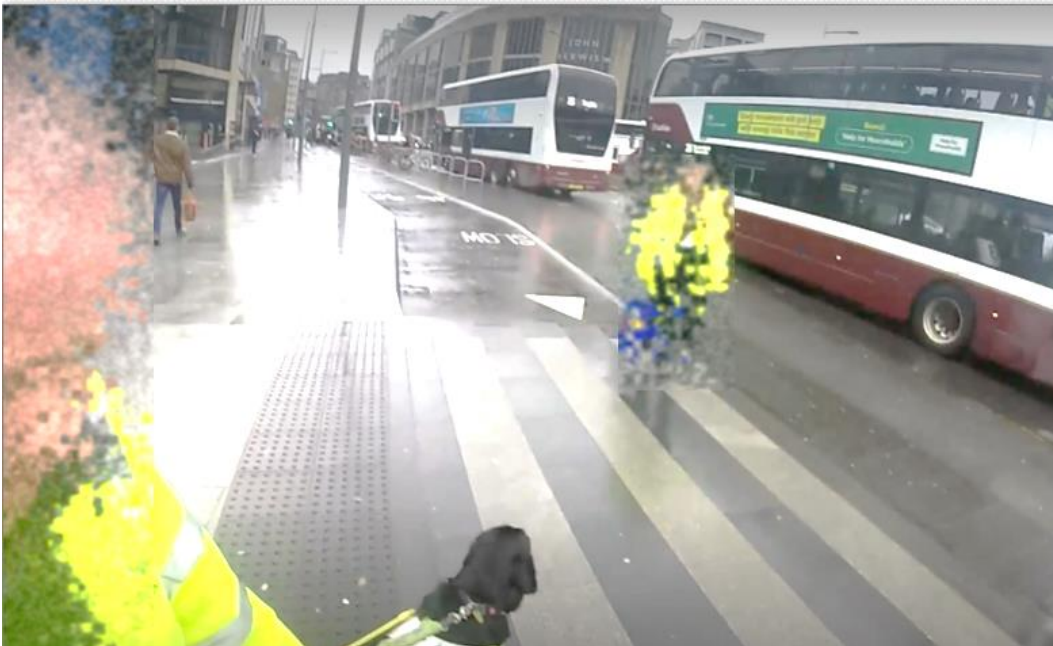
**Figure 4-9: Raised table cycle crossing Picardy Place**

The participant noted that the kerb height separating the road and the cycleway was acceptable, in general, except for the previously described raised table arrangement crossing.

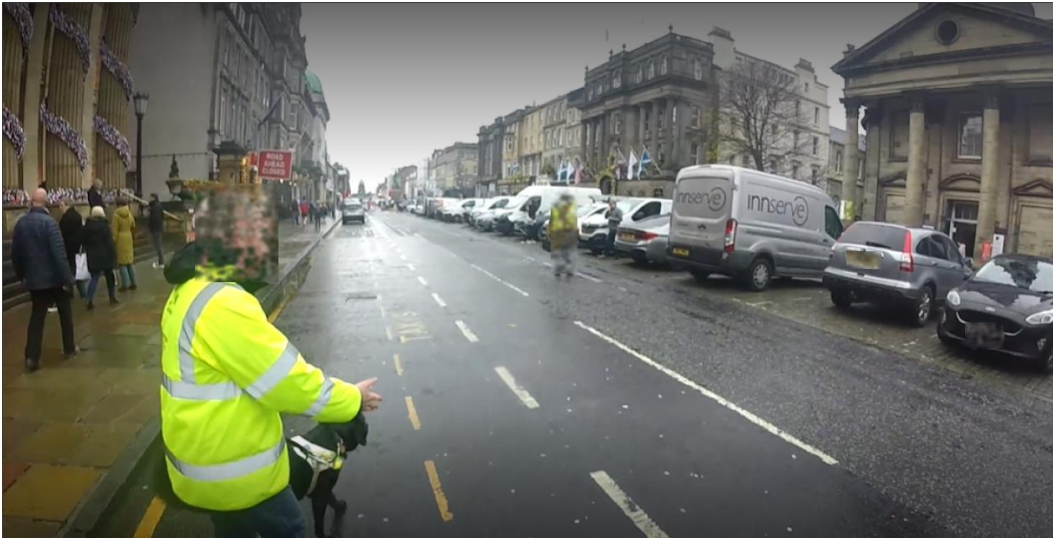
**Figure 4-10: Guide dog crossing diagonally without clear crossing point**

An important issue noted at all the site visit locations was when the guide dog, that was suitably trained, found it difficult to walk straight across the road several times during the visit. As shown in Figure 4-10, the guide dog frequently adopted a diagonal route across the road, potentially due to its perception of hazards. George Street contained a central area used for parking, and this may have been an unfamiliar arrangement to the guide dog. However, this is not unusual in Edinburgh.

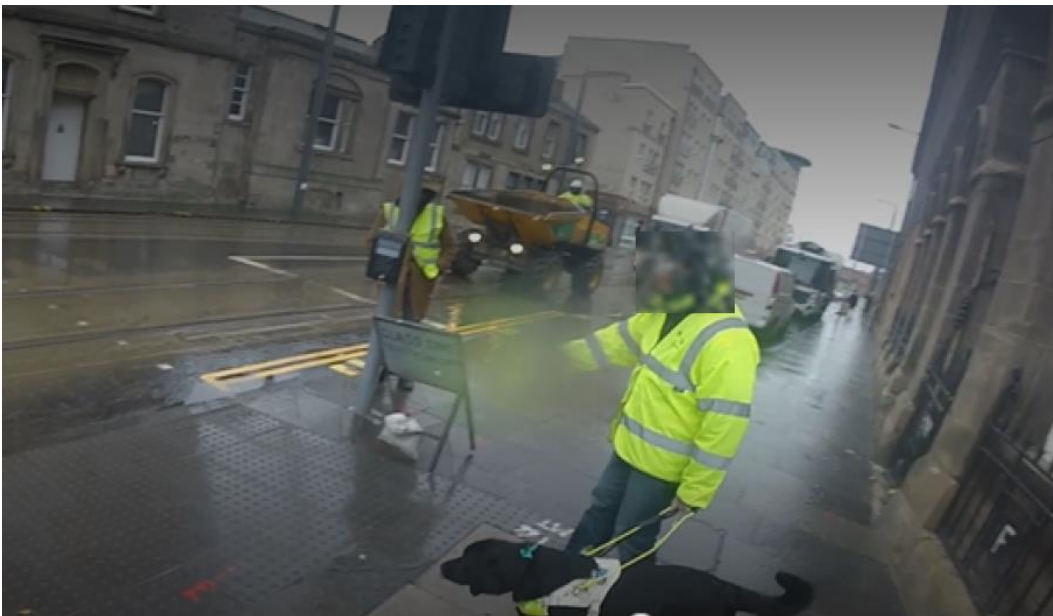
**Figure 4-11: Guide dog guiding participant at push button unit**

Furthermore, in addition to the inability of the guide dog to walk directly across during informal crossings, the guide dog was also evidently confused and unable to guide the participant to the push button unit at the crossing point as shown in Figure 4-11. This was potentially due to the presence of temporary signage but the dog also did not appear to detect the tactile paving.

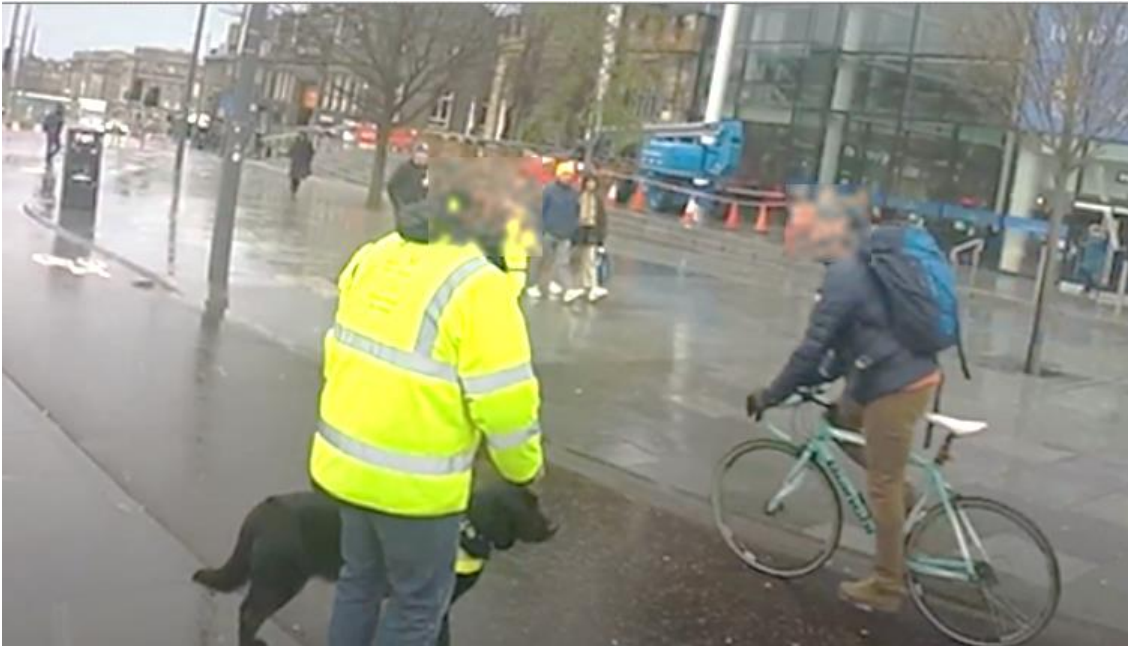
**Figure 4-12: Guide dog interaction with cyclist (Cyclist not stopping)**

The guide dog tended to walk around pedestrians and cyclists. Specifically, the participant noted that his guide dog would usually not stop for the cyclists but would walk around them as shown in Figure 4-12. It should be noted that the cyclists did not stop and often did not slow. The guide dog crossed toward the cyclist and had to take evasive action to avoid a collision as the cyclist passed.

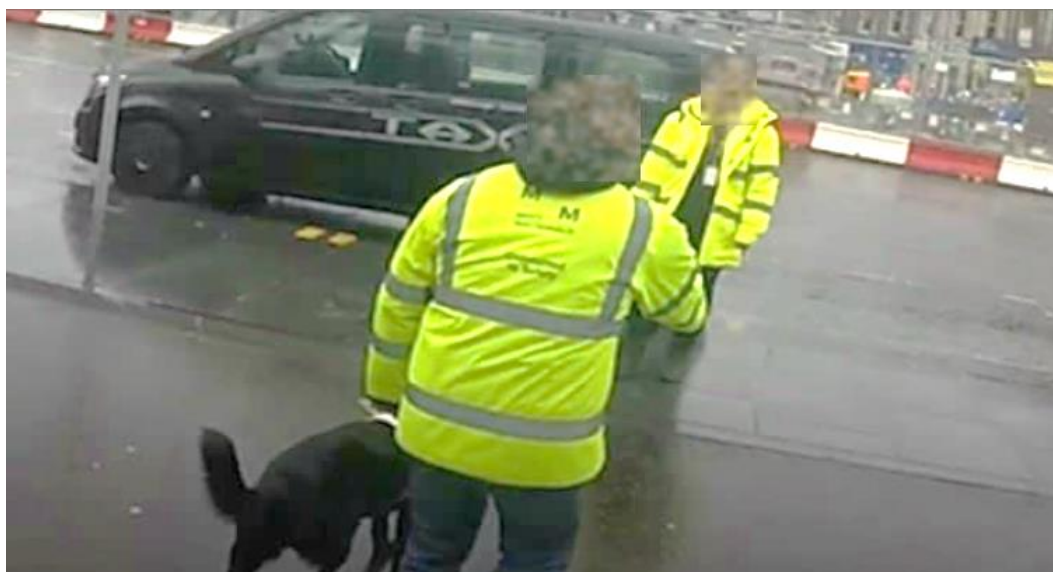
**Figure 4-13: Guide dog mistakenly crossing opposing traffic stream**

Closely related to the interaction of the guide dog, pedestrians and cyclists, the guide dog was further confused walking toward a parked Taxi as shown in Figure 4-13. This may be potentially be due to the parking area not being clearly defined as separated from the carriageway.

It was, however, also possible that the guide dog was confused about the intention of the visually impaired participant. The participant described how he had developed micro signals to the guide dog over time, conveyed with hand and finger movements, but was unclear regarding the nature of these signals. He reported that the dog; that was relatively new to them, was “still learning” these and therefore considered that the results could be variable.

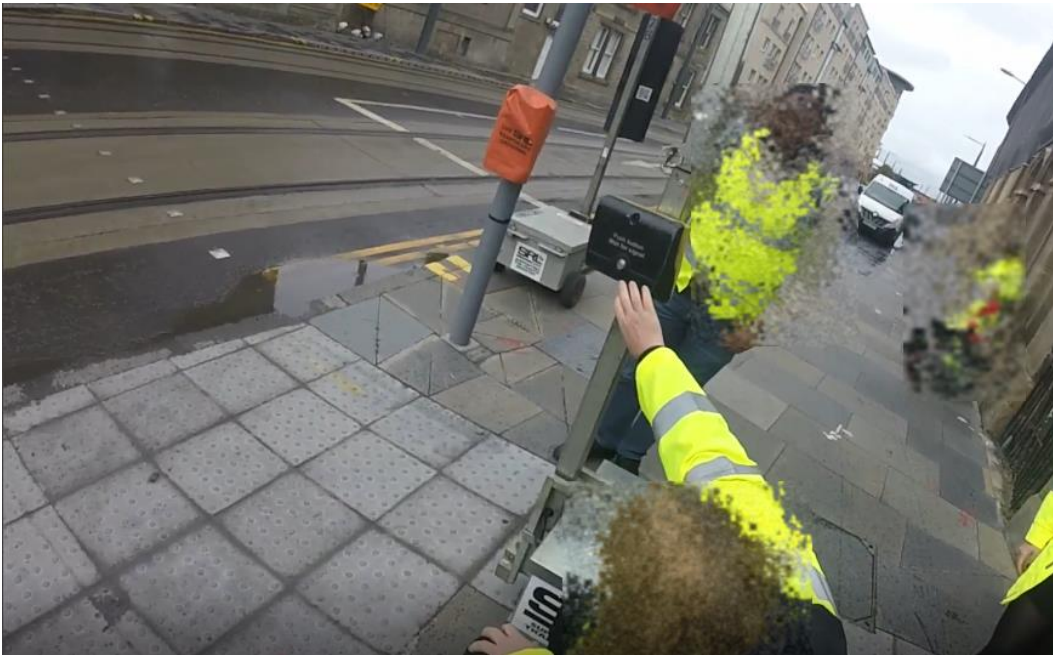
**Figure 4-14: Wheelchair user perceived push button unit to be too high**

newly installed but not yet in use at the time of the interview was at approximately the same height.

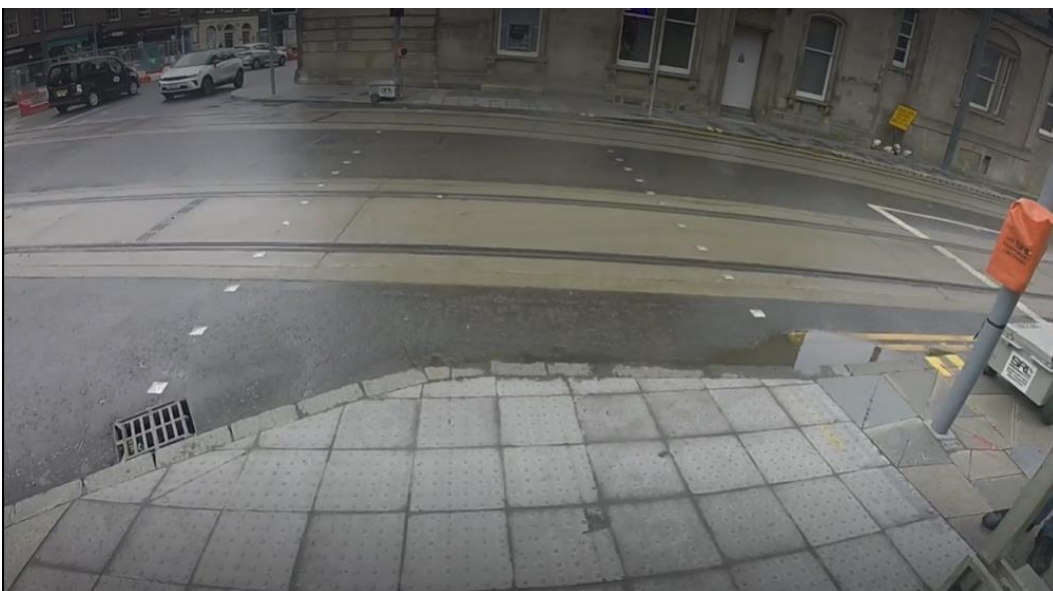
**Figure 4-15: Possibility of wheelchair user rolling down graded tactile paving**

There was also a possibility of the wheelchair rolling forward into the road traffic as there was a gradient leading to the kerb edge shown in Figure 4-15. The proximal kerb was flush with the roadway and the farthest was within capability. It was noted that the tactile paving could not stop the wheelchair from rolling down and that both arms were required for stable braking.

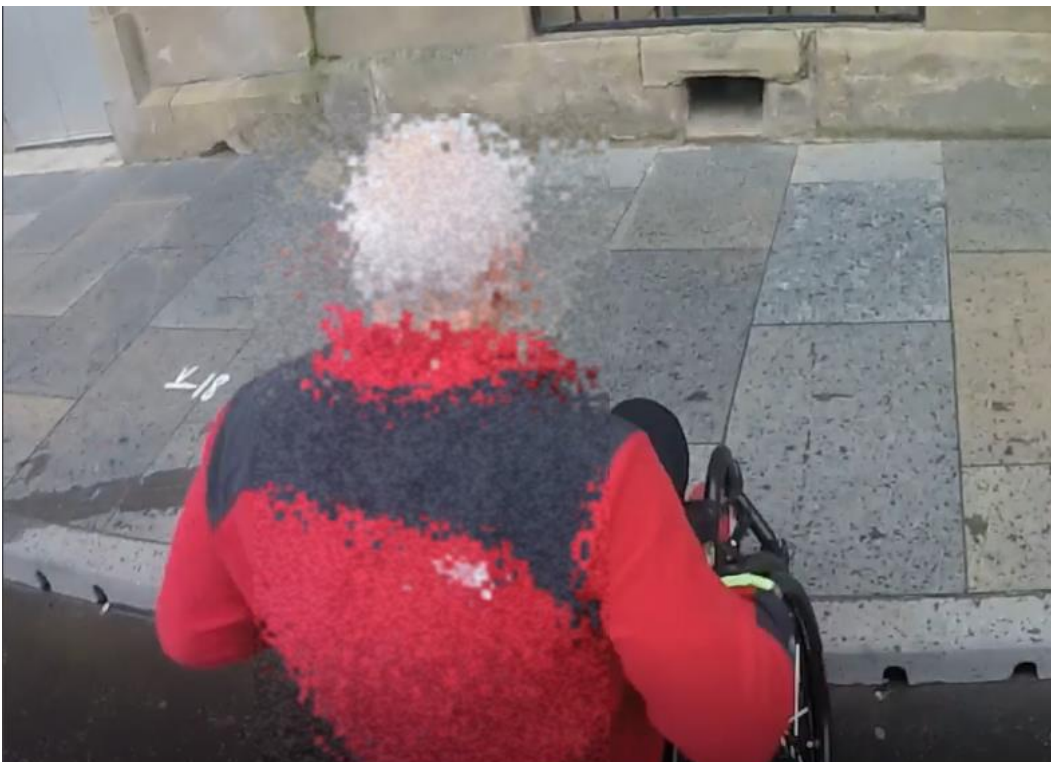
**Figure 4-16: Participant demonstrating how they go up/down kerbs**

As a confident and highly able wheelchair user they reported being happy with this manoeuvre and height of the kerb. However, it was noted that the kerb was likely to be hazardous for many wheelchair users that were perhaps less experienced, less confident, or less physically able in their manoeuvring.

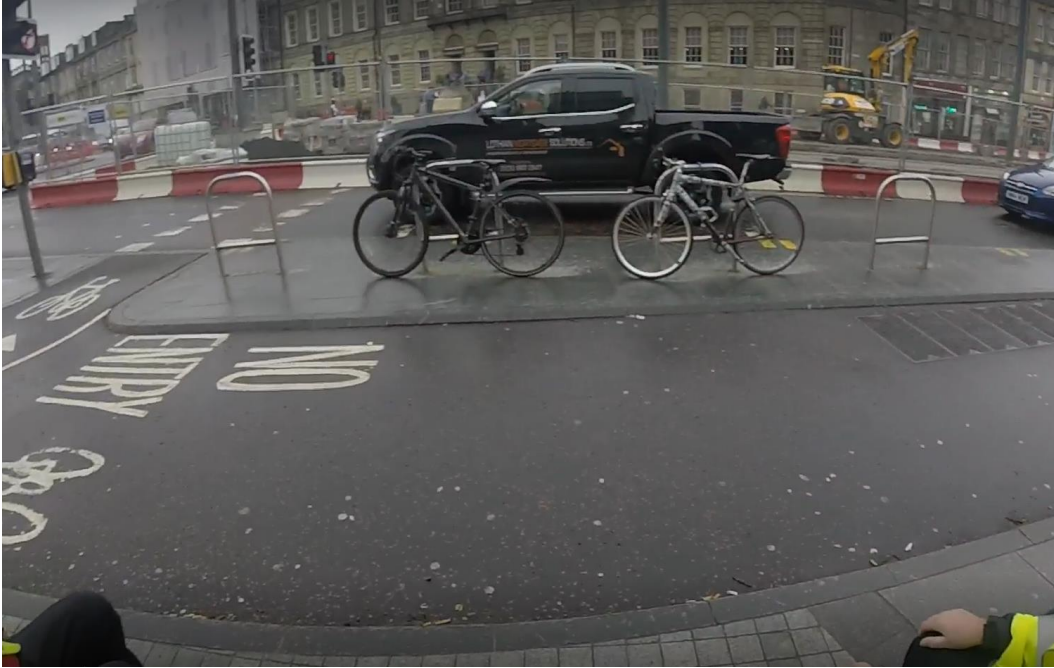
**Figure 4-17: Poor contrast between kerb and cycleway surfacing**

with the wheelchair. It was raised by the participant that the kerb, shown in Figure 4-17, cannot be easily seen due to poor contrast between the kerb and cycleway surfacing.

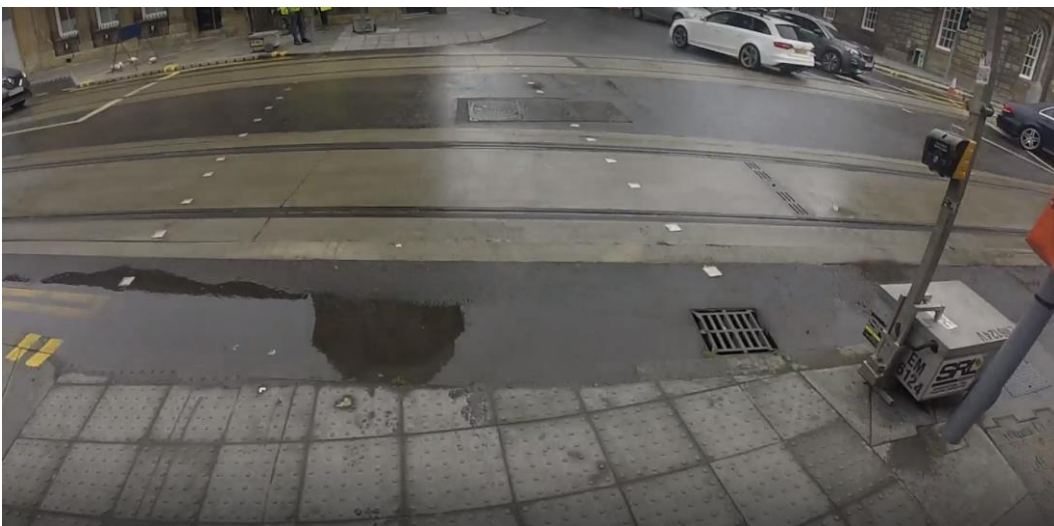
**Figure 4-18: Sloping footway perceived as hazard by participant**

The sloping footway, drainage covers, sloping footway and crossing paths, shown in Figure 4-18, were perceived as hazards that could cause the wheelchair to turn over or tumble.
