# Appendix A19.1: Baseline Conditions

## 1.1 Introduction

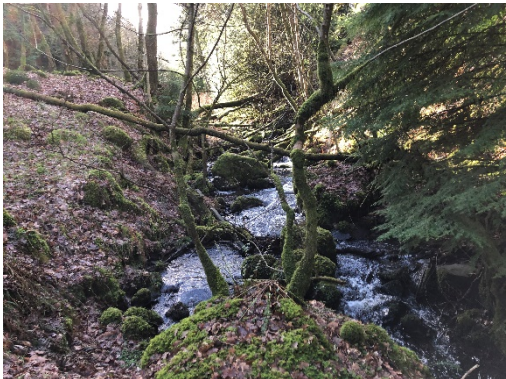
**Table A19.1-1: WF01 (Birnam Burn)**

<p><b>Photograph 1: WF01 (Birnam Burn) – upstream view, upstream of the existing A9</b></p>	Water feature type: Minor watercourse	
	Catchment Area: 4.38km <sup>2</sup>	
	Key hydraulic connections: Sourced on the south-east slopes of King's Seat, formed of two channels which converge and drain into Robin's Dam and then Rohallion Loch, which has outlets at Rohallion Cottage and Byres of Murthly Sawmill. Channels converge south of the Highland Main Line railway at Pass of Birnam, and pass under, then flows down and under the A9 and drain into the River Tay downstream of Roman Bridge.	
	Surrounding land use: Mixed forestry, ancient woodland, rough pasture, arable agricultural, road and rail infrastructure.	
Description of Specific Baseline Conditions		Importance
<b>Flood Risk</b>		
<p>The watercourse is situated in a narrow deeply incised valley upstream of the A9. As a result, <a href="#">SEPA Flood Maps</a> (2024a) indicate no significant flooding for the 0.5% AEP (200-year) event from overtopping along WF01 (Birnam Burn). The mapping shows a small area of flood risk to the existing A9 at its crossing of WF01. However, the SEPA extents do not take account of engineering structures. Multiple properties are located within 100m of the watercourse at Dairy Cottage and Railway Cottages, and at Colryden Lodge.</p> <p>Hydraulic assessment indicates the watercourse is in-bank upstream of the A9 in the design 0.5% AEP (200-year) plus climate change (CC) event. There is &gt;600mm freeboard to the A9 and therefore flood risk is considered low.</p>		low

<b>Hydromorphology</b>		
<p>SEPA Morphology status: not classified.</p> <p>The watercourse displays a low sinuosity planform with steep step-pool and uniform rapid flow types in upstream reaches and tumbling flow types in downstream reaches where the channel has been heavily modified. Bedforms comprise boulder steps and pools with plane-</p>		medium

- culverted beneath the Highland Main Line railway for approximately 50m, a local access track for approximately 4m, the existing A9 for approximately 65m, followed by two further local access tracks for approximately 4m and 5m prior to discharging to WF06 (River Tay);
- lengths of bank and bed protection associated with culvert structures;
- engineered cascades with masonry reinforced walls extending 30m downstream of the existing A9 culvert; and
- seven-span Roman Bridge which is in poor structural condition located 85m downstream of the existing A9 culvert (Bridge piers span the active channel width).

The watercourse is stable under the existing conditions and artificial constraints, in that it appears to be competent to transport the water and sediment supplied from upstream without excessive erosion or deposition.

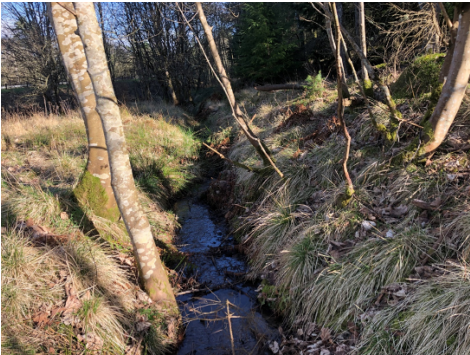
**Table A19.1-2: WF02**

<p><b>Photograph 2: WF02</b></p>	Water feature type: Minor watercourse
	Catchment Area: 0.25km <sup>2</sup>
	Key hydraulic connections: Sourced in south-east slopes of Duncan's Hill, the channel appears north of the Highland Main Line railway at Pass of Birnam, joins WF01 (Birnam Burn) immediately downstream of a historic Roman Bridge, which then drains into the River Tay.
	Surrounding land use: Mixed forestry, ancient woodland, rough pasture, arable agricultural, road and rail infrastructure.
<b>Description of Specific Baseline Conditions</b>	
<b>Flood Risk</b>	
<p>This watercourse has a catchment area less than 3km<sup>2</sup> so is not included in the SEPA Flood Map.</p> <p>Roman Bridge Cottage is located within 100m of the watercourse.</p> <p>Hydraulic assessment indicates that the watercourse is out of bank upstream of the A9 in the design 0.5% AEP (200-year) plus CC event. However, there is &gt;600mm freeboard to the A9 and therefore flood risk is considered low.</p>	low

<b>Hydromorphology</b>	
<p>SEPA Morphology status: not classified.</p> <p>The watercourse displays a low sinuosity planform with steep step-pool flow types in reaches upstream of the existing A9, and exhibits a variable cross-section, with the formation of alternate berms suggesting localised recovery of sinuosity within the confines of an engineered channel in downstream reaches. Bedforms comprise boulder/cobble steps and pools with plane-riffle and plane-bed features. WF02 is poorly channelised prior to discharging into WF01 (Birnam Burn) at the Roman Bridge.</p> <p>Existing pressures include:</p>	medium

- culverted through a masonry box culvert for approximately 5m upstream of the existing A9. WF02 crosses the existing A9 for approximately 50m through a 75cm diameter concrete pipe culvert and associated drop chamber entrance. A third culvert conveys the water feature below a local access track via a masonry box culvert for approximately 14m;
- concrete steps (cascade) with concrete wing walls extend 8m downstream of the existing A9 culvert (a road drainage outfall also discharges on to the cascade at the downstream culvert exit); and
- poorly channelised downstream of local property access where the water feature is conveyed below a local access footpath through a broken ceramic pipe prior to an approximate 10m drop over a masonry wall, discharging into WF01 (Birnam Burn).

The watercourse is stable under the existing conditions and artificial constraints, such that it appears to transport the water and sediment supplied from upstream without excessive erosion or deposition.

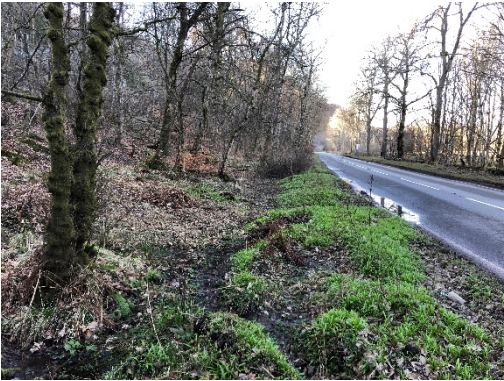
**Table A19.1-3: WF04**

<p><b>Photograph 3: WF04</b></p>	Water feature type: Drainage channel	
	Catchment Area: 0.07km <sup>2</sup> . Length of watercourse: <40m	
	Key hydraulic connections: Sourced on the north-west slopes of Duncan's Hill, channel occurs north of the Highland Main Line railway and the B867 and sinks at Ringwood Cottage south of the A9. No crossing with the A9 found on site and no crossing shown on as-built drawings.	
	Surrounding land use: Mixed forestry, ancient woodland, road and rail infrastructure.	
Description of Specific Baseline Conditions		Importance
<b>Flood Risk</b>		
<p>No crossing with the A9 identified. This short watercourse (&lt;40m long) has a catchment area less than 3km<sup>2</sup> so is not included in the SEPA Flood Map.</p> <p>This watercourse emerges from a spring upstream of a row of four cottages and disappears into a sink immediately upstream of the access road to the cottages. It appears to be groundwater-fed with little surface water contribution as surface contours are broadly perpendicular to the stream. The risk of any surface runoff causing the watercourse to flood its banks is therefore low. As a consequence, the risk of any flooding from the watercourse impacting on the existing A9 is low.</p> <p>Four properties are located within 100m of the watercourse around Ringwood Cottage.</p>		low

<p>The watercourse is a land drain and artificial road drain with a straight planform, which displays no clear hydrological connection to the existing A9, proposed scheme or WF06 (River Tay). As WF04 is an artificial land drain and road drain it displays no natural channel morphology or flow types and is likely ephemeral.</p> <p>No existing pressures are noted on the artificial land and road drain.</p>	
<b>Surface Water Quality</b>	
<p>SEPA Physico-chemical/ Biological elements/ Specific pollutants status: not classified.</p> <p>Low flow value (<math>Q_{95}</math>): 0.0003m<sup>3</sup>/s</p> <p>Diffuse run-off may occur from land uses within the catchment. The majority of the catchment comprises of ancient and historic woodland (~95%) which may be sources of sediment, dissolved organic carbon and nutrients. Run-off from urban development (including the existing A9 and the Highland Main Line railway) includes suspended solids and contaminants bound to them (such as heavy metals and phosphorus); de-icing salt (chloride), oil and related compounds.</p> <p>Within the 500m study area, no CAR Licences are associated with the watercourse.</p>	<p>low</p>

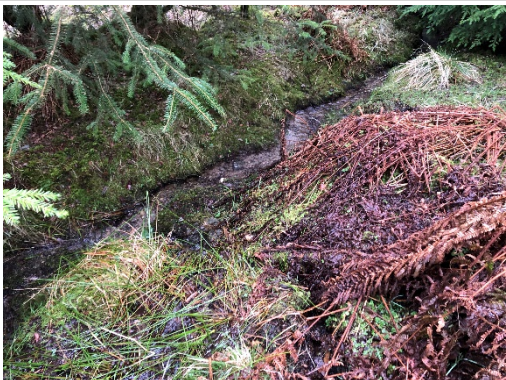
**Table A19.1-4: WF05**

<p><b>Photograph 4: WF05</b></p>	Water feature type: Minor watercourse
	Catchment Area: 0.32km <sup>2</sup>
	Key hydraulic connections: Sourced in Rochanroy Wood, on the eastern slopes of Craig Ruenshin. Channel flows north-east to the Highland Main Line railway, which it is culverted under, then under the B867 where it sinks. The channel occurs again further north in Ring Wood.
	Surrounding land use: Mixed forestry, ancient woodland, road and rail infrastructure.
Description of Specific Baseline Conditions	
Flood Risk	
<p>This watercourse has a catchment area less than 3km<sup>2</sup> so is not included in the SEPA Flood Map.</p> <p>Hydraulic assessment indicates that the watercourse is out of bank upstream of the A9 in the design 0.5% AEP (200-year) plus CC event. However, there is &gt;600mm freeboard to the A9 and therefore the flood risk is considered low.</p>	low
Hydromorphology

<p>SEPA Morphology status: not classified.</p> <p>The watercourse displays a low sinuosity planform with steep step-pool flow types in the upper reaches and uniform tranquil flow types where gradients are shallow. Bedforms comprise boulder and cobble steps and pools, and alternating bar features in upstream reaches. Relict boulders provide bed and bank controls where the channel is not artificially confined.</p> <p>Existing pressures:</p> <ul style="list-style-type: none"> <li>■ culverted beneath a local access track for approximately 5m, the Highland Main Line railway for approximately 30m and the B867 for approximately 20m; and</li> <li>■ lengths of bank and bed protection associated with culvert structures.</li> </ul>	medium

The watercourse is stable under the existing conditions and artificial constraints, in that it appears to be competent to transport the water and sediment supplied from upstream without excessive erosion or deposition.	
<b>Surface Water Quality</b>	
<p>SEPA Physico-chemical/ Biological elements/ Specific pollutants status: not classified.</p> <p>Low flow value (<math>Q_{95}</math>): 0.0014m<sup>3</sup>/s</p> <p>Diffuse run-off may occur from land uses within the catchment. The majority of the catchment comprises of ancient and historic woodland (~90%) which may be sources of sediment, dissolved organic carbon and nutrients. Run-off from urban development (including the Highland Main Line railway) includes suspended solids and contaminants bound to them (such as heavy metals and phosphorus); de-icing salt (chloride), oil and related compounds.</p> <p>Potential pollutants include PBTC-C5 Curling Pond and PBTC-C6 Infilled Pond with potential for contaminants associated with historic activity and infilled with made ground in watercourse.</p> <p>Within the 500m study area, no CAR Licences are associated with the watercourse.</p>	medium

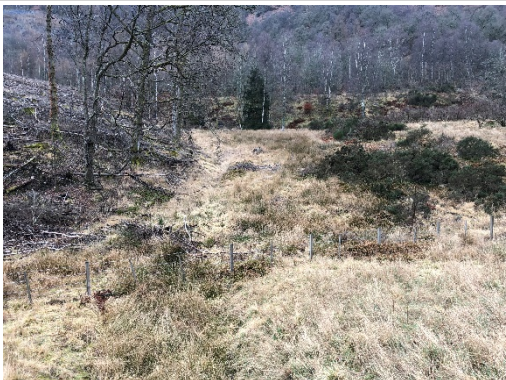
**Table A19.1-5: WF05A**

<p><b>Photograph 5: WF05A (centre of image)</b></p>	Water feature type: Drainage channel
	Catchment Area: 0.43km <sup>2</sup>
	Key hydraulic connections: Sourced on eastern slopes of King's Seat and Birnam Quarry, the channel appears from a culvert on the north side of the Highland Main Line railway, then is culverted under the A9. North of the A9 the channel emerges from the culvert and drains into a marsh bog.
	Surrounding land use: Mixed forestry, ancient woodland, road and rail infrastructure.
Description of Specific Baseline Conditions	Importance
<b>Flood Risk</b>	
<p>This watercourse has a catchment area less than 3km<sup>2</sup> so is not included in the SEPA Flood Map.</p> <p>For the existing A9 culvert, the hydraulic assessment indicates that the watercourse is out of bank upstream of the A9 in the design 0.5% AEP (200-year) plus CC event, however there is &gt;600mm freeboard to the A9 and therefore the flood risk is considered low.</p> <p>For the existing B867 culvert, the hydraulic assessment indicates that the watercourse is out of bank upstream of the railway and A9 in the design 0.5% AEP (200-year) plus climate change (CC) event, however the A9 culvert capacity is greater than the 0.5% AEP (200-year) plus CC peak flow and there is &gt;600mm freeboard to the railway and therefore the flood risk is considered low.</p>	low

<b>Hydromorphology</b>	
<p>SEPA Morphology status: not classified.</p> <p>The watercourse displays a low sinuosity planform with a uniform tranquil and occasional steep step-pool flow types before ponding and dissipating in marshland north-east of the existing A9 carriageway. Relict boulders provide bed and bank controls where the channel is not artificially confined.</p>	low

<p>Existing pressures:</p> <ul style="list-style-type: none"> <li>▪ culverted beneath the Highland Main Line railway and B867 road for approximately 55m and the existing A9 for approximately 55m; and</li> <li>▪ lengths of bank and bed protection associated with culvert structures. A road drainage outfall is present at the downstream headwall of the existing A9 culvert.</li> </ul> <p>Extensive fine sediment and organic material accumulation in a ponded area on the fluvial terrace downstream of the A9 culvert. Evidence suggests high water velocities during high flow events causes scour in the terrace deposits and a backwater effect at the culvert exit. Historical pressures include an abandoned curling pond just south of B867 road where water sinks into a depression and does not reappear as surface flow until further (~80m) downstream.</p> <p>The watercourse cannot be assessed as “stable” under the current conditions, in that it has been so heavily modified and subjected to ephemeral flow conditions that natural channel morphology criteria cannot be applied.</p>

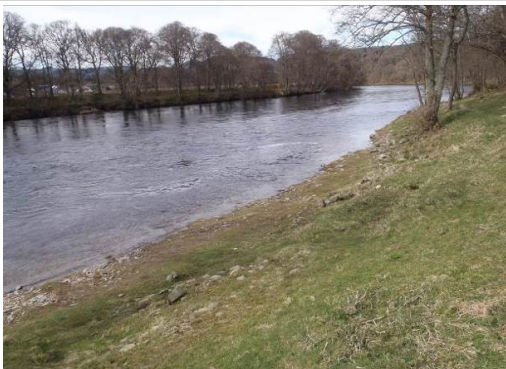
**Table A19.1-6: WF06 (River Tay)**

<p><b>Photograph 6: WF06 (River Tay) – view upstream towards Dunkeld and Birnam</b></p>	Water feature type: Major watercourse	
	Catchment area: 3,210km <sup>2</sup>	
	WFD water body: River Tay (R Tummel to R Isla Confluences) Water body ID: 6499	
	Key hydraulic connections: Principal watercourse within the study area. All water features within the study area form part of the River Tay catchment, with the majority being direct tributaries.	
	Surrounding land use: Arable, rough pasture and commercial forestry.	
SEPA Overall Status: Poor ecological potential (2023 classification year)		
Description of Specific Baseline Conditions		Importance
Flood Risk		
<p>The River Tay flows in a generally southerly direction through the study area and has a catchment area of 3,210km<sup>2</sup> upstream of the gauging station at Caputh (NGR: NO 08389 39575) (approximately 3.1km downstream of the study area). The River Tay is crossed by the existing A9 in the north of the study area at the Tay Crossing. The River Tay passes in close proximity to a number of settlements including (north to south) Inver, Dunkeld, Little Dunkeld and Birnam.</p> <p>SEPA Flood Maps (2024a) indicate fluvial flood risk from the 0.5% AEP (200-year) event to properties on the left bank of the River Tay including a small Sewage Treatment Plant within the grounds of Dunkeld House Hotel. The most notable risk is to properties within Dunkeld including; High Street (approximately 7 properties), Bridge Street (A923) (approximately 10 properties), Atholl Street (A923) (approximately 7 properties), Cathedral Street (approximately 7 properties) and Water Wynd (approximately 3 properties). On the right bank of the River Tay properties within Little Dunkeld are predicted to be at risk, including approximately 75 properties within Willowbank and 8 properties along Burnmouth Road. Properties within Birnam (approximately 8 properties along Torlee Road) are also predicted to flood, as well as Birnam &amp; Dunkeld Sewage Treat Works (National Grid Reference (NGR): NO 04156 41061) south of Birnam.</p>		very high

SEPA Flood Maps (2024a) also shows a section of the existing A9 of approximately 650m between the WF11 (River Braan) crossing and the WF12 (Mill Stream) crossing is located in the floodplain of WF06 (River Tay) and WF11 (River Braan). Most of this section would be overtopped in a 0.5% AEP (200-year) flood. Along the rest of the existing A9 within the study area, the 0.5% AEP (200-year) functional floodplain does not impact on the carriageway.

Detailed baseline hydraulic modelling by Jacobs in Appendix A19.2 (Flood Risk Assessment) shows similar flood extents for the 0.5% AEP (200-year) plus climate change (CC) flood to the 0.5% AEP SEPA Flood Mapping. However, in most places the flooding shown by the Jacobs model is less than that shown on the SEPA flood map. This is primarily attributed to updated hydrology and a more refined topographic representation in the Jacobs model. The Jacobs model for the 0.5% AEP (200-year) plus CC flood event shows the following notable areas of flooding:

<p>SEPA Morphology status: Bad (2023 classification year). The WFD water body has been designated as a heavily modified water body on account of physical alterations that cannot be addressed without a significant impact on water storage for hydroelectricity generation (SEPA 2025).</p> <p>Within the study area, WF06 (River Tay) flows typically south with a sinuous, meandering, single-thread planform. The floodplain is relatively confined throughout this reach with a fragmentary riparian corridor. The river displays various flow types, with predominantly uniform/tranquil flow types within the study area. A wide range of morphological features are present throughout the study area, including numerous locations with large accumulations of pebble and cobble deposits, including point and mid-channel bars (both vegetated and unvegetated), riffles, pools and sections of plane-bed. Bed material comprises boulders, gravel and cobbles. Bridge abutments and boulders provide bank controls. The cobble and boulder bed-material appear to be mobile and forms occasional alternate bars and point bars which display a characteristic imbricated pattern.</p> <p>Existing pressures within the study area include:</p> <ul style="list-style-type: none"> <li>▪ The A9 at Dalguise, which is currently conveyed over WF06 (River Tay) by a three-span bridge. One bridge pier is installed into the channel adjacent to a lateral bar and is showing signs of scour and outflanking where the steel-piling has been exposed. The channel banks are reinforced by gabion baskets extending to a height of 4-5m above the channel and 100m along the bank line. The gabion baskets are currently eroding and have failed on the left bank at the bridge pier, and there is evidence the pier is outflanked during high flows with further erosion of gabion reinforcement. Site surveys also noted geotechnical failures associated with poorly consolidated left bank sediments.</li> <li>▪ Dunkeld Bridge, linking Birnam and Dunkeld, also crosses WF06 (River Tay) within the study area. Dunkeld Bridge is a seven-span rubble bridge with segmental arches; the four central piers are located in-channel with two piers and two abutments located on the banks.</li> <li>▪ Within the wider River Tay catchment, anthropogenic modifications are widespread and affect multiple tributaries. The most significant impact within the River Tay catchment is related to the construction of impoundments (dams) and creation of reservoirs to control flow within the River Garry and River Tummel sub-catchments for the <a href="#">Tummel Hydro Schemes</a> (SSE Renewables, 2021), a large hydroelectricity generation scheme comprising 9 power stations, 4 major dams constructed between 1930 and 1962. Numerous smaller dams, weirs and flow diversions (tunnels) are also present across the catchment as part of the scheme.</li> </ul>	<p>very high</p>

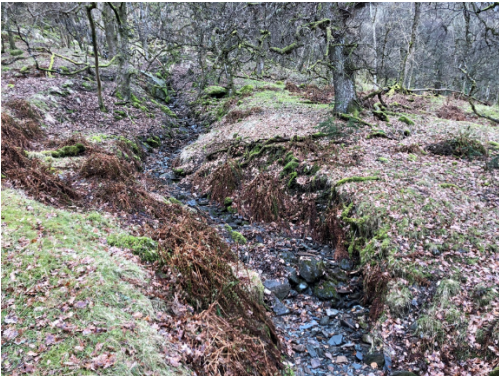
**Table A19.1-7: WF07**

<p><b>Photograph 7: WF07</b></p>	Water feature type: Drainage channel	
	Catchment Area: 0.59km <sup>2</sup>	
	Key hydraulic connections: Sourced on north-east slopes of King's Seat/ Birnam Hill. Spreads out on slopes 150m south-east of Highland Main Line railway, dry channel continues to rail line, culverted under, spreads out south of A9.	
	Surrounding land use: Mixed forestry, ancient woodland, rough grazing, road and rail infrastructure.	
Description of Specific Baseline Conditions		Importance
<b>Flood Risk</b>		
<p>This watercourse has a catchment area less than 3km<sup>2</sup> so is not included in the SEPA Flood Map.</p> <p>Hydraulic assessment of the existing culvert beneath the Highland Main Line railway and existing A9 during the 0.5% AEP (200-year) plus CC event indicates that the A9 is at risk of flooding as headwater level is above the existing A9 road level. Investigations into the culvert to the River Tay have indicated that the culvert capacity is unlikely to convey the design flow and that the condition of the structure is unknown. Manholes have been identified at Perth Road which also appear to include surface water contributions from surrounding catchments.</p>		very high

<b>Hydromorphology</b>		
<p>SEPA Morphology status: not classified.</p> <p>The watercourse displays a low sinuosity planform with steep step-pool and tumbling flow types in upstream reaches and uniform rapid to tranquil in lower reaches. Bedforms comprise boulder steps and pools with plane-riffle and plane-bed features. Relict boulders provide bed and bank controls where the channel is not artificially confined. No open channel identified downstream of inlet to Highland Main Line railway culvert.</p>		low

<p>Existing pressures:</p> <ul style="list-style-type: none"> <li>▪ culverted via 2.6m offline box culvert for approximately 15m beneath the Highland Main Line railway; and</li> <li>▪ ephemeral channel</li> </ul> <p>The watercourse cannot be assessed as “stable” under the existing conditions, in that it is subject to ephemeral flow conditions that it precludes applying “natural channel morphology” criteria.</p>	
<b>Surface Water Quality</b>	
<p>SEPA Physico-chemical/ Biological elements/ Specific pollutants status: not classified.</p> <p>Low flow value (<math>Q_{95}</math>): 0.0026m<sup>3</sup>/s</p> <p>Diffuse run-off may occur from land uses within the catchment. The majority of the catchment comprises of ancient and historic woodland (~82%) which may be sources of sediment, dissolved organic carbon and nutrients. Run-off from urban development (including the existing A9 and the Highland Main Line railway) includes suspended solids and contaminants bound to them (such as heavy metals and phosphorus); de-icing salt (chloride), oil and related compounds.</p> <p>Within the 500m study area, no CAR Licences are associated with the watercourse.</p>	<p>medium</p>

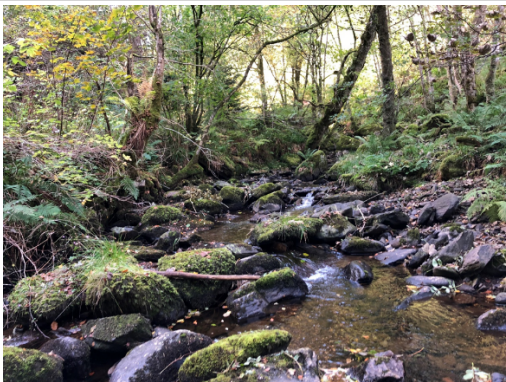
**Table A19.1-8: WF08 (Inchewan Burn)**

<p><b>Photograph 8: WF08 (Inchewan Burn) – (typical example of a medium water feature)</b></p>	Water feature type: Medium watercourse
	Catchment Area: 5.77km <sup>2</sup>
	Key hydraulic connections: Sourced on north and north-west slopes of Obney Hills and drains Balhomish Loch. Watercourse flows north-east to Little Dunkeld and Birnam, culverted under roads and the Highland Main Line railway, and drains into the River Tay north-east of Burnmouth Road.
	Surrounding land use: Mixed forestry, ancient woodland, exposed moorland, rough grazing, road and rail infrastructure and urban.
Description of Specific Baseline Conditions	
Flood Risk	
<p>WF08 (Inchewan Burn) flows in a generally north east direction before meeting WF06 (River Tay) at Birnam in the study area and has a catchment area of 5.77km<sup>2</sup>. WF08 (Inchewan Burn) is crossed by the existing A9 close to the Dunkeld and Birnam Station. WF08 (Inchewan Burn) passes in close proximity to Little Dunkeld and Birnam and flows into the River Tay SAC.</p> <p>SEPA Flood Maps indicate that the majority of the existing A9 between Pass of Birnam and the Tay Crossing is located outwith of the predicted 0.5% AEP (200-year) flood extent, and not at risk from WF08 (Inchewan Burn).</p> <p>Baseline hydraulic modelling of the 0.5% AEP (200-year) plus CC flood event and the SEPA Flood Maps have similar flood extents in some areas, however there are areas where the flood extents differ. Due to backwater effects near the confluence with the River Tay, the model predicts the Inchewan Burn to overtop and floodwater to merge with floodwater from the River Tay, inundating Little Dunkeld and affecting 40-50 properties, including the Royal School of Dunkeld between the A923 Tay crossing and the WF08 (Inchewan Burn) confluence.</p>	very high

The watercourse displays a low to medium sinuosity planform with steep step-pool, tumbling and uniform/rapid flow types. Bedforms comprise bedrock cascades, boulder steps and pools, and cobble/gravel plane-riffles. The finer sand and gravel bed-material appears to be mobile, forming alternate, lateral bars. Bedrock outcrops, glacial erratics and boulders provide bed and bank controls.

- a weir structure approximately 5m in length, 900m upstream from the A9 road bridge is associated with a broad, shallow pool upstream, 15m in length, which is infilling with gravel- and sand-size sediment. The backwater effect from the in-filling pond and weir extends approximately 12m upstream;

- artificial steps and pools have been constructed downstream from the Highland Main Line Railway and under the existing A9 road bridge. It is understood that these features were created to replace former gabion bed reinforcement. The artificial steps and pools are largely intact, however, there is evidence of undercutting, incision and mid-channel deposition suggesting mild instability. The right and left banks are also constrained by 70m of gabion baskets through the artificial step-pool reach, and further constrained by stone blockwork and boulders 420m downstream to the footbridge near the River Tay confluence.

The watercourse is stable under the existing conditions and artificial constraints, in that it appears to be competent to transport the water and sediment supplied from upstream without excessive erosion or deposition.

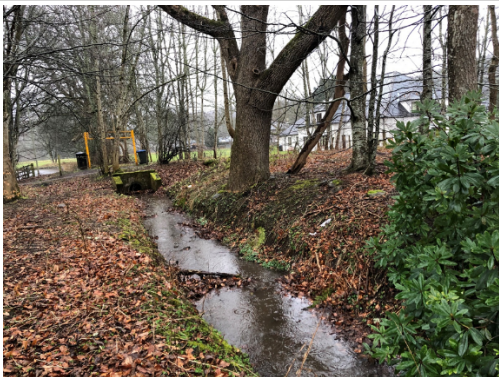
**Table A19.1-9: WF09**

<p><b>Photograph 9: WF09 – (typical example of a small water feature)</b></p>	Water feature type: Minor watercourse
	Catchment Area: 0.76km <sup>2</sup>
	Key hydraulic connections: Sourced north-east of Balhomish Loch and slopes of Ladywell Plantation. Watercourse flows north-east to the A822, then is culverted from Ladywell Cottage to just south of the A9, culverted under the A9 and under roads in Little Dunkeld and Birnam, and drains into the River Braan by the recreational grounds.
	Surrounding land use: Mixed forestry, ancient woodland, arable agricultural, urban and recreational, road and rail infrastructure.
Description of Specific Baseline Conditions	Importance
<b>Flood Risk</b>	
<p>This watercourse has a catchment area less than 3km<sup>2</sup> so is not included in the SEPA Flood Map.</p> <p>Multiple properties are located within 100m of the watercourse at Ladywell Mill, Ladywell Cottage and at Braan Cottage.</p> <p>For the existing A9 culvert, the hydraulic assessment of the existing A9 culvert for the 0.5% AEP (200-year) plus CC flood event indicates that the flow is out of bank and the A9 is at risk of flooding as headwater level is above the existing A9 road level.</p> <p>For the existing culvert beneath the unnamed access road to Dunkeld and Birnam Recreation Club, the preliminary hydraulic assessment indicates that the watercourse is out of bank upstream of the unnamed access road in the design 0.5% AEP (200-year) plus CC event.</p>	very high

<b>Hydromorphology</b>	
<p>SEPA Morphology status: not classified.</p> <p>The watercourse displays a low sinuosity planform with evidence of artificial straightening and realignment, and uniform tranquil and pool-riffle flow types. Bridge protection structures, including culverts and bank revetments provide bed and bank controls. Alternating bars were observed within recovering reaches.</p>	medium

<p>Existing pressures:</p> <ul style="list-style-type: none"> <li>▪ culverted beneath Ladywell Cottage for approximately 38m, the A822 for approximately 420m, the existing A9 for approximately 50m, a local access road for approximately 20m and a public footpath for approximately 2m; and</li> <li>▪ lengths of bank and bed protection associated with culvert structures and straightened /realigned channel.</li> </ul> <p>The watercourse lacks competence under the existing conditions and artificial constraints, in that it appears to be unable to transport the water and sediment supplied from upstream without excessive deposition in reaches downstream from the A9.</p>	
<b>Surface Water Quality</b>	
<p>SEPA Physico-chemical/ Biological elements/ Specific pollutants status: not classified.</p> <p>Low flow value (<math>Q_{95}</math>): 0.0034m<sup>3</sup>/s</p> <p>Located within the River Tay SAC, but the watercourse itself is considered to exhibit 'Poor' ecosystem quality due to reduced connectivity to the wider catchment or a lack of resources to support fish species of conservation interest.</p> <p>Diffuse run-off may occur from land uses within the catchment. The majority of the catchment comprises of ancient and historic woodland (~59%) which may be sources of sediment, dissolved organic carbon and nutrients. Run-off from rough grazing could include biological pollutants. Run-off from urban development (including the existing A9 and the Highland Main Line railway) includes suspended solids and contaminants bound to them (such as heavy metals and phosphorus); de-icing salt (chloride), oil and related compounds.</p> <p>Potential pollutants include PBTC-C22 Disused Quarry (now Ladywell Landfill) with potential for contaminants associated with historic and current activity, 40m away from culverted section of channel.</p> <p>Within the 500m study area, no CAR Licences are associated with the watercourse.</p>	<p>medium</p>

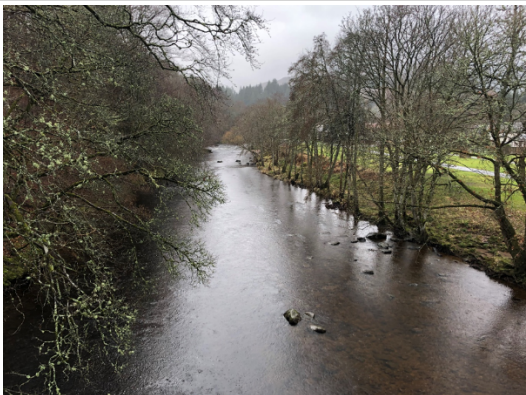
**Table A19.1-10: WF11 (River Braan)**

<p><b>Photograph 10: WF11 (River Braan)</b> (example of a medium/large WFD water body)</p>	Water feature type: Major watercourse
	Catchment Area: 211.09km <sup>2</sup>
	WFD water body: River Braan Water body ID: 6576
	Key hydraulic connections: Sourced as the outlet of Loch Freuchie, the watercourse flows east through Strathbraan valley with multiple tributaries joining from uplands catchments in both north and south directions. The River Braan conflues with the River Tay on its south bank west of Little Dunkeld.
	Surrounding land use: Arable agricultural, rough pasture, mixed forestry, ancient woodland, road and rail infrastructure.
Description of Specific Baseline Conditions	
Flood Risk	
<p>WF11 (River Braan) flows in a generally north east direction and meets WF06 (River Tay) downstream of Inver in the study area and has a catchment area of 211km<sup>2</sup>. WF11 (River Braan) is crossed by the existing A9 between Little Dunkeld and Inver. WF11 (River Braan) passes in close proximity to Inver and Little Dunkeld. WF11 (River Braan) is part of the River Tay SAC.</p> <p>SEPA Flood Maps indicate fluvial flood risk from the 0.5% AEP (200-year) event to properties on the left bank of WF11 (River Braan), including the Old Inn, Ladeside Cottages, Inver Mill Farm and Inver Mill Caravan Site. On the right bank approximately 70 static caravans within Inver Mill Holiday Park are shown to be at risk. According to the SEPA Flood Maps, a section of the existing A9 of approximately 650m between the WF11 (River Braan) crossing and the WF12 (Mill Stream) crossing is located in the floodplain of the River Tay and River Braan. Most of this section would be overtopped in a 0.5% AEP (200-year) plus CC flood event.</p> <p>Baseline hydraulic modelling of the 0.5% AEP (200-year) plus CC flood event and the SEPA Flood Maps have similar flood extents in some areas, however there are areas where the flood extents differ:</p>	very high

<ul style="list-style-type: none"> <li>the model predicts overtopping on both banks of WF11 (River Braan) and WF12 (Mill Stream) upstream of the A9 WF11 (River Braan) crossing, with significant flood depths between 1.0-1.2m affecting up to 20-25 properties;</li> <li>the model predicts WF11 (River Braan) overtops the right bank and floods Inver Mill Caravan site, affecting 65-70 static caravans with depths between 1.5-3.6m, and inundates the unclassified road to Inver at the southern boundary of the caravan site;</li> <li>the model predicts the main channel of WF11 (River Braan) overtops the right bank near The Hermitage Junction; floodwater is predicted to flow south and pond against the Highland Main Line Railway embankment; and</li> <li>the model predicts floodwater from WF11 (River Braan) and WF12 (Mill Stream) will merge with floodwater from the River Tay, ponding against the A9 embankment and flooding the existing A9 carriageway over a length of several hundred meters to varying depths up to 0.6m.</li> </ul>

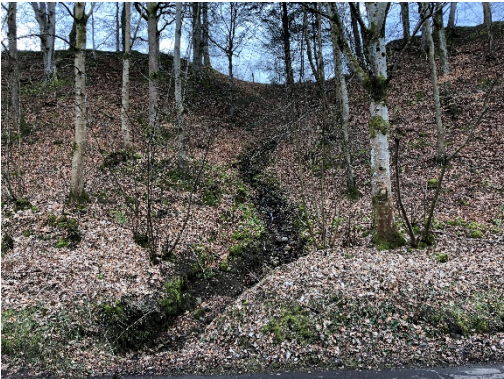
**Table A19.1-11: WF11A**

<p><b>Photograph 11: WF11A</b></p>	Water feature type: Drainage channel
	Catchment Area: 0.31km <sup>2</sup>
	Key hydraulic connections: Sourced within the WF11 (River Braan) catchment on the slopes of the Ladywell Plantation. The channel emerges south of the Highland Main Line railway, which it is then culverted under, reappearing in the woodland to the north of the line, then culverted under a local road, the reappears and enters WF11 (River Braan) at the east end of Inver Mill Holiday Park.
	Surrounding land use: Mixed forestry, mainly ancient, arable agriculture and road and rail infrastructure.
Description of Specific Baseline Conditions	
Flood Risk	
<p>This watercourse has a catchment area less than 3km<sup>2</sup> so is not included in the SEPA Flood Map.</p> <p>Inver Mill Holiday Park is located within 100m of the watercourse.</p> <p>This watercourse is situated outside the A9 scheme boundary and flooding from it does not impact on the project area. It has therefore not been assessed further on flood risk.</p>	low

Hydromorphology	
<p>SEPA Morphology status: not classified.</p> <p>The watercourse displays a low sinuosity planform with steep step-pool flow types in reaches downstream of the Highland Main Line railway. Bedforms comprise boulder steps and pools and boulder cascades on steeper gradients. Relict boulders provide bed and bank controls.</p> <p>Existing pressures:</p>	low

- culverted through a pipe culvert in the upper reaches of the Highland Main Line railway for approximately 35m, as suggested by a series of manholes observed; and
- culverted beneath the local access road to Inver for approximately 8m.

The watercourse cannot be assessed as “stable” under existing conditions, in that it has been so heavily modified and subjected ephemeral flow conditions that natural channel morphology criteria cannot be applied.

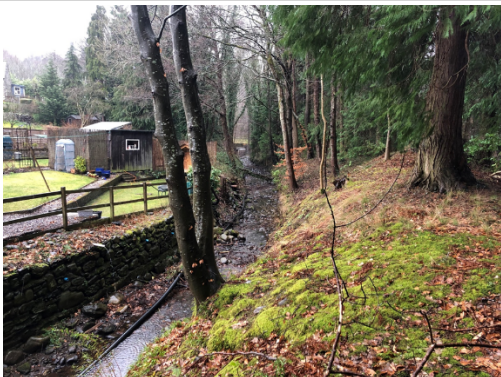
**Table A19.1-12: WF12 (Mill Stream)**

<p><b>Photograph 12: WF12 (Mill Stream)</b></p>	Water feature type: Artificial watercourse
	Catchment Area: 0.02km <sup>2</sup>
	Key hydraulic connections: Artificial channel taking water from WF11 (River Braan) at Inver Mill, with large culverted sections, discharges into WF06 (River Tay) at NGR NO 01704 42329
	Surrounding land use: Urban, grassland, woodland, road infrastructure.
Description of Specific Baseline Conditions	
Flood Risk	
<p>WF12 (Mill Stream) flows from WF11 (River Braan) at NO 01573 42153 to WF06 (River Tay) at NO 01704 42329 through Inver in the study area. It has a small surface catchment of 0.02km<sup>2</sup> but any flooding along it originates from WF11 (River Braan) or WF06 (River Tay). WF12 (Mill Stream) is crossed by the existing A9 upstream of the WF11 (River Braan) crossing. WF12 (Mill Stream) is within close proximity to properties in Inver. WF12 (Mill Stream) flows into the River Tay SAC.</p> <p>This watercourse has a catchment area less than 3km<sup>2</sup> so is not included in the SEPA Flood Map, however the SEPA Flood Maps (2024b) do show the short section of approximately 650m from the WF11 (River Braan) crossing to the WF12 (Mill Stream) crossing that runs through the functional floodplain (area with greater than 0.5% probability of flooding in any year) of the River Tay and River Braan.</p> <p>WF12 (Mill Stream) has been included as a principal Stage 3 baseline hydraulic modelling of WF11 (River Braan) and WF06 (River Tay) for the 0.5% AEP (200-year) plus CC flood event includes WF12 (Mill Stream) and the model outputs and SEPA Flood Maps have similar flood extents in some areas, however there are areas where the flood extents differ:</p> <ul style="list-style-type: none"> <li>the model predicts overtopping on both banks of WF12 (Mill Stream) and WF11 (River Braan) upstream of the A9 WF11 crossing, with significant flood depths between 1.0-1.2m affecting up to 20-25 properties; and</li> </ul>	very high

<ul style="list-style-type: none"> <li>the model predicts floodwater from WF11 (River Braan) and WF12 (Mill Stream) will merge with floodwater from WF06 (River Tay), ponding against the A9 embankment and flooding the existing A9 carriageway over a length of several hundred meters to varying depths up to 0.6m.</li> </ul>	
<b>Hydromorphology</b>	
<p>SEPA Morphology status: not classified.</p> <p>The watercourse is an engineered channel and displays an artificial planform from the off-take of flow from a meander of WF11 (River Braan) approximately 145m upstream of the existing A9, plane bed uniform/tranquil to uniform/rapid flow types in upstream and downstream reaches. Bedforms comprise homogenous plane-bed features downstream of the mill lade and upstream of the existing A9 crossing. Relict boulders downstream of the mill lade provide bed and bank controls where the channel is not artificially confined with revetments.</p> <p>Existing pressures:</p> <ul style="list-style-type: none"> <li>masonry engineered channel for approximately 55m towards a historic mill;</li> <li>concrete chute approximately 20m long which carries flow to where the wheel for the mill would have been located;</li> <li>culverted beneath residential properties and local access roads for approximately 65m and the existing A9 for approximately 40m;</li> <li>flows through an artificially straightened channel with masonry left bank protection for approximately 100m behind residential gardens (Ladeside Cottages);</li> <li>artificially straightened channel with left bank masonry protection for approximately 100m upstream of A9 culvert; and</li> <li>masonry bed protection for approximately 5m upstream of the existing A9 culvert entrance to 20m downstream on the culvert apron, extending to the confluence with WF06 (River Tay).</li> </ul> <p>The watercourse cannot be assessed as “stable” under the existing conditions, in that it has been so heavily modified that it precludes applying “natural channel morphology” criteria.</p>	<p>low</p>

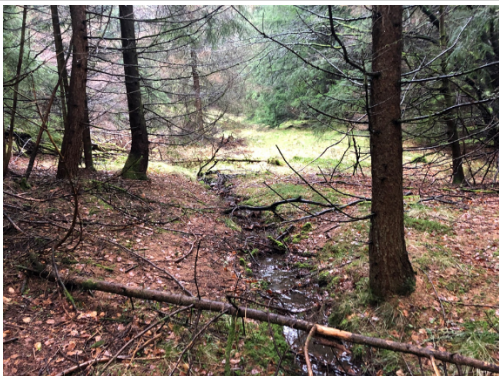
**Table A19.1-13: WF12A**

<p><b>Photograph 13: WF12A</b></p>	Water feature type: Drainage channel
	Catchment Area: 0.33km <sup>2</sup>
	Key hydraulic connections: Sourced in northern slopes of Craigvinean Forest. Watercourse flows east then south down to the A9, which it is culverted under to the north side of the Highland Main Line railway where it reappears and drains into the River Tay opposite Dunkeld House.
	Surrounding land use: Mixed woodland, ancient woodland, road and rail infrastructure.
Description of Specific Baseline Conditions	
Flood Risk	
<p>This watercourse has a catchment area less than 3km<sup>2</sup> so is not included in the SEPA Flood Map.</p> <p>The hydraulic assessment indicates that the watercourse is in-bank upstream of the A9 in the design 0.5% AEP (200-year) plus CC event. There is &gt;600mm freeboard to the A9 and therefore the flood risk is considered low.</p>	low
Hydromorphology

<p>SEPA Morphology status: not classified.</p> <p>The watercourse displays a low sinuosity planform with steep step-pool and uniform rapid flow types. Bedforms comprise cobble steps and pools with and plane-bed features.</p> <p>Existing pressures:</p> <ul style="list-style-type: none"> <li>▪ culverted beneath the existing A9 and Highland Main Line railway for approximately 100m; and</li> <li>▪ lengths of bank and bed protection associated with culvert structures.</li> </ul> <p>The watercourse is stable under the existing conditions in that it appears to be competent to transport the water and sediment supplied from upstream without excessive erosion or deposition.</p>	medium

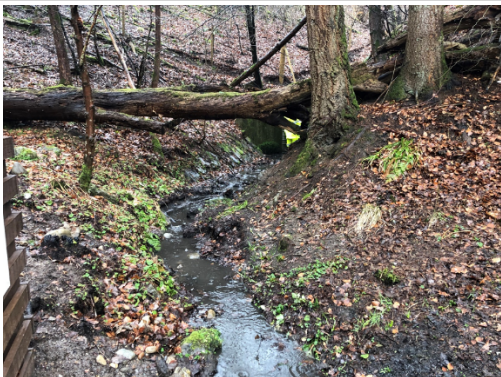
**Table A19.1-14: WF12B**

<p><b>Photograph 14: WF12B</b></p>	Water feature type: Drainage channel
	Catchment Area: 0.36km <sup>2</sup>
	Key hydraulic connections: Sourced on the eastern slopes north of Craig Vinean. Channel occurs less than 30m west from the A9, which it is culverted under to the north side of the Highland Main Line railway where it reappears and drains into the River Tay.
	Surrounding land use: Mixed forestry, ancient woodland, road and rail infrastructure.
Description of Specific Baseline Conditions	
Flood Risk	
<p>This watercourse has a catchment area less than 3km<sup>2</sup> so is not included in the SEPA Flood Map.</p> <p>The watercourse crosses the A9 where the road is in cutting. Upstream of the A9 the watercourse cross section is above the existing road level. A hydraulic assessment of the existing A9 culvert during the 0.5% AEP (200-year) plus CC flood event indicates that the headwater level is above the culvert soffit and the watercourse is therefore at risk of flooding the existing A9.</p>	very high

Hydromorphology	
<p>SEPA Morphology status: not classified.</p> <p>The watercourse displays a low sinuosity planform with plane-bed features and is dominated by storm-generated overland flow forming a poorly-defined channel upstream from the A9, with uniform tranquil flow types in downstream reaches.</p> <p>Existing pressures:</p> <ul style="list-style-type: none"> <li>conveyed beneath the existing A9 and Highland Main Line railway for approximately 80m;</li> <li>lengths of bank and bed protection associated with culvert structures; and</li> <li>small wooden bridge crosses WF12B to allow the public footpath along the banks of the River Tay to continue.</li> </ul>	low

The watercourse cannot be assessed as “stable” under existing conditions, in that it has been so heavily modified and subjected ephemeral flow conditions that natural channel morphology criteria cannot be applied.	
<b>Surface Water Quality</b>	
<p>SEPA Physico-chemical/ Biological elements/ Specific pollutants status: not classified.</p> <p>Low flow value (<math>Q_{95}</math>): 0.0016m<sup>3</sup>/s</p> <p>Diffuse run-off may occur from land uses within the catchment. The majority of the catchment comprises of ancient and historic woodland (~90%) which may be sources of sediment, dissolved organic carbon and nutrients. Run-off from urban development (including the existing A9 and the Highland Main Line railway) includes suspended solids and contaminants bound to them (such as heavy metals and phosphorus); de-icing salt (chloride), oil and related compounds.</p> <p>Within the 500m study area, no CAR Licences are associated with the watercourse.</p>	medium

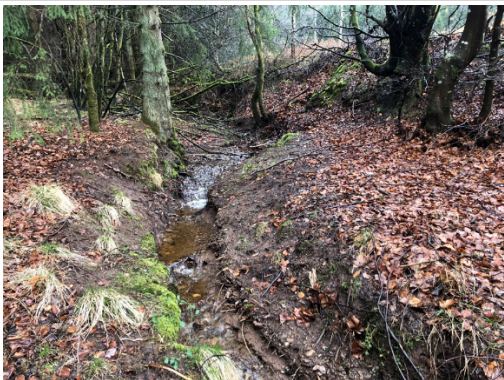
**Table A19.1-15: WF13**

<p><b>Photograph 15: WF13 – upstream view towards existing A9 culvert outlet (typical example of a small water feature)</b></p>	Water feature type: Minor watercourse
	Catchment Area: 0.97km <sup>2</sup>
	Key hydraulic connections: Sourced on the slopes west of Inver Wood, surrounding Creag Bheag. The water feature comprises of two channels that flow east and meet ~300m west of the A9, then flow as a single channel down to the A9, which it is culverted under to the north side of the Highland Main Line railway where it reappears and drains into the River Tay.
	Surrounding land use: Mixed forestry, ancient woodland, rough grazing, arable agricultural, road and rail infrastructure.
Description of Specific Baseline Conditions	
Flood Risk	
<p>This watercourse has a catchment area less than 3km<sup>2</sup> so is not included in the SEPA Flood Map.</p> <p>The hydraulic assessment indicates that the watercourse is out of bank upstream of the A9 in the design 0.5% AEP (200-year) plus CC event, however there is &gt;600mm freeboard to the A9 and therefore the flood risk is considered low.</p>	low

Hydromorphology	
<p>SEPA Morphology status: not classified.</p> <p>The watercourse displays a low sinuosity planform with step-pool and pool – riffle bedforms and flow types and plane bed features. Mid channel and point bars were noted. Relict boulders and trees provide bank controls where the channel is not artificially confined.</p> <p>Existing pressures:</p> <ul style="list-style-type: none"> <li>conveyed beneath the Old Military Road and local access track for approximately 6m by a stone arch culvert;</li> </ul>	high

<ul style="list-style-type: none"> <li>▪ culverted beneath the existing A9 for approximately 45m;</li> <li>▪ conveyed below the Highland Main Line railway through a for approximately 12m masonry arch bridge; and</li> <li>▪ bank and bed protection associated with existing structures.</li> </ul> <p>The watercourse is stable under the existing conditions, in that it appears to be competent to transport the water and sediment supplied from upstream without excessive erosion or deposition.</p>	
<b>Surface Water Quality</b>	
<p>SEPA Physico-chemical/ Biological elements/ Specific pollutants status: not classified.</p> <p>Low flow value (<math>Q_{95}</math>): 0.0043m<sup>3</sup>/s</p> <p>Located upstream of the River Tay SAC but the watercourse itself is considered to exhibit 'Moderate' ecosystem quality as conditions present are suitable for supporting a range of aquatic ecology including macroinvertebrates and macrophytes species.</p> <p>Diffuse run-off may occur from land uses within the catchment. The majority of the catchment comprises of ancient and historic woodland (~68%) which may be sources of sediment, dissolved organic carbon and nutrients. Run-off from urban development (including the existing A9 and the Highland Main Line railway) includes suspended solids and contaminants bound to them (such as heavy metals and phosphorus); de-icing salt (chloride), oil and related compounds.</p> <p>Within the 500m study area, no CAR Licences are associated with the watercourse.</p>	medium

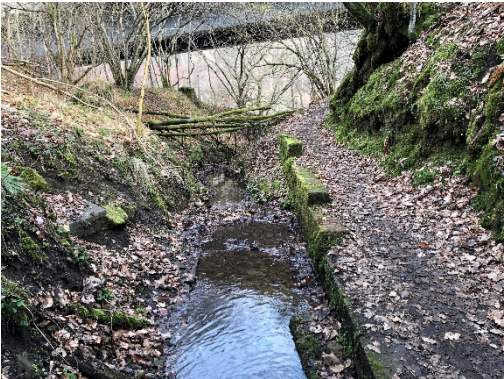
**Table A19.1-16: WF14**

<p><b>Photograph 16: WF14</b></p>	Water feature type: Minor watercourse	
	Catchment Area: 0.64km <sup>2</sup>	
	Key hydraulic connections: Sourced on the slopes between Creag an Eunaich and Creag Bheag. Channel flows north-east past Newton Craig, down to local roads west of the A9, which it passes under through structures, including the Highland Main Line railway and the A9, then drains into the River Tay where the A9 crosses the River Tay.	
	Surrounding land use: Mixed forestry, ancient woodland, road and rail infrastructure.	
Description of Specific Baseline Conditions		Importance
Flood Risk		
<p>This watercourse has a catchment area less than 3km<sup>2</sup> so is not included in the SEPA Flood Map. The watercourse crosses under the B898 through a masonry culvert (Crossing 14A). Downstream of this, it passes under the A9 Tay bridge where the bridge deck is several metres above the river level. The risk of flooding to the A9 is therefore negligible.</p> <p>The hydraulic assessment indicates that the watercourse is out of bank upstream of the B898 in the design 0.5% AEP (200-year) plus CC event. However, there is &gt;600mm freeboard to the A9 and therefore the flood risk to the B898 is considered low.</p>		low

Hydromorphology		
<p>SEPA Morphology status: not classified.</p> <p>The watercourse displays a low sinuosity planform with steep step-pool and uniform/tranquil flow types in the downstream reach. Bedforms comprise boulder steps and pools with plane-riffle and plane-bed features. Bed armor appears to be static and occasional alternate bars were seen along the watercourse.</p> <p>Existing pressures:</p>		medium

- watercourse passes under Inver Bridge, downstream of the masonry arch culvert below the Highland Main Line railway, and discharges into WF06 (River Tay). Right bank protection was observed to extend downstream of the masonry arch culvert prior to Inver bridge.

- The watercourse is stable under the existing conditions, in that it appears to be competent to transport the water and sediment supplied from upstream without excessive erosion or deposition.

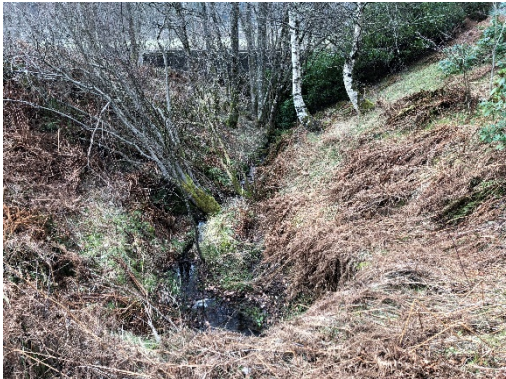
**Table A19.1-17: WF16**

<p><b>Photograph 17: WF16</b></p>	Water feature type: Minor watercourse
	Catchment Area: 0.29km <sup>2</sup>
	Key hydraulic connections: Sourced on western slope of Craig a Barns. Channel flows west, down to a local road east of the A9, which it passes under through structures, then continues east under the A9 and a local access, then drains into the River Tay.
	Surrounding land use: Mixed forestry, ancient woodland and road infrastructure.
Description of Specific Baseline Conditions	
Flood Risk	
<p>The catchment area is less than 3km<sup>2</sup> therefore is not shown on SEPA flood mapping.</p> <p>The hydraulic assessment indicates that the watercourse is in bank in the design 0.5% AEP (200-year) plus CC event. The A9 culvert capacity is greater than the 0.5% AEP (200-year) plus CC peak flow and there is a &gt;600mm freeboard to the A9, therefore the flood risk is considered to be low.</p> <p>The watercourse flows through an area of ancient woodland upstream of the A9 with hydrological low importance to the woodland. There are no other receptors within the vicinity of the watercourse and therefore the sensitivity is considered to be low.</p>	low

Hydromorphology	
<p>SEPA Morphology: not classified.</p> <p>The watercourse displays a low sinuosity planform with steep step-pool and uniform rapid flow types in upstream reaches where the channel is not heavily modified. Bedforms comprise boulder steps and pools upstream and downstream of the existing A9. Bed material comprises relic boulders, cobbles gravel and silt. Relic boulders provide natural bed and bank controls where the channel is not artificially modified.</p>	medium

The watercourse appears stable under the existing conditions and artificial constraints. However, there is little evidence to suggest that coarse sediment is being transported from upstream reaches to step-pool reaches downstream from the A9. Site observations indicate that this is likely to result from a combination of factors which may include: ephemeral flow regime, scarce sediment supply and constraints from existing culverts and concrete cascade steps upstream of the A9.

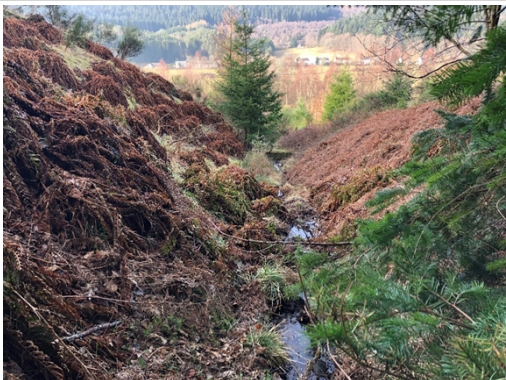
**Table A19.1-17: WF18**

<p><b>Photograph 17: WF18</b></p>	Water feature type: Minor watercourse
	Catchment Area: 0.17km <sup>2</sup>
	Key hydraulic connections: Sourced on western slope of Craig a Barns. Channel flows west, down to a local road east of the A9, which it passes under through structures, then continues east under the A9 and a local access, then drains into the River Tay.
	Surrounding land use: Mixed forestry, ancient woodland and road infrastructure.
Description of Specific Baseline Conditions	
Flood Risk	
<p>The catchment area is less than 3km<sup>2</sup> therefore is not shown on SEPA flood mapping.</p> <p>The hydraulic assessment indicates that the watercourse is in bank and below the A9 road level in the design 0.5% AEP (200-year) plus CC event. However, the A9 culvert capacity is greater than the 0.5% AEP (200-year) plus CC peak flow and there is a &gt;600mm freeboard to the A9, therefore the flood risk is considered to be low.</p> <p>The watercourse flows through an area of ancient woodland upstream of the A9 with hydrological low importance to the woodland. There are no other receptors within the vicinity of the watercourse and therefore the sensitivity is considered to be low.</p>	low

Hydromorphology	
<p>SEPA Morphology: not classified.</p> <p>The watercourse displays a low sinuosity planform with steep step-pool and uniform rapid flow types in upstream reaches where the channel is not heavily modified. Bedforms comprise boulder steps and pools upstream and downstream of the existing A9. Bed material comprises relic boulders, cobbles gravel and silt. Relic boulders provide natural bed and bank controls where the channel is not artificially modified.</p>	medium

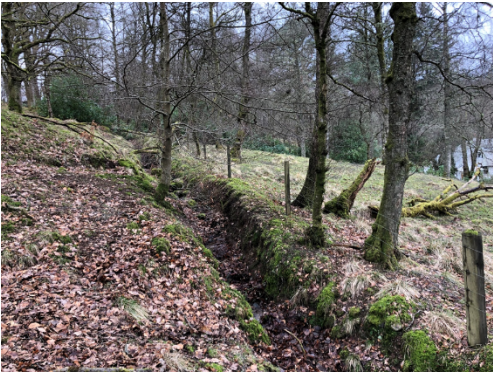
**Table A19.1-18: WF186**

<p><b>Photograph 18: WF186</b></p>	Water feature type: Drainage channel
	Catchment Area: 0.05km <sup>2</sup>
	Key hydraulic connections: Channel runs through woodland from Larachmhor cottage to Craigmore cottage.
	Surrounding land use: Ancient woodland, urban.
Description of Specific Baseline Conditions	
Flood Risk	
<p>This watercourse has a catchment area less than 3km<sup>2</sup> so is not included in the SEPA Flood Map.</p> <p>This short (112m) ditch dug broadly along a contour does not appear to have an outlet and no significant impact on the conveyance route of the catchment runoff it intercepts. The ditch may have been dug to reduce the risk of flooding from surface runoff from the steep hillside to the cottages situated downslope and may provide minor storage (flood attenuation) and encourage infiltration into the ground. Multiple properties are located within 100m of the watercourse at Birnam Glen. The water feature is not a source of flood risk to the scheme.</p>	low

Hydromorphology	
<p>SEPA Morphology status: not classified.</p> <p>The watercourse displays a low sinuosity planform with steep step-pool and uniform tranquil flow types in upstream reaches. Bedforms comprise boulder steps and pools with plane-bed features on shallower gradients. Relic boulders which provide frequent bed and bank controls where the channel is not artificially confined. Evidence of localised berm formation upstream (~0.45m wide) suggests a recovery in sinuosity. Flow appears to discharge to ground upon reaching the Highland Main Line railway where there was no evidence of a culvert with no obvious hydrological connection to the existing A9 or the River Tay.</p> <p>Existing pressures:</p>	low

<ul style="list-style-type: none"> <li>▪ culverted below a local access road from Craigbeithe for approximately 3.5m; and</li> <li>▪ confined by a masonry stone wall, upon exit from the culvert, for approximately 15m on the left bank and 7m on the right bank.</li> </ul> <p>The watercourse cannot be assessed as “stable” under the current conditions in that it has been so heavily modified and subjected to ephemeral flow conditions that natural channel morphology criteria cannot be applied. However, no evidence of excessive erosion or deposition was noted.</p>	
<b>Surface Water Quality</b>	
<p>SEPA Physico-chemical/ Biological elements/ Specific pollutants status: not classified.</p> <p>Low flow value (<math>Q_{95}</math>): not applicable, artificial drainage channels.</p> <p>Diffuse run-off may occur from land uses within the catchment. The majority of the catchment comprises of ancient and historic woodland which may be sources of sediment, dissolved organic carbon and nutrients. Run-off from urban development includes suspended solids and contaminants bound to them (such as heavy metals and phosphorus); de-icing salt (chloride), oil and related compounds.</p> <p>Within the 500m study area, no CAR Licences are associated with the watercourse.</p>	low

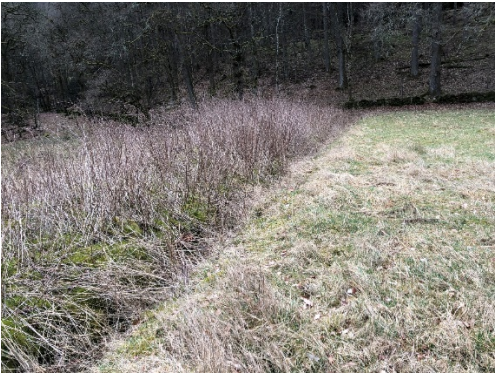
**Table A19.1-18: WF187**

<p><b>Photograph 19: WF187</b></p>	Water feature type: artificial drainage channels and ponds
	Catchment Area: N/A
	Key hydraulic connections:
	Surrounding land use: Landfill site, mixed woodland, urban.
Description of Specific Baseline Conditions	
Flood Risk	
These water features have a catchment area less than 3km <sup>2</sup> so is not included in the SEPA Flood Map. Small surface drains and ponds associated with Ladywell Landfill that do not drain to the A9. There is therefore no flood risk anticipated.	low
Hydromorphology	
WFD hydromorphology status: not classified. Trapezoidal drainage ditches associated with Ladywell Landfill, which display no clear hydrological connection to the existing A9 or the proposed scheme. As WF187 is an artificial land drain it displays no natural channel morphology or flow types and is likely ephemeral.	low
Surface Water Quality	
SEPA Physico-chemical/ Biological elements/ Specific pollutants status: not classified. Low flow value (Q <sub>95</sub> ): not applicable, artificial drainage channels. Diffuse run-off may occur from land uses within the catchment. The majority of the catchment comprises of the Ladywell Landfill site, and may contain sources of contaminants associated with present use and its historic use as a quarry. Within the 500m study area, no CAR Licences are associated with the watercourse.	low
