Forth Replacement Crossing

Employer's Delivery Team Construction Vibration Monitoring Report

> M9 Junction 1a Contract (November 2012)

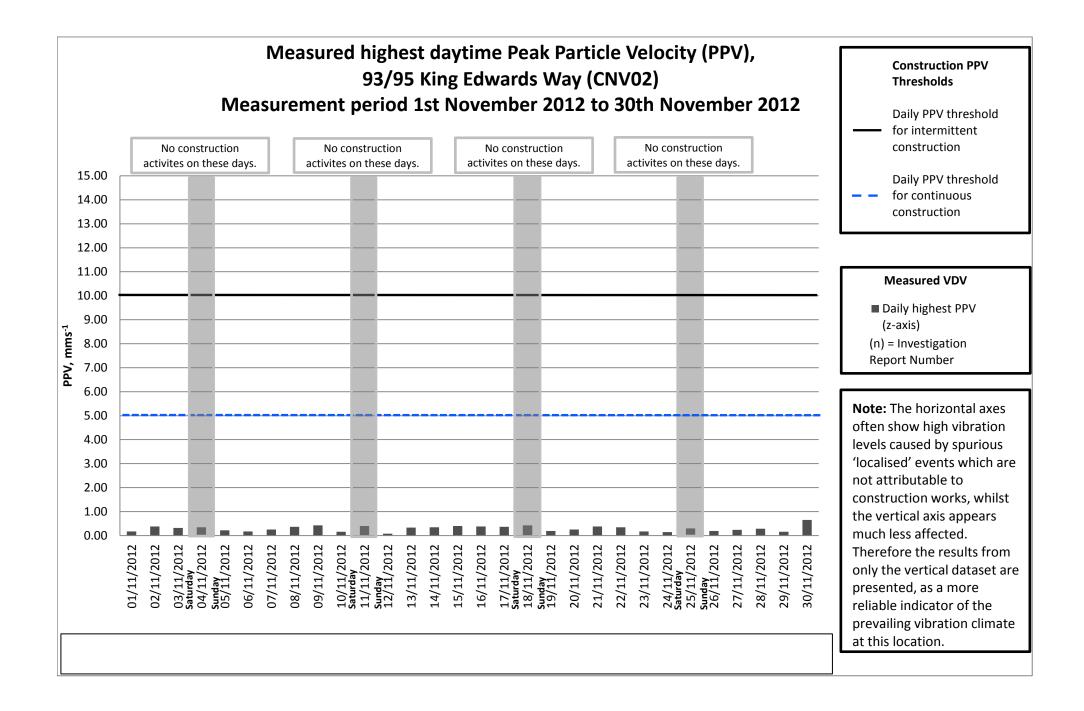
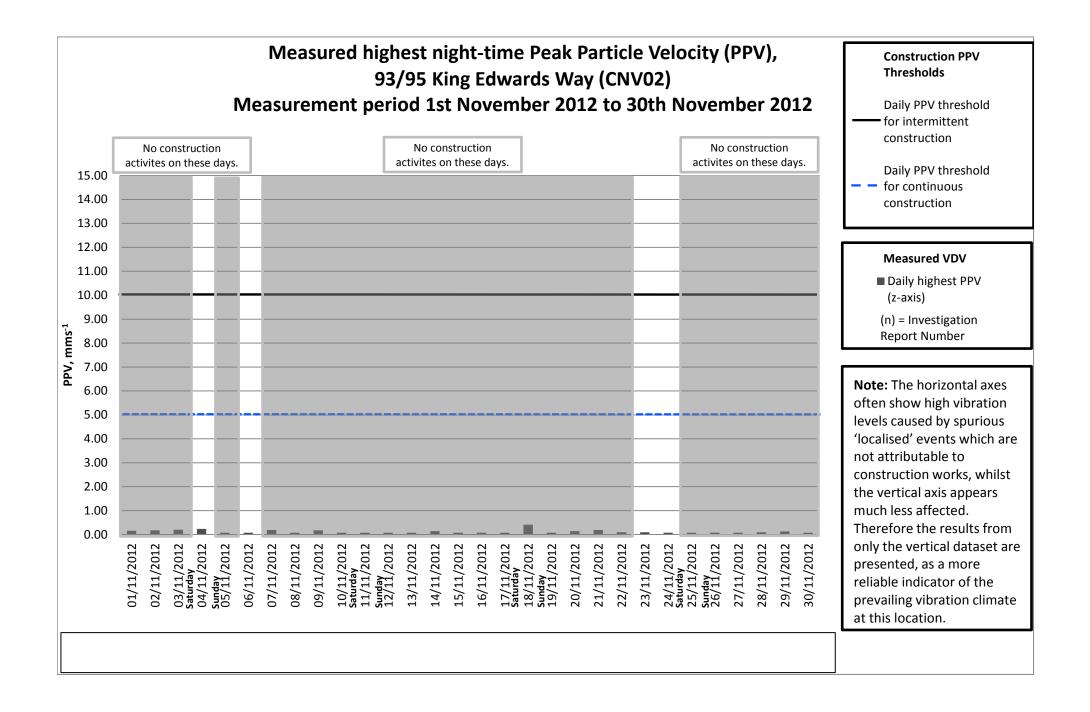
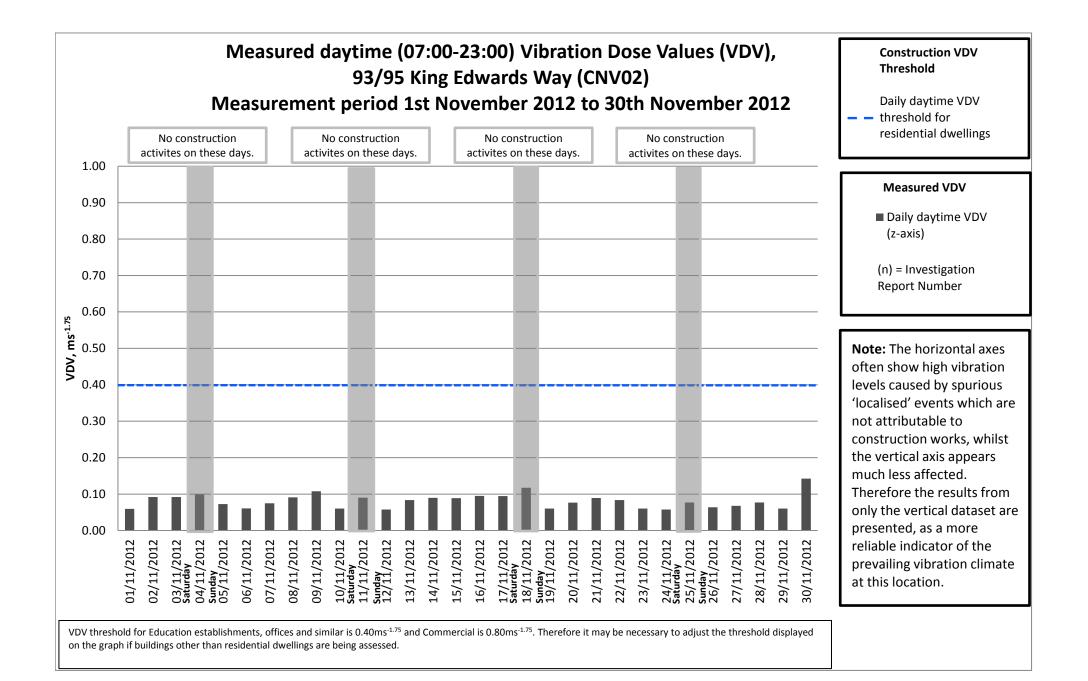
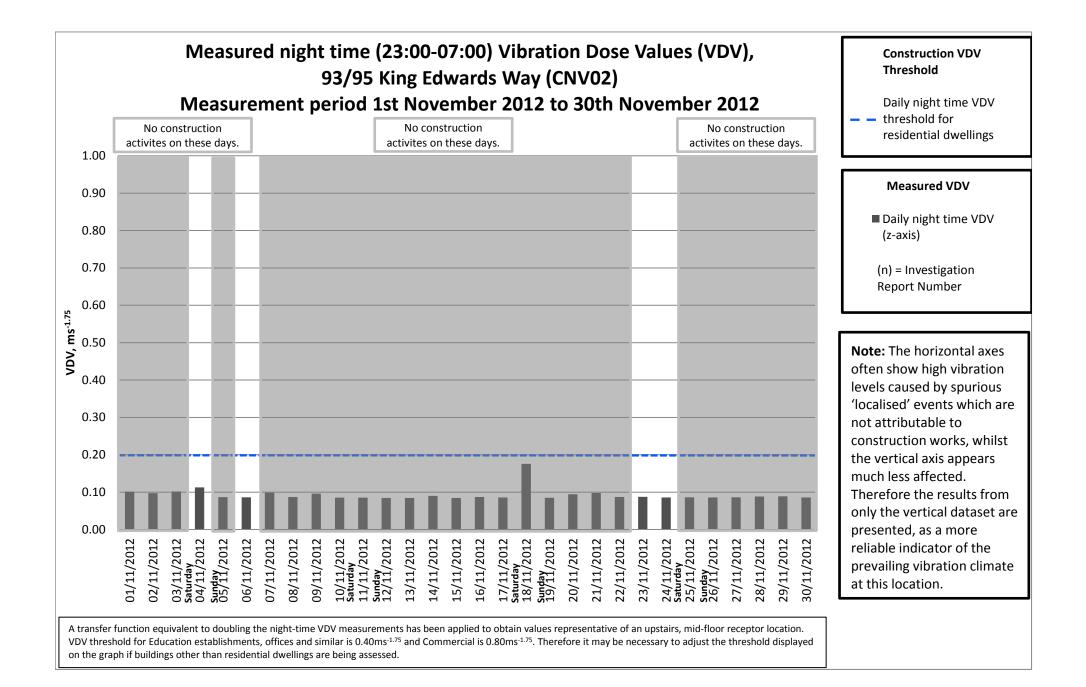
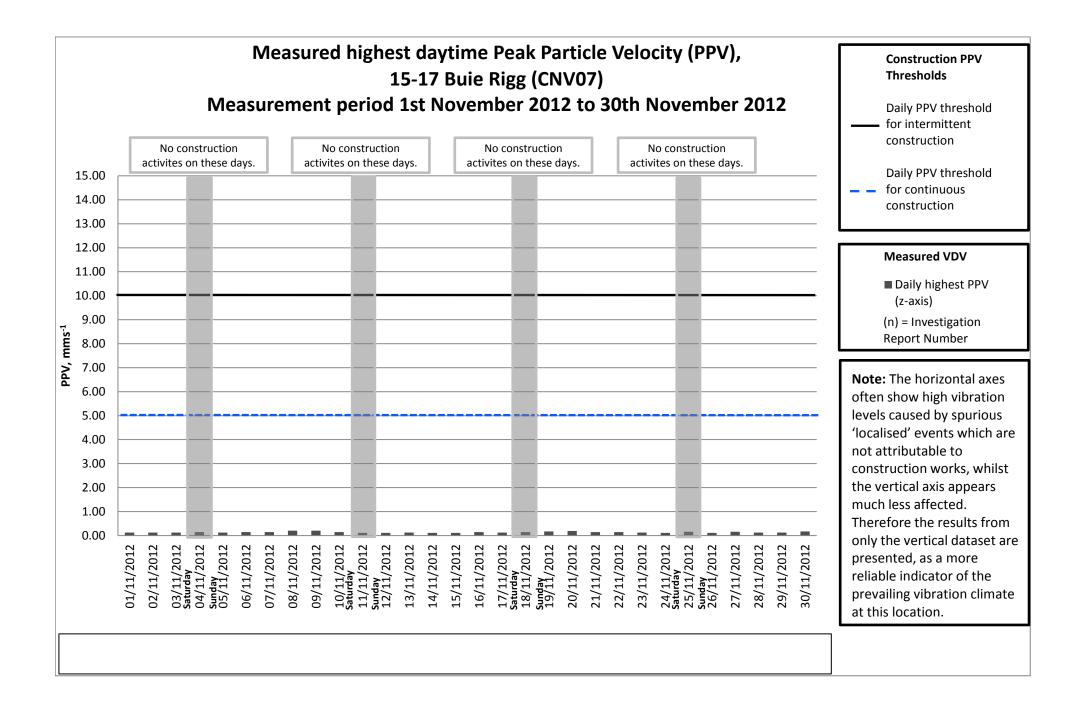
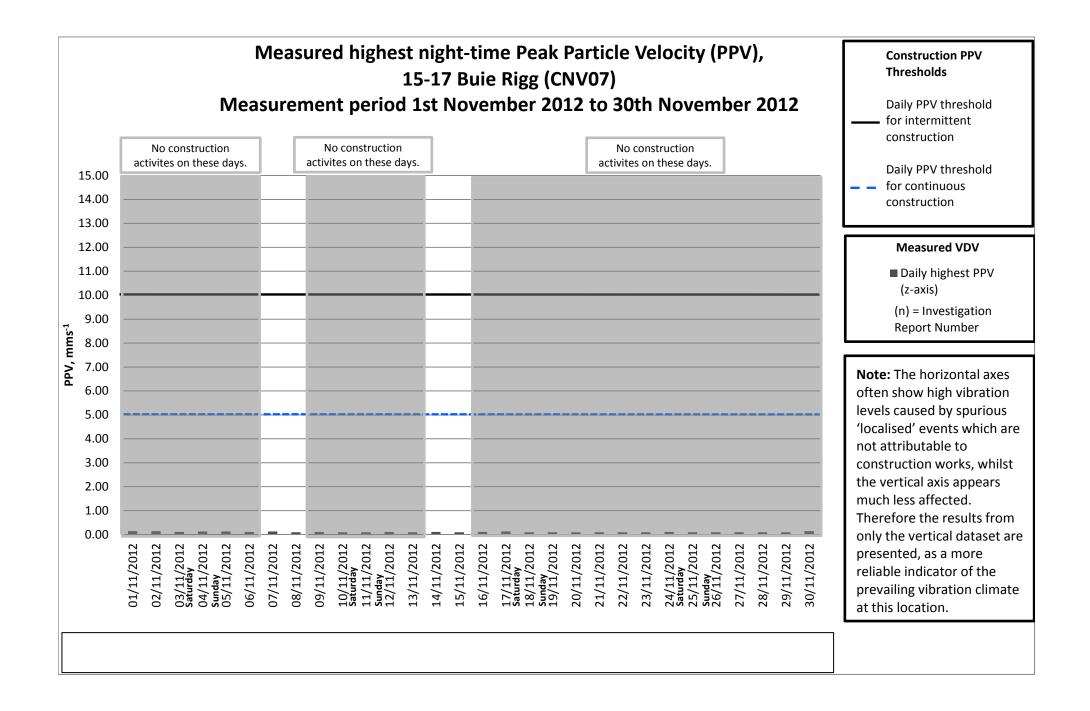
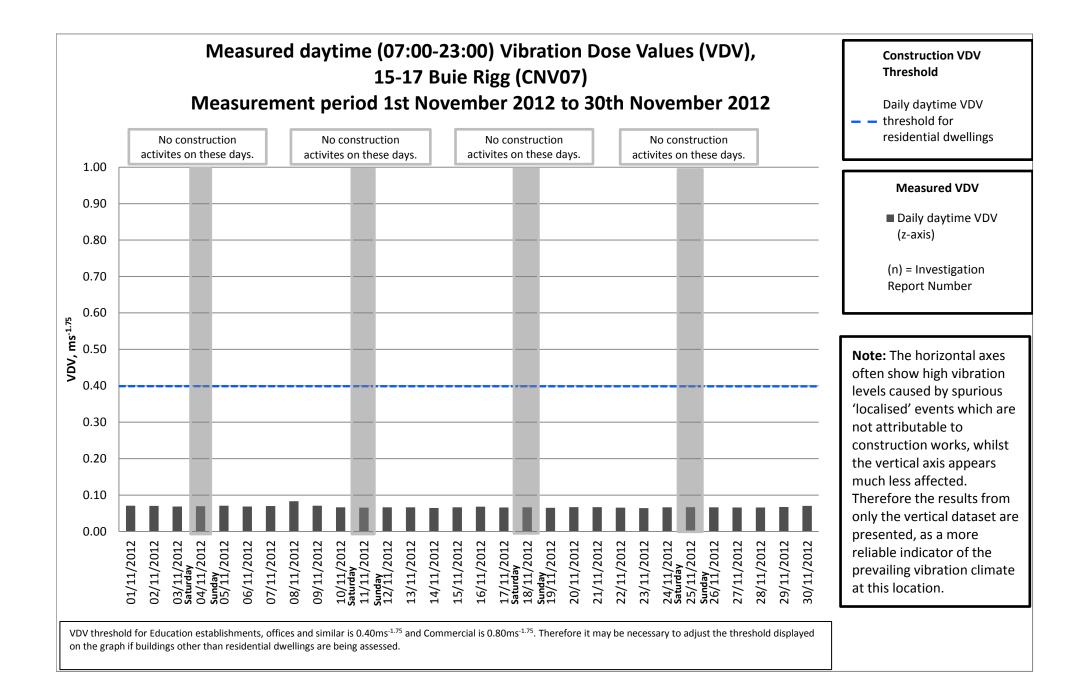
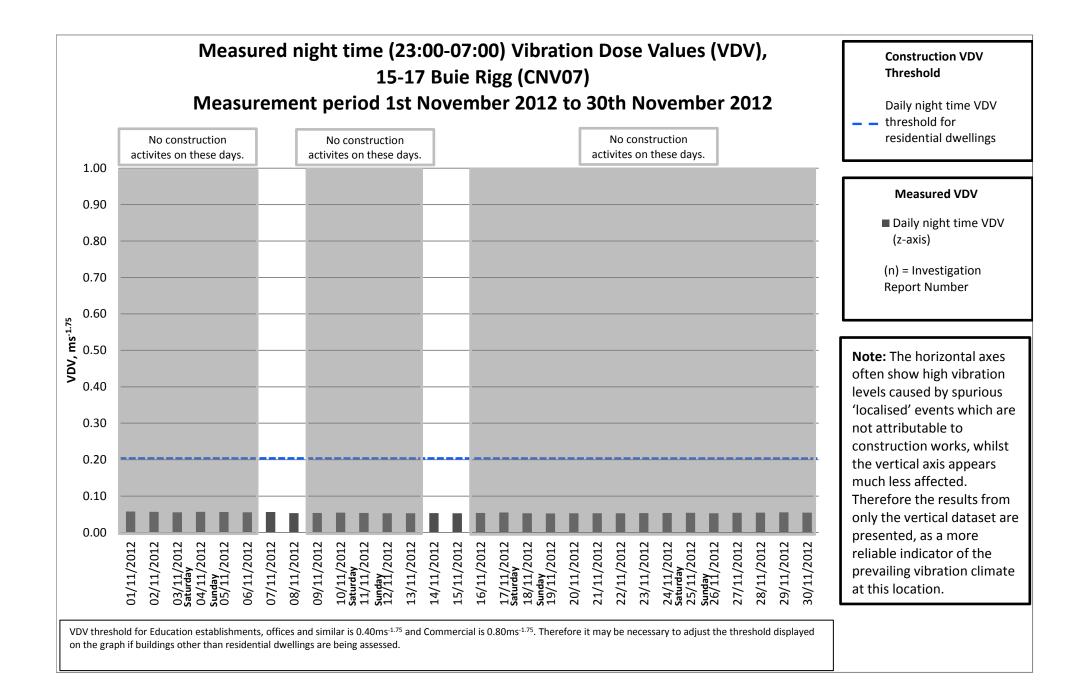
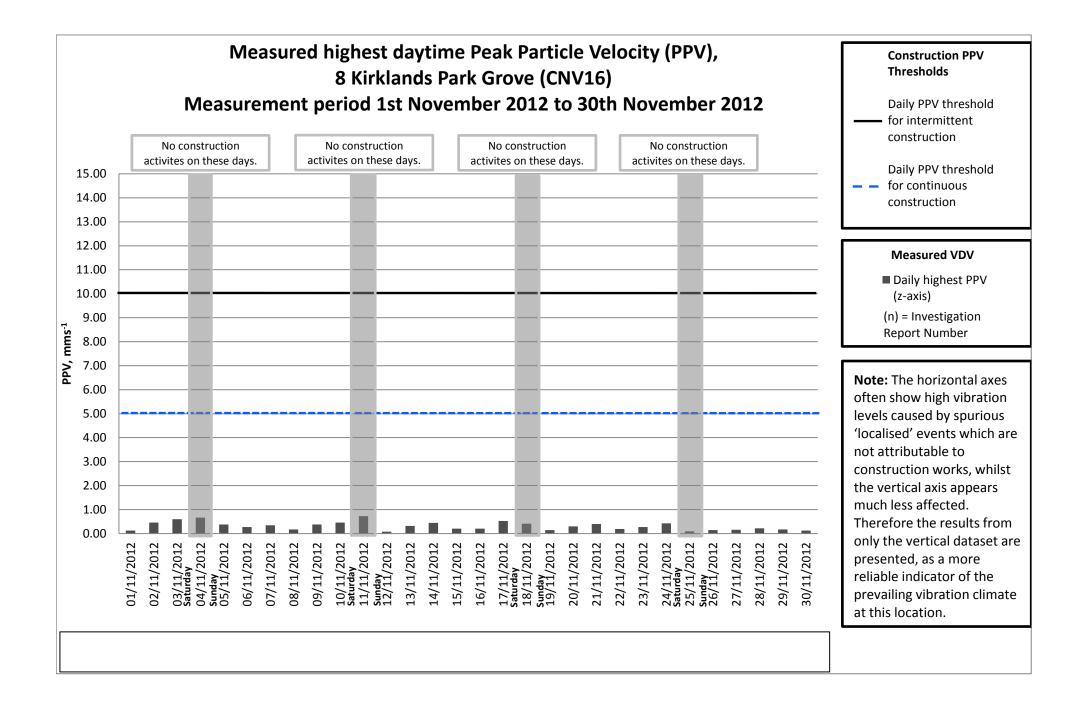
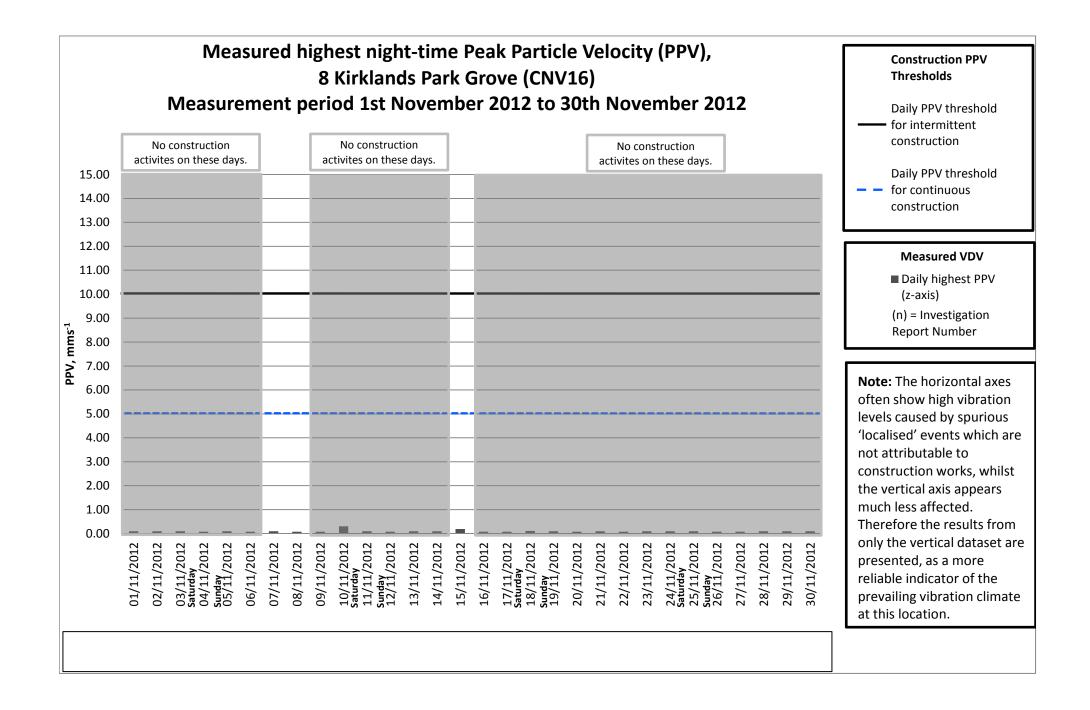
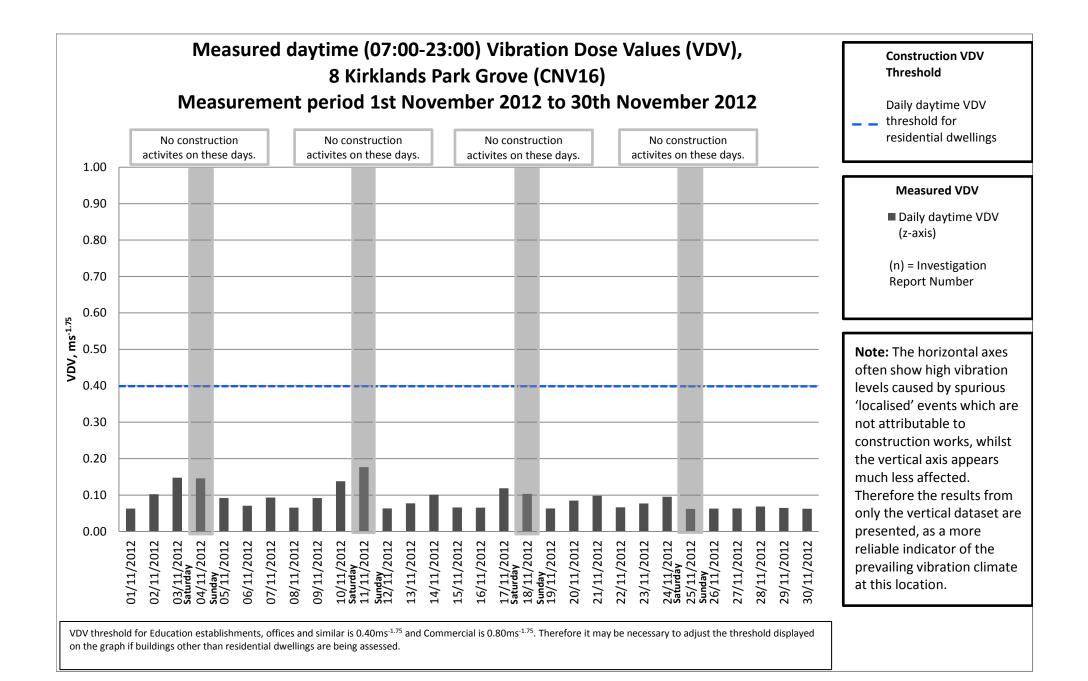
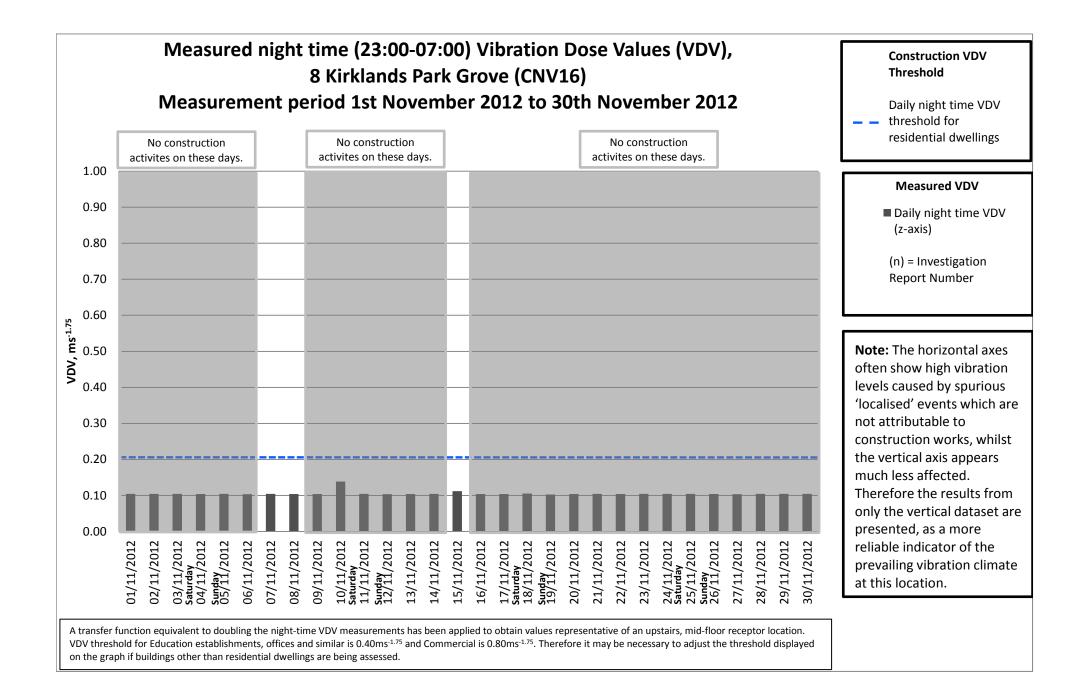
APPENDIX A – M9 J1A CONTRACT CONSTRUCTION VIBRATION CHARTS

- 2.2 The results of the M9 J1a Contract construction vibration monitoring are provided in chart format in Appendix A of this report.
- 2.3 The charts show the Vibration Dose Values (VDV) and Peak Particle Velocities (PPV) recorded at receptors. VDV levels are recorded in order to monitor the potential for disturbance to the occupants of buildings (as discussed in BS 6472) and PPV values are recorded in order to monitor the potential for damage to buildings (as discussed in BS 7385).

- 2.4 The charts indicate that all construction activities in the period were carried out in accordance with the vibration thresholds set out in the project Code of Construction Practice.
- 2.5 No exceedances of the VDV threshold level were recorded in the month of November.
- 2.6 No exceedances of the PPV threshold level were recorded in the month of November.
