# FORTH REPLACEMENT CROSSING

# **CONSTRUCTION NOISE MONITORING REPORT: DECEMBER 2014**

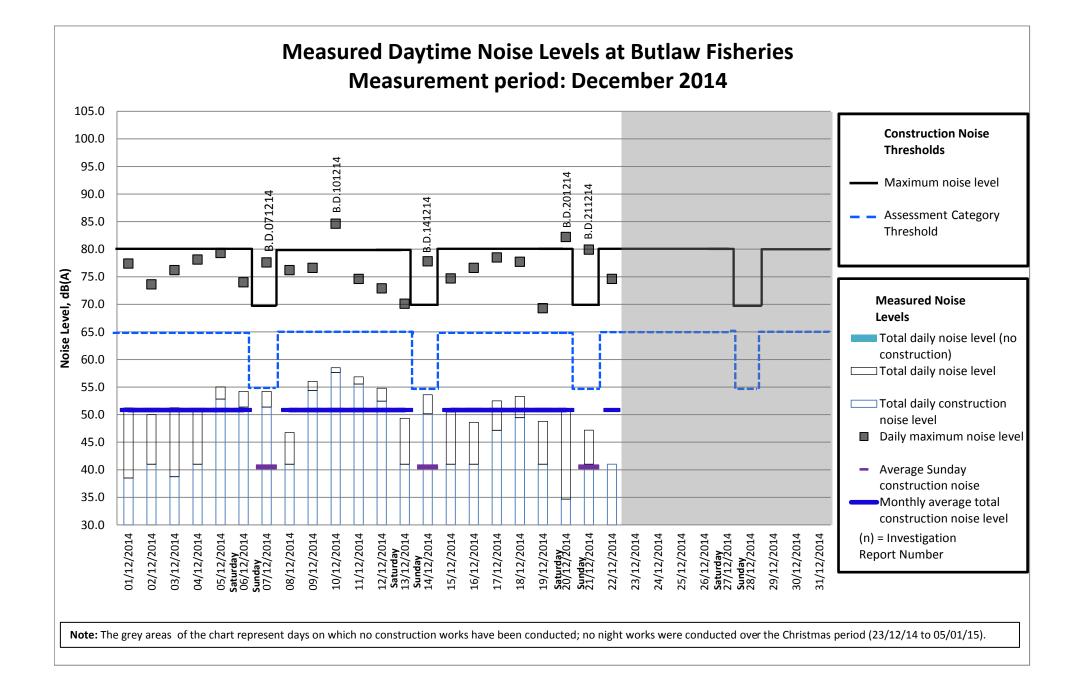
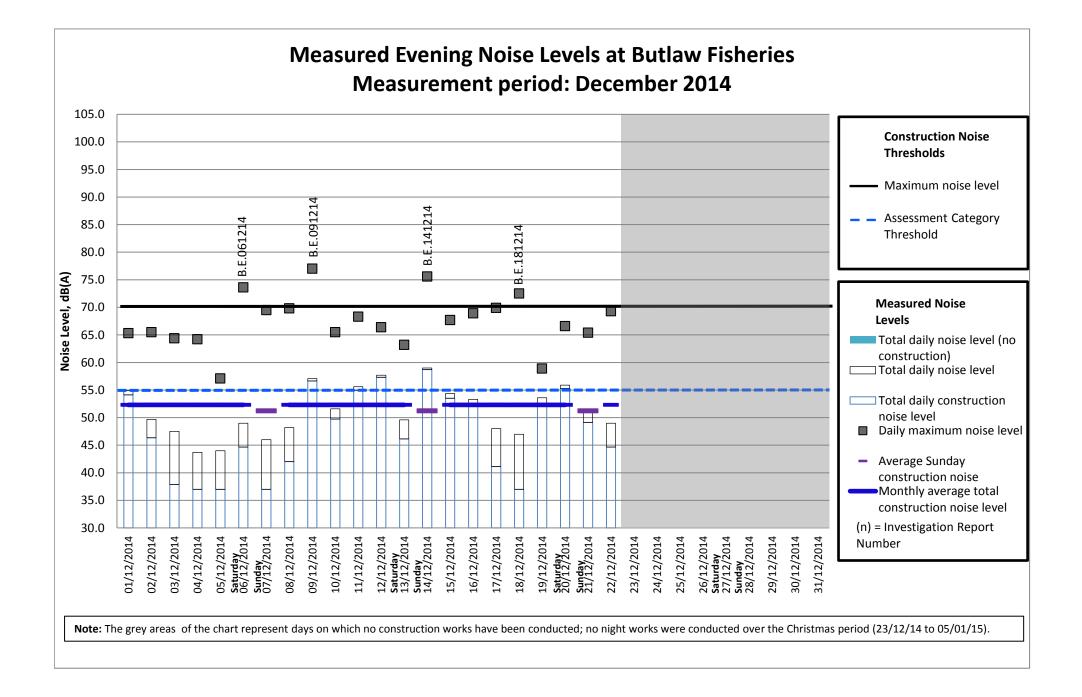
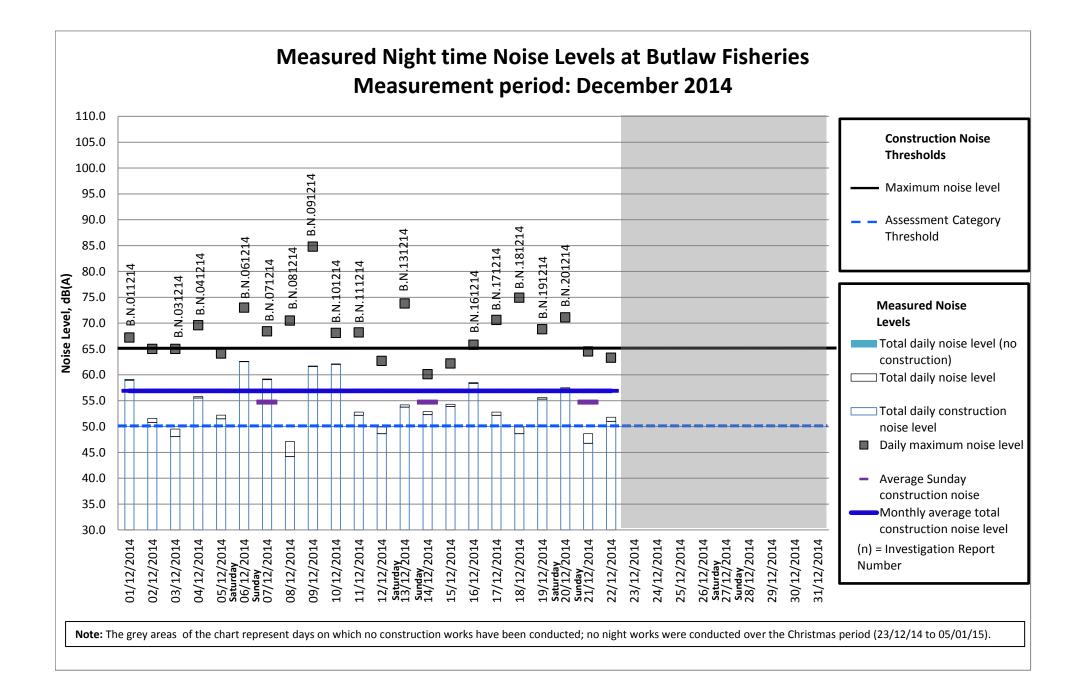
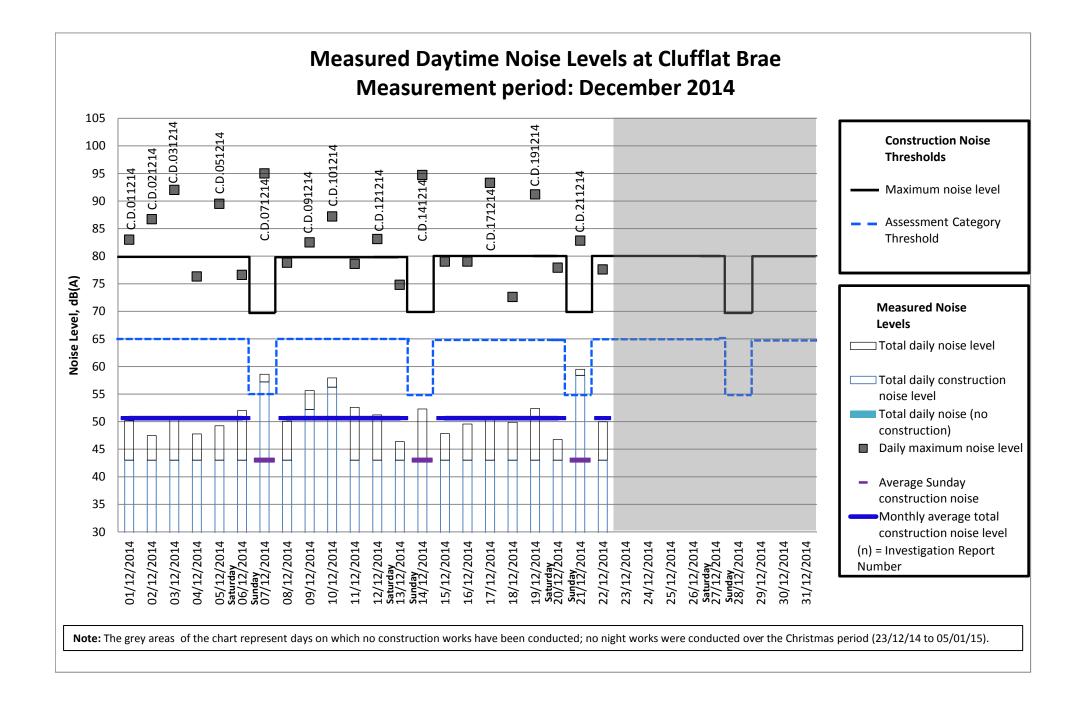
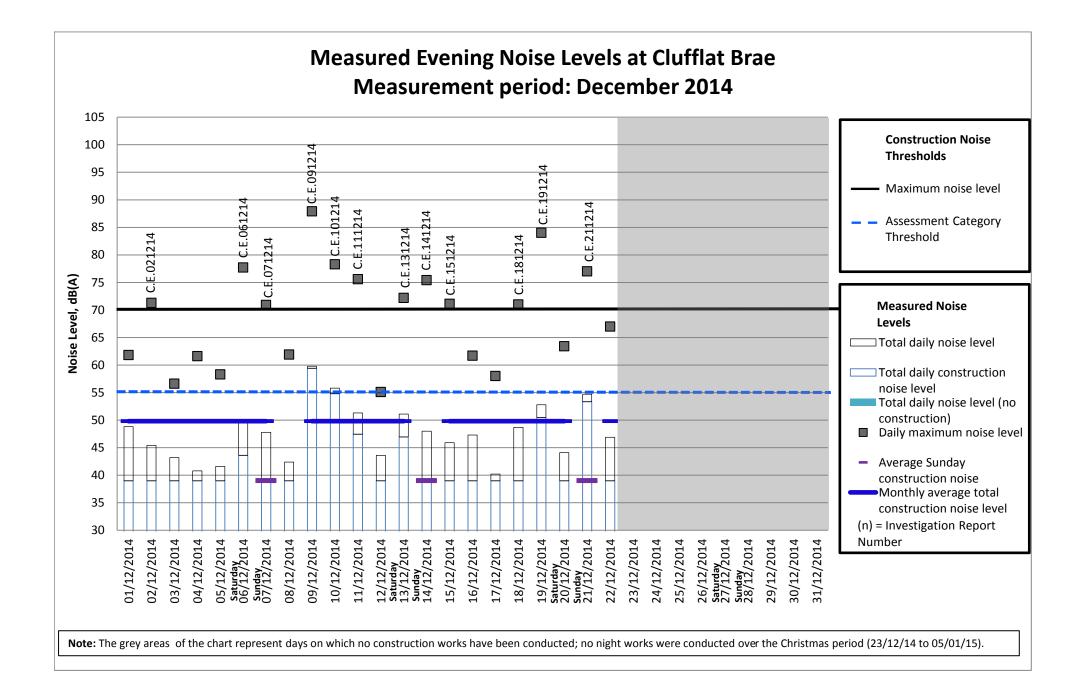
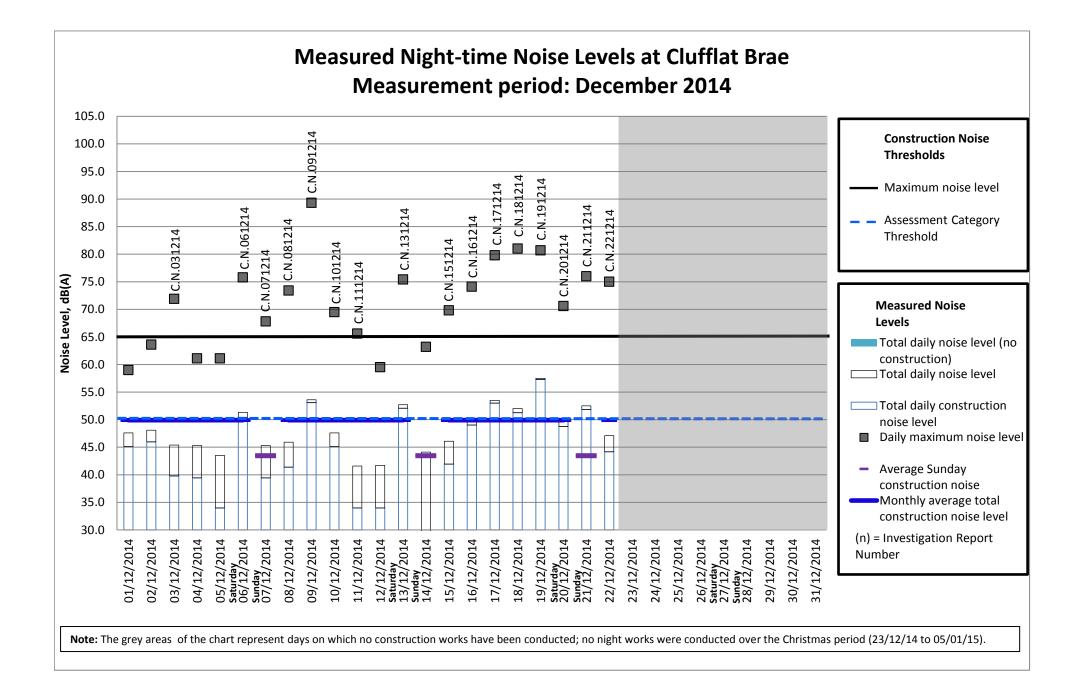
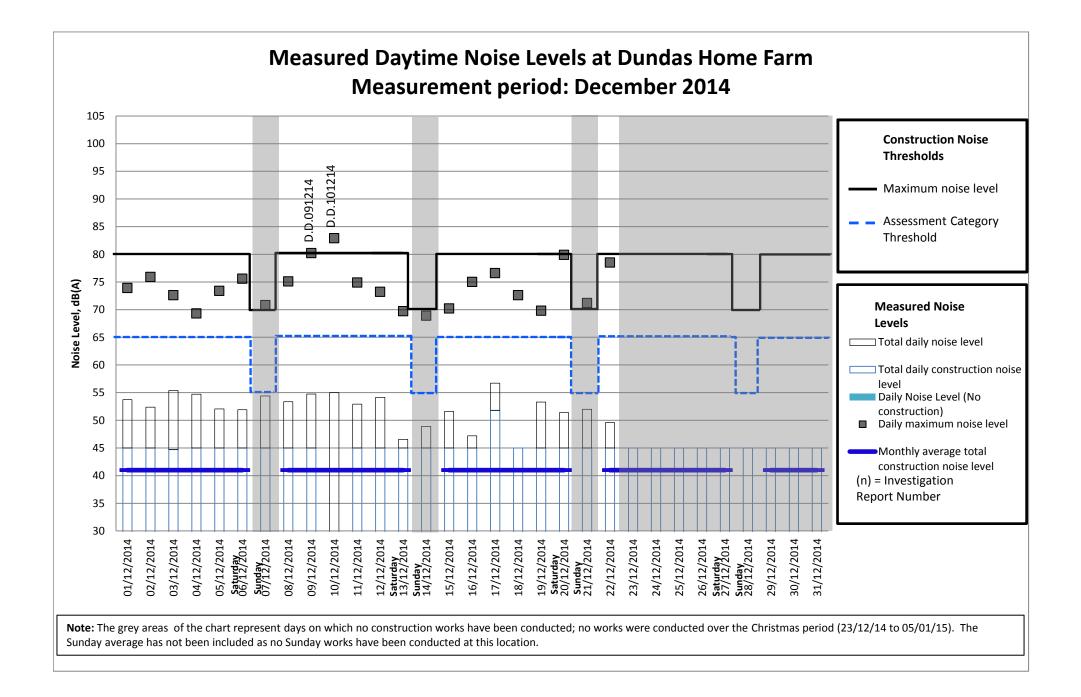
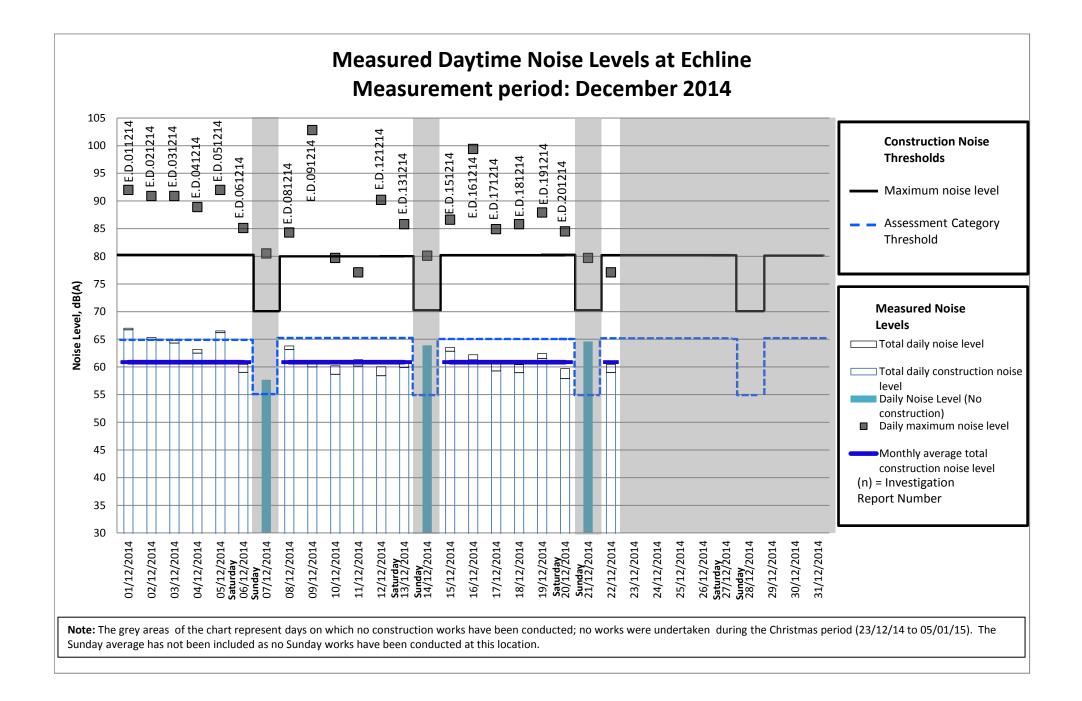
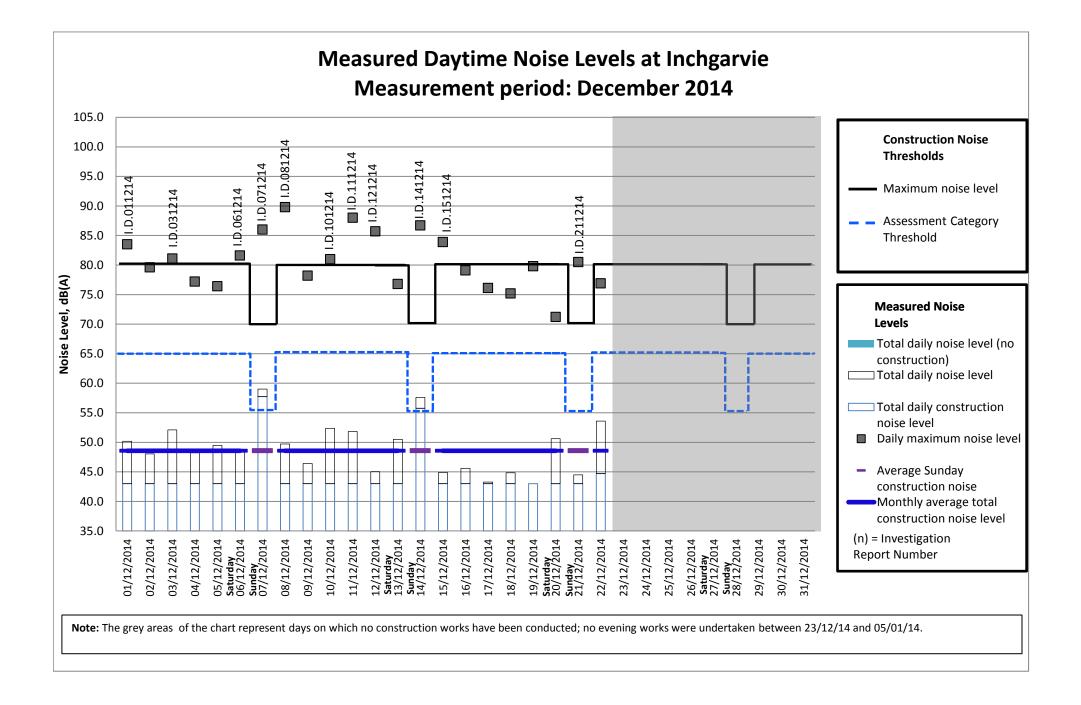
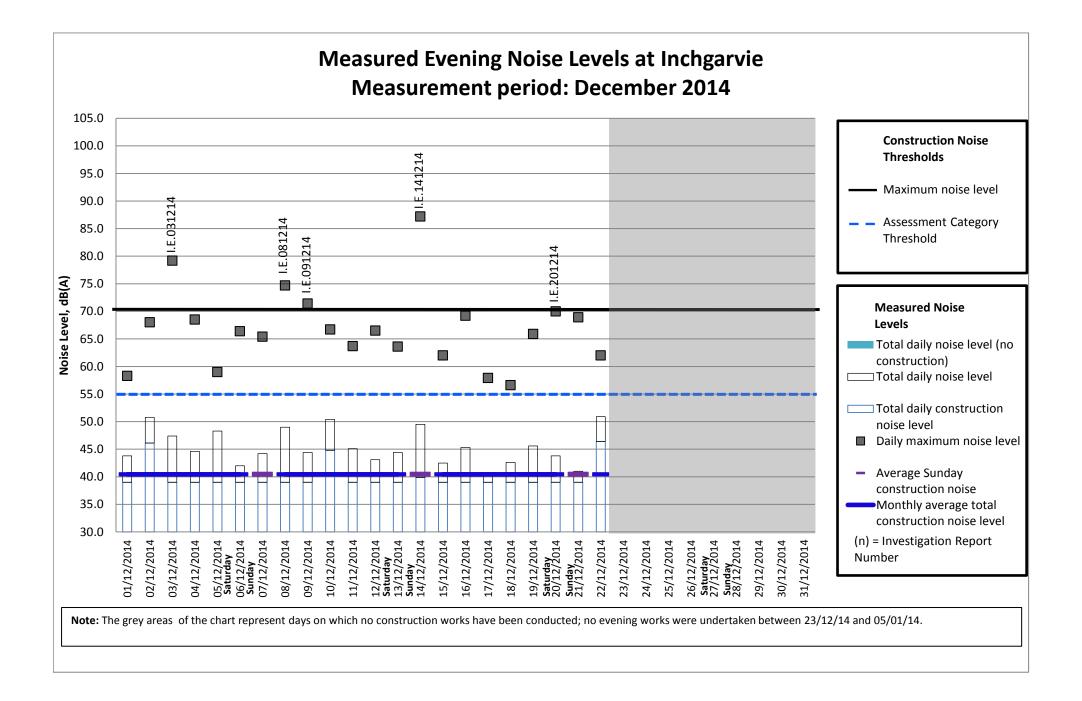
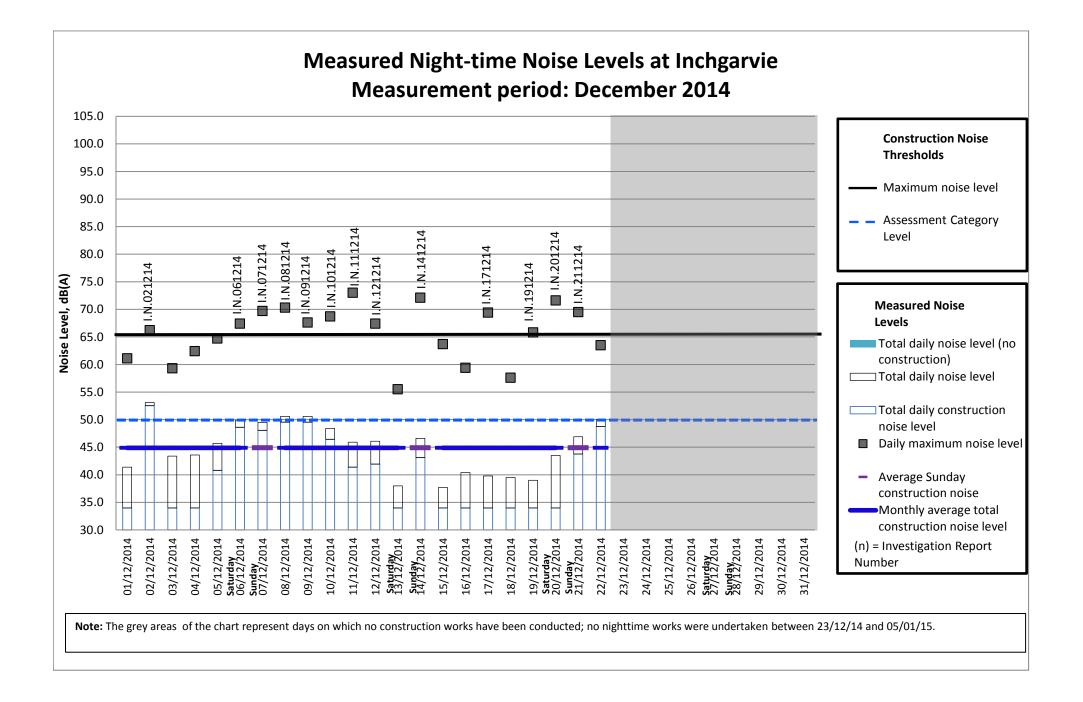
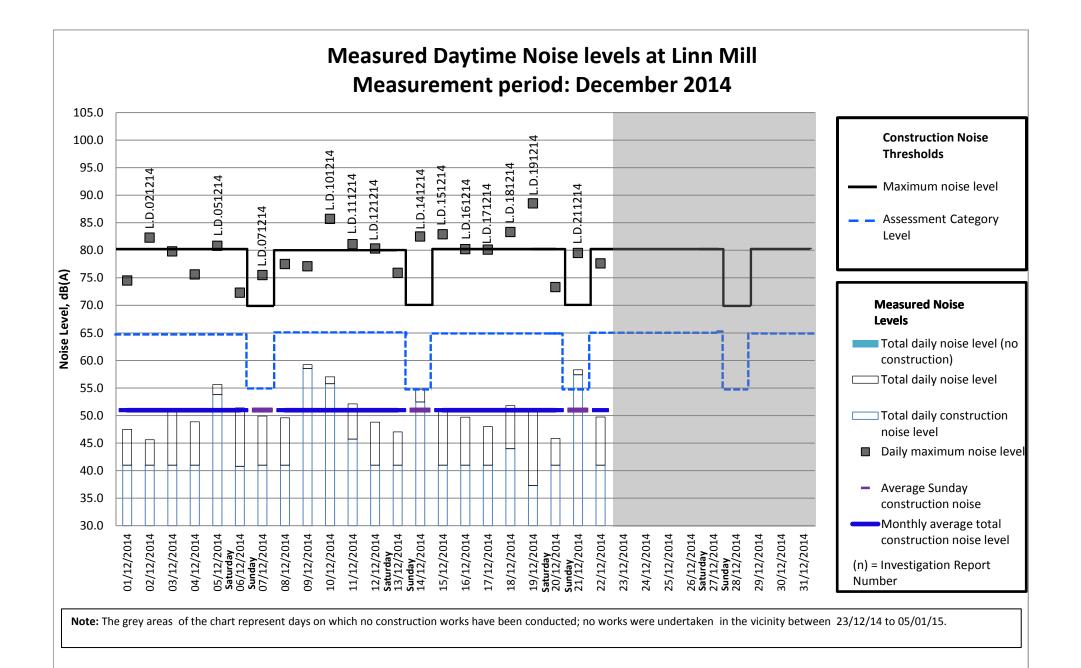
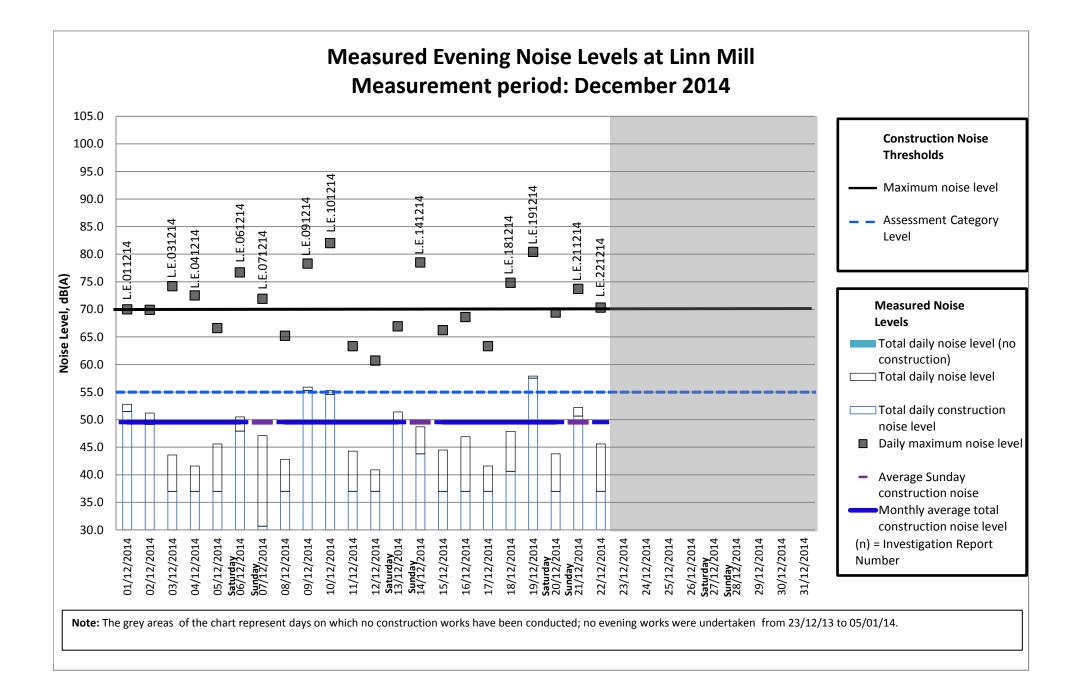
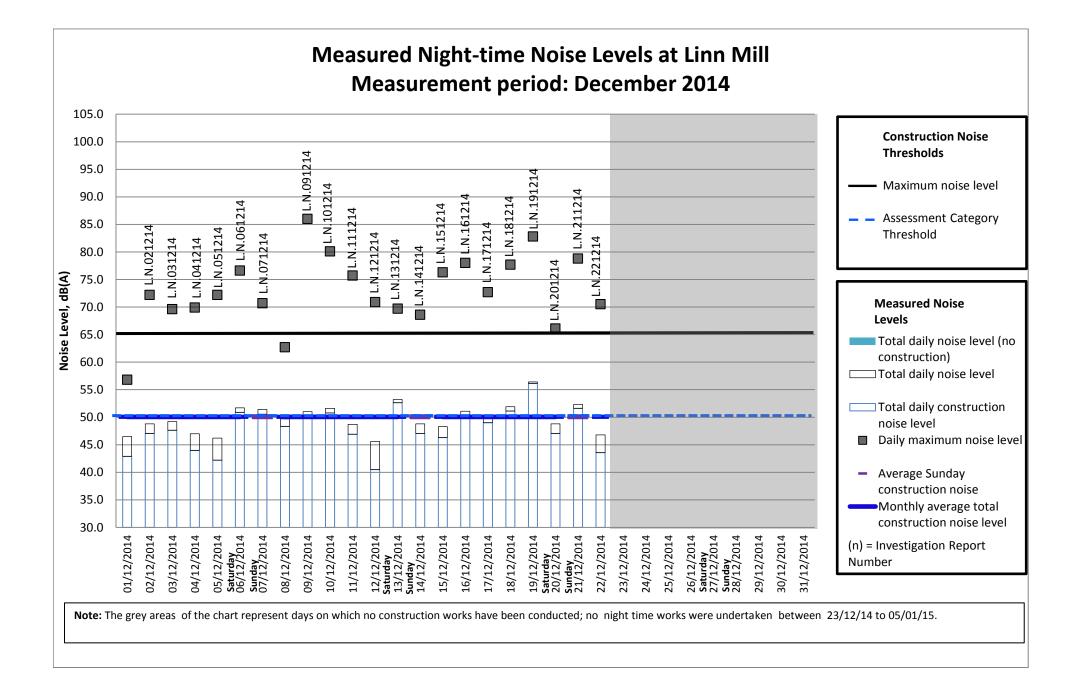
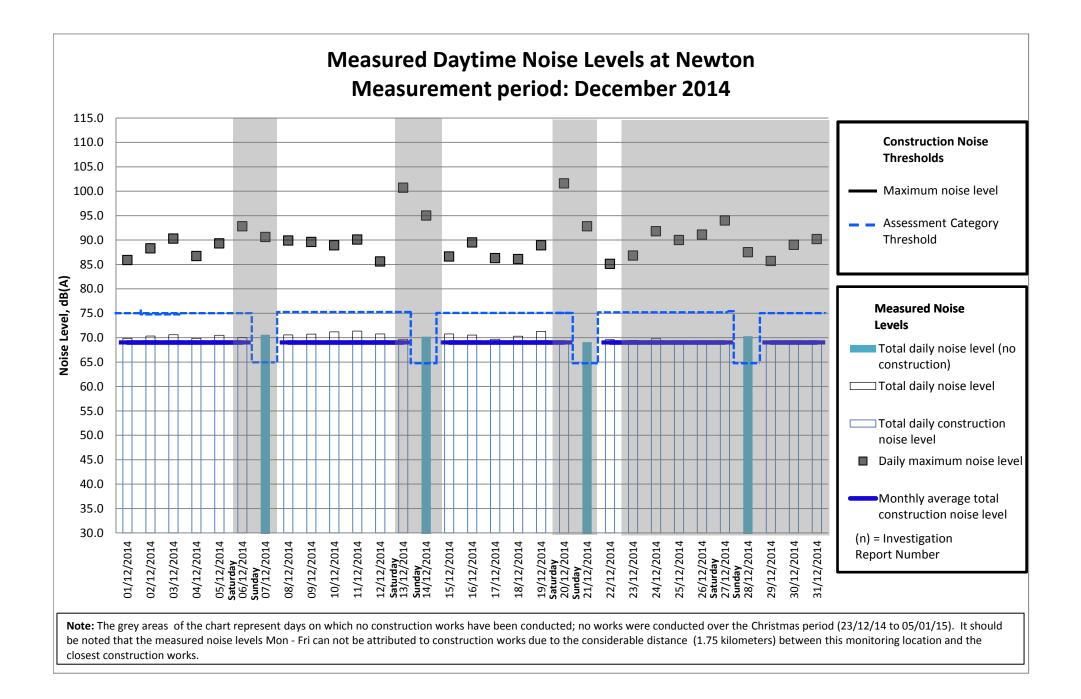
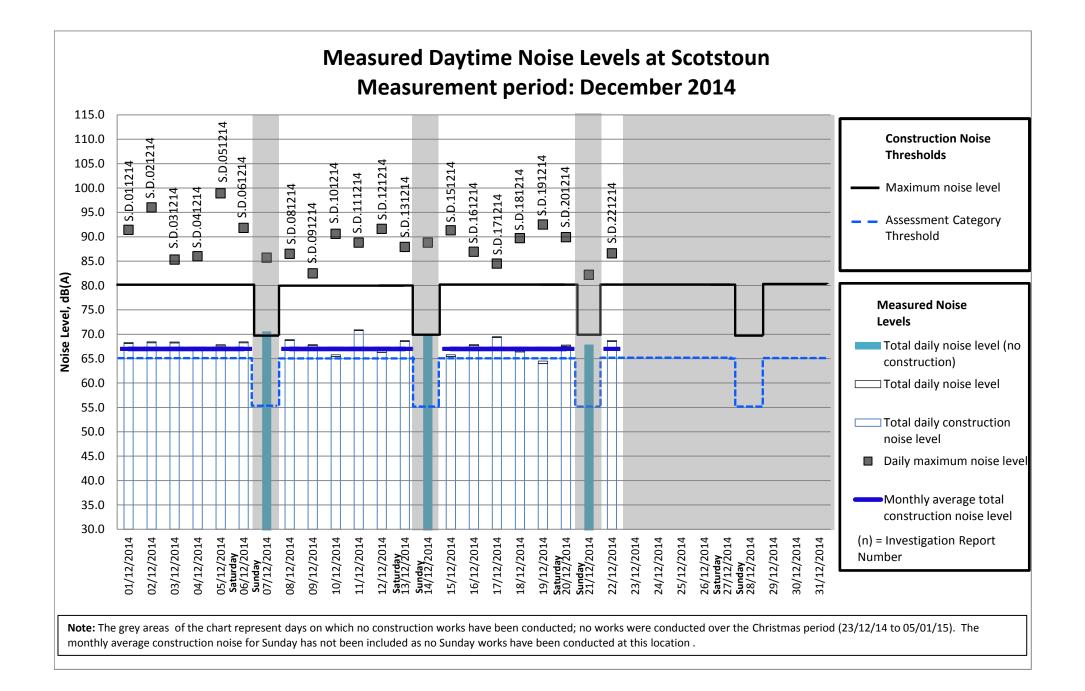
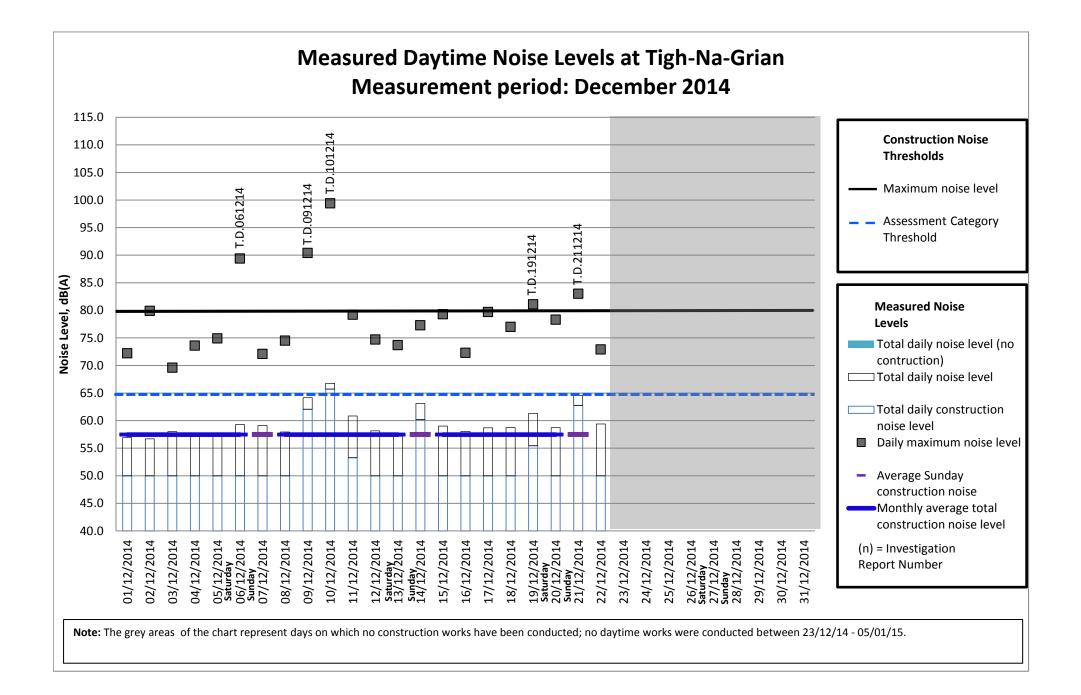
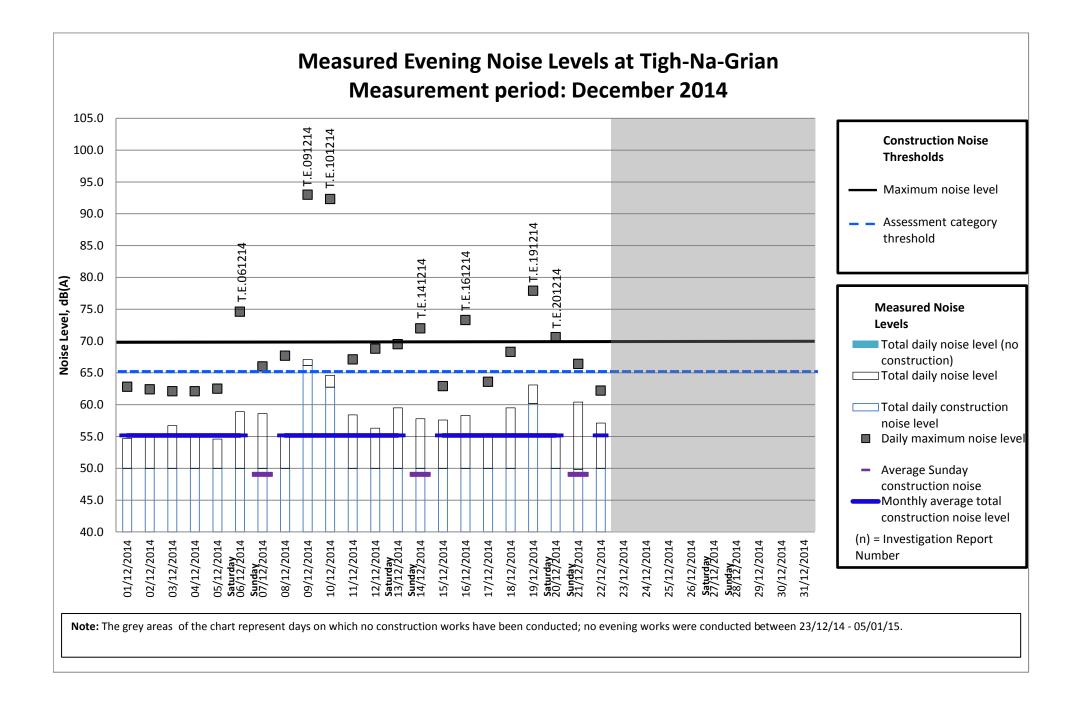
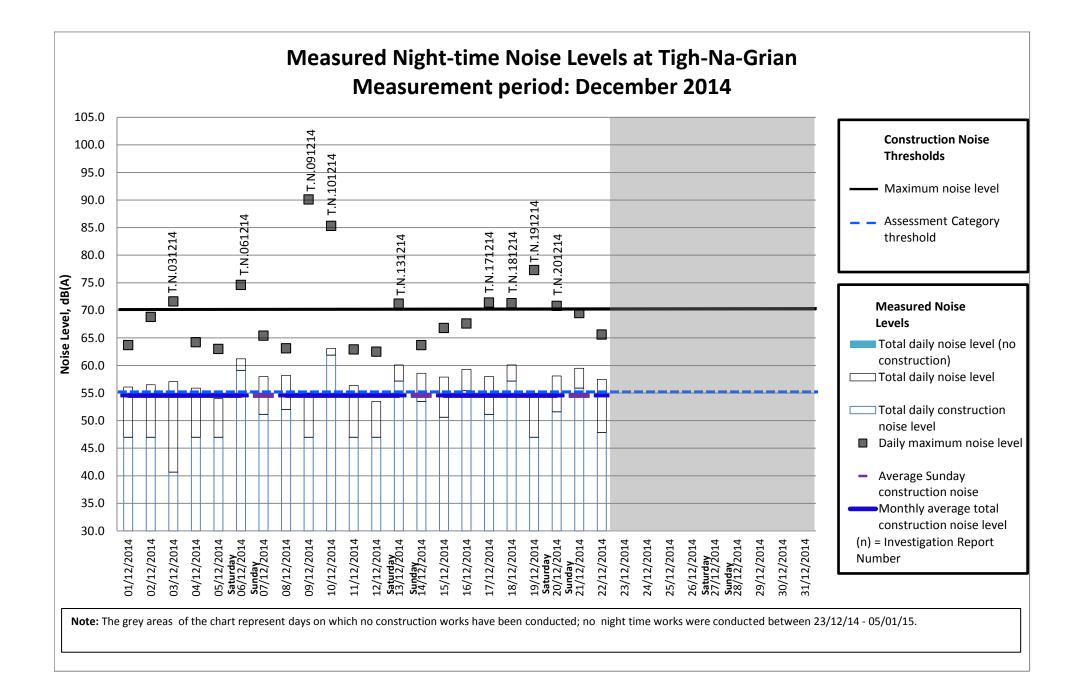
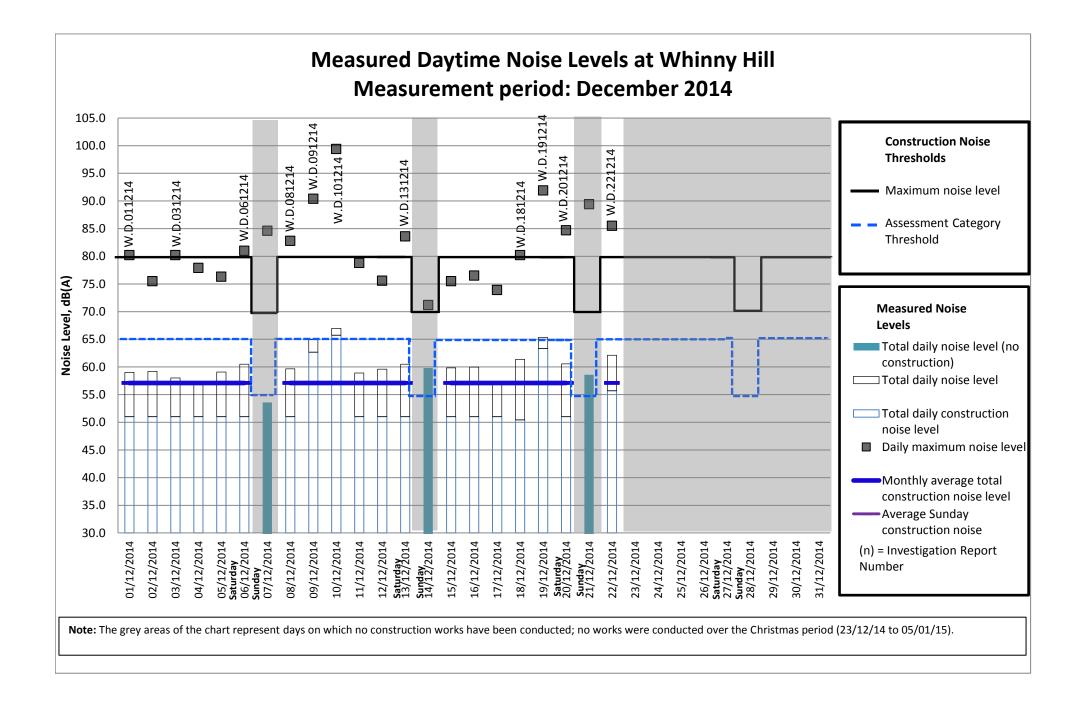
**APPENDIX A**

- **3.1** All noise monitoring results for construction days have been presented in charts using the template provided in the Construction Noise Monitoring Information Note, as available on the project website (<u>http://www.transportscotland.gov.uk/files/documents/projects/forth-replacement/FRC\_Construction\_Noise\_Monitoring\_Information\_Note\_2\_.pdf</u>). All charts can be found in the appendices of this report.

- **3.2** With regard to the noise monitoring results charts, the following should be noted:
  - All locations are considered as either 'Main Crossing' or 'Network Connections', as set out in Table 1. Main Crossing works are undertaken during the day, evening and night time periods. Network connection works, however, are undertaken during the daytime only. The inclusion of data in the graphs reflects this. Although Linn Mill is considered as a network location, the potential for marine works near the south shore to be heard has been recognised. As a result, evening and night time data has been included for this location although no network connection construction activities have been undertaken during these periods.

- Noise data for days, evening and nights on which no construction works were conducted have been excluded from the monthly average results presented in the graph. Additionally, no investigations into the L<sub>AFmax</sub> exceedances during these periods have been made as they would have been caused by non-construction related factors. However, noise results (L<sub>Aeq</sub> and L<sub>AFmax</sub>) for any days, evenings and nights on which no construction works have been conducted have been presented in the graphs in greyed out areas.

- An average for Sunday construction noise data has been included on the graphs where applicable; in locations where no Sunday works have been undertaken no average is shown.

- As set out in the CoCP, the assessment time for evening, nights and Sunday daytime is 1 hour periods. To present the construction noise results for these periods, therefore, the maximum L<sub>AFmax</sub> (fast time response) and maximum L<sub>Aeq</sub> within the overall evening/night time period has been taken. It should be noted, therefore, that the average shown for these periods is an average of only the highest L<sub>Aeq</sub> results.

- Where noise data is missing for days, evening or nights during which construction works were conducted, this has been indicated. Results for Northleg are unavailable due to inaccessibility of the location. Springfield location were temporarily down due to logistical difficulties and will be reinstated imminently.

- **3.3** Results demonstrate that the monthly average total construction noise results for daytime were within the threshold levels for all monitoring locations for December 2014, with the exception of Scotstoun. For the evening period, all monitoring locations were within the threshold levels. For the night time periods, there were exceedances at location; Butlaw Fisheries. With regard to the Sunday averages (for applicable monitoring locations), there were exceedances at Butlaw Fisheries.

- **3.4** The exceedances noted are not thought to have been caused by increased noise levels due to construction. Each of the exceedances of the averages and Sunday averages, with the exception of the daytime averages at Scotstoun, were found to be affected by increased noise levels due to traffic. Audio demonstrates that the increased levels were caused by waves and birds at Butlaw Fisheries and raindrops at Linn Mill have also contributing to increased levels at these locations. Inchgarvie Lodge had a number of exceedances due to residential activity. With regard to the averages reported for evening, night time and Sunday periods, it should be noted that these averages are based only on the highest L<sub>Aeq</sub> levels for 1 hour periods which can affect the averages.

- **3.5** The exceedance of the daytime average at Scotstoun is due to increased background noise levels due to the location of the meter directly adjacent to the road. The average for December is consistent with levels for previous months.
