Project FORTH REPLACEMENT CROSSING

# CONSTRUCTION NOISE MONITORING REPORT: MARCH 2014

REP-00173

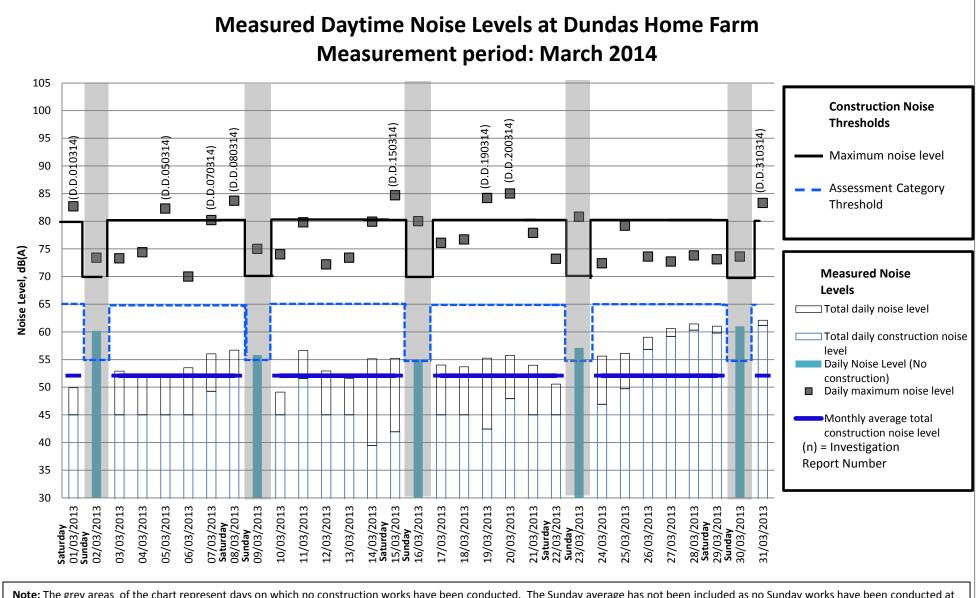
**Note:** The grey areas of the chart represent days on which no construction works have been conducted. The Sunday average has not been included as no Sunday works have been conducted at this location.

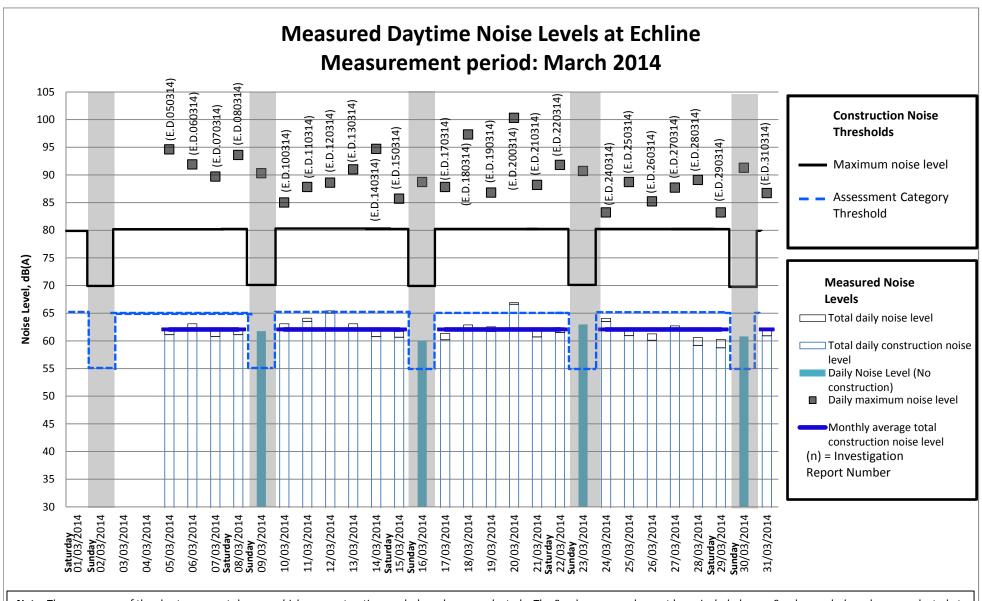
**Note:** The grey areas of the chart represent days on which no construction works have been conducted. The Sunday average has not been included as no Sunday works have been conducted at this location. Data is missing for 01/03/14 -04/03/14 due to device error.

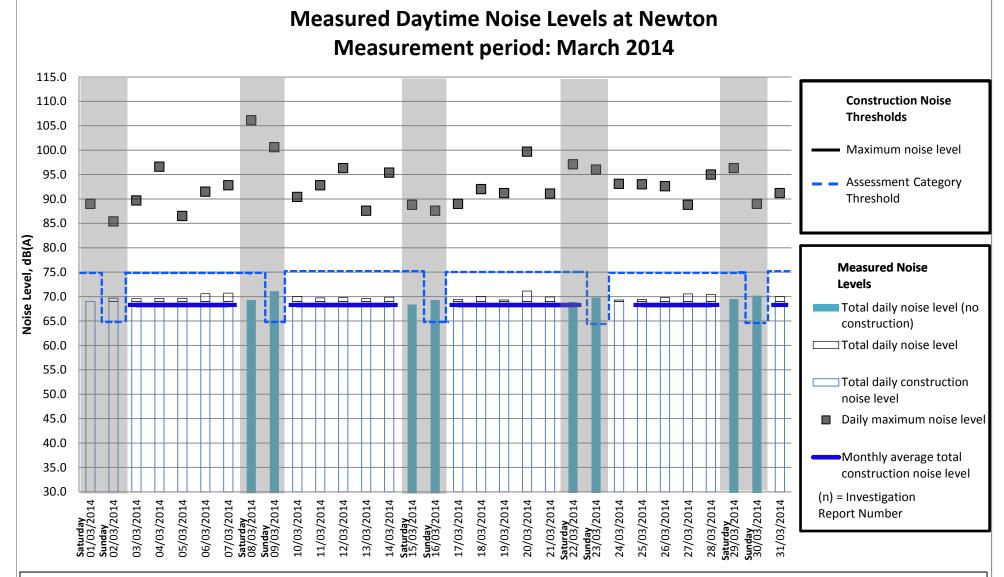
**Note:** The grey areas of the chart represent days on which no construction works have been conducted. It should be noted that the measured noise levels Mon - Fri can not be attributed to construction works due to the considerable distance (1.75 kilometers) between this monitoring location and the closest construction works.

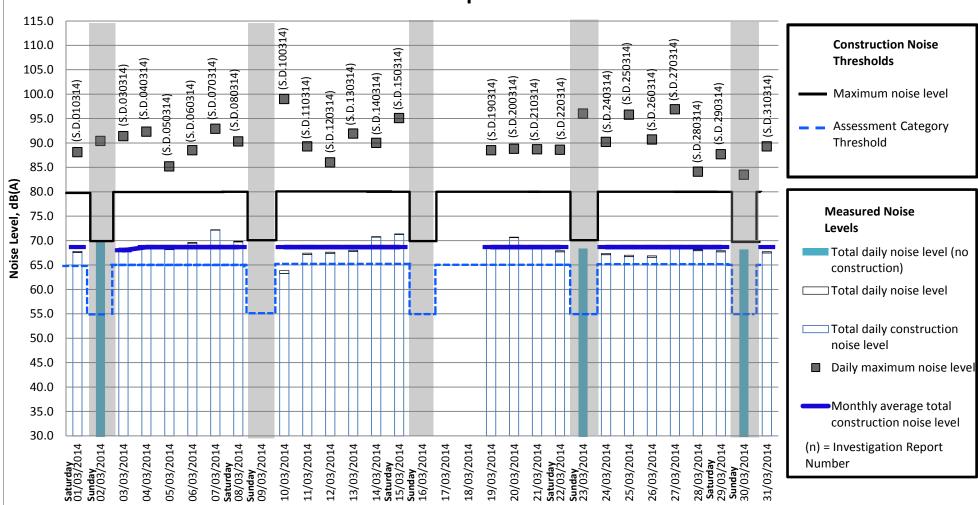
**Note:** The grey areas of the chart represent days on which no construction works have been conducted. The monthly average construction noise for Sunday has not been included as no Sunday works have been conducted at this location. Data is missing from the 17/03/14 & 18/03/14 due to device error.

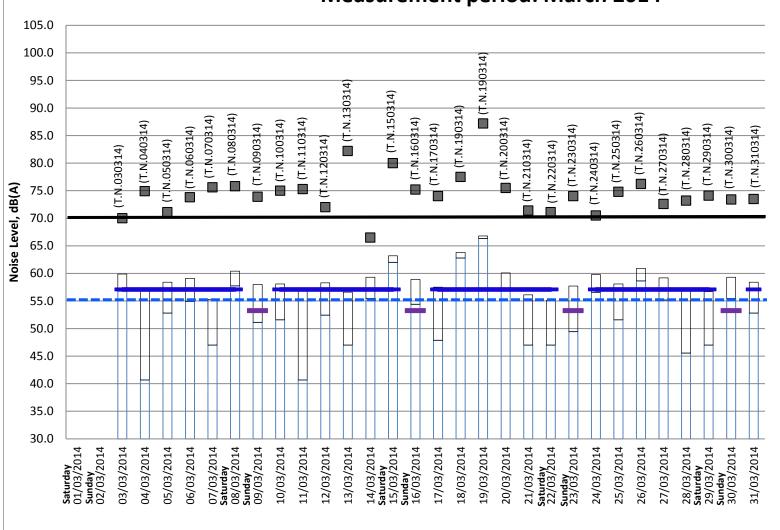
## Measured Night-time Noise Levels at Tigh-Na-Grian Measurement period: March 2014

Note: Data is missing on 01/03/14 & 02/03/14 due to device error
