Project FORTH REPLACEMENT CROSSING

# CONSTRUCTION NOISE MONITORING REPORT: OCTOBER 2013

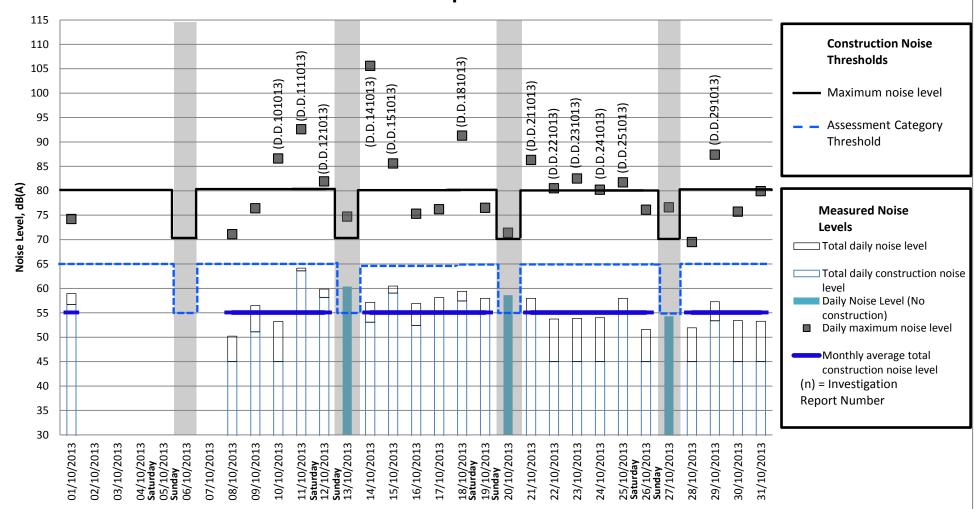
**Note:** The grey areas of the chart represent days on which no construction works have been conducted. The monthly average construction noise for Sunday has not been included as no Sunday works have been conducted at this location. Data is missing for 02/10/13 to 07/10/13 due to loss of power to the device caused by a third party.

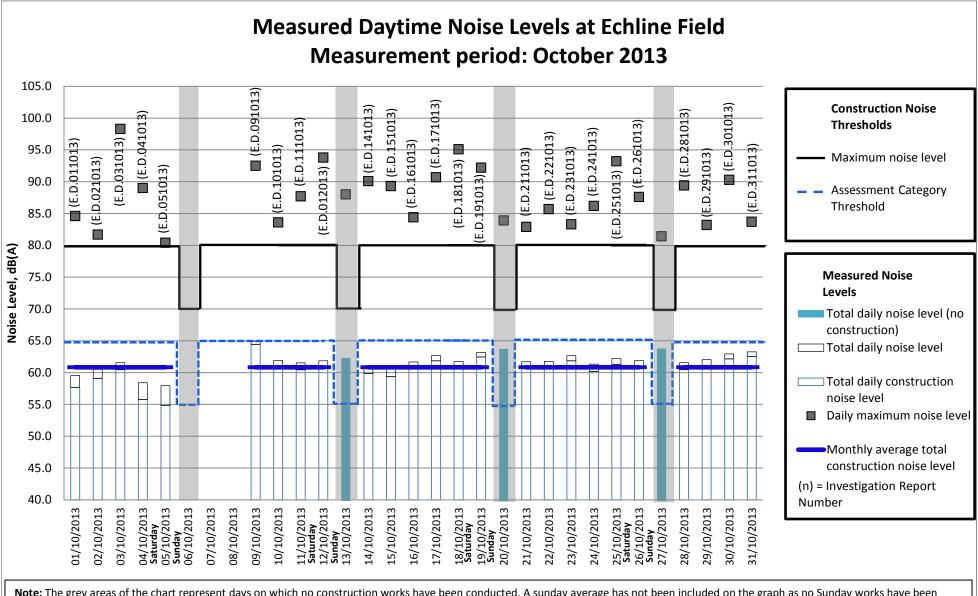
**Note:** The grey areas of the chart represent days on which no construction works have been conducted. A sunday average has not been included on the graph as no Sunday works have been undertaken at this location. Data is missing for 06/10/13 to 08/10/13 due to a device error.

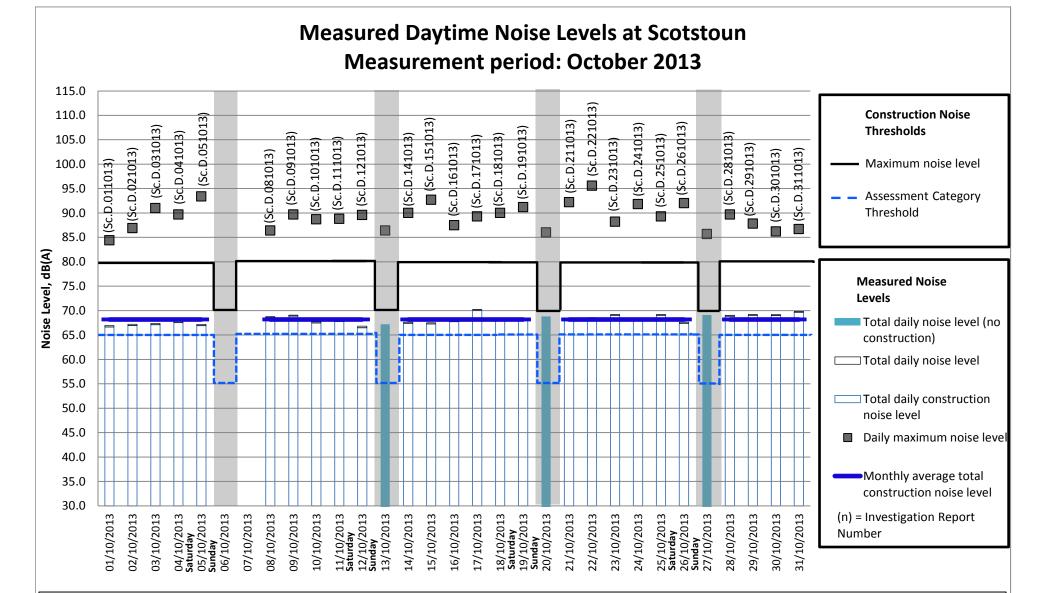
Note: The grey areas of the chart represent days on which no construction works have been conducted. The monthly average construction noise for Sunday has not been included as no Sunday works have been conducted at this location. Data is missing at

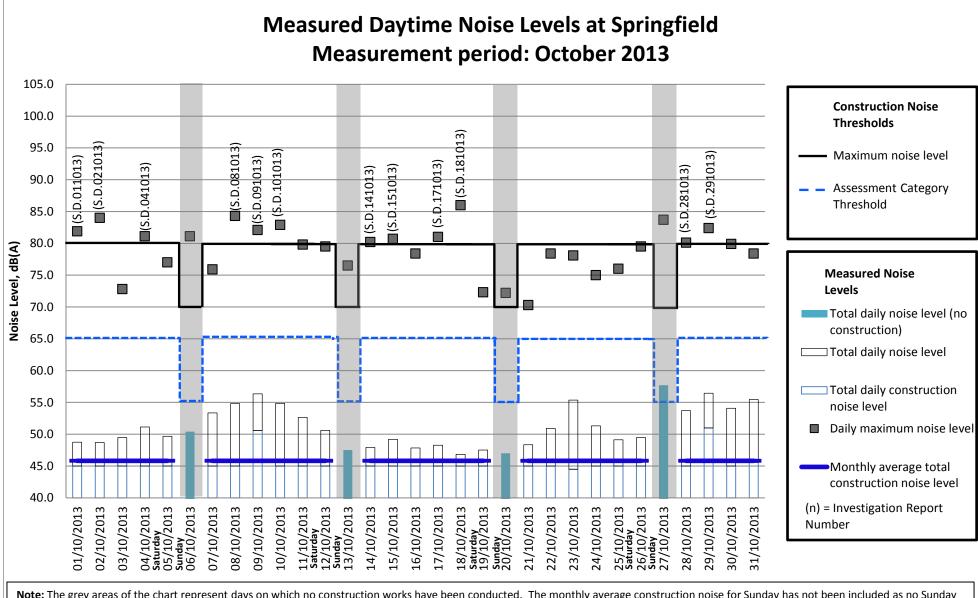
**Note:** The grey areas of the chart represent days on which no construction works have been conducted. The monthly average construction noise for Sunday has not been included as no Sunday works have been conducted at this location.

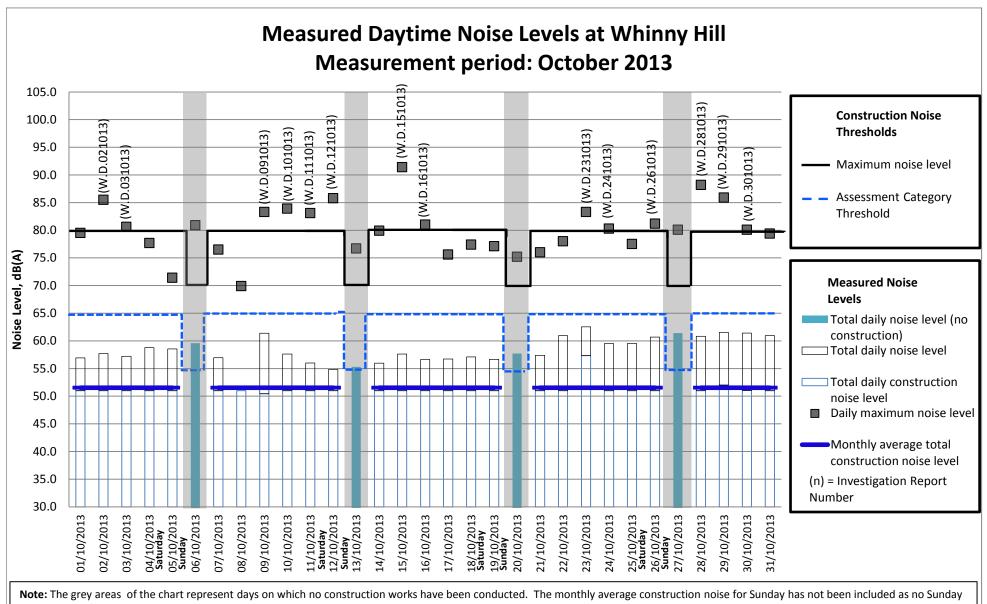
works have been conducted at this location during this period.
