Project FORTH REPLACEMENT CROSSING

VIBRATION MONITORING REPORT APRIL 2015

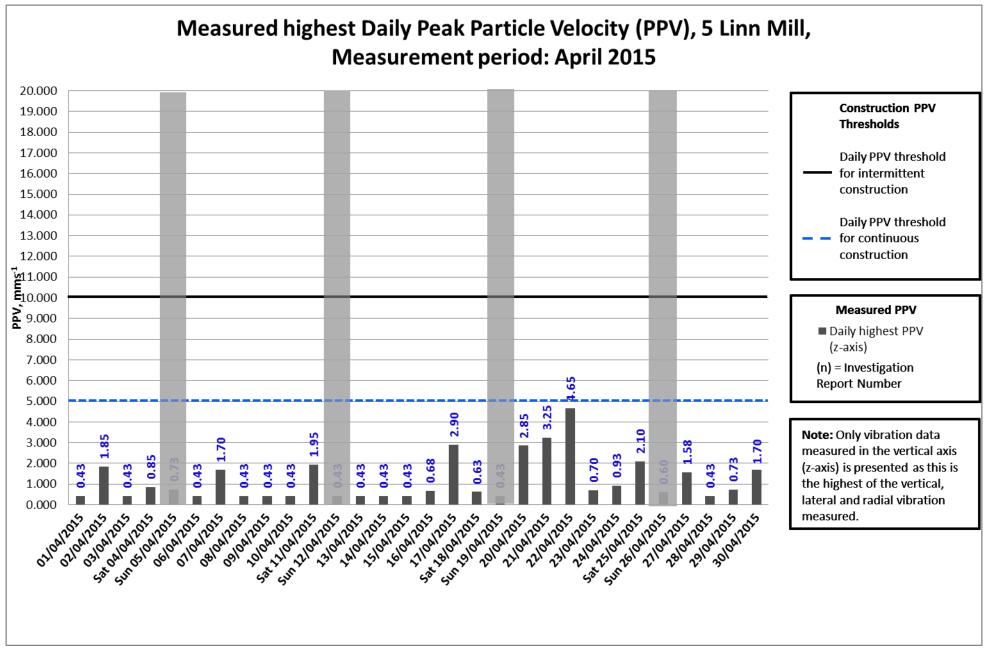
• The grey areas of the chart represent the days on which no construction works were undertaken; no works were conducted in the vicinity of the Linn Mill monitor on Sundays.

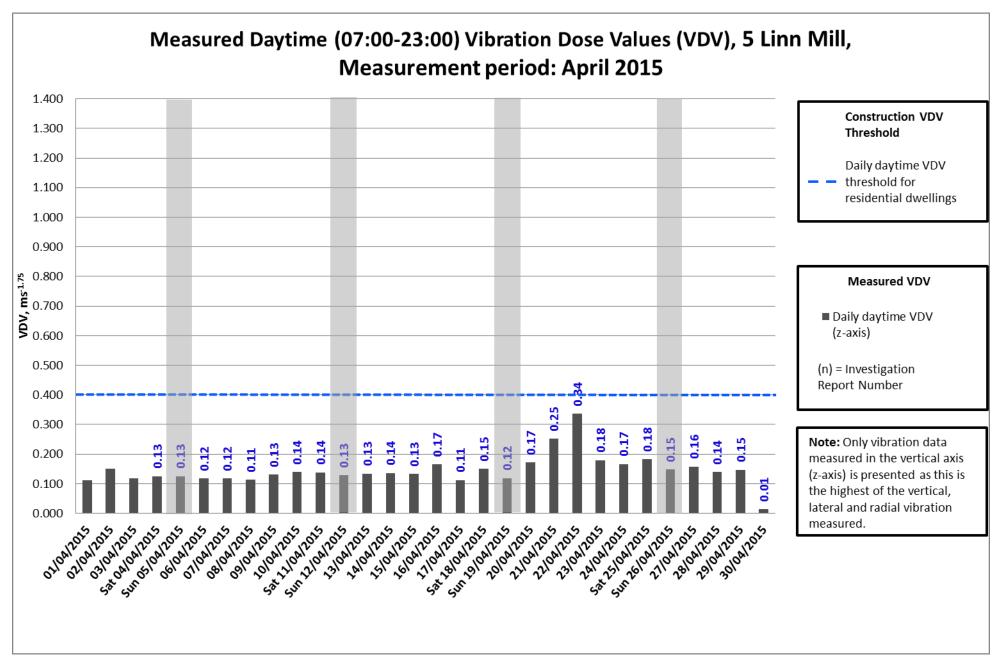
• The grey areas of the chart represent the days on which no construction works were undertaken; no works were conducted in the vicinity of the Linn Mill monitor on Sundays.

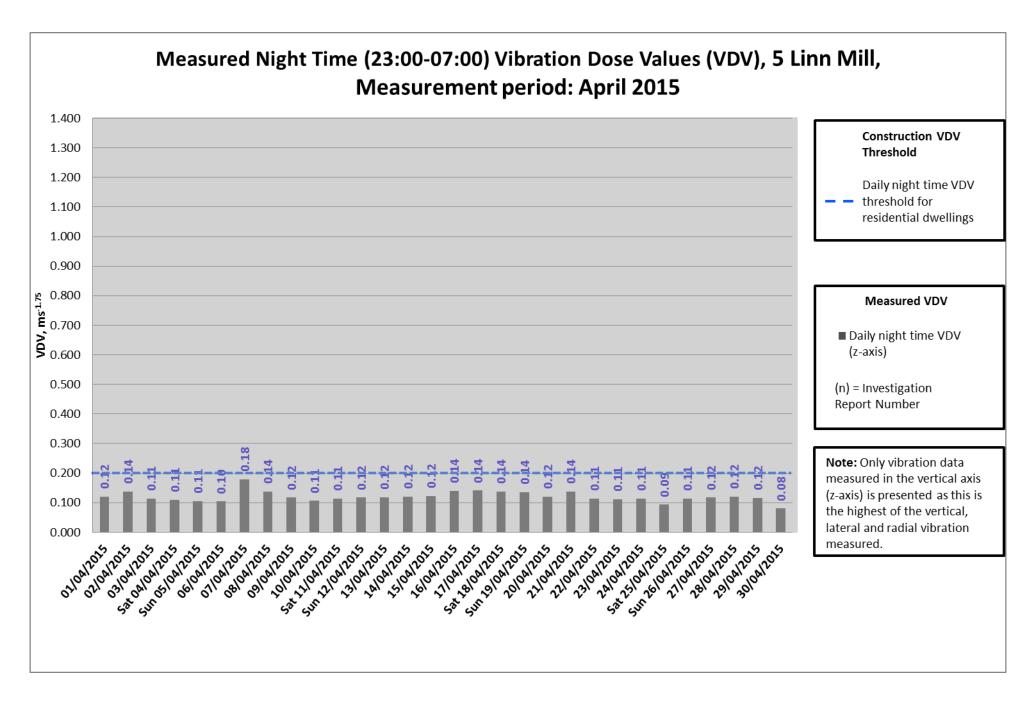
• The grey areas of the chart represent the days on which no construction works were undertaken; no night time works were conducted in the vicinity of the Linn Mill vibration monitor throughout the month of April 2015. This graph is included for illustrative purposes only.

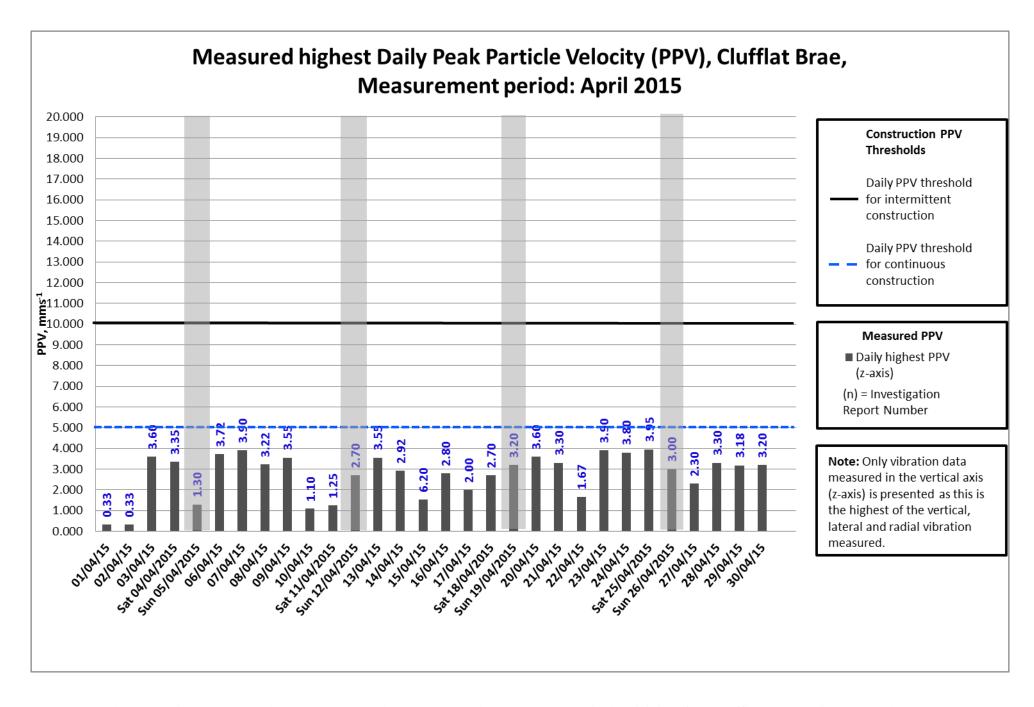
• The grey areas of the chart represent the days on which no construction works were undertaken; no works were conducted in the vicinity of the Clufflat Brae monitor on Sundays.

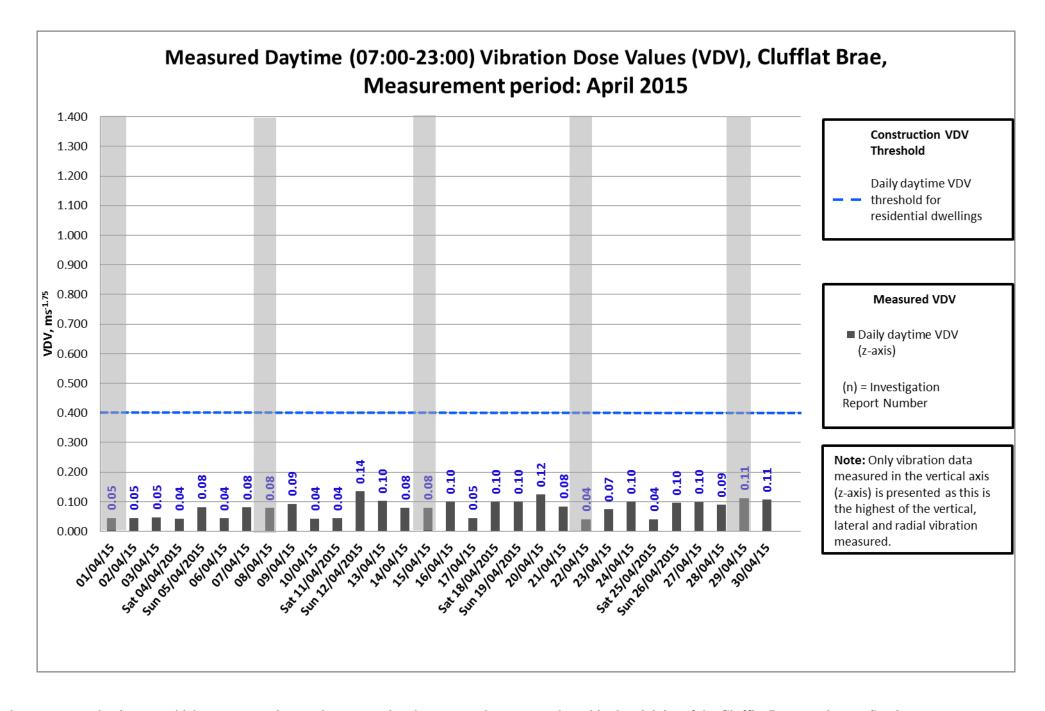
• The grey areas of the chart represent the days on which no construction works were undertaken; no works were conducted in the vicinity of the Clufflat Brae monitor on Sundays.

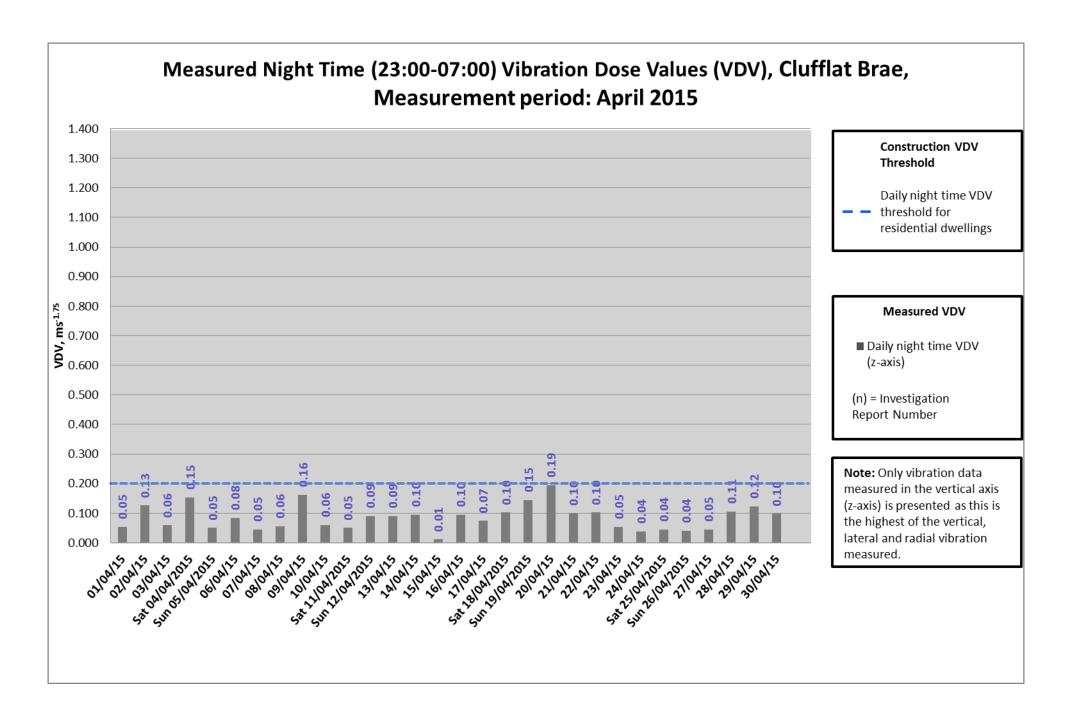
• The grey areas of the chart represent the days on which no construction works were undertaken; no night time works were conducted in the vicinity of the Clufflat Brae vibration monitor throughout the month of April 2015. This graph is included for illustrative purposes only.

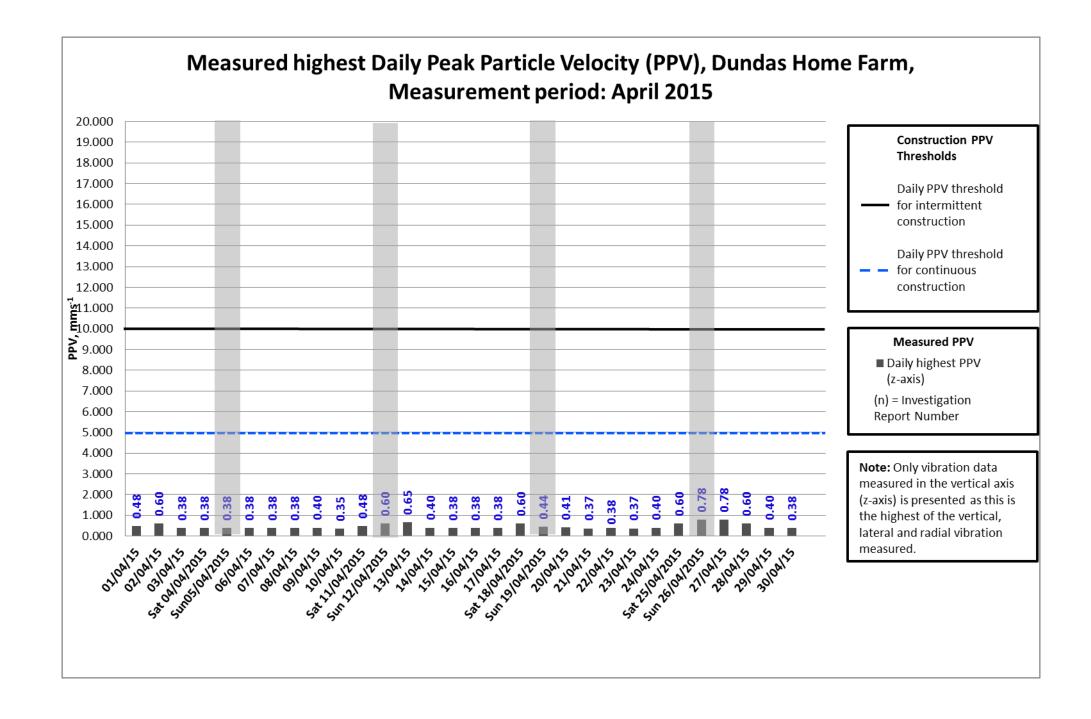
• The grey areas of the chart represent the days on which no construction works were undertaken; no works were conducted in the vicinity of the Dundas monitor on Sundays.

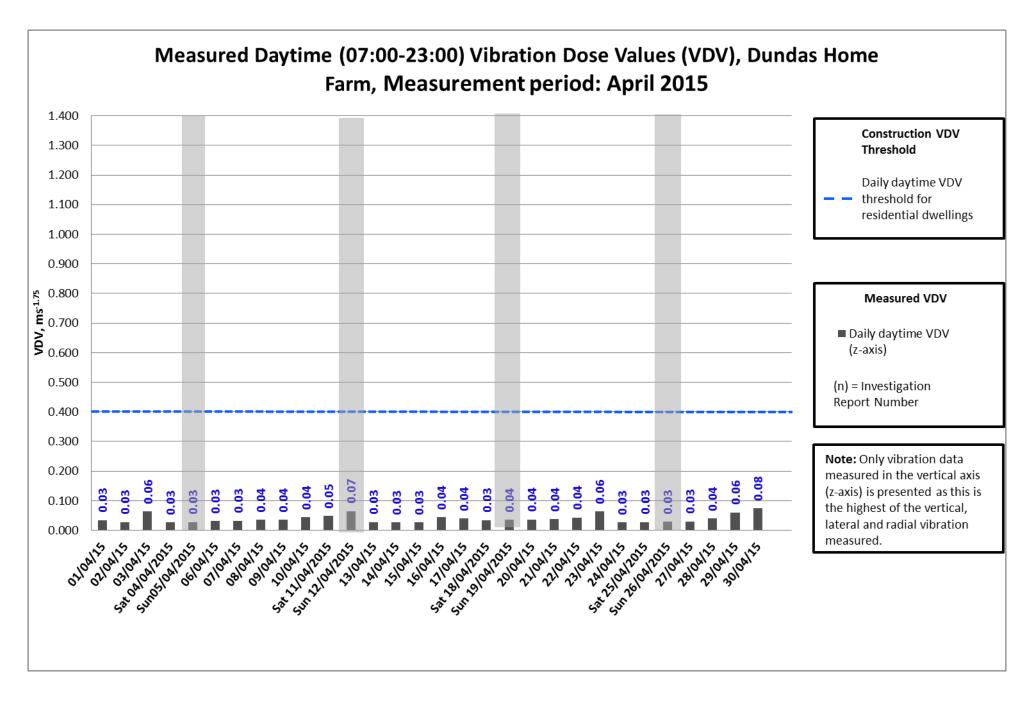
• The grey areas of the chart represent the days on which no construction works were undertaken; no works were conducted in the vicinity of the Dundas monitor on Sundays.

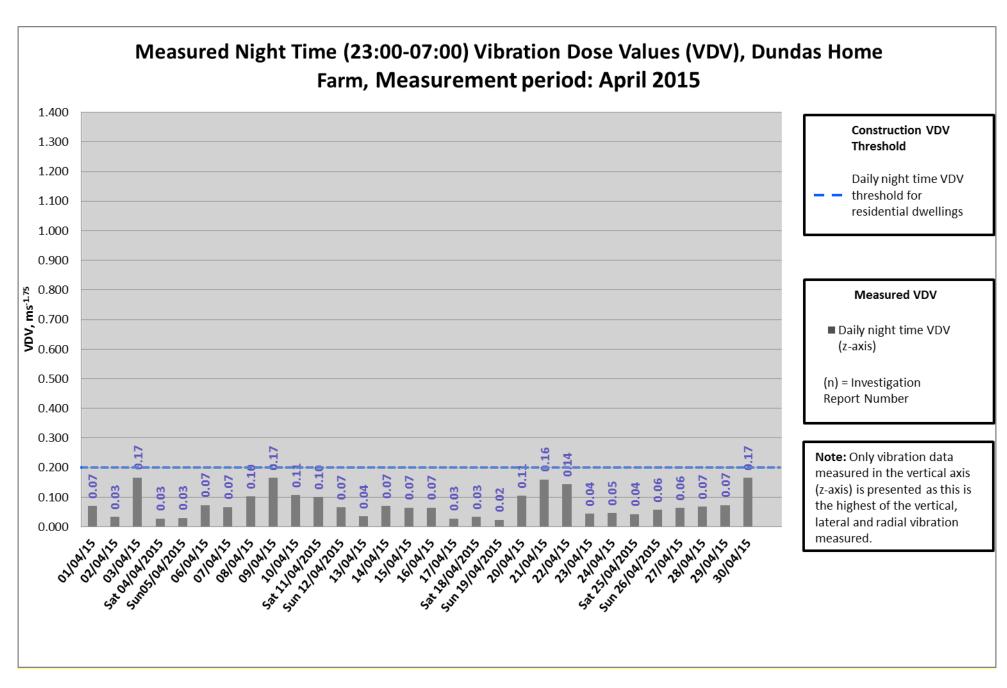
• The grey areas of the chart represent the days on which no construction works were undertaken; no night time works were conducted in the vicinity of the Dundas Home Farm vibration monitor throughout the month of April 2015. This graph is included for illustrative purposes only.

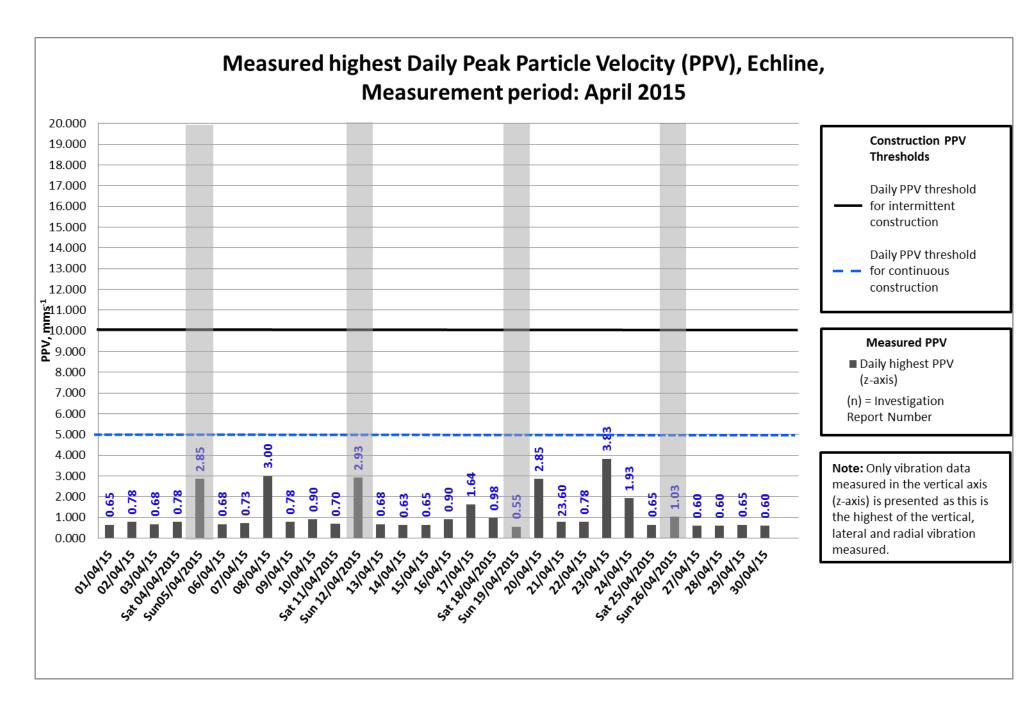
• The grey areas of the chart represent the days on which no construction works were undertaken; no works were conducted in the vicinity of the Echline monitor on Sundays.

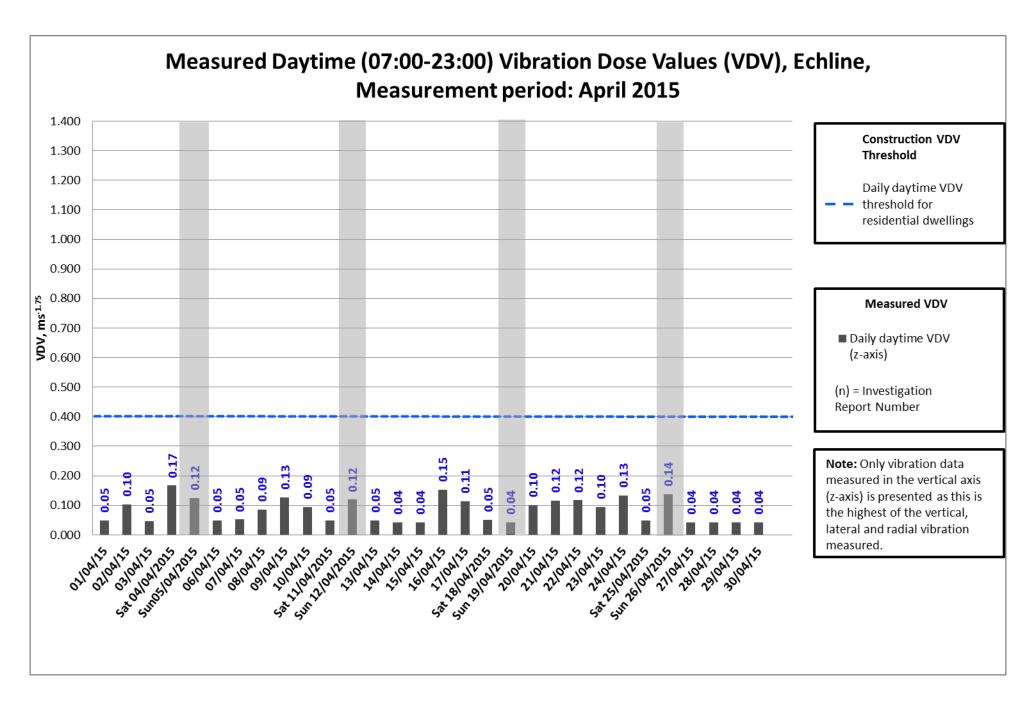
• The grey areas of the chart represent the days on which no construction works were undertaken; no works were conducted in the vicinity of the Echline monitor on Sundays.

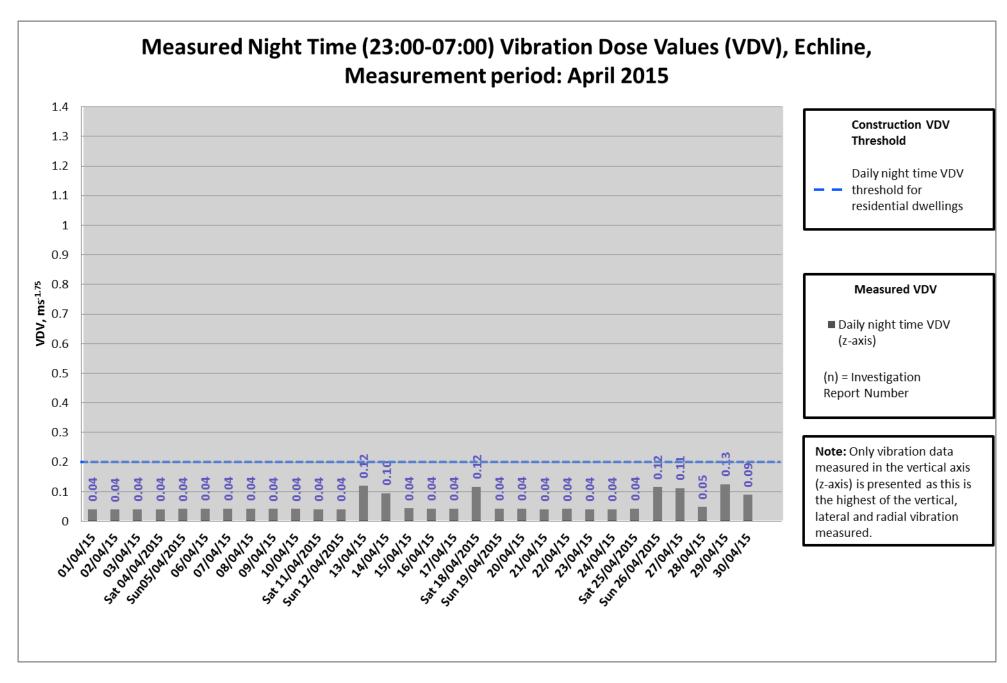
• The grey areas of the chart represent the days on which no construction works were undertaken; no night time works were conducted in the vicinity of the Echline vibration monitor throughout the month of April 2015. This graph is included for illustrative purposes only.

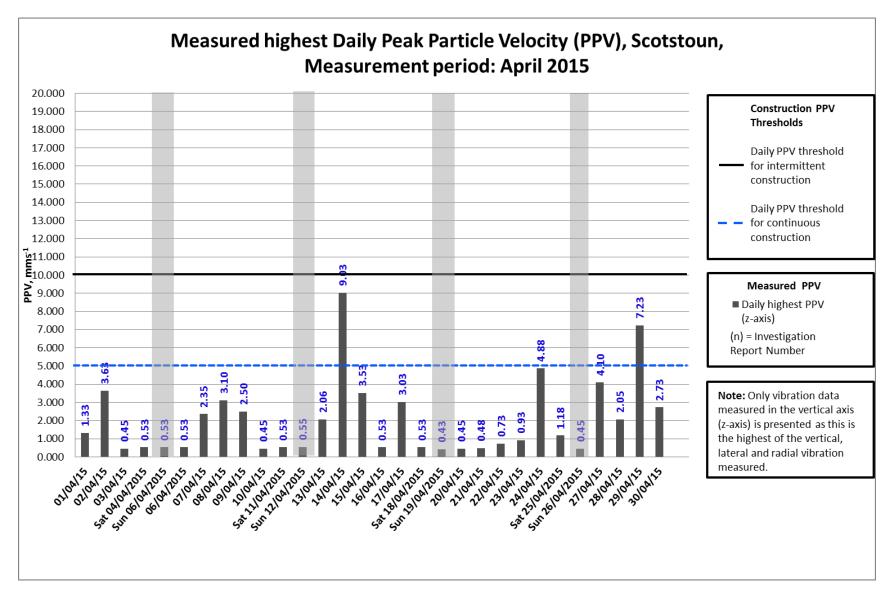
- The grey areas of the chart represent the days on which no construction works were undertaken; no works were conducted in the vicinity of the Scotstoun monitor on Sundays.
- Works moved to within 20m of the Scotstoun monitor which resulted in a significant increase of PPV values recorded on 14/04/15 during road extension works on the B800 which involved the use of vibratory machinery. See Vibrock PPV graph below which coincides with the use of vibratory roller adjacent to the Vibrock equipment stationed in the same area. These values are within the intermittent threshold of 10mm/s.

- 2.8. These thresholds are set to protect against building damage. For this monitoring period, all the exceedances have been investigated thoroughly and appear to have been generated as a result of standalone, instantaneous events arising from local interferences, the exact source of which remains unknown.

- **2.12.** In addition, detailed investigation of all exceedances (i.e. review of PPV levels over 30 seconds periods) has shown that each resulted from isolated, non-construction related events, which likely occurred close to the monitoring station.

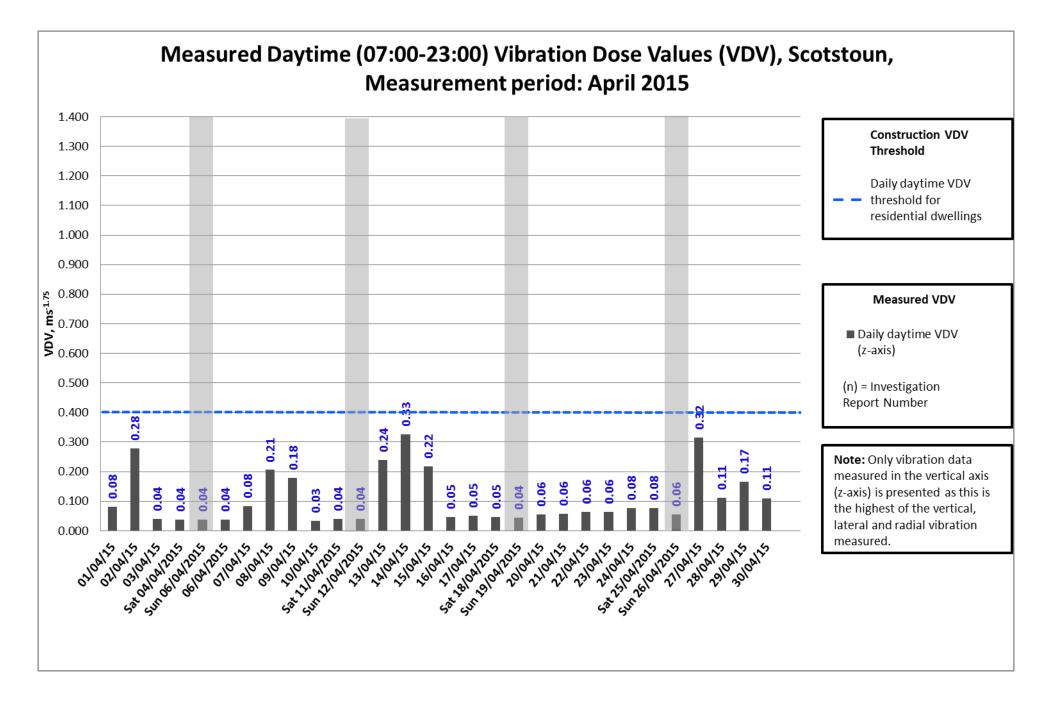
• The grey areas of the chart represent the days on which no construction works were undertaken; no works were conducted in the vicinity of the Scotstoun monitor on Sundays.

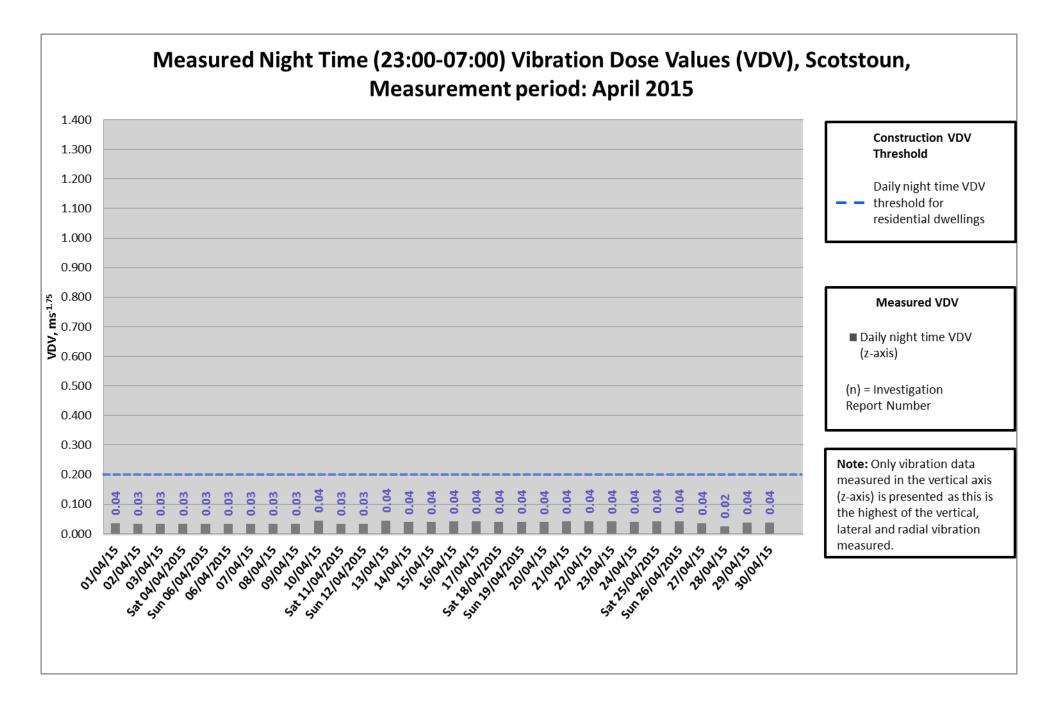
• The grey areas of the chart represent the days on which no construction works were undertaken; no night time works were conducted in the vicinity of the Scotstoun vibration monitor throughout the month of April 2015. This graph is included for illustrative purposes only.

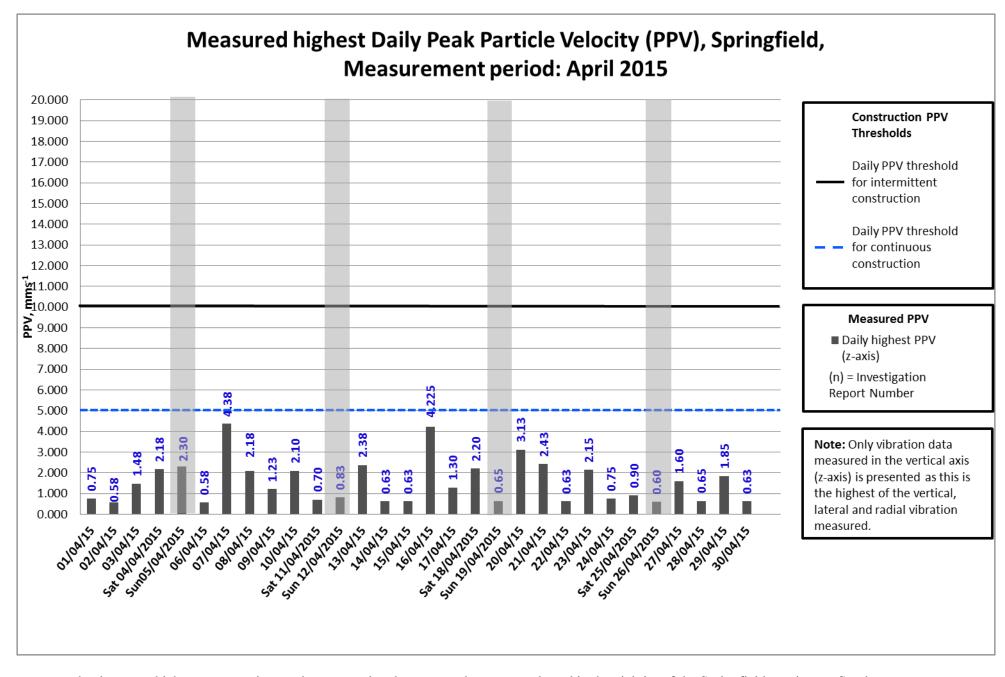
• The grey areas of the chart represent the days on which no construction works were undertaken; no works were conducted in the vicinity of the Springfield monitor on Sundays.

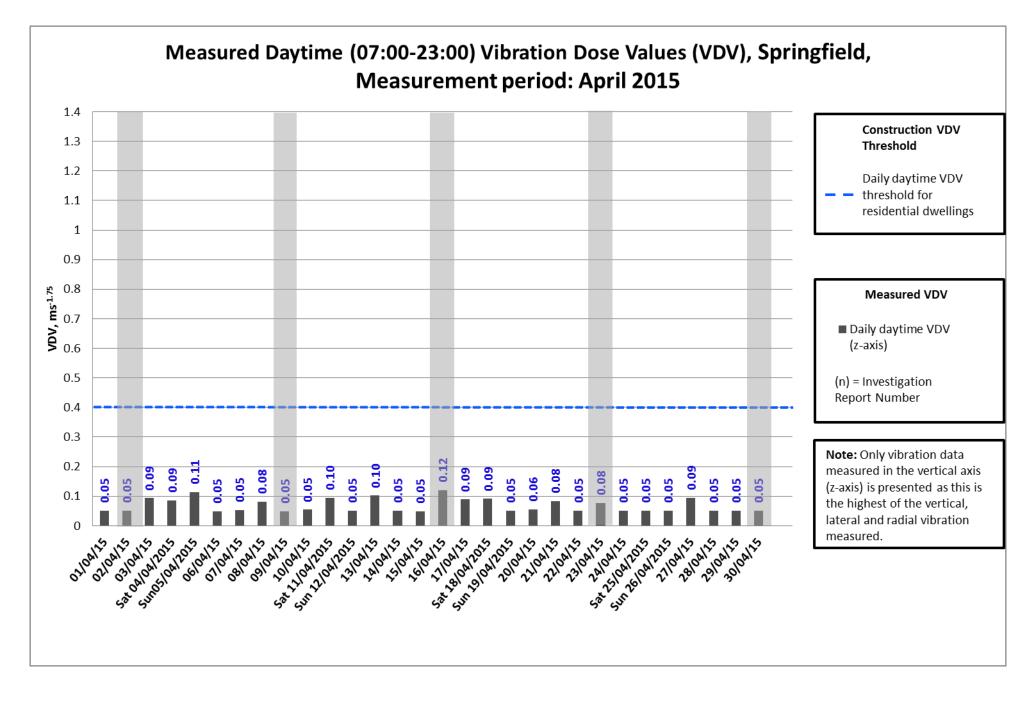
• The grey areas of the chart represent the days on which no construction works were undertaken; no works were conducted in the vicinity of the Springfield monitor on Sundays.

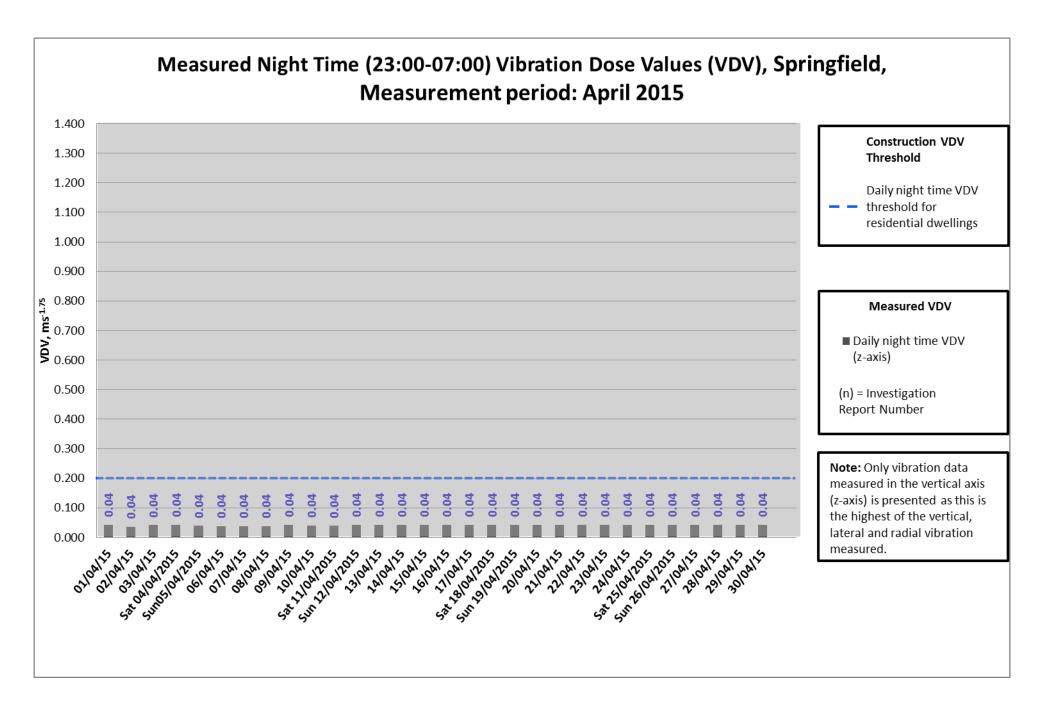
• The grey areas of the chart represent the days on which no construction works were undertaken; no night time works were conducted in the vicinity of the Springfield vibration monitor throughout the month of April 2015. This graph is included for illustrative purposes only.

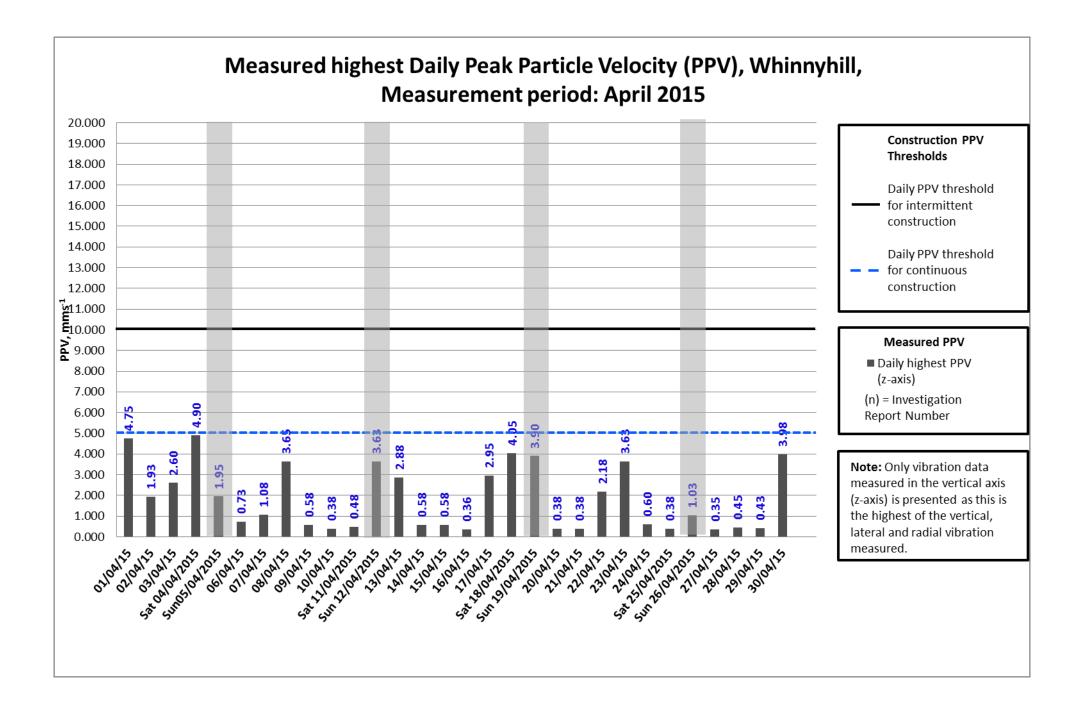
• The grey areas of the chart represent the days on which no construction works were undertaken; no works were conducted in the vicinity of the Whinnyhill monitor on Sundays.

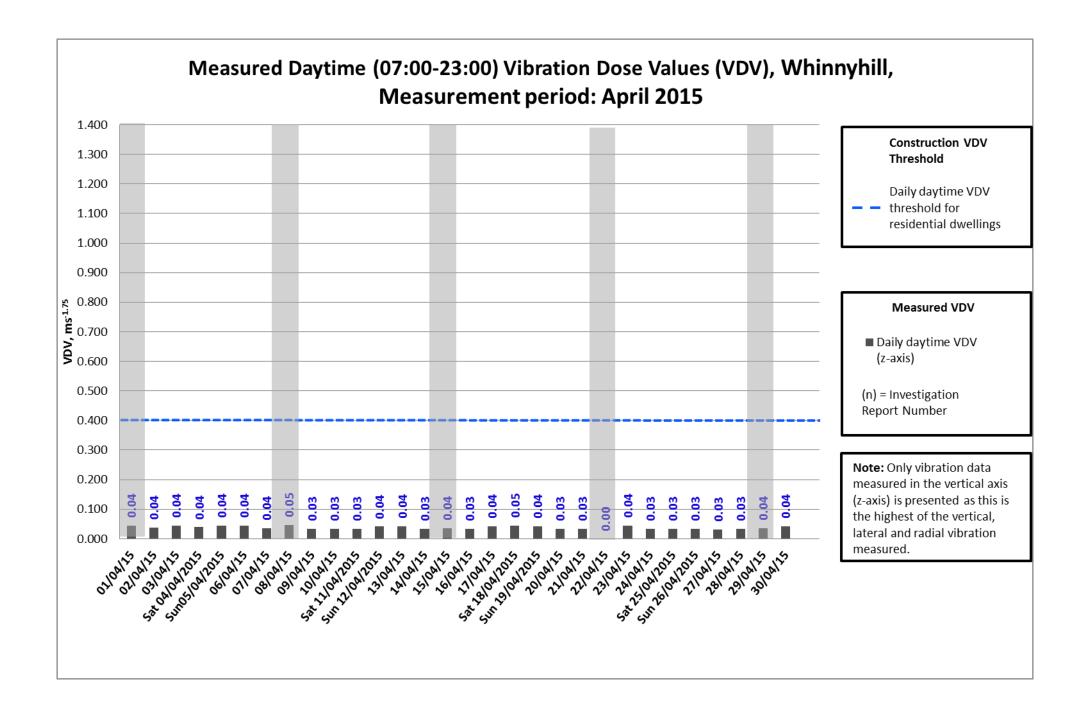
• The grey areas of the chart represent the days on which no construction works were undertaken; no works were conducted in the vicinity of the Whinnyhill monitor on Sundays.

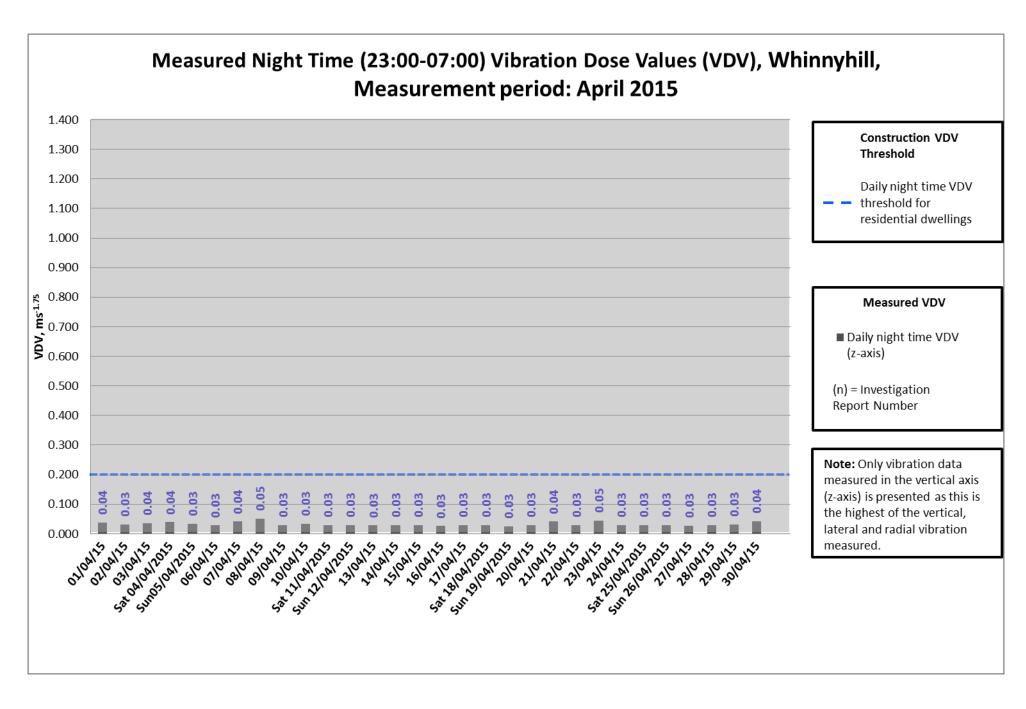
• The grey areas of the chart represent the days on which no construction works were undertaken; no night time works were conducted in the vicinity of the Whinnyhill vibration monitor throughout the month of April 2015. This graph is included for illustrative purposes only.
