Project Name :
A90/A937 Laurencekirk Junction Improvement Scheme
Stage 3 Environmental Impact Assessment Report

Drawing Title :
Design Alternatives Option 3

Figure No :
Figure 2.4

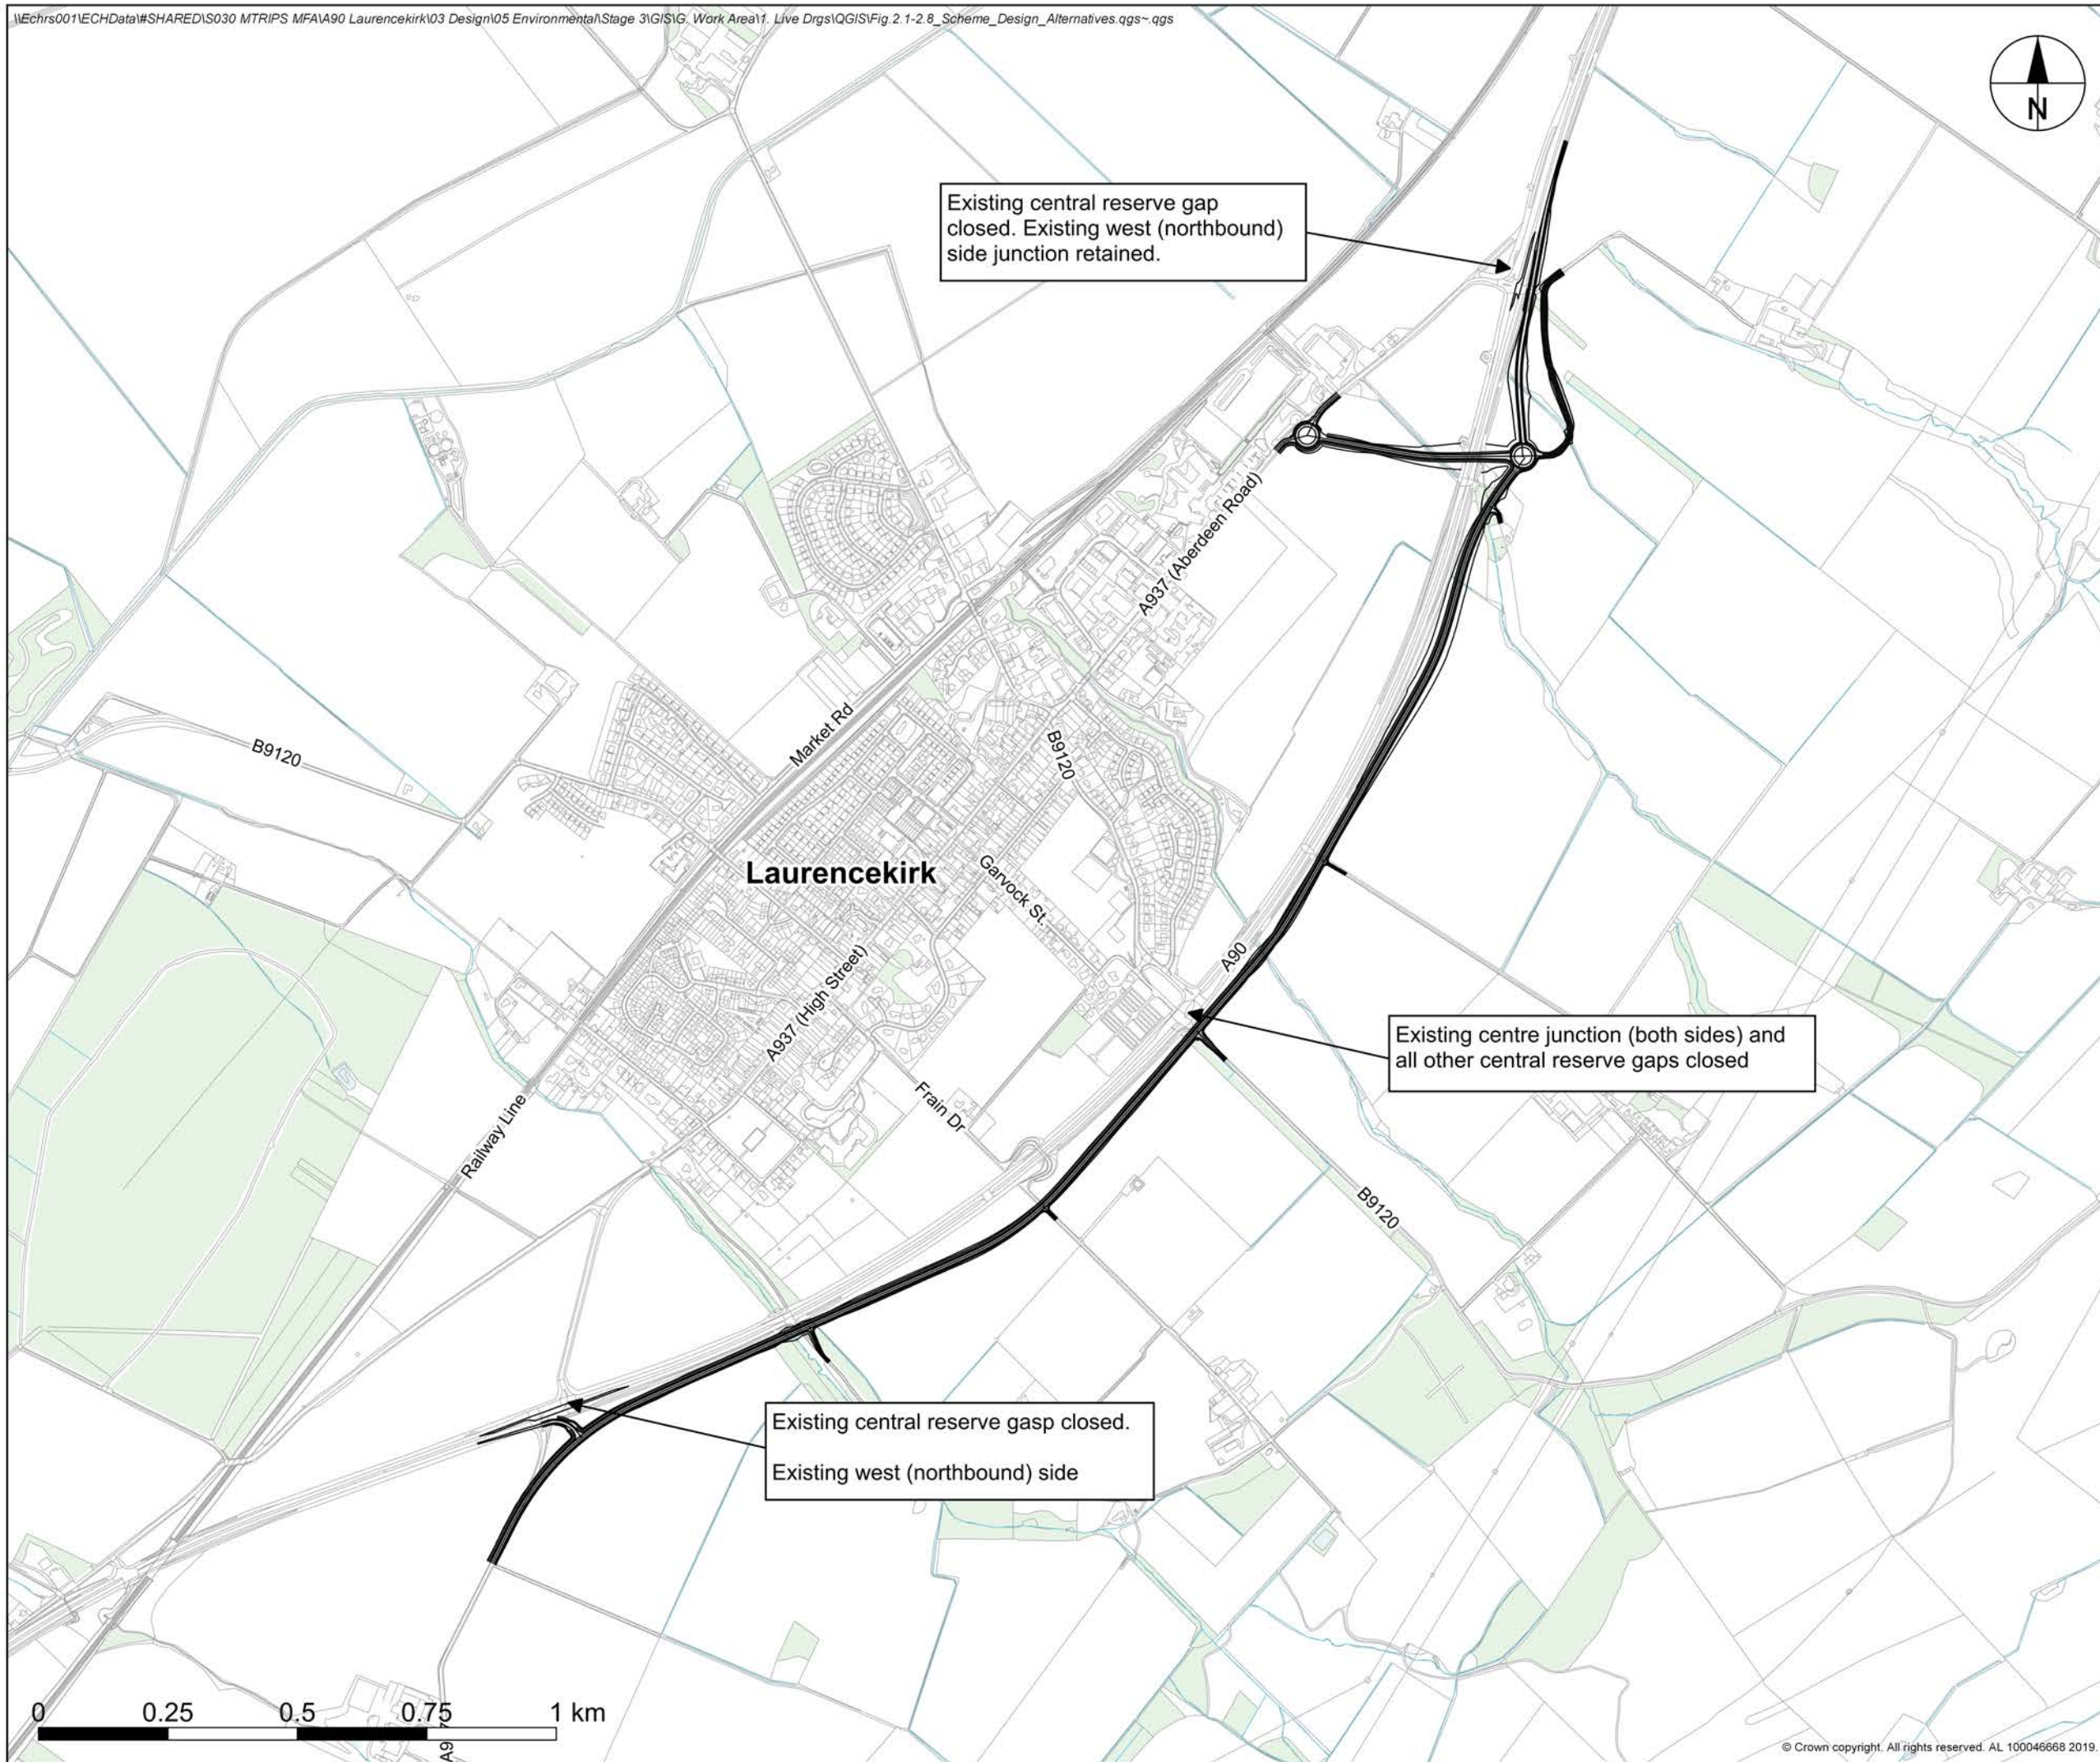
Existing central reserve gap closed. Existing west (northbound) side junction retained.

Existing centre junction (both sides) and all other central reserve gaps closed

Existing central reserve gap closed.
Existing west (northbound) side
