**FORTH REPLACEMENT CROSSING**

**AIR QUALITY MONITORING REPORT  
 JUNE 2015**

**REP-00238**

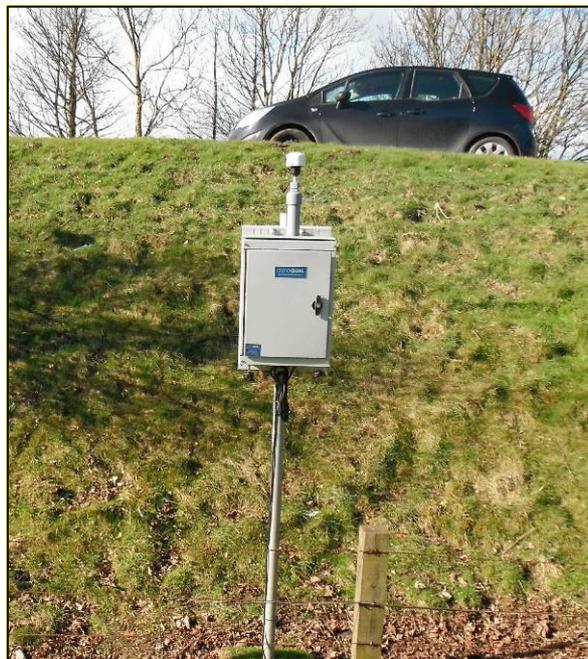
**Figure 2: Example of an installed Automatic Light Scatter Dust Meter**

**2.2.** Light scatter type monitoring equipment have been selected as a site monitoring tool to create a live network which assesses the levels of fugitive particulate matter, principally airborne dust. These monitors require less space, maintenance and power than other real time monitors such as a Tapered Element Oscillating Microbalance (TEOM) which is used and designed to measure particulate levels to exceedingly high standards, including measuring long-term compliance to statutory limits. Light scatter meters are more practicable to deploy. However, the meters do generally record levels higher than those measured by the TEOM. The meters can also be affected by atmospheric moisture content which further increases reported levels. Accordingly, any elevations of statutory limits should be treated as precautionary exceedances. The monitors are reliable for on-site monitoring and the establishment of action thresholds to ensure unforeseen activities generating significant dust are identified and suitably controlled. Light scatter meters are becoming the construction and waste industries norm for particulate dust monitoring.

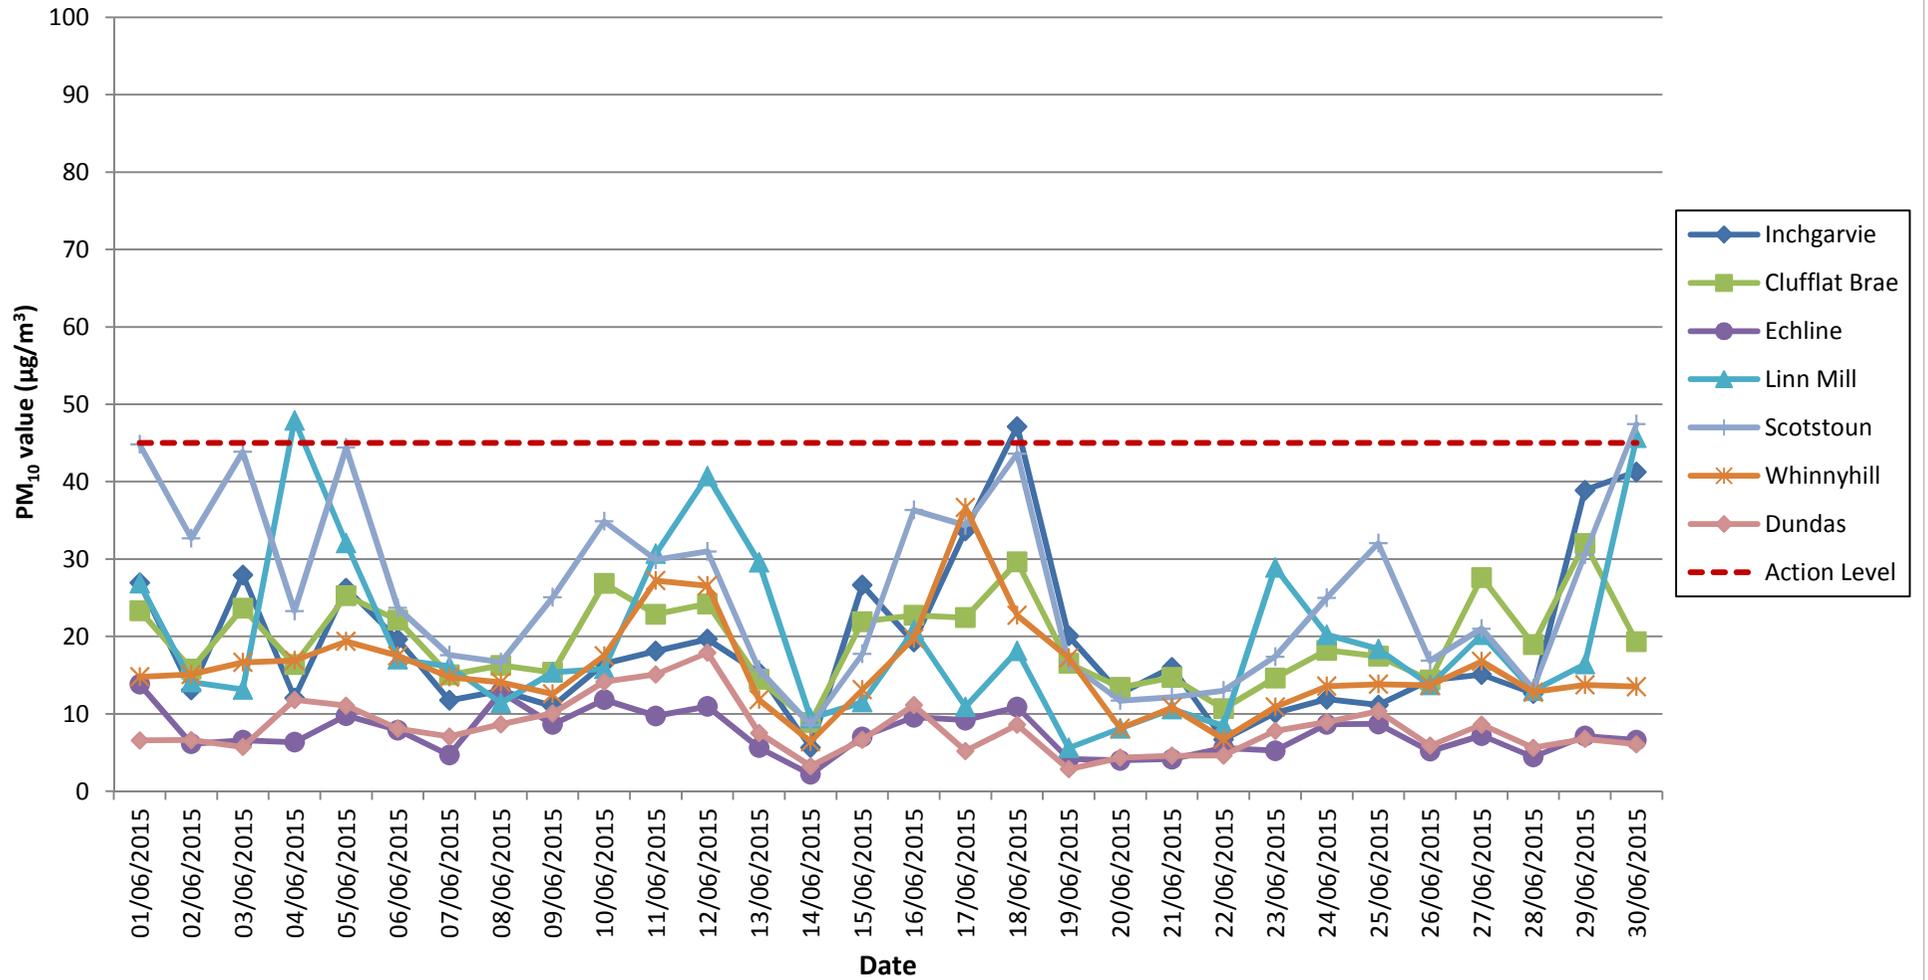
**3.1.1.** Light scatter results for June 2015 have been presented in a monthly chart; this can be found in Appendix A. Results show that the PM<sub>10</sub> levels were mostly below threshold levels throughout the month with the exception of three periods (4<sup>th</sup>, 18<sup>th</sup> and 30<sup>th</sup> June). Linn Mill registered above the action level on the 4<sup>th</sup> and 30<sup>th</sup> June, and also showed an increase on the 12<sup>th</sup> June (although still below the action level on this date). The other light scatter meters in the vicinity (Inchgarvie and

Clufflat Brae) do not show a similar increase on these days, with the exception of Inchgarvie on the 29<sup>th</sup> and 30<sup>th</sup> June. All monitors registered increased levels on the 18th June and the Inchgarvie results reached the action level on that day. These dates all correspond with dry weather conditions. Increased PM<sub>10</sub> levels were also recorded at Scotstoun on 1<sup>st</sup>, 3<sup>rd</sup>, 5<sup>th</sup>, 18<sup>th</sup> and 30<sup>th</sup> June with the action level reached on the 30th June. This is likely to be because the PM<sub>10</sub> monitor is now located within the area where works are being carried out (see 3.1.3).

## Particulate Matter (PM10) Results for all Monitoring Locations

- 3.1.3.** During June, site operations continued around the B800 north of the bridge over the A90. These works currently extend up to the fence line where the Scotstoun PM<sub>10</sub> monitor is located. These works include landscaping, surfacing and earthworks in the vicinity of the monitor. This means that the monitor is essentially on-site and that operations are now closer to some receptors. Although results are widely in line with

other monitors, with the exception of the increases noted in 3.1.1, the monitor generally registered some of the highest levels across site during June. This is likely due to the construction works being undertaken directly adjacent to the monitor and would not reflect migration of dust beyond the immediate works area. FCBC will continue to monitor this area closely over the next few months as works in this area progress.

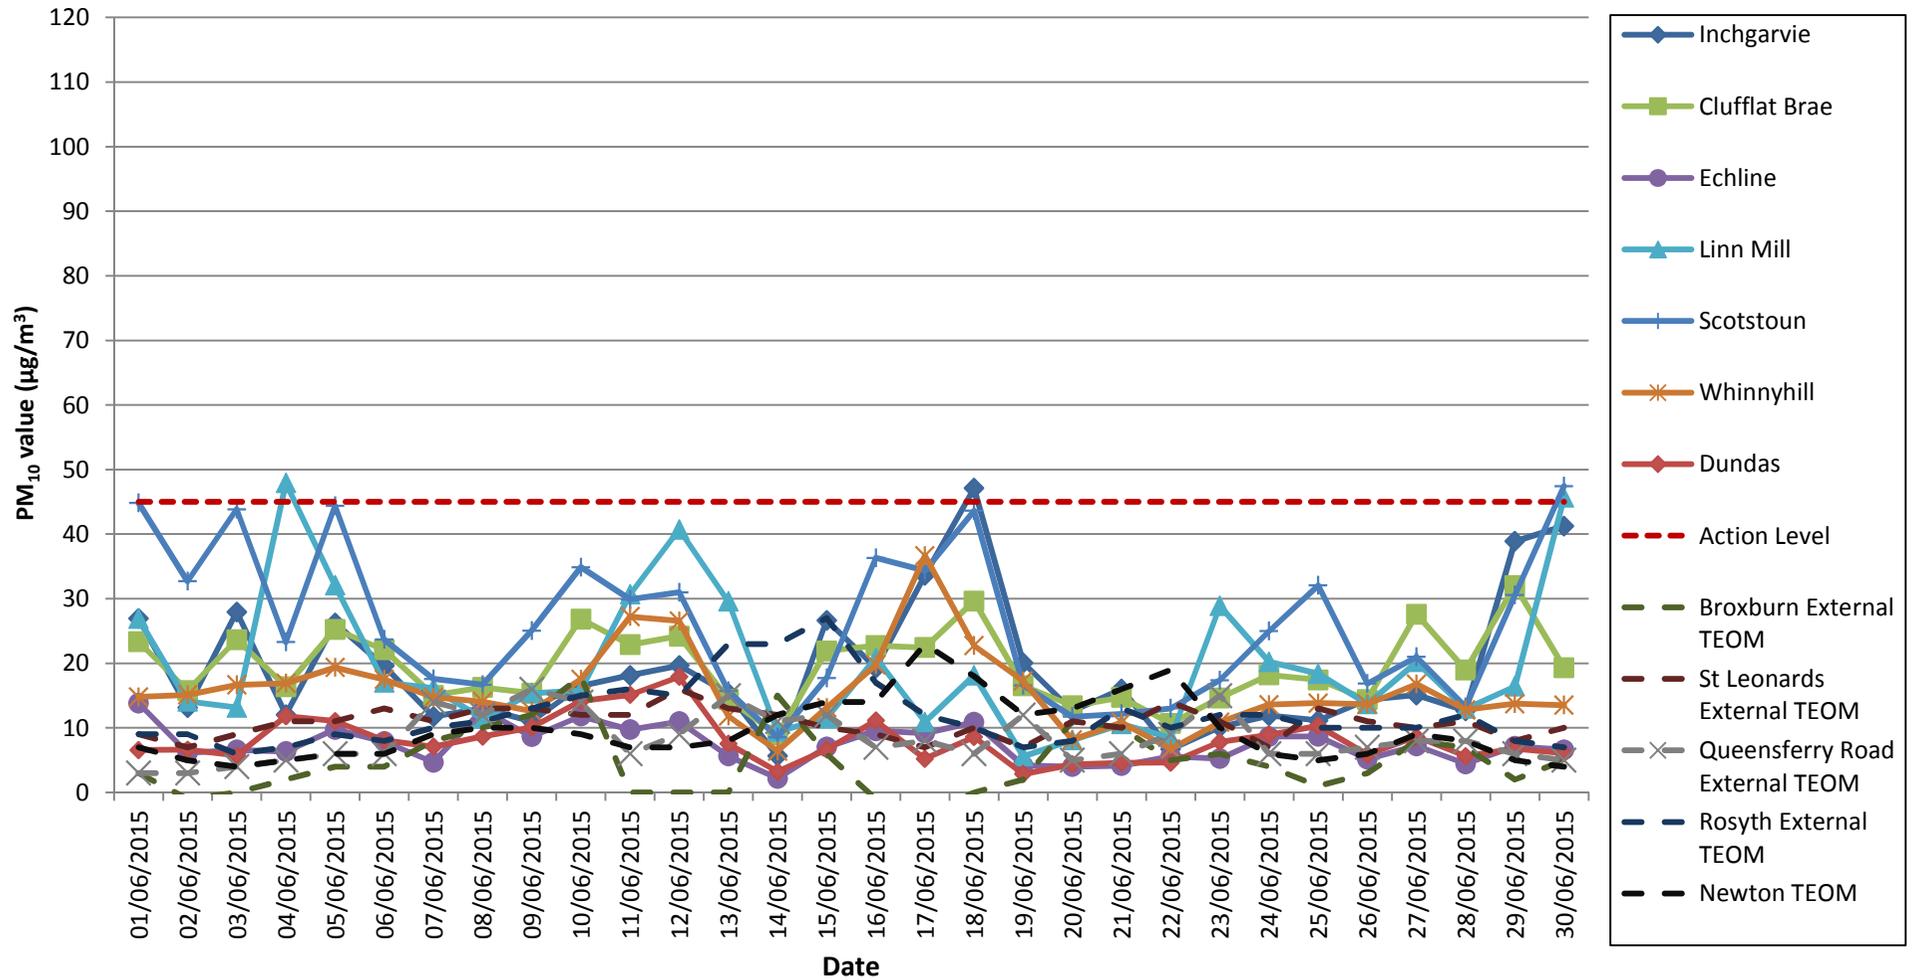
- 3.1.2.** The PM<sub>10</sub> results have also been compared to the daily mean results obtained from the TEOM air quality monitoring stations located in Newton, Rosyth, and Broxburn, and from the TEOM FDMS station located at Queensferry Road and St Leonards, Edinburgh (an urban background site). The TEOM at Newton was installed by West Lothian Council, facilitated by FCBC, during June 2012. The comparison between the light scatter and TEOM results demonstrates that both sets of results generally follow the same pattern, indicating that the pattern observed throughout June was largely driven by regional changes in air quality, with the exception of increases observed for Linn Mill, Inchgarvie, Clufflat Brae and Scotstoun during the month. In particular, the increases at Linn Mill on the 4<sup>th</sup> June, Linn Mill and Inchgarvie on the 30<sup>h</sup> June and Scotstoun throughout the month did not correspond to high TEOM results. The elevated levels of PM<sub>10</sub> at Linn Mill and Inchgarvie may be due partly to construction activities, particularly the main carriageway earthworks or dust arising from bare ground areas during dry conditions. Increased inspections will be carried out in this area to ensure any dust generating activities are adequately mitigated.

# Air Quality Monitoring: Particulate Matter (PM10) Results for all Monitoring Locations, including TEOM data

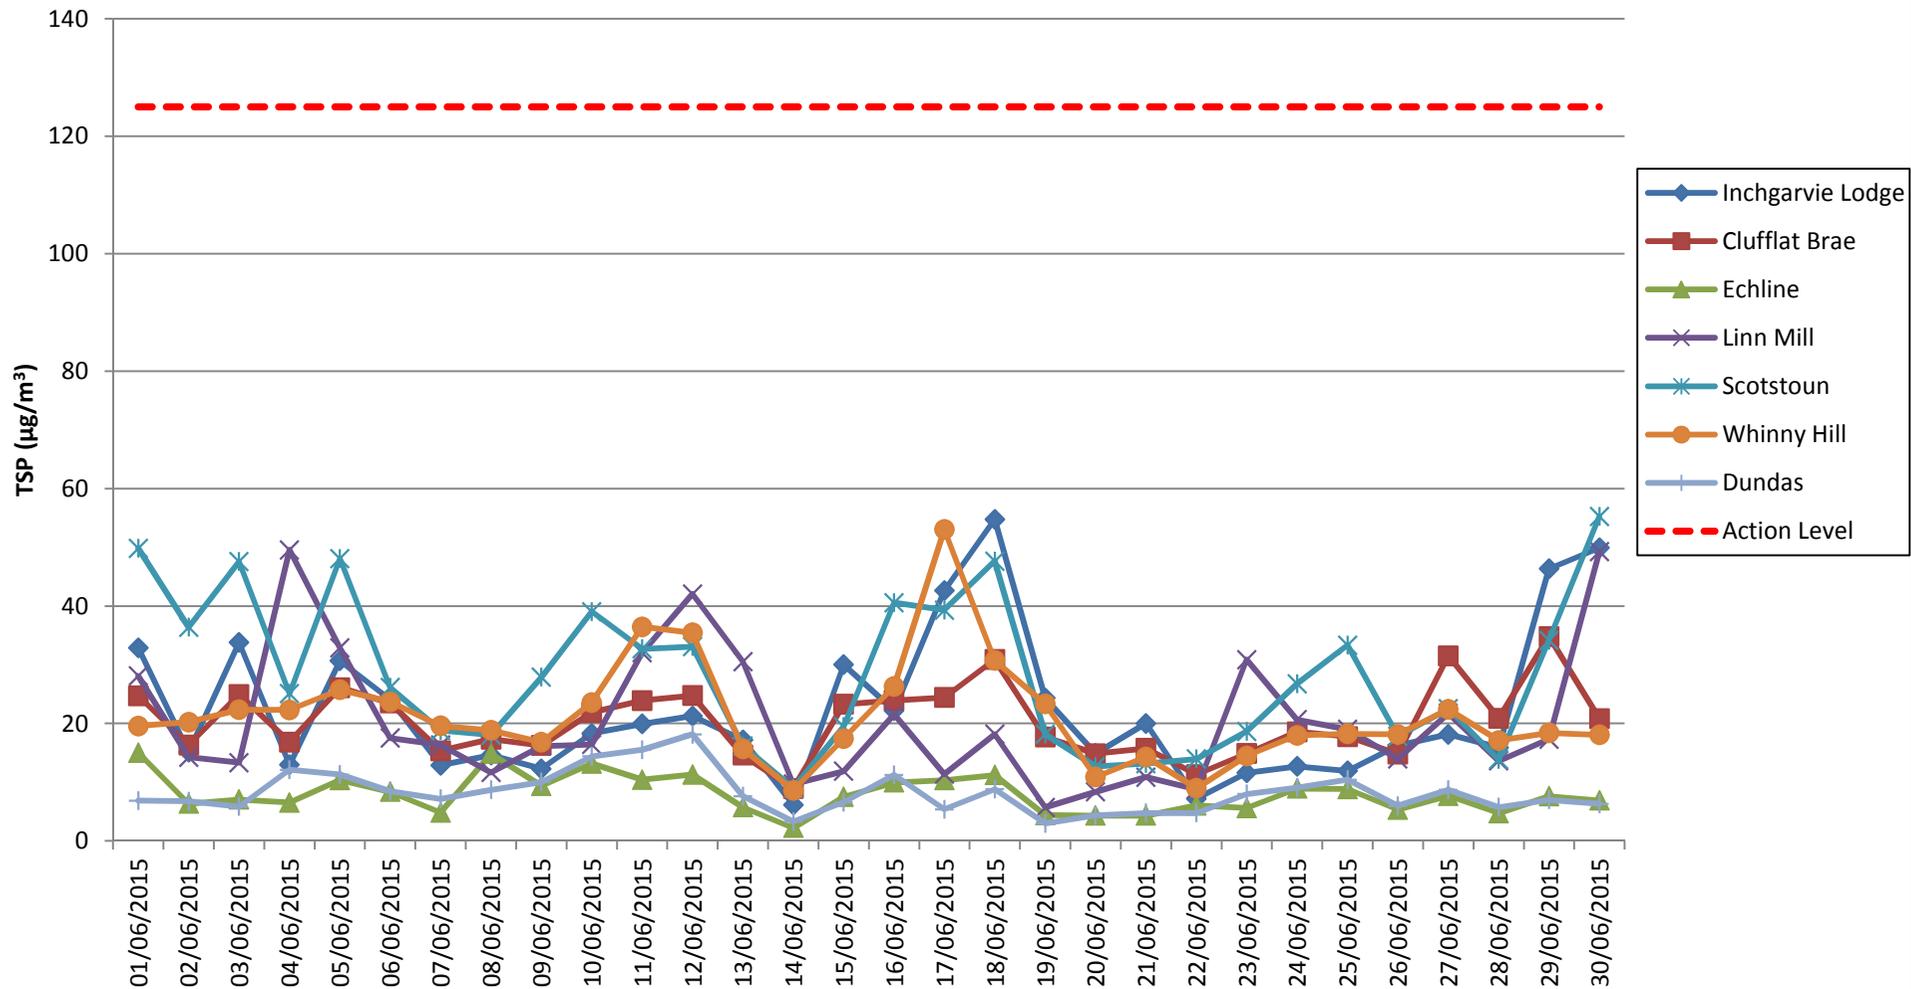
**3.2.1.** The TSP results for June 2015 have been presented in a monthly chart; this can be found in Appendix B. The TSP levels at monitoring locations during June were found to be generally low and all within the threshold level. All locations across the site were mostly found to follow a similar pattern (similar to that observed for PM<sub>10</sub> levels) but with higher levels noted at a few locations. As mentioned in 3.1.3. the Scotstoun monitor is currently located immediately adjacent to work activities which are being monitored closely at present. As with PM<sub>10</sub> it is considered that, in general, the TSP levels across site were influenced by regional changes in TSP levels, with the exception of the increases corresponding to the higher PM<sub>10</sub> levels noted in 3.1.2..

# Total Suspended Particles (TSP) Results June 2015

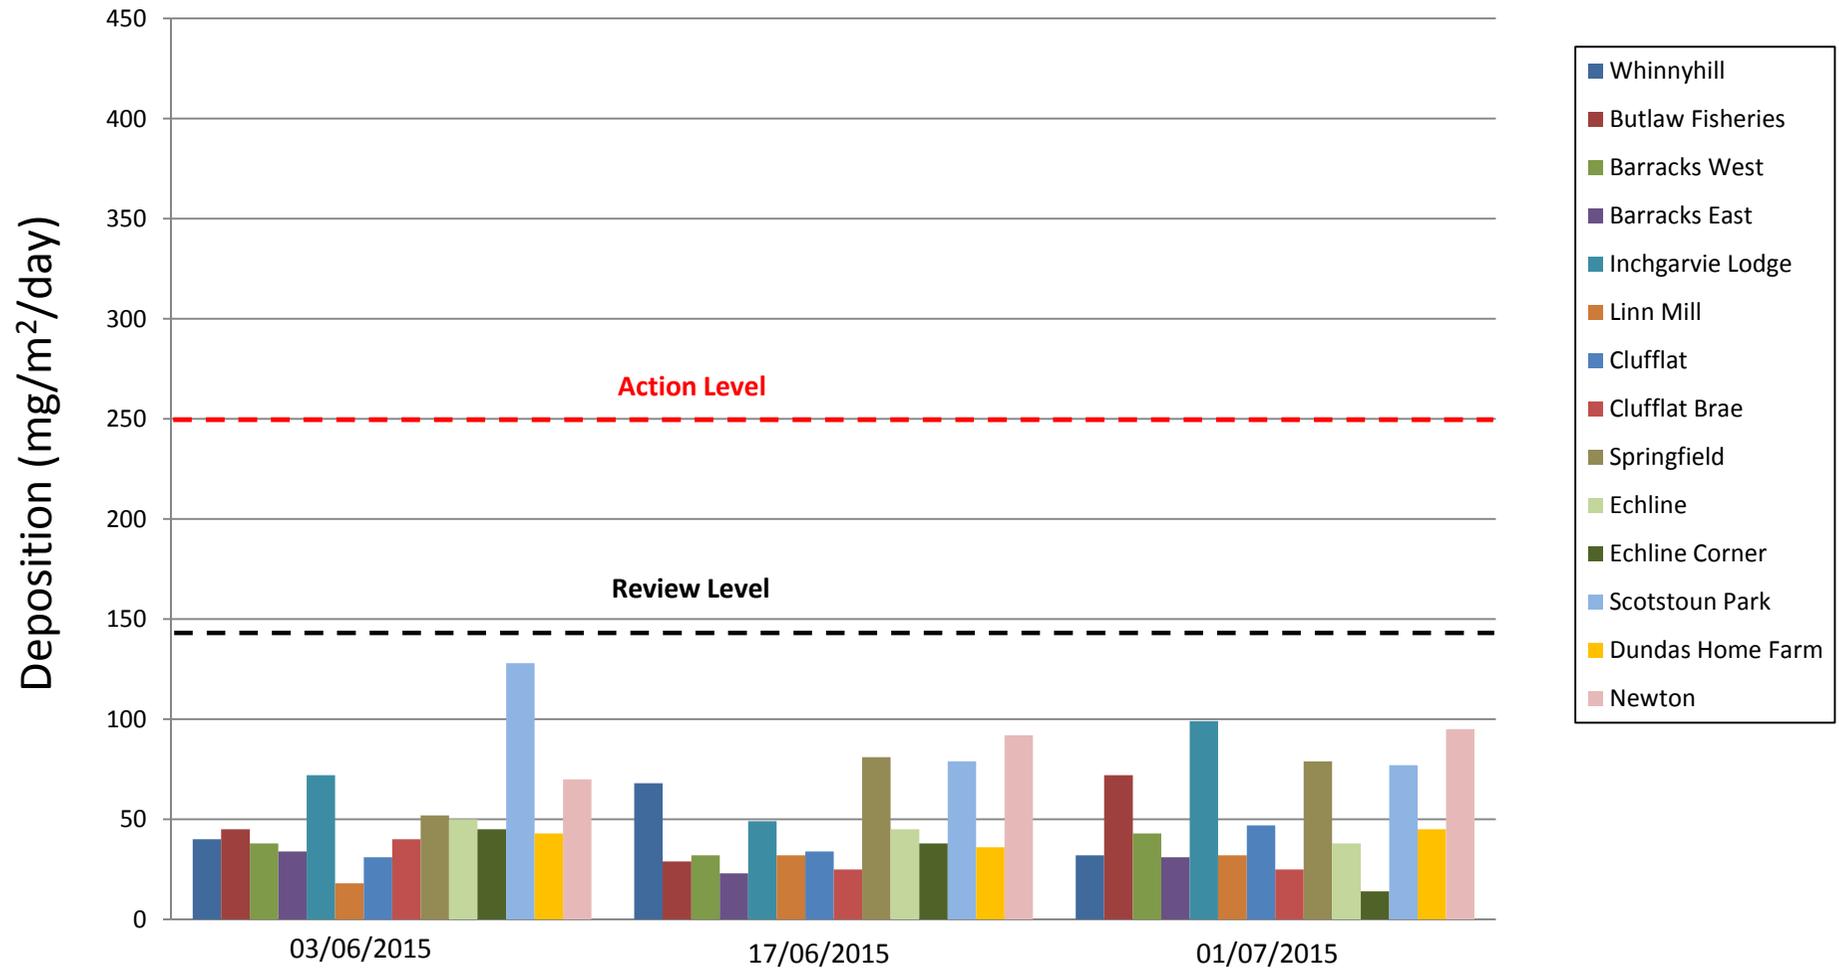
**3.3.1.** The Frisbee dust deposition results for June 2015 have been presented in a chart and can be found in Appendix C. This includes an additional Frisbee (Echline Corner) currently located south of the A904 in proximity to the Echline monitor. This temporary Frisbee is used to provide additional information and its results are presented alongside the 13 permanent monitors. Frisbee dust deposition results were collected fortnightly, and the results averaged over this fortnight period to give a daily dust deposition rate. Three collections were made to cover the results for June; these occurred on the 3<sup>rd</sup> and 17<sup>th</sup> June and the 1<sup>st</sup> July 2015.

**3.3.2.** The site action level for the dust deposition rate has been set at 250 mg/m<sup>2</sup>/day. Exceedances of this level are treated as a potential incident and a review of the works in the vicinity of the site is instigated. A lower site review level has been set at 140 mg/m<sup>2</sup>/day. Where concentrations exceed the lower review threshold the site works are reviewed to ensure good practice is implemented; it is essentially a warning that additional controls may be required.

**3.3.3.** During June there were no exceedances of either the site review or action levels, although it is noted that the result for Scotstoun for the fortnight ending 3<sup>rd</sup> July indicates higher dust deposition than at the other locations (see 3.1.3).

## Frisbee Dust Deposition Results: June 2015
