Project **FORTH REPLACEMENT CROSSING**

**AIR QUALITY MONITORING REPORT  
NOVEMBER 2015**

**REP-00258** Rev  
**00**

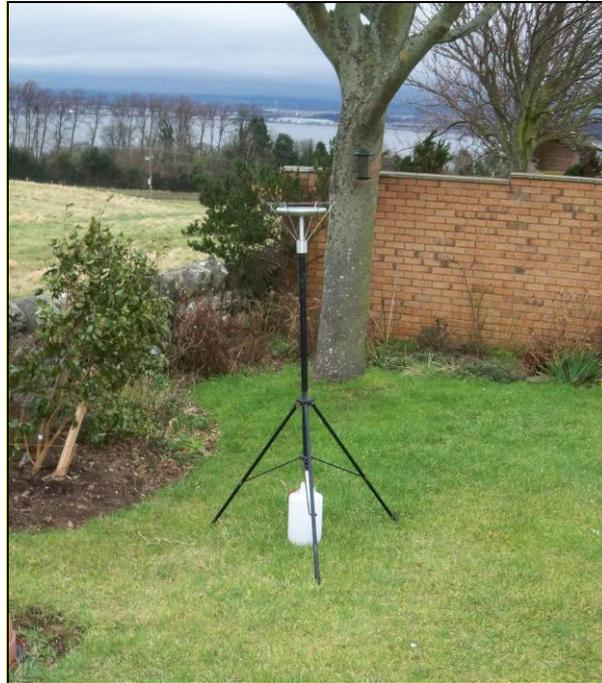
**Figure 1: Example of an Installed Frisbee Gauge Meter**

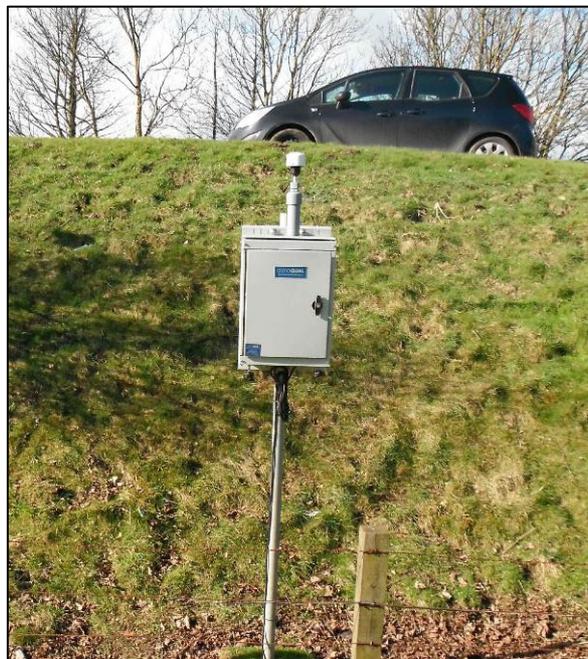
**Figure 2: Example of an installed Automatic Light Scatter Dust Meter**

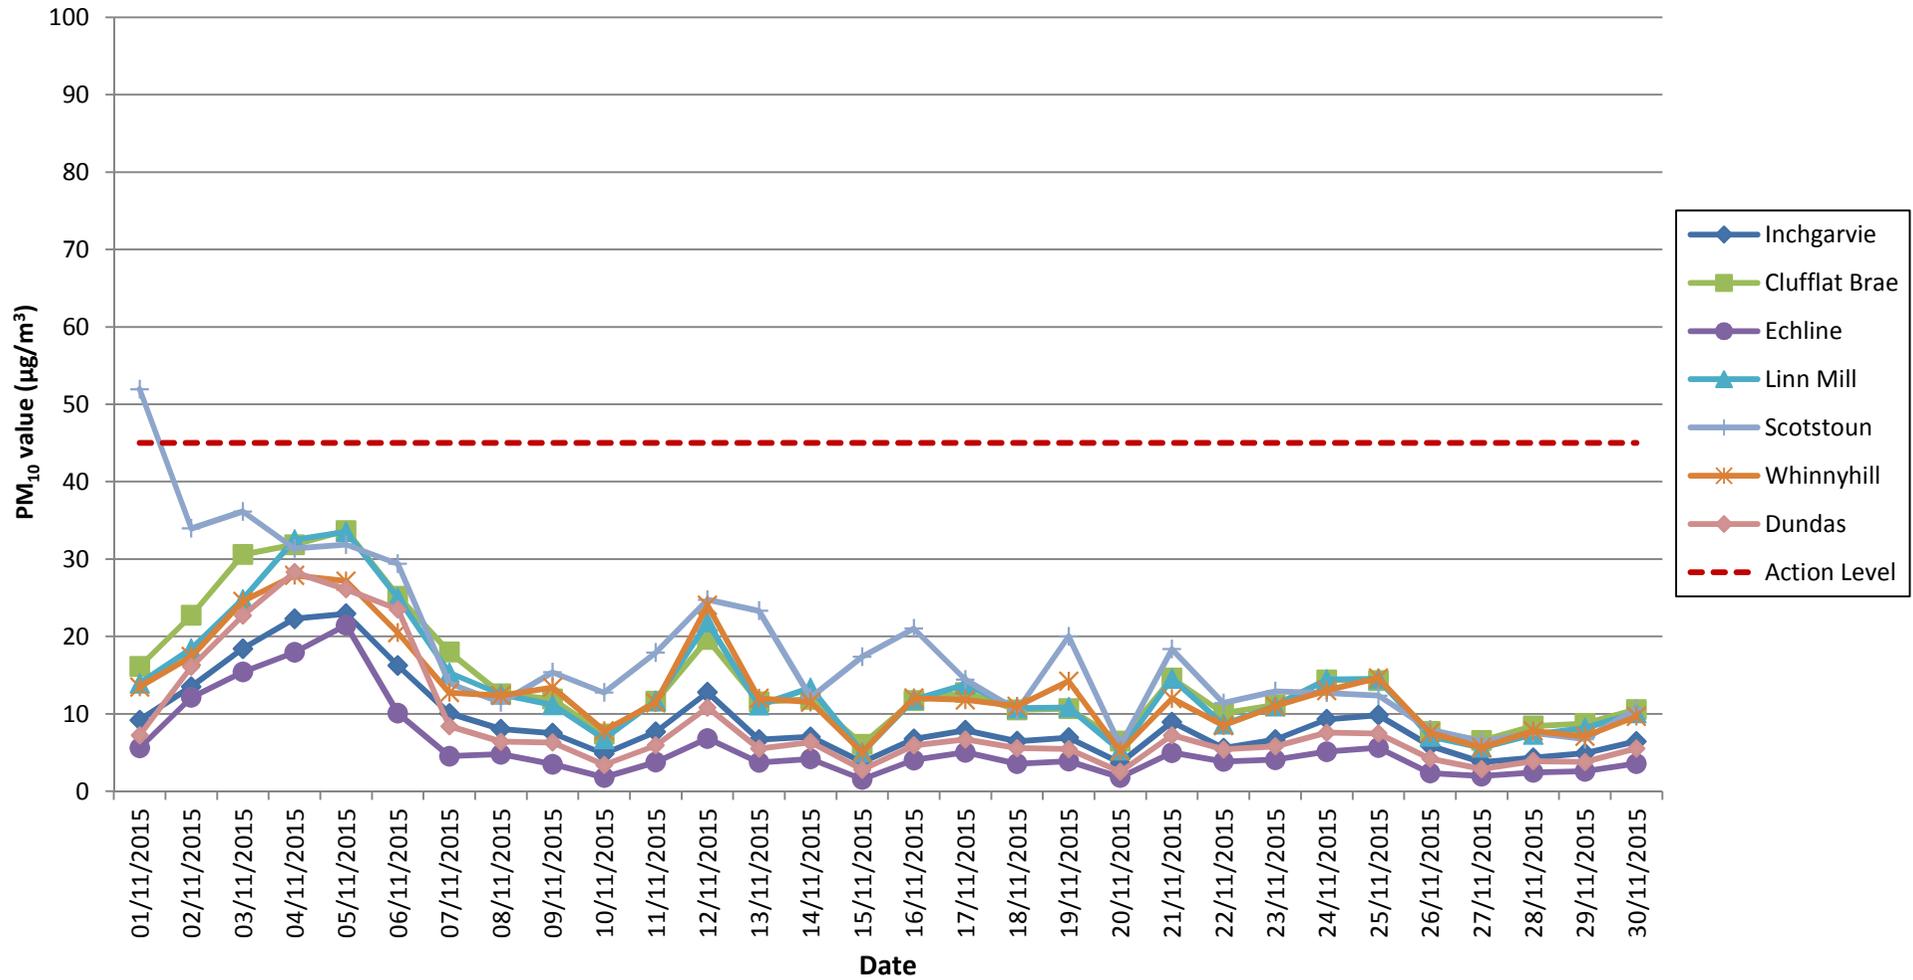
## **APPENDIX A: LIGHT SCATTER METER RESULTS**

**3.1.1.** Light scatter results for November 2015 have been presented in a monthly chart; this can be found in Appendix A. Results show that the PM<sub>10</sub> levels were mostly below threshold levels throughout the month with the exception of one exceedance at Scotstoun on the 1<sup>st</sup> November. This exceedance corresponds to dry weather conditions and is likely to have been caused by the B800 bridge demolition work that took place on this day (see 3.1.3).

Newton, Rosyth, and Broxburn, and from the TEOM FDMS station located at Queensferry Road and St Leonards, Edinburgh (an urban background site). The TEOM at Newton was installed by West Lothian Council, facilitated by FCBC, during November 2012. The comparison between the light scatter and TEOM results demonstrates that both sets of results generally follow the same pattern, indicating that the pattern observed throughout November was largely driven by regional changes in air quality. However, there were a few exceptions at Scotstoun (see 3.1.3).

- 3.1.3.** During November, site operations continued around the B800 north of the bridge over the A90. These works currently extend up to the fence line where the Scotstoun PM<sub>10</sub> monitor is located. These works include landscaping, surfacing and earthworks in the vicinity of the monitor. The demolition of the B800 bridge was also a major activity with the second section being demolished over the weekend of 31<sup>st</sup> October/ 1<sup>st</sup> November. This means that the monitor is essentially on-site and that operations are now closer to some receptors. However, with the exception of the exceedance on the 1<sup>st</sup> November, results throughout the month are all under the threshold. It is noted that on the 2<sup>nd</sup>, 3<sup>rd</sup>, 13<sup>th</sup>, 15<sup>th</sup> and 16<sup>th</sup> November, the PM<sub>10</sub> levels were slightly elevated compared to the other monitors. FCBC will continue to monitor this area closely over the next few months as works in this area progress, and provide mitigation as necessary. Demolition of the B800 bridge is now complete.

## Particulate Matter (PM10) Results for all Monitoring Locations

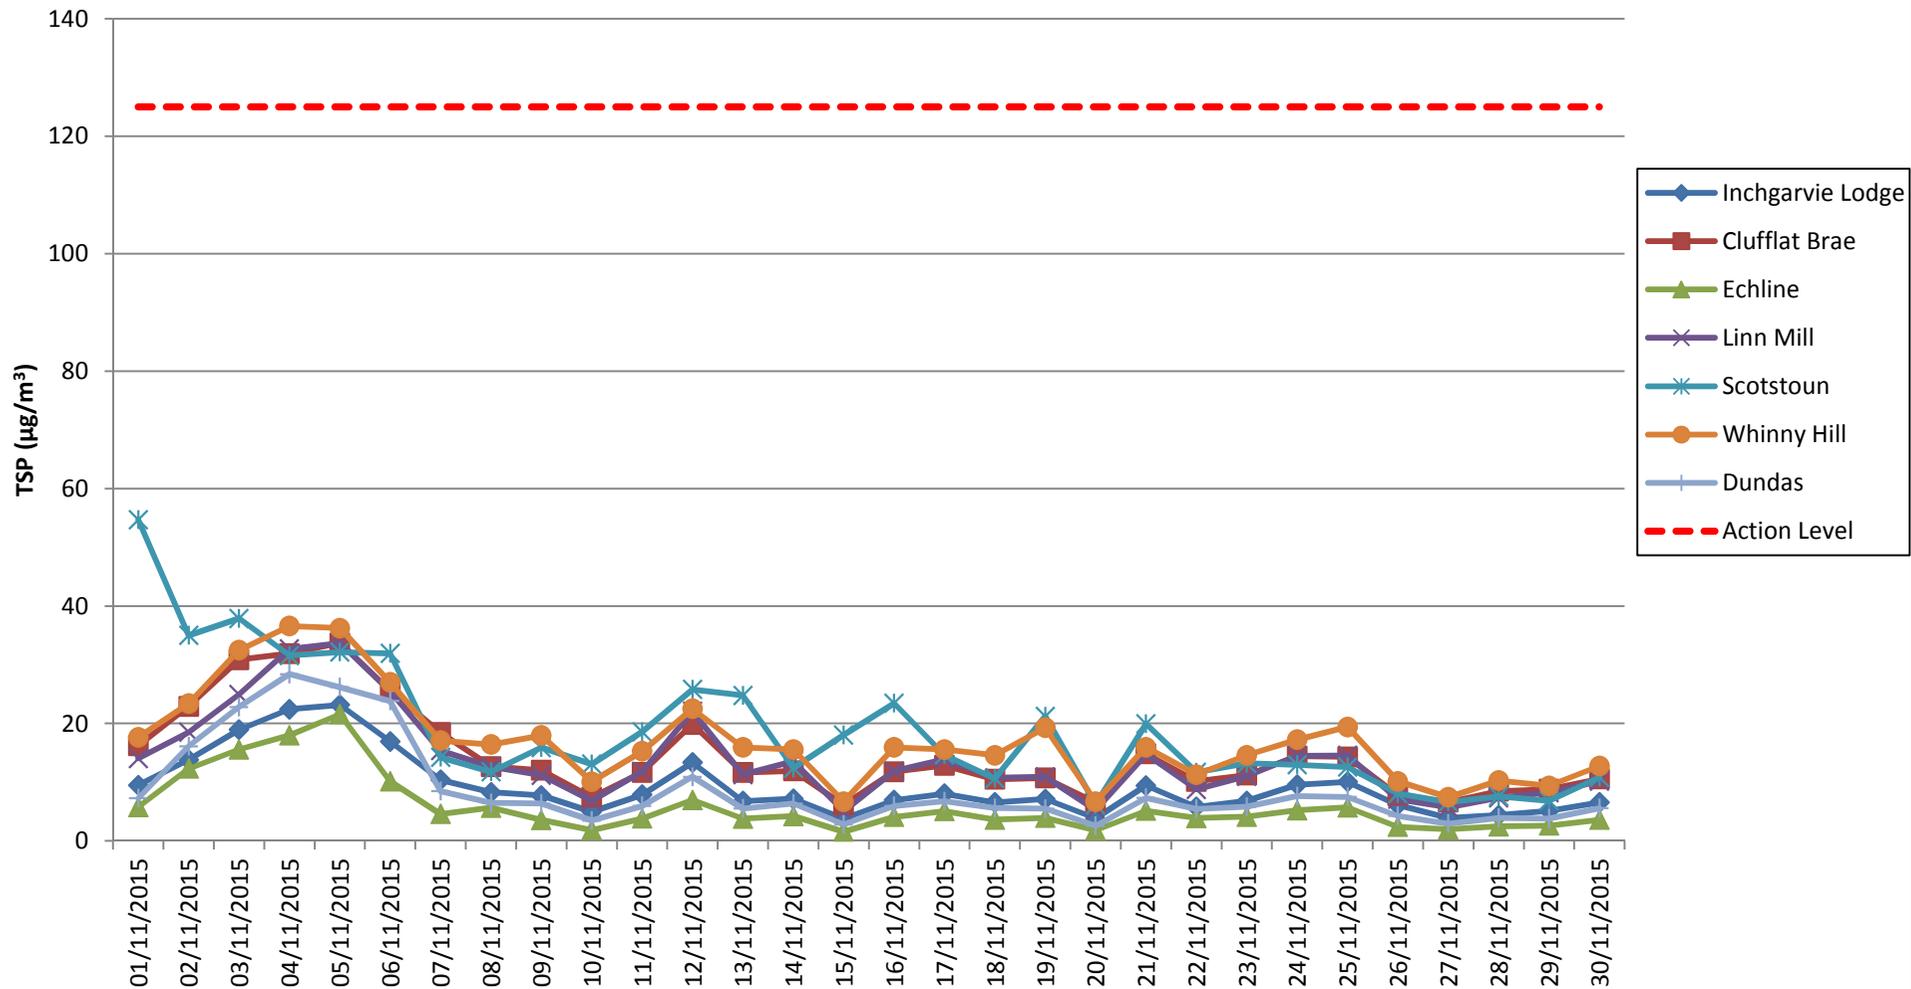
## **APPENDIX B: TOTAL SUSPENDED PARTICLES**

- 3.2.1.** The TSP results for November 2015 have been presented in a monthly chart; this can be found in Appendix B. The TSP levels at monitoring locations during November were found to be generally low and all within the threshold. All locations across the site were mostly found to follow a similar pattern (similar to that observed for PM<sub>10</sub> levels). As with PM<sub>10</sub> it is considered that, in general, the TSP levels across site were influenced

by regional changes in TSP levels, with the exception of the increases corresponding to the higher PM<sub>10</sub> levels noted at Scotstoun on the 2<sup>nd</sup>, 3<sup>rd</sup>, 13<sup>th</sup>, 15<sup>th</sup> and 16<sup>th</sup> November.

# Total Suspended Particles (TSP) Results November 2015

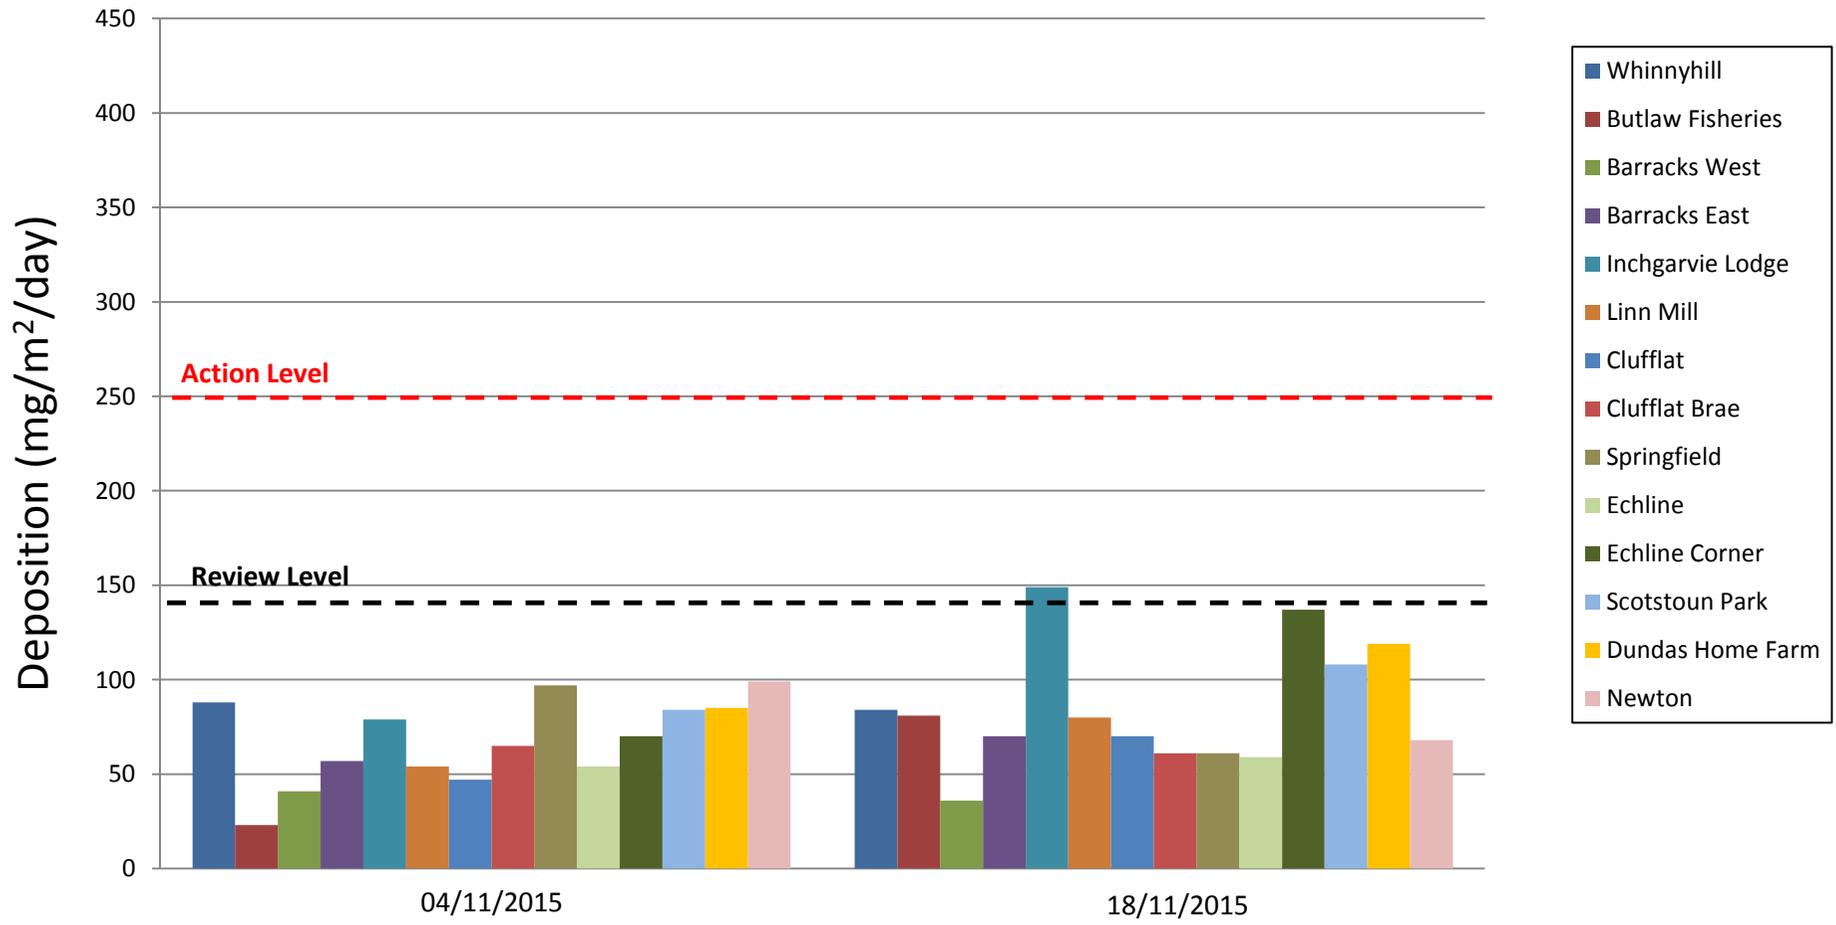
## **APPENDIX C: FRISBEE GAUGE RESULTS**

- 3.3.1.** The Frisbee dust deposition results for November 2015 have been presented in a chart and can be found in Appendix C. This includes an additional Frisbee (Echline Corner) currently located south of the A904 in proximity to the Echline monitor. This temporary Frisbee is used to provide additional information and its results are presented alongside the 13 permanent monitors. Frisbee dust deposition results were collected fortnightly, and the results averaged over this fortnight period to give a daily dust deposition rate. Two collections were made to cover the results for November; these occurred on the 4<sup>th</sup> and 18<sup>th</sup> November 2015.

- 3.3.2.** The site action level for the dust deposition rate has been set at 250 mg/m<sup>2</sup>/day. Exceedances of this level are treated as a potential incident and a review of the works in the vicinity of the site is instigated. A lower site review level has been set at 140 mg/m<sup>2</sup>/day. Where concentrations exceed the lower review threshold the site works are reviewed to ensure good practice is implemented; it is essentially a warning that additional controls may be required.

- 3.3.3.** During November there was one exceedance of the review level at Inchgarvie for the fortnight concluding 18<sup>th</sup> November. The Inchgarvie light scatter meter registered levels well below the action levels for both TSP and PM<sub>10</sub> during the period. The other two Frisbees in that area at Clufflat and Clufflat brae were also well under the review level. The main carriageway works being undertaken during this period potentially gave rise to dust although dusty conditions were not observed during site visits or reported. The ground conditions for the period were mostly

wet. Therefore, it is unlikely that construction activities contributed to the dust deposition result. FCBC will continue to monitor this area and provide mitigation as necessary.

## Frisbee Dust Deposition Results: November 2015
