Project **FORTH REPLACEMENT CROSSING**

**AIR QUALITY MONITORING REPORT  
FEBRUARY 2015**

Document number	Rev
<b>REP -00217</b>	<b>00</b>

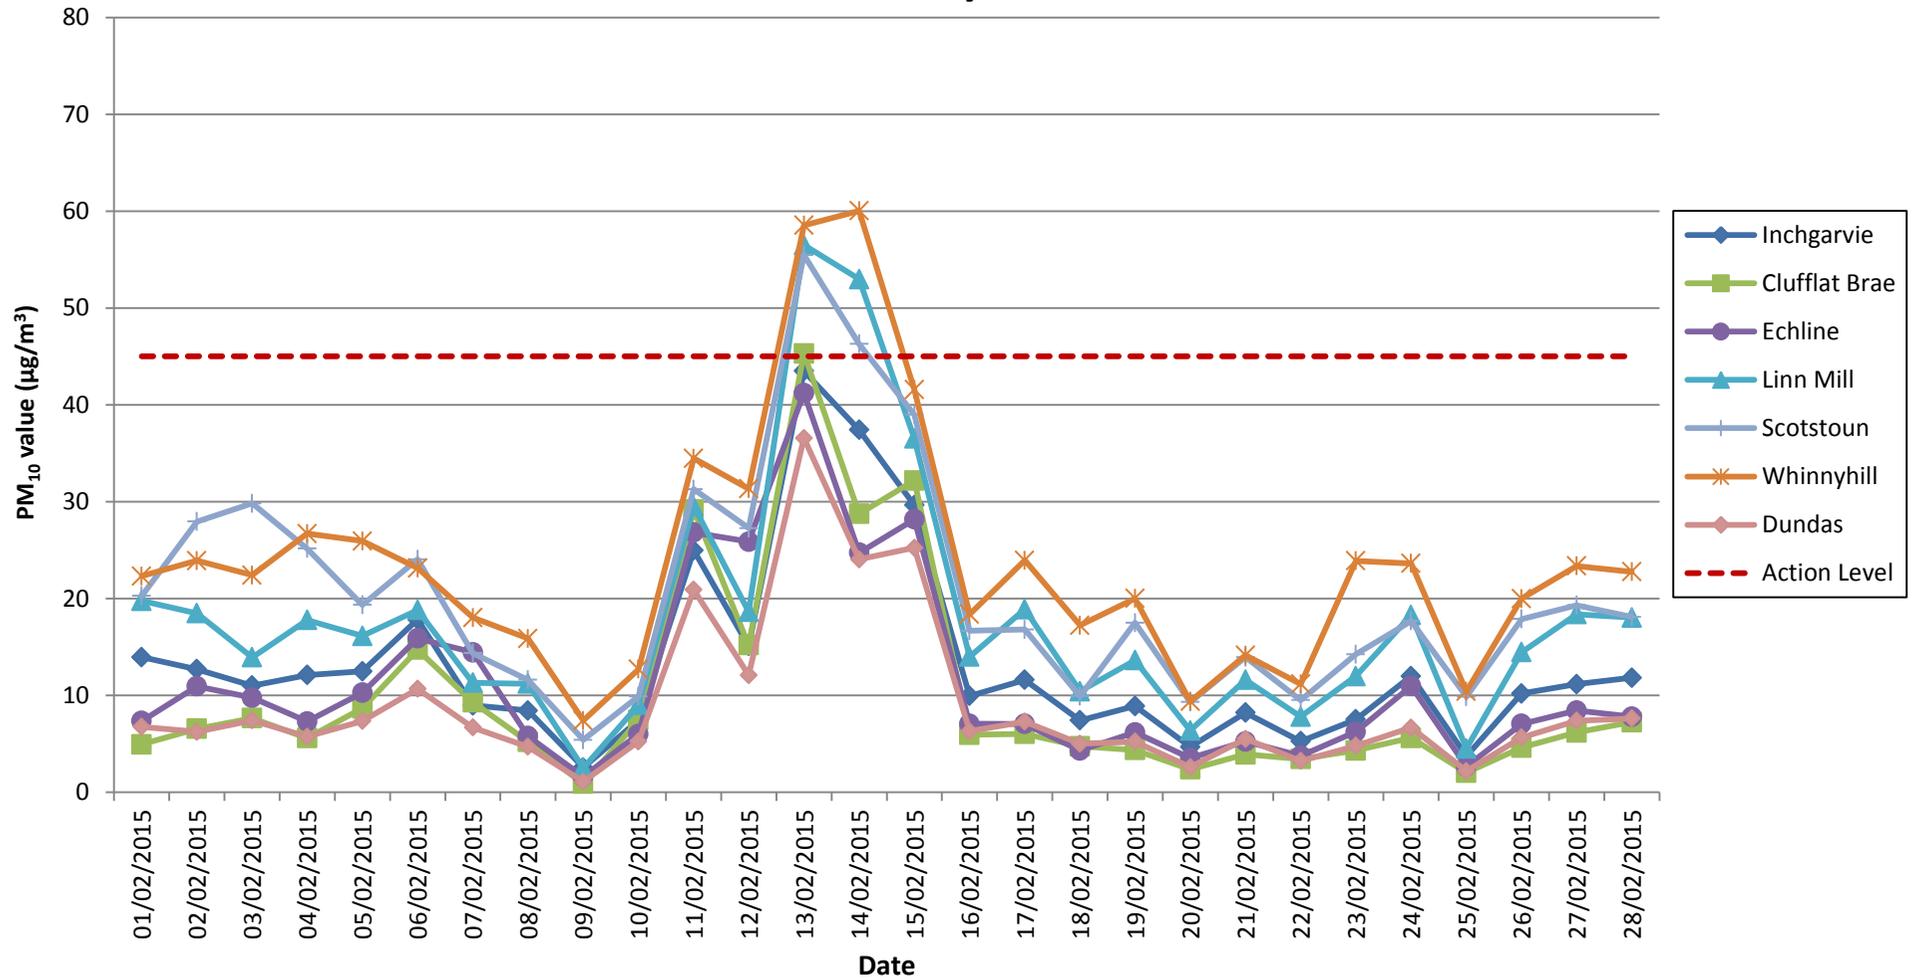
## Particulate Matter (PM10) Results for all Monitoring Locations

**3.1.1.** Light scatter results for February 2015 have been presented in a monthly chart; this can be found in Appendix A. Results show that the PM<sub>10</sub> levels were below threshold levels throughout the month with the exception of the 13<sup>th</sup> and 14<sup>th</sup> February. On these dates the monitors at Whinnyhill, Linn Mill and Scotstoun registered levels above the action level. In addition, the Clufflat Brae monitor recorded an exceedance of the action level on the 13<sup>th</sup> February. During the period 13<sup>th</sup> – 15<sup>th</sup> February all seven monitors registered increased levels.

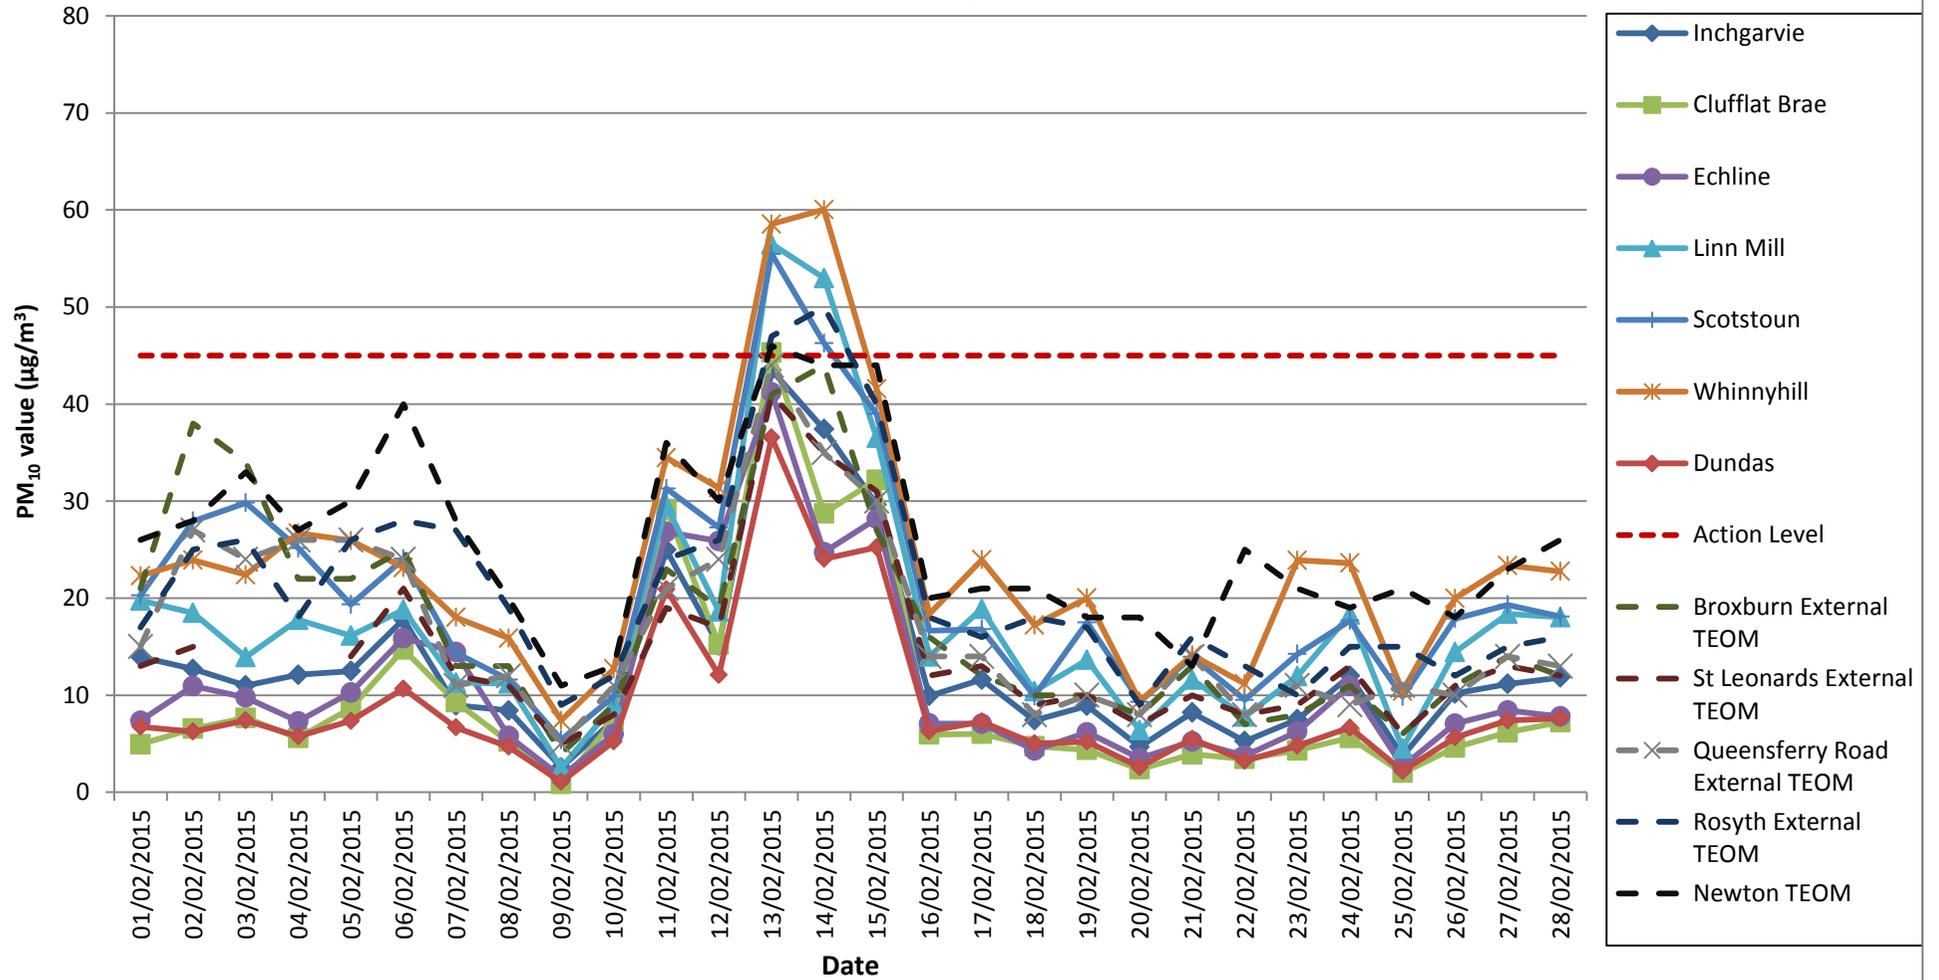
# Air Quality Monitoring: Particulate Matter (PM10) Results for all Monitoring Locations, including TEOM data February 2015

**3.1.2.** The PM<sub>10</sub> results have also been compared to the daily mean results obtained from the TEOM air quality monitoring stations located in Newton, Rosyth, and Broxburn, and from the TEOM FDMS station located at Queensferry Road, Edinburgh. The TEOM at Newton was installed by West Lothian Council, facilitated by FCBC, during May 2012. The comparison between the light scatter and TEOM results demonstrates that both sets of results generally follow the same pattern, including an increase in levels over the period 13<sup>th</sup> – 15<sup>th</sup> February, indicating that the pattern observed throughout February was largely driven by regional changes in air quality rather than being caused by construction related activities.

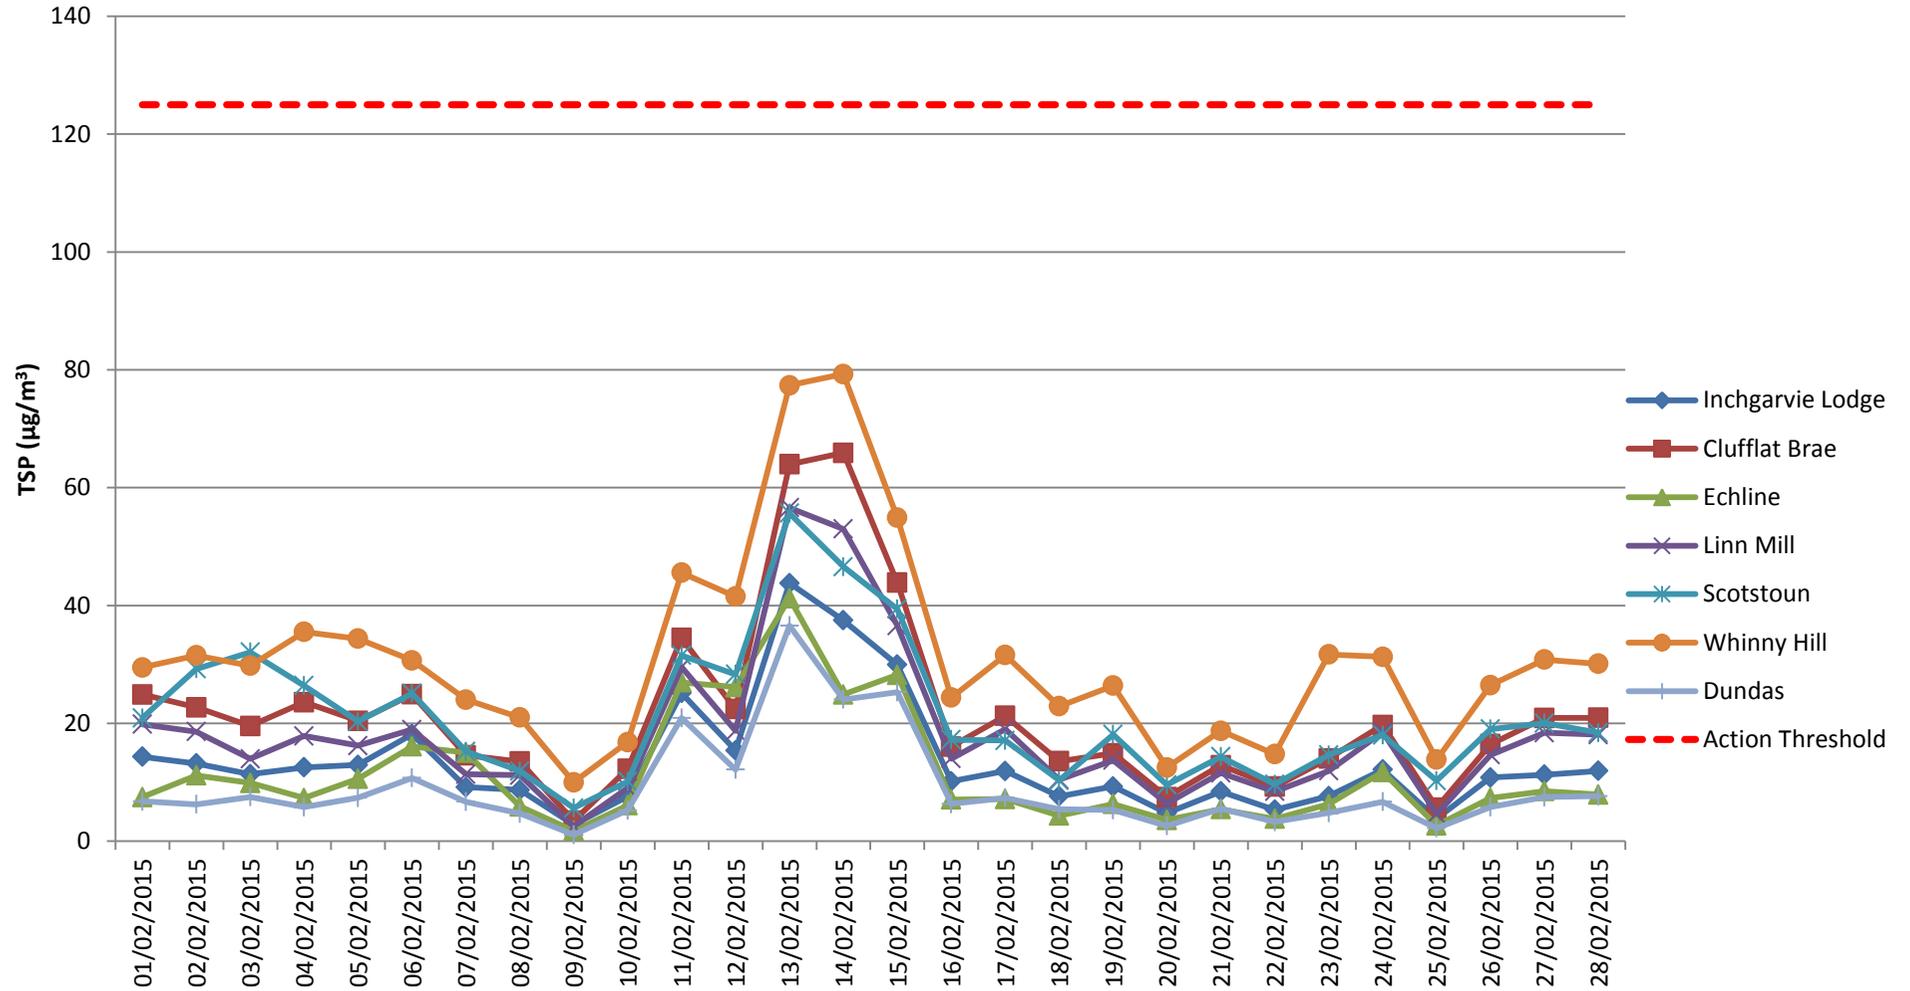
# Total Suspended Particles (TSP) Results February 2014

**3.2.1.** The TSP results for February 2015 have been presented in a monthly chart; this can be found in Appendix B. The TSP levels at monitoring locations during February were found to be low and all within the threshold level. All locations across the site were mostly found to follow a similar pattern, including an increase during the 13<sup>th</sup>-15<sup>th</sup> February, similar to that observed for PM<sub>10</sub> levels. This demonstrates that, in general, the levels were influenced by regional changes in TSP levels, rather than construction works.

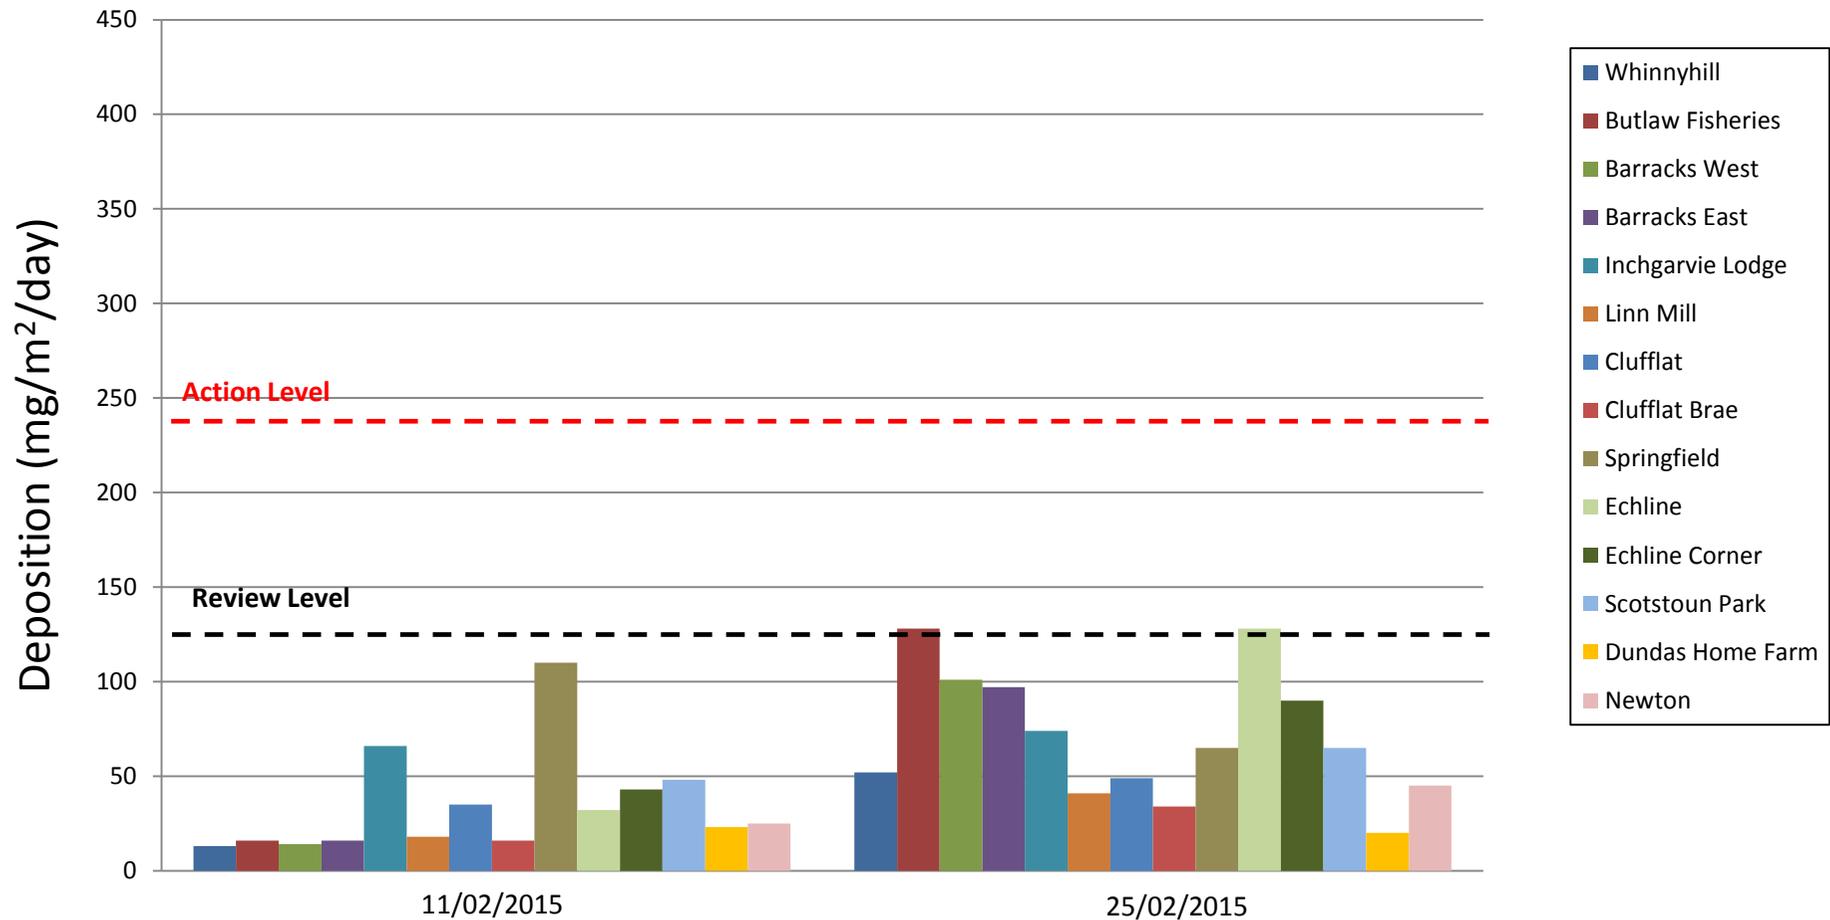
## Frisbee Dust Deposition Results: February 2015

**3.3.1.** The Frisbee dust deposition results for February 2015 have been presented in a chart and can be found in Appendix C. This includes an additional Frisbee (Echline Corner) currently located south of the A904 in proximity to the Echline monitor. This temporary Frisbee is used to provide additional information and its results are presented alongside the 13 permanent monitors. Frisbee dust deposition results were collected fortnightly, and the results averaged over this fortnight period to give a daily dust deposition rate. Two collections were made in February, on the 11<sup>th</sup> and 25<sup>th</sup>. The collection on the 11<sup>th</sup> February represents the period covering the previous 21 days. The delay was

- 3.3.2.** The site action level for the dust deposition rate has been set at 250 mg/m<sup>2</sup>/day. Exceedances of this level are treated as a potential incident and a review of the works in the vicinity of the site is instigated. A lower site review level has been set at 140 mg/m<sup>2</sup>/day. Where concentrations exceed the lower review threshold the site works are reviewed to ensure good practice is implemented; it is essentially a warning that additional controls may be required.
- 3.3.3.** During February there were two exceedances of the site review level and no exceedances of the action level (see Table 2).

**3.3.5.** During the period ending the 25<sup>th</sup> February the Echline gauge registered dust deposition results above the review level. During this time the gauge was located immediately adjacent to minor works occurring on along the B924. A review of these works has therefore been undertaken. Although there were no activities that would give rise to any significant dust generation taking place in the area, work was ongoing in direct proximity to the gauge, including soiling the adjacent verge area. No dust was observed migrating from these works during this period. Two other gauges are located in close proximity to this monitor (Echline Corner and Springfield). Both of these gauges registered levels below the review level during the period. PM<sub>10</sub> and TSP data were low for the period at the locations in close proximity (Echline, Clufflat and Inchgarvie) with the exception of the 13<sup>th</sup> - 15<sup>th</sup> (See section 3.1.1). After a thorough review it was concluded that the raised levels may have been a result of the Frisbee gauge being located directly within the verge soiling works during this period but any dust created was contained to site and not allowed to migrate beyond this. It should be noted that even with the gauge being located within the works, dust deposition levels were still well below the action level. Works in the immediate proximity to the gauge were completed in early March.

**3.3.6.** During the period ending the 25<sup>th</sup> February the Butlaw gauge registered above the review level. However, a review of works was undertaken and it was found that no construction activities that would be likely to give rise to dust took place in the area during this period. PM<sub>10</sub> and TSP data were very low at the closest monitors (Clufflat and Inchgarvie). After a thorough review it was concluded that the results cannot be explained by FCBC construction activities undertaken during this period.

**Note:** The collection on the 11<sup>th</sup> February represents the period covering the previous 21 days. The delay was due to a logistical problem with the courier returning sample bottles from the testing laboratory.
