**FCBC**  
Queensferry  
Crossing

Project **FORTH REPLACEMENT CROSSING**

**AIR QUALITY MONITORING REPORT  
FEBRUARY 2016**

**REP-00270**

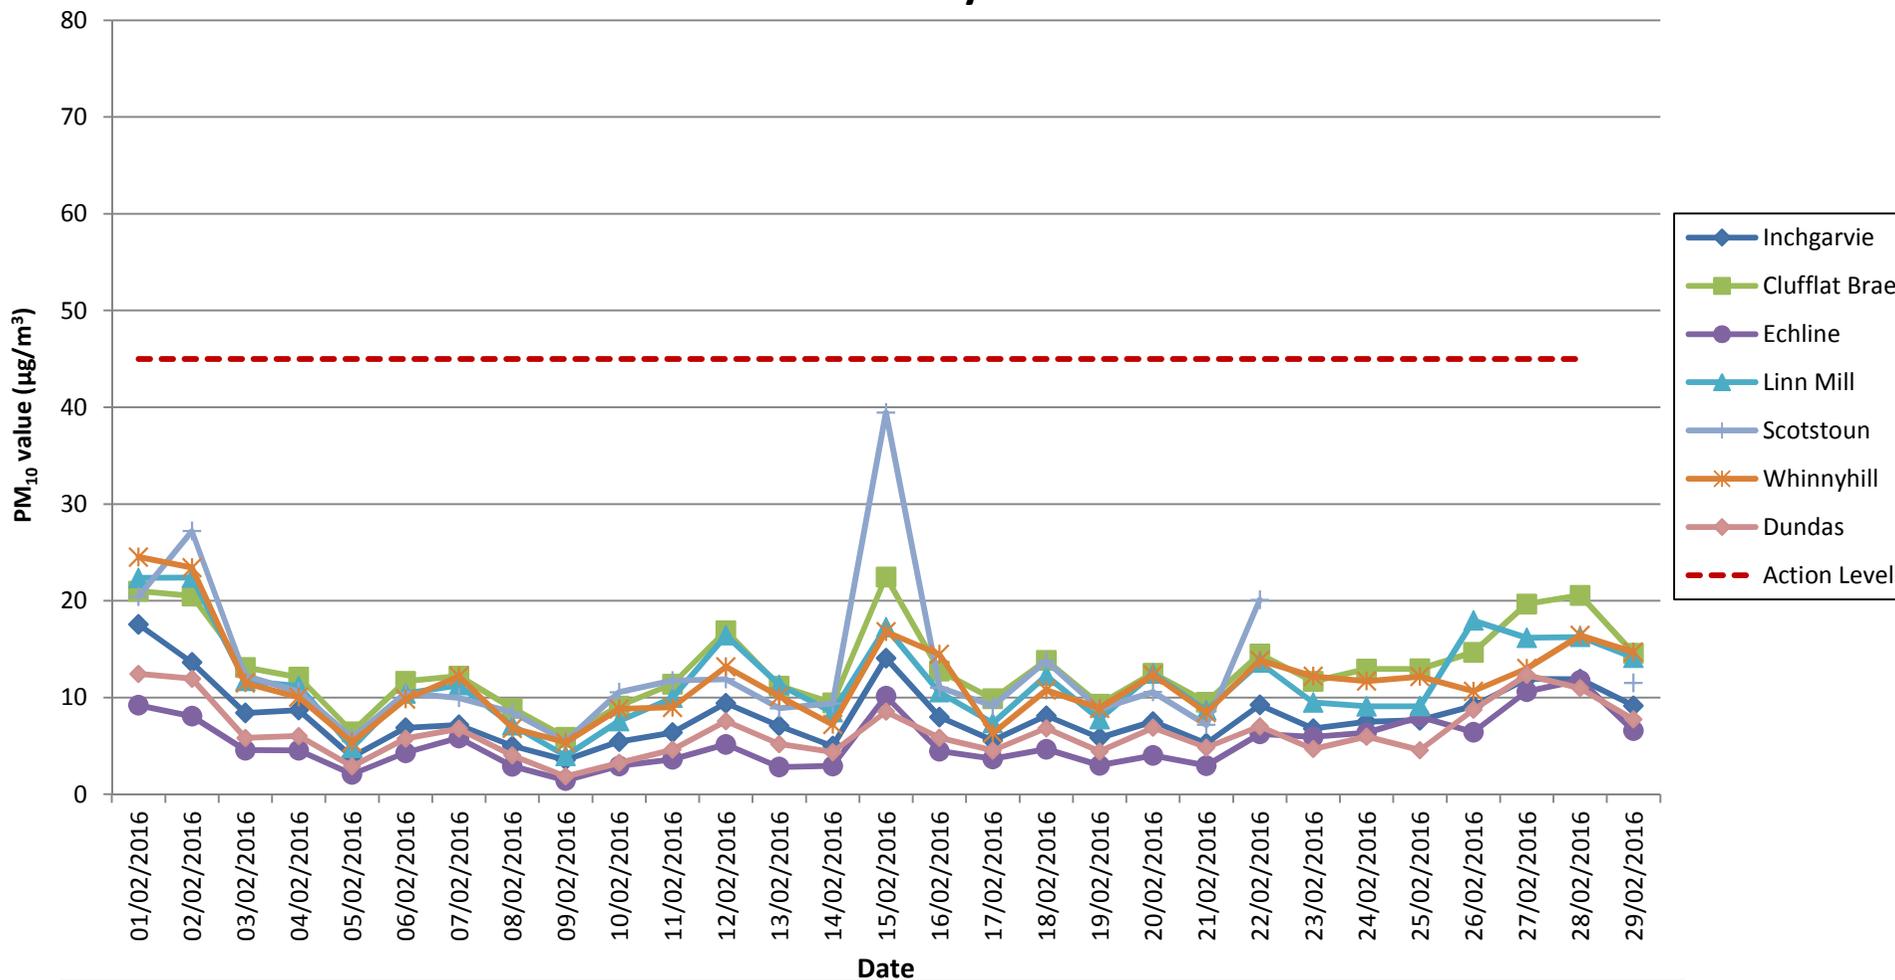
## Particulate Matter (PM10) Results for all Monitoring Locations

**3.1.1.** Light scatter results for February 2016 have been presented in a monthly chart; this can be found in Appendix A. Results show that the PM<sub>10</sub> levels were well below threshold levels throughout February. All monitors generally follow the same pattern throughout the month.

Note: There is no data at the Scotstoun monitor between 23/02/2016 and 28/02/2016 due to a electrical problem at the monitor. This was back online on the 29/02/2016

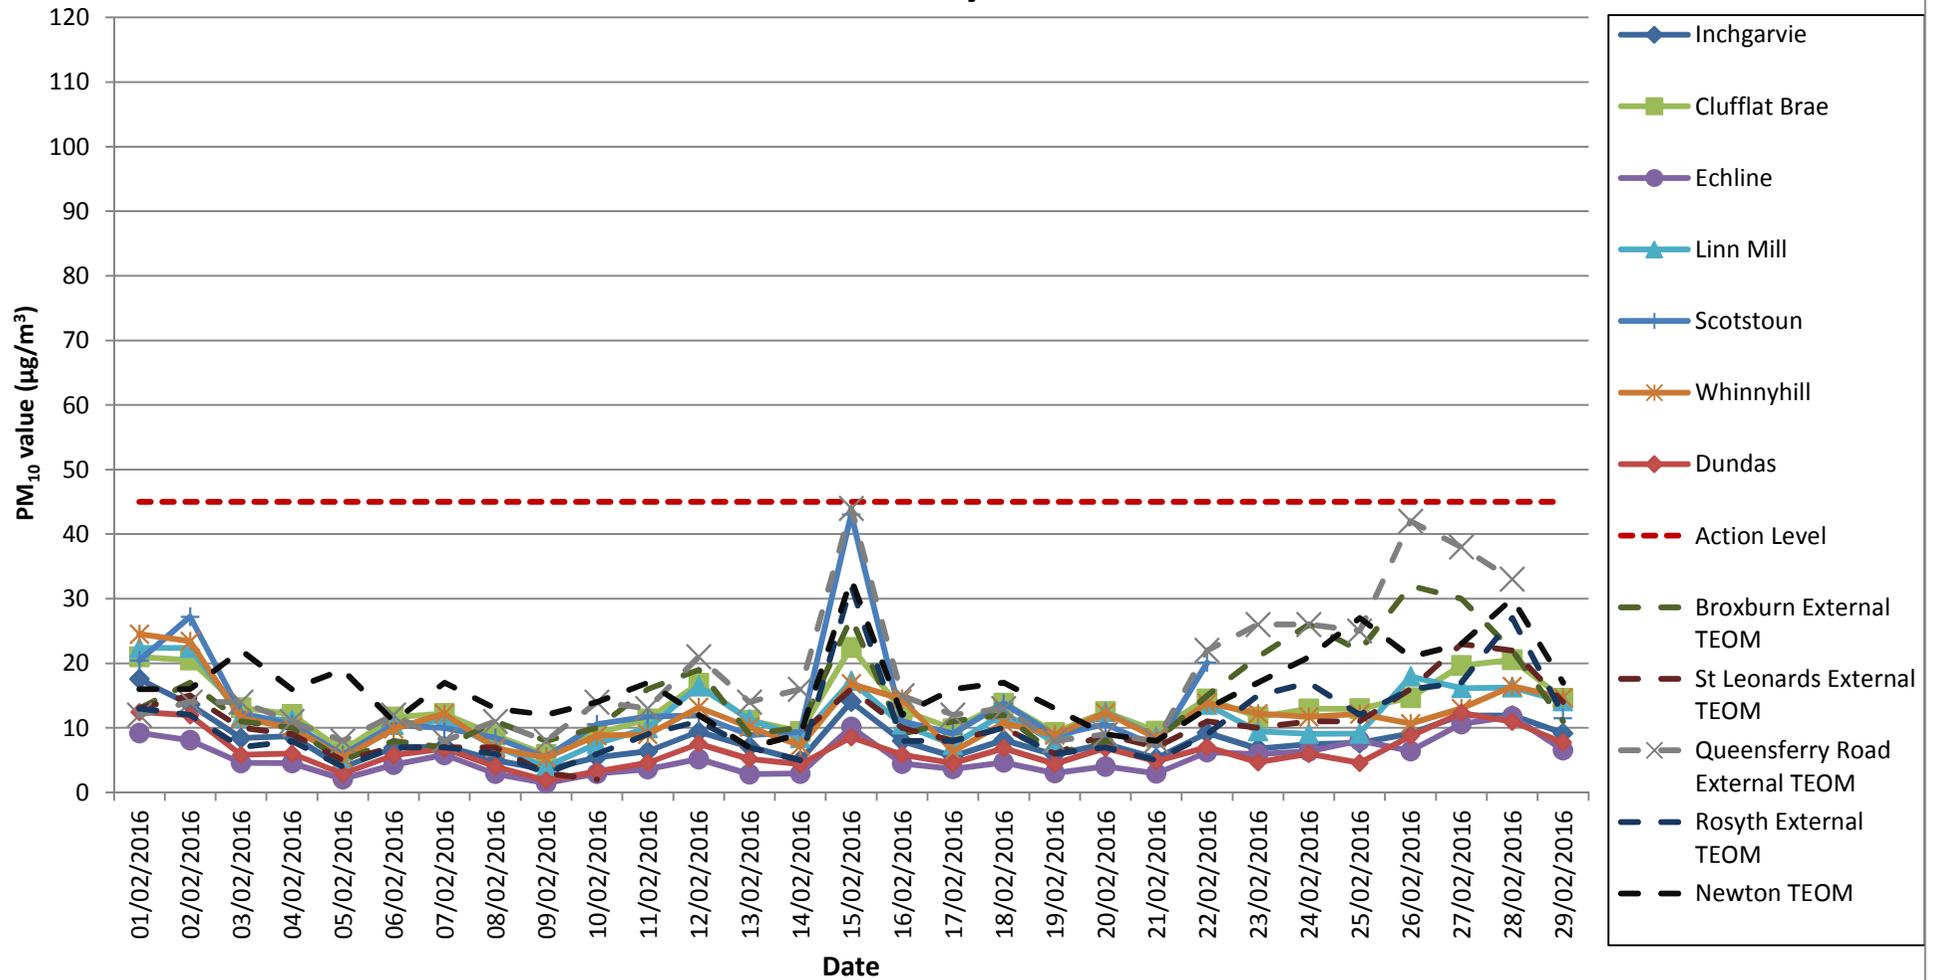
## Air Quality Monitoring: Particulate Matter (PM10) Results for all Monitoring Locations, including TEOM data February 2016

**3.1.2.** The PM<sub>10</sub> results have also been compared to the daily mean results obtained from the TEOM air quality monitoring stations located in Newton, Rosyth, and Broxburn, and from the TEOM FDMS station located at Queensferry Road and St Leonards, Edinburgh (an urban background site). The TEOM at Newton was installed by West Lothian

Council, facilitated by FCBC, during January 2012. The comparison between the light scatter and TEOM results demonstrates that both sets of results generally follow the same pattern, including a peak on 15 February, indicating that the pattern observed throughout February was largely driven by regional changes in air quality.

**Note:** There is no data at the Scotstoun monitor between 23/02/2016 and 28/02/2016 due to a electrical problem at the monitor. This was back online on the 29/02/2016

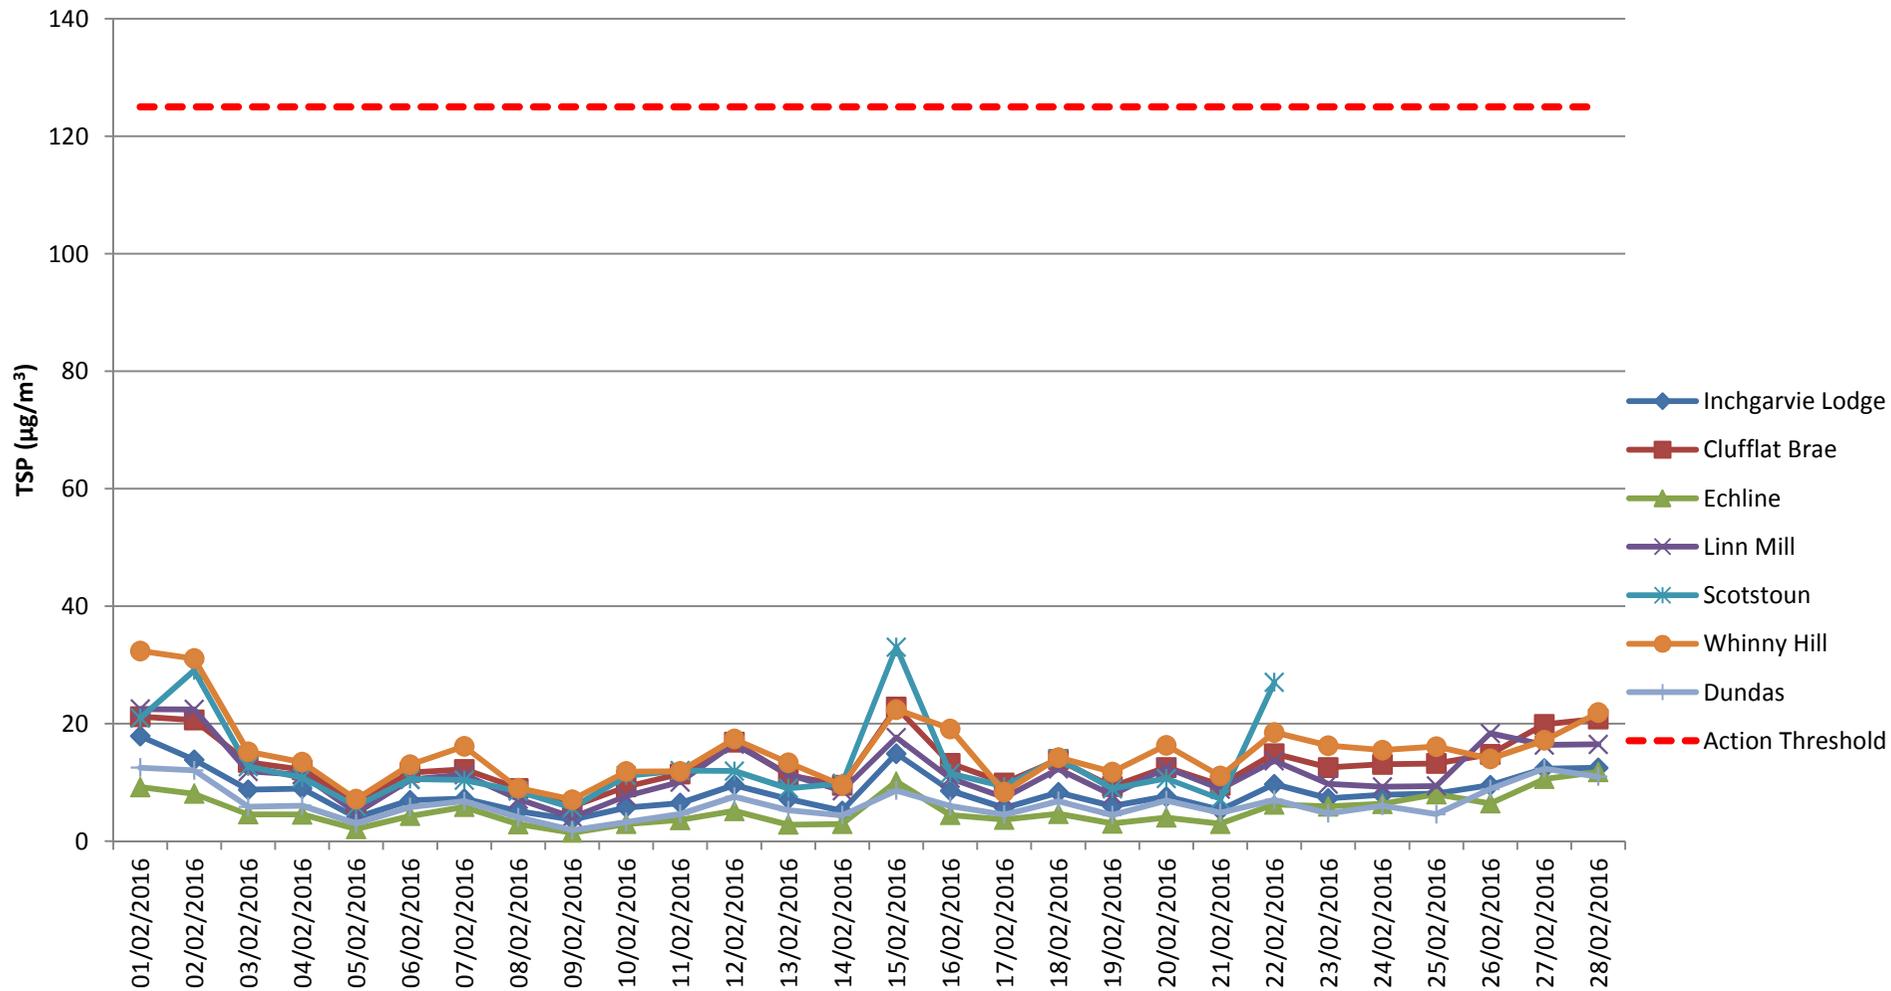
## Total Suspended Particles (TSP) Results February 2016

**3.2.1.** The TSP results for February 2016 have been presented in a monthly chart; this can be found in Appendix B. The TSP levels at monitoring locations during February were found to be low and all within the threshold. All locations across the site were found to follow a similar pattern (similar to that observed for PM<sub>10</sub> levels). As with PM<sub>10</sub> it is considered that the TSP levels across site were influenced by regional changes in TSP levels.

Note: There is no data at the Scotstoun monitor between 23/02/2016 and 28/02/2016 due to a electrical problem at the monitor. This was back online on the 29/02/2016

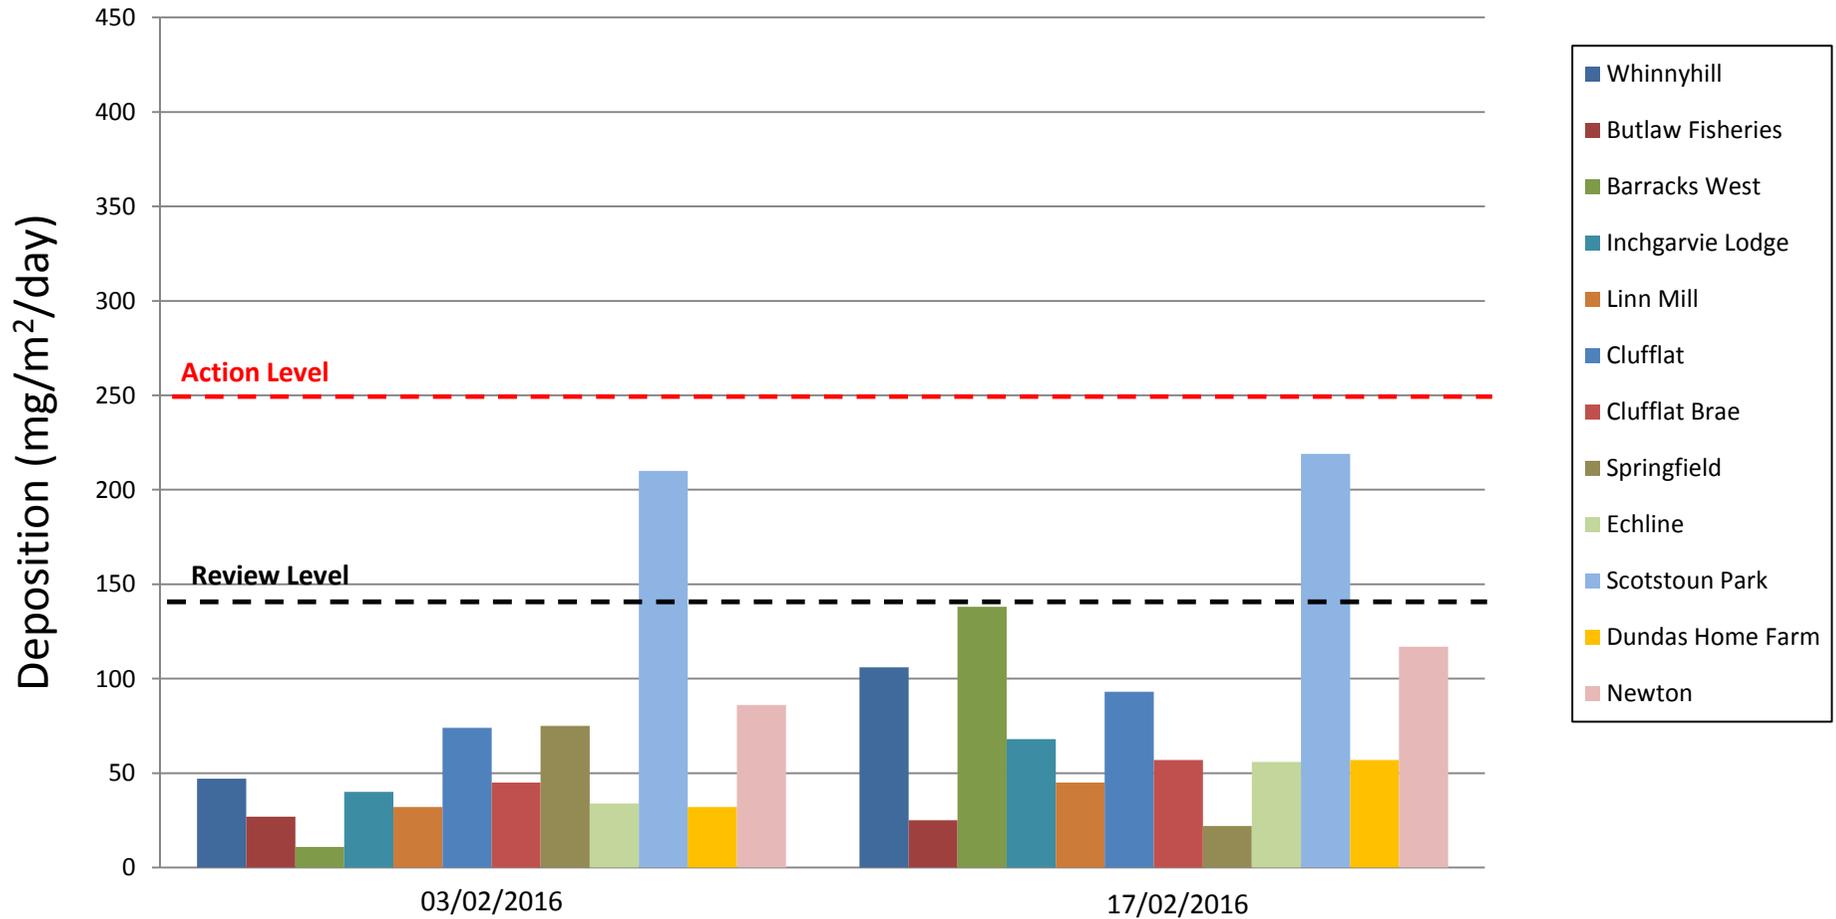
# Frisbee Dust Deposition Results: February 2016

**3.3.1.** The Frisbee dust deposition results for February 2016 have been presented in a chart and can be found in Appendix C. Two collections were made in February; these occurred on the 3<sup>rd</sup> and 17<sup>th</sup> February 2016.

**3.3.2.** The site action level for the dust deposition rate has been set at 250 mg/m<sup>2</sup>/day. Exceedances of this level are treated as a potential incident and a review of the works in the vicinity of the site is instigated. A lower site review level has been set at 140 mg/m<sup>2</sup>/day. Where concentrations exceed the lower review threshold the site works are reviewed to ensure good practice is implemented; it is essentially a warning that additional controls may be required.

**3.3.3.** During February there were two exceedances of the review level at Scotstoun for the fortnight concluding 3<sup>rd</sup> February and 14<sup>th</sup> February. Although there were FCBC earthworks on the mainline in the area (approx. 190 metres), the ground conditions for the period were mostly wet and damp and there was no dust observed on site. In addition, the light scatter meters at Scotstoun indicated very low levels of PM<sub>10</sub> and TSP during this fortnight. These exceedances may have been caused from another construction site (not part of the FRC project) that is located closer to the Scotstoun frisbee, on the other side of the B800 (approx. 80 metres). This other construction work started in December with earthworks being undertaken. It is considered unlikely that FCBC construction works caused these exceedances. However, FCBC will continue to monitor this area closely as works progress and provide mitigation as necessary. FCBC will also provide an additional temporary Frisbee at Scotstoun to further investigate the exceedances.
