## **REPORT INTO THE BREAKDOWN OF THE MV HAMNAVOE**

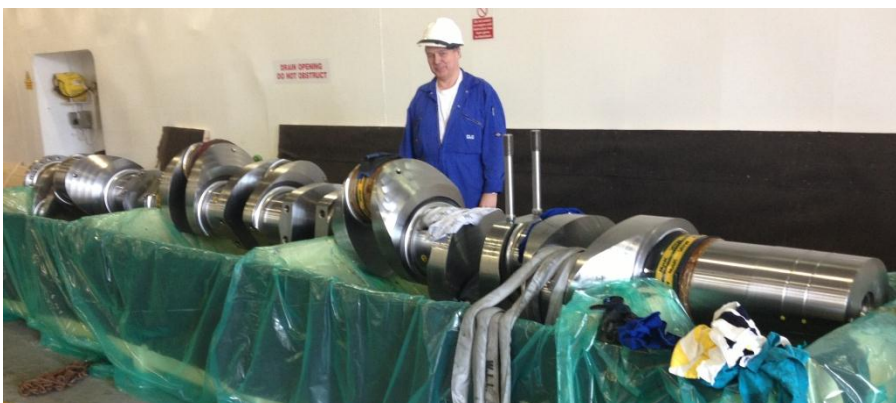
Figure 1. Serco NorthLink Technical Manager, Chris Adams with the replacement crankshaft.

2.6 Replacing the damaged crankshaft was a major and complex operation. The damaged engine had to be stripped down and all component parts stored in preparation for rebuild. Pipes supplying water, electricity and other essential services had to be rerouted and a hole cut in the car deck to allow the damaged crankshaft to be lifted out.

2.7 The new 4.5 ton crankshaft then had to be slowly lowered into place and then all the other component parts of the Starboard Main Engine reassembled, the supply pipes reconnected and the car deck repaired. Sea trials took place on Sunday, 19 May and the
