Roads for All

**The Trunk Road Network
Disability Equality Scheme
and
Action Plan**

Appendices

**Transport Scotland
Glasgow
4 December 2006**

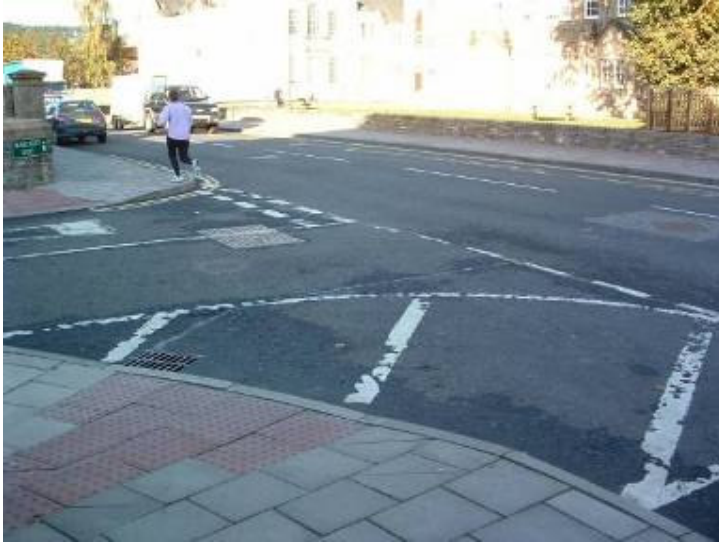
Tactile blister paving is used to warn visually impaired people where there is a lack of a kerb height change in level between the road and the pavement. The faults observed included the use of red tactile paving at

uncontrolled crossings. Some visually impaired people depend on the correct layout and colour of tactile paving to know which type of crossing they have encountered and to orientate them to cross the road.

Incorrectly installed tactile paving

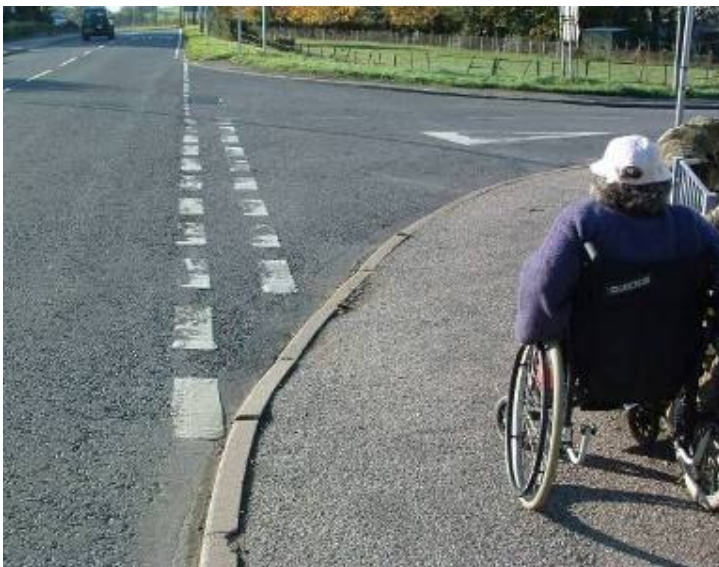
Where dropped kerbs are provided many are not flush and some have upstands more than 6mm. People who use wheelchairs and people who have difficulty walking can find such upstands difficult to negotiate.

Lack of dropped kerbs and tactile paving

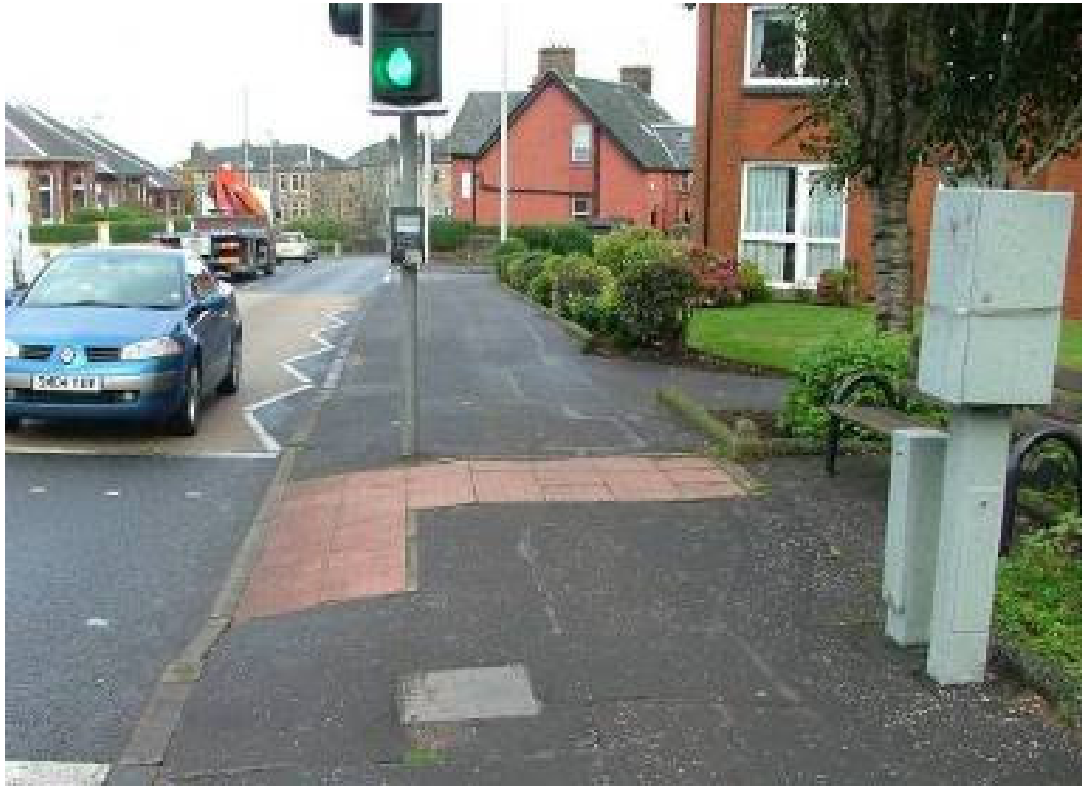
Some crossings were found to have steep gradients on the approach to the dropped kerb. People who use wheelchairs can find this a problem because it can be difficult to go up or down a steep slope and there is a risk of rolling on to the road.

Steep approach to a dropped kerb

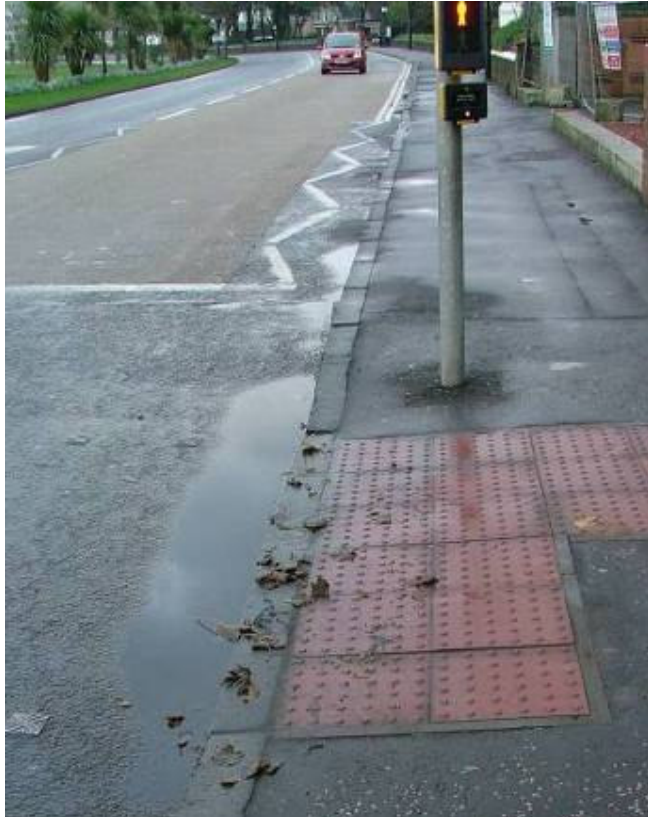
Poor drainage was observed at some crossing points. This can result in ponding. This is a hazard and a nuisance in wet and icy conditions and it also causes the build up of silt which can obscure the edge of the kerb and tactile paving slabs.

Poor drainage causing ponding at a crossing point

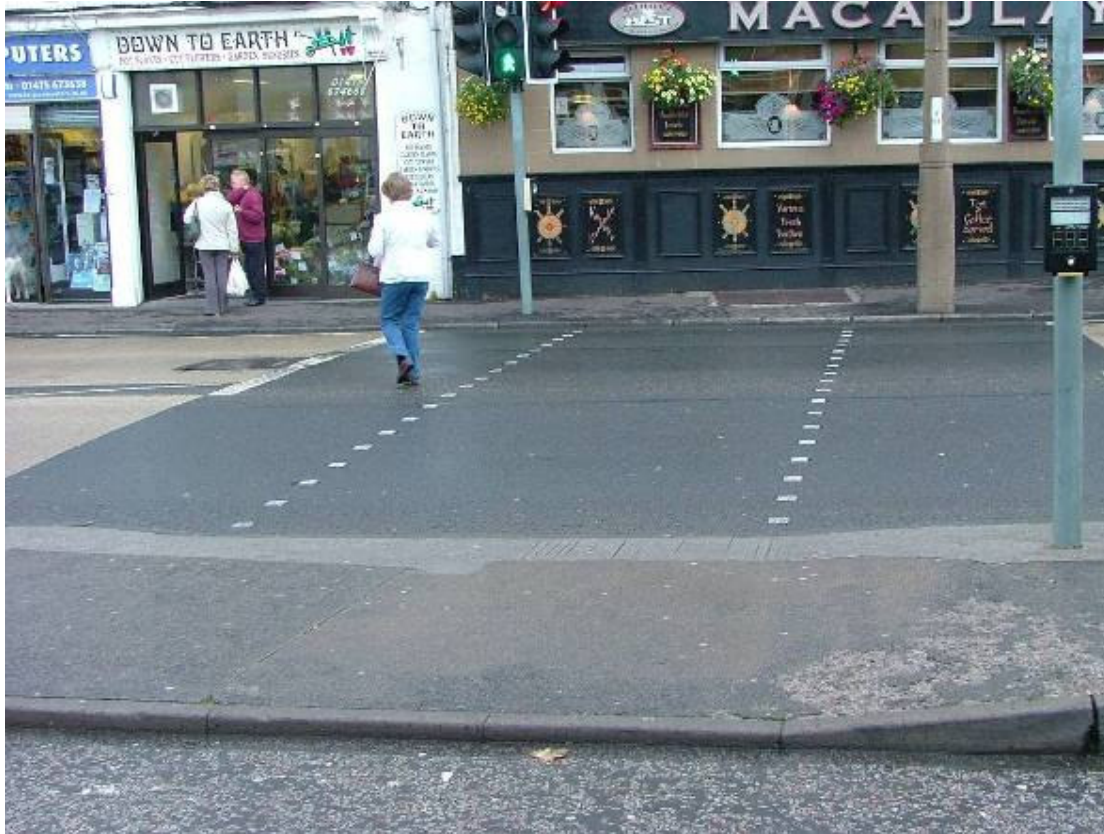
All the issues raised in the previous section also apply to crossings controlled by traffic signals. At crossings activated by push buttons, many visually impaired people rely on the tactile paving layout to guide them to the control unit.

Lack of tactile paving at a controlled crossing

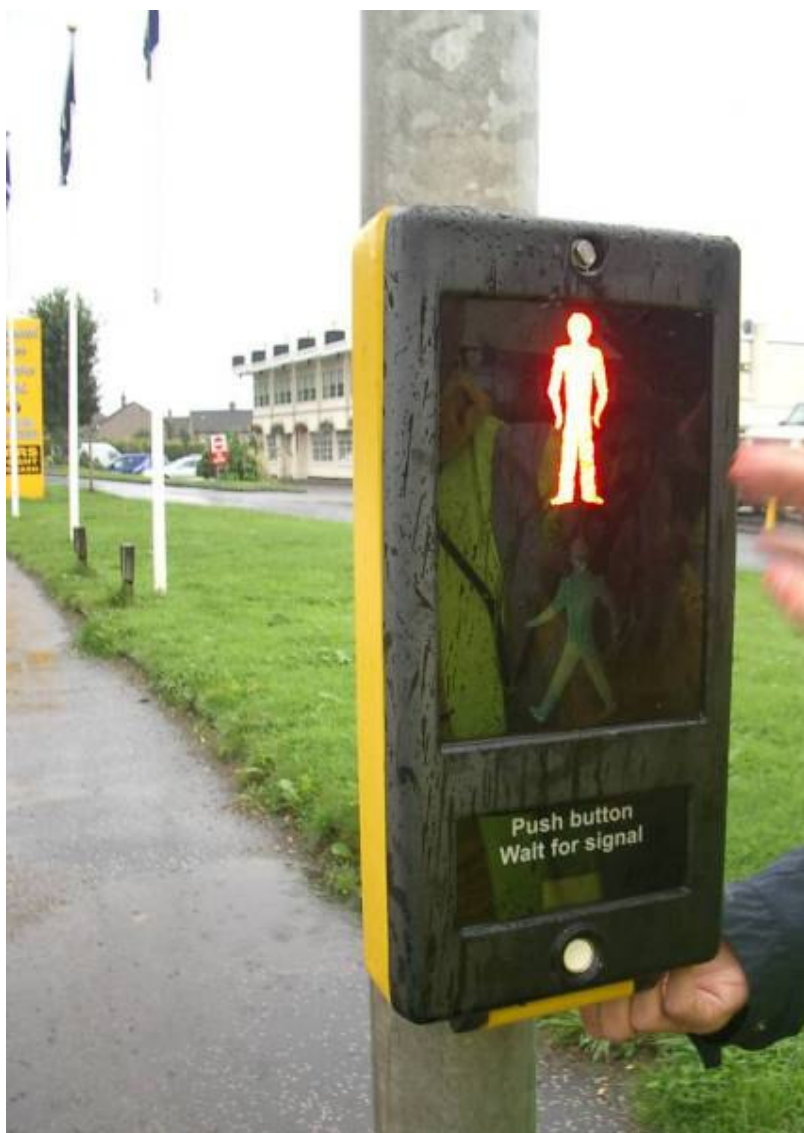
The audit did not find any controlled pedestrian crossings which included all the features of a “puffin” crossing. Some crossings included an audible signal to indicate to visually impaired people that traffic had been signalled to stop. However, very few installations included infra-red detectors to extend the green man time, red/green man indicators on the control unit, tactile rotating cones for deaf-blind people, or large push-buttons which can be used by people with limited manual dexterity.

Controller with red/green man symbols and tactile rotating cone but without large push-button

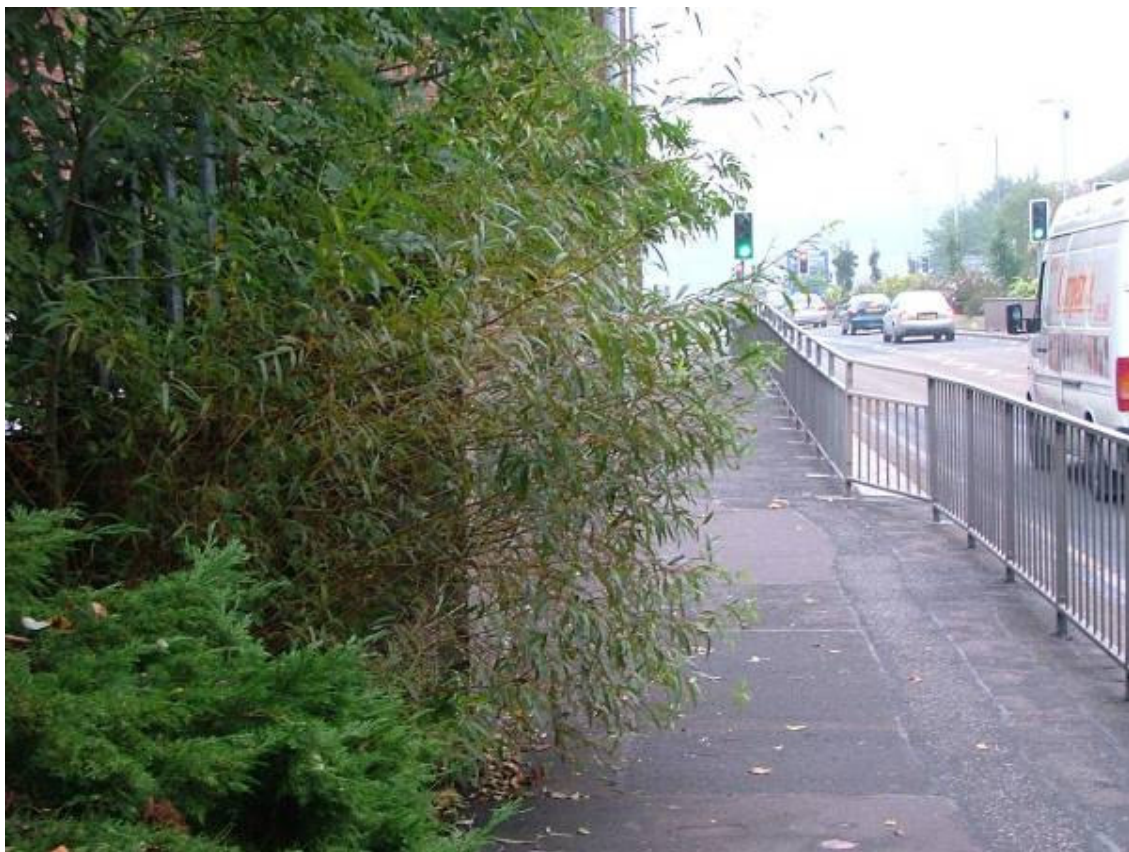
Narrow pavements mean that it can be difficult for people to pass safely or without inconvenience. This particularly affects wheelchair users and motorised scooter users and people who use guide dogs or canes to aid their mobility. Causes of narrow pavements observed in the audit included the encroachment of vegetation at both ground level and above. Overhanging vegetation and sign poles are a particular problem for visually impaired people.

Vegetation overhanging the pavement

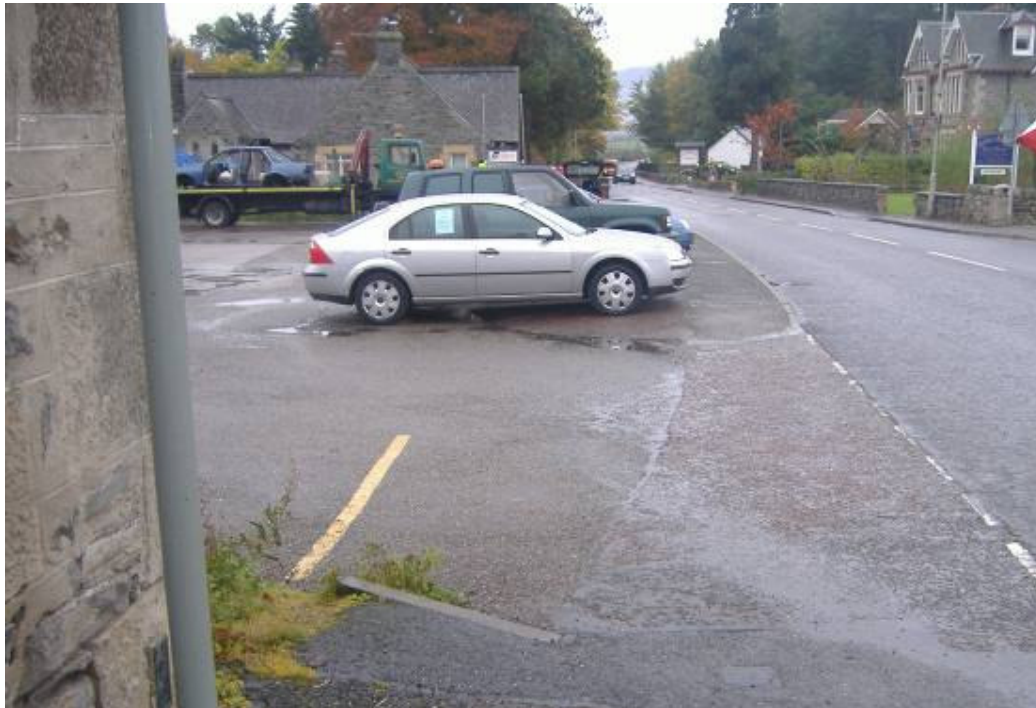
Obstructions on the pavement can be either fixed or movable. Those obstructions observed during the audit included badly sited street furniture, sign poles, street lighting columns, shop displays and parked cars. In some cases, there are a series of obstructions located at different positions on the pavement which can combine to cause a “slalom” effect.

Parked cars obstructing the pavement

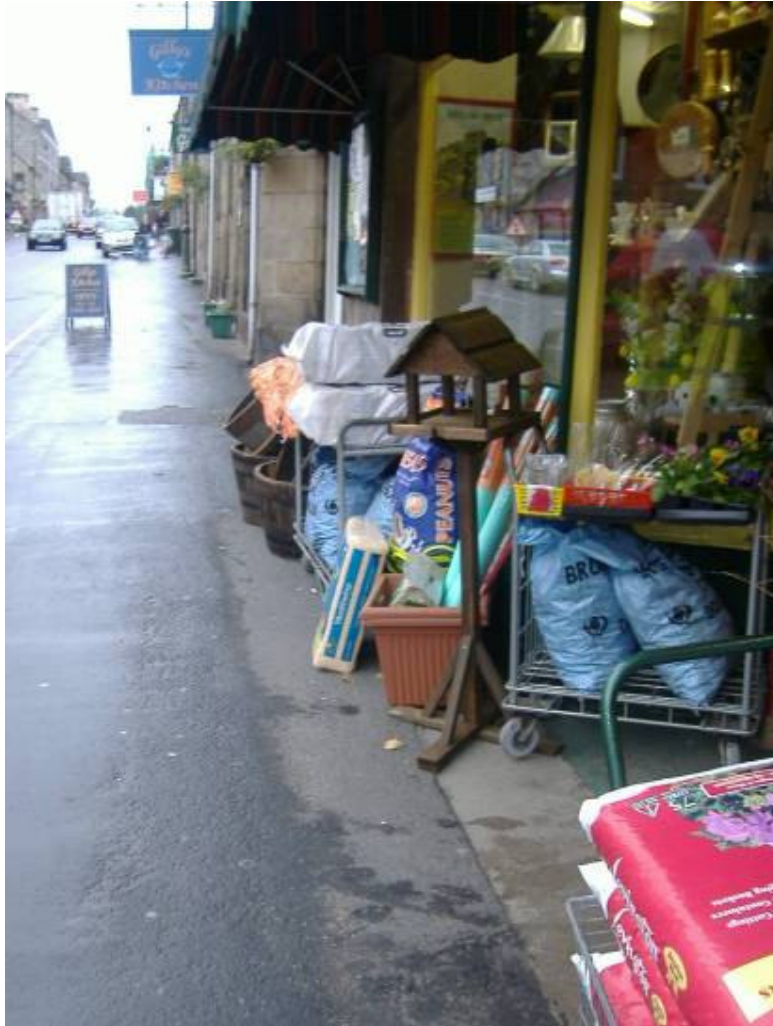
Shop display and signboards obstructing the pavement

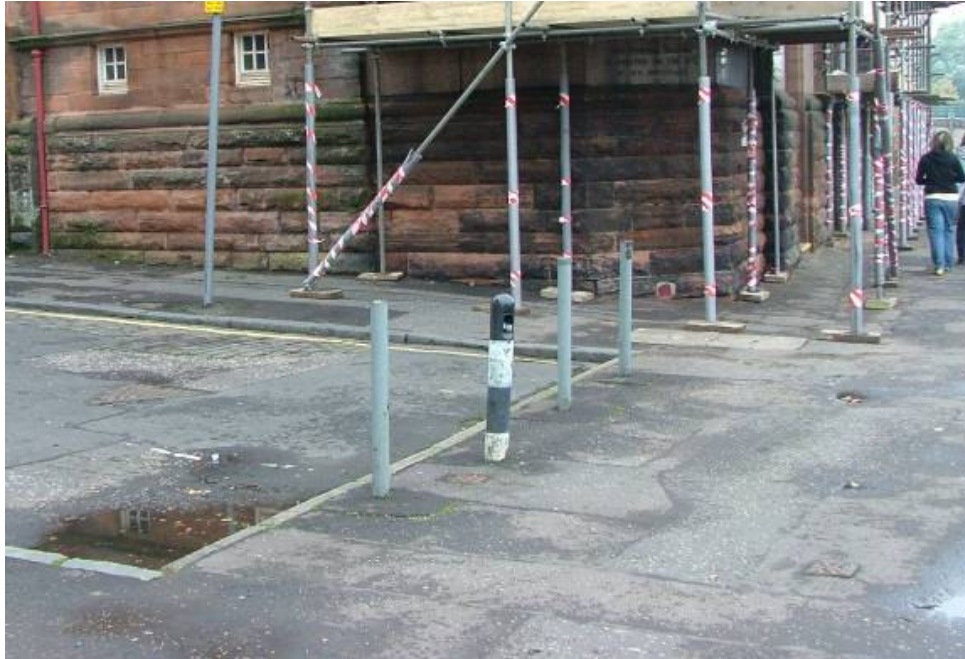
The audit findings found that most street furniture did not contrast in colour and tone with the background. This makes it difficult for visually impaired people to detect and as a result can be a collision hazard.

Bollards lacking colour contrast and scaffolding obstructing the pavement

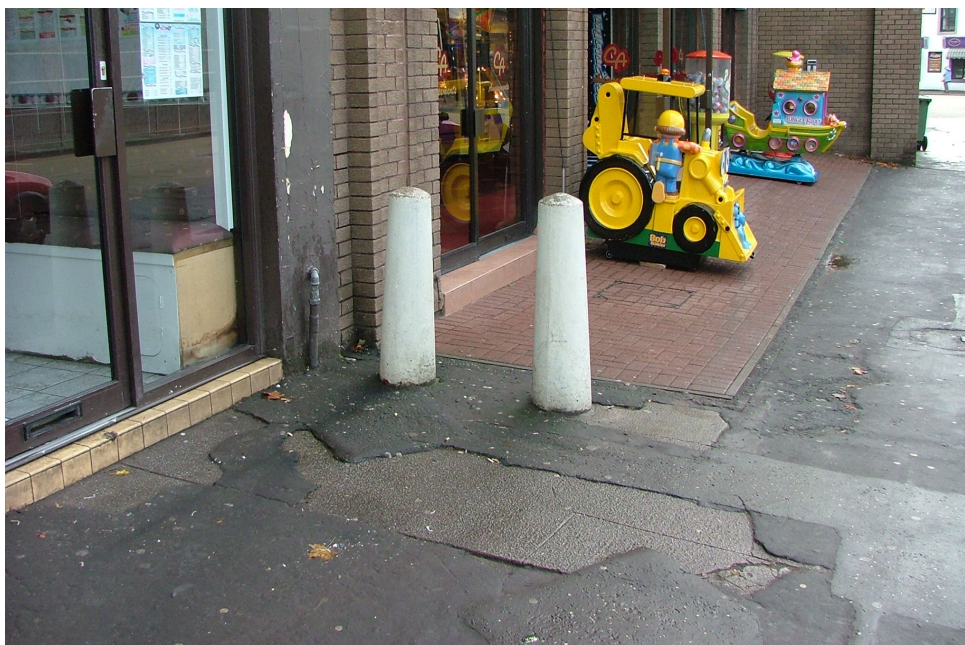
Uneven surfaces were found on many pavements and footpaths. These were caused by such features as tree roots, manhole covers, uneven or broken surfacing materials.

Uneven footway and bollards obstructing the pavement

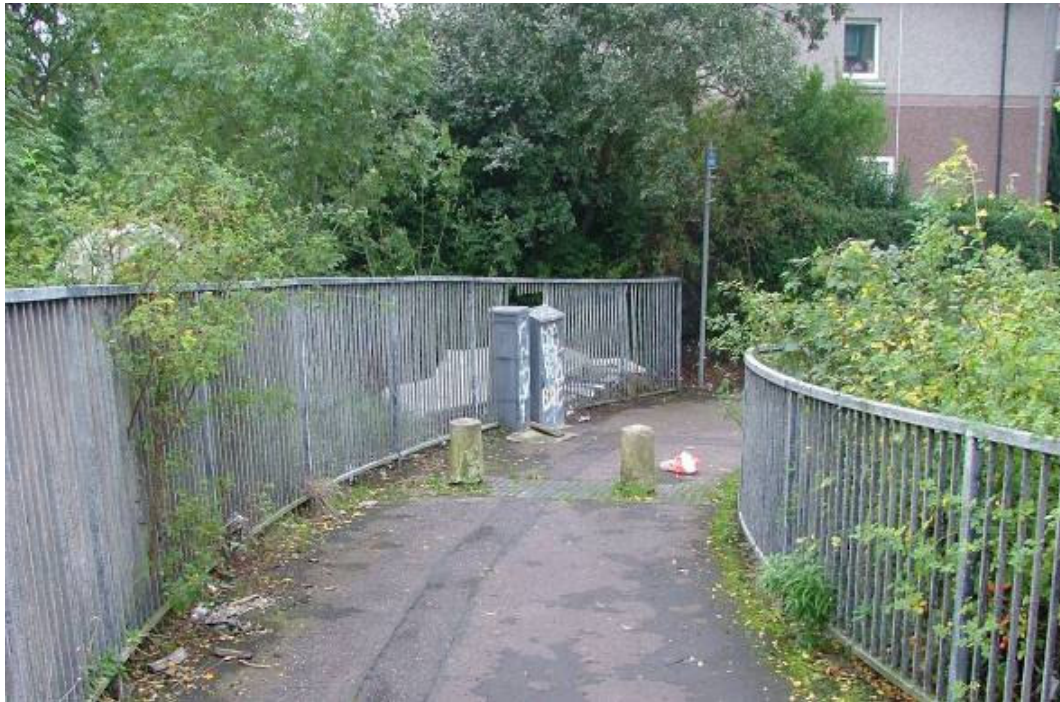
Some remote footpaths, particularly those leading to footbridges over motorways, were found to be overgrown, defaced by graffiti and in a poor state of repair. These conditions make such routes unattractive. They are therefore less accessible for vulnerable people to use for personal security and safety reasons.

Overgrowing vegetation, graffiti and litter give this footpath a feeling of insecurity

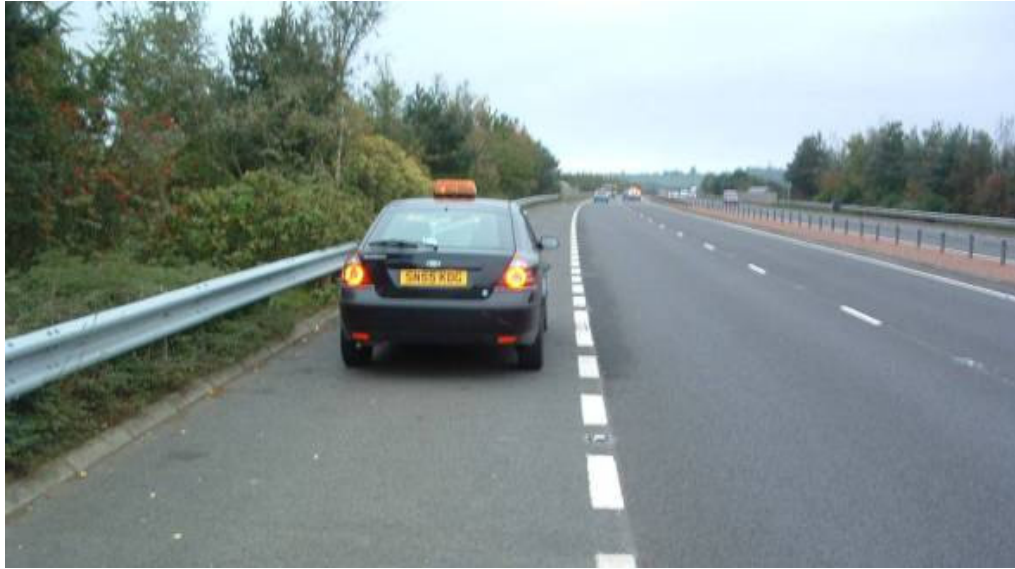
Many lay-bys were found to lack a footway or pavement which means that people have no safe place to get out of their vehicle.

In most lay-bys without a separation strip, there was insufficient clearance between the car and passing traffic to open the door safely and exit the vehicle. This is a particular problem for people with mobility impairments including wheelchair users.

Narrow lay-by and lack of pavement

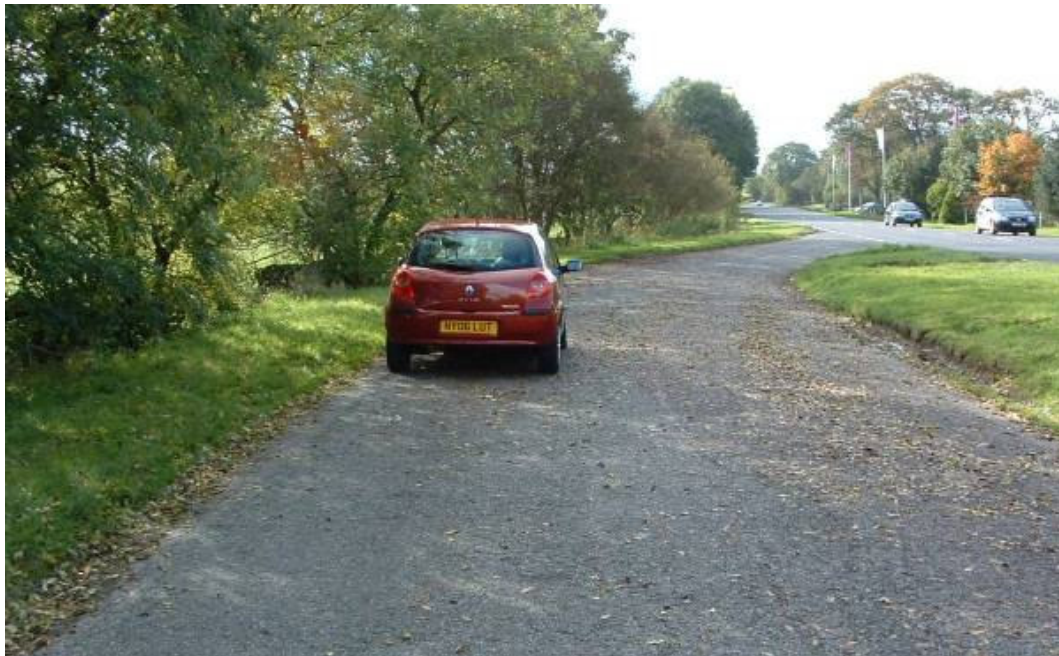
Some lay-bys have been created from redundant sections of road. Often these are on curves and have steep cross-falls or slopes. These can be difficult for wheelchair users transferring from their vehicle to their wheelchair.

Steep slope in lay-by

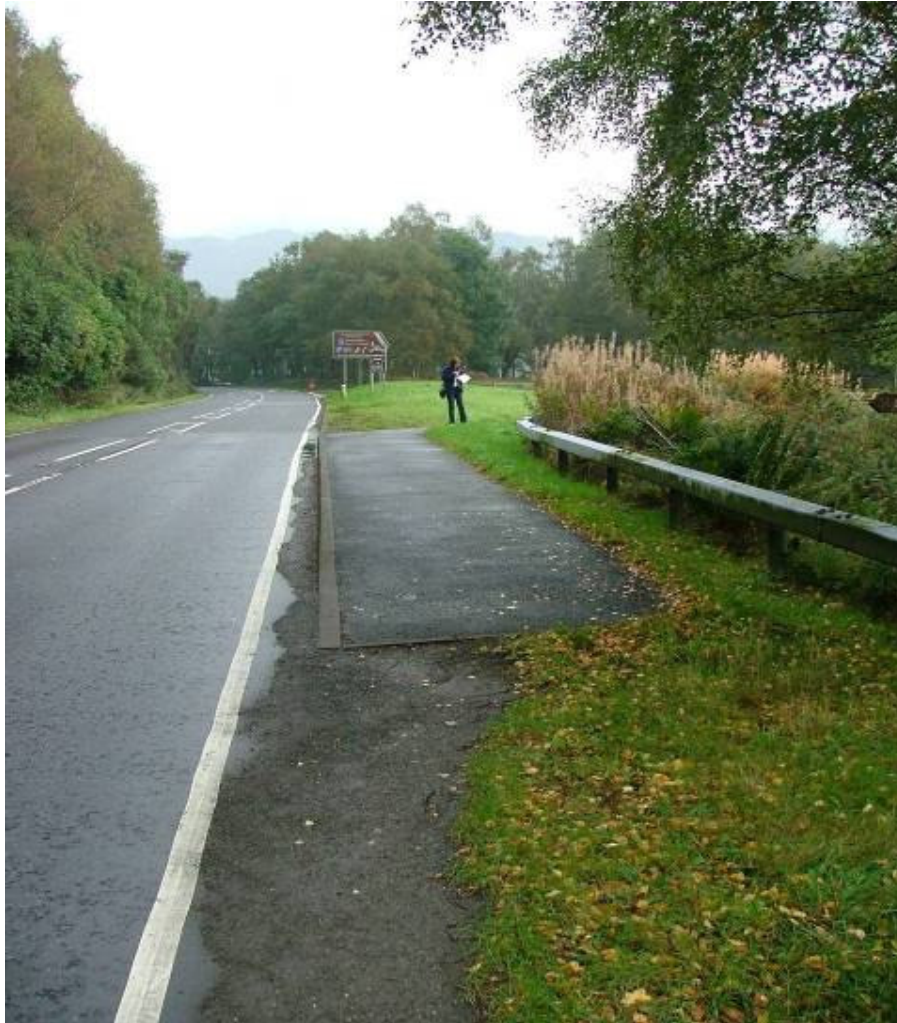
The audit found that in rural areas, it was common for footpaths to start and stop haphazardly. This was particularly evident on the edges of rural villages and at certain visitor attractions where the lack of continuity of the route would prevent many disabled people from making a full journey.

Sudden end of pavement

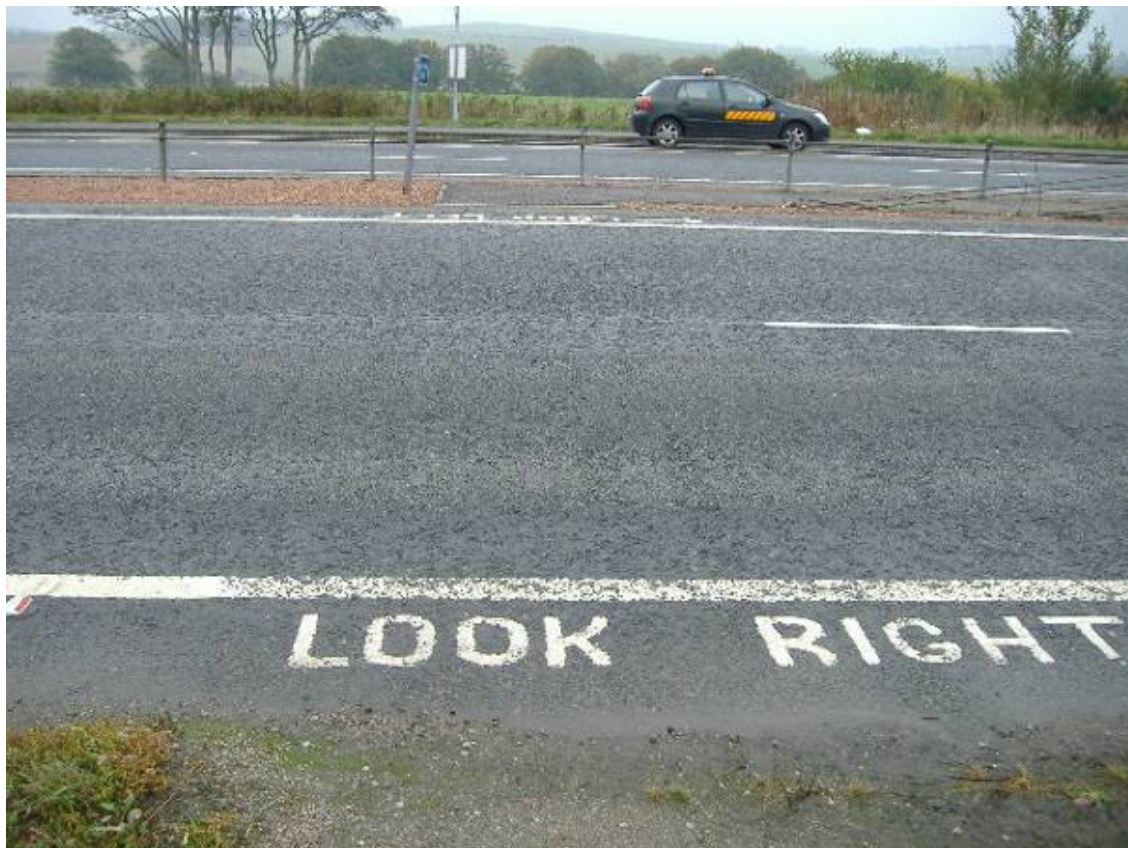
A major concern noted along several rural roads, including high-speed dual carriageways, was the lack of safe crossing points between bus stops on opposite sides of the road. In some instances, although a crossing place was indicated, it would be especially difficult for anyone with a mobility or visual impairment to cross safely thus making return journeys problematic.

Crossing between bus stops on this high-speed road is difficult

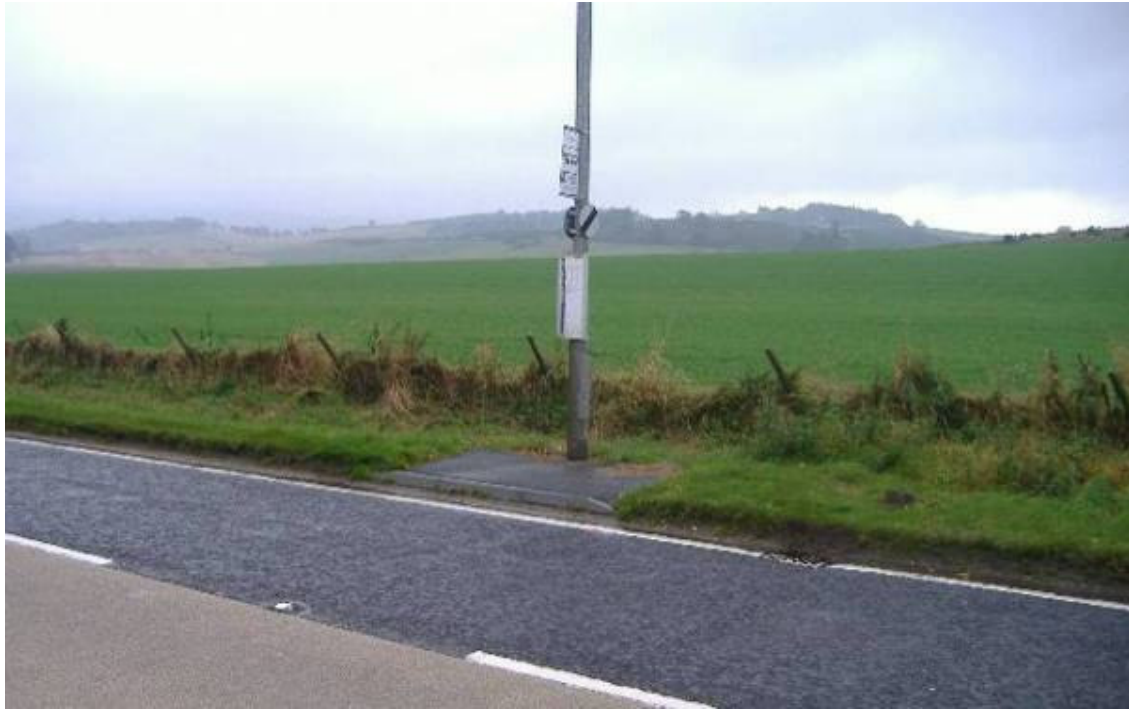
Many rural bus stops were noted to be some distance away from the footway network and housing. This remoteness makes journeys by bus difficult or impossible for some people.

Remote bus stop unconnected to other pavements or footpaths

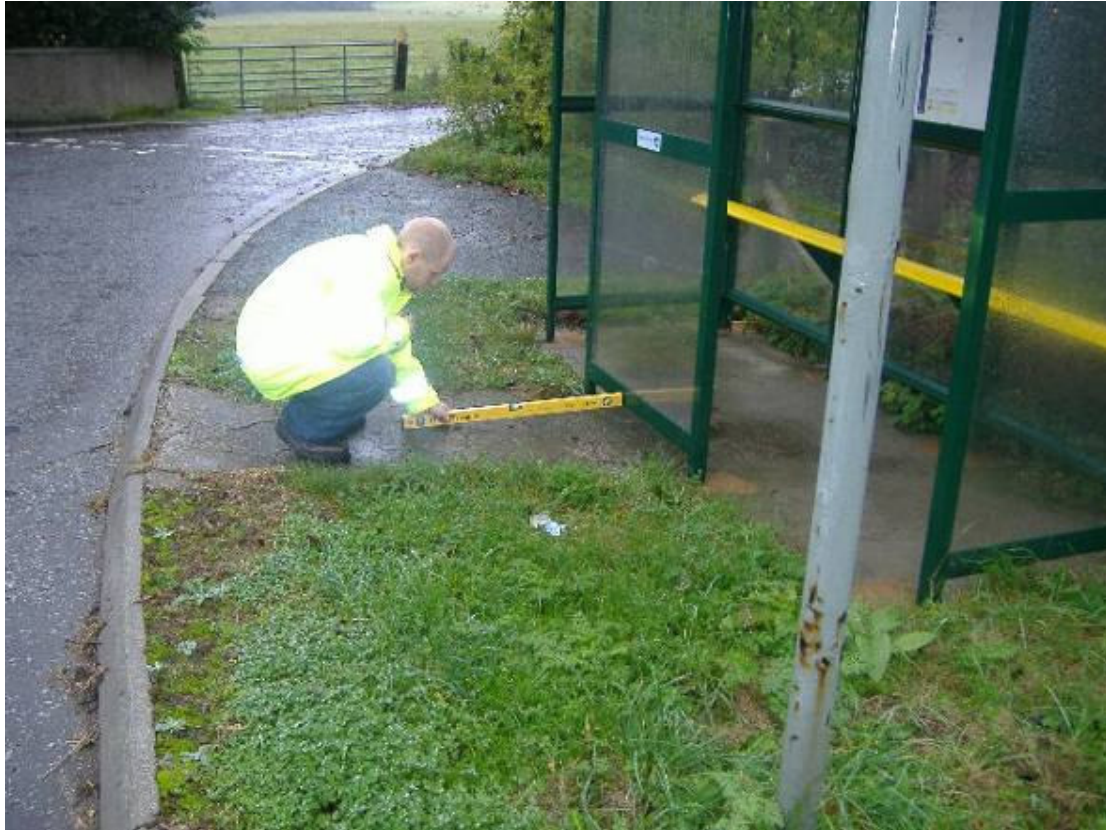
At bus stops, there was a lack of raised kerbs making boarding and alighting buses difficult for people with mobility impairments.

Most bus shelters on the routes audited were not accessible to wheelchair users. Problems observed included narrow entrances, overgrown and uneven footpaths, and slopes that were too steep for wheelchair users and others with mobility impairments.

Inaccessible bus shelter with no raised boarding kerb

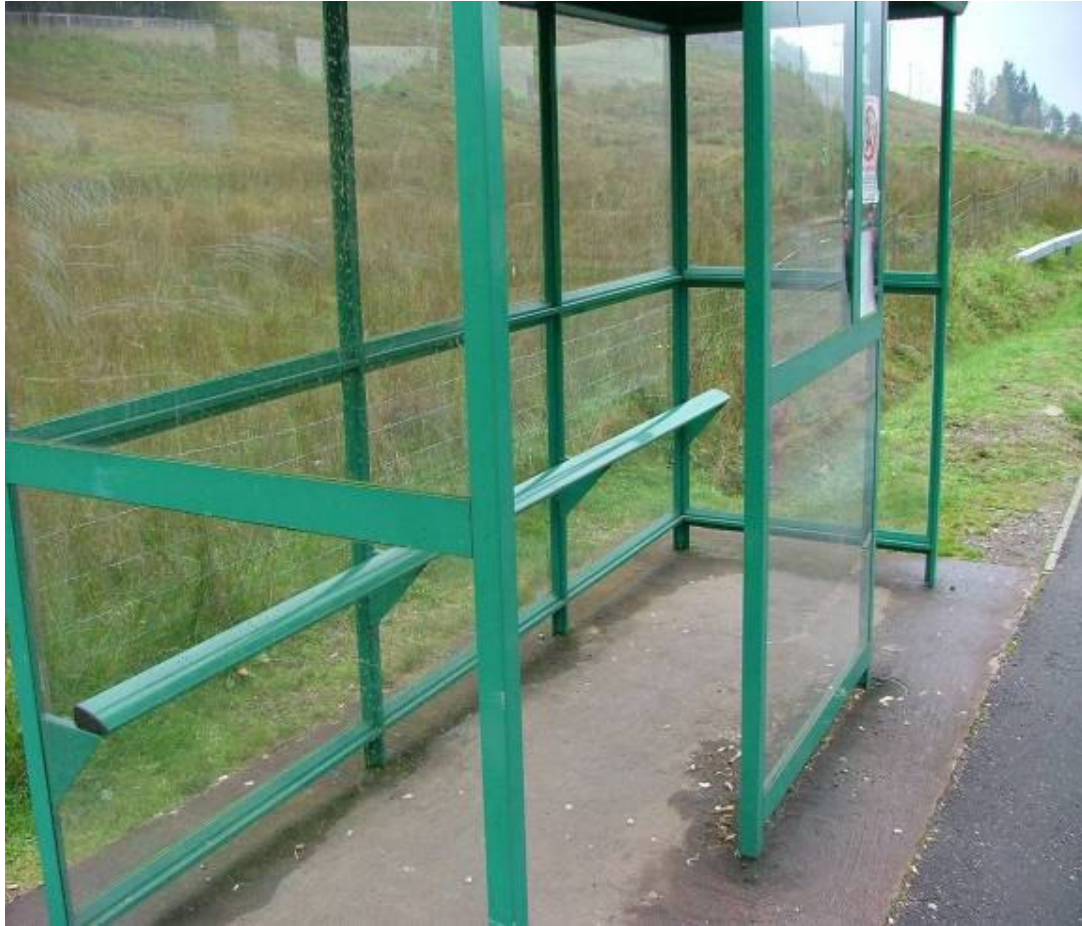
In general, bus shelters did not have seating and where seats were provided, most were perched rails that are not suitable for many disabled people.

Bus shelter with narrow 'perched rail' seating

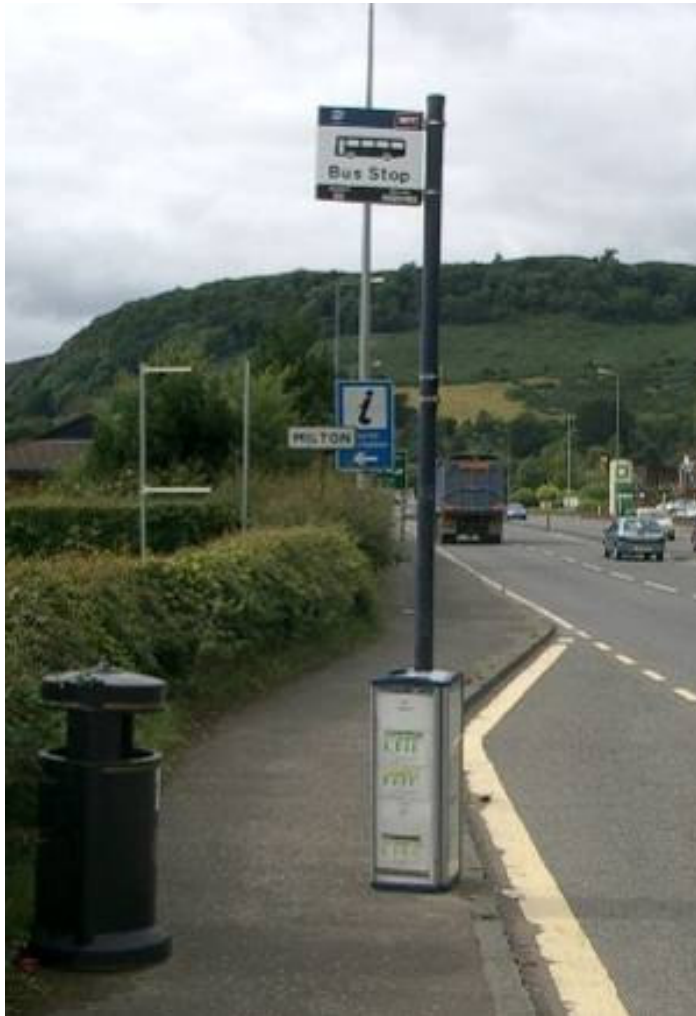
Text used for timetables and travel information was too small to be read easily by many people. This is compounded by inadequate lighting and information positioned wrongly at many bus stops.

Timetable information not provided in suitable format

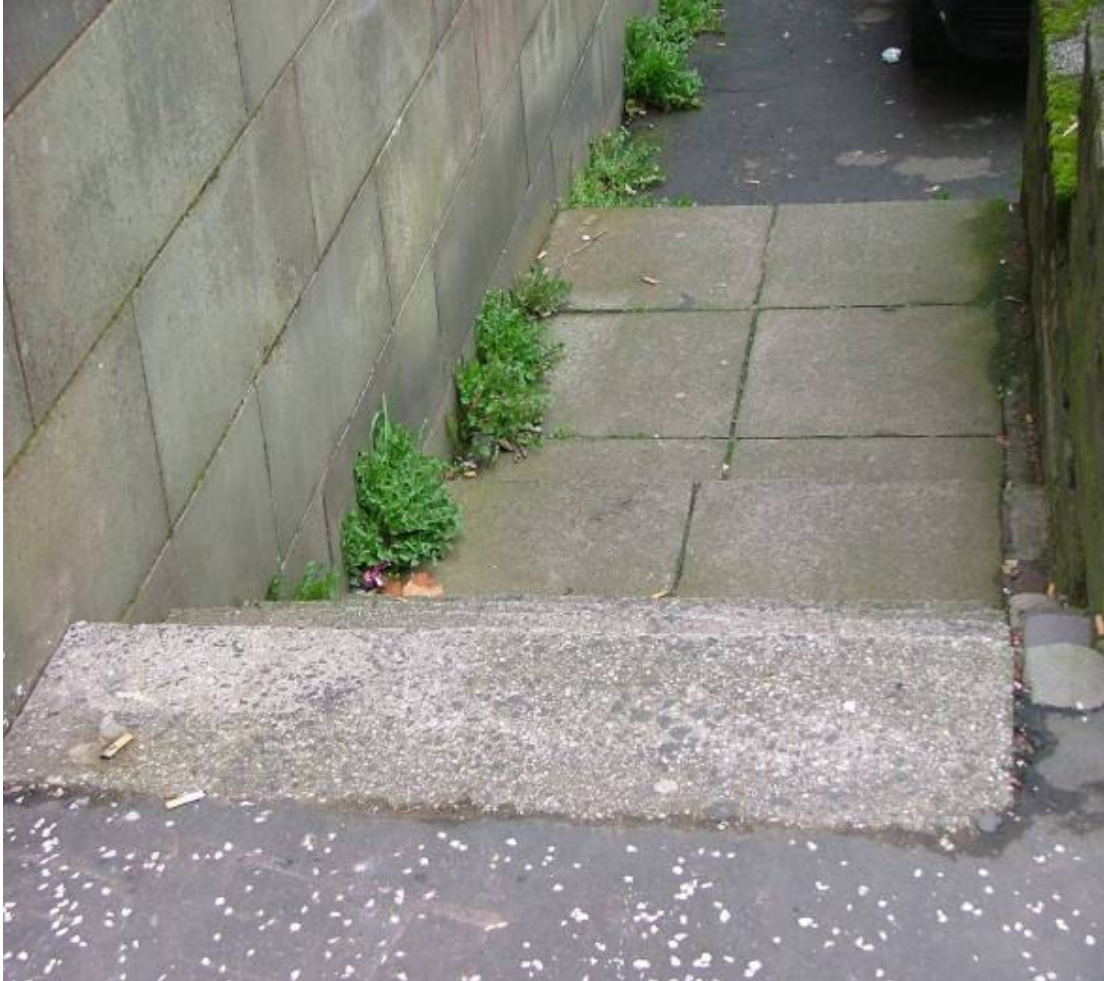
There was a general lack of corduroy tactile warning surface at the top and bottom of steps which is recommended good practice. Therefore, there is no warning of this hazard for visually impaired people.

Some steps and ramps were found to lack handrails on one or both sides. This feature is important for the safe use of steps for many groups of disabled people including people with mobility impairments.

Stairs lacking handrails, corduroy tactile paving and colour contrast nosings.

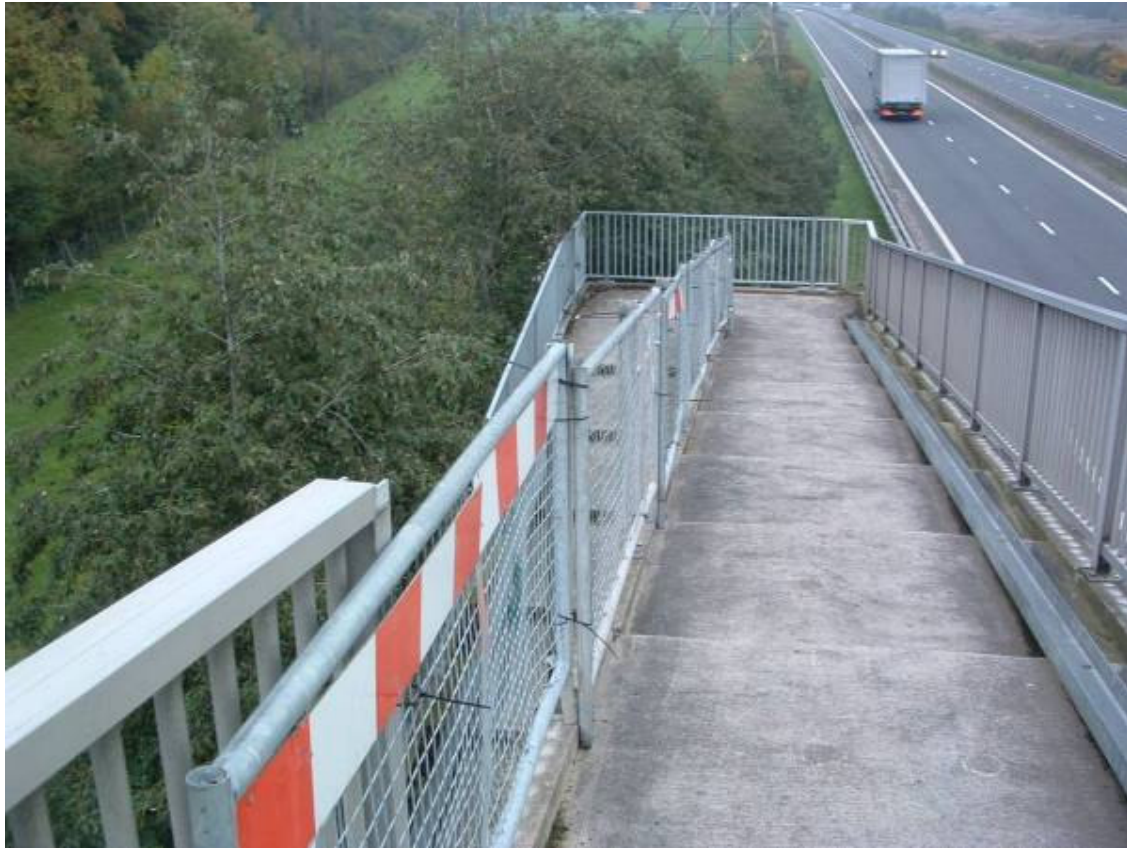
Stepped ramps were found on a number of footbridges. These are dangerous and difficult to use for many, and are extremely difficult to negotiate independently by wheelchair users.

Stepped ramp unsuitable for wheelchairs

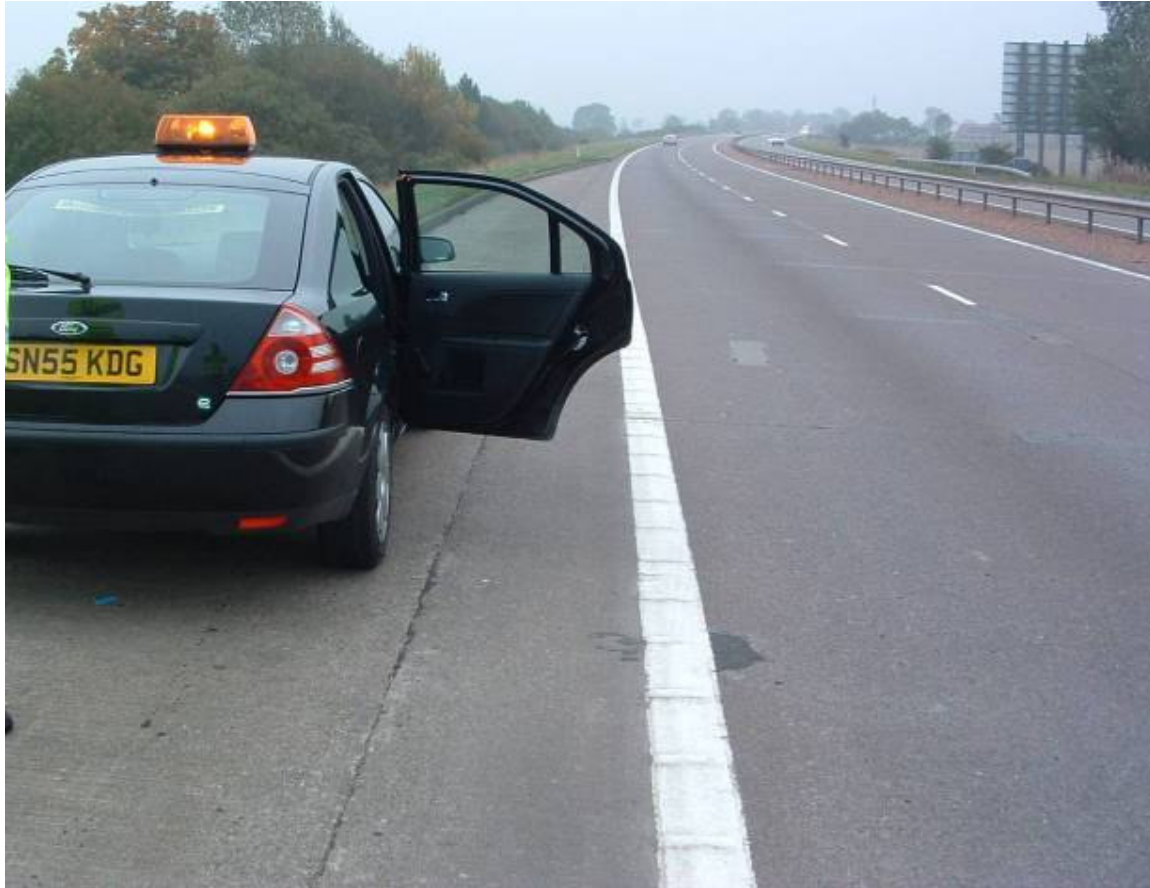
The audit found that the width of some hard shoulders and emergency lay-bys on motorways makes it difficult for some wheelchair users to safely exit a vehicle. This situation provides an incompatibility with the current recommended advice to all users, which is to exit vehicles in an emergency situation. Safety fences, kerbs, and steep embankment slopes also create barriers which prevent people heeding this advice.

Emergency lay-by width too narrow for some wheelchair user to exit vehicle safely

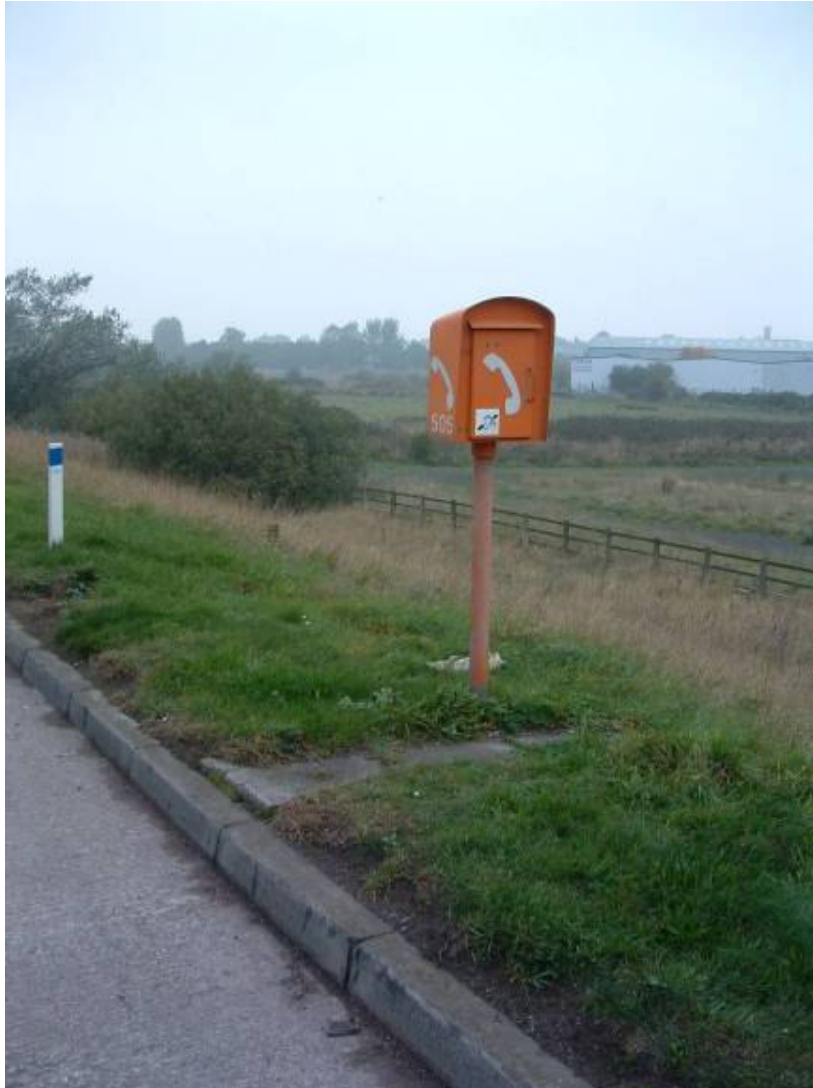
Many emergency telephones were found to be inaccessible for a number of reasons including being obstructed by safety fences, no dropped kerbs, uneven paving, the lack of hard-standing and the height of the telephone. There was also a lack of internal emergency telephone lighting, illegible hand-written information and the lack of alternative means of communication such as a text phone.

Emergency telephone not accessible to all

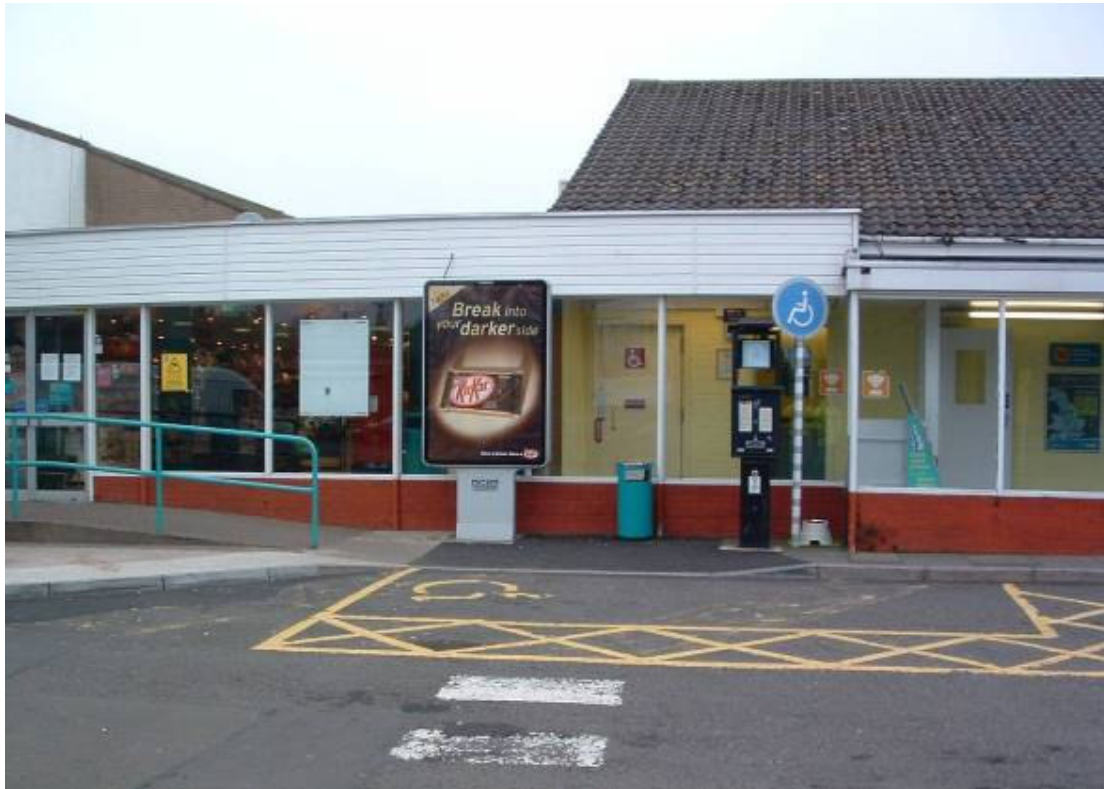
A pilot audit was undertaken at one service area by a disabled person, which identified a number of deficiencies.

Disabled parking bay blocking access to the dropped kerb
