Project FORTH REPLACEMENT CROSSING

# **CONSTRUCTION NOISE MONITORING REPORT: APRIL 2015**

REP-00230 00

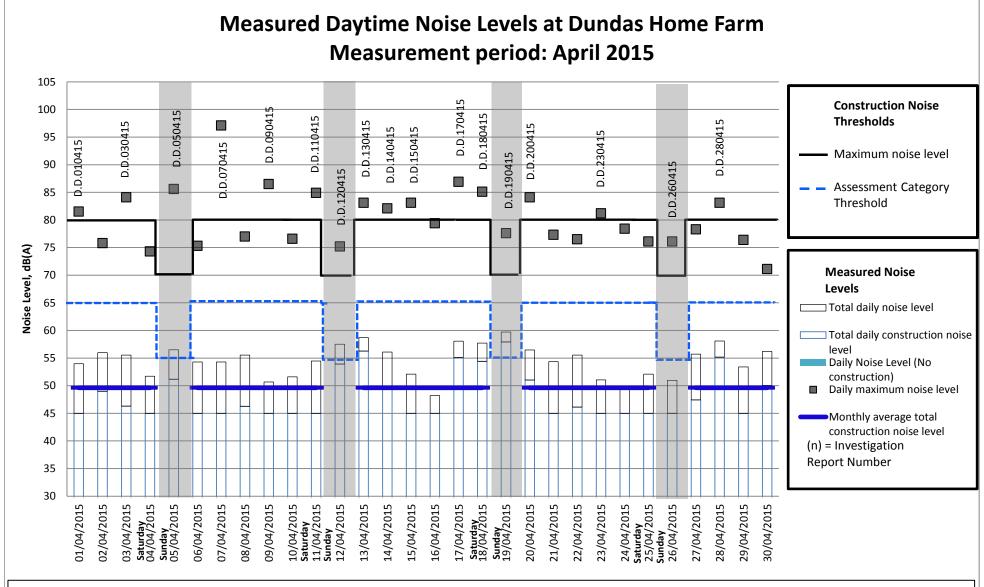
**Note:** The grey areas of the chart represent days on which no construction works have been conducted. The Sunday average has not been included as no Sunday works have been conducted at this location.

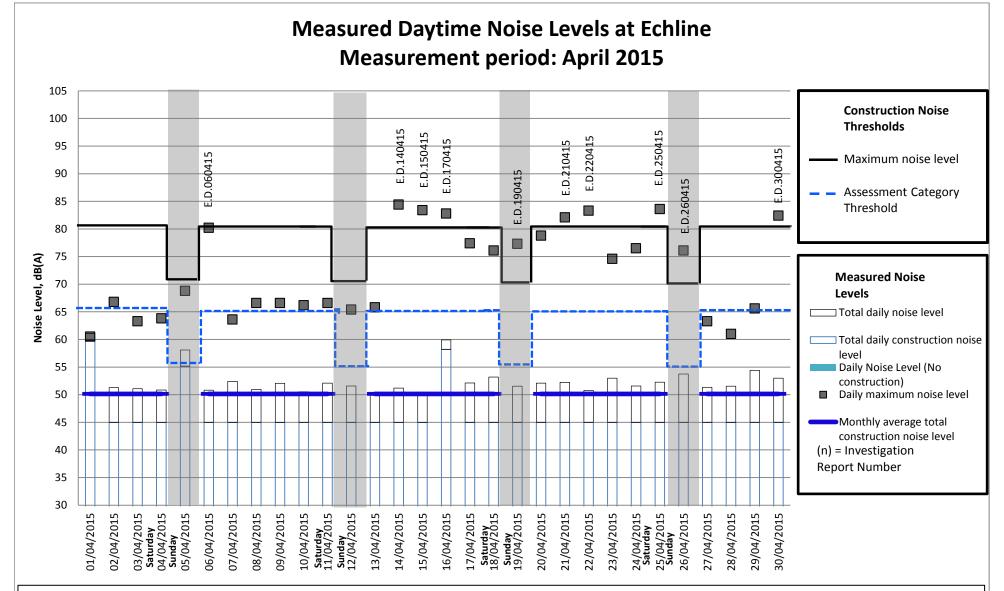
**Note:** The grey areas of the chart represent days on which no construction works have been conducted. The Sunday average has not been included as no Sunday works have been conducted at this location.

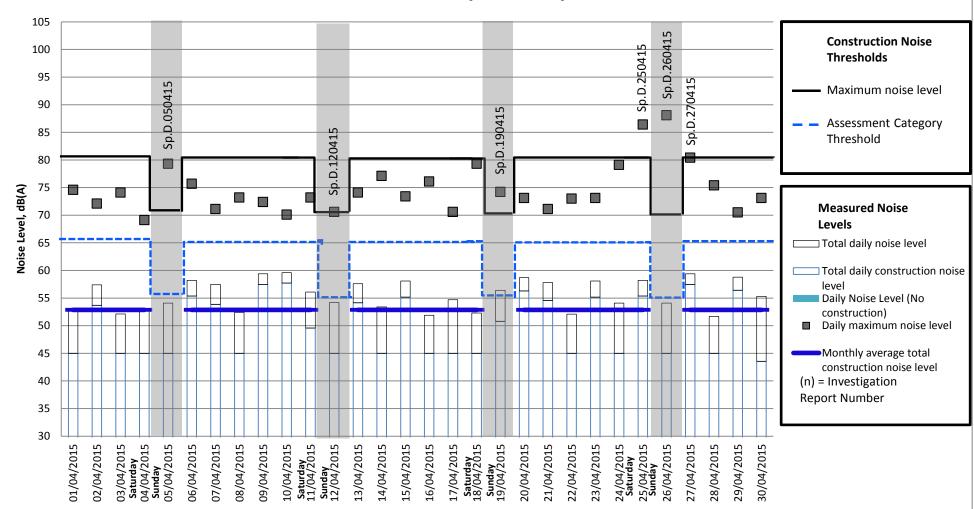
**Note:** The grey areas of the chart represent days on which no construction works have been conducted. The Sunday average has not been included as no Sunday works have been conducted at this location.
