Project **FORTH REPLACEMENT CROSSING**

**CONSTRUCTION NOISE MONITORING REPORT: FEBRUARY 2016**

Document number	Rev
<b>REP-00271</b>	<b>00</b>

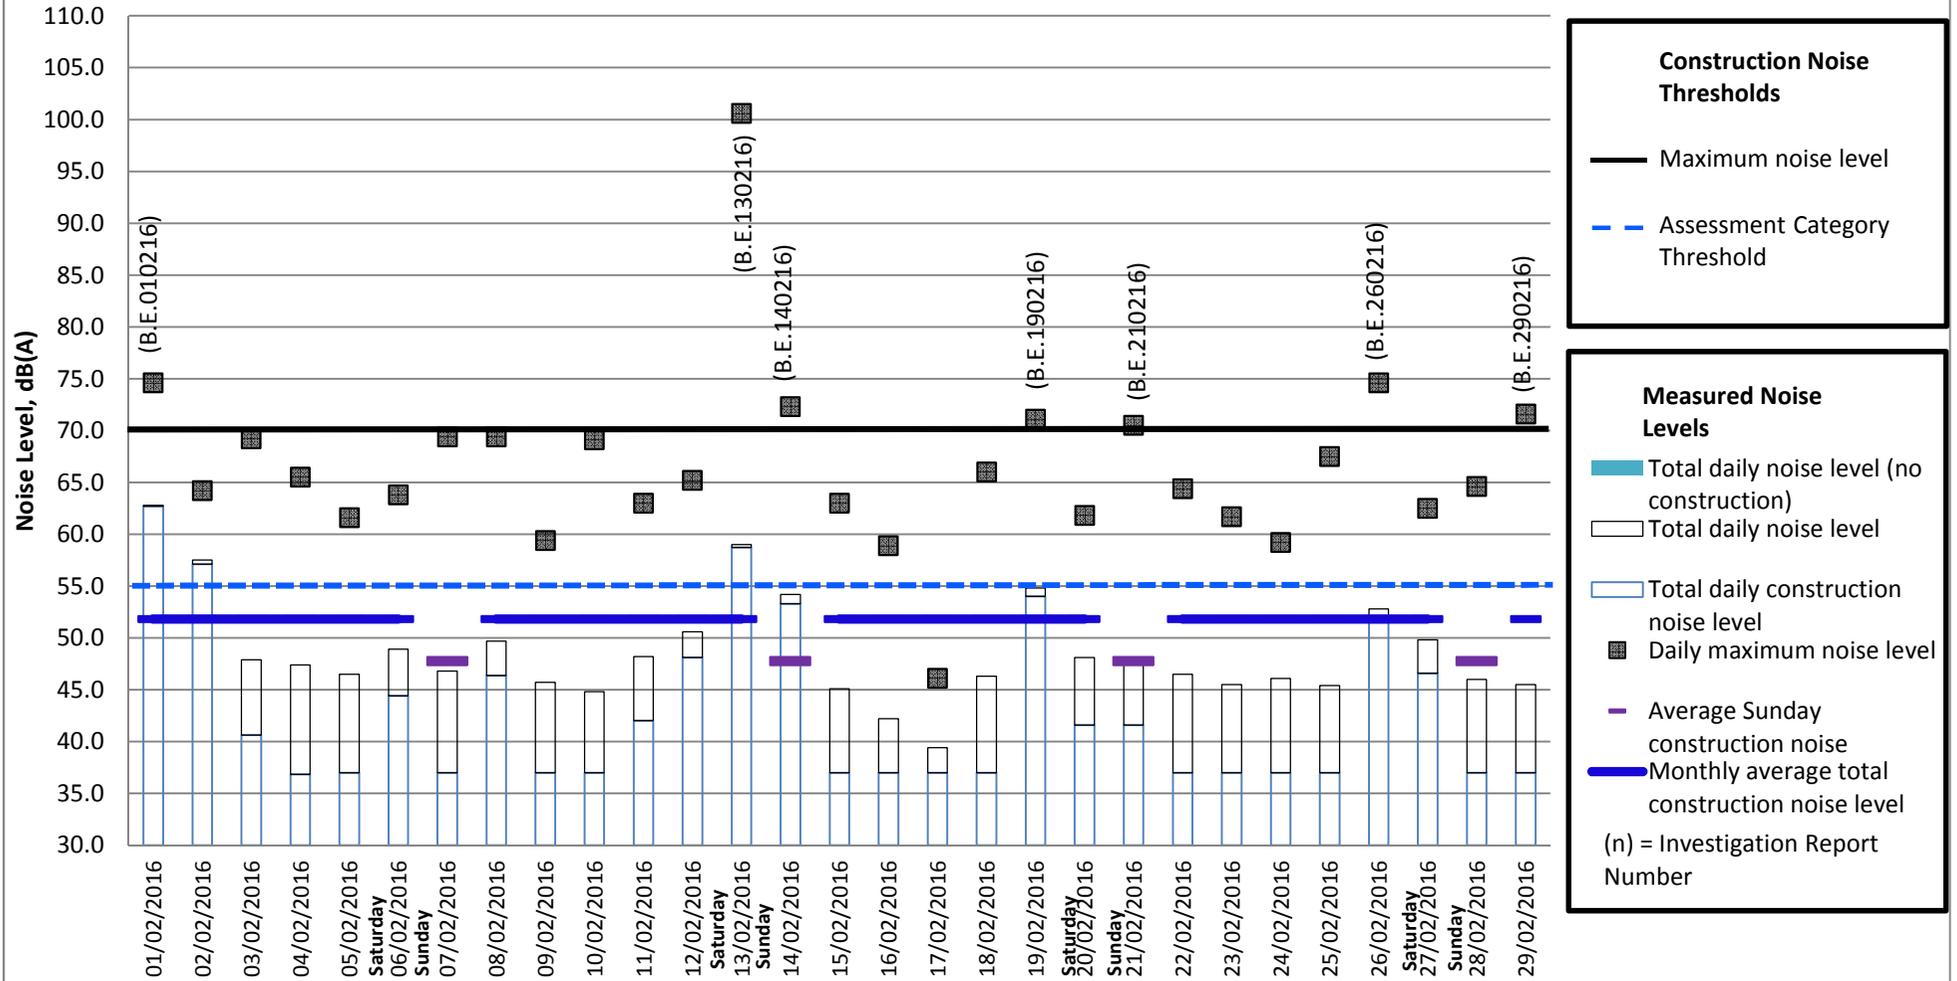
## Measured Evening Noise Levels at Butlaw Fisheries

**Note:** After investigation, it was concluded that the exceedance of the LAeq 'Total Daily Construction' on the 1st 2nd and 13th were caused by wind

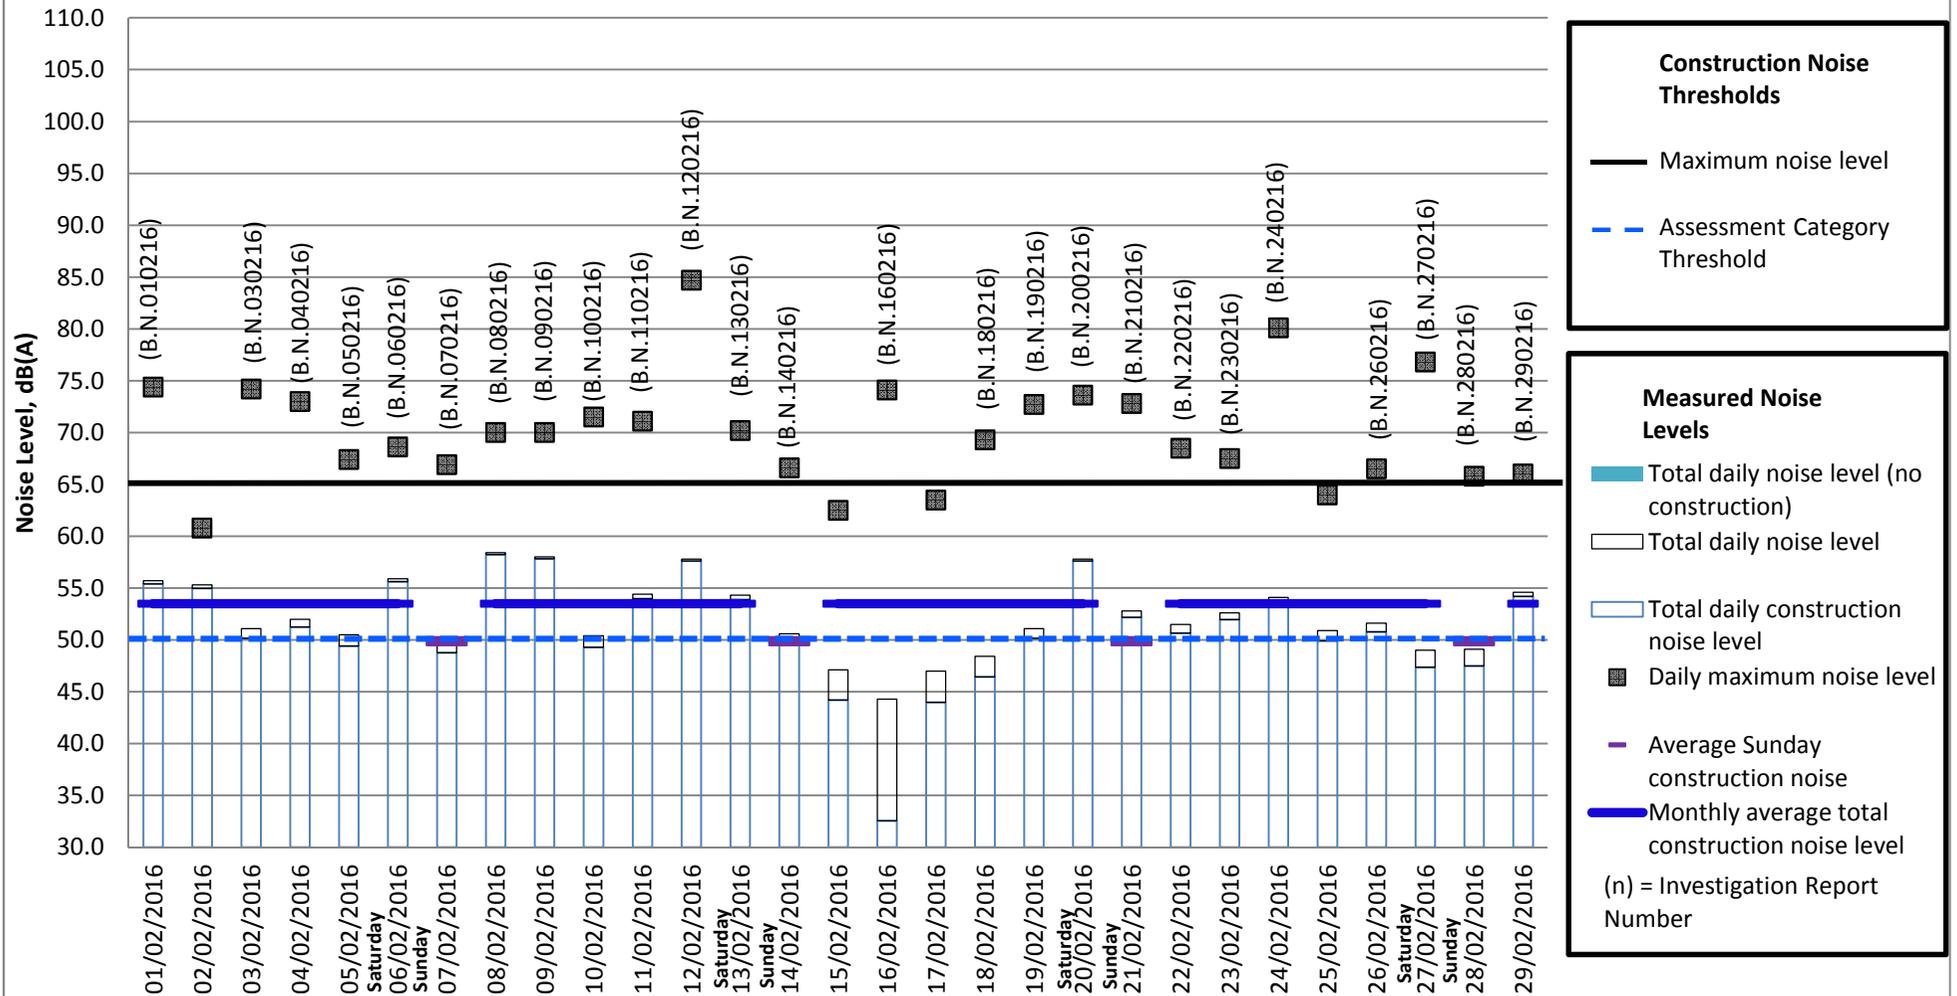
## Measured Night time Noise Levels at Butlaw Fisheries Measurement period: February 2016

**Note:** After investigation, it was concluded that the exceedance of the LAeq 'Total Daily Construction' throughout the month was caused by wind, birds and waves.

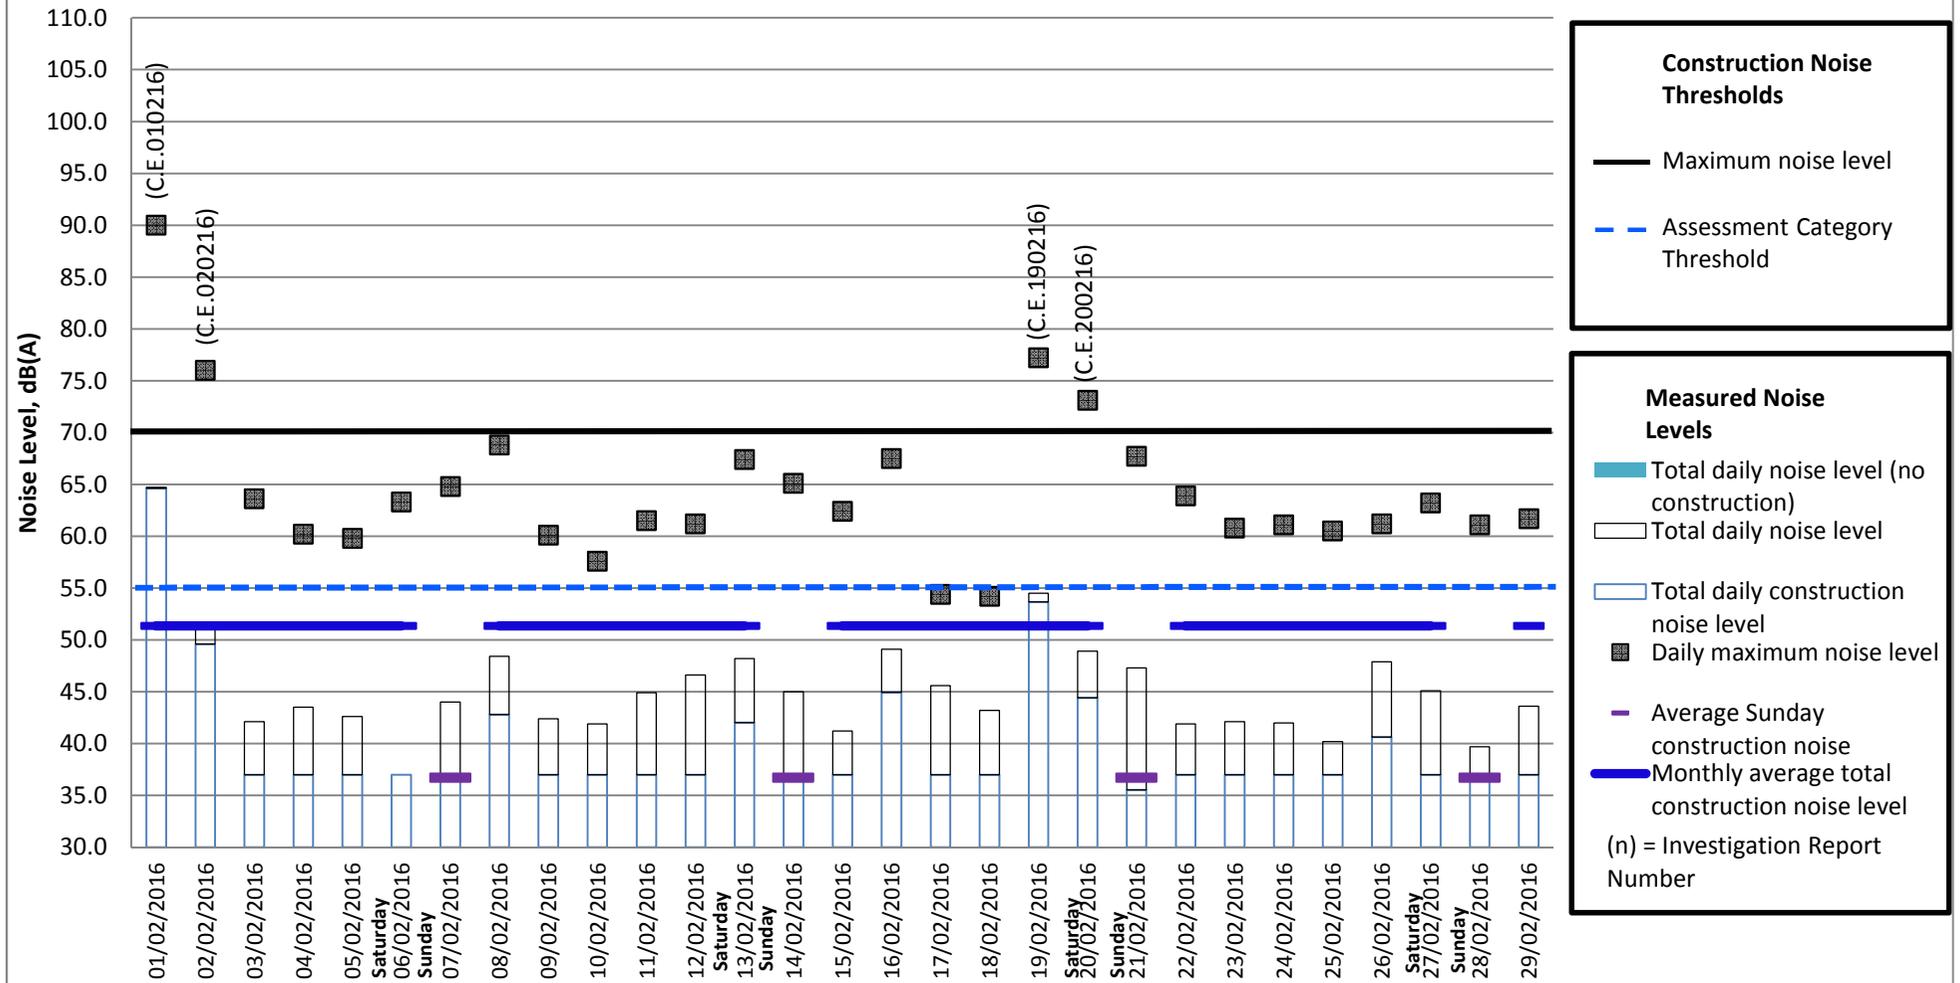
## Measured Evening Noise Levels at Clufflat Brae Measurement period: February 2016

**Note:** After investigation, it was concluded that the exceedance of the LAeq ' Total Daily Construction' on the 1st was caused by wind

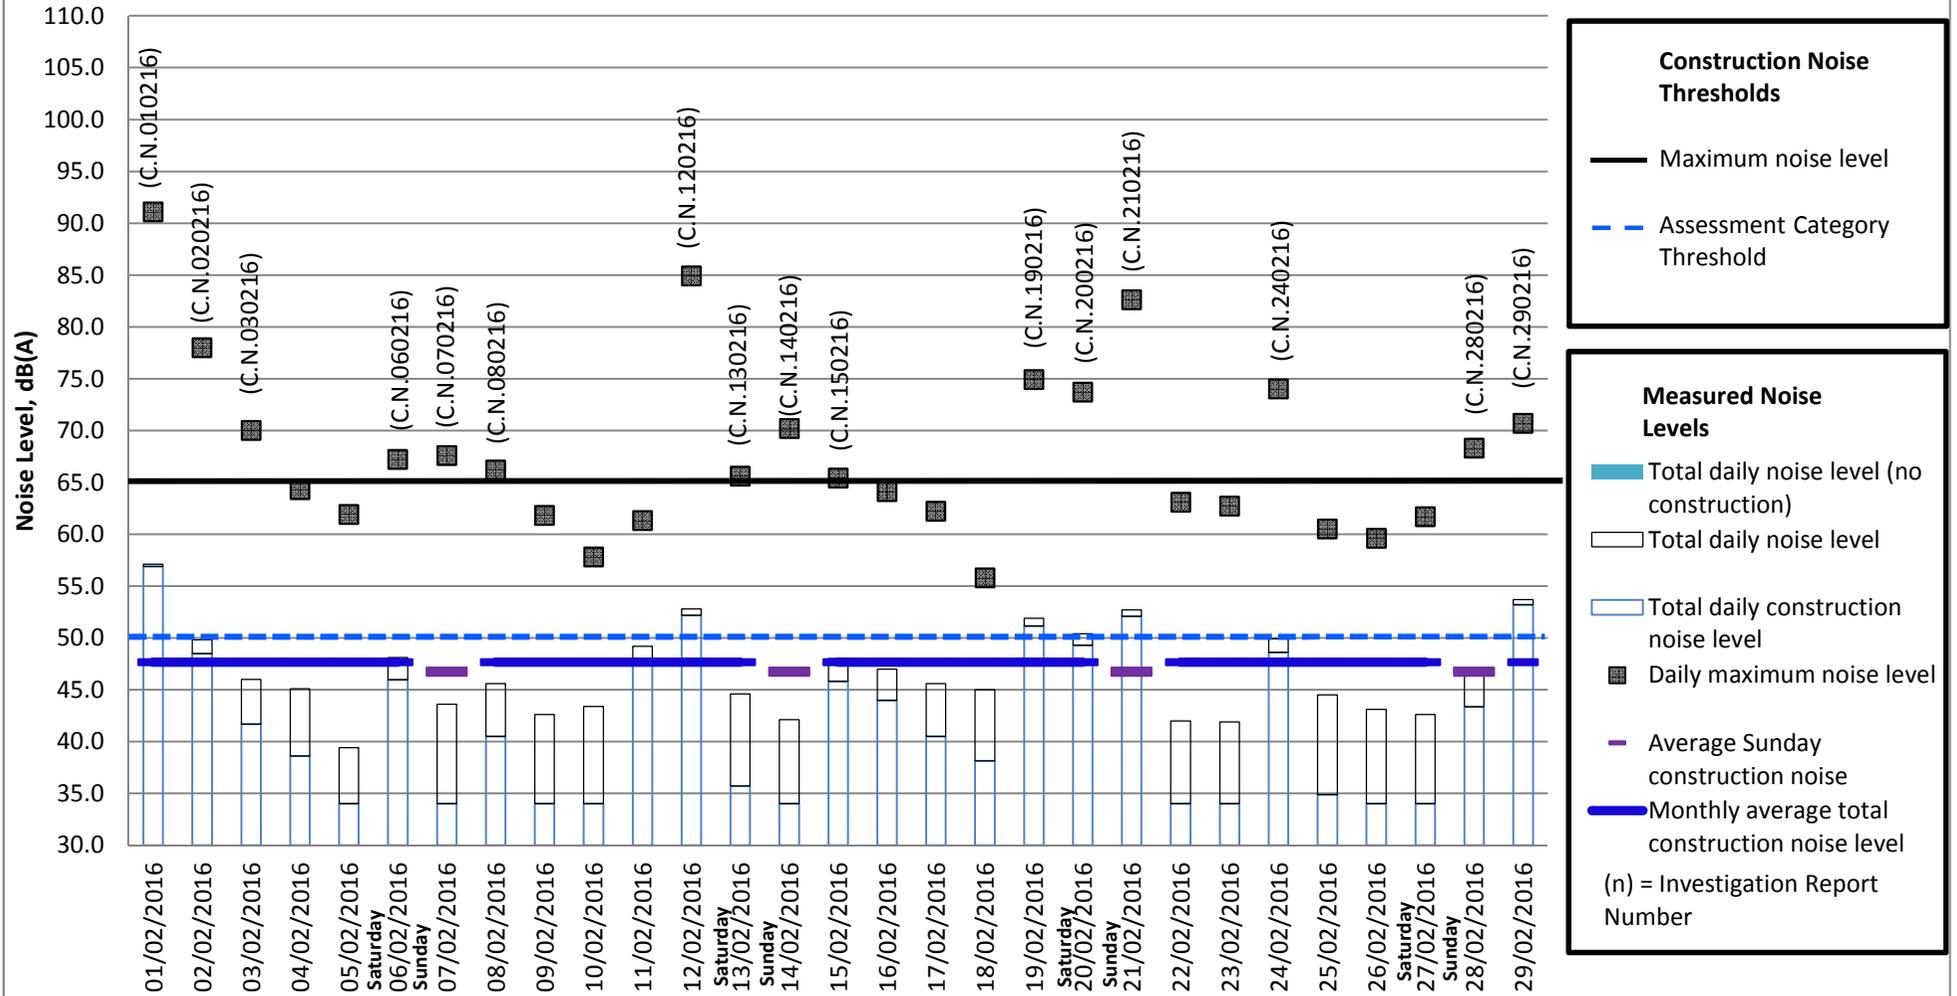
## Measured Night time Noise Levels at Clufflat Brae Measurement period: February 2016

**Note:** After investigation, it was concluded that the exceedance of the LAeq 'Total Daily Construction' throughout the month was caused by birds and wind.

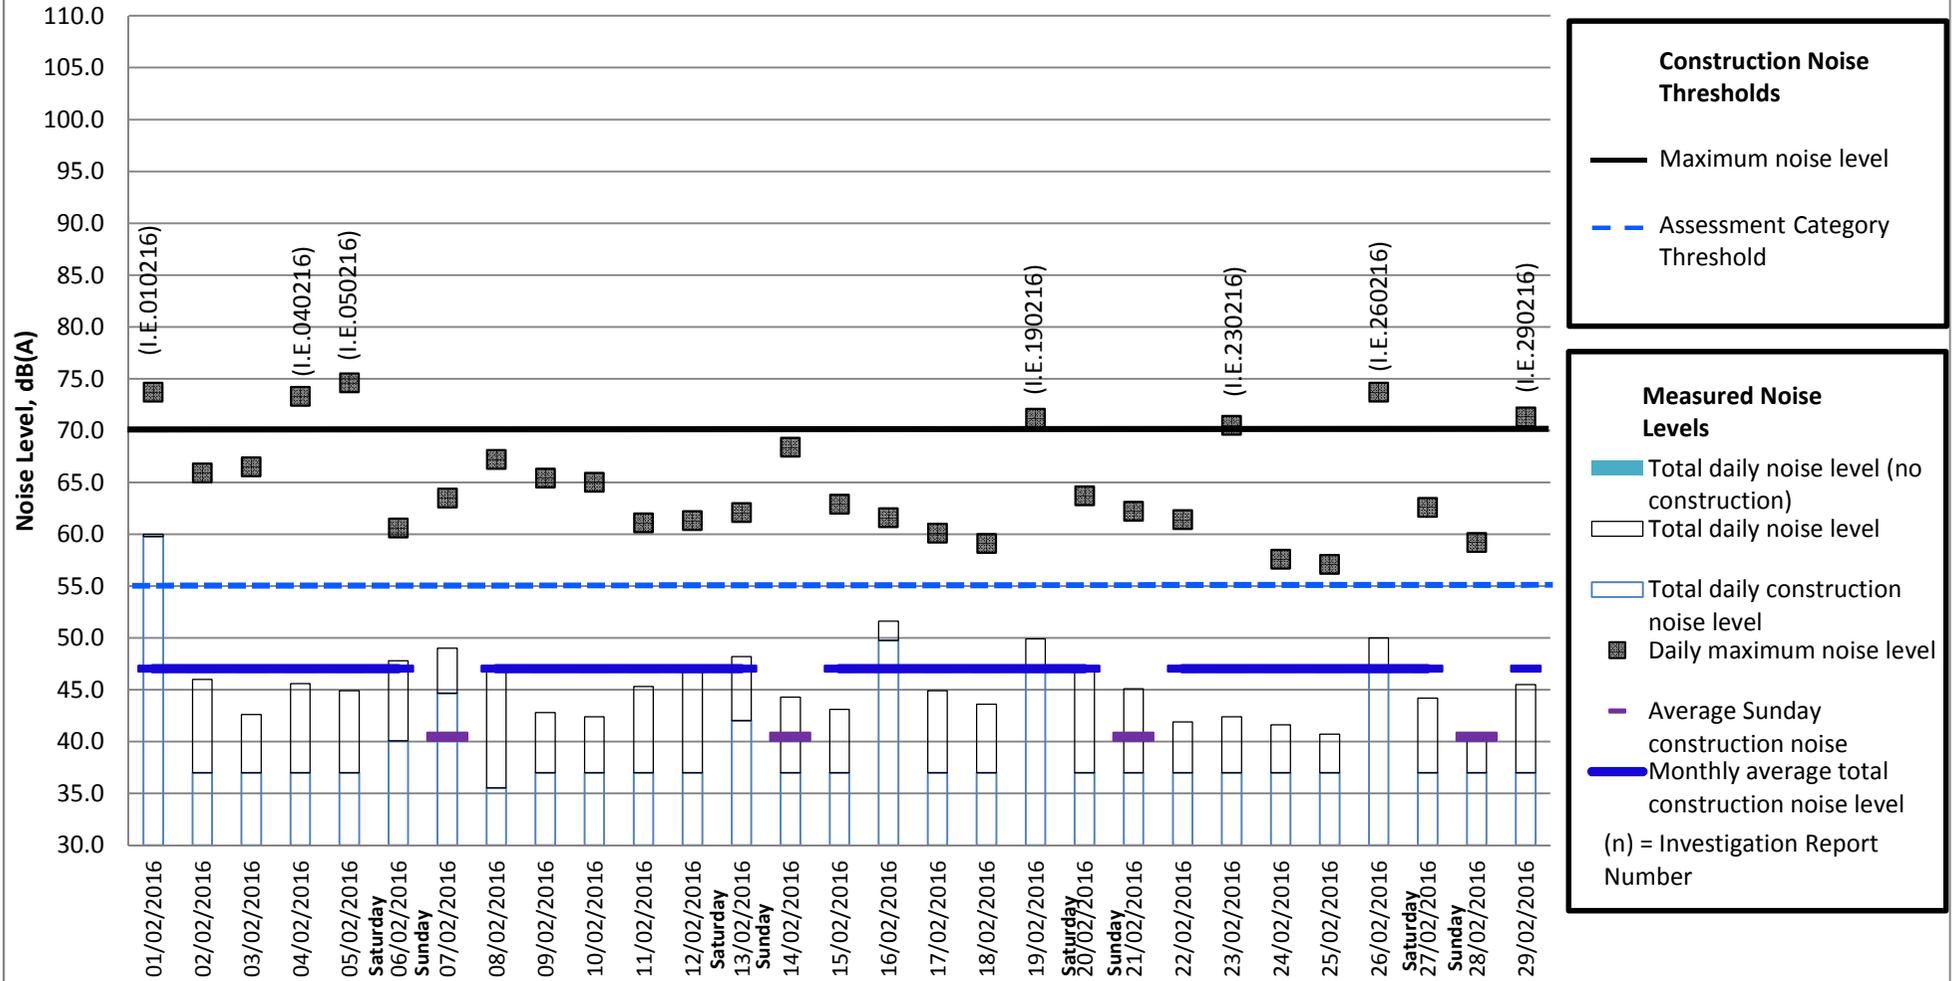
## Measured Evening Noise Levels at Inchgarvie Measurement period: February 2016

**Note:** After investigation, it was concluded that the exceedance of the LAeq 'Total Daily Construction' on the 1st was caused by wind.

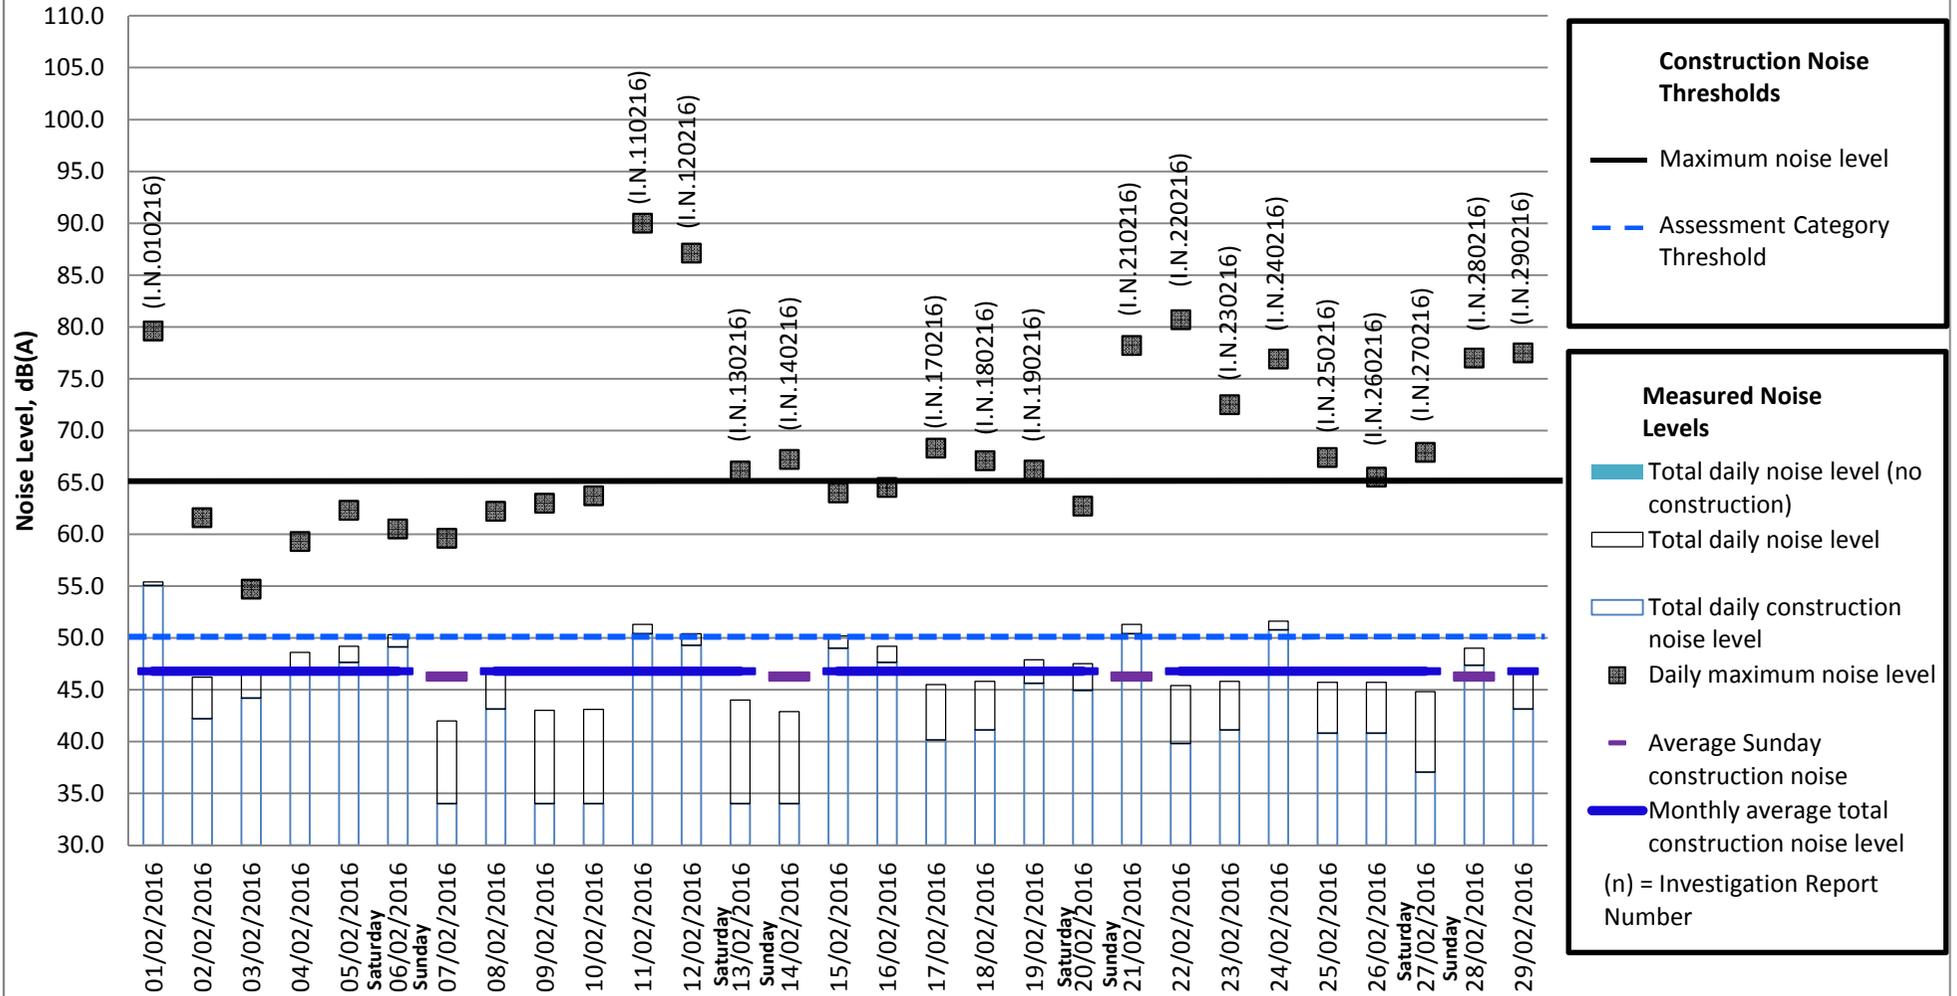
## Measured Night time Noise Levels at Inchgarvie Measurement period: February 2016

**Note:** After investigation, it was concluded that the exceedance of the LAeq 'Total Daily Construction' on the 1st was caused by wind

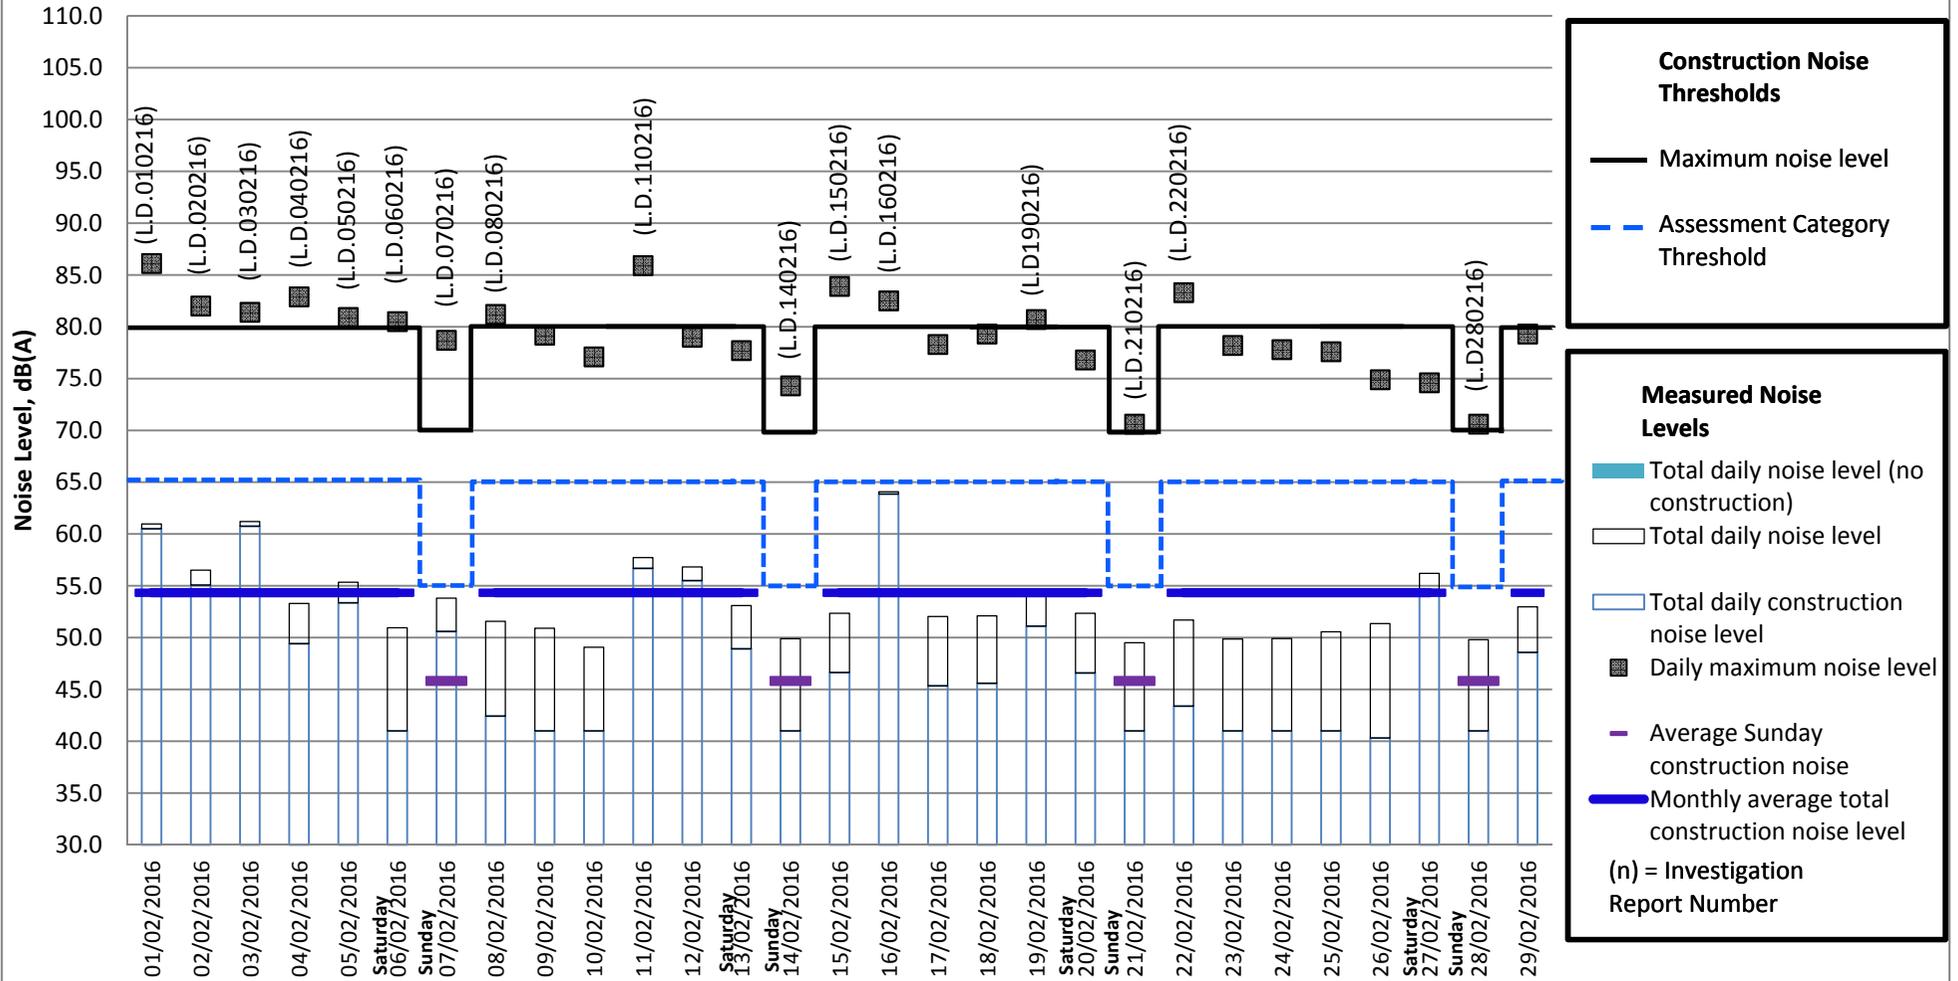
# Measured Daytime Noise Levels at Linn Mill

- 3.6** During the month of February it was noted that there was construction related noise at Linn Mill. The  $L_{AFmax}$  exceedances on the 3<sup>rd</sup>, 15<sup>th</sup>, 16<sup>th</sup> and 19<sup>th</sup> February occurred during the day and seemed to be coming from the Scaffold/Timber storage area which is near the noise monitor. The Environmental team have contacted the relevant site agent and asked that staff be reminded to keep noise to a minimum, the environmental team will continue to monitor the situation closely. There was one exceedance during February at Tigh-na-grian which occurred during the night time period. This exceedance was caused by hammering and site teams were reminded about noise levels. There were exceedances at Inchgarvie and Clufflat on the 10<sup>th</sup> February that resulted from metal being dropped into a skip from the AVS area. Site staff were emailed regarding the incident and reminded of noise levels.

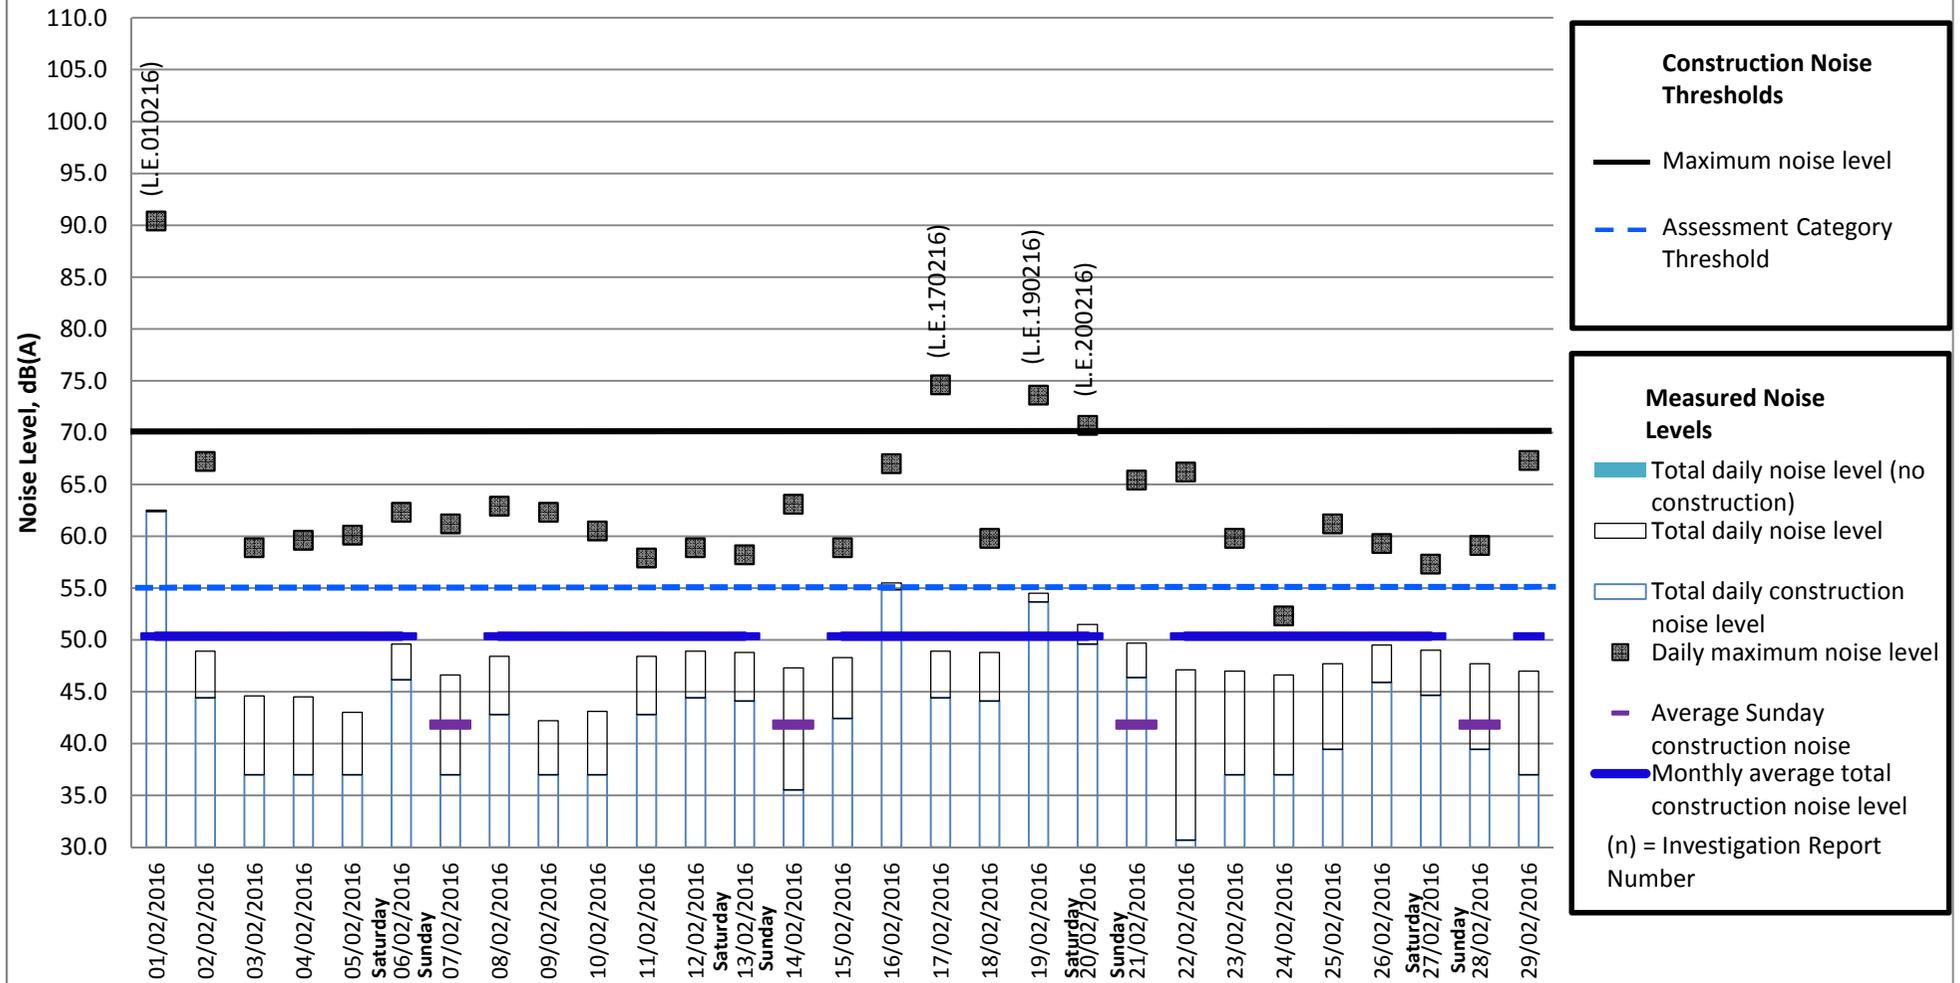
## Measured Evening Noise Levels at Linn Mill Measurement period: February 2016

**Note:** After investigation, it was concluded that the exceedance of the LAeq 'Total Daily Construction' on the 1st was caused by wind

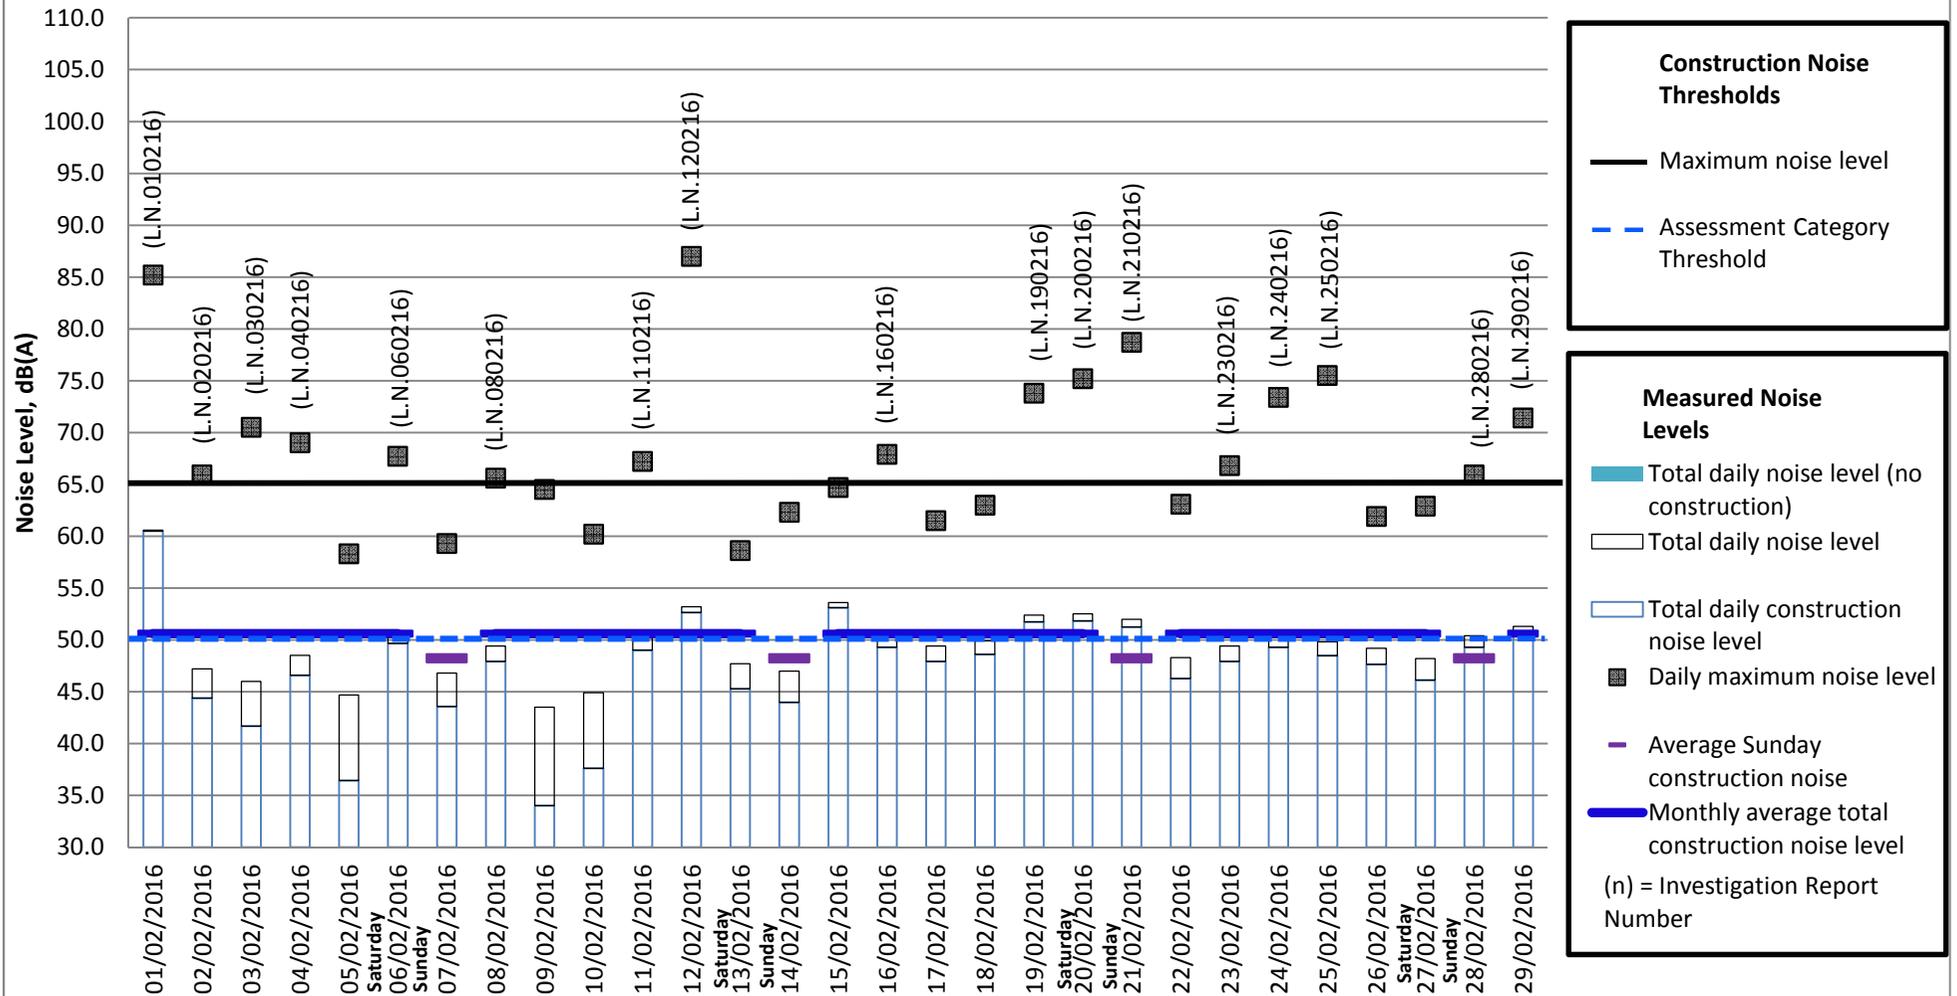
## Measured Night time Noise Levels at Linn Mill Measurement period: February 2016

**Note:** After investigation, it was concluded that the exceedance of the LAeq 'Total Daily Construction' on the 1st was caused by wind

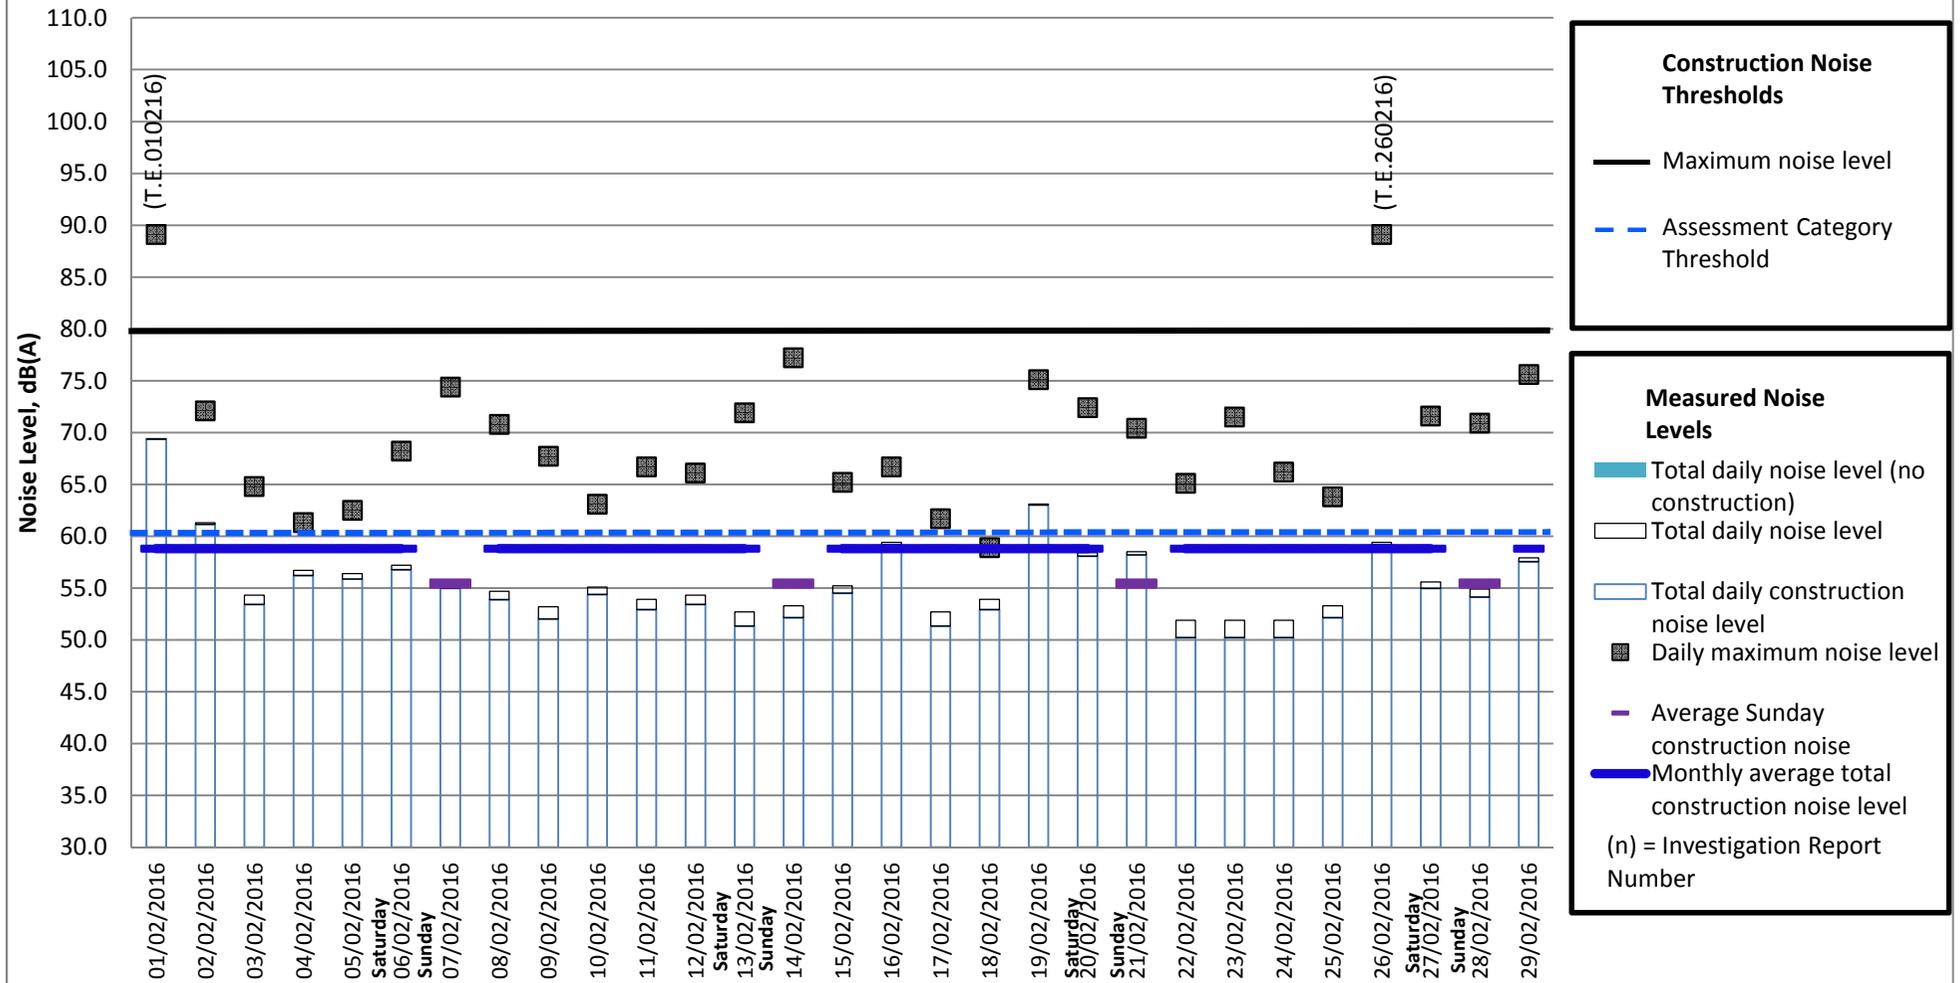
## Measured Evening Noise Levels at Tigh-Na-Grian Measurement period: February 2016

**Note:** After investigation, it was concluded that the exceedance of the LAeq 'Total Daily Construction' on the 1st was caused by wind

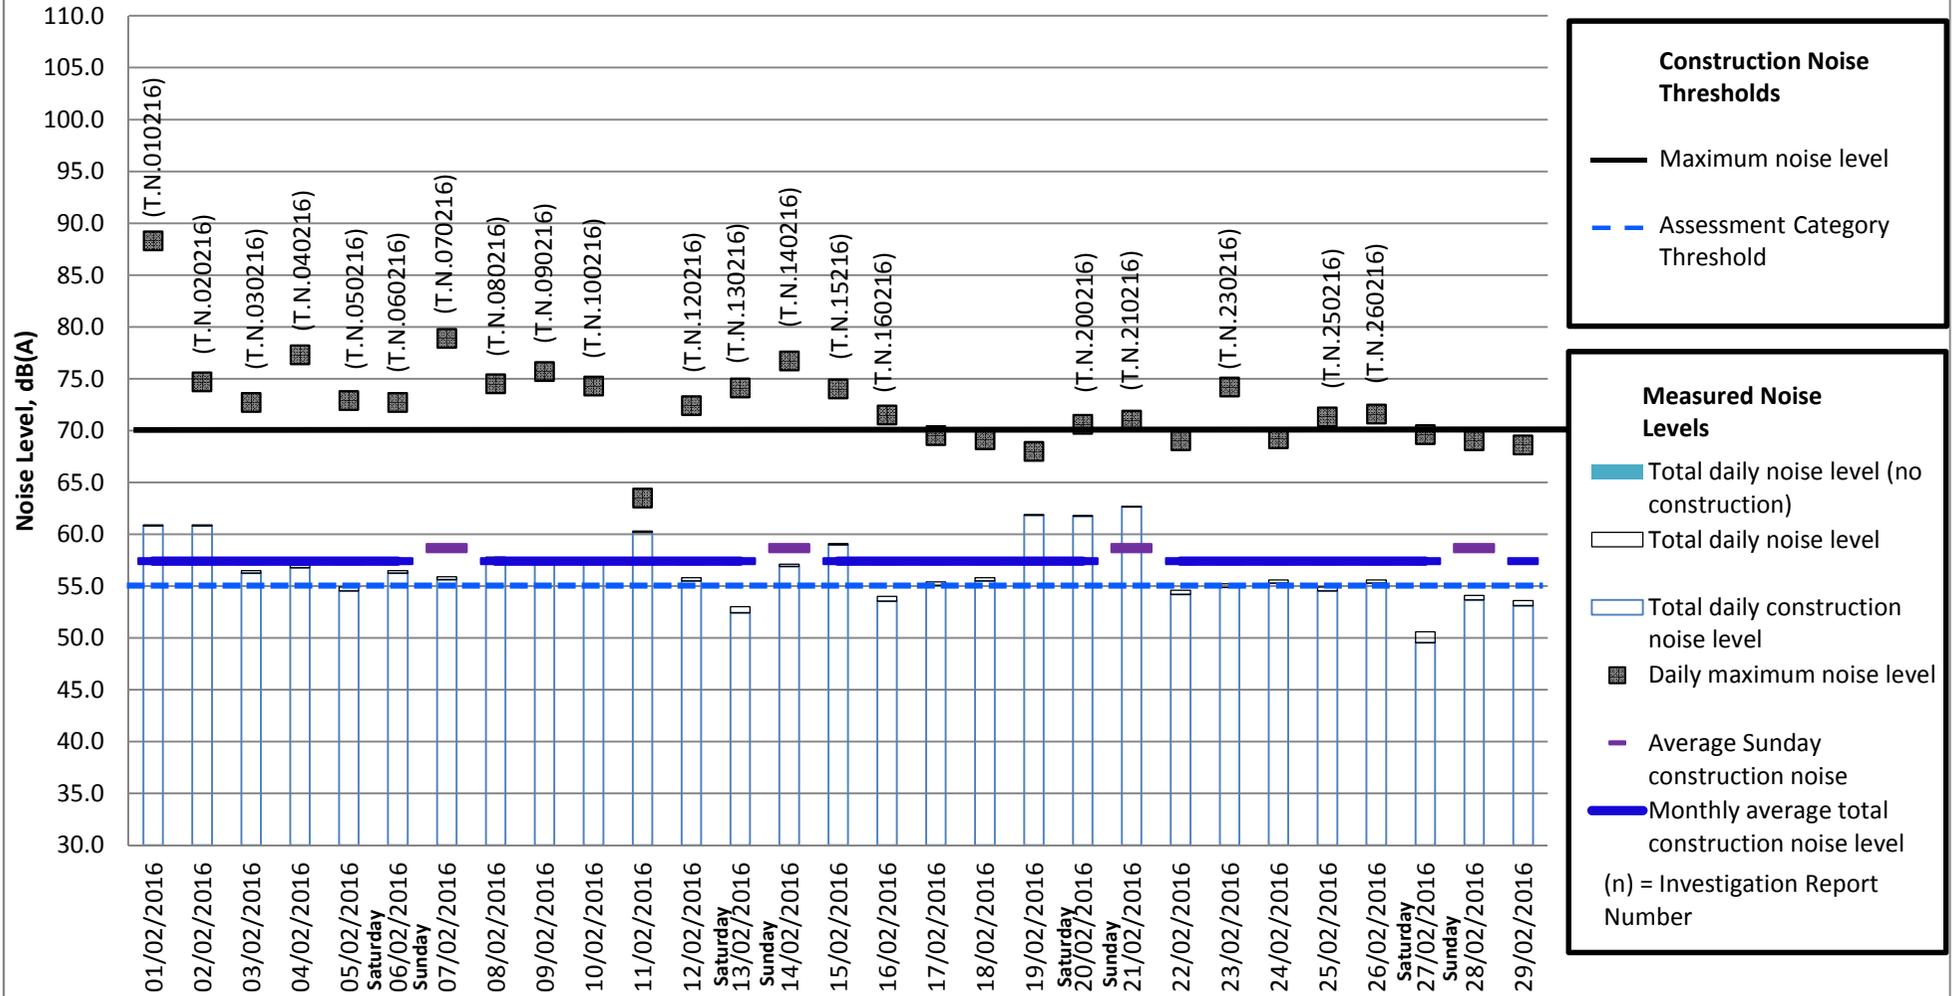
## Measured Night time Noise Levels at Tigh-Na-Grian Measurement period: February 2016

**Note:** After investigation, it was concluded that the exceedance of the LAeq 'Total Daily Construction' throughout site was caused by wind and birds
