Project **FORTH REPLACEMENT CROSSING**

**CONSTRUCTION NOISE MONITORING REPORT: FEBRUARY 2016**

Document number	Rev
<b>REP-00271</b>	<b>00</b>

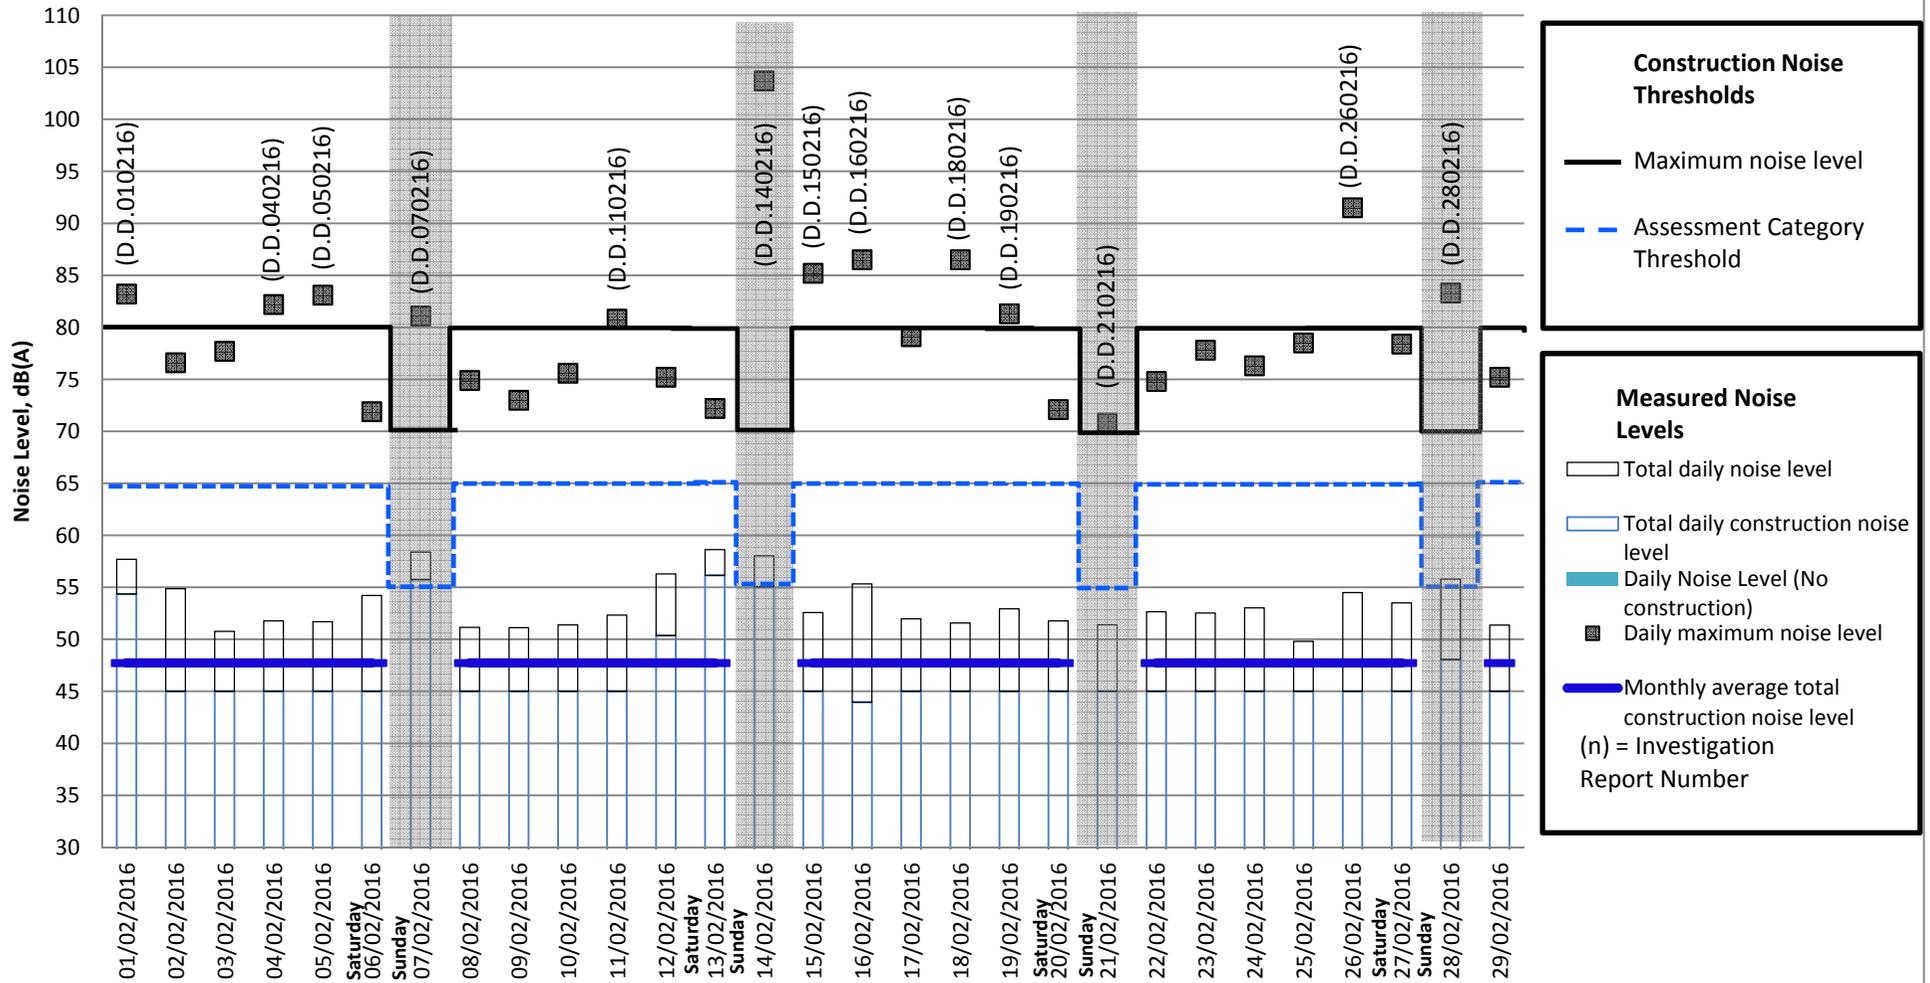
# Measured Daytime Noise Levels at Dundas Home Farm

**Note:** The grey areas of the chart represent days on which no construction works have been conducted.

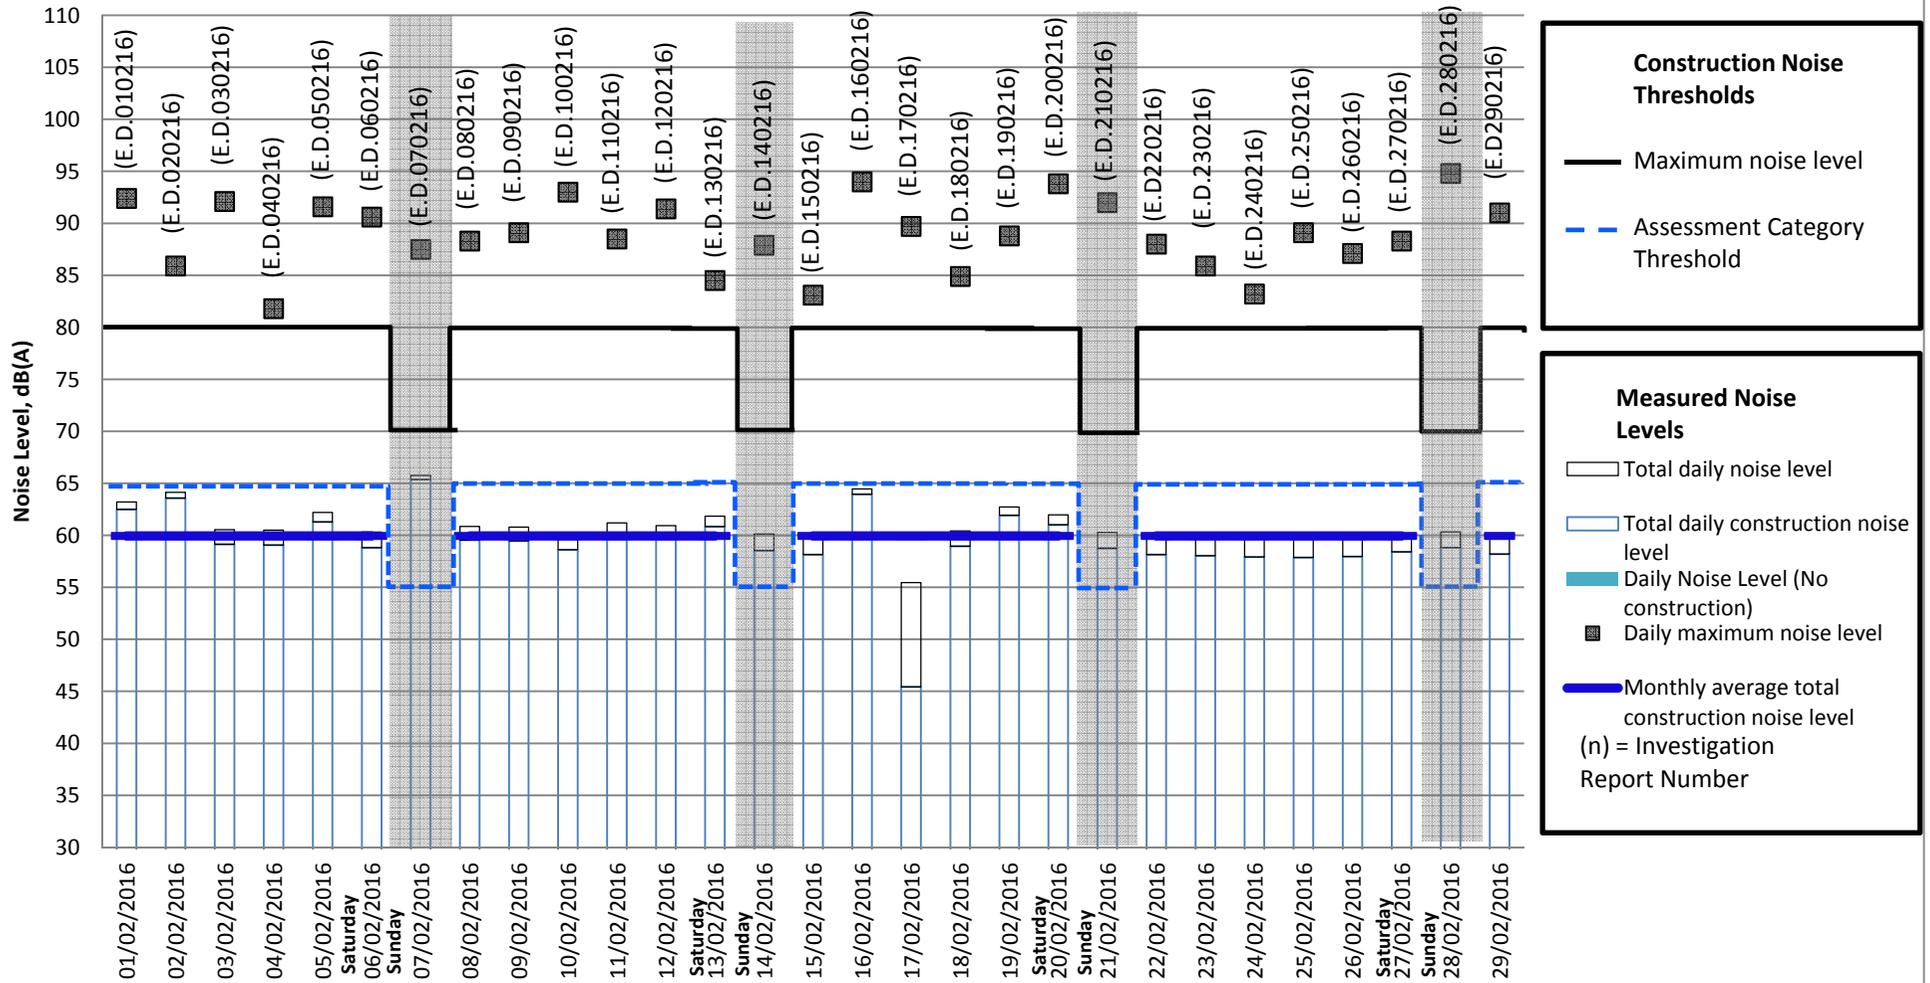
## Measured Daytime Noise Levels at Echline Measurement period: February 2016

**Note:** The grey areas of the chart represent days on which no construction works have been conducted.

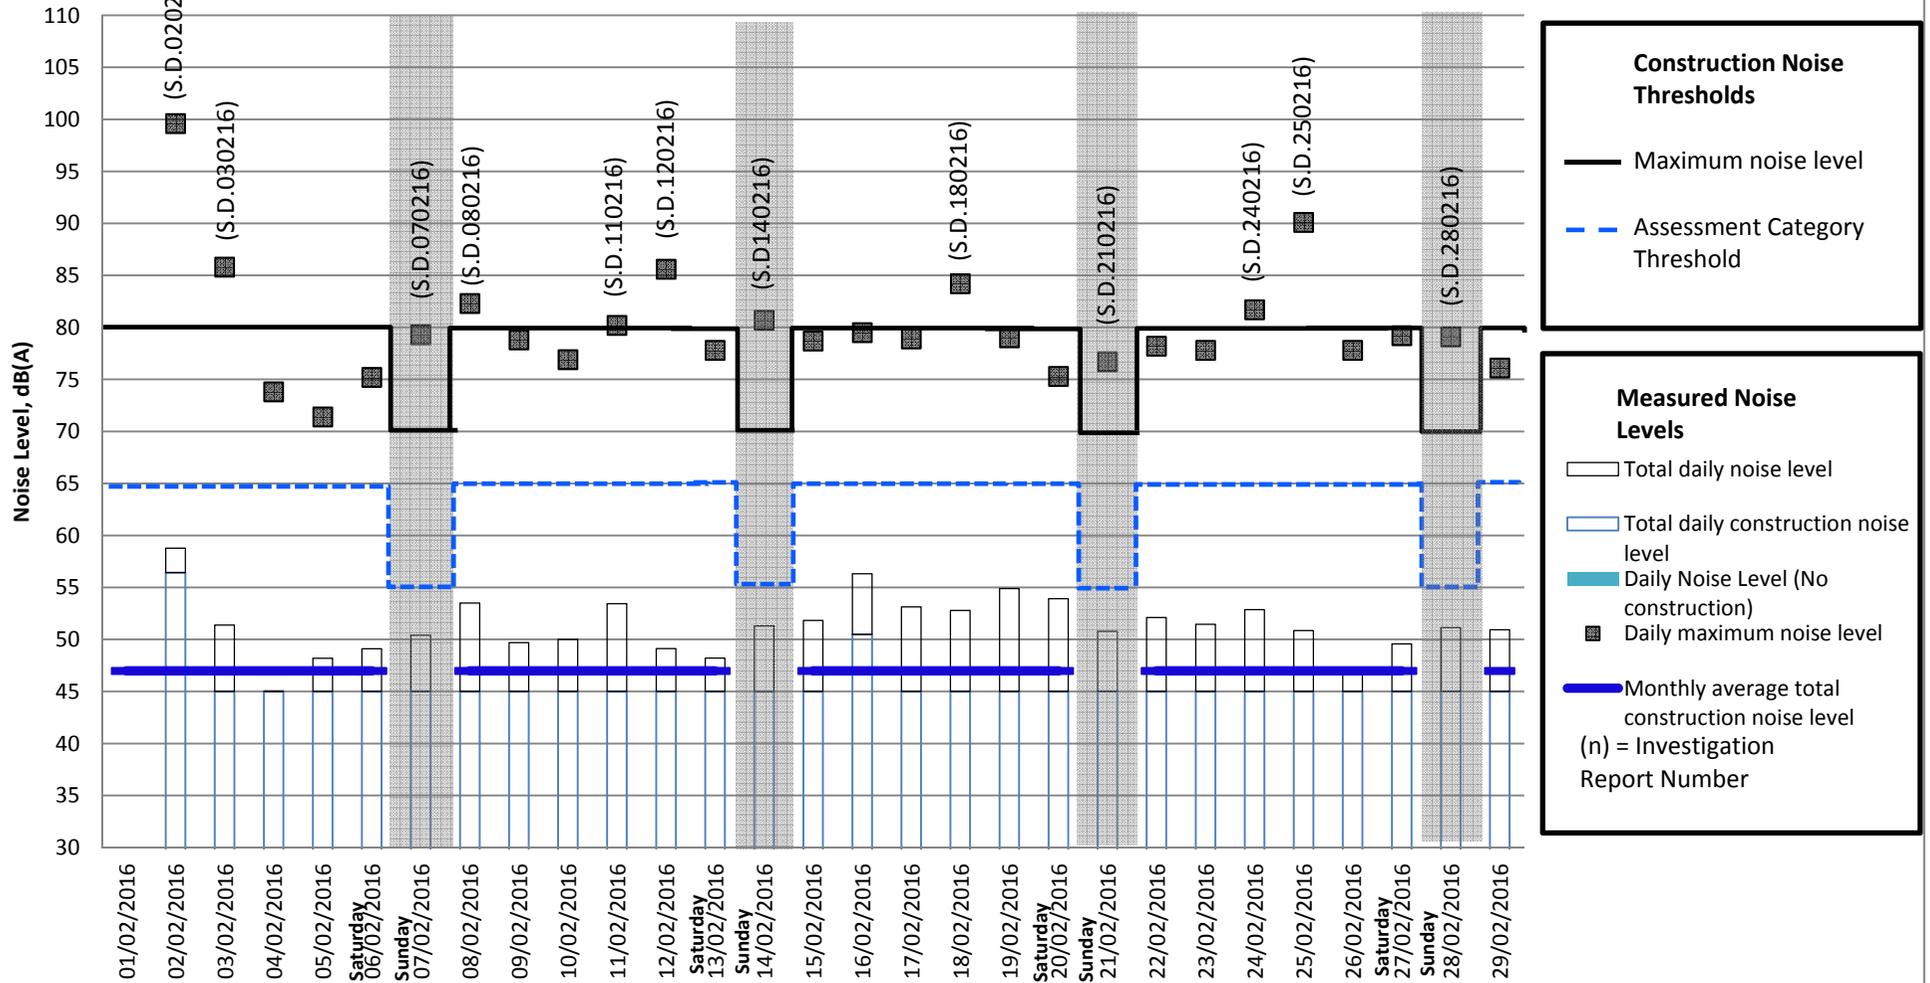
## Measured Daytime Noise Levels at Springfield Measurement period: February 2016

**Note:** The grey areas of the chart represent days on which no construction works have been conducted; There is no data on the 01/02/16 due to a problem with the monitor.

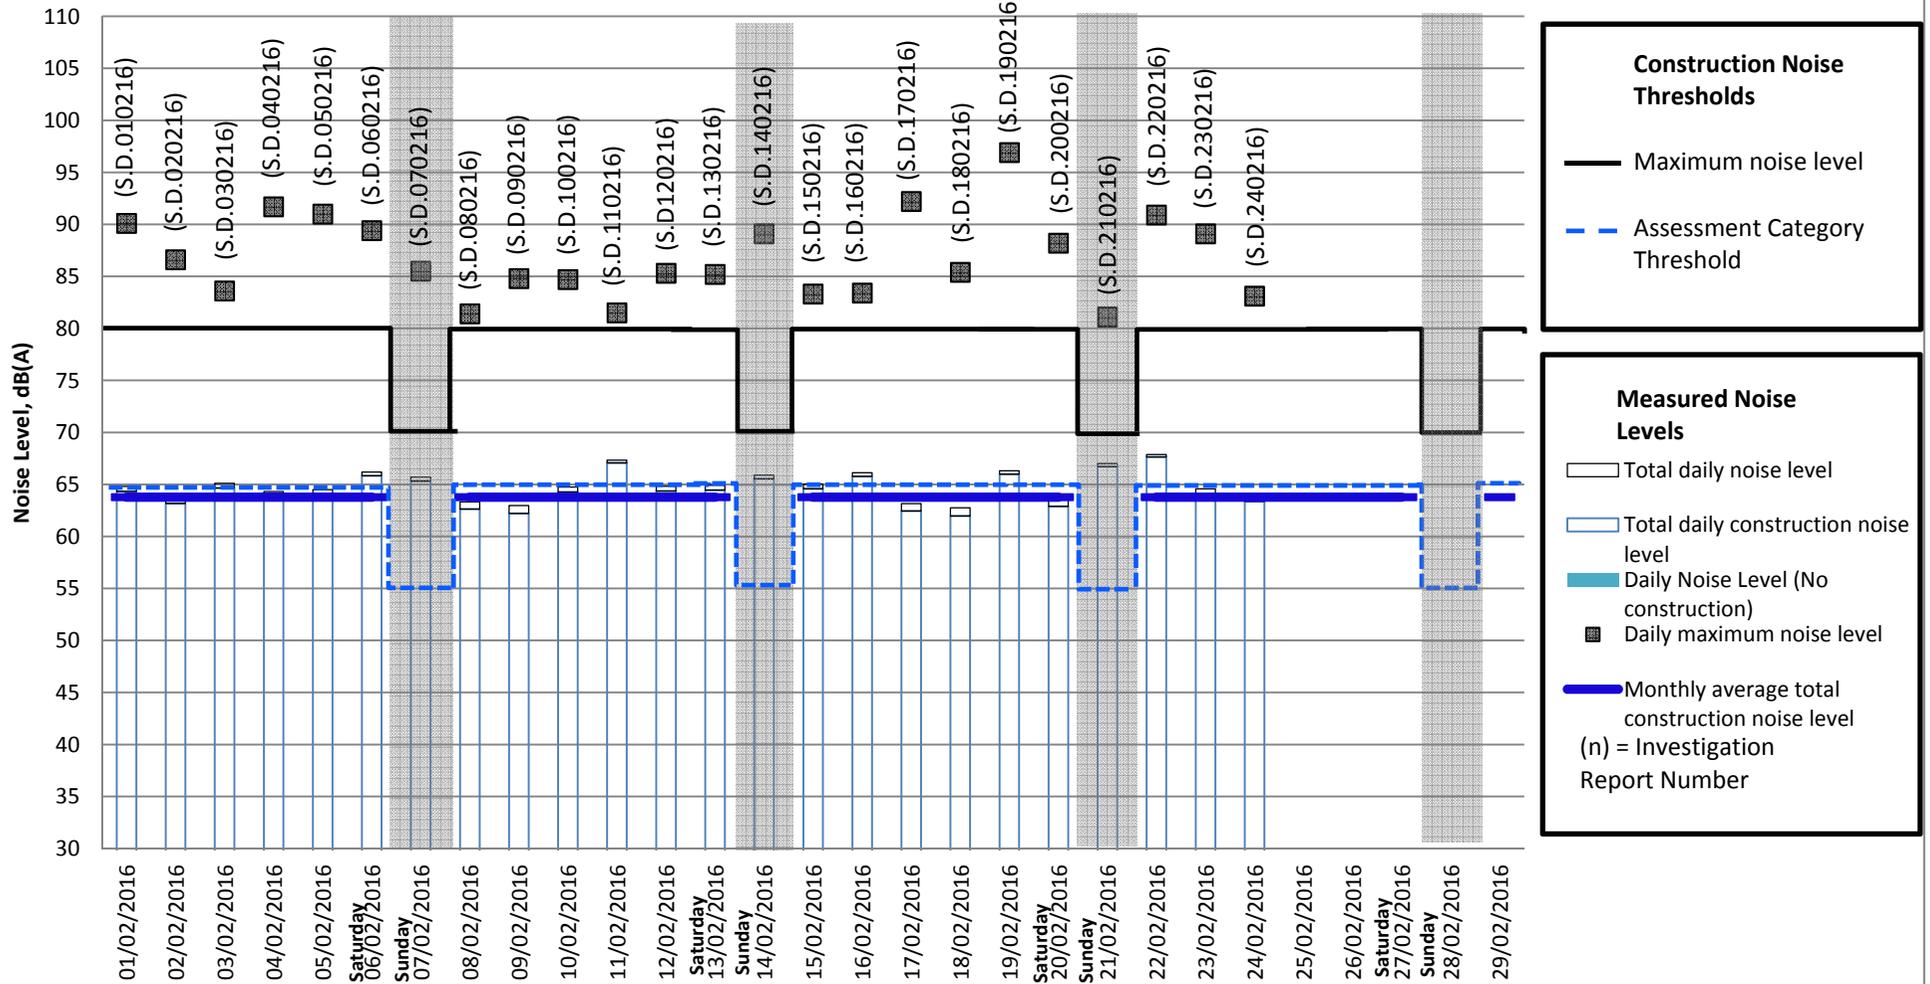
## Measured Daytime Noise Levels at Scotstoun Measurement period: February 2016

**Note:** The grey areas of the chart represent days on which no construction works have been conducted; No data is available from the 25/02/16 - 29/02/2016 due to electrical issues. This was resolved on the 01/03/2016.

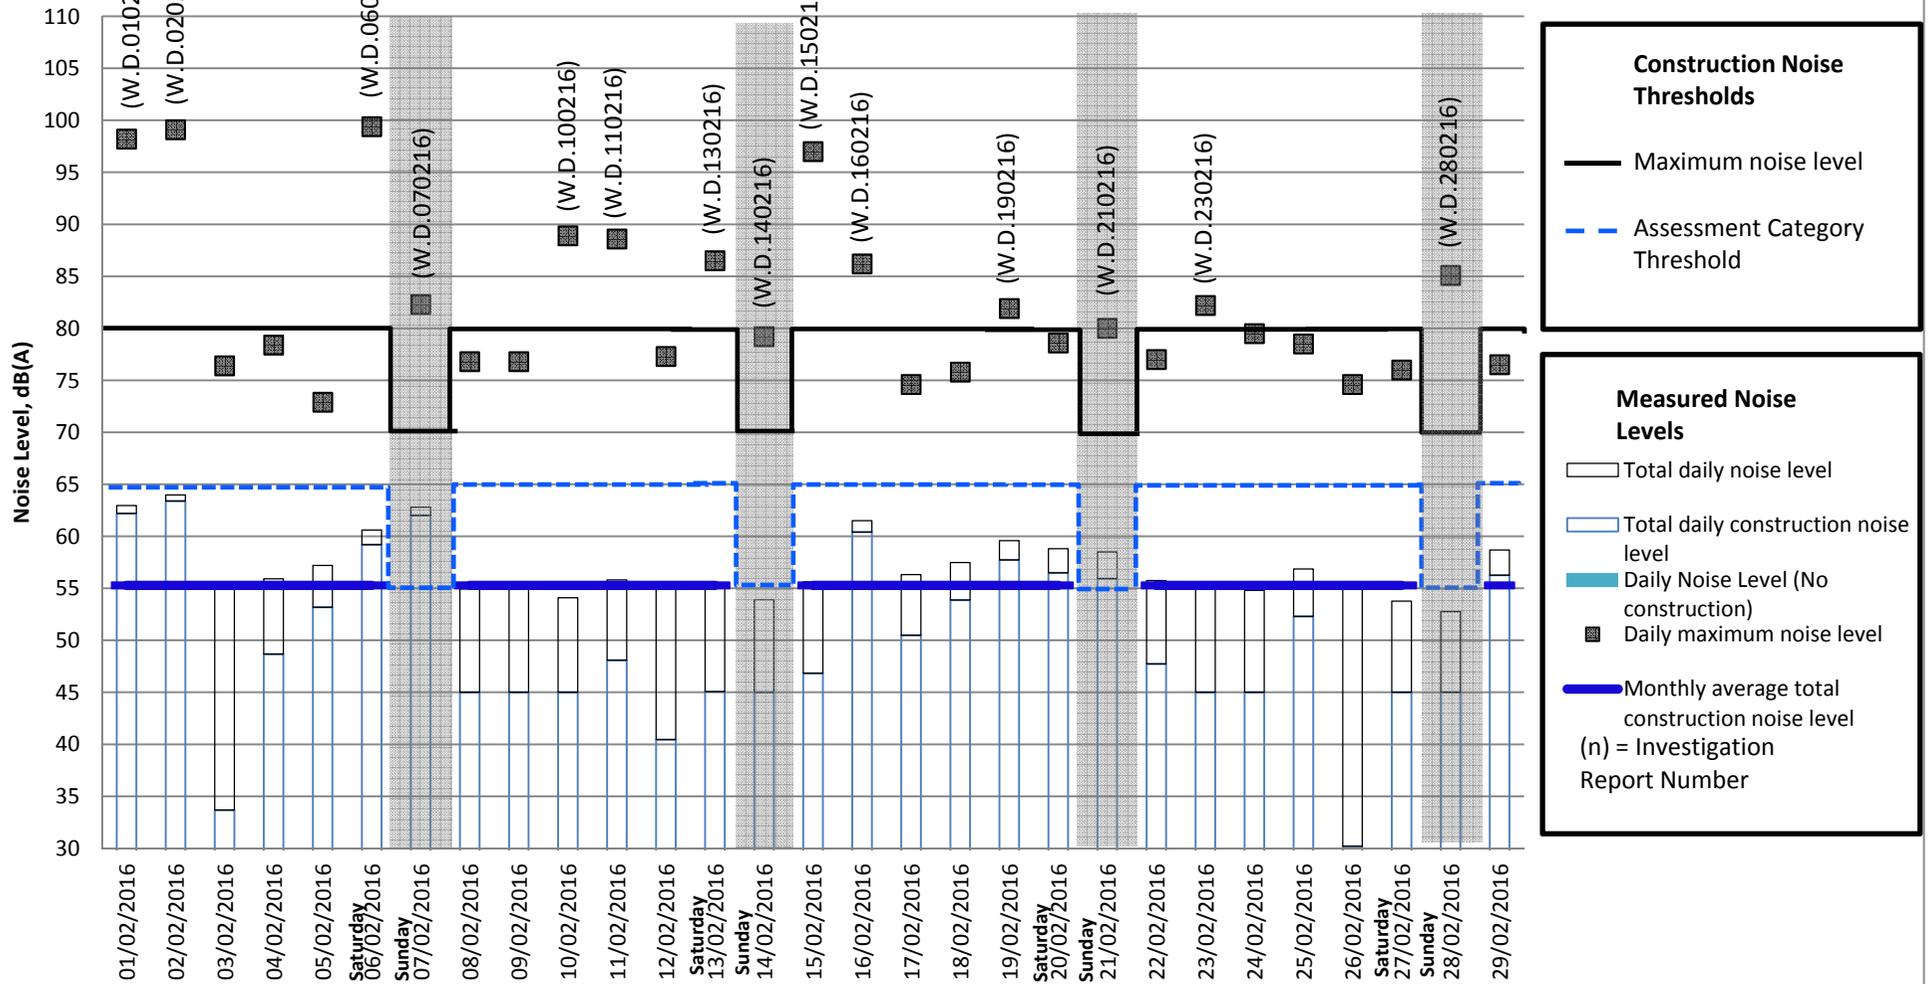
# Measured Daytime Noise Levels at Whinnyhill

**Note:** The grey areas of the chart represent days on which no construction works have been conducted

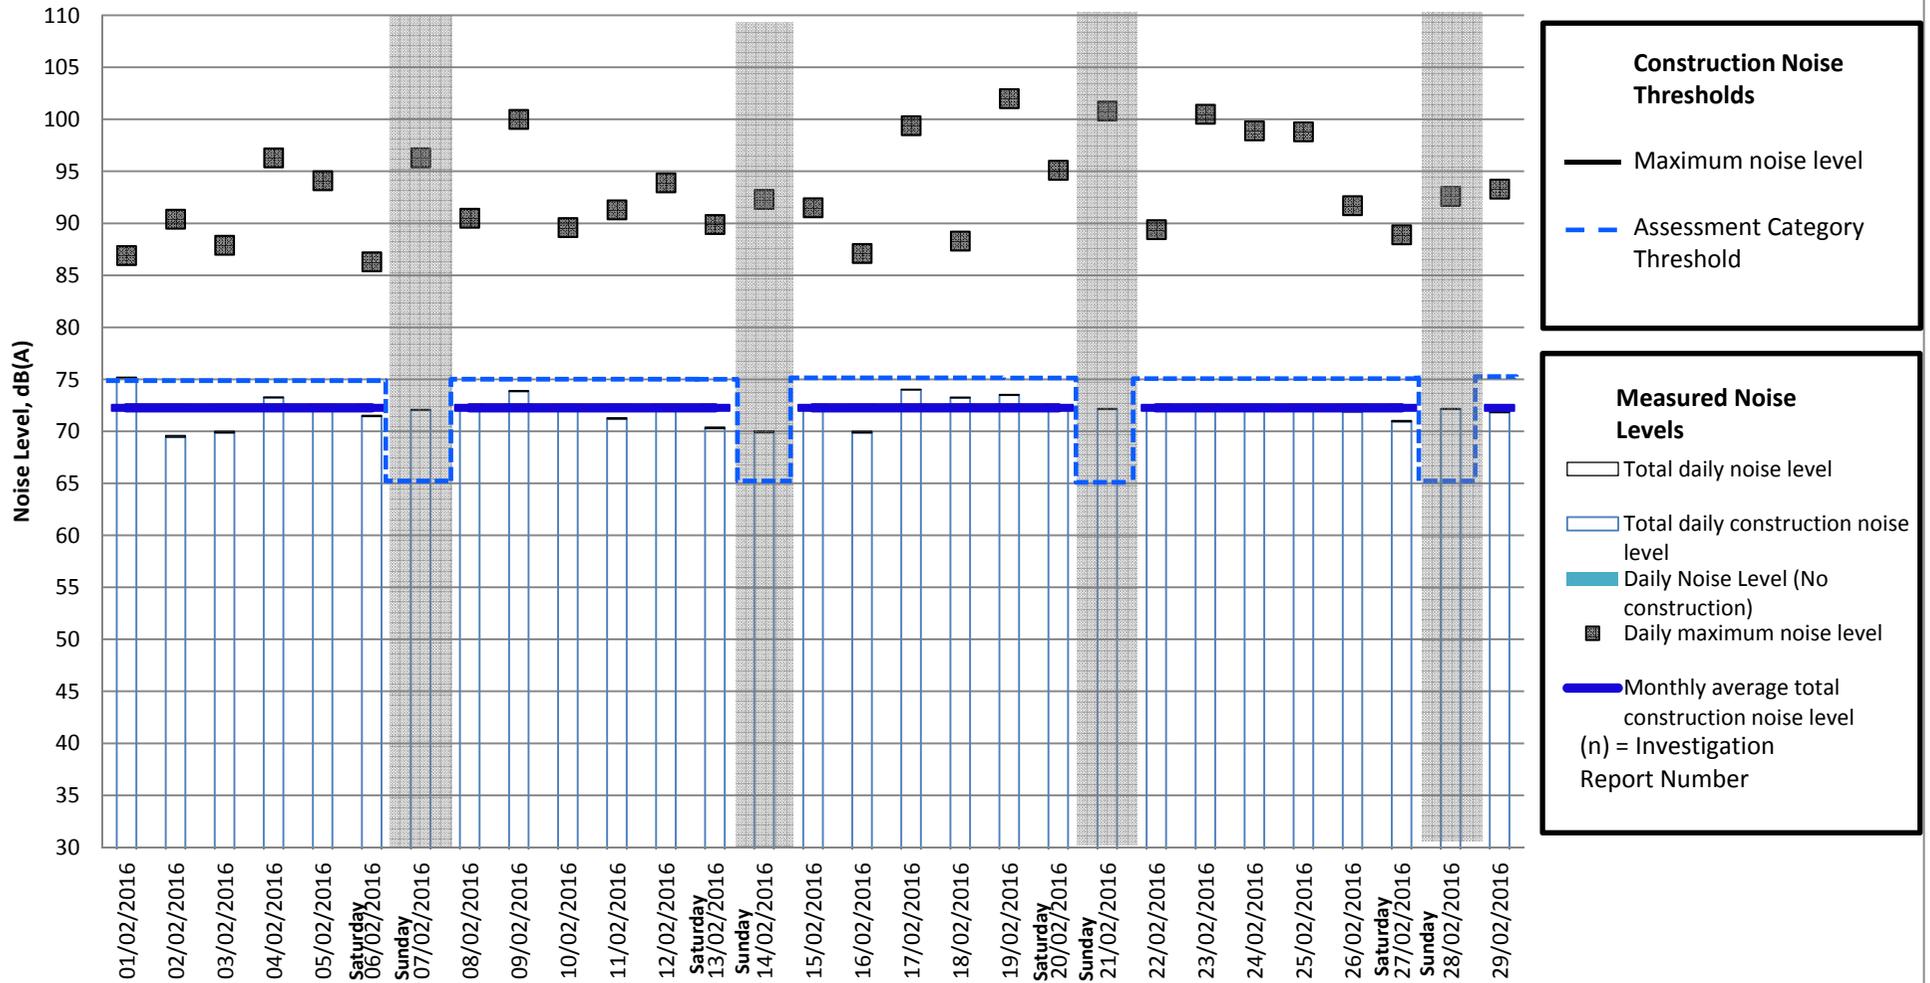
## Measured Daytime Noise Levels at Newton Measurement period: February 2016

**Note:** The grey areas of the chart represent days on which no construction works have been conducted
