River Geomorphological Survey

Fluvial Geomorphological Survey of the A68 Annfield Bridge Extension; Headshaw Burn

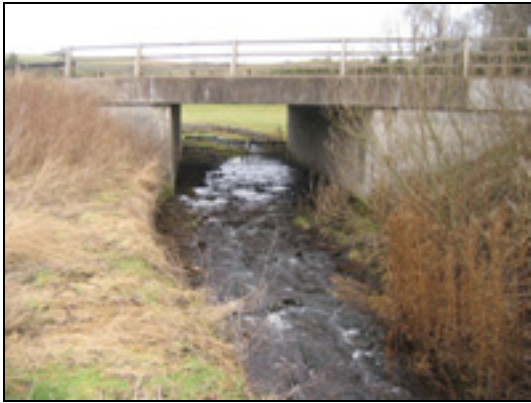
The Headshaw Burn is a 1st order tributary of the Leader Water and is designated as a Special Area of Conservation (SAC). At the site of interest a current bridge of 5.35 metres spans the burn (Plate 1). The width of the bridge is and its height above the bed of the burn is 2.76 metres. Scrutiny of the Ordnance Survey 1862 map of the reach shows the channel planform position and geometry and location of bridges to be as it is today. Associated with the bridge is a wall reinforcement extending 17 metres upstream (Plate 2) on the left bank and 35 metres downstream on the right bank. The proposal is to extend the current bridge dimensions by 6 metres in width in the upstream direction with a possible further 3 metre extension being proposed if a feeder lane is required. The original bridge span had been designed perpendicular to the A68, appears to have created the meander bend geometry at the bridge entrance and exit. This will have created erosion that is now protected by the walled sections and creation of the partially vegetated point bar at the entrance to the bridge. The plan is to build the bridge extension by sheet piling the burn and in this way maintaining the flow, prevent ingress of fine sediment, and provide a dry environment to construct the bridge footings.

Plate 1: The Annfield bridge and Headshaw Burn.

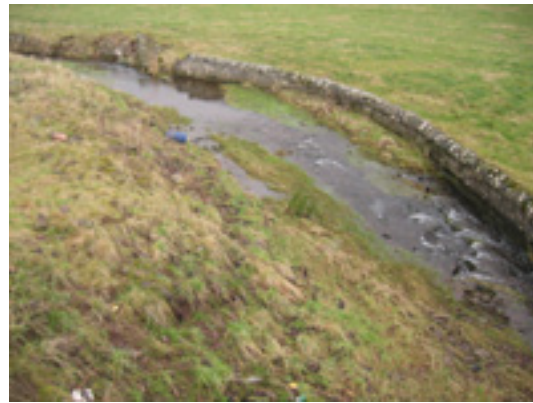
Plate 2: Bank protection upstream of the Annfield Bridge.

downstream of the bridge consideration could be given to its removal and replacement with soft engineering. A range of geotextiles and seeding alternatives would be possible; a specialist supplier such as Maccaferri (Hugh Ellis, 01865 770055) would be able to advise on the most appropriate materials and costs.

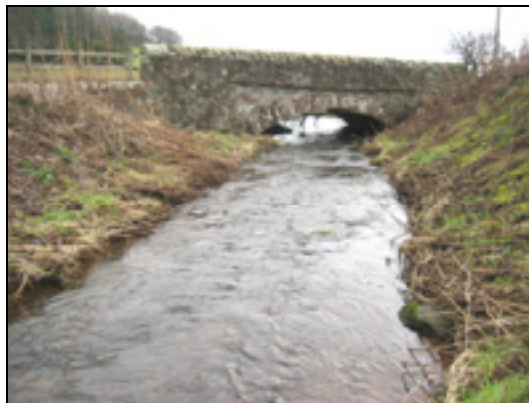
Upstream of the A68 Annfield Bridge an older bridge is present (Plate 3) which carries the D45715 to Carfrae. This has a smaller flow capacity than the Annfield Bridge but Mr David Murphy stated that locals say that it never ponds water behind it.

Plate 3: The old bridge carrying the D4715 over the Headshaw Burn.

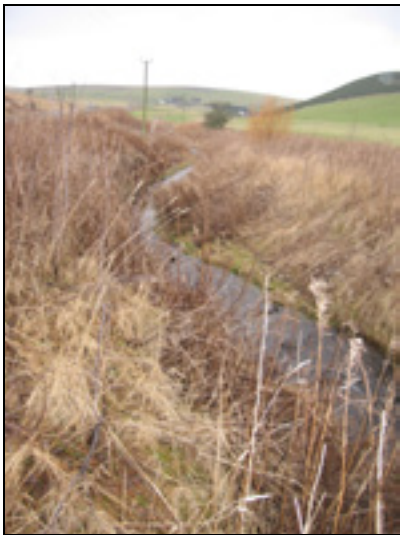
The banks along the 500 metre reach are steep and some minor bank slumping is present. Indeed the 100 metre channel reach upstream of the old bridge appears to have been straightened through an area of artificial ground within unusually high banks (Plate 4). This probably took place during earlier upgrading of the A68. The banks are vegetated but absence of river margin trees is noted. Overall the planform and channel morphology appears stable with the bed material being conveyed during flood events.

Plate 4: The Headshaw Burn set deep within a straight channel in artificial ground.

- Consideration to re-routing the 100 metre partially degraded reach of the Headshaw Burn immediately upstream of the old burn around the margins of the made ground. This would increase the channel length, create a channel with more natural banks and bed and river margin heterogeneity but overall the increase in ecological value of the reach may only be slight. The channel would require similar dimensions to the existing channel and the bed material from the existing reach would need to be transferred. The reach would also need electrofishing to allow transfer of any species. Permission for such a re-routing would need to be sought from SEPA.

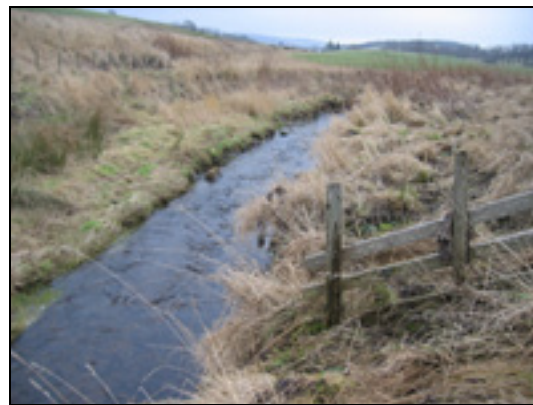
Plate 5: The geomorphic character of the channel downstream showing the nature of its bed, its uniform bank morphology and fenced margins.

Downstream of the Annfield bridge, the stream is very similar to upstream and once again appears to have been artificially modified (Plate 5), but in this case, for land drainage. The channel deepening has appeared to create headwater erosion that has been thwarted by a log placed across the channel which acts as a very small weir. As with upstream the plane bed morphology and past river management activity has resulted in an absence of geomorphologically and ecologically significant features such as exposed gravel bars, deep pools, and backwaters.
