Project **FORTH REPLACEMENT CROSSING**

**AIR QUALITY MONITORING REPORT  
NOVEMBER 2014**

**REP -00205**

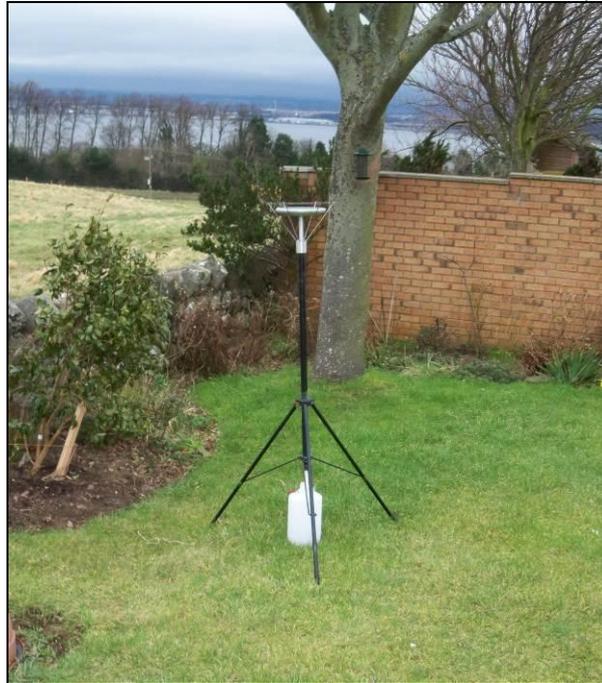
**Figure 1: Example of an Installed Frisbee Gauge Meter**

**2.1.** Air quality is being monitored on site using both automatic light scatter dust meters and Frisbee gauge dust deposition monitoring. Thirteen Frisbee gauges are set up at sensitive locations across the site to measure dust deposition rates (Figure 1). Seven automatic light scatter meters have also been installed at various sensitive locations to measure real time particulate matter (PM<sub>10</sub>) concentrations and the Total Suspended Particle (TSP) concentrations (Figure 2). These meters are calibrated annually. Table 1 lists the air quality monitoring equipment present at each monitoring location, including the date it was installed.

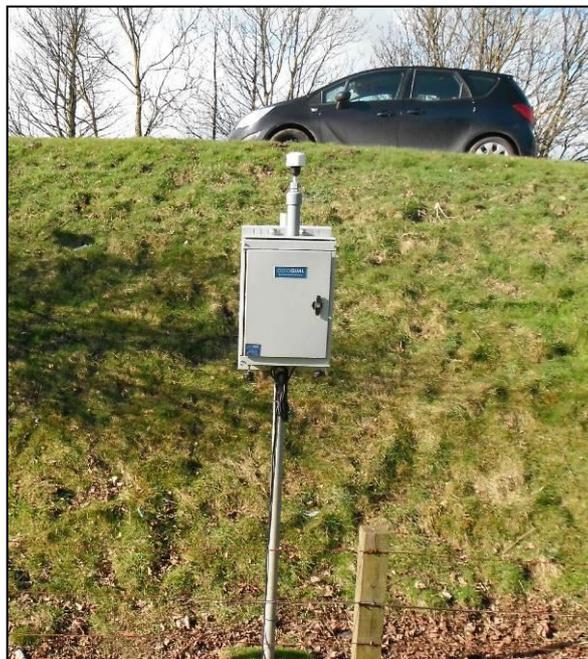
**Figure 2: Example of an installed Automatic Light Scatter Dust Meter**

**2.2.** Light scatter type monitoring equipment have been selected as a site monitoring tool to create a live network which assesses the levels of fugitive particulate matter, principally airborne dust. These monitors require less space, maintenance and power than other real time monitors such as a Tapered Element Oscillating Microbalance (TEOM) which is used and designed to measure particulate levels to exceedingly high standards, including measuring long-term compliance to statutory limits. Light scatter meters are more practicable to deploy. However, the meters do generally record levels higher than those measured by the TEOM. The meters can also be affected by atmospheric moisture content which further increases reported levels. Accordingly, any elevations of statutory limits should be treated as precautionary exceedances. The monitors are reliable for on-site monitoring and the establishment of action thresholds to ensure unforeseen activities generating significant dust are identified and suitably controlled. Light scatter meters are becoming the construction and waste industries norm for particulate dust monitoring.

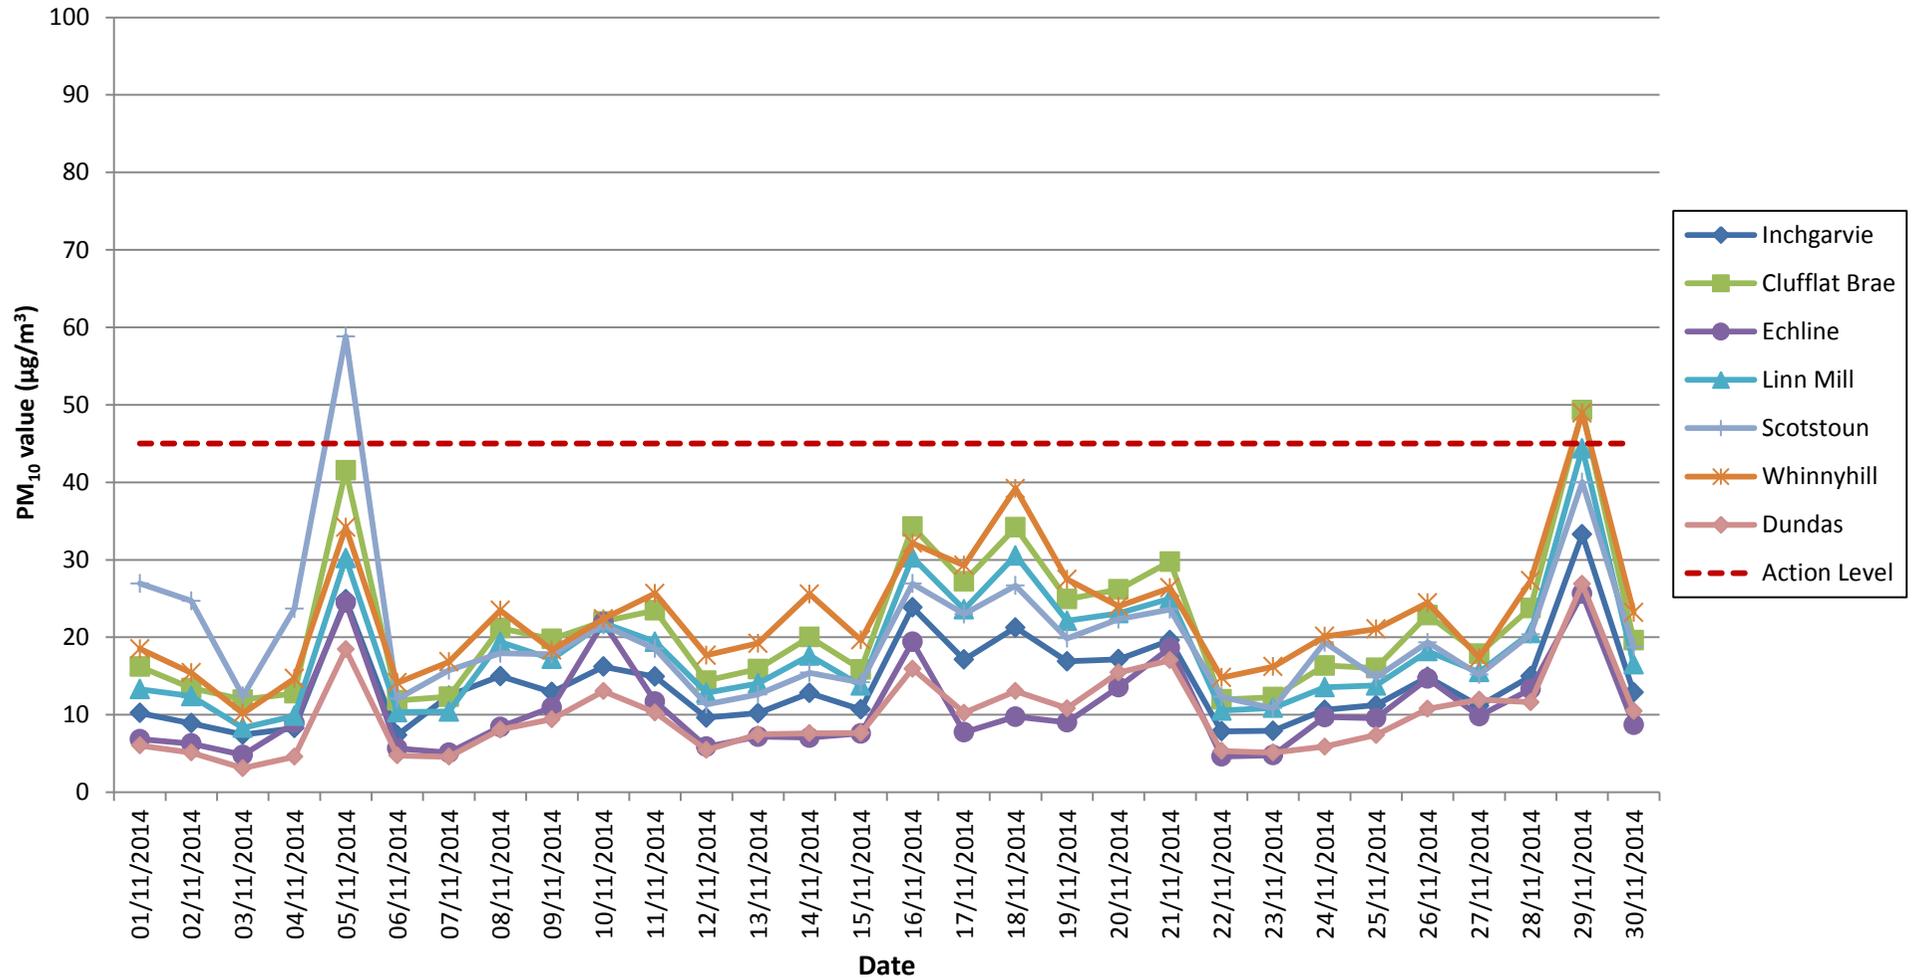
## Particulate Matter (PM10) Results for all Monitoring Locations

### November 2014

**3.1.1.** Light scatter results for November 2014 have been presented in a monthly chart; this can be found in Appendix A. Results show that the PM<sub>10</sub> levels were below threshold levels throughout the month with the exception of two days. The Scotstoun monitor registered levels above the Action Level on the 5<sup>th</sup> and the Clufflat and Whinny Hill monitors registered above the Action Level on the 29<sup>th</sup>. All the monitors follow the same general pattern throughout the month.

**3.1.2.** Raised levels were seen at all monitors on the 5<sup>th</sup> November, with the Scotstoun monitor registering levels over the Action Level. For the exceedances of the Action Level, a review of the works in each of the areas, weather conditions, and the mitigation measures in place was undertaken. During the 5<sup>th</sup> November levels across all monitors saw a significant increase in levels after 6:00pm. Land based construction activities finished by 7:00pm so it is concluded that the increases observed across all the monitors are caused by regional conditions, with

the possibility of bonfires and fireworks (Bonfire Night) contributing to high levels at some locations.

**3.1.3.** Raised levels were also observed across all monitors on site on Saturday 29<sup>th</sup> November, including levels above the Action Level at Whinnyhill and Clufflat. As with all exceedances of the Action Level, a review of the works in each of the areas, weather conditions, and the mitigation measures in place was undertaken. Due to it being a Saturday, very little work was being undertaken across site with no works that would create dust. The only activities in the exceedance related areas were welding in the launch sections and some kerbing and drainage work on the North Networks area. This combined with the fact that a similar increase was seen across all the monitors suggests the increase was caused by a regional event rather than construction related activities.

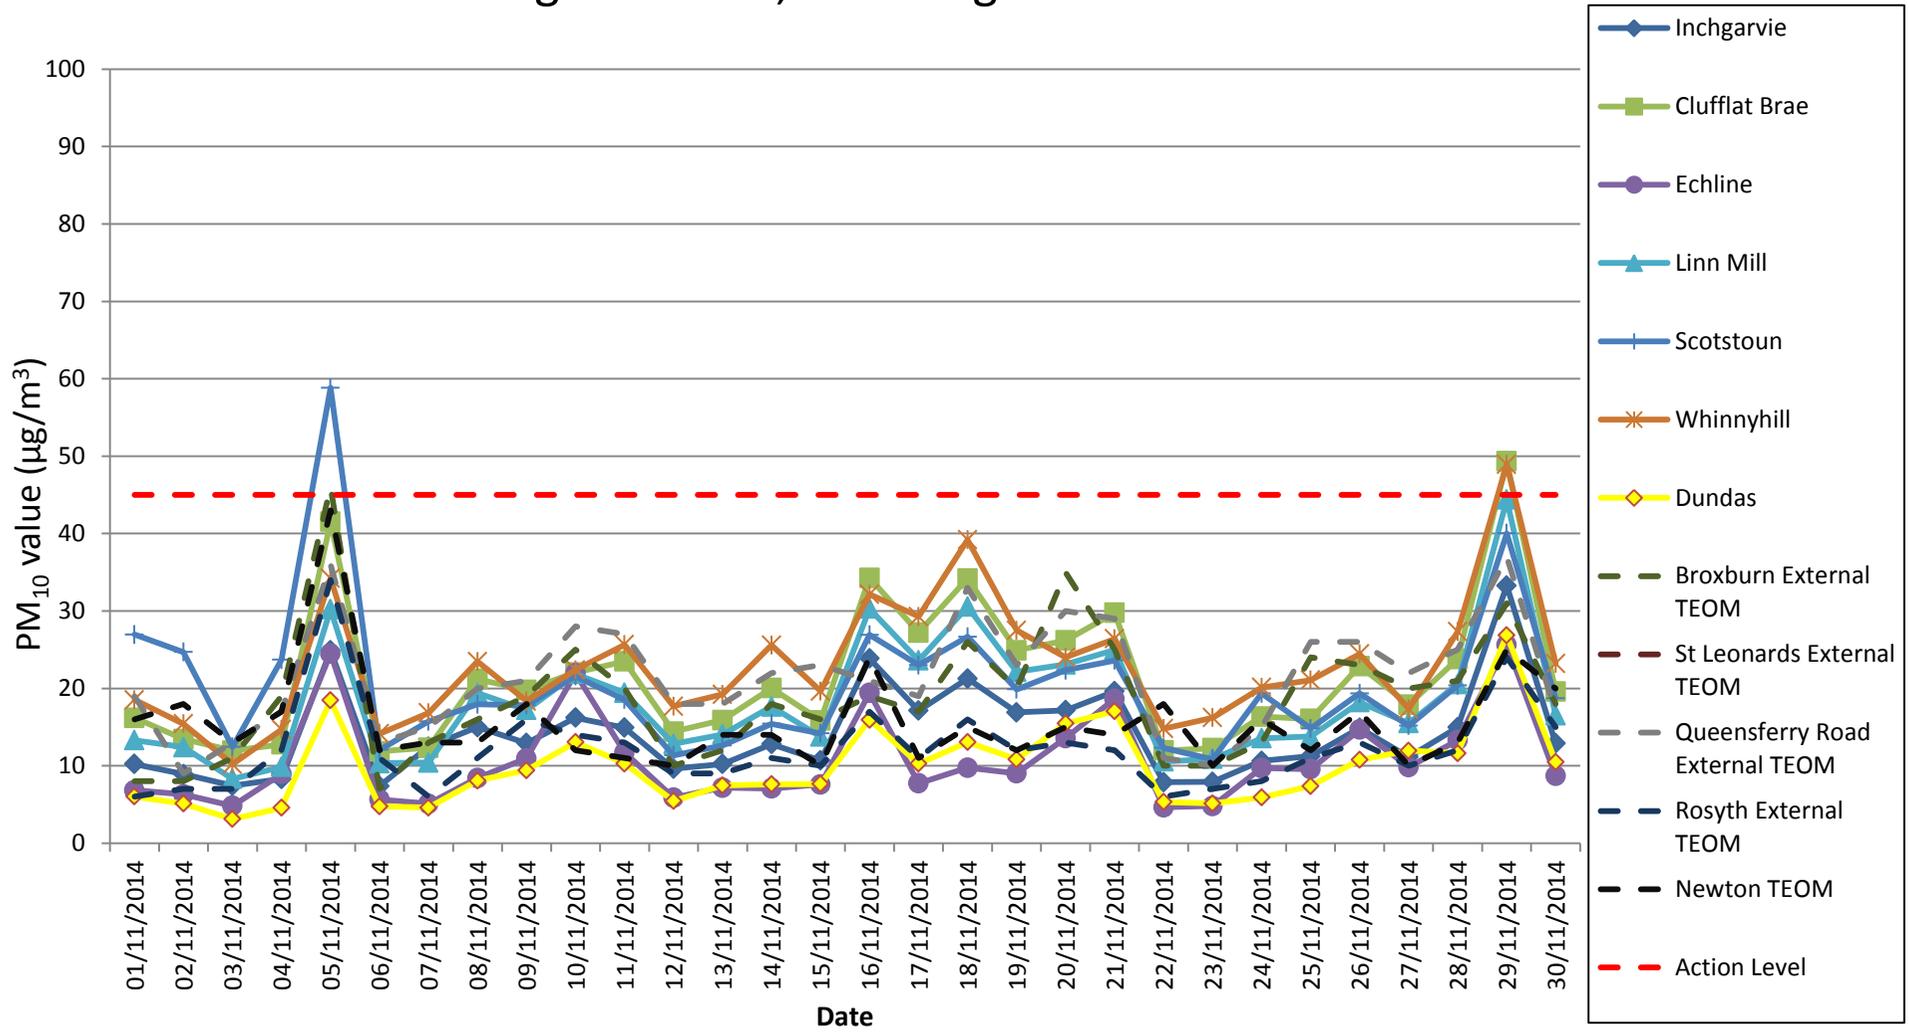
## Air Quality Monitoring: Particulate Matter (PM10) Results for all Monitoring Locations, including TEOM data November 2014

Note: TEOM data missing from scottish air quality for the St Leonards monitor since 12th September.

**3.1.4.** The PM<sub>10</sub> results have also been compared to the daily mean results obtained from the TEOM air quality monitoring stations located in Newton, Rosyth, and Broxburn, and from the TEOM FDMS station located at Queensferry Road, Edinburgh. No data was available from the TEOM FDMS monitor at St Leonards, Edinburgh. The TEOM at Newton was installed by West Lothian Council, facilitated by FCBC, during May 2012. The comparison between the light scatter and TEOM results demonstrates that both sets of results generally follow the same pattern at similar levels, indicating that the pattern observed throughout November was largely driven by regional changes in air quality.

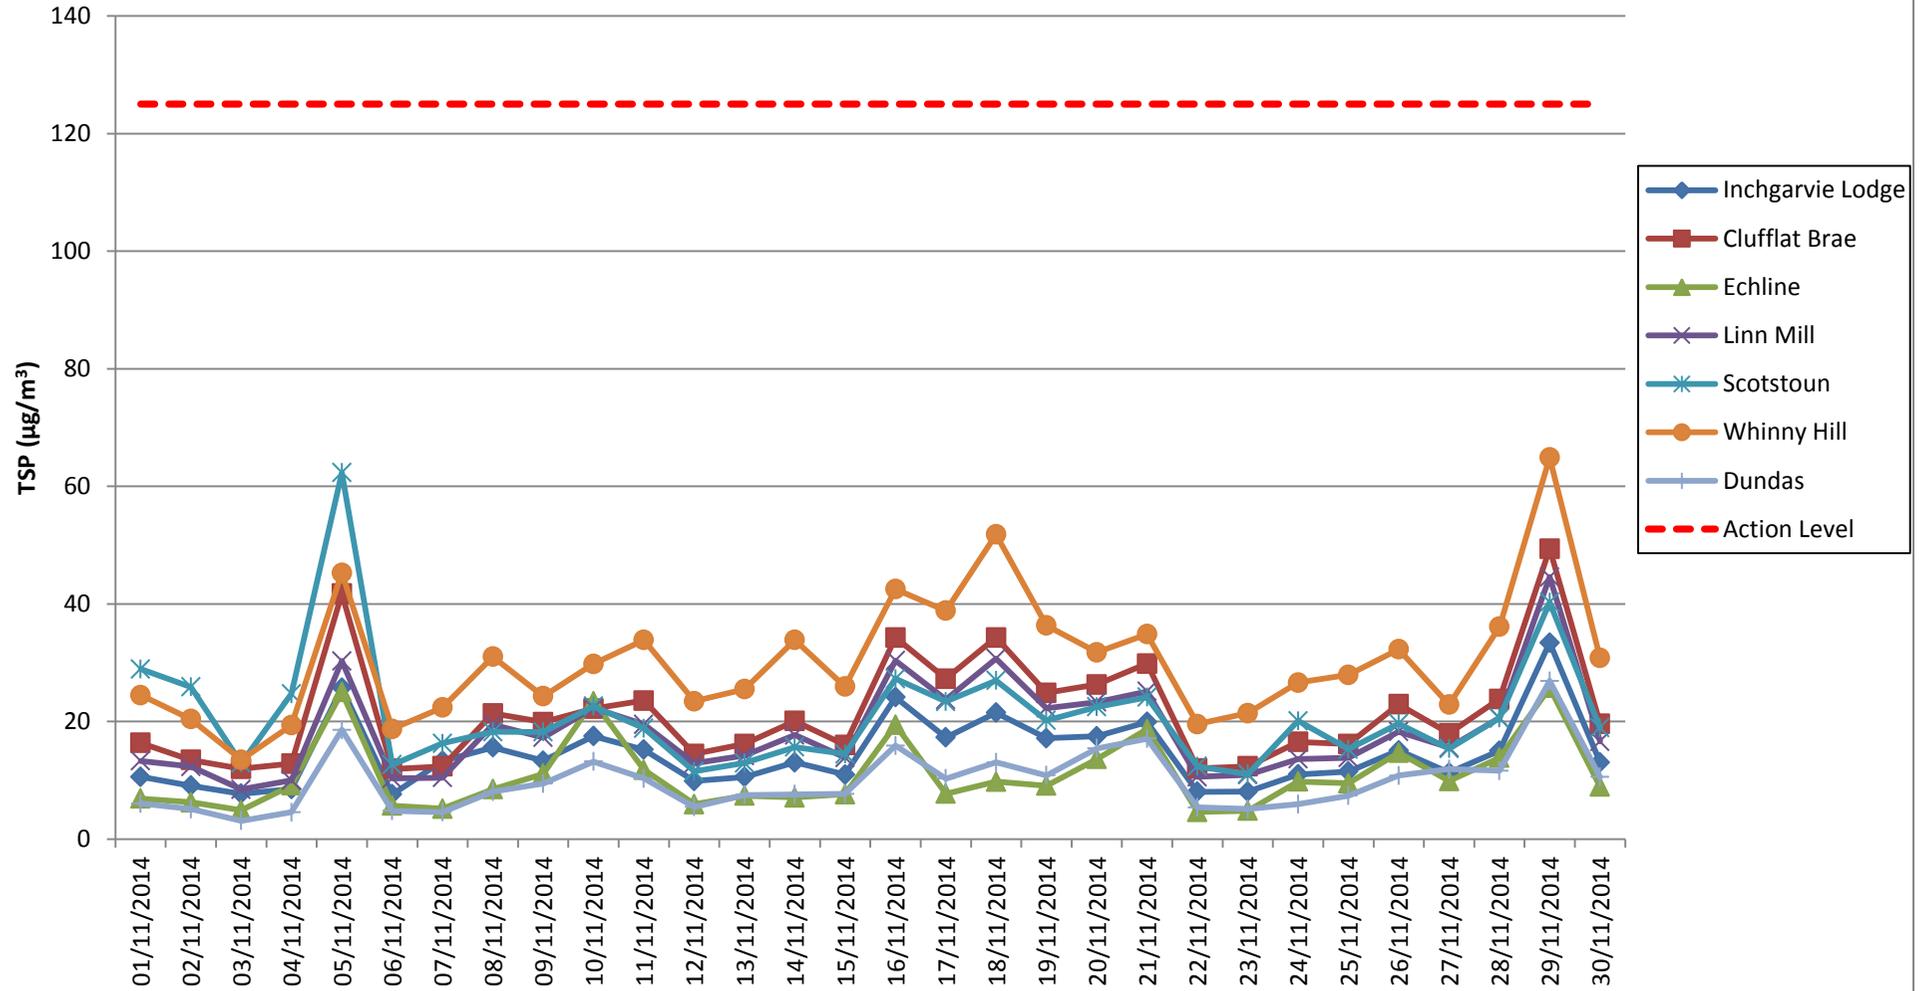
# Total Suspended Particles (TSP) Results November 2014

**3.2.1.** The TSP results for November 2014 have been presented in a monthly chart; this can be found in Appendix B. The TSP levels at monitoring locations during November were found to be low and all within the threshold level. All locations across the site were mostly found to follow a similar pattern, demonstrating that, in general, the levels were

influenced by regional changes in TSP levels, rather than construction works.

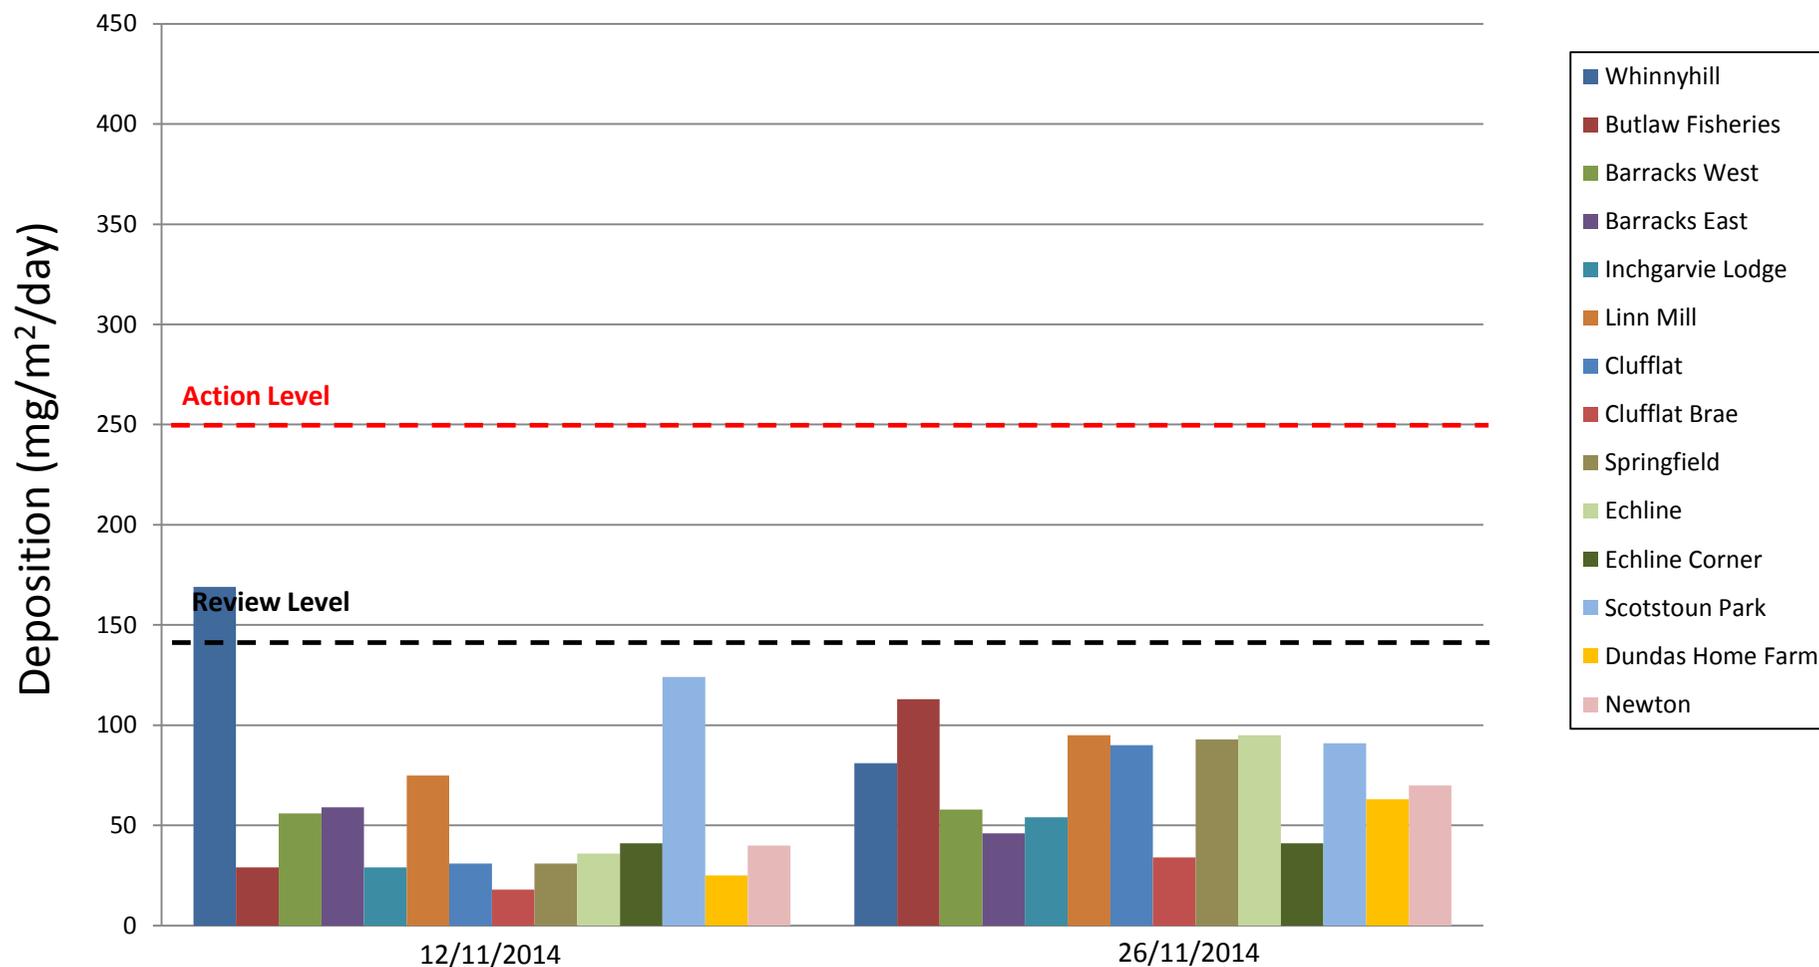
## Frisbee Dust Deposition Results: November 2014

Note: Echline Corner gauge not collected on 12/11/2014. Collection on 26/11/2014 was analysed to cover the four week period ending 26/11/2014.

- 3.3.1.** The Frisbee dust deposition results for November 2014 have been presented in a chart and can be found in Appendix C. This includes an additional Frisbee (Echline Corner) currently located south of the A904 in proximity to the Echline monitor. This temporary Frisbee is used to provide additional information and its results are presented alongside the 13 permanent monitors. Frisbee dust deposition results were collected fortnightly, and the results averaged over this fortnight period to give a daily dust deposition rate. Two collections were made in November, on the 12<sup>th</sup> and 26<sup>th</sup>. The next collection will take place on the 10<sup>th</sup> December 2014.

- 3.3.5.** During the two week period ending the 12<sup>th</sup> November the Whinnyhill gauge registered above the Review Level. However, a review of works was undertaken and it was found that no construction activities that would be likely to give rise to dust took place in the area during this period. PM<sub>10</sub> and TSP data were very low for the period at the same location with the exception of the 5<sup>th</sup> November (see Section 3.1.2). After a thorough review it was concluded that the results cannot be explained by FCBC construction activities undertaken during this period.
