SCOTTISH ROAD NETWORK LANDSLIDES STUDY: IMPLEMENTATION

M G Winter (Transport Research Laboratory),
F Macgregor (Consultant to Transport Scotland) and
L Shackman (Transport Scotland)

Published by Transport Scotland, October 2008

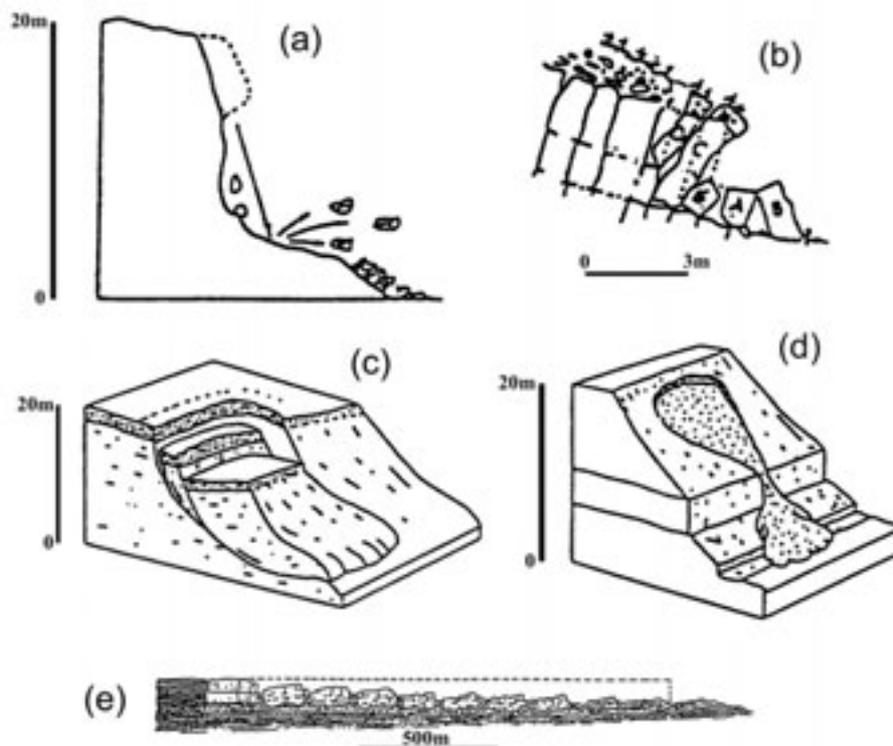
Figure 2.1 – Types of landslide: (a) falls, (b) topples, (c) slides, (d) flows, and (e) spreads (after Escario *et al.*, 1997).

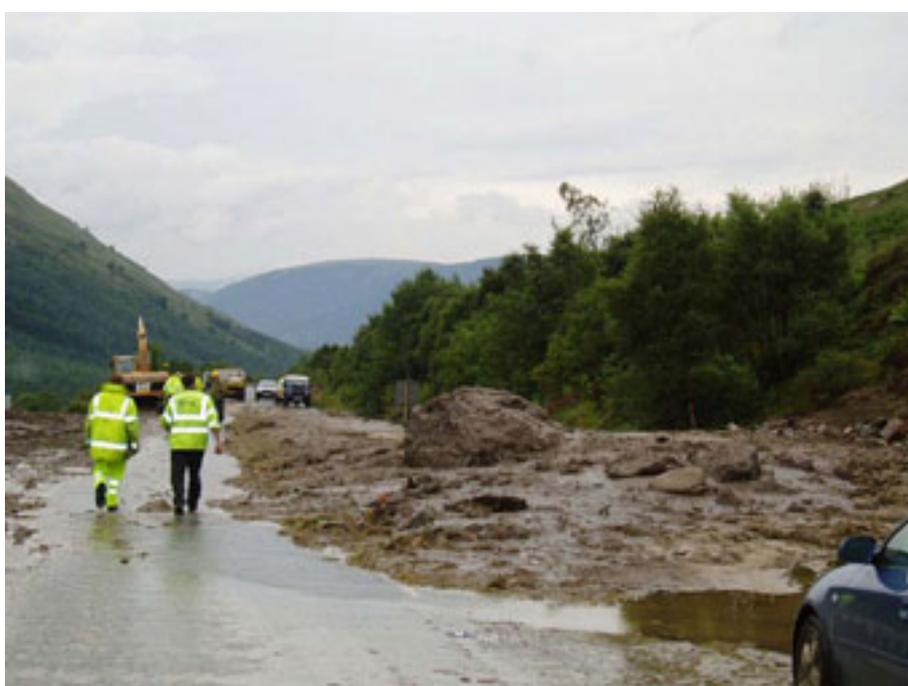
Figure 2.3 – Debris fan containing boulders (estimated up to 9 tonnes) at A83 Cairndow.

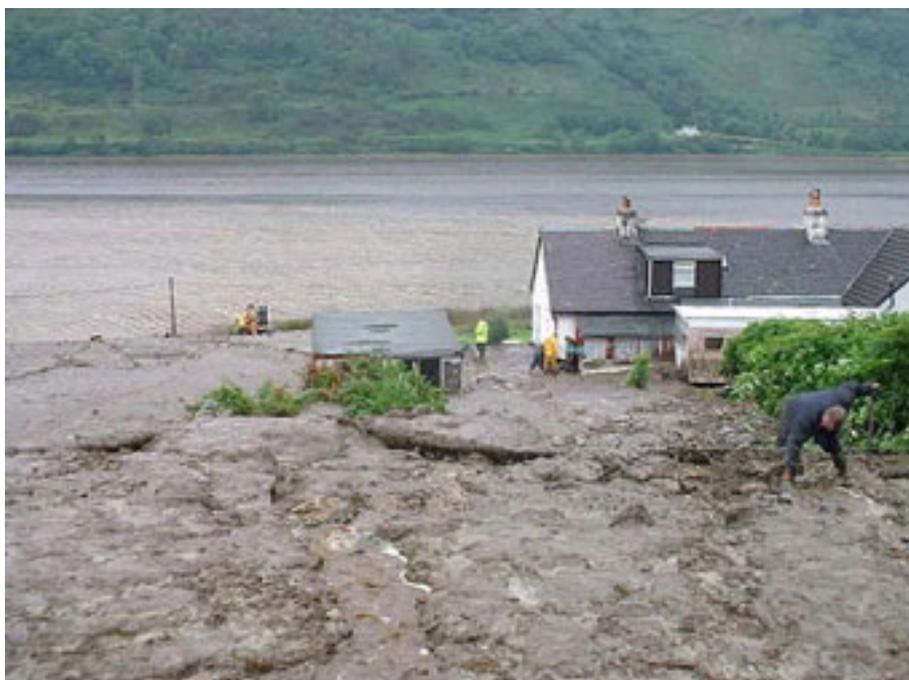
Figure 2.4 – Debris flow above the A83 to the west of Cairndow showing the effects on a roadside cottage and the trunk road immediately downslope from the cottage.

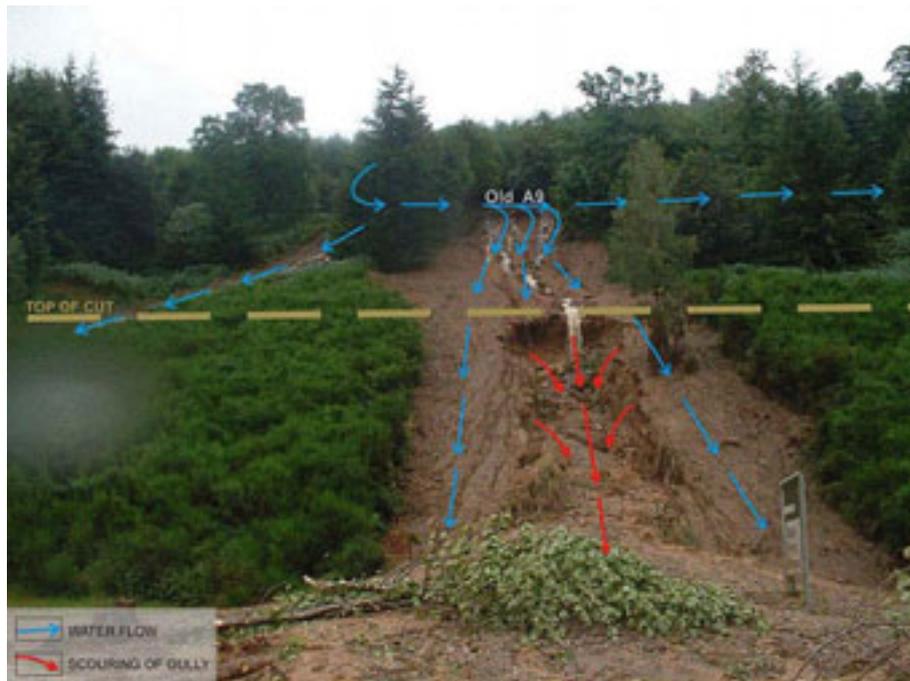
Figure 2.6 – Influence of old road on debris flow at A9 Dunkeld. The central flow is shown and the northern flow can also be seen on the left of the picture. Photograph dated 11 August 2004. (Courtesy of Alan Mackenzie, BEAR.)

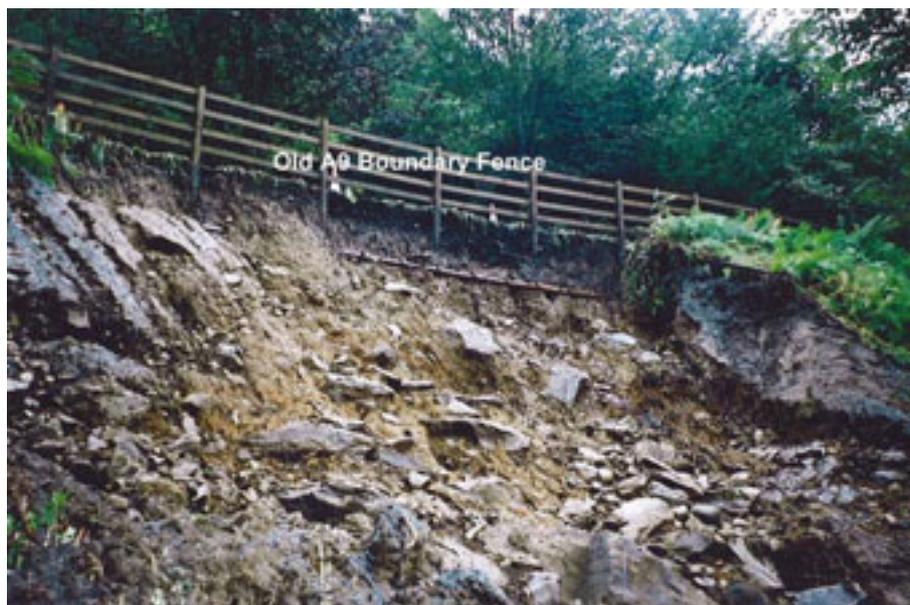
Figure 2.7 – Instability at the downslope edge of the old A9 above the central debris flow. Photograph dated 12 August 2004. (Note that the brown pipe running horizontally across the backscarp is a telecommunications duct.)

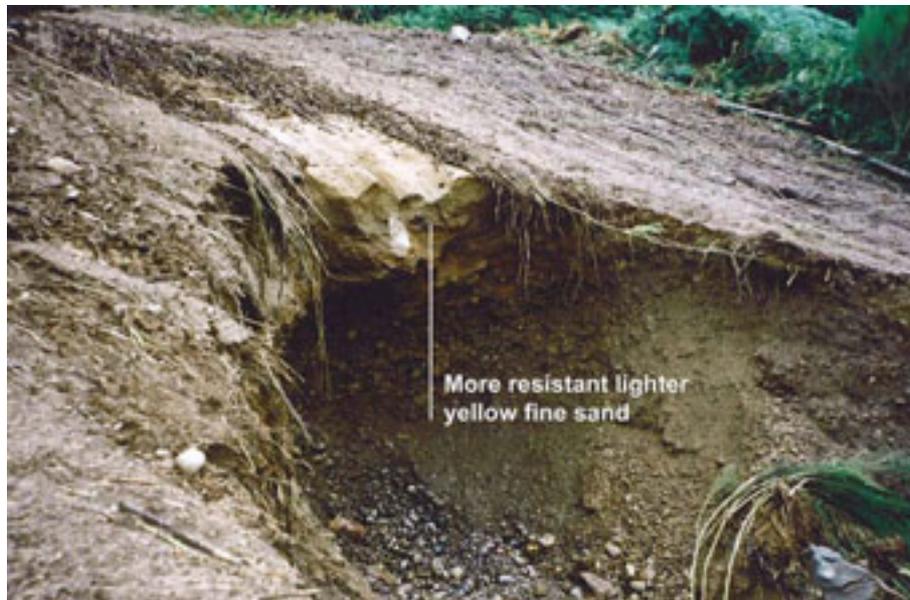
Figure 2.8 – The top of the central erosion gully at the top of the cut slope. The overhang of the denser yellow fine sand is clearly visible and it appeared that this material was better able to shed the water and debris. Photograph dated 12 August 2004.

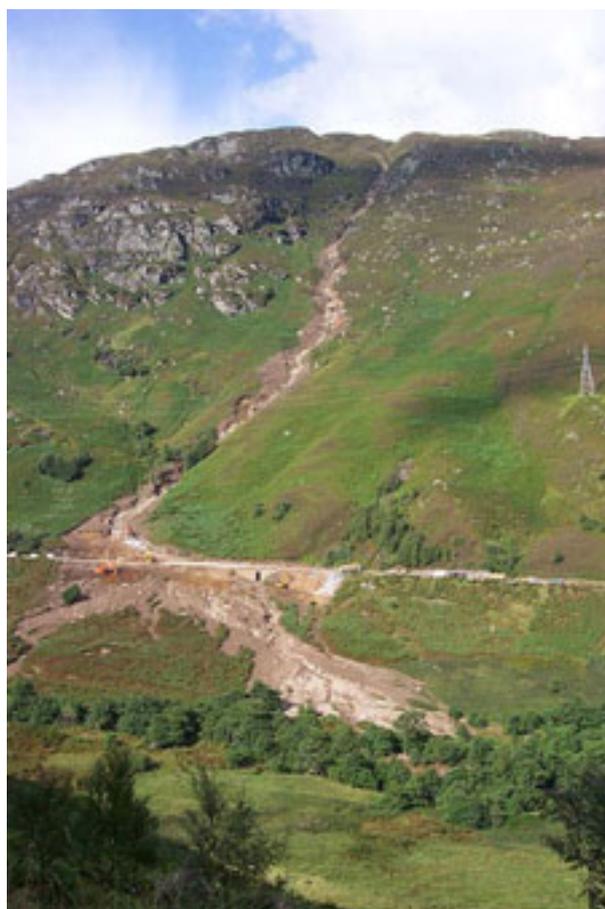
Figure 2.11 – View of the northern A85 Glen Ogle debris flow two days after the event, showing the sharp bend in the channel just above road level.

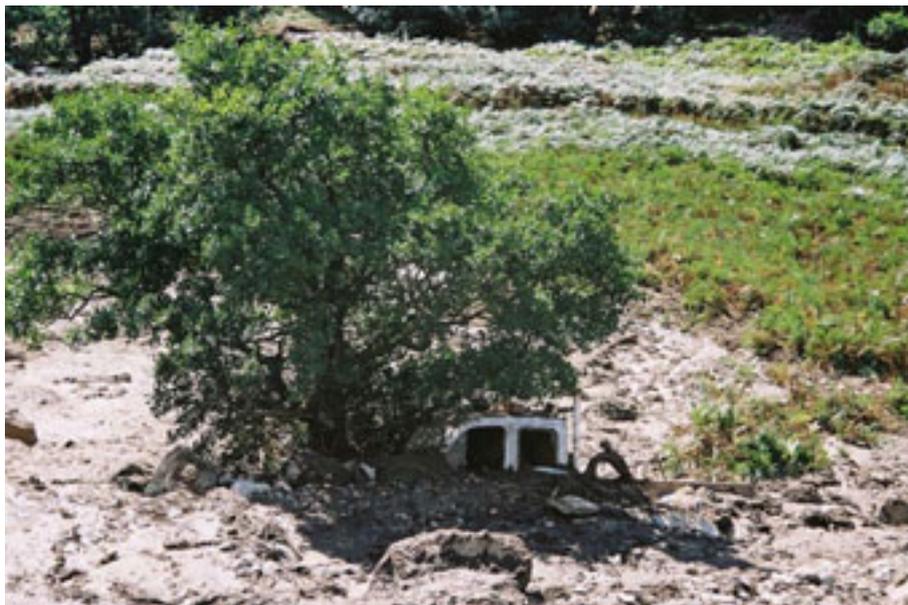
Figure 2.12 – A85 Glen Ogle showing the Trunk Road Operating Company vehicle that was swept away by the northern debris flow.

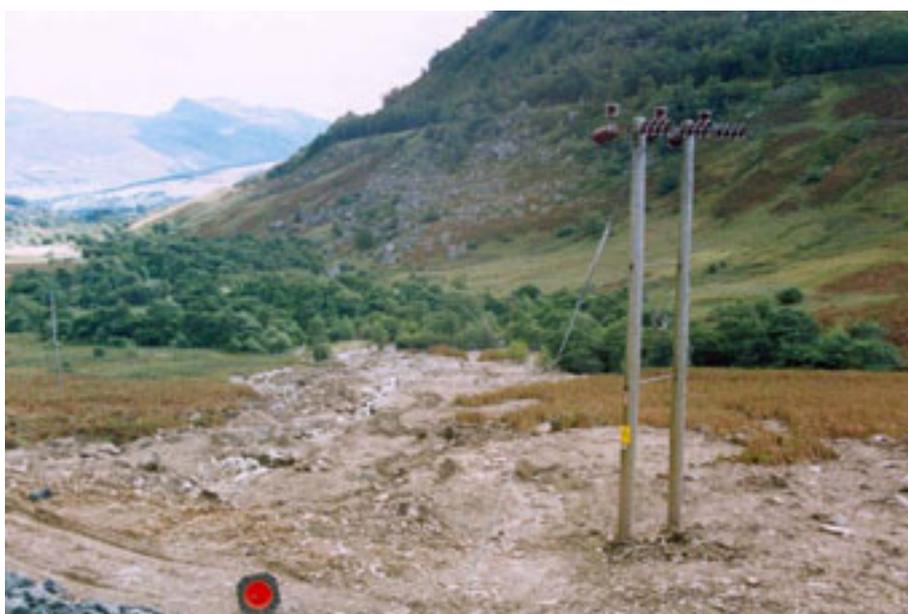
Figure 2.13 – The debris fan formed by the northern debris flow in Glen Ogle viewed from the A85 trunk road, looking towards Glen Ogle Burn and down the valley towards Lochearnhead.

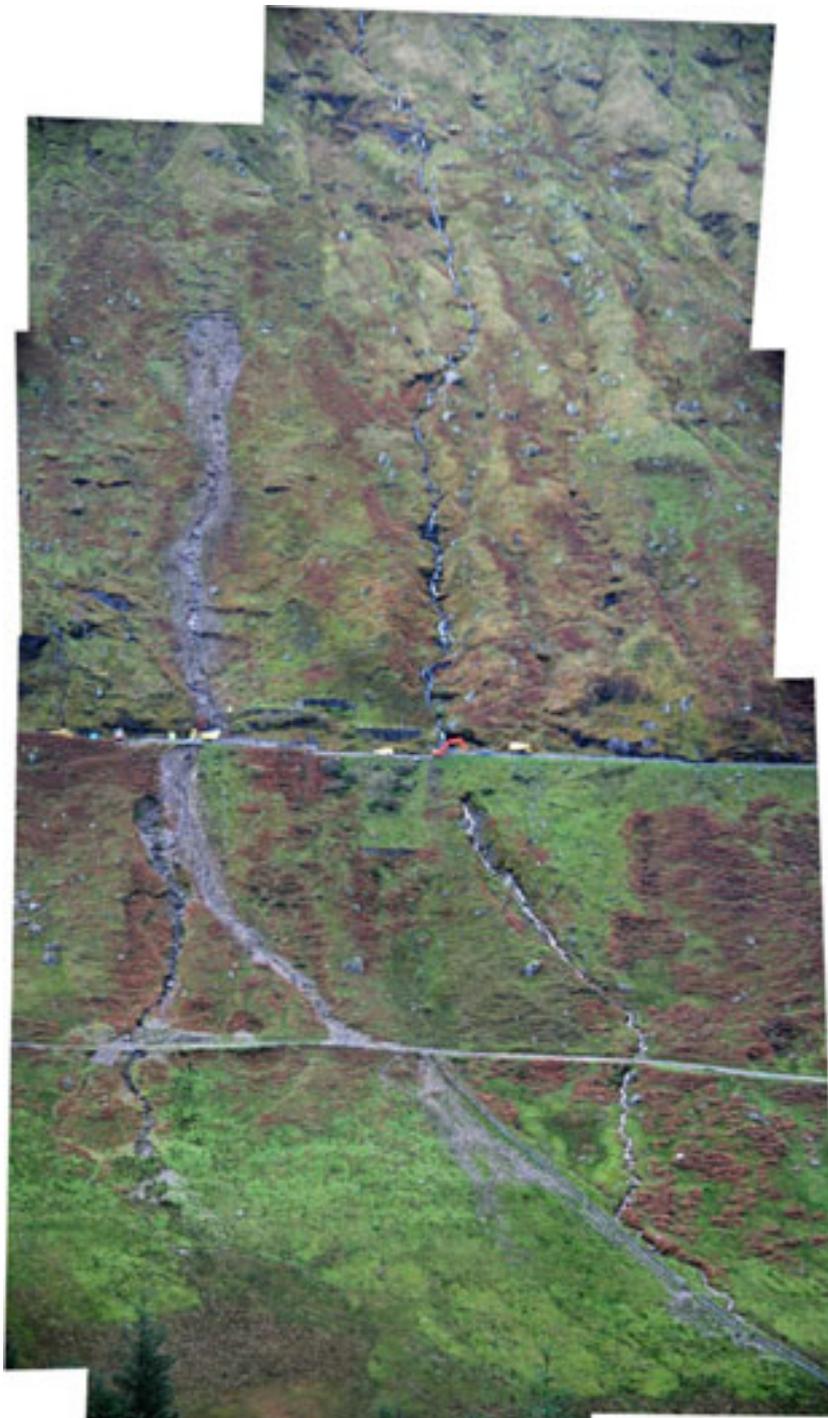
Figure 2.15 – View of the debris flows above and below the A83 on the approach to the Rest and be Thankful (from NGR NN 23160 06559 on the opposite side of Glen Croe). The head scar is at approximately 370m AOD, the A83 at 240m AOD and the old road at 180m AOD.

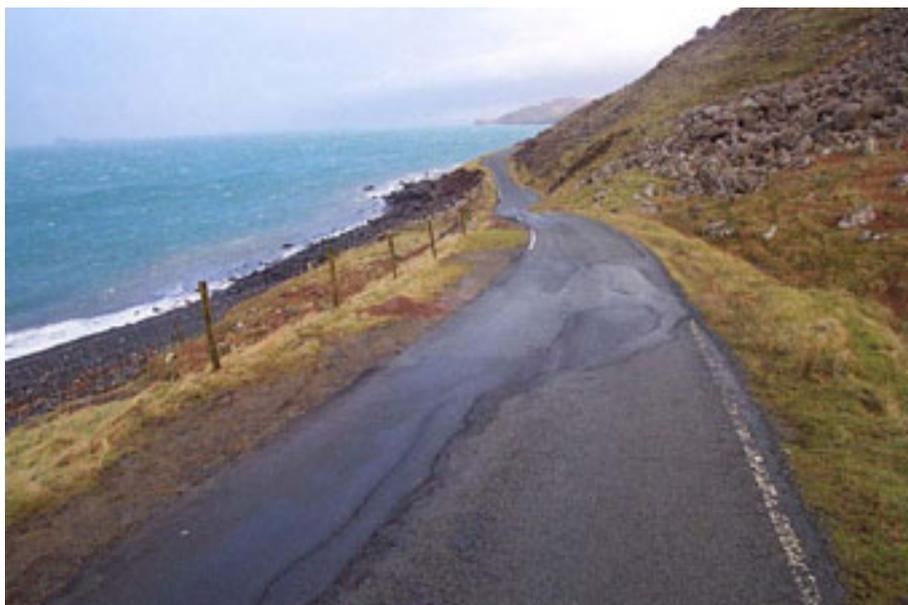
Figure 2.17 – Road at Duntulm, Skye being moved by mass movement of boulder field, accelerated by erosion at toe

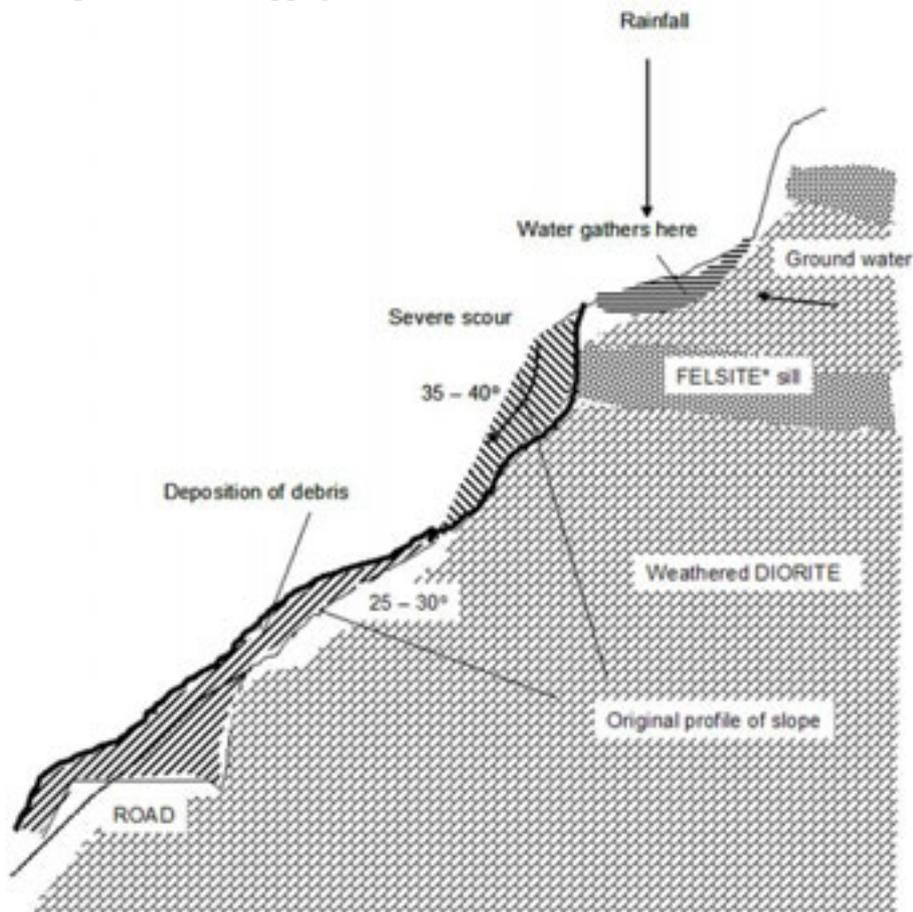
Figure 2.21 – Glenelg Landslip, likely failure mechanism.

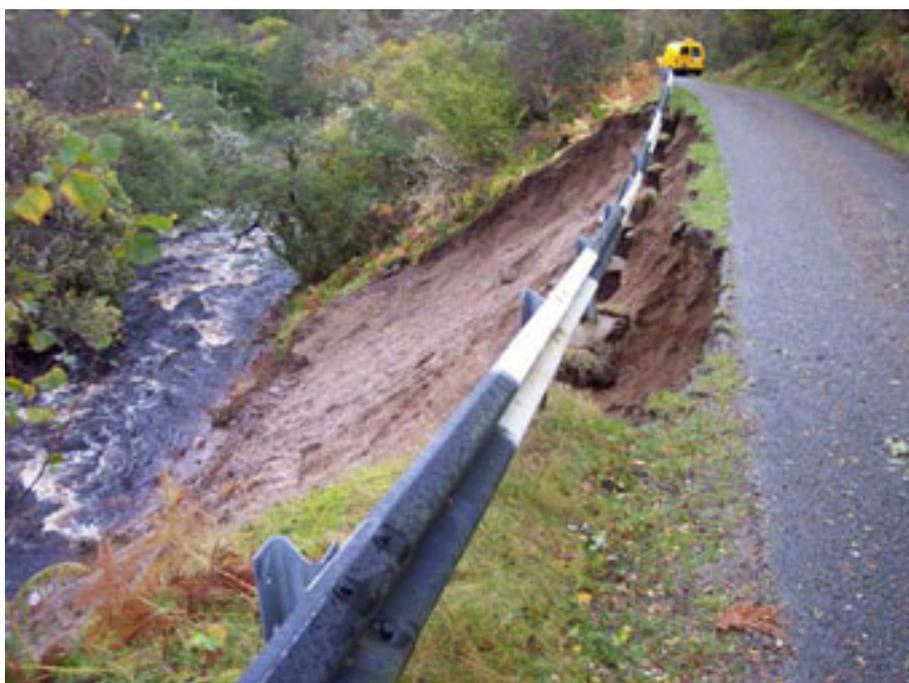
Figure 2.23 – Landslide at Torboll, 26 October 2006.

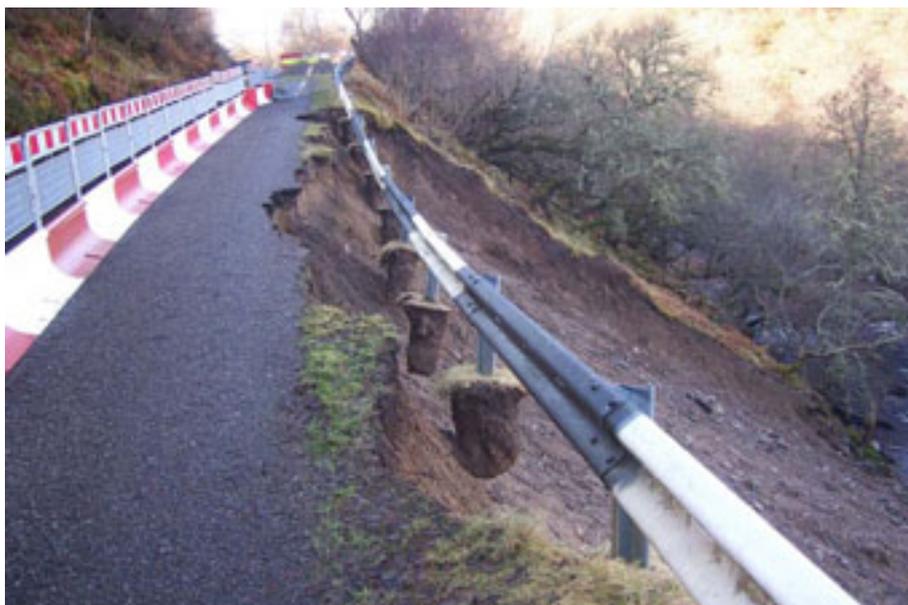
Figure 2.24 – Torboll, showing ongoing erosion, 14 February 2007.

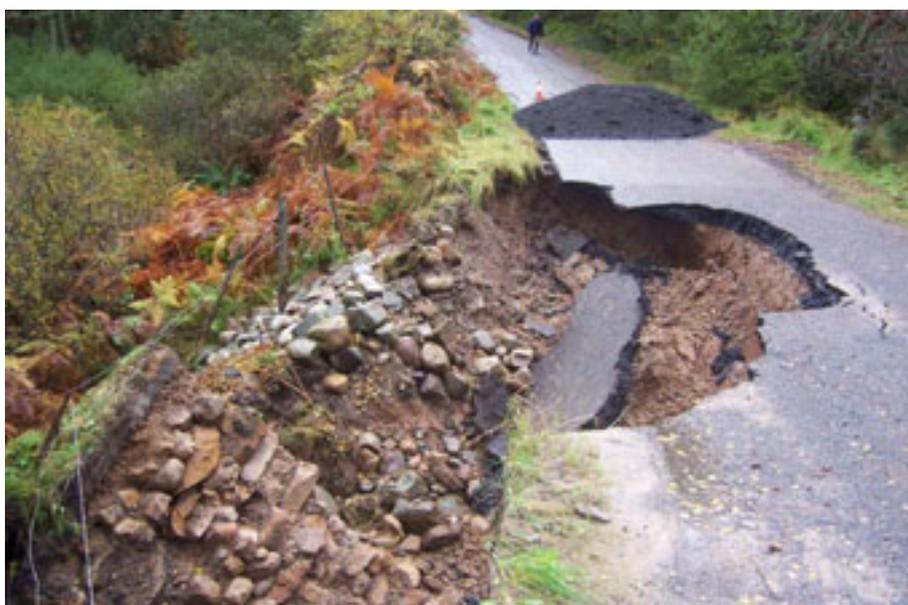
Figure 2.25 – Landslide at Quebec Bridge, October 2006.

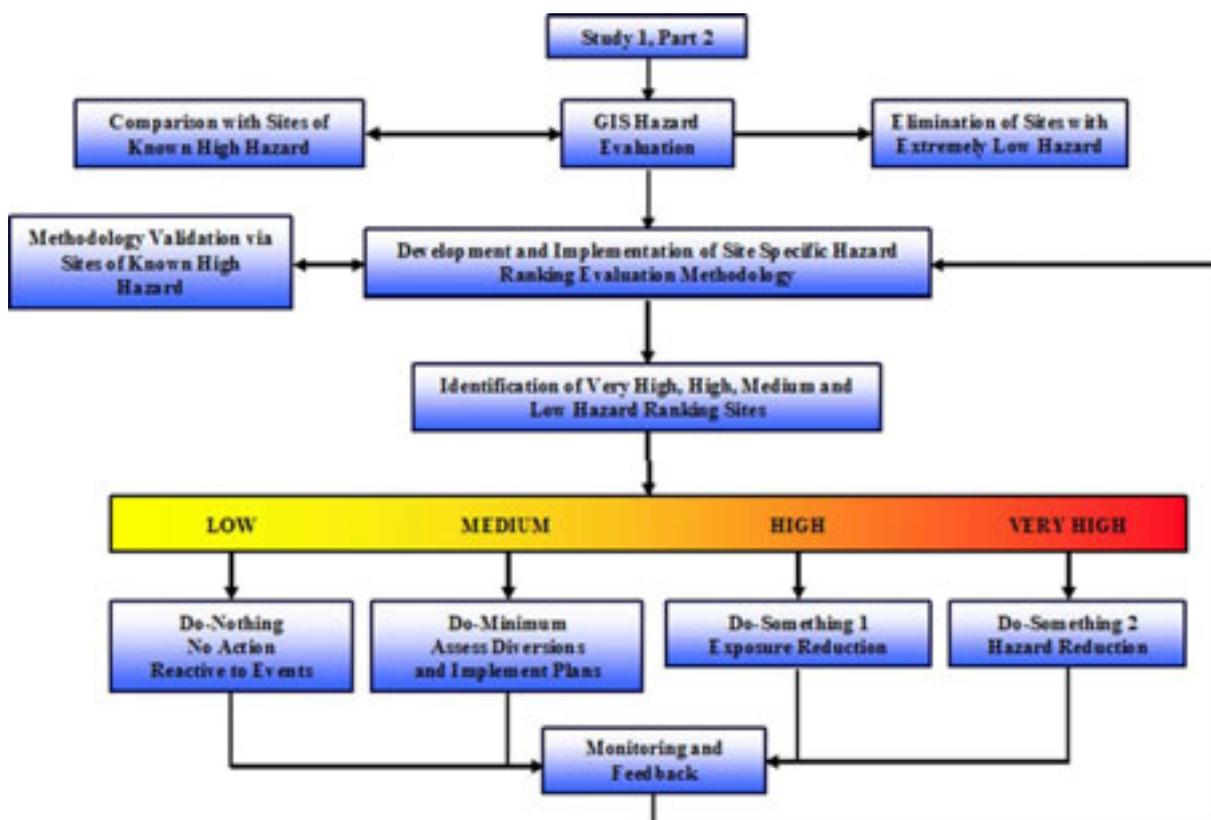
Figure 3.1 – Outline flowchart of the current study.

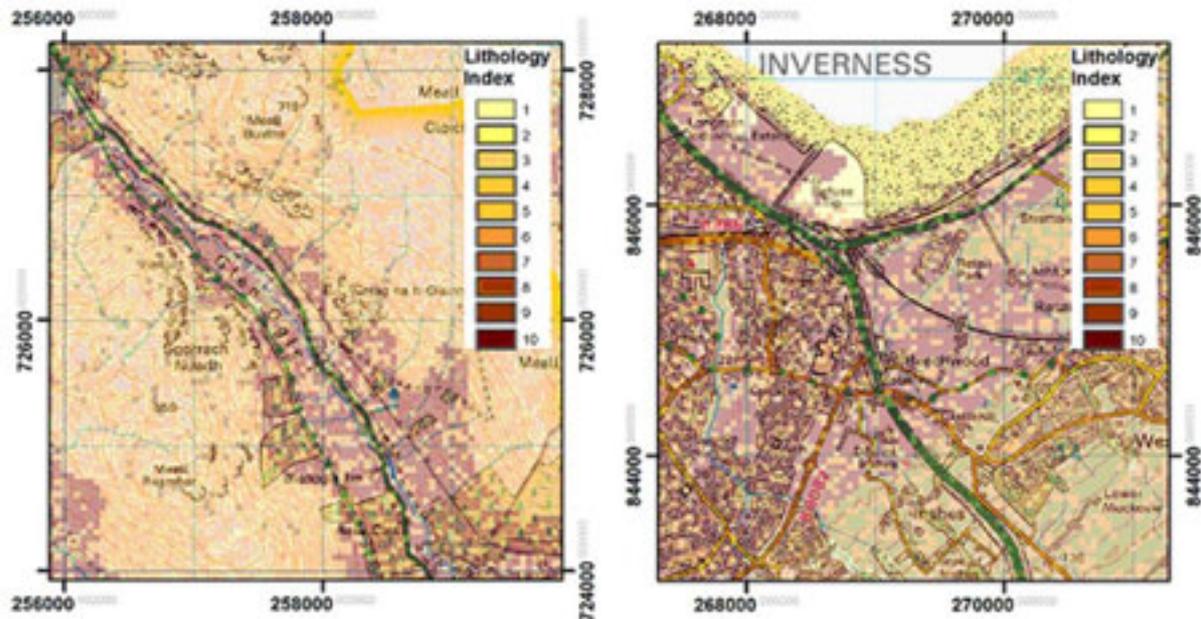
Figure 4.5 – Availability of debris material. Excerpts from the GIS showing the variation in availability of debris material scoring for two areas; (left) Glen Ogle and (right) Inverness. The legend in the diagram refers to this as lithology index, reflecting the scoring of the source material. (OS Data © Crown Copyright. All rights reserved Scottish Government 100020540, 2008.)

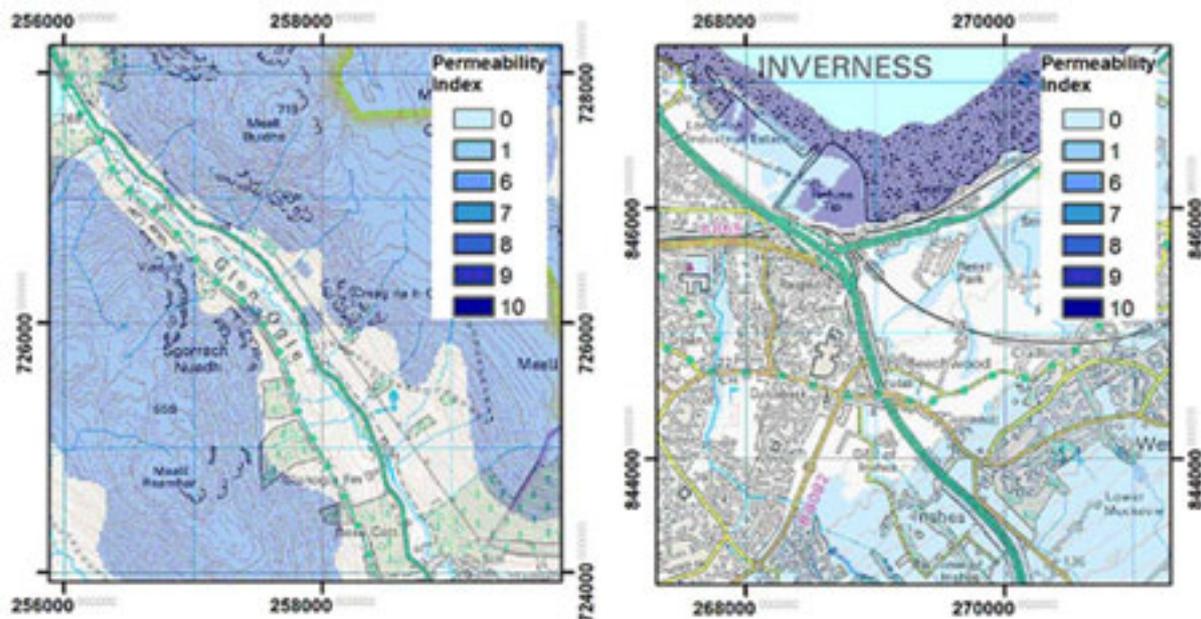
Figure 4.6 – Excerpts from the GIS showing the variation in water conditions (permeability) for two areas; (left) Glen Ogle and (right) Inverness. (OS Data © Crown Copyright. All rights reserved Scottish Government 100020540, 2008.)

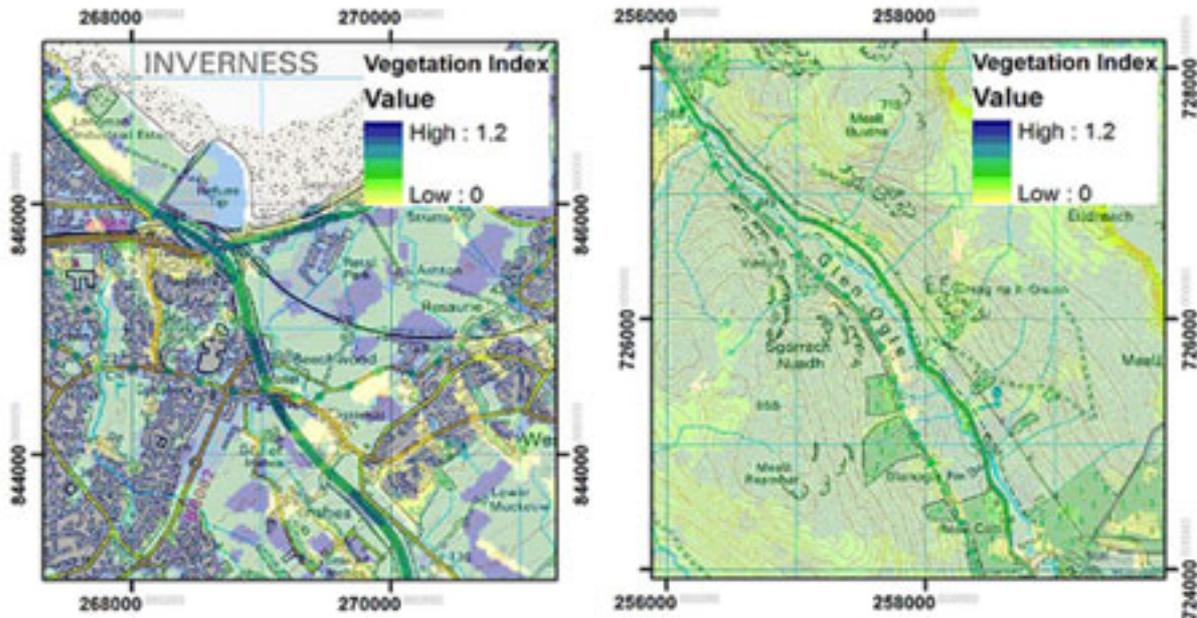
Figure 4.7 – Excerpts from the GIS showing the variation in Vegetation conditions from satellite data for two areas; (left) Glen Ogle and (right) Inverness. (OS Data © Crown Copyright. All rights reserved Scottish Government 100020540, 2008.)

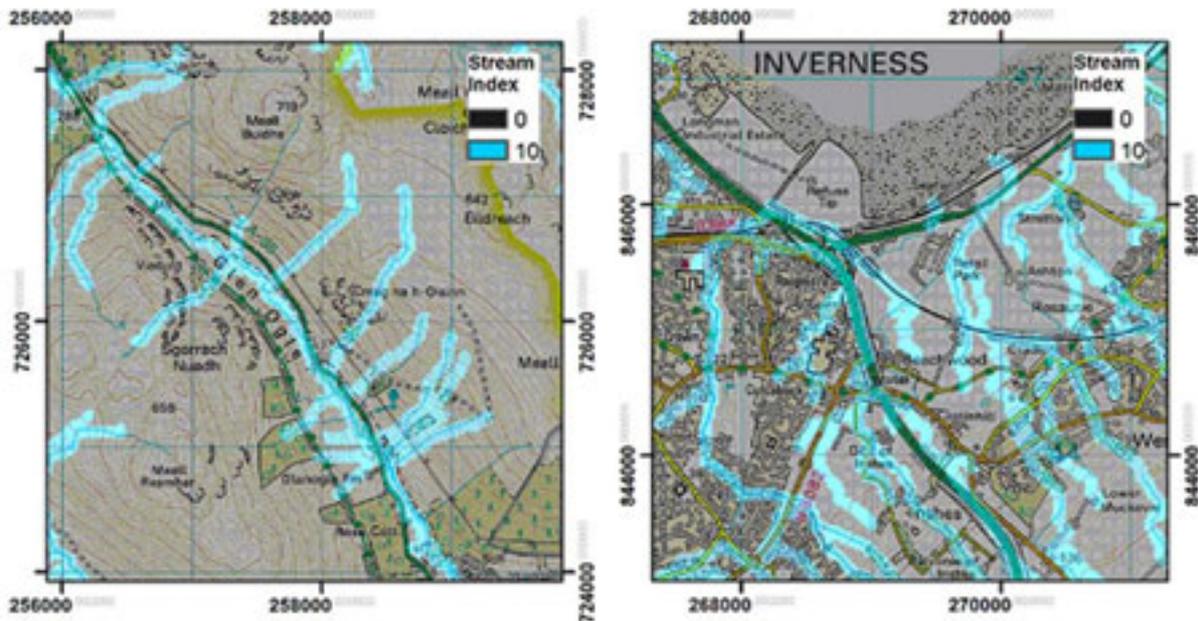
Figure 4.9 – Excerpts from the GIS showing the processed stream data as extracted from the Digital Terrain Model for two areas; (left) Glen Ogle and (right) Inverness. (OS Data © Crown Copyright. All rights reserved Scottish Government 100020540, 2008.)

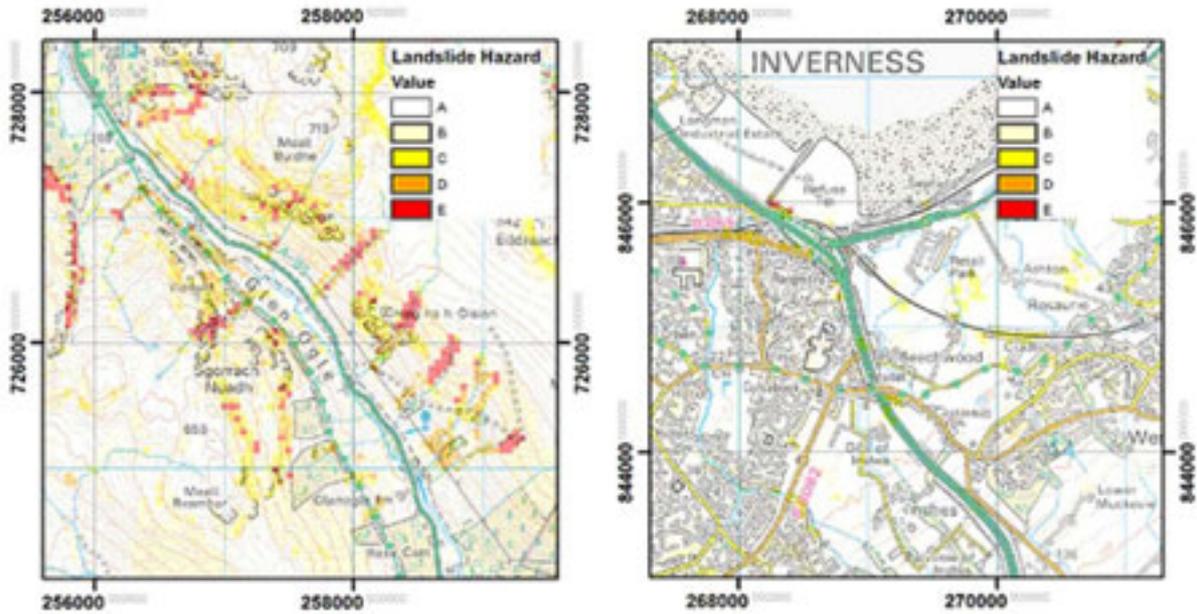
Figure 4.11 – Excerpts from the GIS showing the landslide hazard assessment for two areas: (left) Glen Ogle and (right) Inverness. (OS Data © Crown Copyright. All rights reserved Scottish Government 100020540, 2008.)

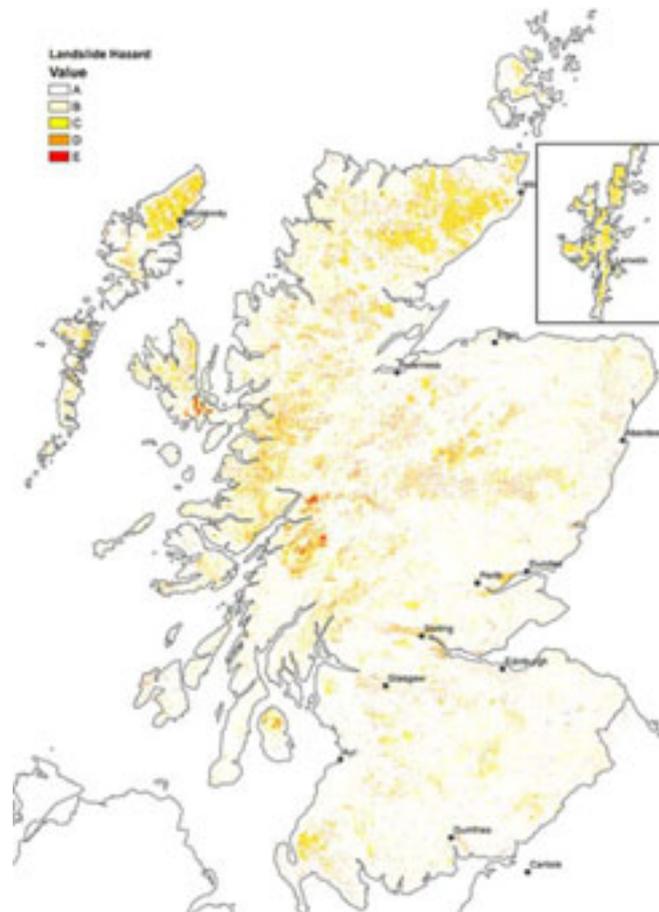
Figure 4.12 – Indicative 1:2,000,000 debris flow hazard across Scotland. For more detail please refer to the digital data available separately. (Note that as reproduced herein the map is not to scale.)

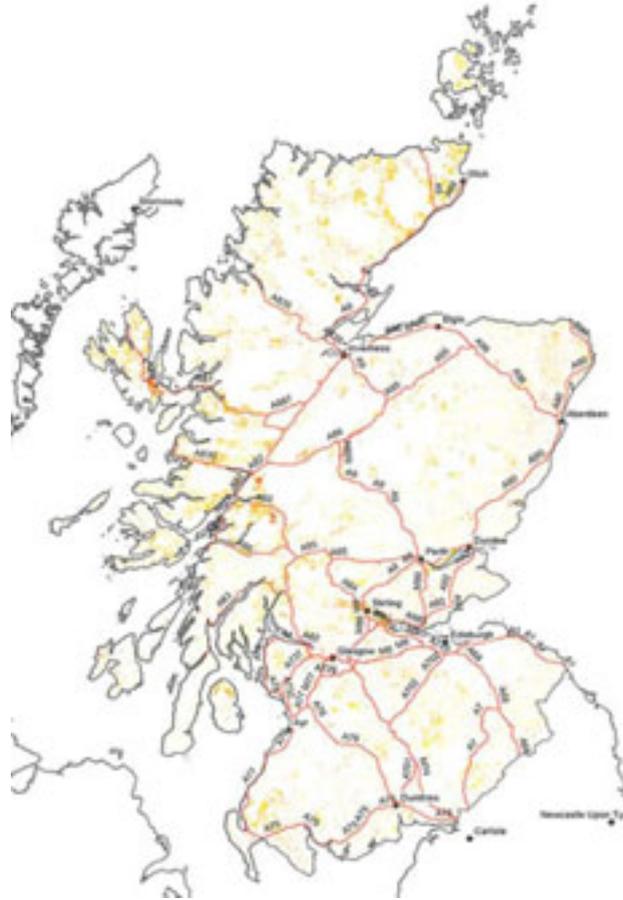
Figure 4.13 – Indicative 1:2,000,000 debris flow hazard across Scotland showing the Trunk Road Network. For more detail please refer to the digital data available separately. (Note that as reproduced herein the map is not to scale.)

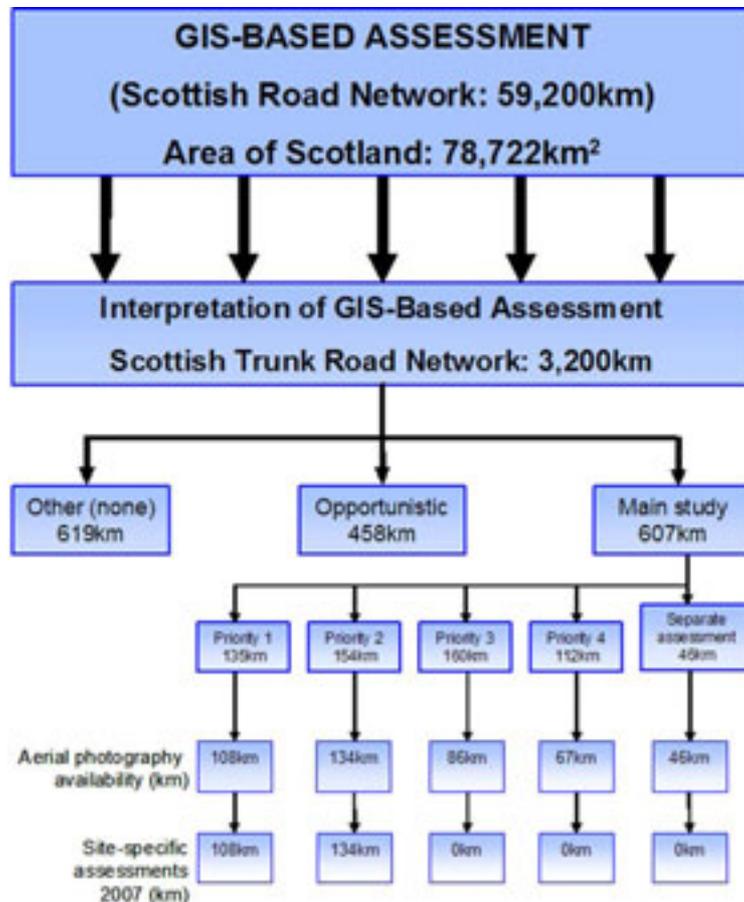
Figure 5.4 – Diagram illustrating the process by which the GIS-based assessment and its subsequent interpretation ‘home-in’ upon sites of high hazard.

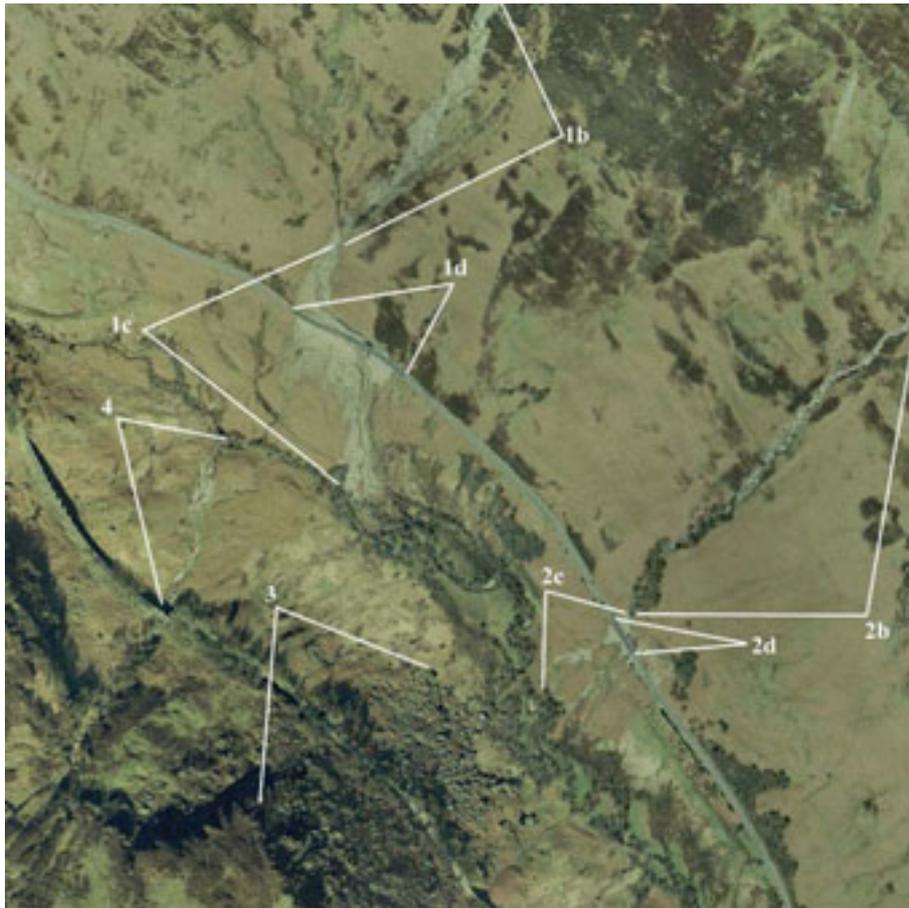
Figure 6.1 – Aerial photograph showing the northerly (N) and southerly (S) debris flows that occurred in Glen Ogle in August 2004 with key features marked. The photograph represents a 1km by 1km square; north is to the top.

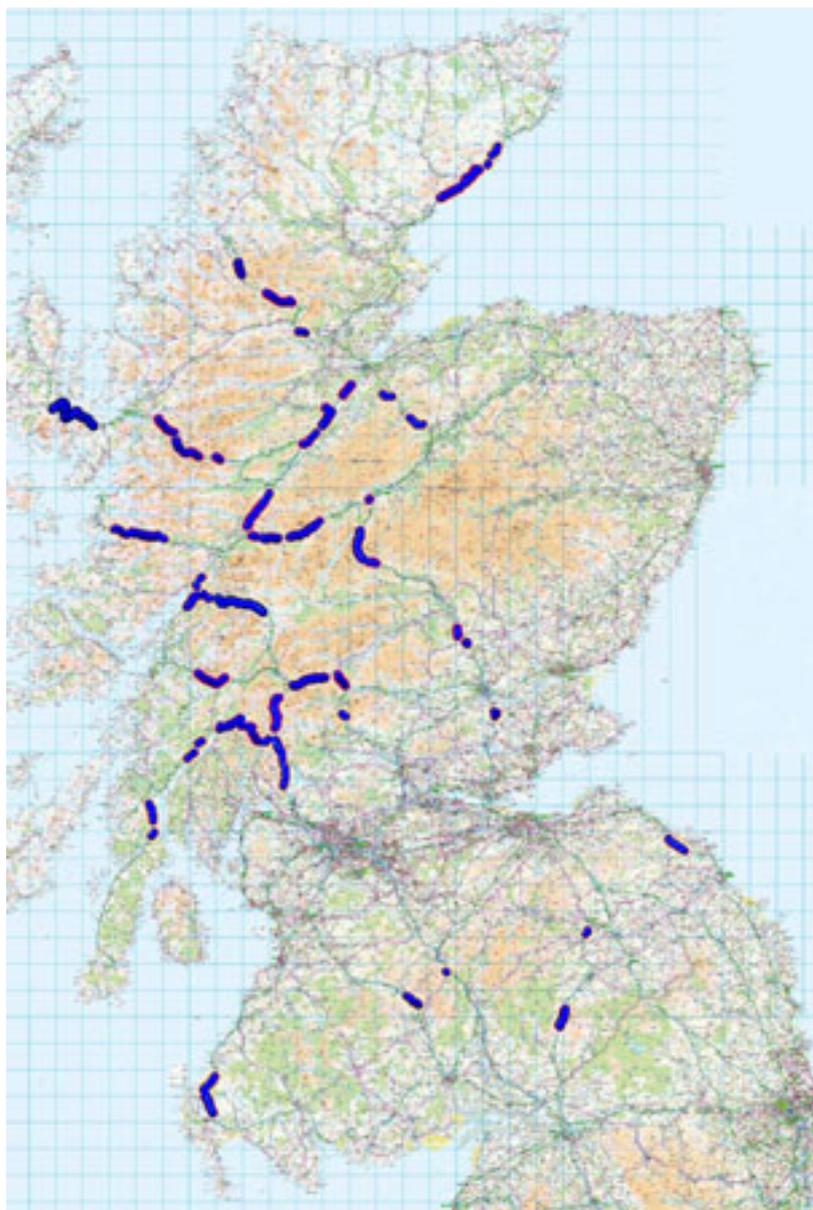
Figure 7.1 – Sites with a hazard ranking score of 100 or greater. (© Crown Copyright. All rights reserved Scottish Government 100020540, 2008.)

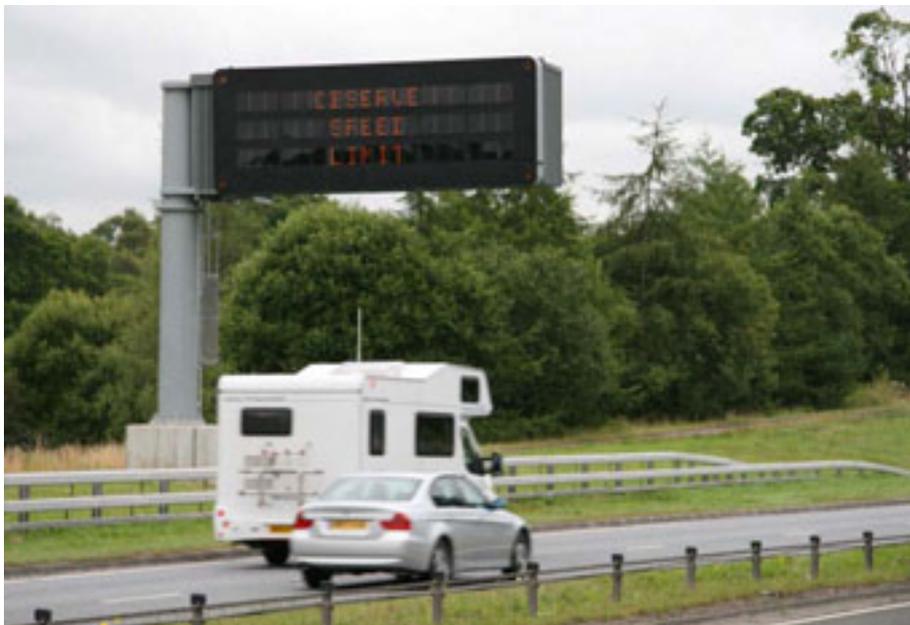
Figure 8.3 – A variable message sign located on the A9. The network of such signs in Scotland is being significantly increased and will form a crucial part of the strategy for warning road users of hazards including landslides.

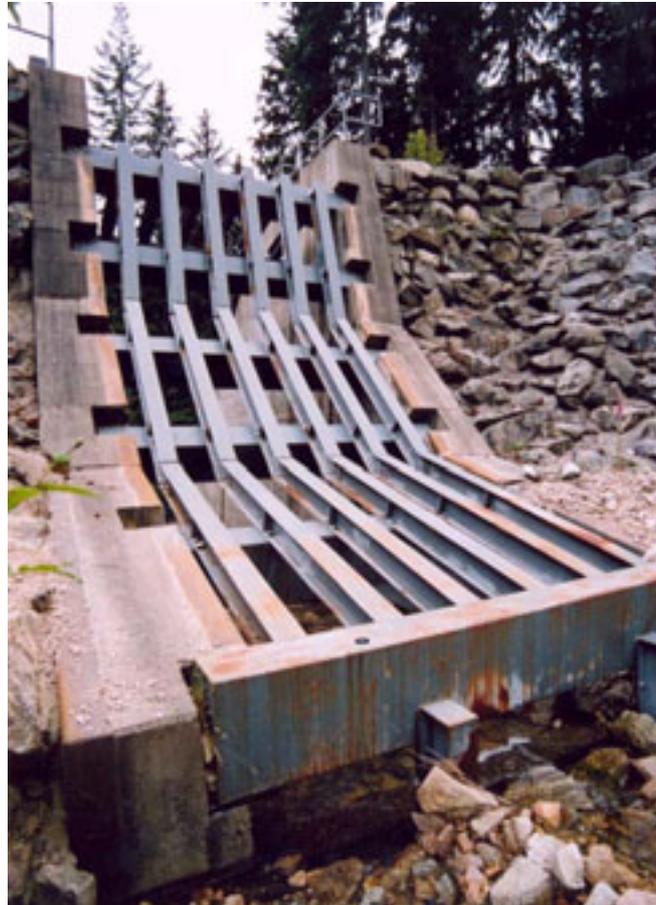
Figure 8.11 – Downstream drainage outlet of debris basin, Mackay Creek, North Vancouver, British Columbia, Canada. The black disc visible on the base of the structure is 72mm in diameter.

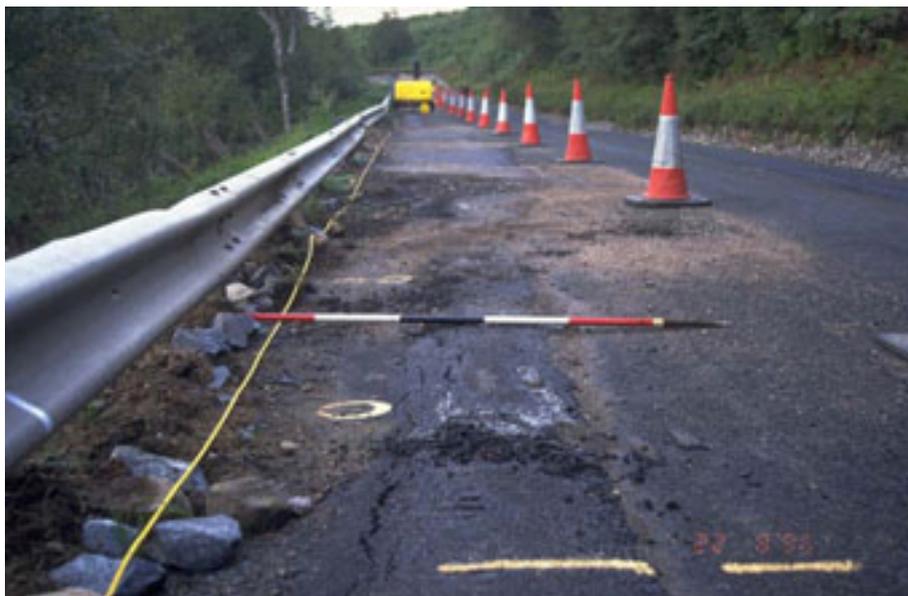
Figure 8.23 – Deformation of the A86 carriageway alongside Loch Laggan due to a series of minor landslides.

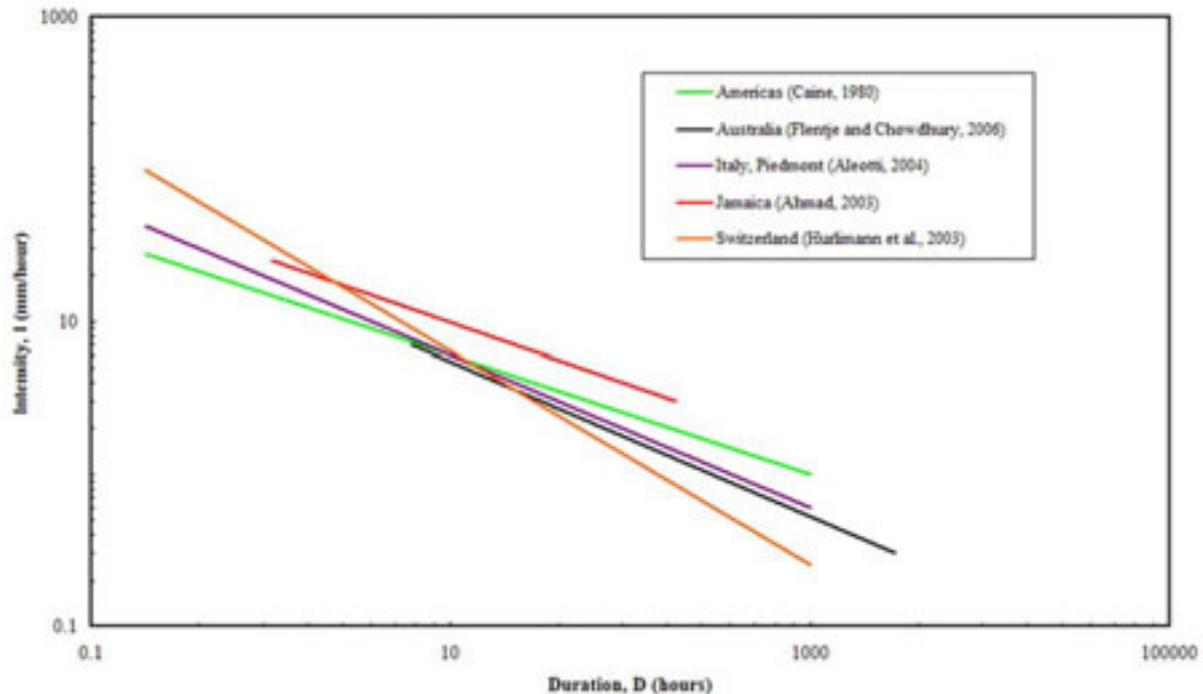
Figure 9.3 – Comparison of landslide trigger thresholds based on rainfall intensity-duration for different parts of the world.

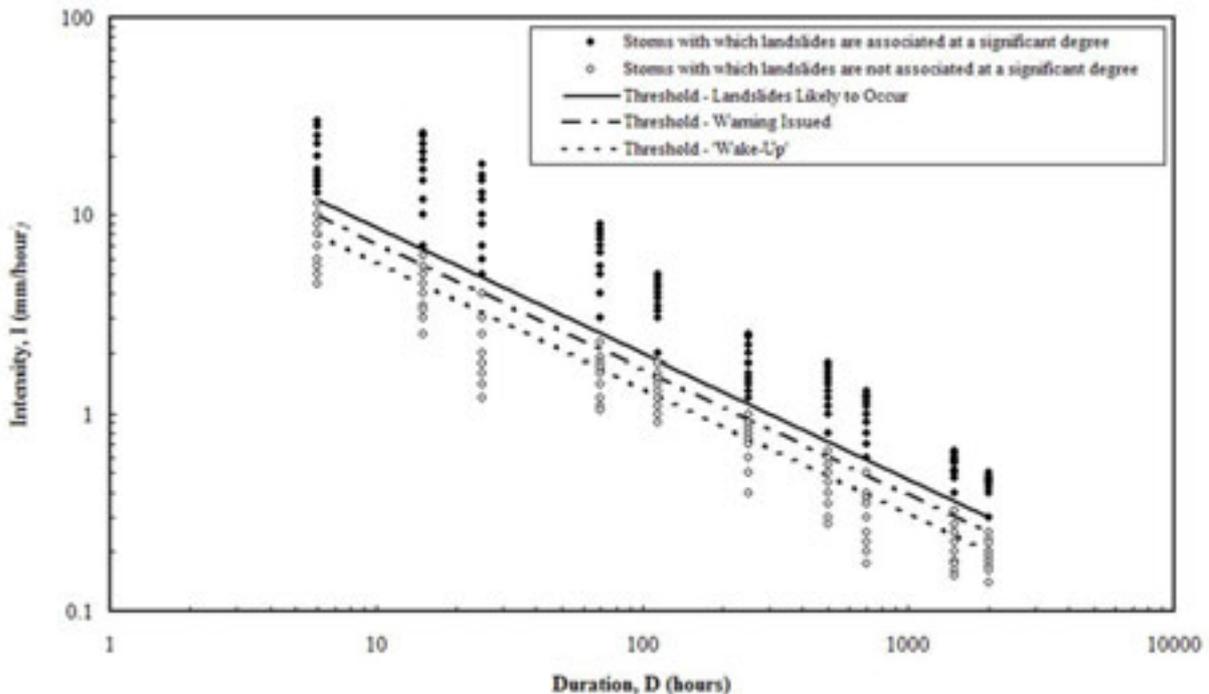
Figure 9.4 – Development of a purely hypothetical rainfall intensity-duration threshold for landslides.
