SCOTTISH ROAD NETWORK LANDSLIDES STUDY: IMPLEMENTATION

M G Winter (Transport Research Laboratory),
F Macgregor (Consultant to Transport Scotland) and
L Shackman (Transport Scotland)

Published by Transport Scotland, October 2008

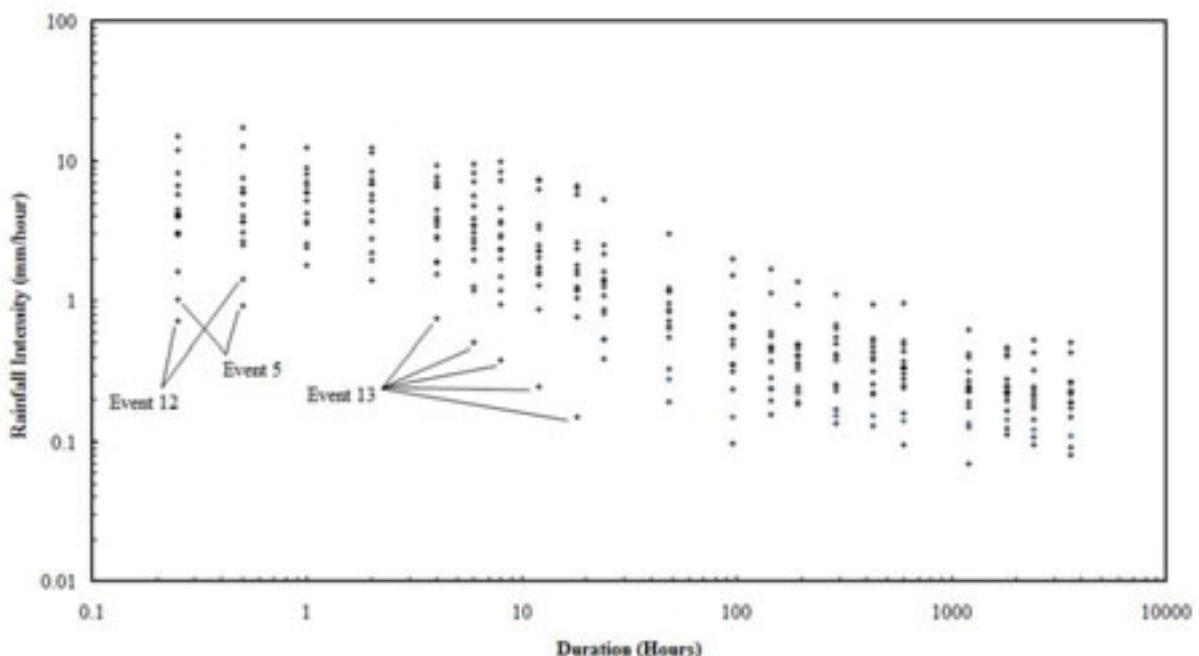
Figure 9.6 – Combined plot of intensity versus duration data for the 16 analysed debris flow events.

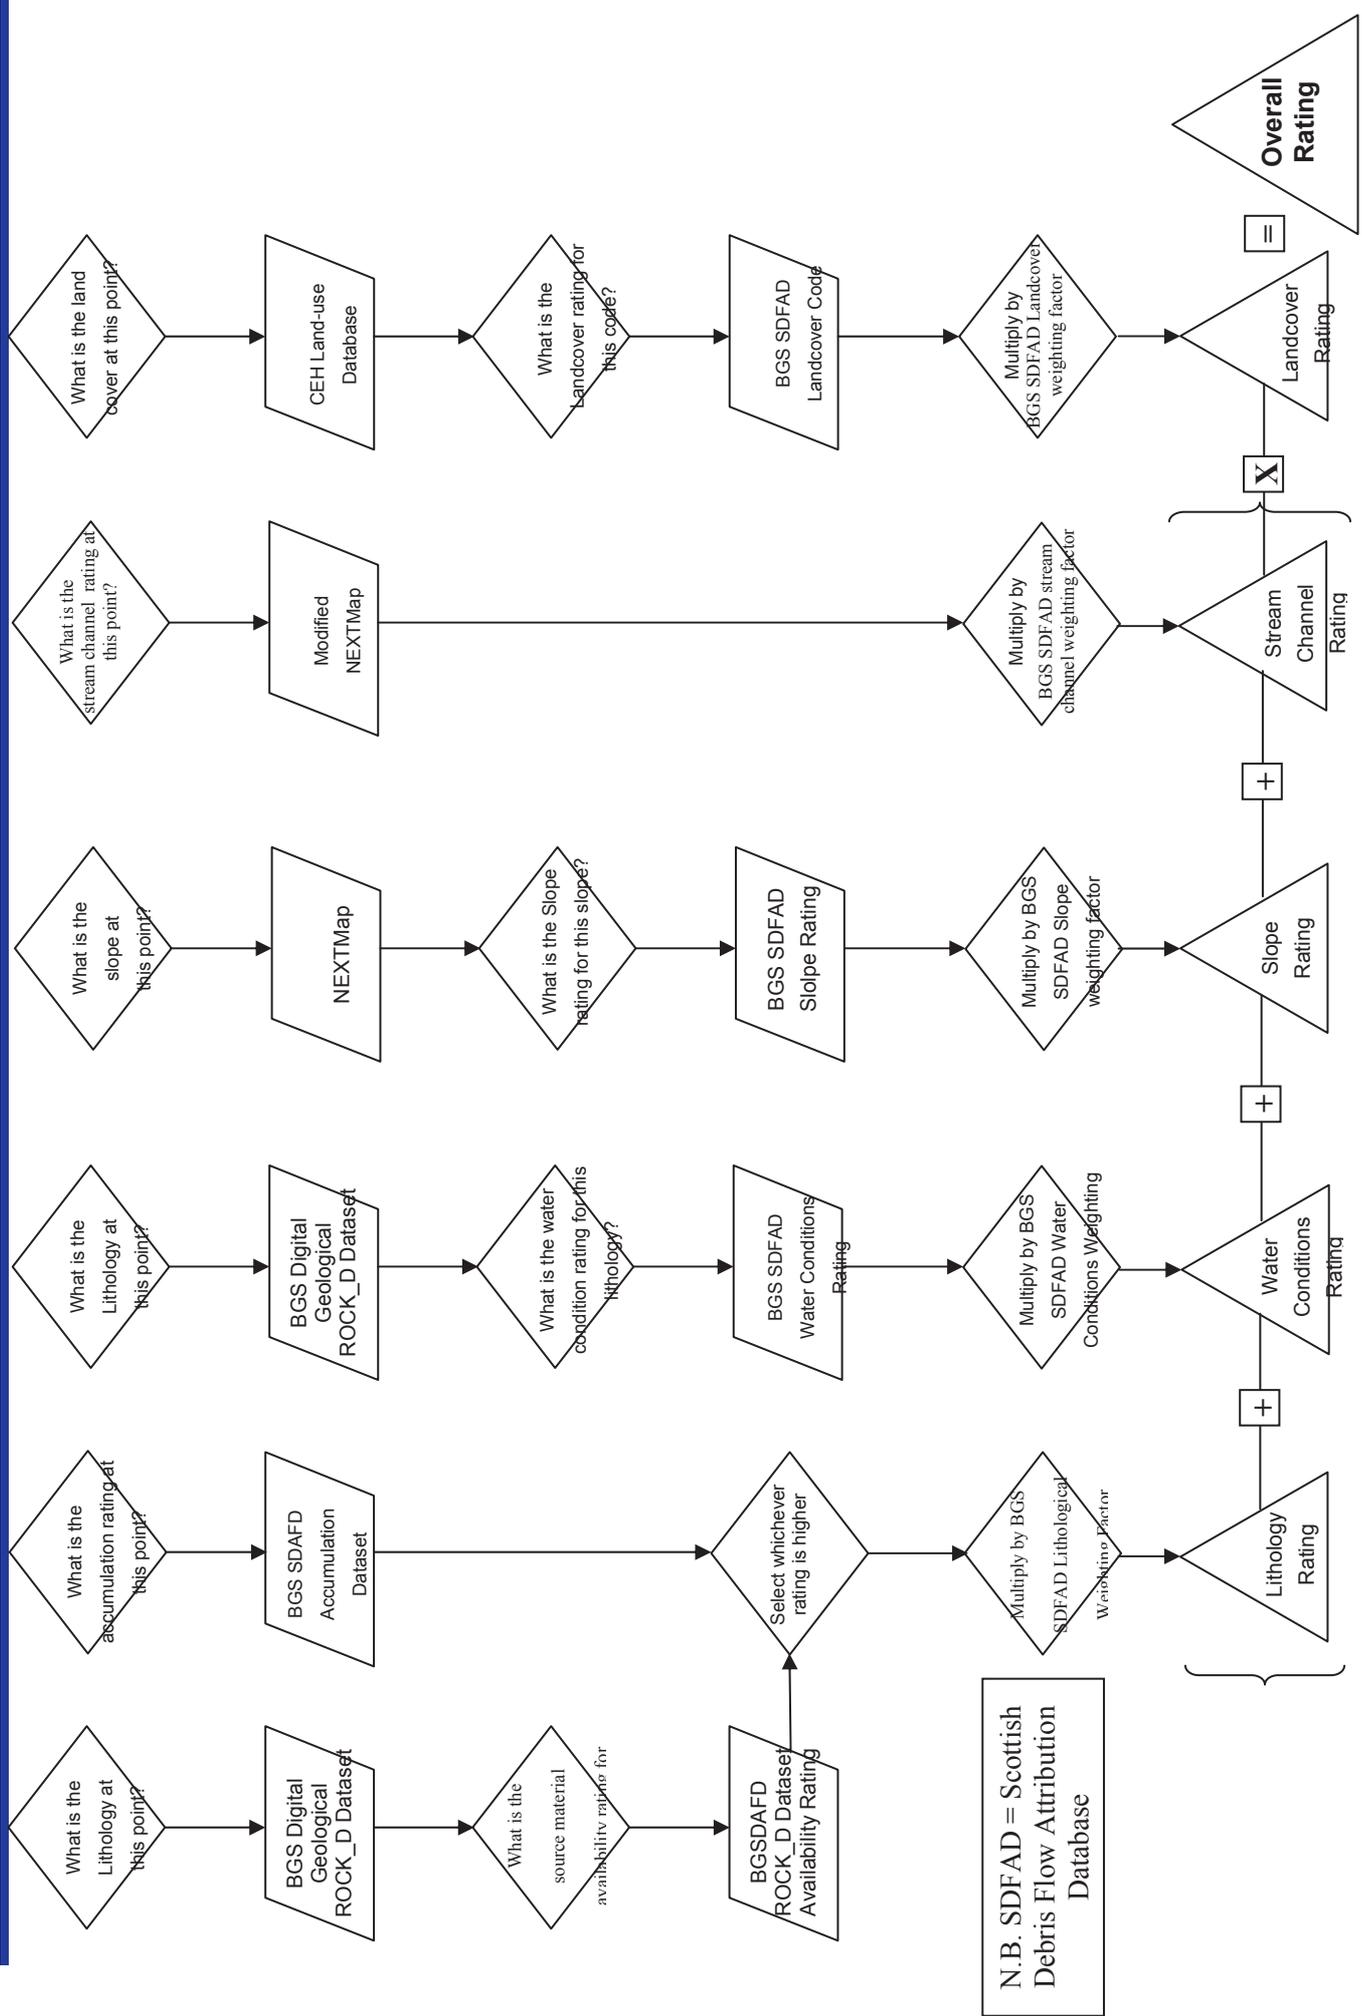
Figure A.1 - Methodology Flowchart.

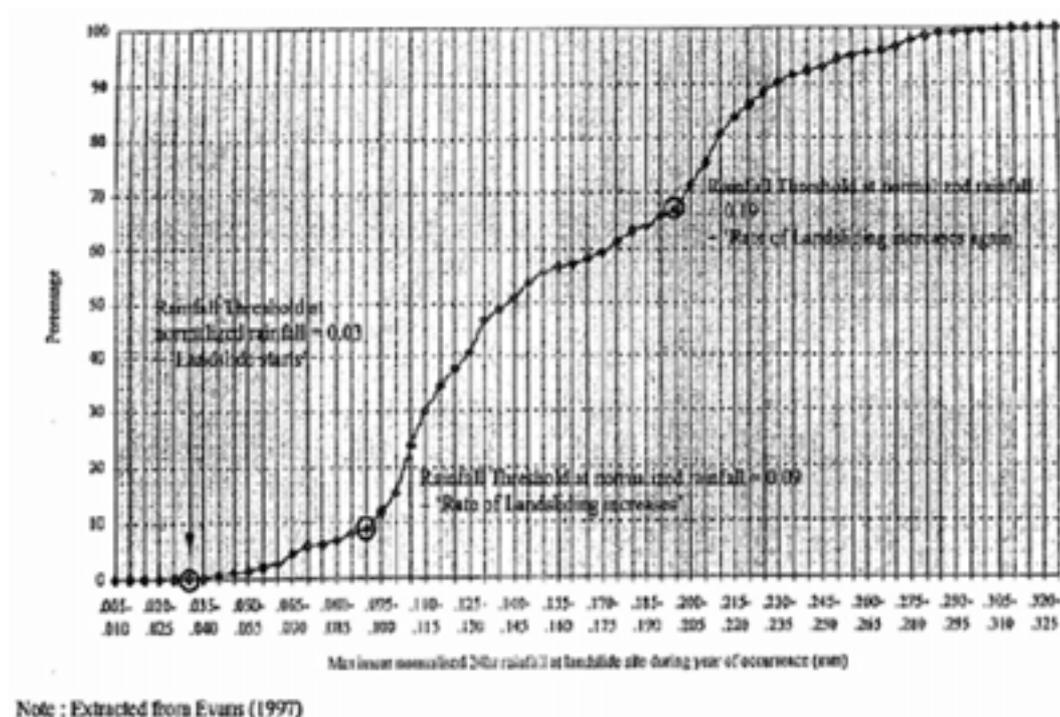
Figure G.5 – Cumulative percentage of natural terrain landslides against normalised maximum rolling 24-hour rainfall (1985 to 1994).

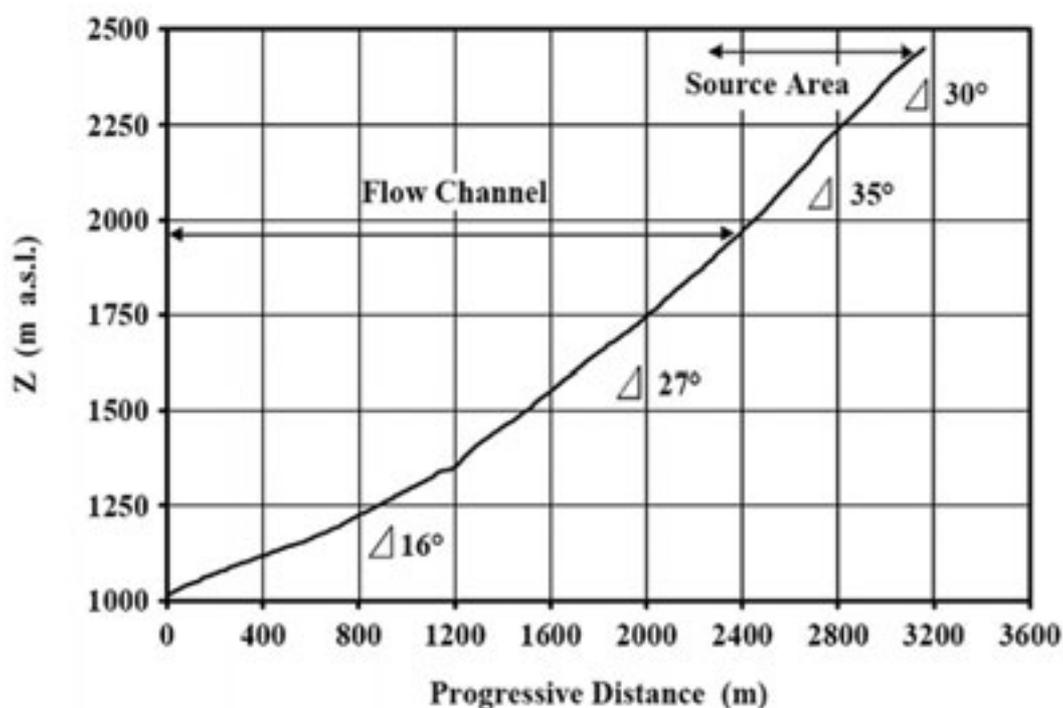
Figure G.12 – Longitudinal profile of a flow channel, the upper part of the source area and mean slope angles in the different sectors (from Bacchini and Zannoni, 2002).

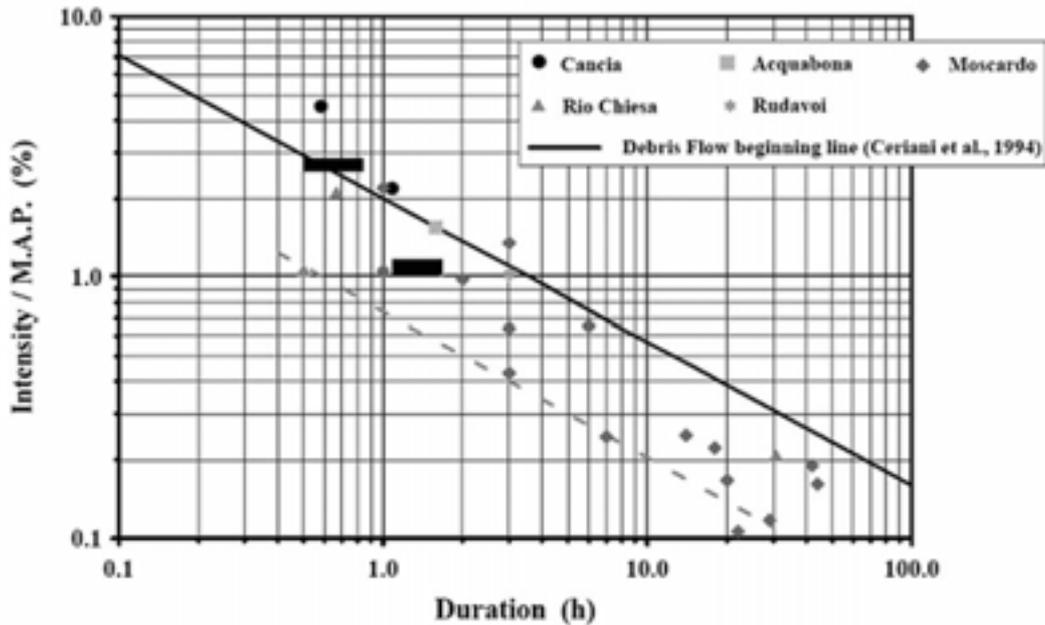
Figure G.13 – Normalised rainfall intensity (intensity/MAP) versus duration and debris flow correlation. The dashed line shows the debris flow threshold proposed for the study area (from Bacchini and Zannoni, 2002).

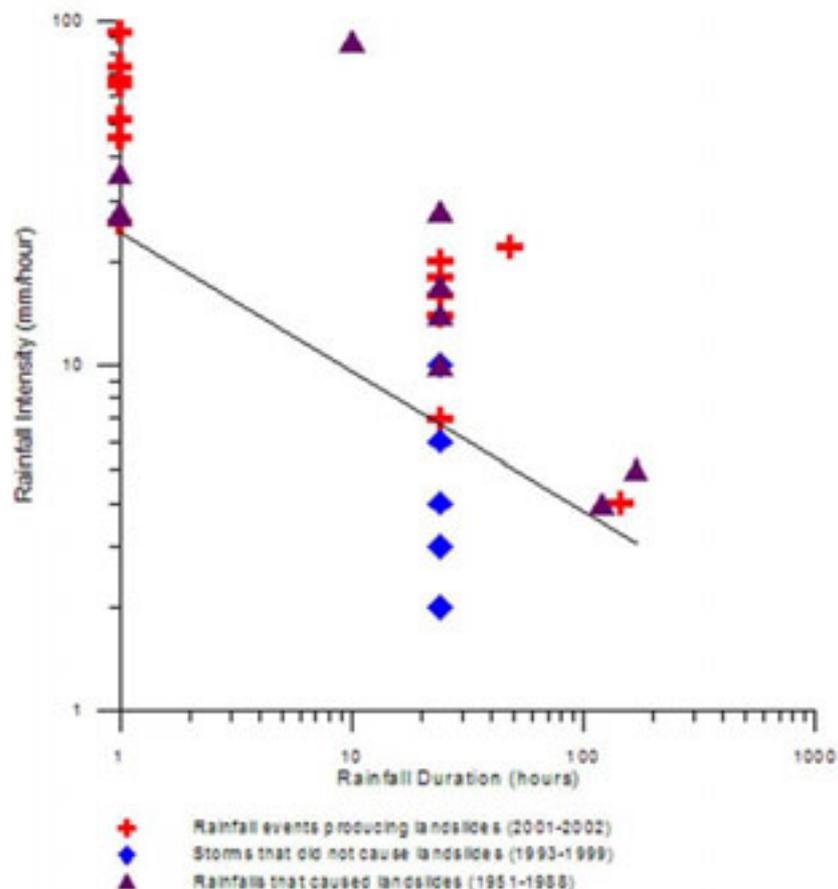
Figure G.14 – Rainfall intensity-duration threshold for shallow landslides in eastern Jamaica, using data from 19 storms between 1951 and 2002 (from Ahmad, 2003).

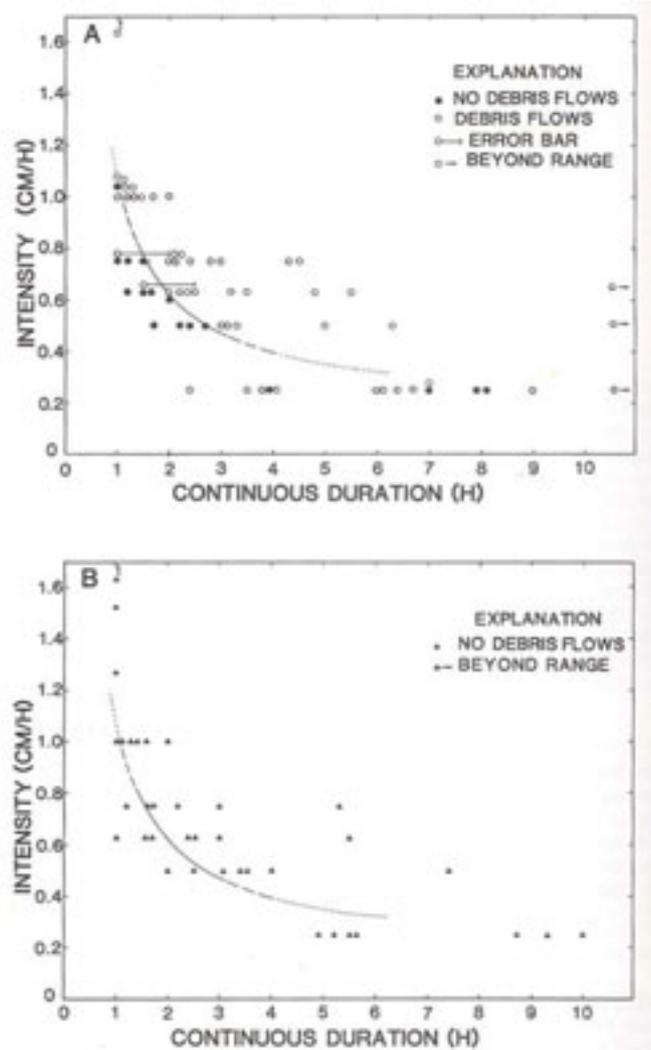
Figure G.25 – Intensity-duration data for storms in the Santa Cruz Mountains in California: (a) data for storms following 28cm of antecedent rainfall; (b) data for storms that did not follow 28cm of antecedent rainfall (from Wieczorek, 1987).

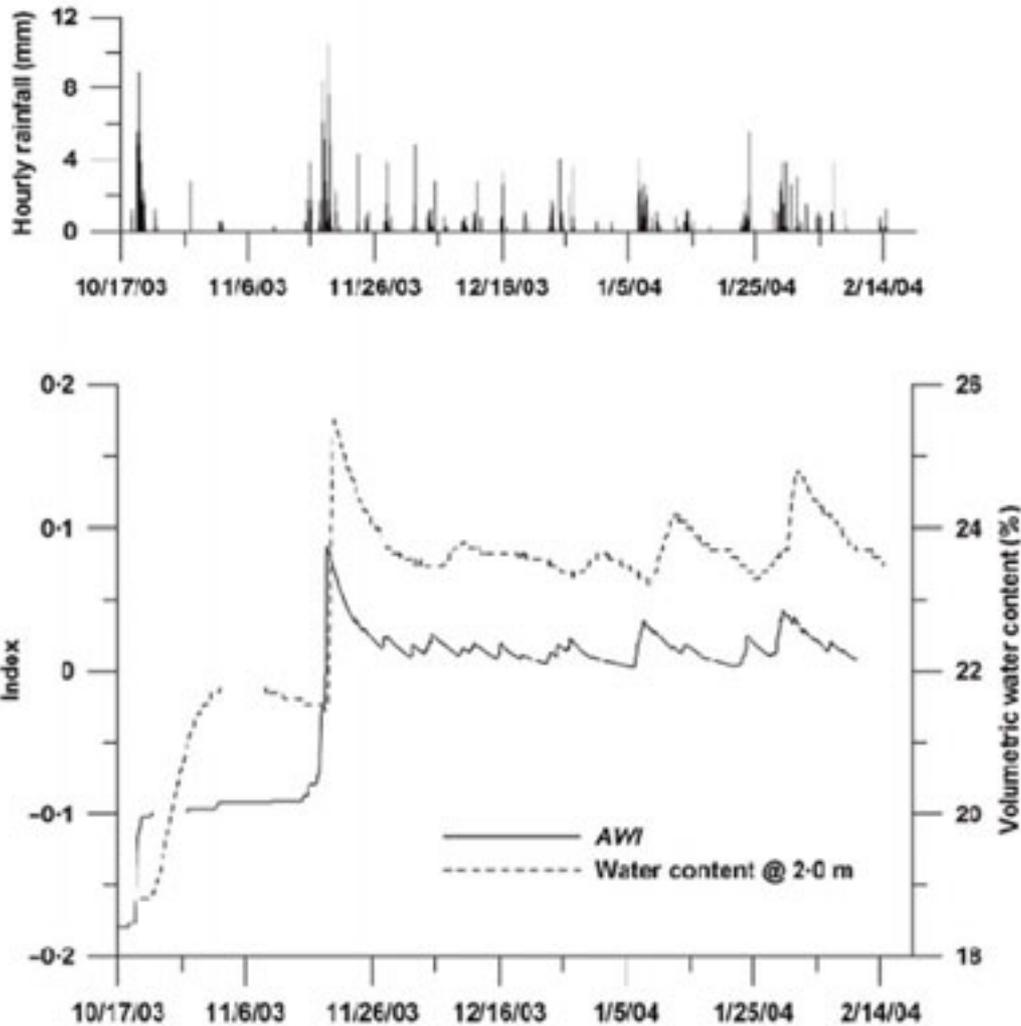
Figure G.26 – Rainfall, volumetric water content, and the Antecedent Water Index (AWI) for the Edmonds field site for the period 17 October 2003 to 14 February 2004 (from Godt *et al.*, 2005).

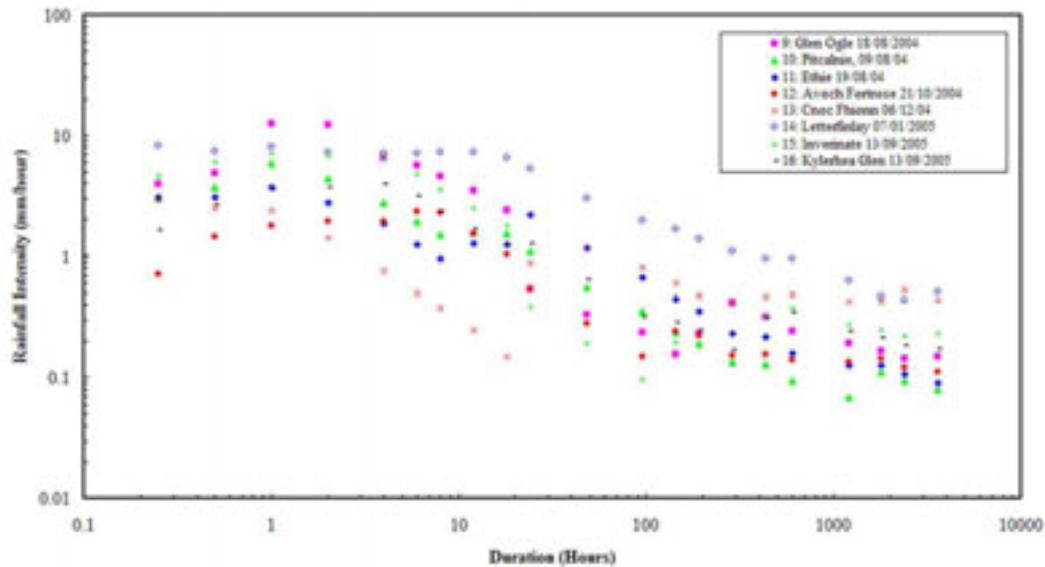
Figure H.7 – Combined plot of intensity versus duration for events 9 to 16.
