## APPENDIX 8.1

### WATER FEATURES SURVEY

## **A82 Crianlarich Bypass**

### **WATER FEATURES SURVEY**

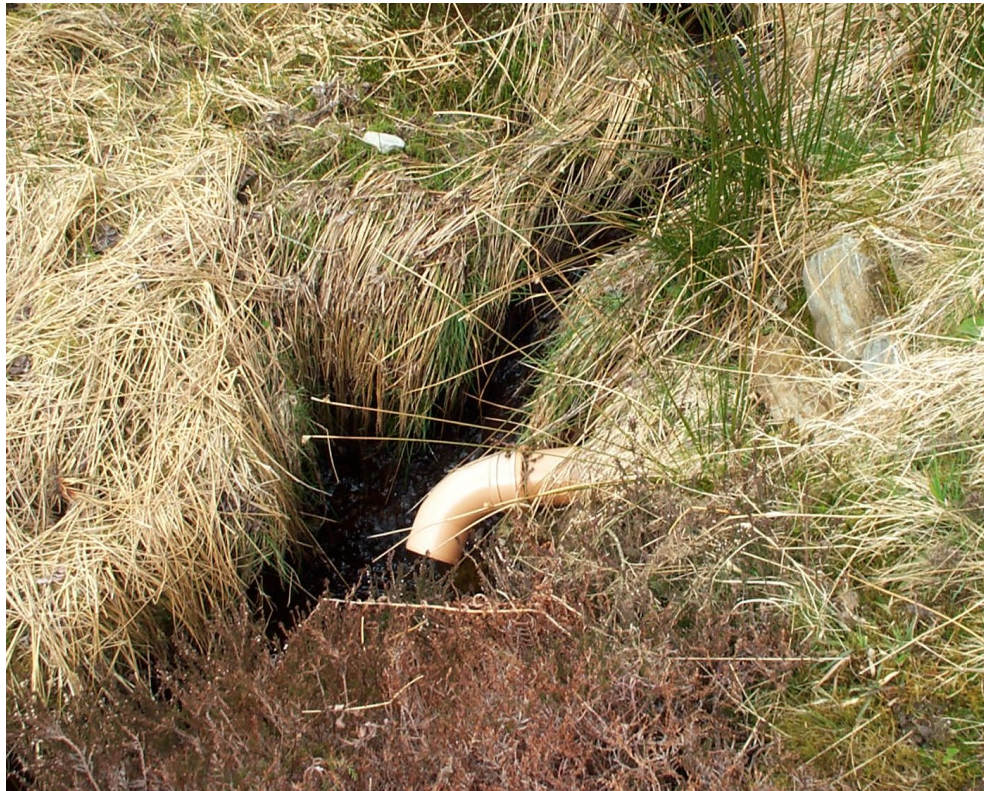
Ref:	National Grid Reference	Name and Address of Occupier	Source Type	Use	Discharge	Comments
A	NN 3834 2535	Mr Ramsey, Gleannfiadh Lodge Willow Brae Crianlarich	Septic Tank	Domestic	To surface water	2500l tank located to the south-west of house. Septic tank discharge to a local burn as shown in Photograph A1 at NN 3836 2532 – (outlet located at NN 3836 2532)
B	NN 3838 2527	Hotel	Septic Tank	Disused	NA	Old septic tank served Hotel prior to its connection to the main sewage, has been disused for approx 10 years
C	NN 3843 2499	Hill View B&B Glenfalloch Road Crianlarich	Septic Tank	Domestic/ Commerical	Probable Groundwater	Unable to speak to owner, tank located on front lawn by main road. No visible outlet at local burn – likely to discharge to groundwater
D	NN 3845 2491	Mrs Elliot, 1 Glenfalloch Road Crianlarich	Septic Tank	Domestic	Groundwater	Septic tank used by three house (1-3 Glenfalloch Road) soakaway to groundwater

**Photograph A1:** Septic tank discharge pipe into local burn (feature 2.4) – looking west from location NN 38356 25323

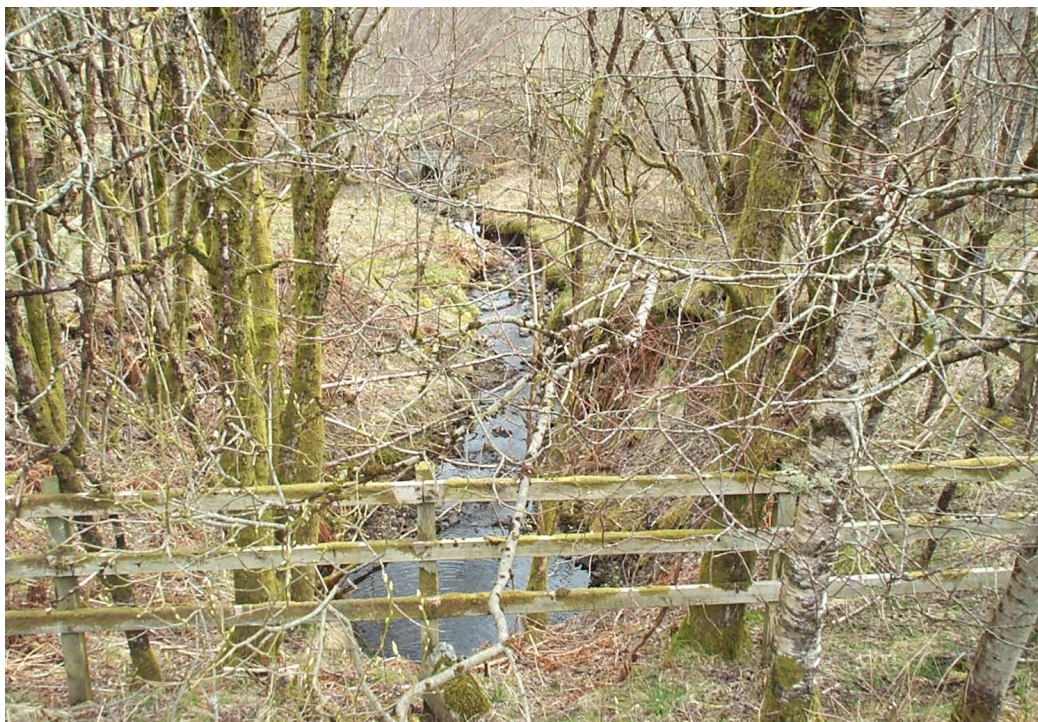
1.2	NN 3791 2564	-	Burn	None	-	Burn passing under A82 flowing NE towards River Fillan. Approx 0.7m wide, 0.2m deep NGR at culvert. Photograph 1.2 shows culvert under road looking NE from NN 3791 2564

**Photograph 1.2:** Burn 1.2 passing out from underneath A82 looking north-east from NN 37927 25643

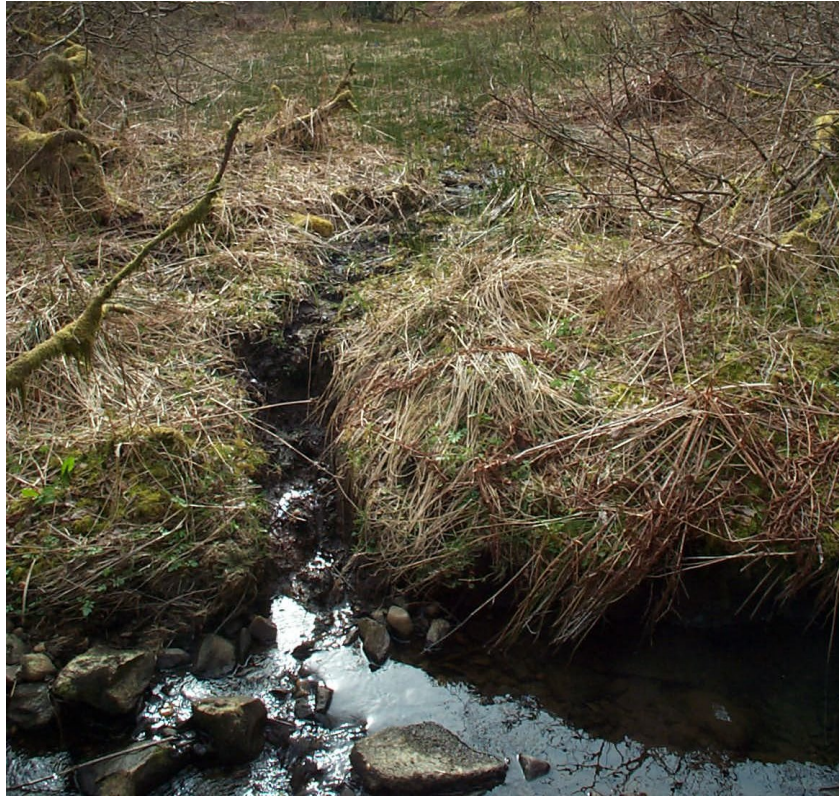
1.3	NN 3795 2567	-	Marsh	None	-	Marshy ground by the side of the burn
1.4	NN 3798 2566	-	Collects	None	-	Small collects from marshy ground on eastern bank of burn (feature 1.2). Water flows into burn at this location. Photograph 1.4 shows marsh and collects from NN 3795 2567

**Photograph 1.4:** Marshy ground and collects (Feature 1.4) on the eastern side of burn 1.2 looking east from NN 37952 25669

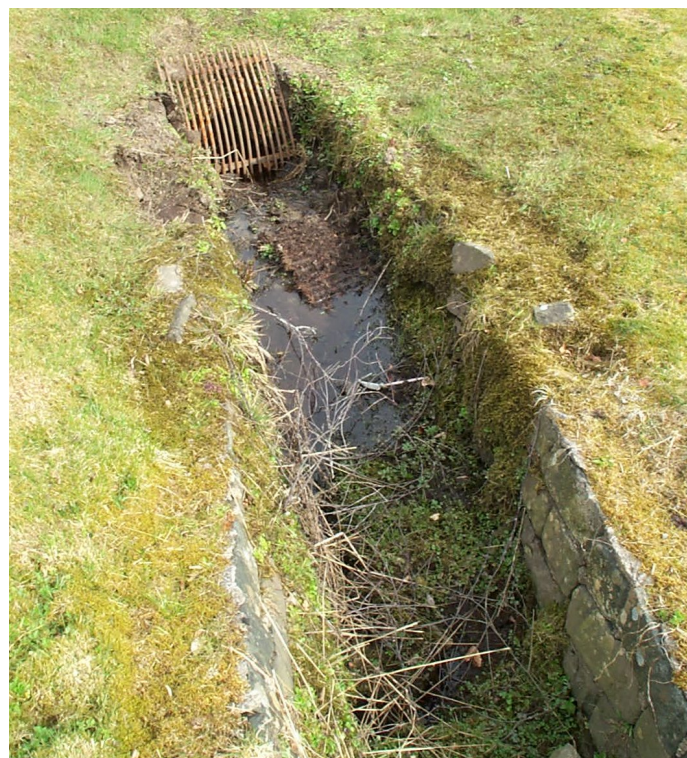
1.10	NN 3823 2544	-	Burn	None	-	Small burn passes under Willow Brae and A82 before joining feature 1.9 on N side of A82. Reinforced sides made of stone approx 0.6m wide and up to 0.5m deep shown in photograph 1.10 from NN 3823 2546

**Photograph 1.10:** Culvert for burn 1.10 underneath A82 looking north from NN 38232 25455

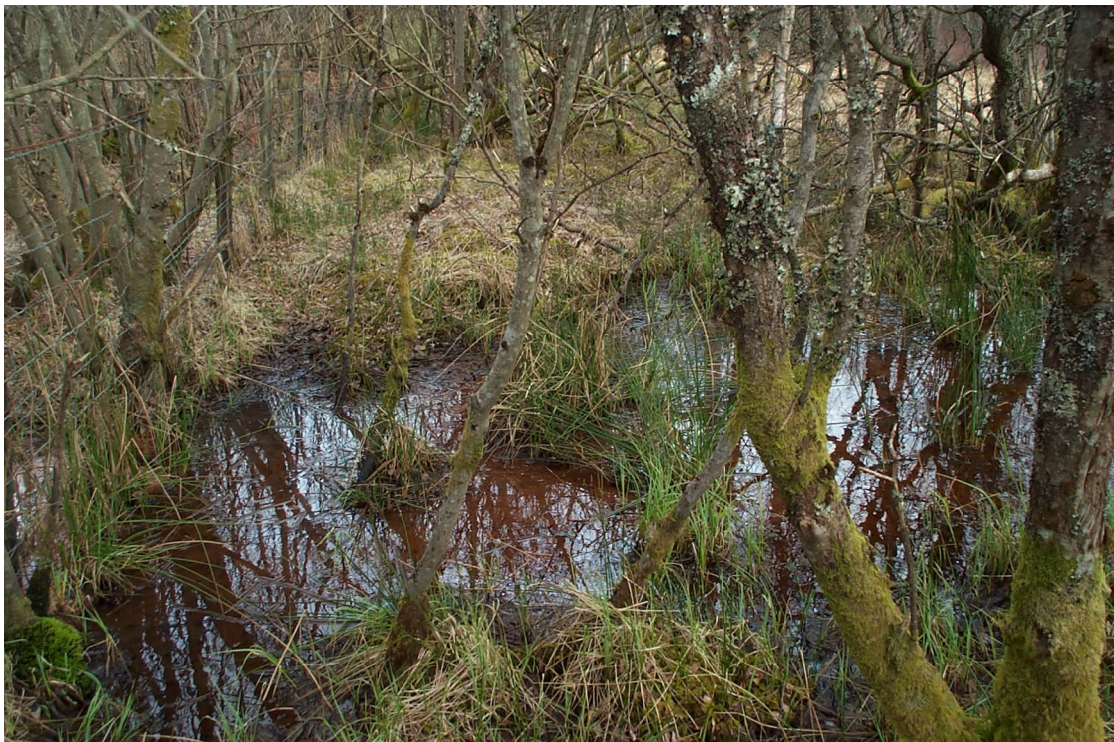
1.11	NN 3824 2554	-	Burn	None	-	Burn created by the joining of features 1.10 and 1.9. Approx. 0.2m wide and 0.2m deep
2.1	NN 3825 2554	-	Spreads	None	-	Spreads for feature 1.11 on north side of railway embankment as shown in photograph 2.1 from NN 3816 2559

**Photograph 2.1:** Spreads (feature 2.1) for burn 1.11 looking north-west from NN 38162 25586

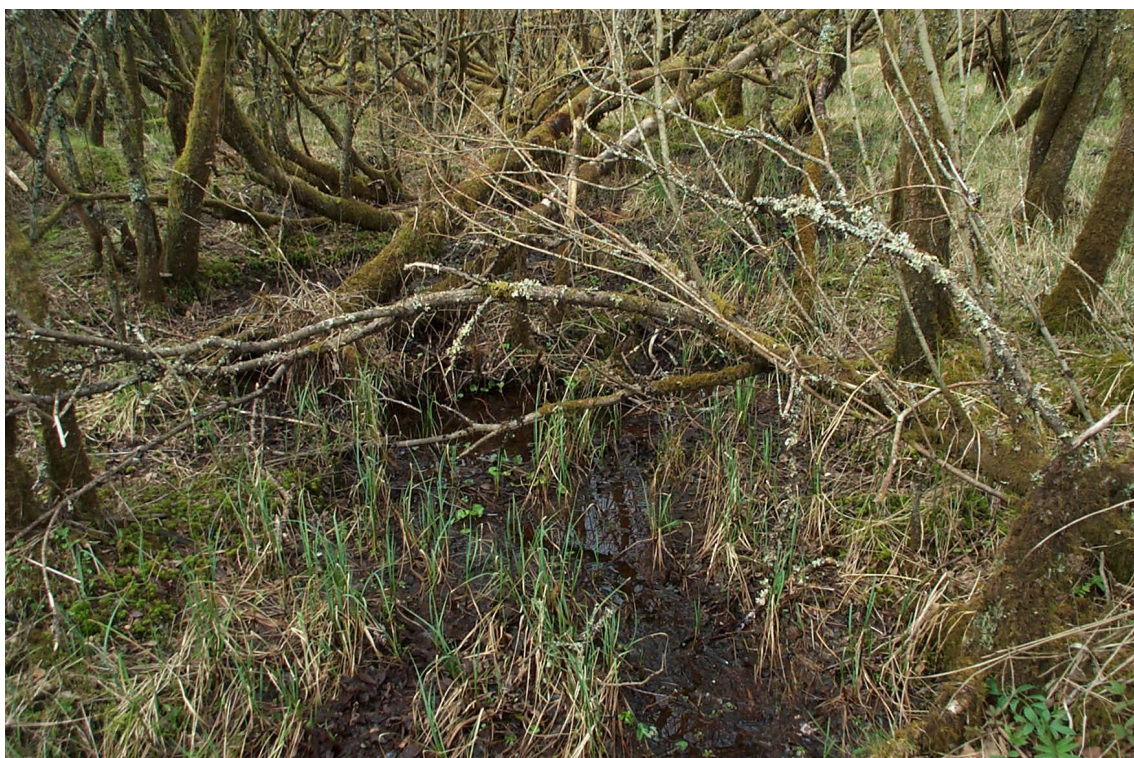
2.2e	NN 3829 2554	-	Tributary Burn	None	-	Small side burn of feature 2.3 approx 0.1m wide and up to 0.1m deep
2.2f	NN 3829 2554	-	Collects	None	-	Collects for feature 2.2e shown in photograph 2.2 from NN 3829 2554

**Photograph 2.2:** Collects (feature 2.2f) for burn 2.2a looking west from NN 38285 25538

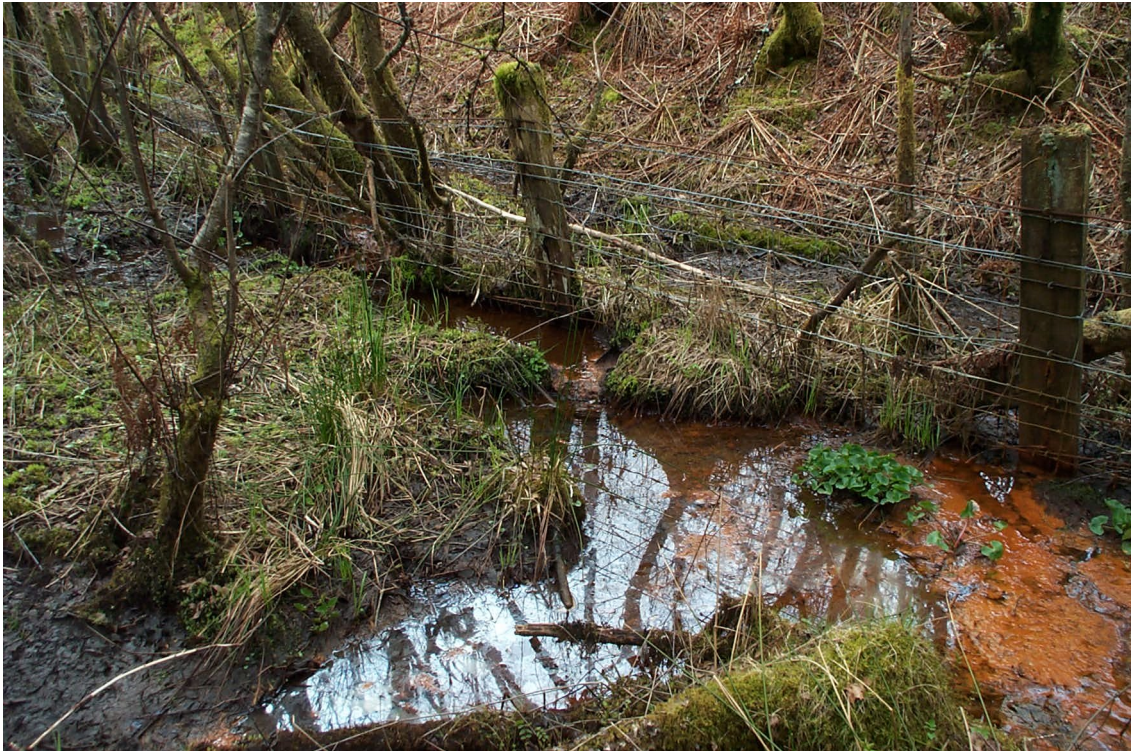
2.3a	NN 38312556	-	Burn	None	-	Burn flows north into River Fillan. Approx 0.3m wide and up to 1.2m deep
2.3b	NN 3828 2552	-	Collects	None	-	Collects for feature 2.3a. Shown in photograph 2.3 at railway embankment looking S from NN 3828 2552

**Photograph 2.3:** Collects (feature 2.3b) for burn 2.3a looking south-west from NN 38275 25519

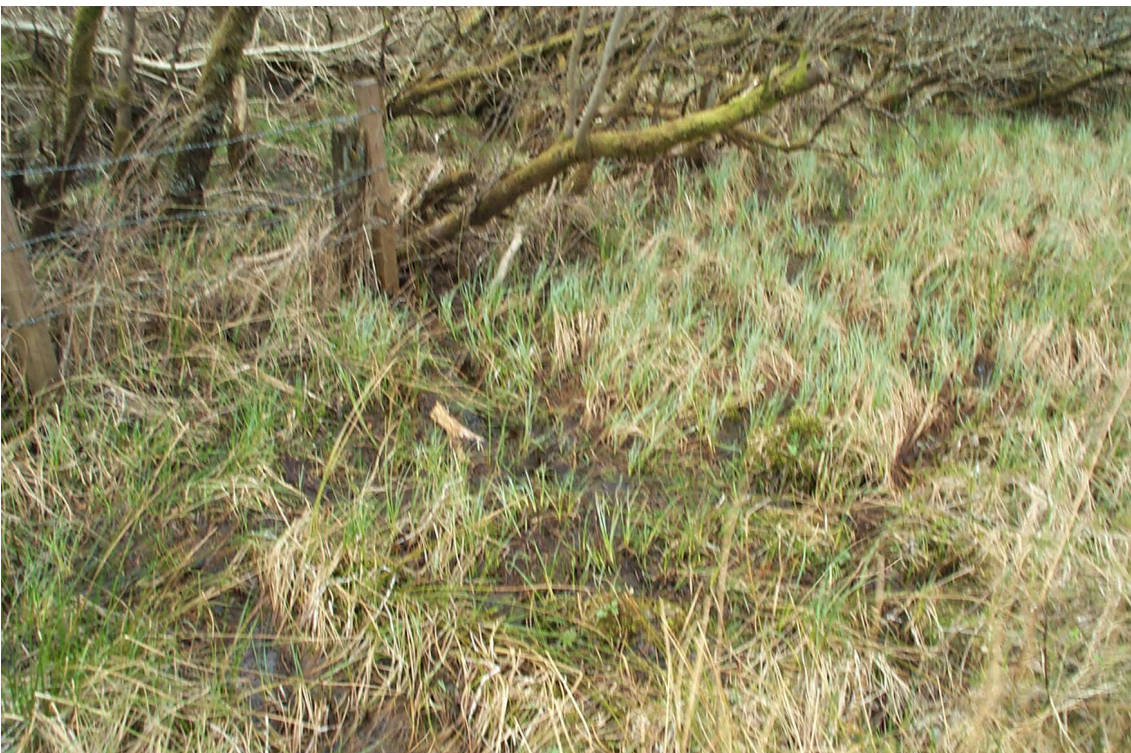
2.6	NN 3833 2532	-	Collects	None	-	Small collects joins burn 2.4 at this location
2.7	NN 3850 2551	-	Collects	None	-	Boggy pond which acts as a collects for feature 2.8,

Ref:	National Grid Reference	Name and Address of Occupier	Source Type	Use	Discharge	Comments
						shown in photograph 2.7 looking S from NN 3850 2551
2.8	NN 3847 2552	-	Drainage Ditch	None	-	Drainage Ditch discharges into River Fillan. Approx 0.15m wide and 0.1m deep

**Photograph 2.7:** Collects (feature 2.7) for drainage ditch 2.8 looking south from NN 38496 25508

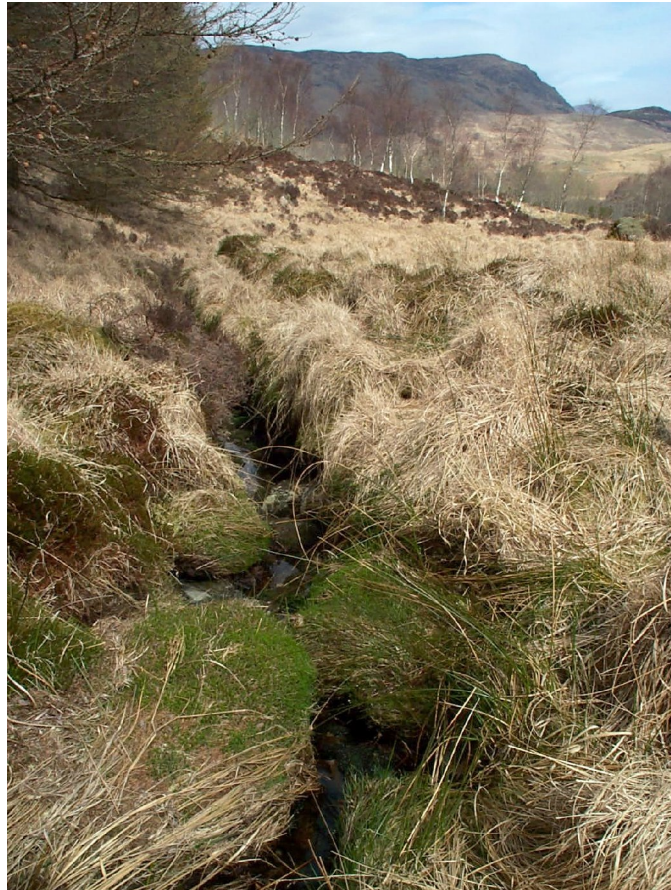
2.9	NN 3844 2554	-	Drainage Ditch	None	-	Drainage Ditch discharges into River Fillan. Approx 0.25m wide and 0.15m deep
3.1	NN 3853 2515	-	Burn	None	-	Burn runs down the eastern side of Crianlarich (and A85) before joining with feature 2.4 and discharging into River Fillan. Approx 1m wide and up to 0.7m deep. Shown in photograph 3.1 from NN 3827 2492

**Photograph 3.1:** Steam 3.1 looking west from NN 38270 24923

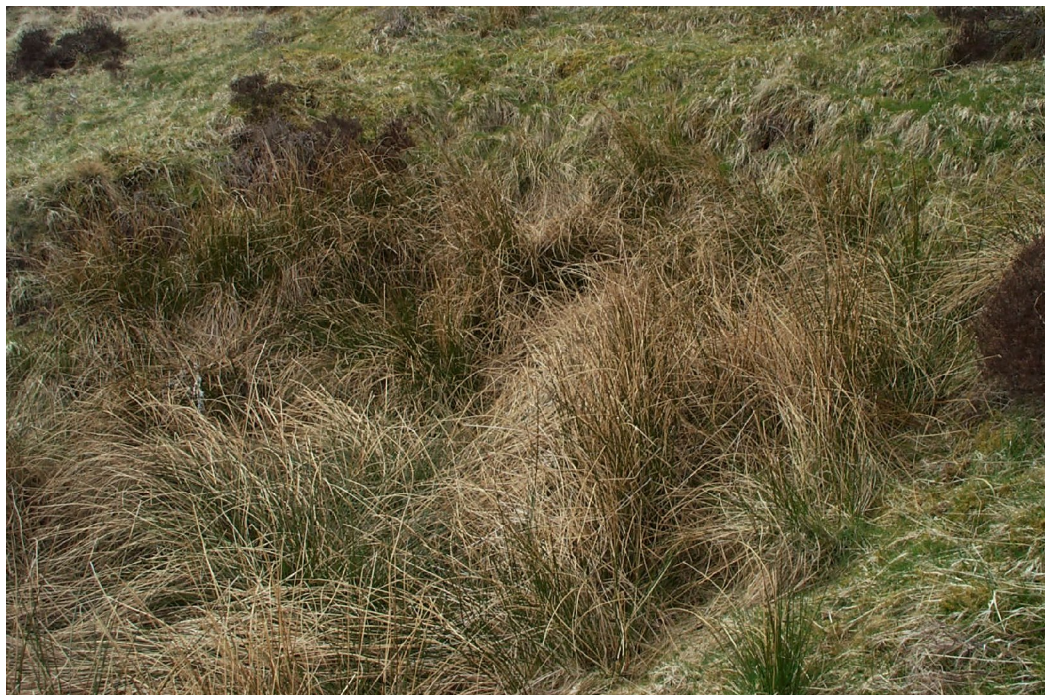
3.4	NN 3827 2486	-	Spring	None	-	Very small spring shown in photograph 3.4 looking W from NN 3827 2486
3.5	NN 3827 2492	-	Tributary burn	None	-	Tributary for feature 3.1 flowing N approx 0.2m wide and 0.3m deep

**Photograph 3.4:** Small spring (feature 3.4) issuing from hill side, looking south-west from NN 38271 24860

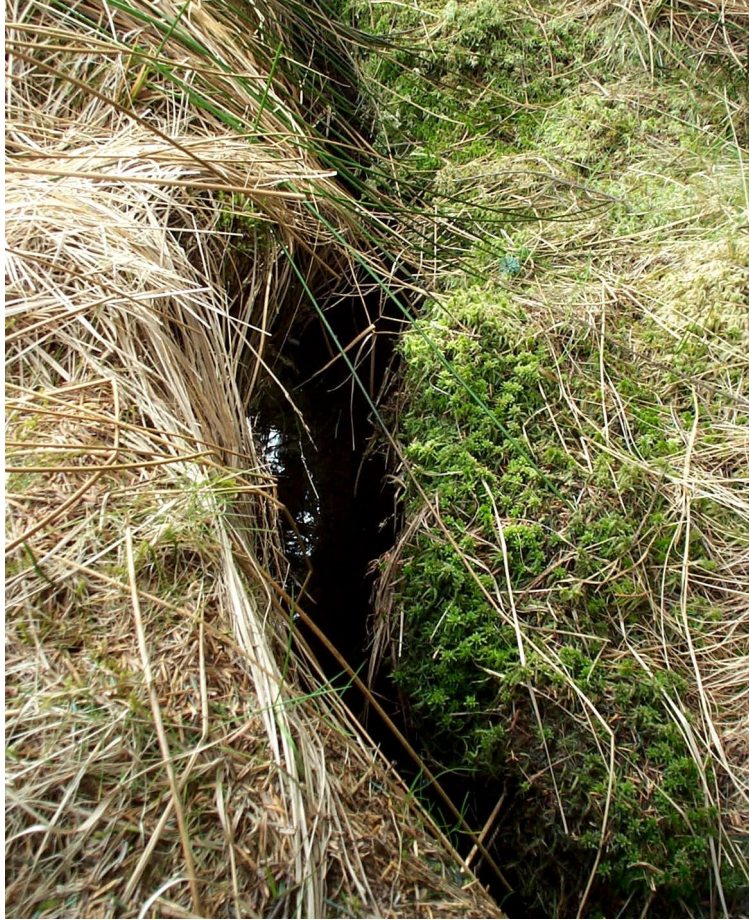
3.6	NN 3833 2500	-	Tributary burn	None	-	Tributary to feature 3.1 flowing E approx 0.15m wide and 0.15m deep
3.7	NN 3833 2511	-	Drainage Ditch	None	-	Drainage Ditch flowing NE towards A85 approx 0.45m wide and 0.3m deep. Shown in photograph 3.7 looking W from NN 3833 2511

**Photograph 3.7:** Drainage Ditch (feature 3.7) running west to east looking upstream from NN 38333 25110
