## Appendix 4d Otter Habitat Assessment Report

## A82 Pulpit Rock Road Improvement

# Report to inform screening for Appropriate Assessment for Scheme Construction: Otter Habitat Assessment of Upper Loch Lomond

Report  
March 2010

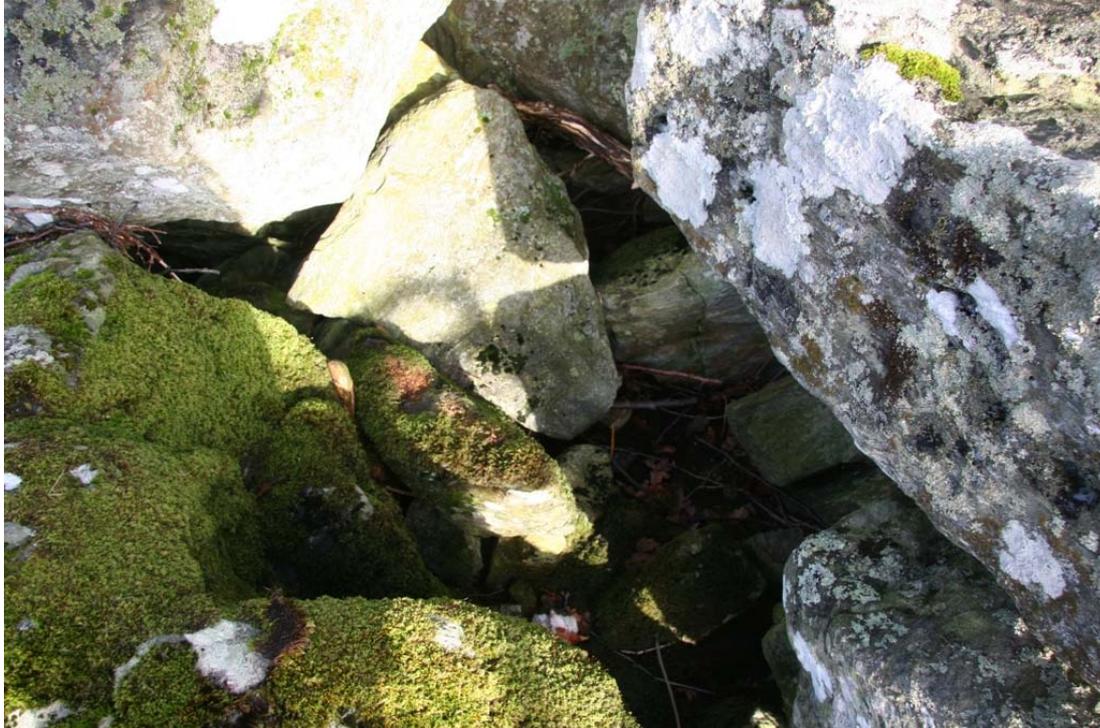
**Plate [A] Example of Otter laying up area**

**Laying up area** – relates to a partially enclosed site used by otters as a transitory / short term refuge, such sites were commonly associated with rocky shorelines.

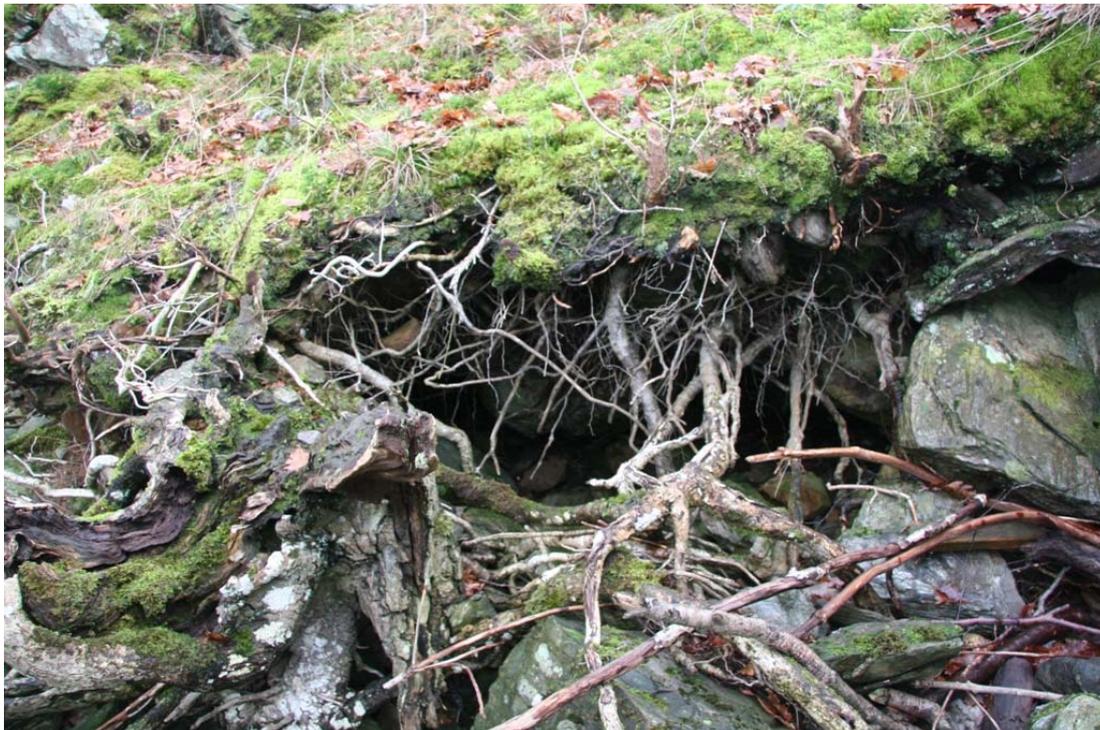
**Plate [B] Example of an otter Holt within an undercut embankment, trees roots and scree**

**Otter Holt** – for the purpose of this report the term holt relates to an enclosed chamber or chambers used by otters as a refuge, which were located within embankments, under boulders, tree roots or a combination.

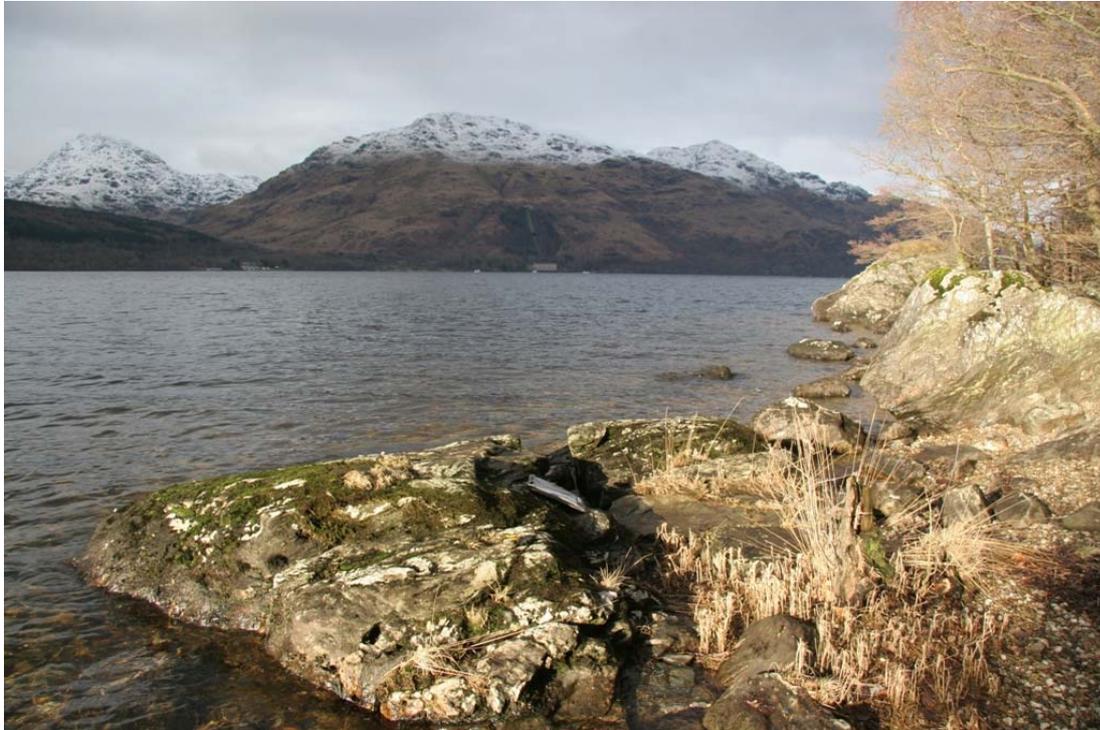
**Plate [C] Example of a stand alone otter sprainting site**

Stand alone spraint sites were recorded in a number of shoreline locations; again a number of sites contained multiple spraints of varying age. Such sites are often associated with the conservation of resources; sprainting is used as a means of preventing competition from other otters and relate to feeding areas rather than territory<sup>3</sup>.

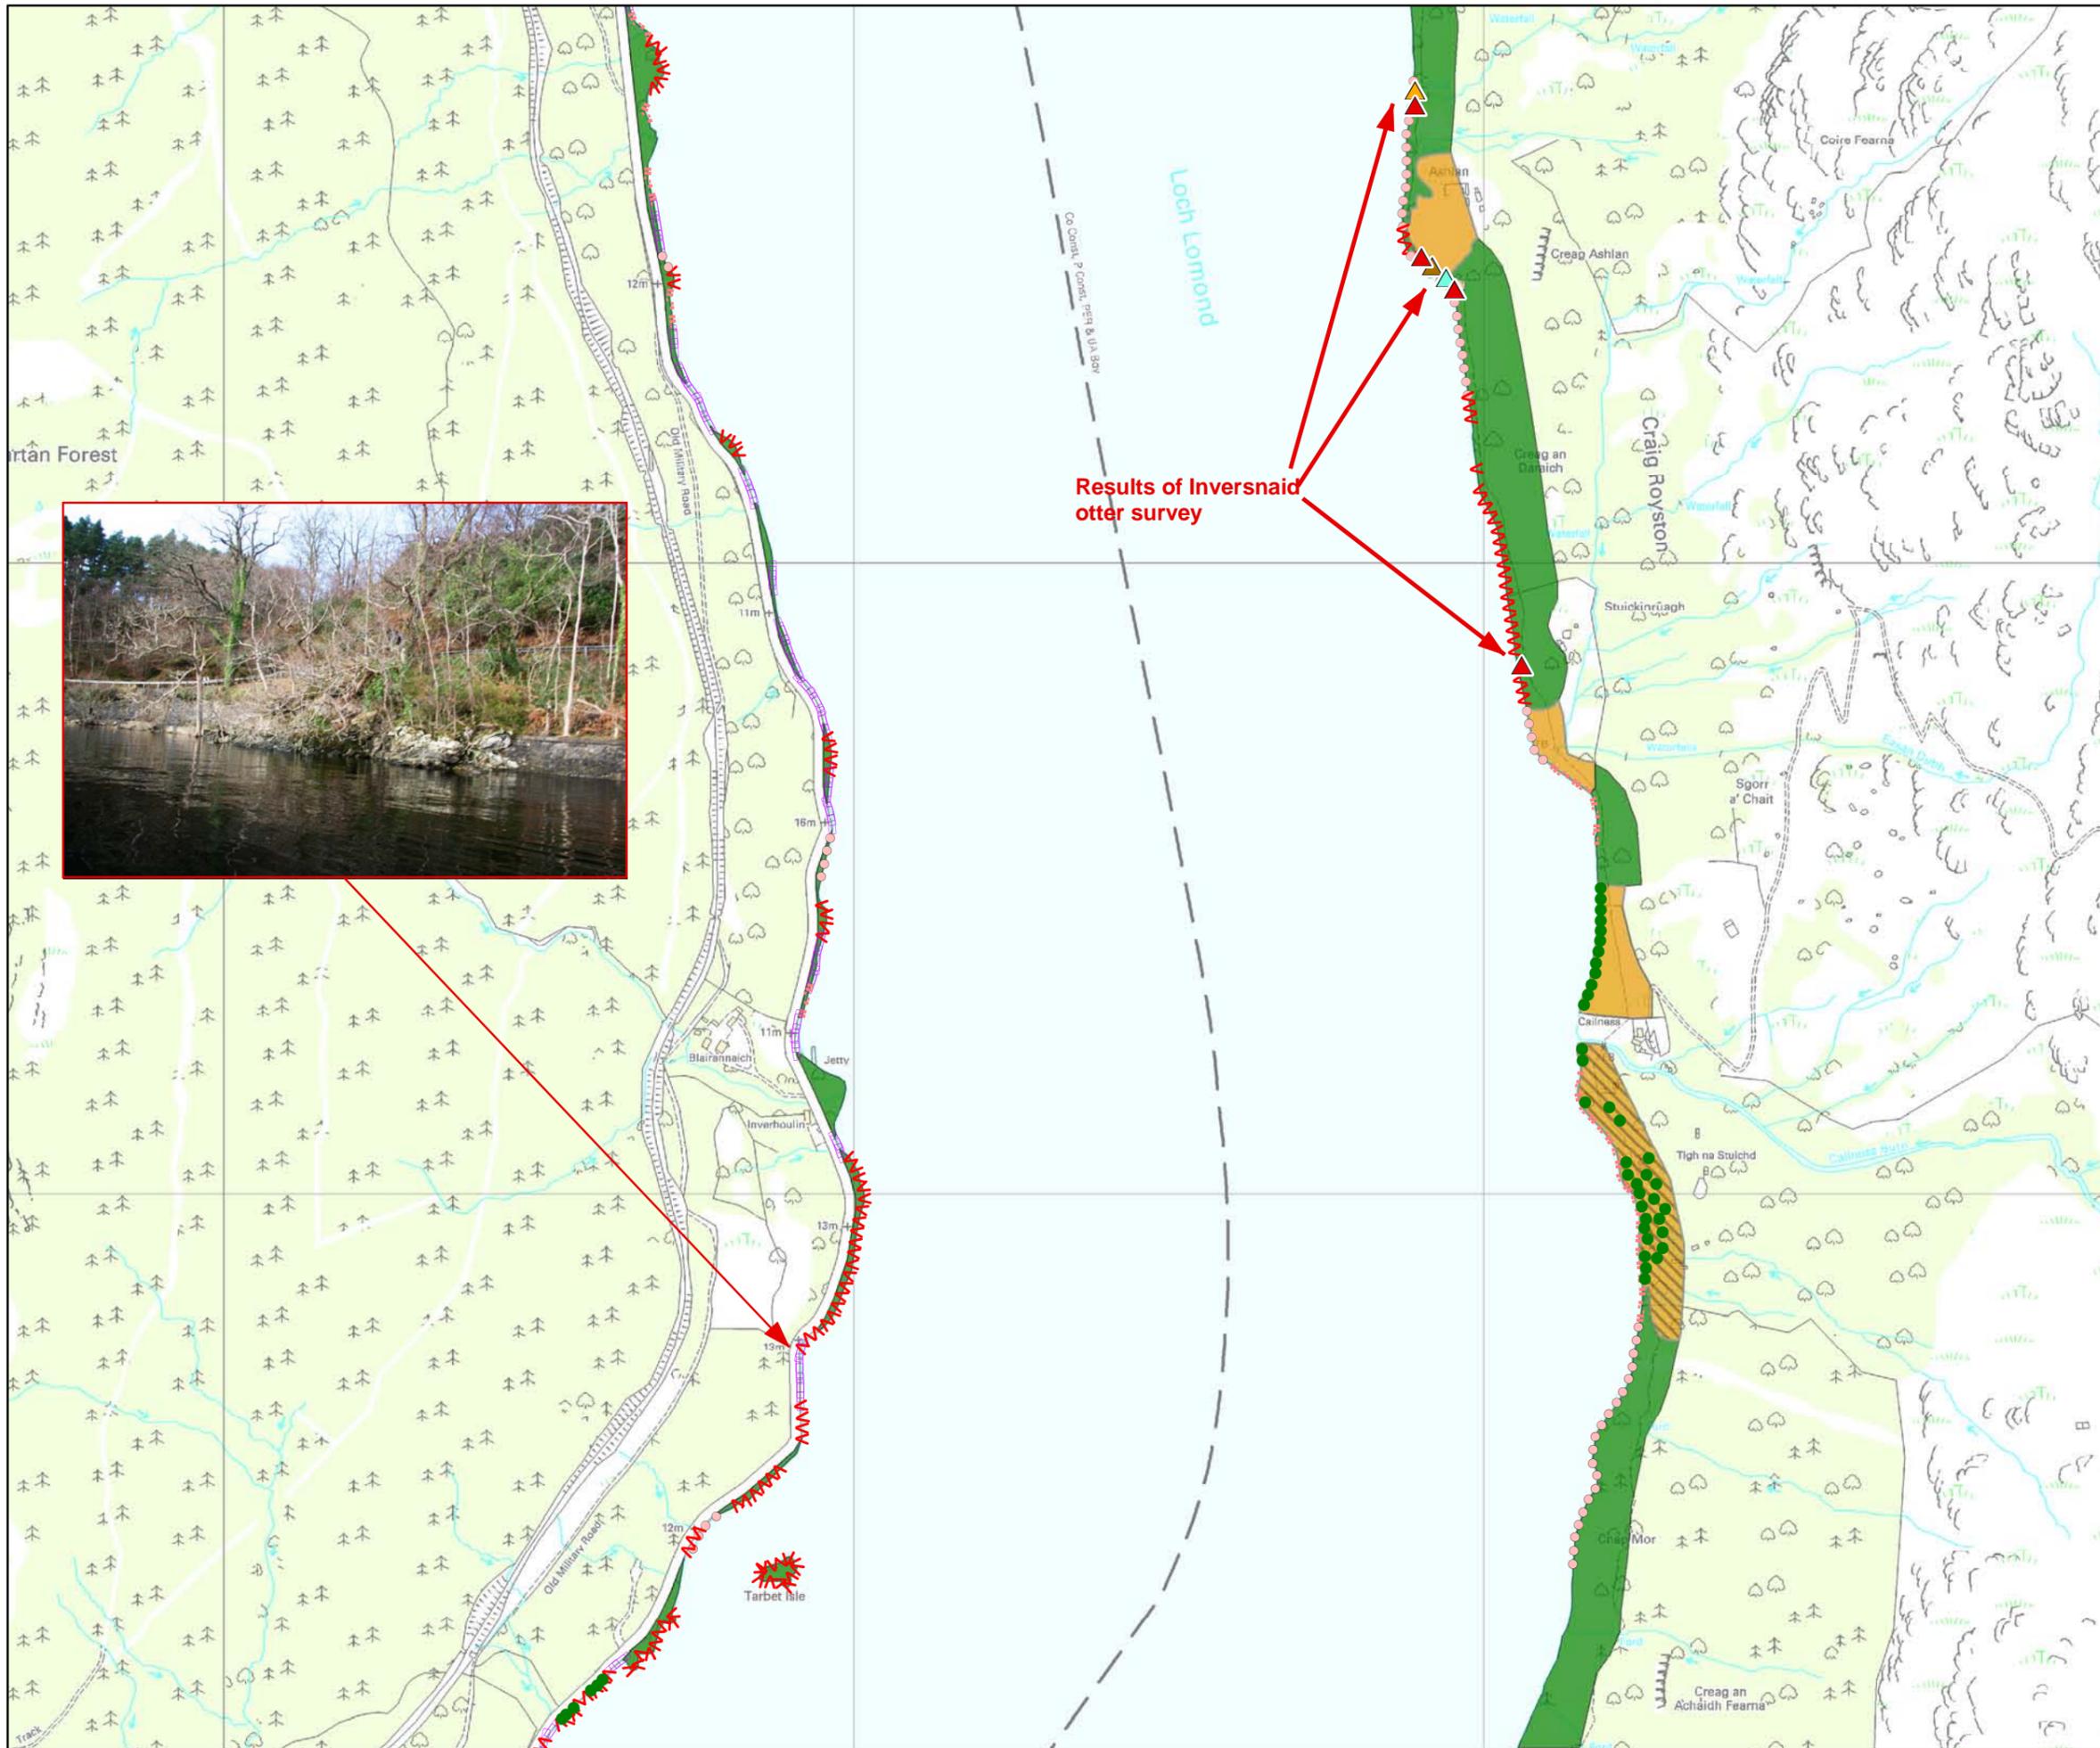
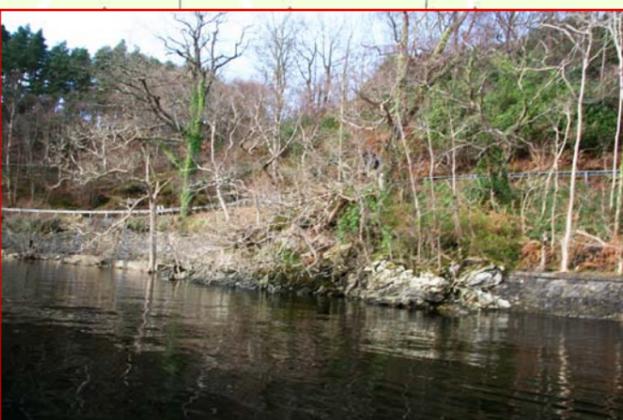
Drawing Number **FIGURE 1** Rev

Results of Inversnaid otter survey

Results pertaining to the Phase 1 Habitat survey are shown in Figures 1 to 6 and Table 8.

Table 1 details additional information relating to the East Shore walk over survey findings, whilst holt locations etc. are shown on the Phase 1 habitat maps (Figures 1 to 6).

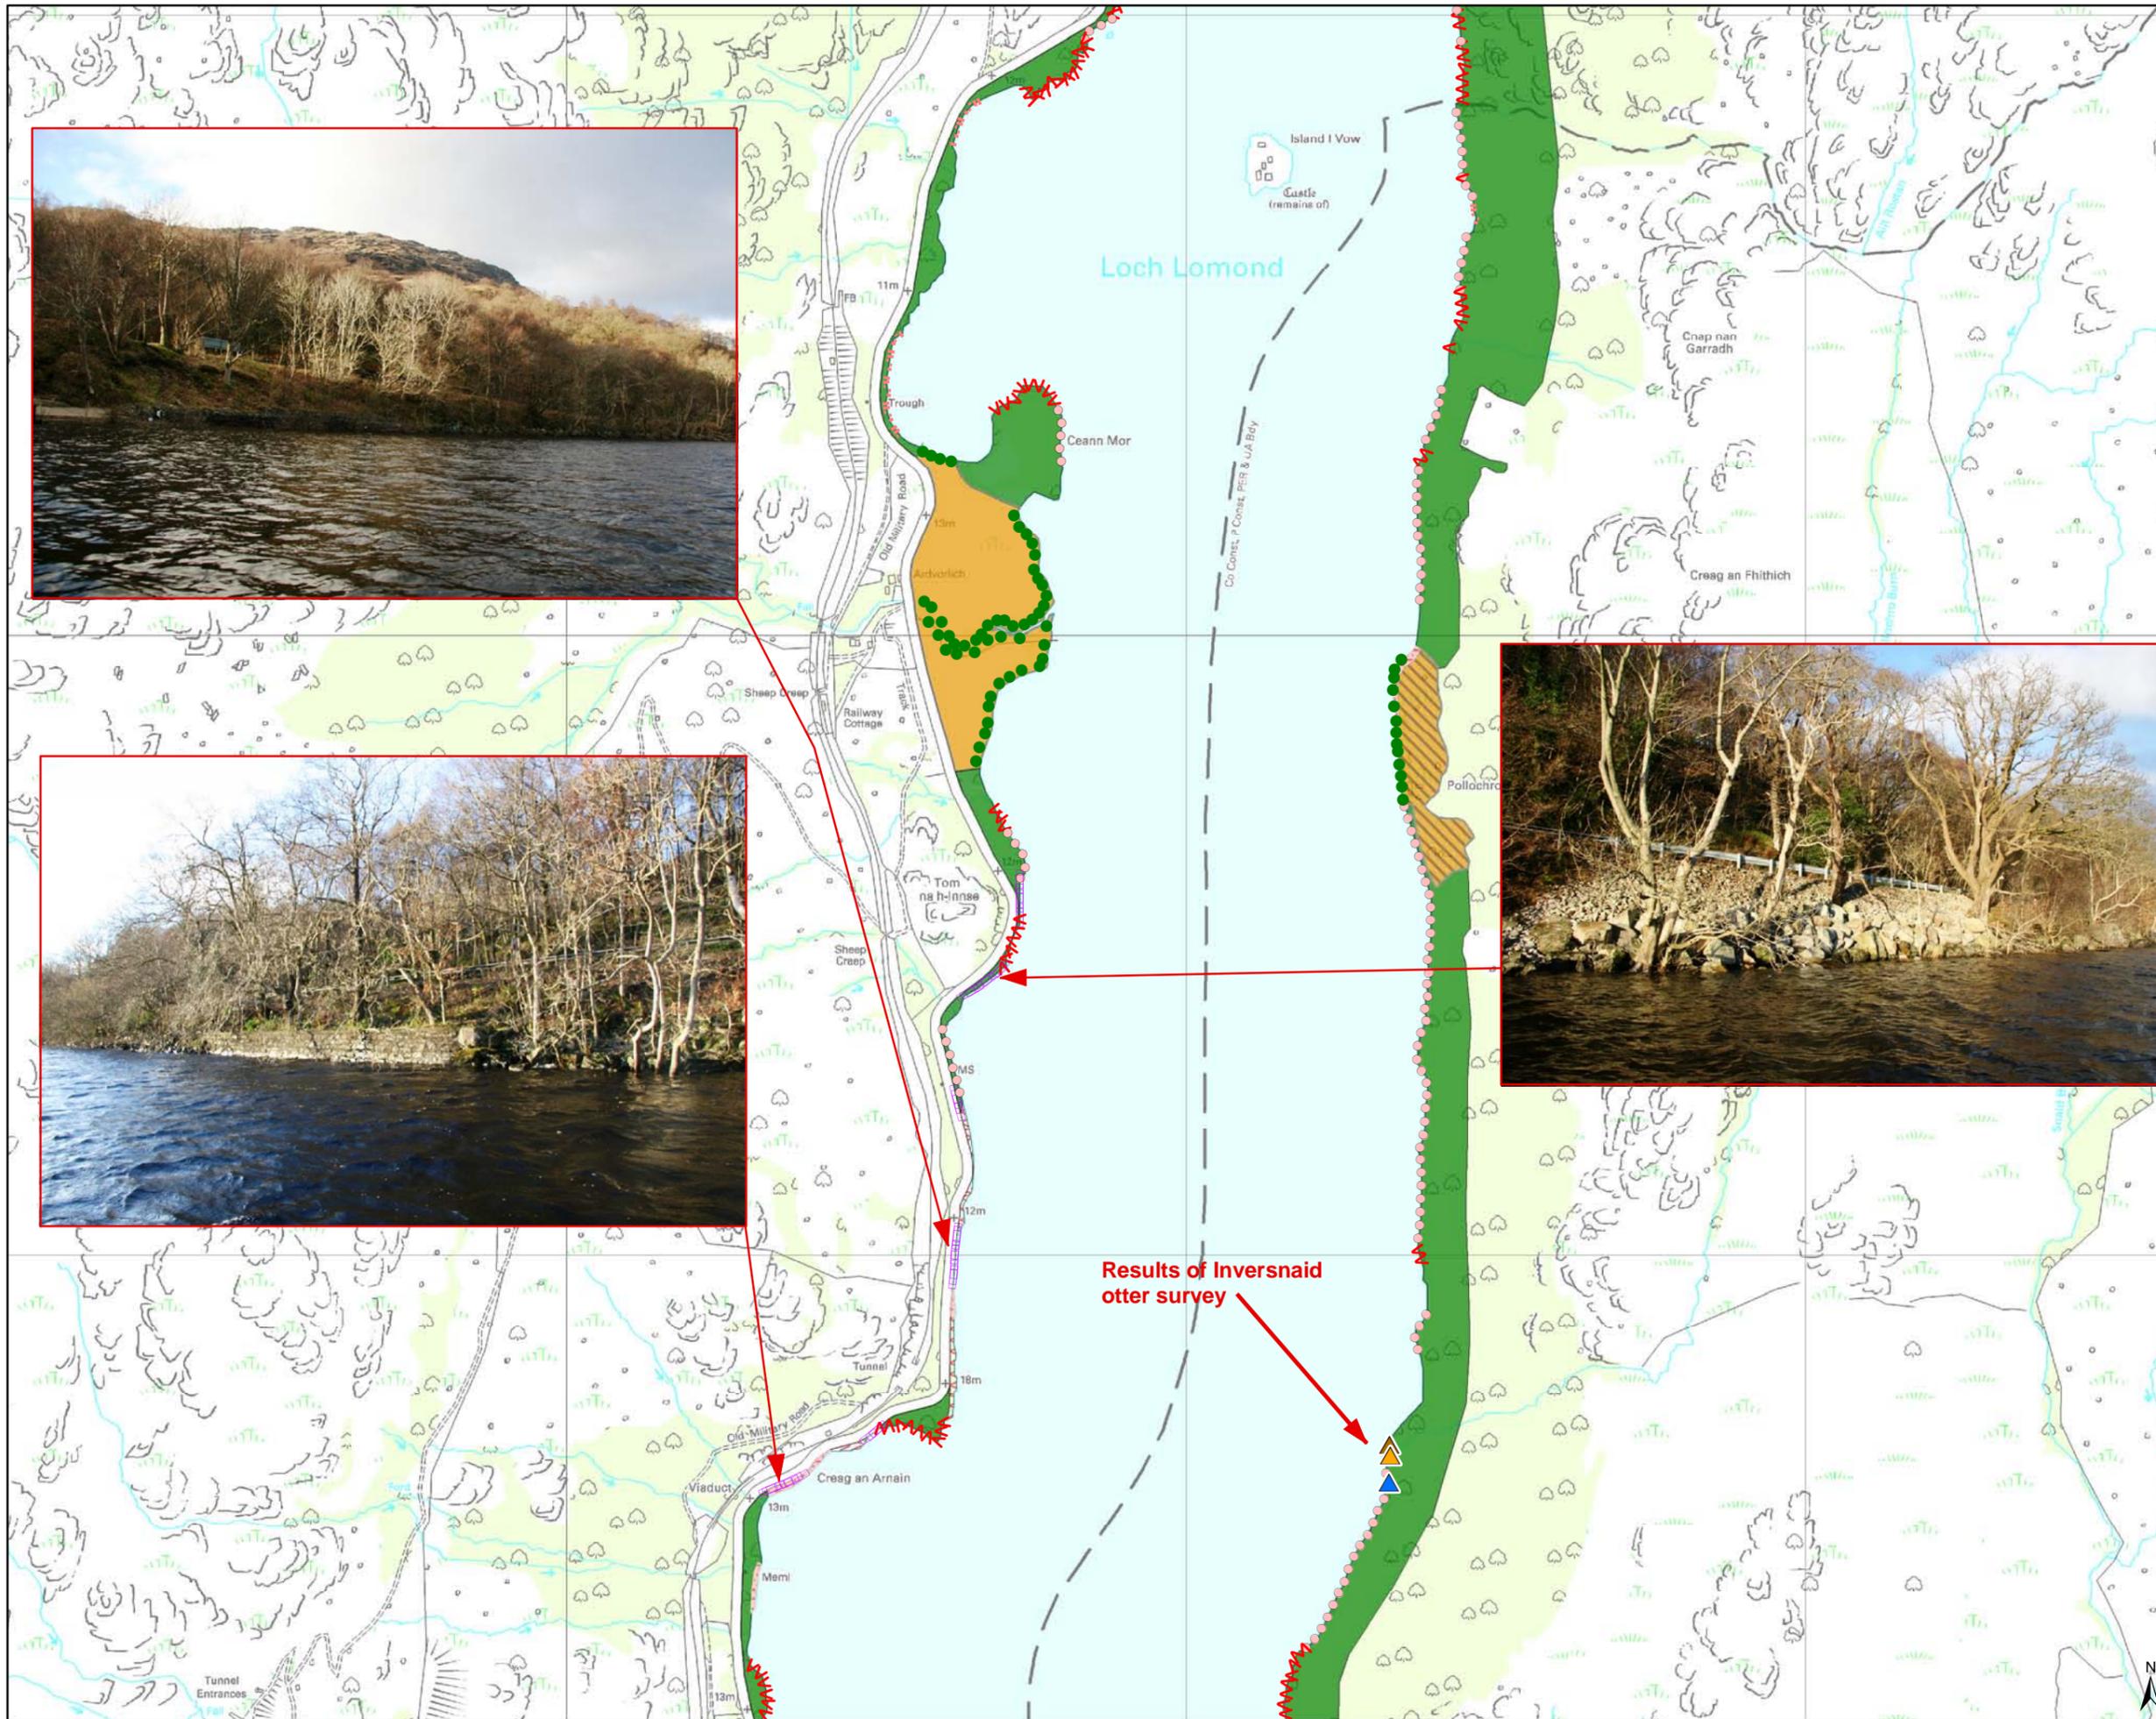
Drawing Number: **FIGURE 2**

**Otter Evidence (from separate local surveys)**

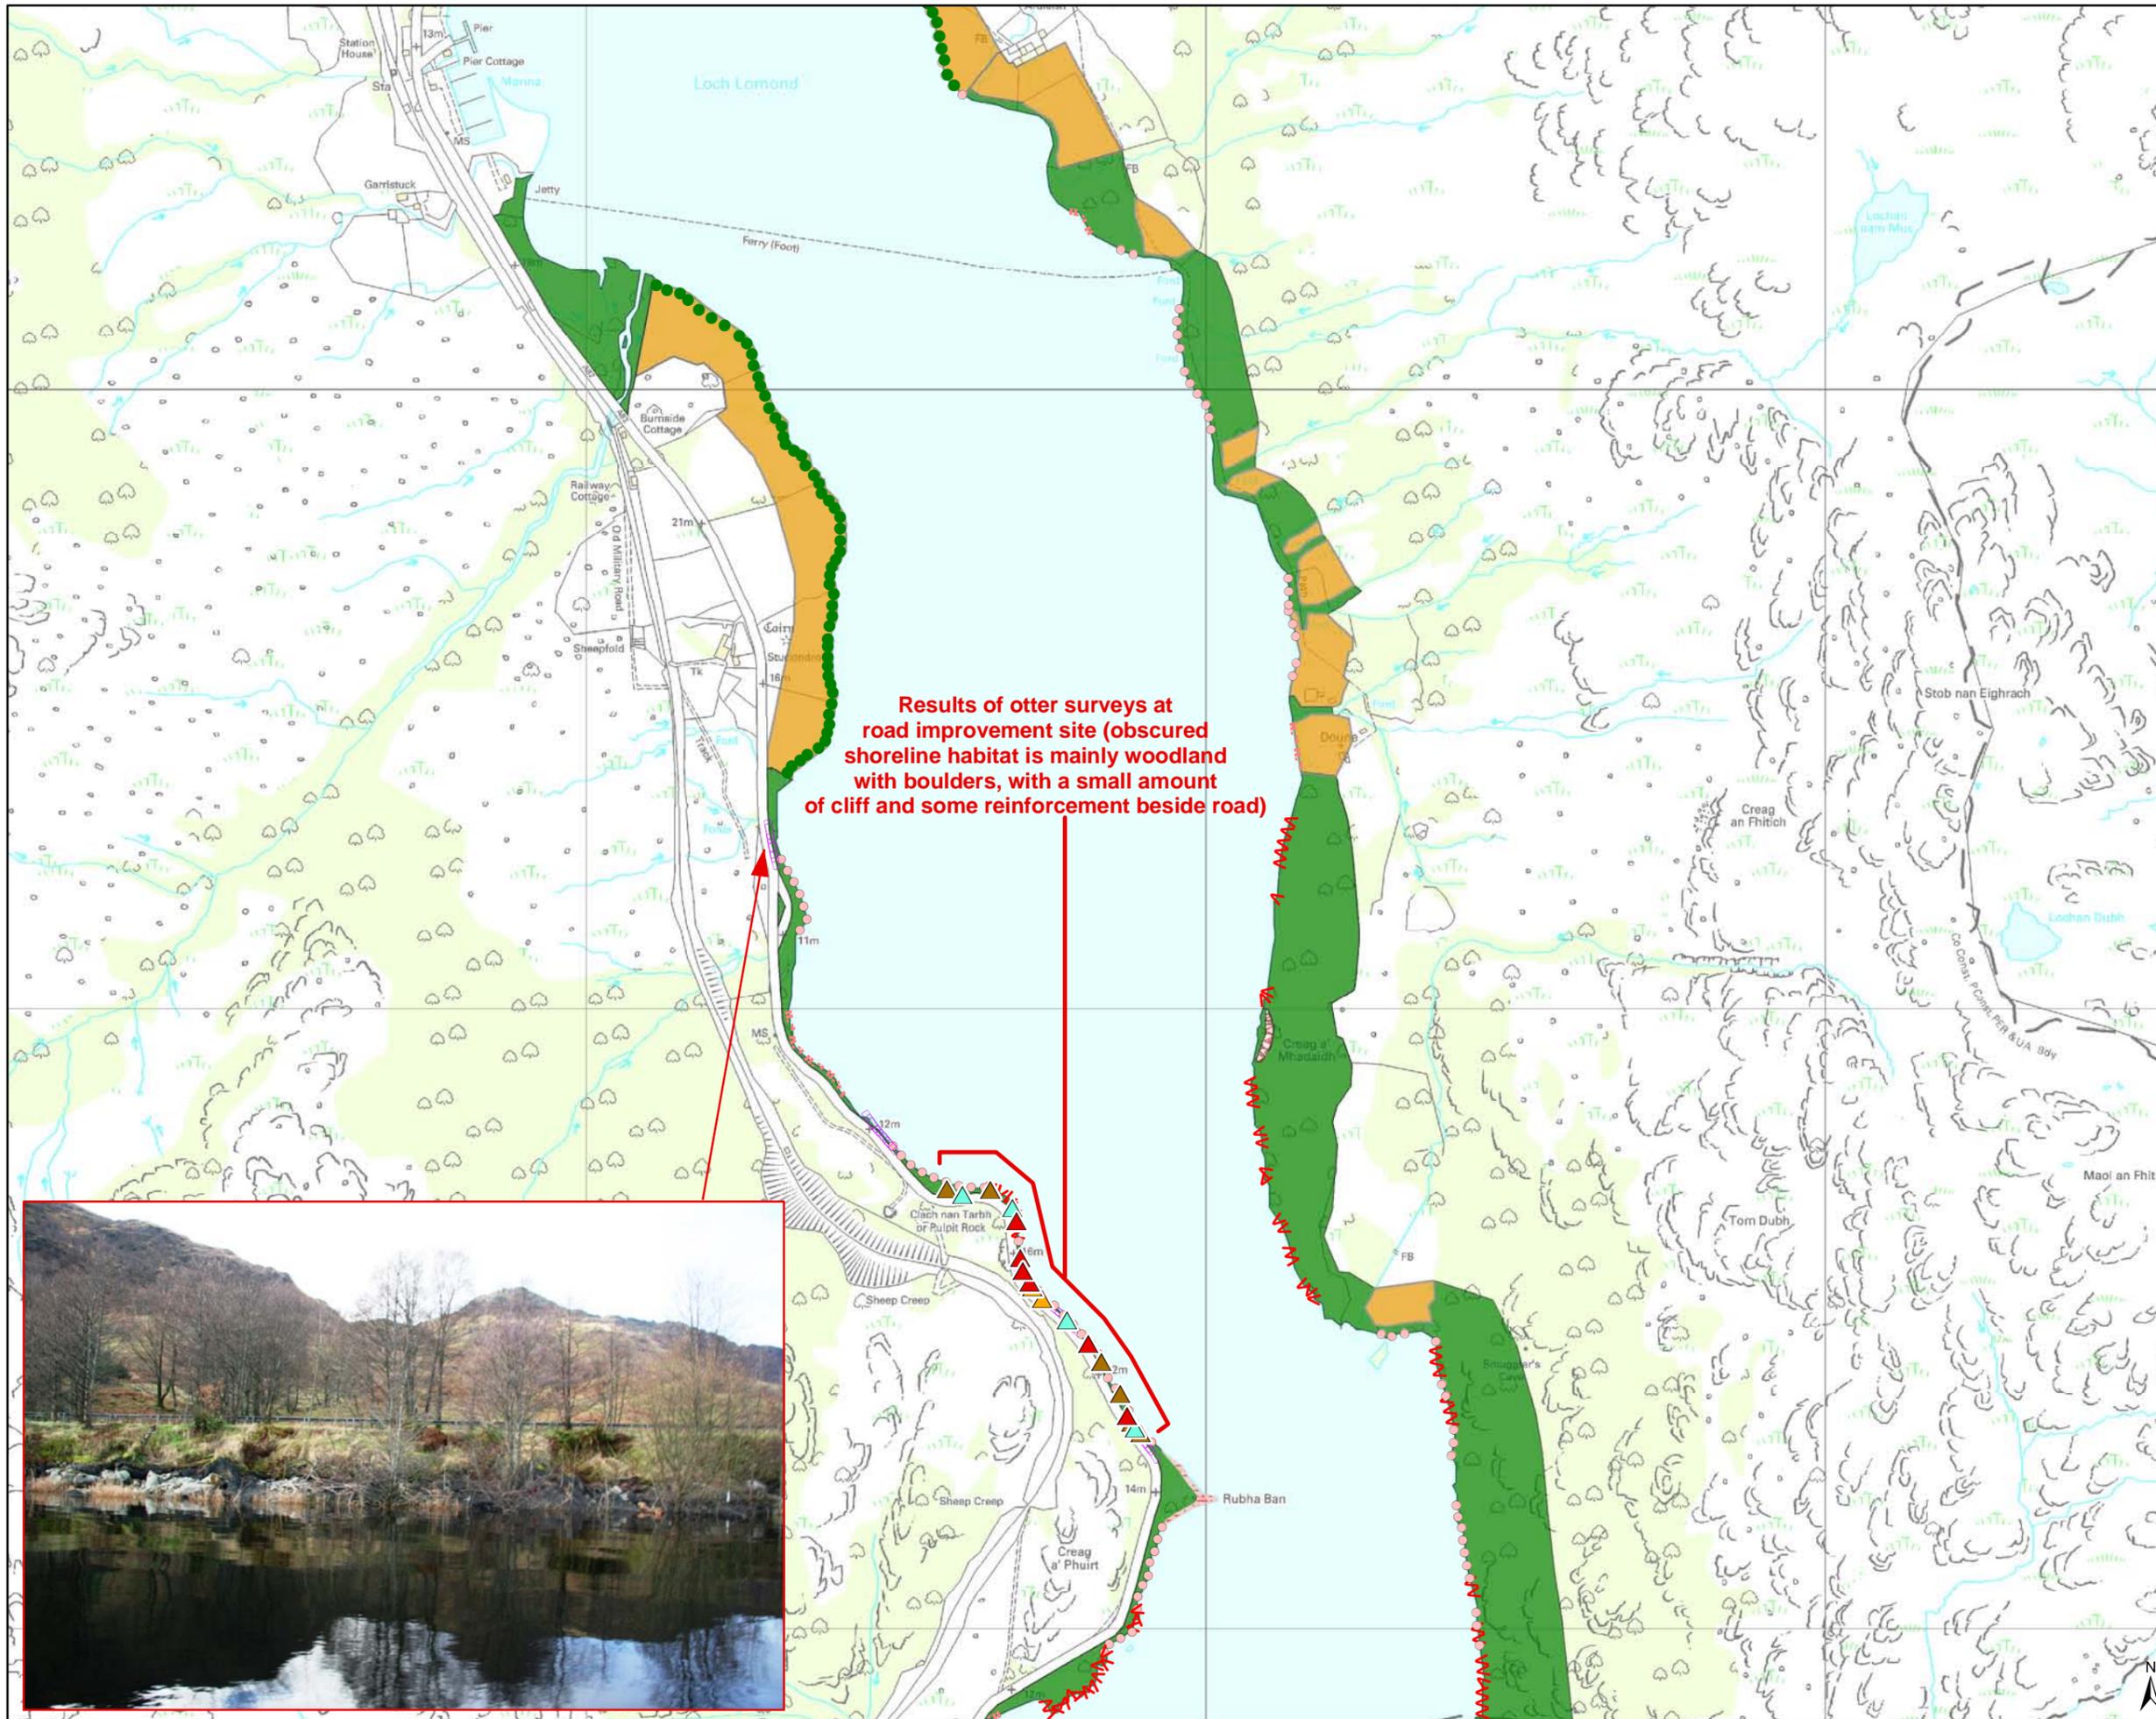
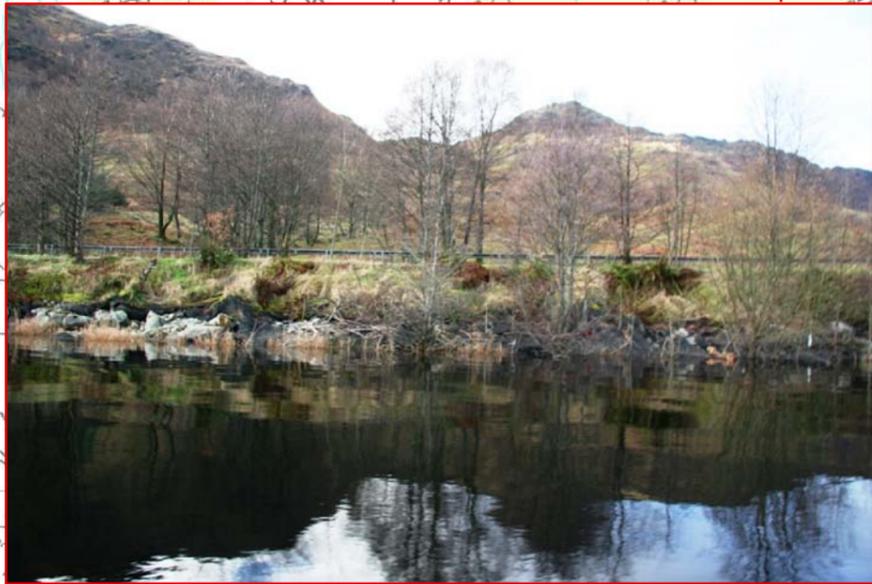
Drawing Number: **FIGURE 3** Rev

**Results of otter surveys at road improvement site (obscured shoreline habitat is mainly woodland with boulders, with a small amount of cliff and some reinforcement beside road)**

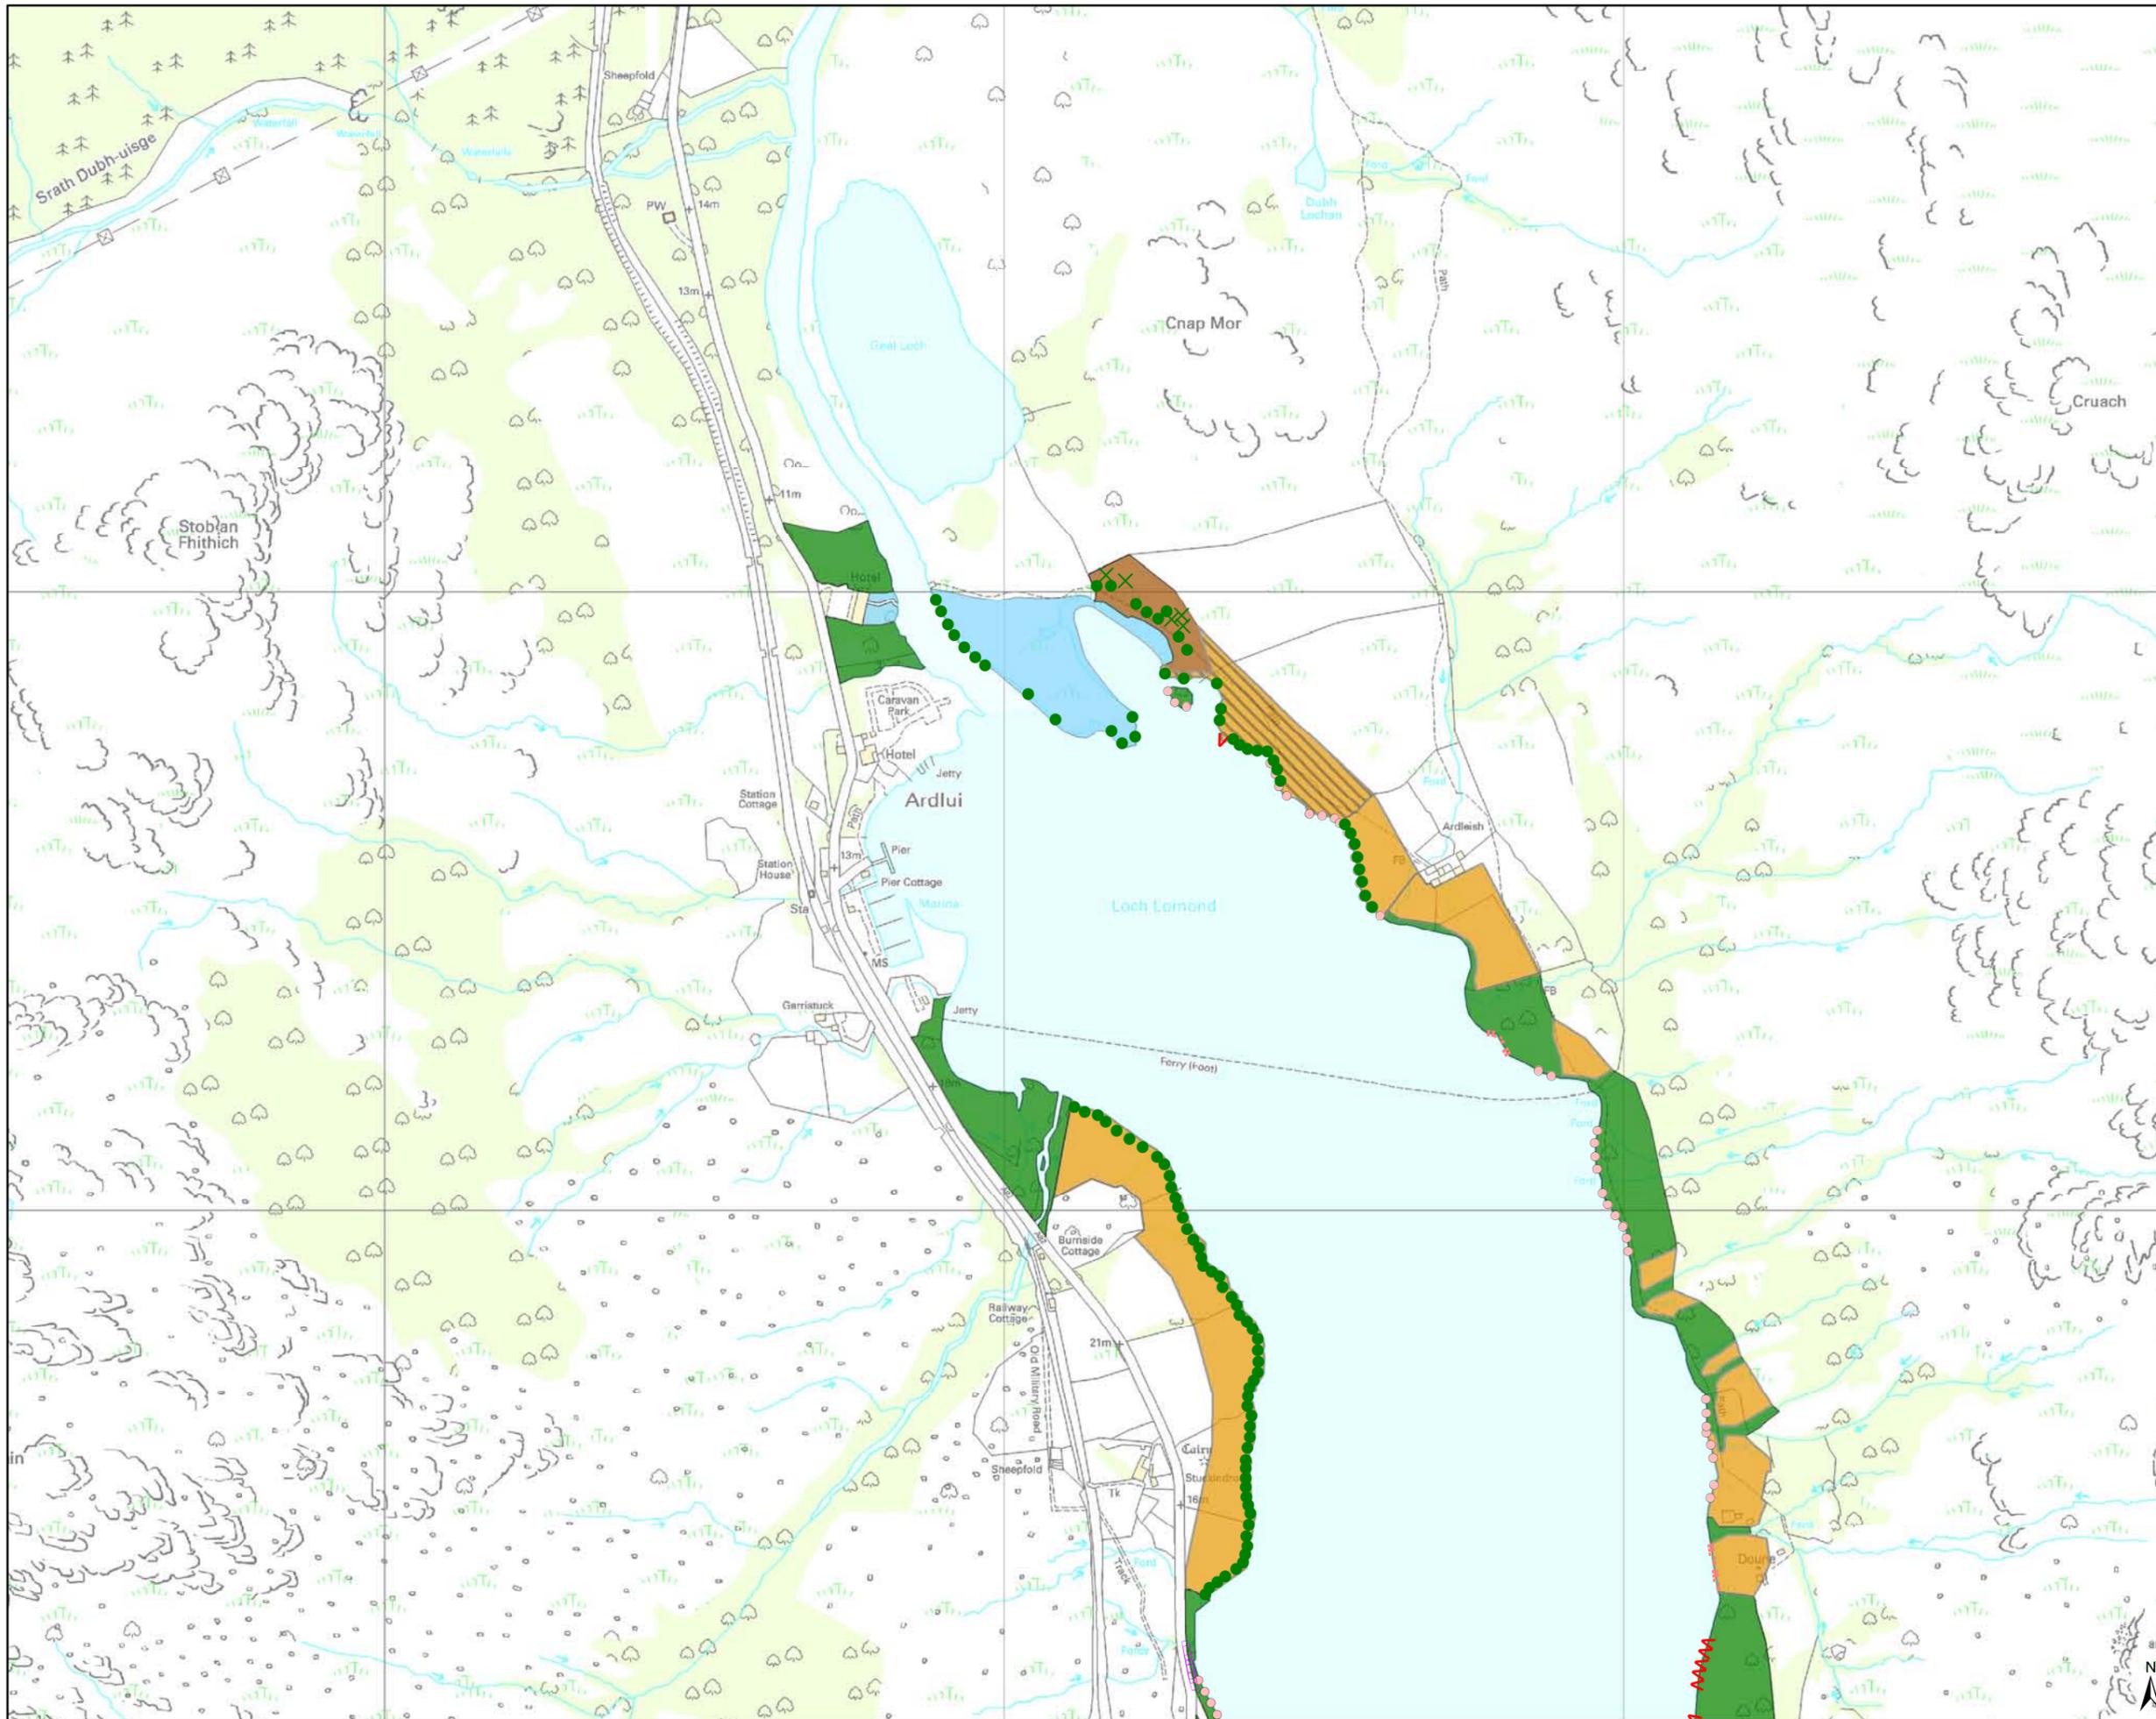
Drawing Number: **FIGURE 4** Rev

**Otter Evidence (from separate local surveys)**

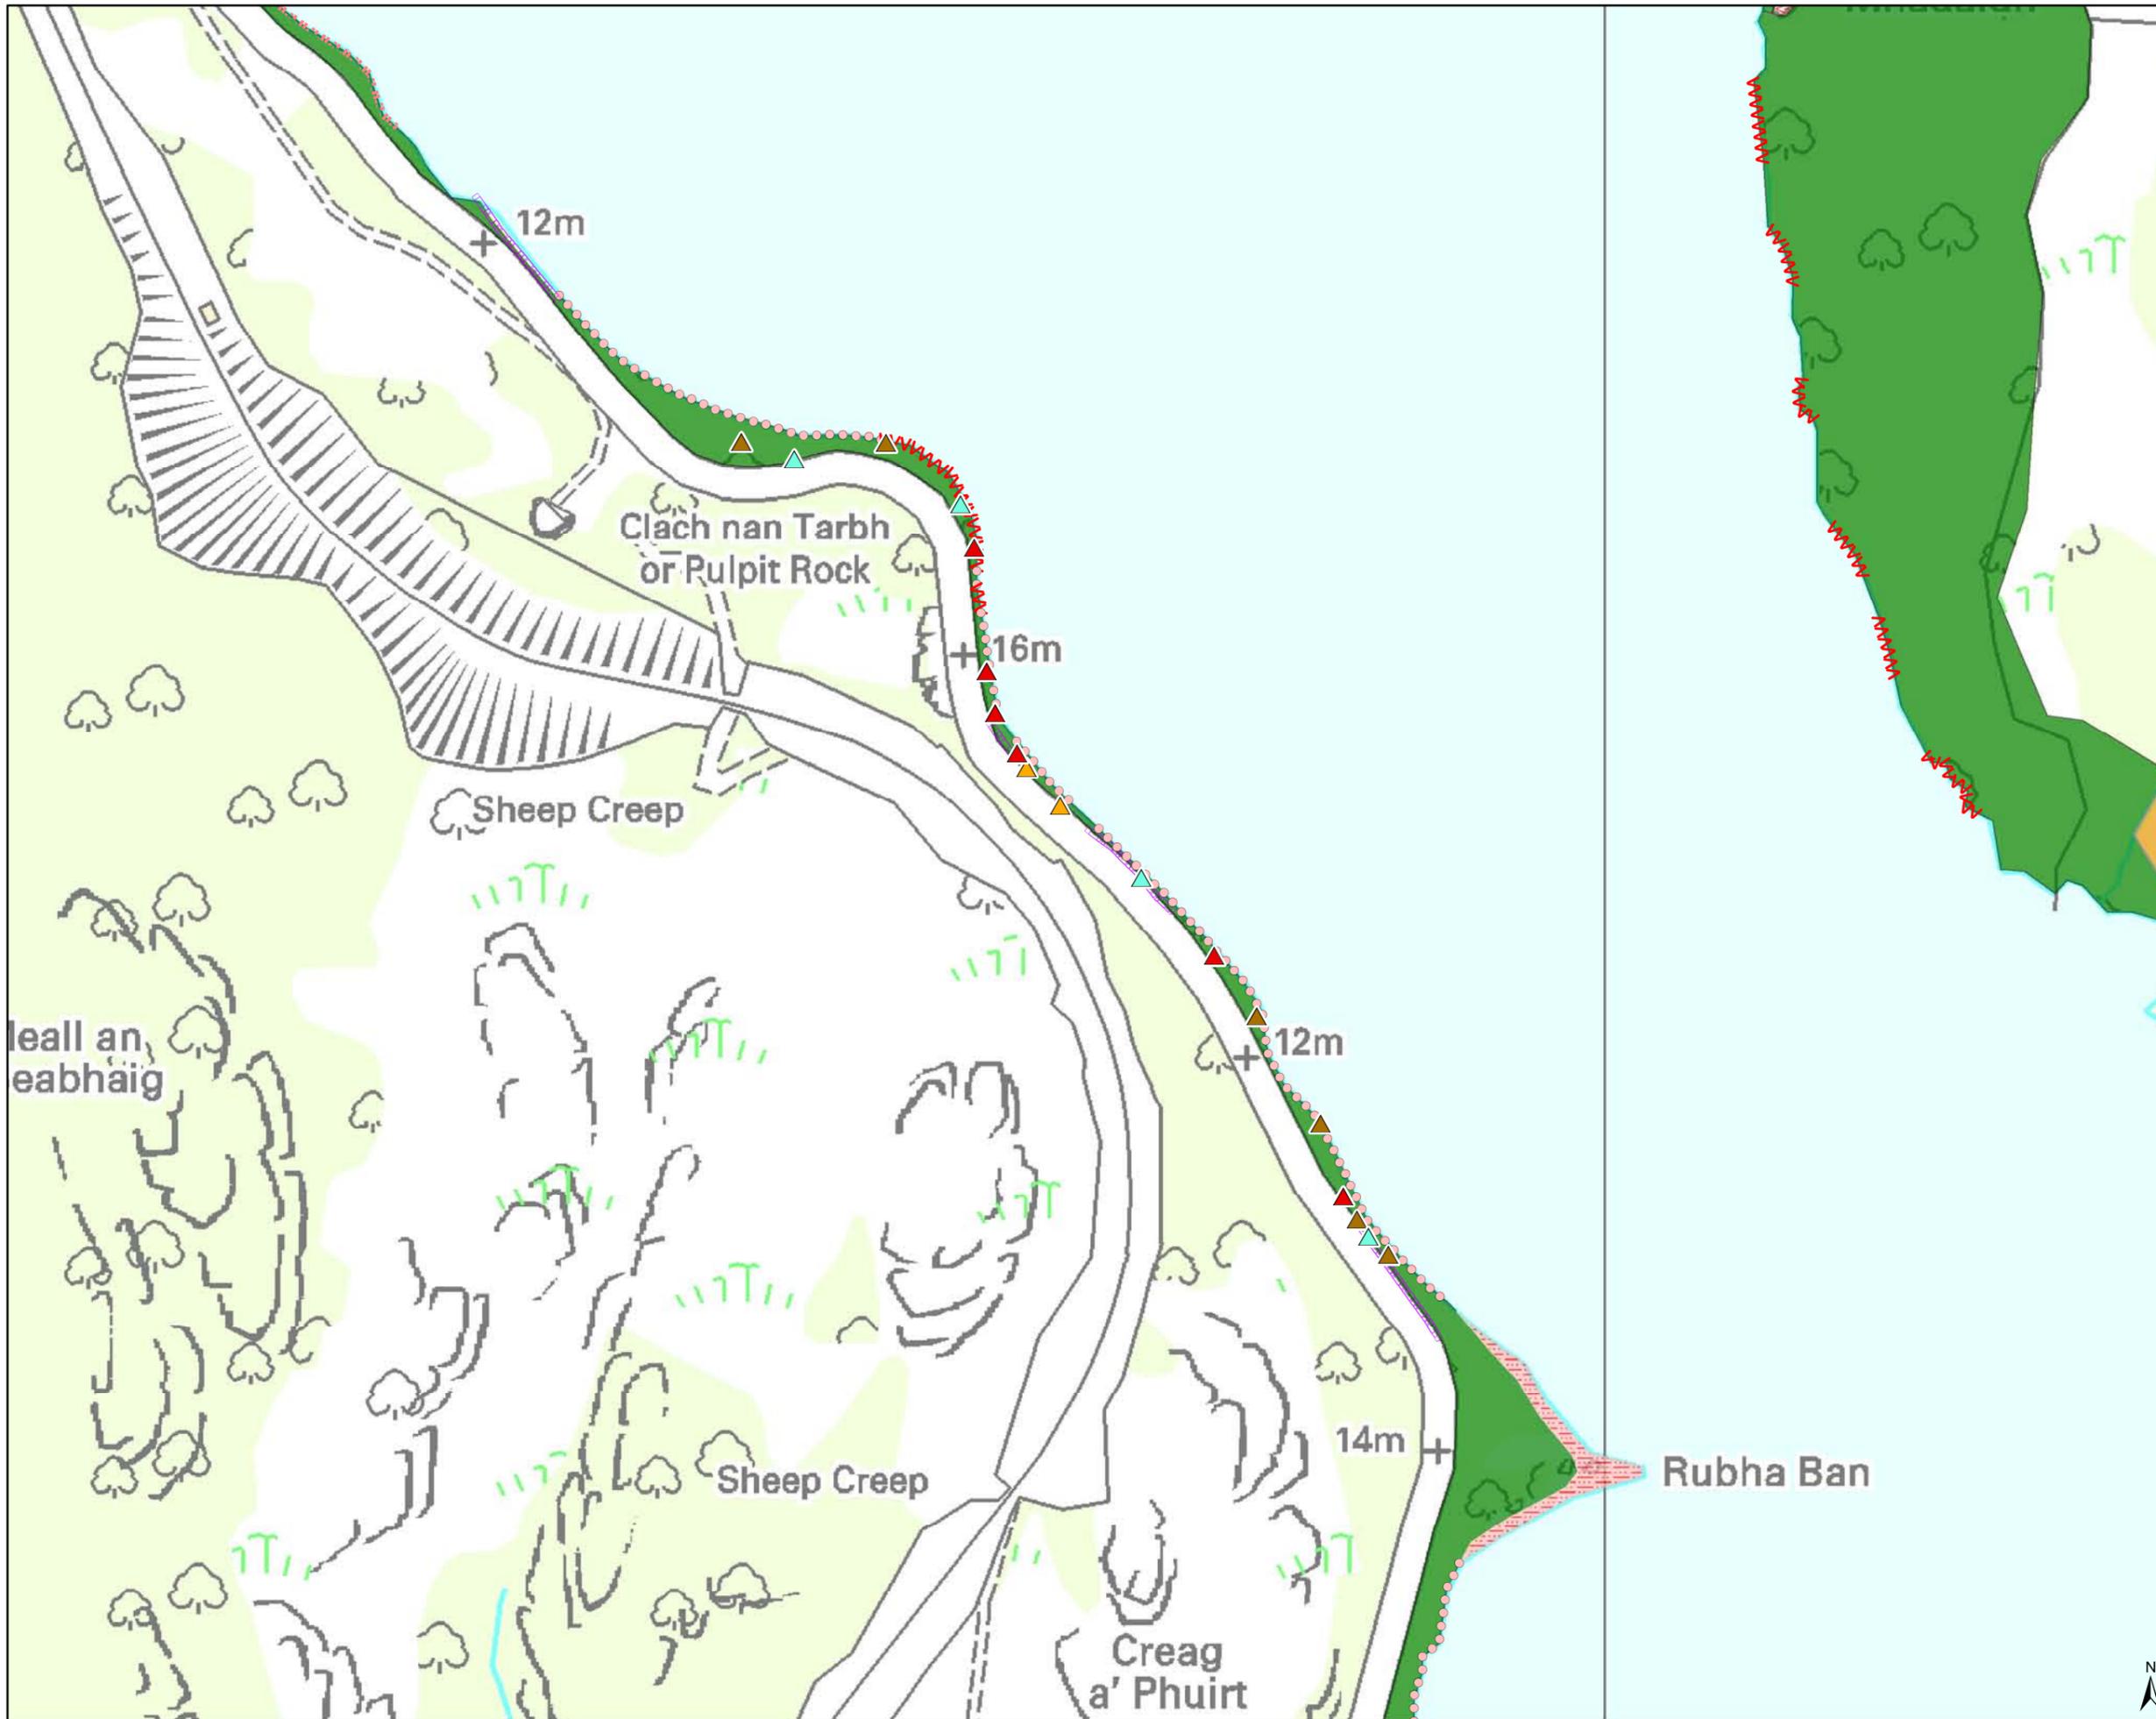
Drawing Number: **FIGURE 5** Rev

**Otter Evidence (from separate local surveys)**
