## Appendix 5 Target Notes

From 2012 Phase 1 Habitat Survey. Where features have been previously target noted in the 2007 ES, (Volume 2, Appendix A3a) these are cross-referenced to the Atkins TN

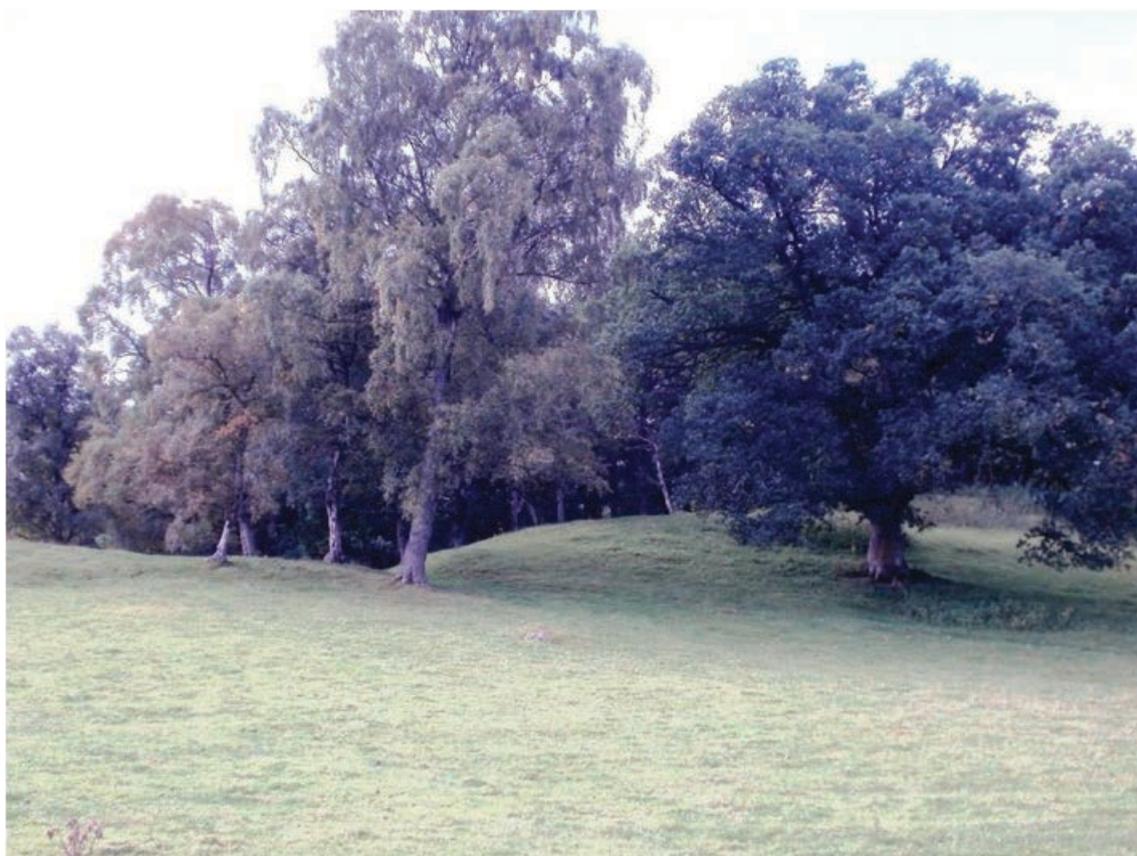
**TN 2.** Open stand of mature parkland oaks and birches over semi-unimproved, sheep-grazed acid grassland dominated by fine-leaved grasses (*F. rubra*, *Agrostis capillaris*, *Anthoxanthum odoratum*) with harebell, autumn hawkbit (*Leontodon autumnalis*), cat's ear (*Hyochoeris radicata*) devil's bit scabious, bird's foot trefoil (*Lotus corniculatus*), mouse-ear hawkweed (*Pilosella officinarum*), germander speedwell (*Veronica chamaedrys*), tormentil, heath dog violet, common mouse-ear (*Cerastium fontanum*) and heath bedstraw (*Galium saxatile*).

Photograph 1. TN 2 Parkland habitat

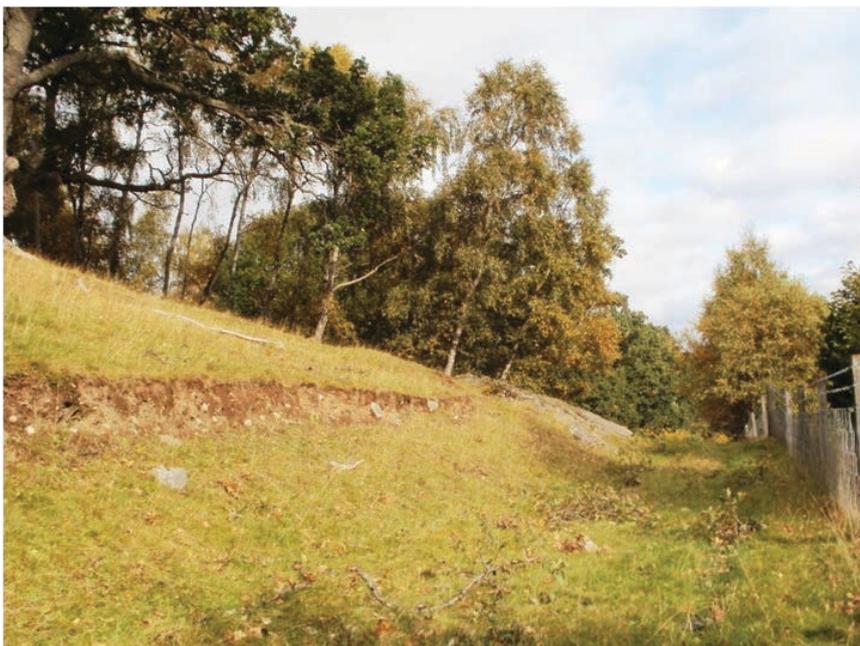
General Wade's Road (below) runs through this site in a shallow cutting with bumblebee nests in the bare earth face.

Photograph 2. Alignment of General Wades' road above steep cutting face of the A9 (right of picture).

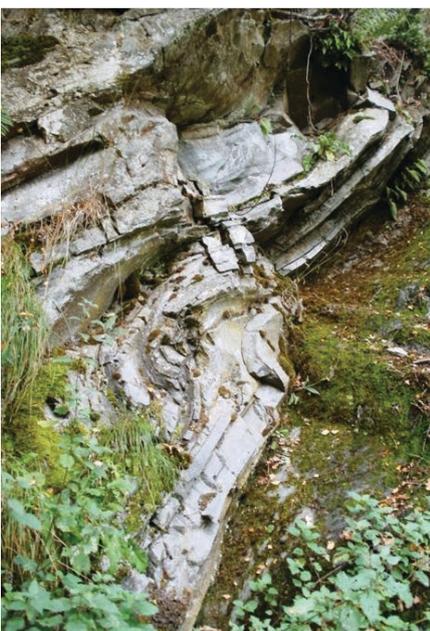
Photograph 3. Complex folding in the outcropping rocks

**TN 3.** Small quarry in mature oak wood with hazel and rowan. Quarry showing exposures of complex, folded gneisses. Similar exposures occur along the A9 verges in this area with seeding birch and oak, fescue grasses, ferns (*Dryopteris felix-mas*, *Polypodium vulgare*) and foxglove (*Digitalis purpurea*).

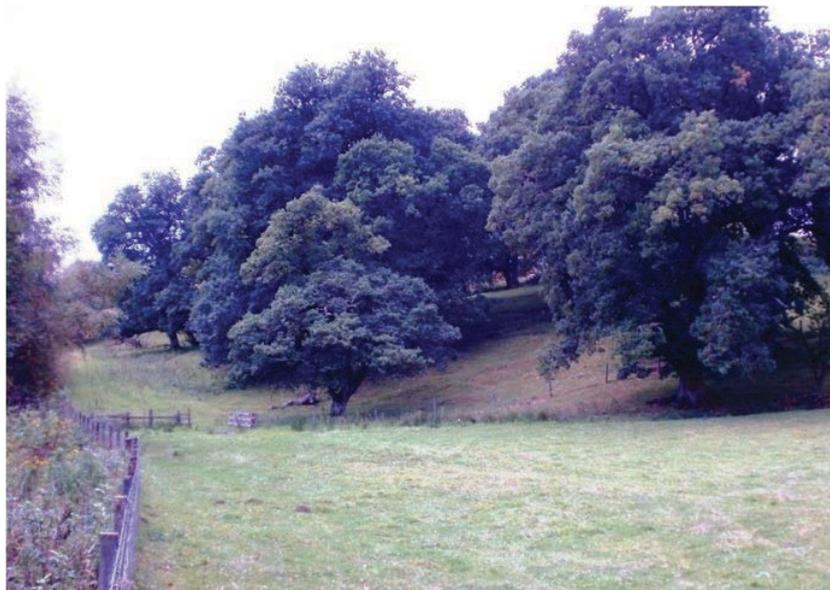
North of the quarry is a small stream between the woodland edge and the field of semi-improved grassland with the narrow and shallow channel mainly occluded by flote-grass (*Glyceria fluitans*) and a variety of wetland herbs along its course, brooklime (*Veronica beccabunga*), marsh willow-herb (*Epilobium palustre*), creeping buttercup (*Ranunculus repens*), water forget-me-not (*Myosotis cespitosa/laxa*), lesser spearwort and water crowfoot (*Ranunculus flammula*, *R. hederacea*). The stream flows eastwards and in culvert under the roadside embankment of colonising birch over on under the A9 through a long culvert passing under the road and a wide embankment on the western verge. Young birches on the embankment with coarse grasses, some dog's mercury (*Mercurialis perennis*) and devil's-bit scabious.

Photograph 4. Looking south to the course of the small burn at TN 3 indicated by rushes along the boundary of the field and woods beyond. Alignment of A9 in the left of picture.

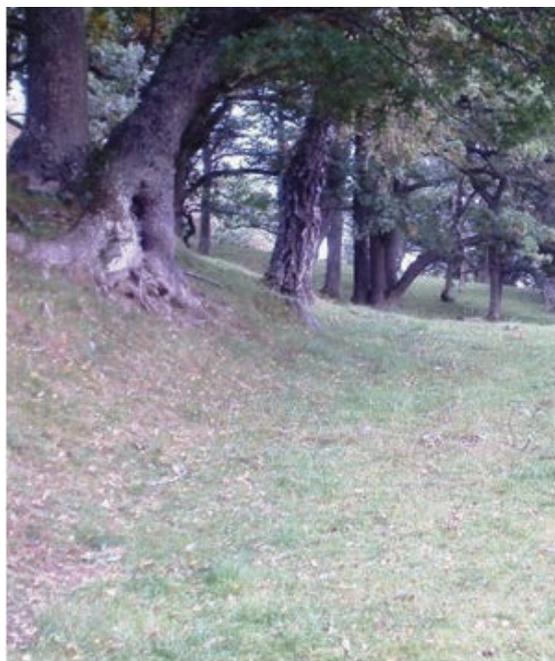
Photograph 5 below: Alignment of G. Wade's Road through parkland habitat to north.

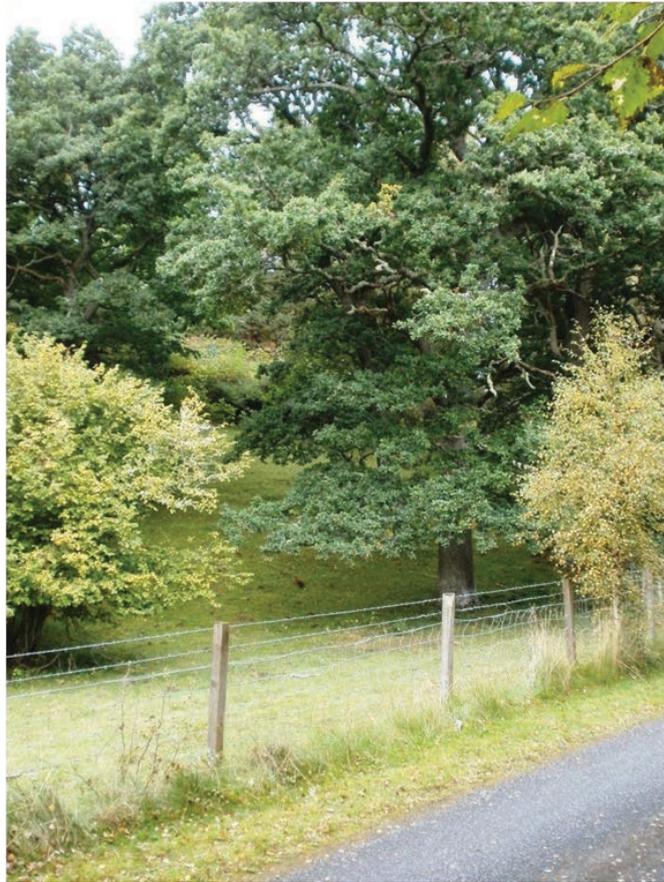
Photograph 6. Woods on the slope between Dunachton Lodge and its access lane

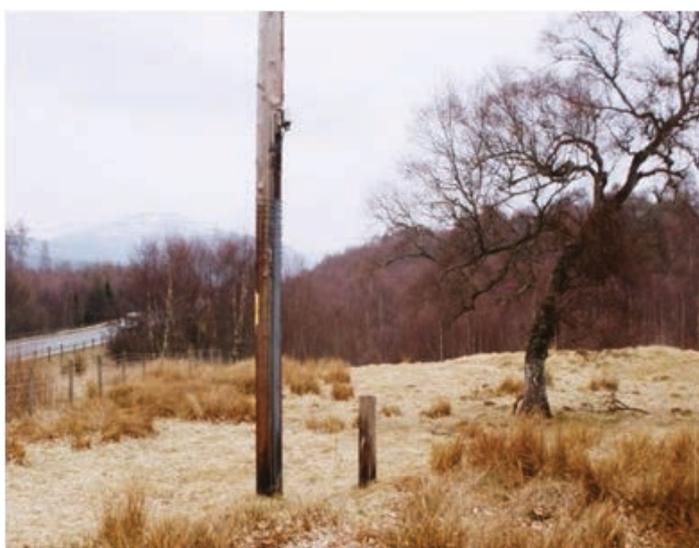
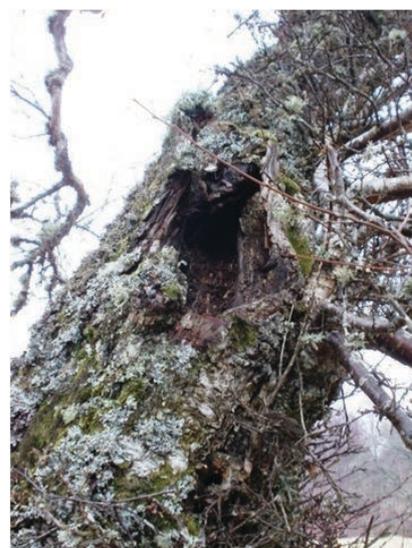
**TN 6.** Semi-improved, species-poor grazed field on a slope down to the B9152 with scattered mature oak, birch and coppiced hazel and occasional patches of bracken and soft rush (*Juncus effusus*). An old downy birch in the northern section of this field, close to the Dunachton Burn, and in the area of the bridge diversion during construction, contains a significant trunk cavity suitable for roosting bats (Photographs 7 & 8, opposite top).

Photographs 7 & 8. Old birch in area of Dunachton bridge (left of picture, looking north) diversion works with cavity extending upwards into the main trunk, around 2.5 metres above ground level providing good roosting conditions for bats.

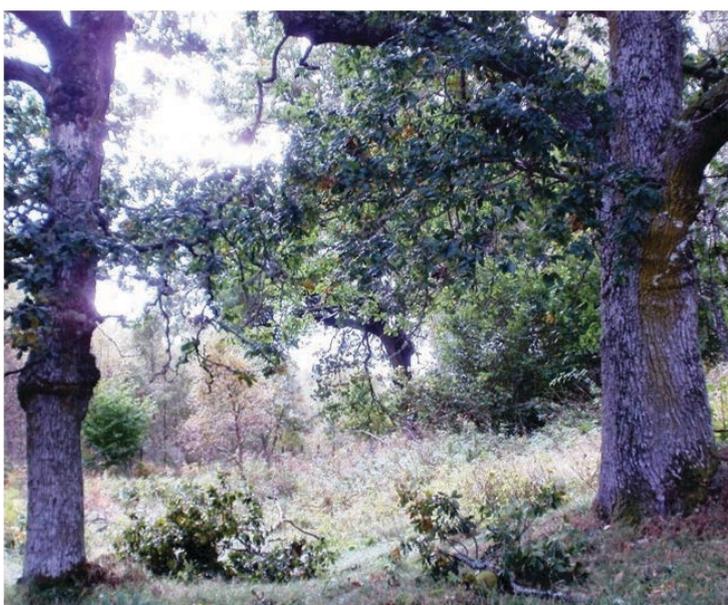
**TN 7.** Large, old oaks in an enclosed open woodland with birch, hazel and rowan. Some trees may have potential for bat roosts. A varied ground flora comprises patches of grassland (*Holcus mollis*, *Dactylis glomeratus*), scrub (*Rubus fruticosus*) bracken and tall herb (*Urtica dioica*) with male fern, grading into a heathy understory up-slope (*Vaccinium myrtillus* & *Deschampsia flexuosa*) with patches of wood sorrel (*Oxalis acetosa*).

Photograph 9 TN 7 Enclosed oak woodland

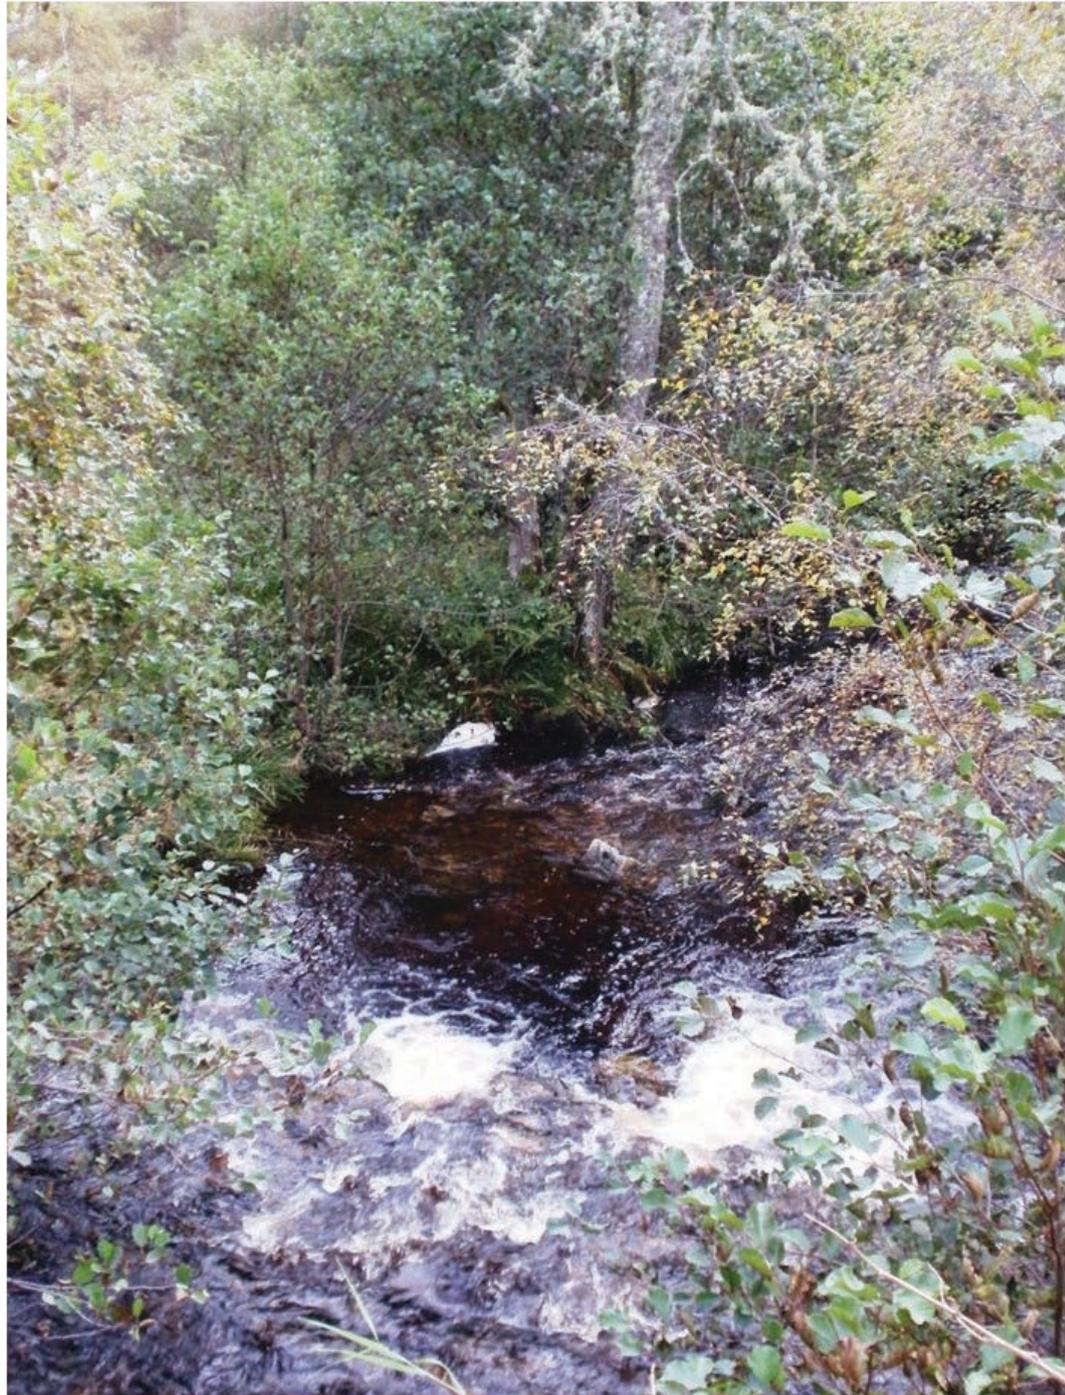
Photograph 10. Dunachton burn flowing through riparian woods of alder birch and willow.

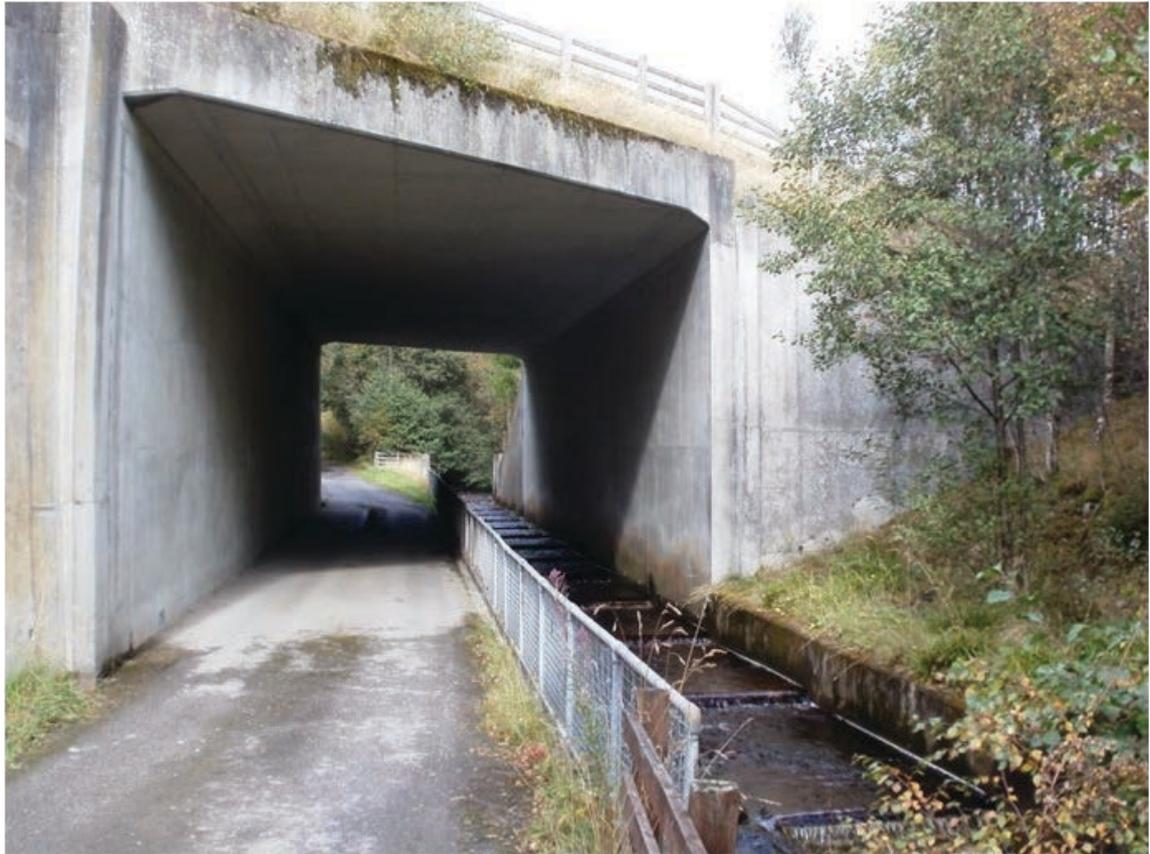
Photograph 11. Looking west along the underpass by the Dunachton burn with fish pass shown. Bridge re-construction should allow for a dry ledge on the north side of the burn (or a mammal ledge retro-fitted) and fencing between the burn and the underpass should be permeable to passage by the larger mammals (otter, badger, wild cat).

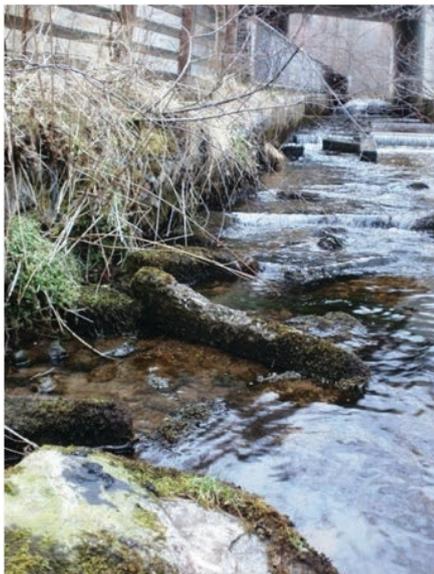
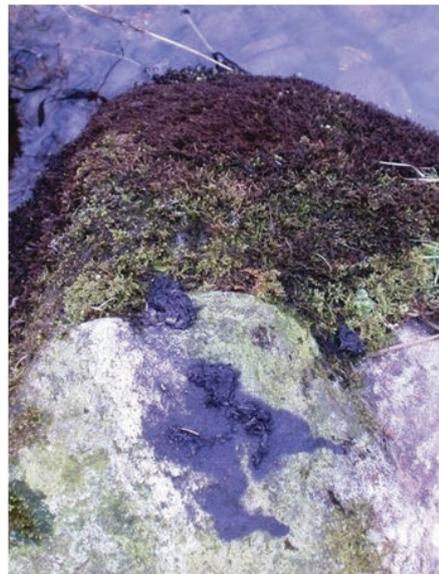
Photograph 12 & 13. Otter spraint on boulder by the bridge recorded in March 2013

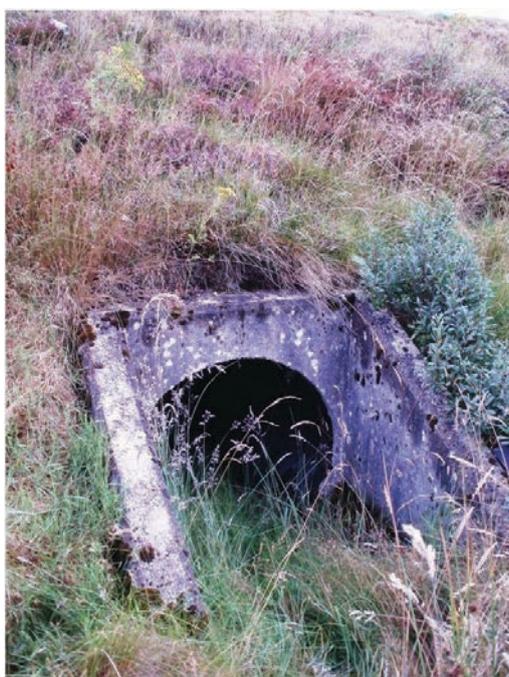
Photograph 14. Culvert under A9 between sites at TN 9 & 10. A dry culvert for mammal passage is proposed at this location with guide fencing.

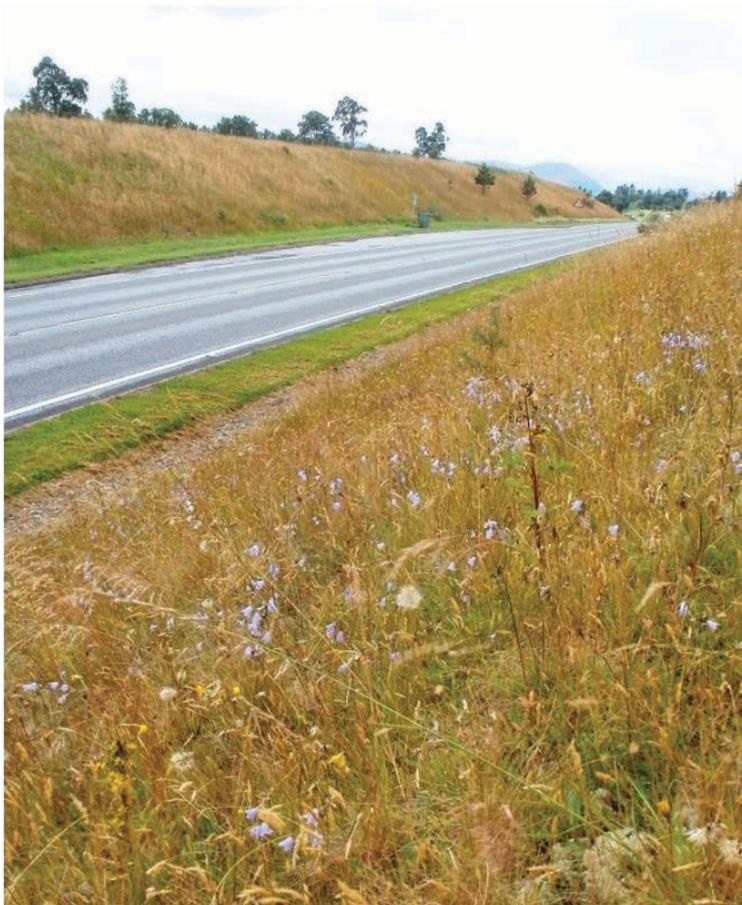
**TN 11.** South easterly facing bank on the western verge of the A9, here in shallow cutting, supports an attractive open, though somewhat species-poor community of fine-leaved grasses dominated by red fescue and sweet vernal-grass with harebell, cat's ear, autumn hawkbit, mouse-ear hawkweed, birds' foot trefoil and scattered heather. Patches of grey Cladonia lichens are frequent.

Photograph 15. Cutting slope at TN 11 looking southwards along the A9

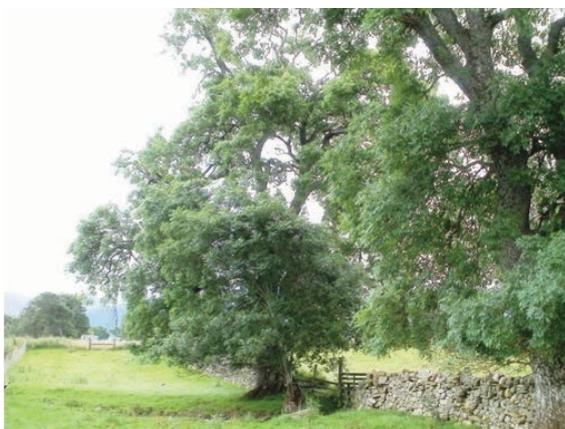
Photograph 16, top left. Veteran ash along the stone wall west of the Lealt burn upstream of the A90 culvert. Any reconstruction necessary of stone walling should ensure that moss or lichen encrusted surfaces are restored with the colonised face outwards.

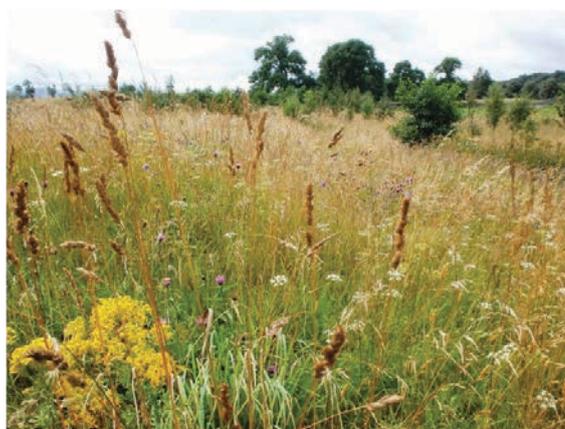
Photograph 17, top right, Lealt burn grasslands in an enclosed young woodland plantation

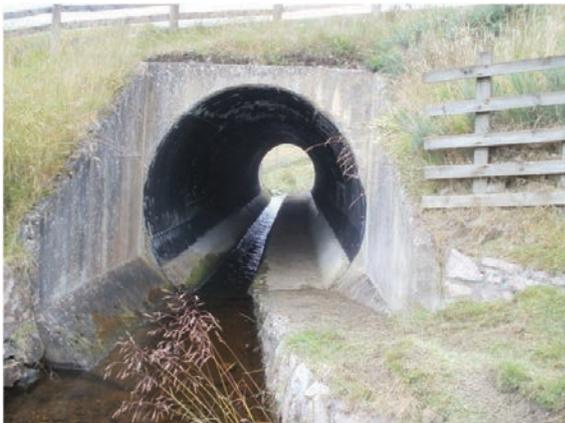
Photograph 18, left. Lealt Burn culvert with broad dry ledge for farm stock access, providing good access for also for native wild mammals including deer.

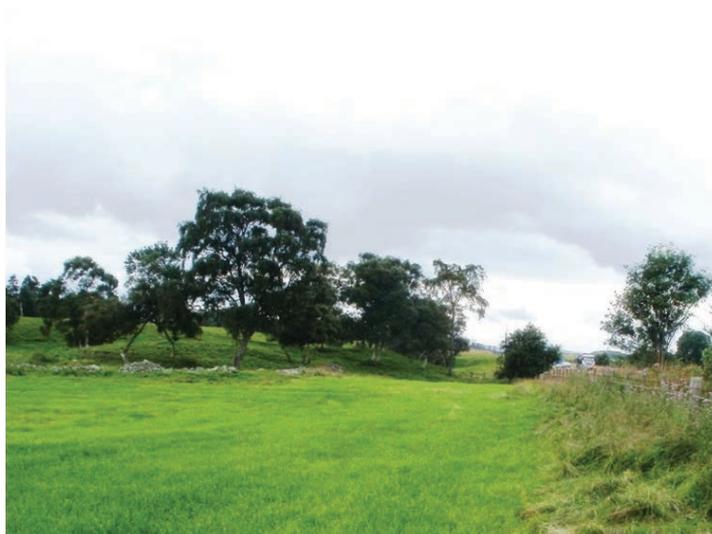
**TN16.** Small hill north of the Leault Burn with a sparse stand of mature aspen (*Populus tremula*) and a large pile of stones in the field corner to the north of this which may provide a refuge for amphibia and common lizard (Photograph 15 below).

Photograph 19. Looking south to the mound with mature poplar to the east of the A9 with the pile of stones on the edge of the re-seeded pasture.

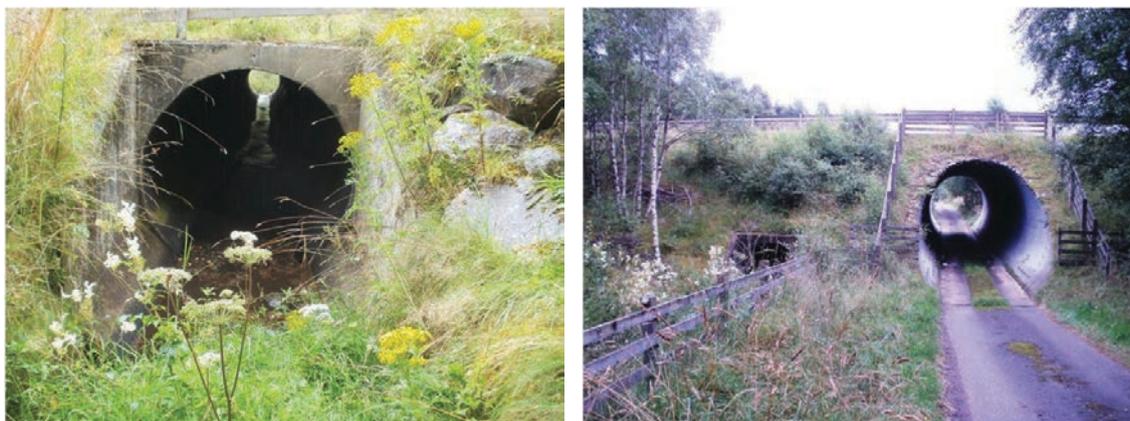
Photograph 20 & 21. Baldow Smiddy culvert and underpass. Provision of a dry culvert here is not necessary as long as any fence between the burn and side road is permeable to passage by the larger mammals in order to provide access into the underpass. (Retrofitting dry ledge within the culvert should also be considered)

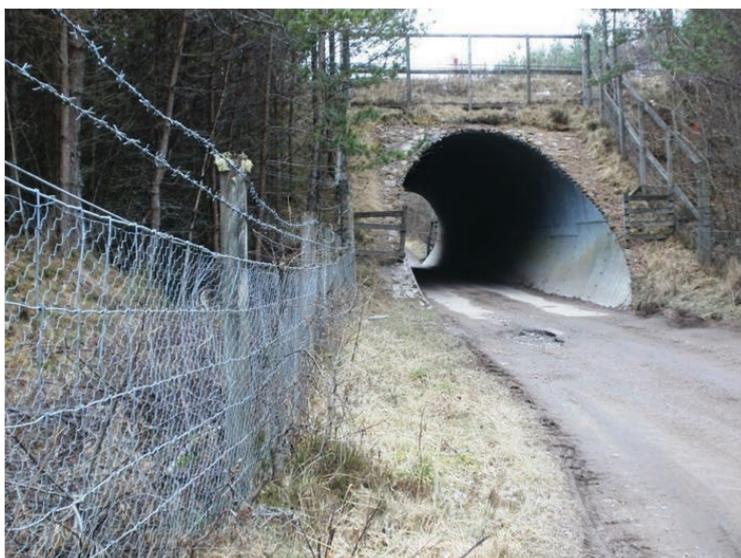
Juniper bushes (Atkins TN 12) occur between the large pond and the fence by the road to Alvie Lodge/ Alvie Home Farm. Chicken-wire mesh on the fences along this section provide an impediment to free passage by wildlife between the woods and the underpass (Photograph 22, opposite). Arrangements should be in place to remove sections of such mesh as part of the improvement works to allow permanent access for wildlife between the underpass and the adjacent woods.

Photograph 22. Mesh fencing renders the underpass unusable to wildlife such as badgers and may encourage species such as pine marten or wild cat to climb the A9 highway fence to cross the alignment in preference to using the underpass.

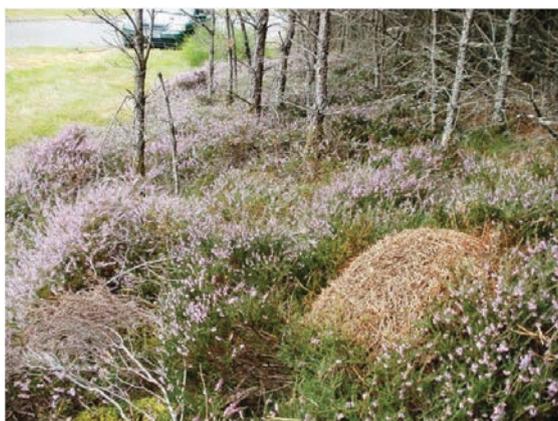
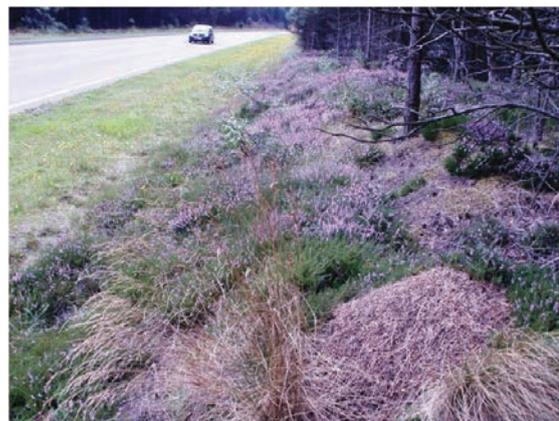
Photographs 23 (left) & 24 (right). Wood ant (*Formica lugubris*) nests in typical locations along the A9 western verge, on the sunlit edge of the young pine woods.

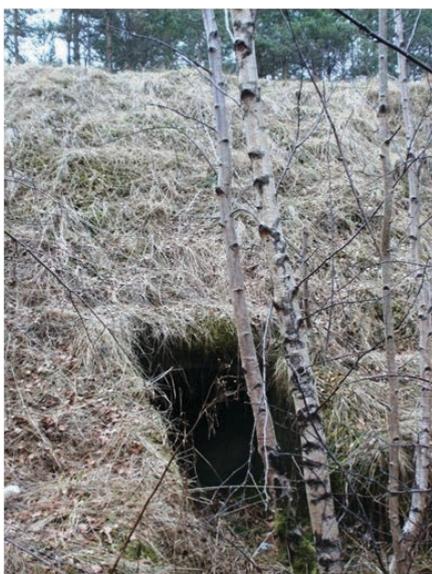
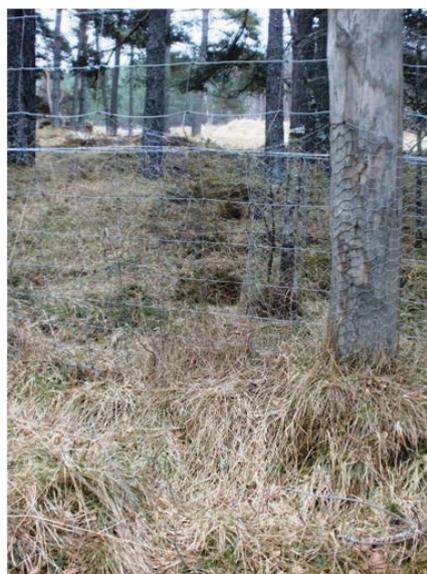
A pipe culvert under the A9 is present here, but is dry, potentially providing a valuable mammal underpass point but prevented from functioning effectively by the mesh applied to the highway deer fencing (Photographs 25 & 26) . Such old, and new culverts must be opened up to effective use by mammals as part of the improvement works by ensuring appropriate fencing design to allow continuity of passage.

Photographs 25 & 26. Pipe culvert rendered inefficient by the mesh of the adjacent deer fence. A lightly used trail is present along the road-side edge of the deer fence suggesting occasional use by wildlife moving within the road corridor.

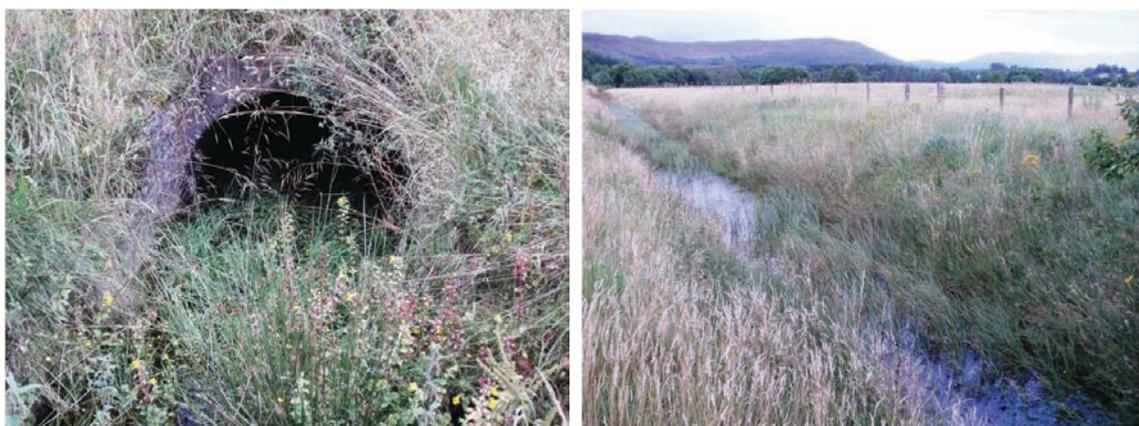
North of this cutting is a watercourse, culverted under the road with roadside drainage ditches on either side of the A9 inflowing from the north (Atkins TN 20) that have colonised with an array of aquatic species, presumably from the adjacent watercourse. Aquatic plant species include a high cover of the non-native monkey flower (*Mimulus sp.*) sharp-flowered rush, soft rush, bulbous rush, marsh marigold, spearwort, broad-leaved pondweed (*Potamogeton natans*) and bottle sedge (Photographs 23 & 24). Burn flows north-east, past Dalraddy farm, into Loch Alvie

Photographs 27 & 28 below. Dalraddy culvert and roadside ditch on the east of the A9. Provide dry culvert for mammal passage with guide fencing.

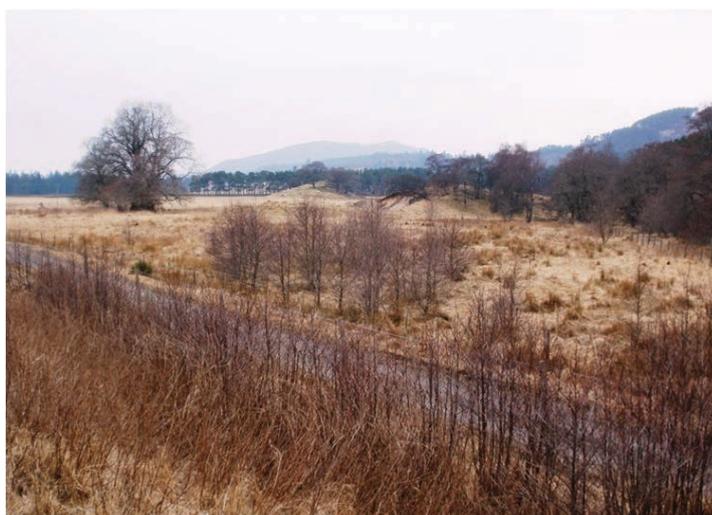
Photograph 29. Site for woodland mitigation, taken looking south-west from the A9 with the Allt an Fhearna right of picture and the stand of veteran wych elm in the far left.

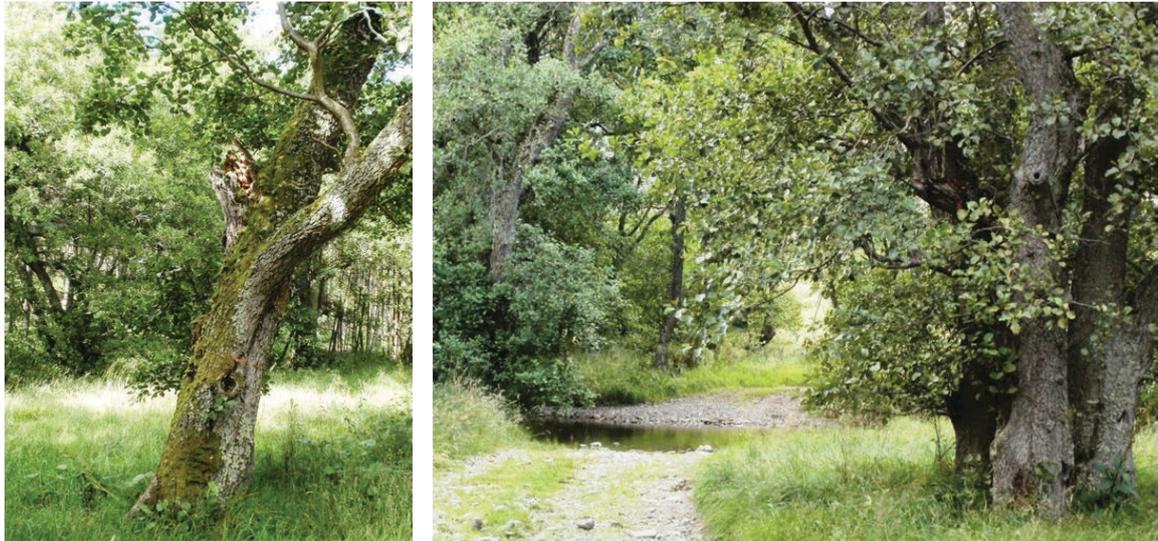
Mature alder woodlands dominate the banks of the Allt an Fhearna together with grey and goat willows, birch and the occasional aspen (Atkins TN 25) and some of the mature alder trees may also have potential for bat roosts (Photographs 30 & 31 below). Younger wet woodland of alder (Photograph 32) dominates the narrow flood-plain between the river and the eastern embankment of the A9 with older trees along the river banks. Scats and spraints indicate use of the Allt an Fhearna corridor and underpass under the A9 by pine marten and otter (Photographs 33 - 35 below).

Photographs 30 & 31 below. Older alders in the riparian woodlands by the Allt an Fhearna. Cavities in any trees to be removed for bridge works will require inspections for bat roosts.

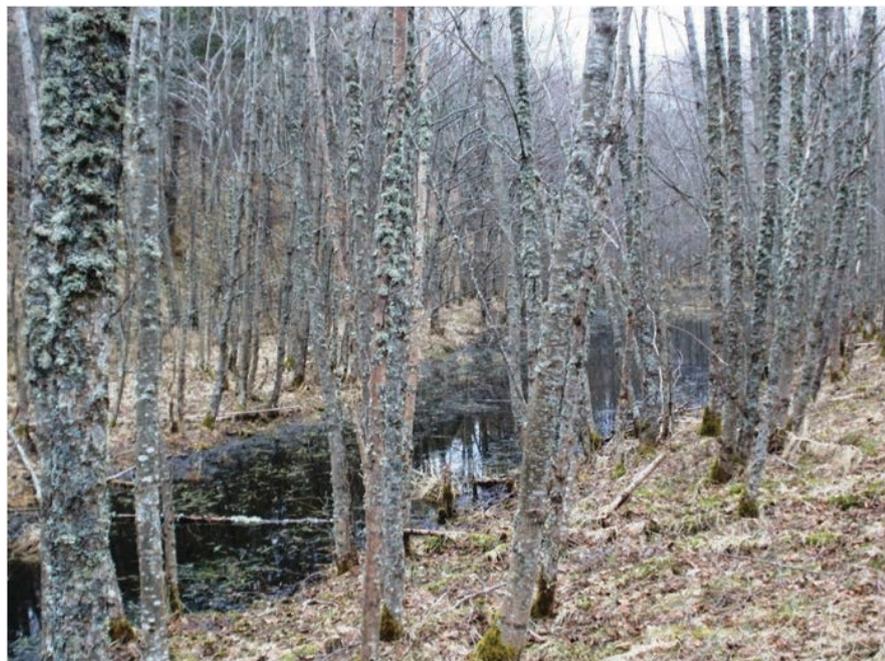
Photograph 32. Looking north through wet alder woods between the A9 embankment (left of picture) and the Allt an Fhearna (right).

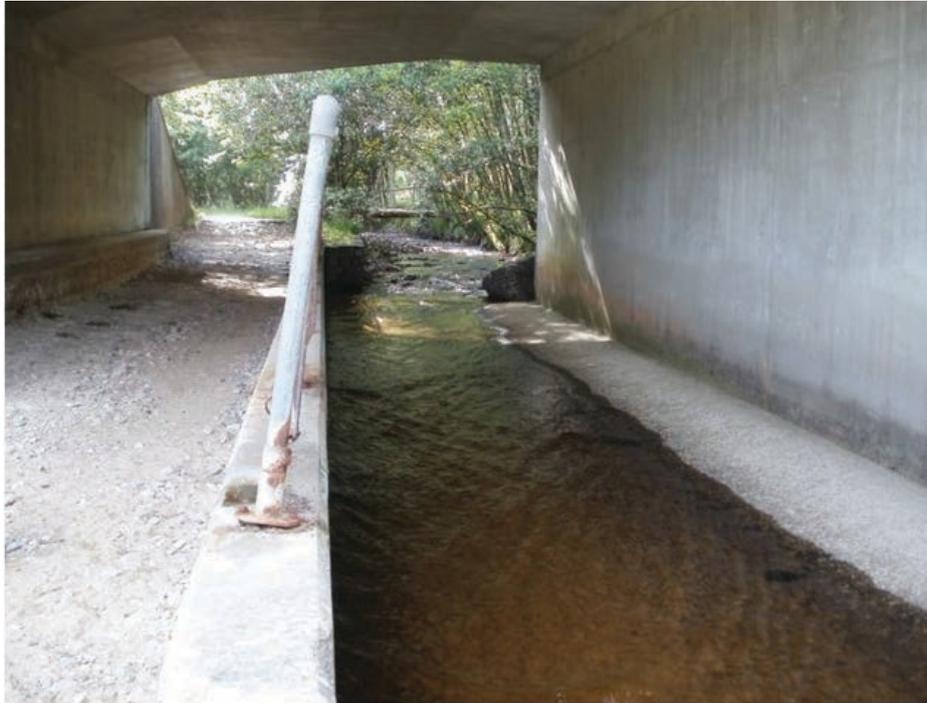
Photograph 33. Otter spraint staining a boulder downstream of the A9 bridge

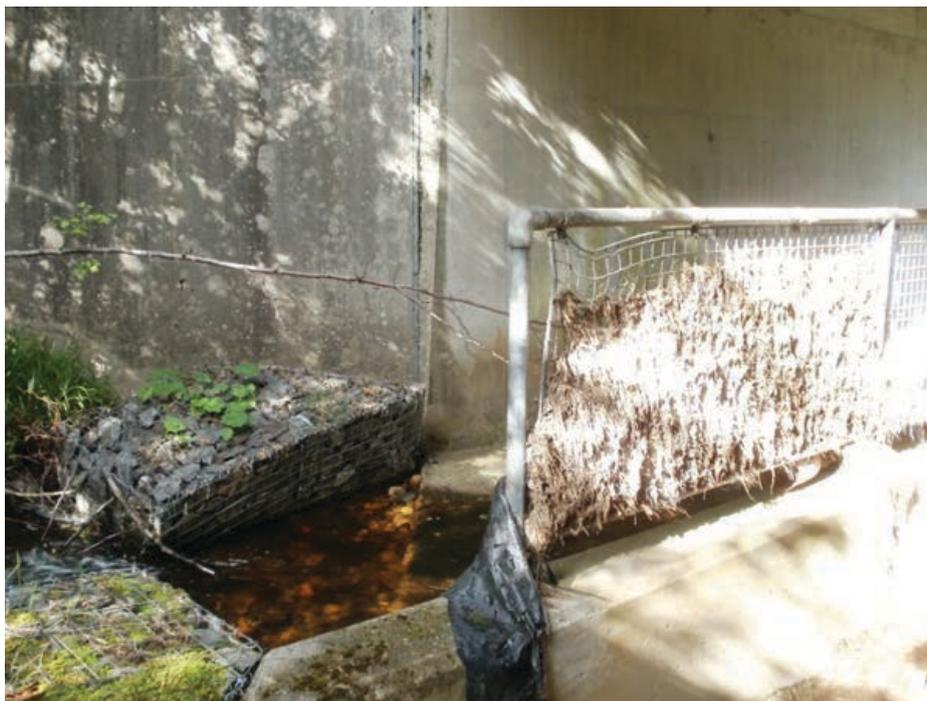
Photographs 34 & 35. Allt an Fhearna and underpass. Note trash line on fencing indicating height of spate flows. Bridge works should allow for retention of dry ledge or retro-fit ledge on north bridge abutment at a height to accommodate mean high-water levels to allow passage to mammals.
