Project **FORTH REPLACEMENT CROSSING**

CONSTRUCTION NOISE MONITORING REPORT: OCTOBER 2014

Document number	Rev
REP-00203	01

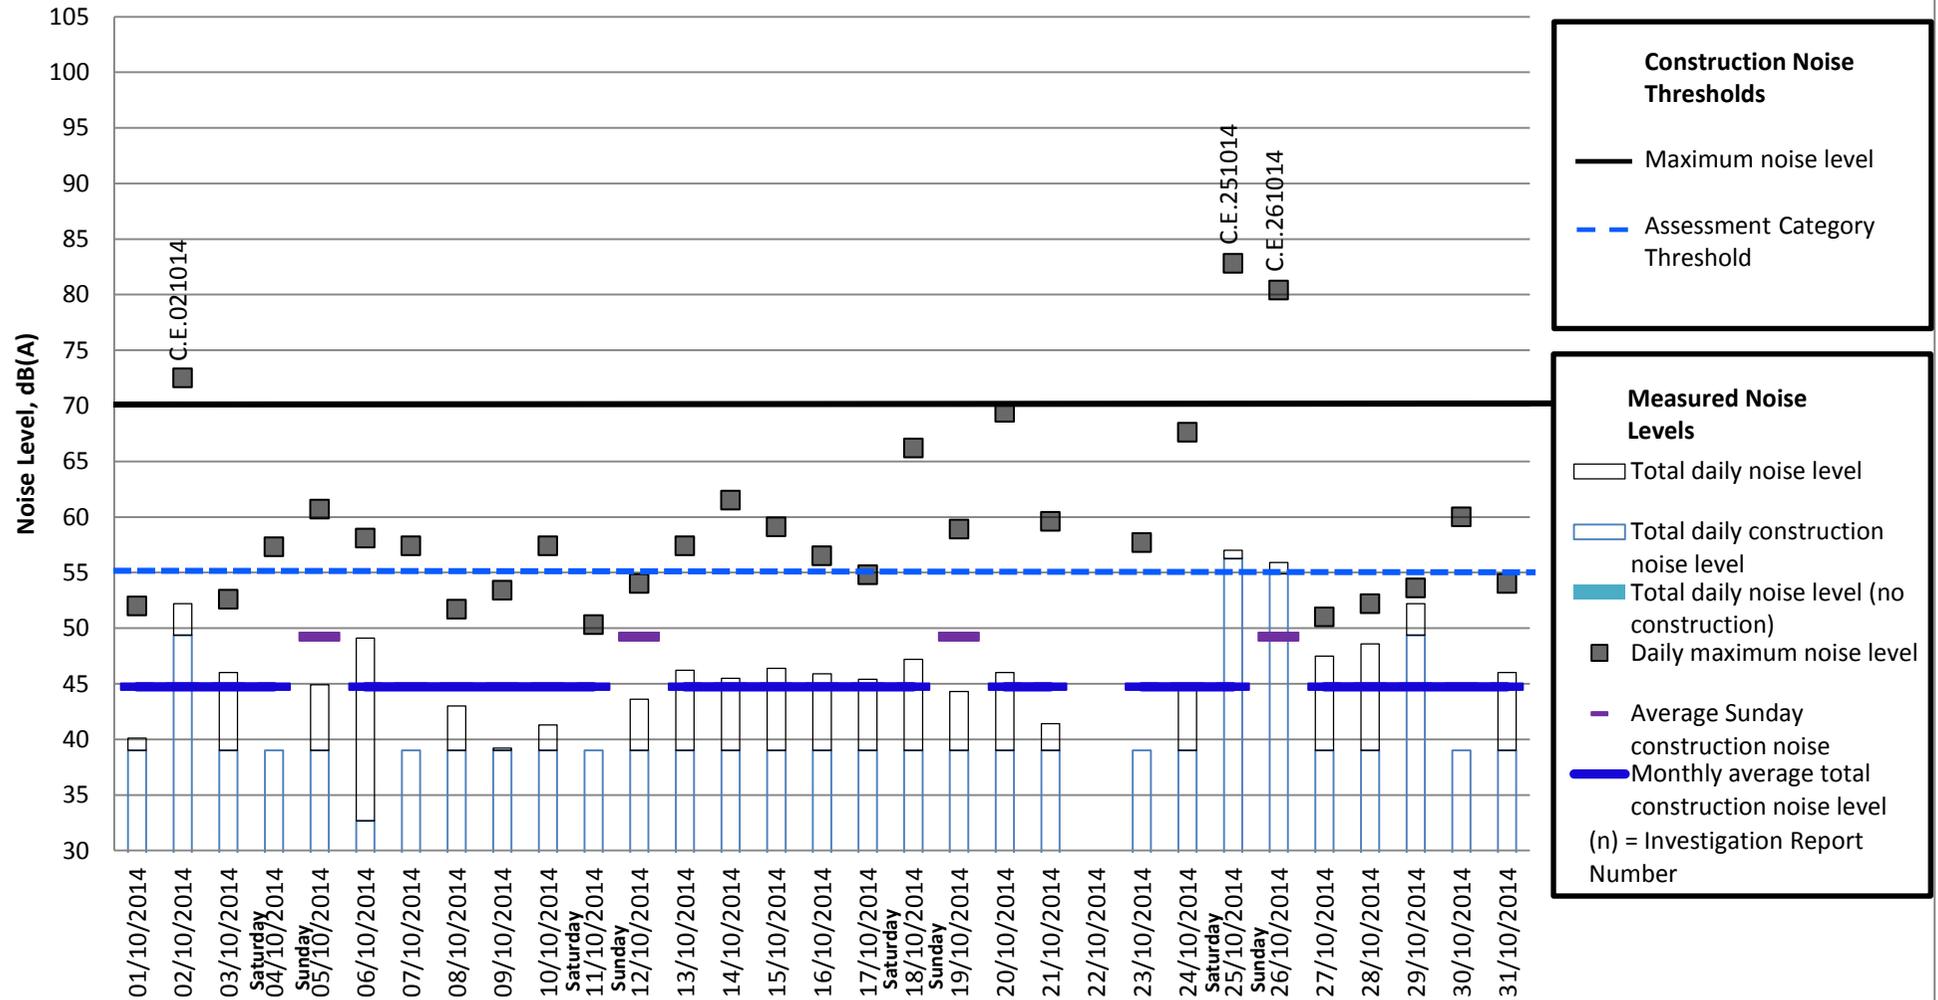
Measured Evening Noise Levels at Clufflat Brae Measurement period: October 2014

Note: Data is missing from the 22/10/14 due to a device error.

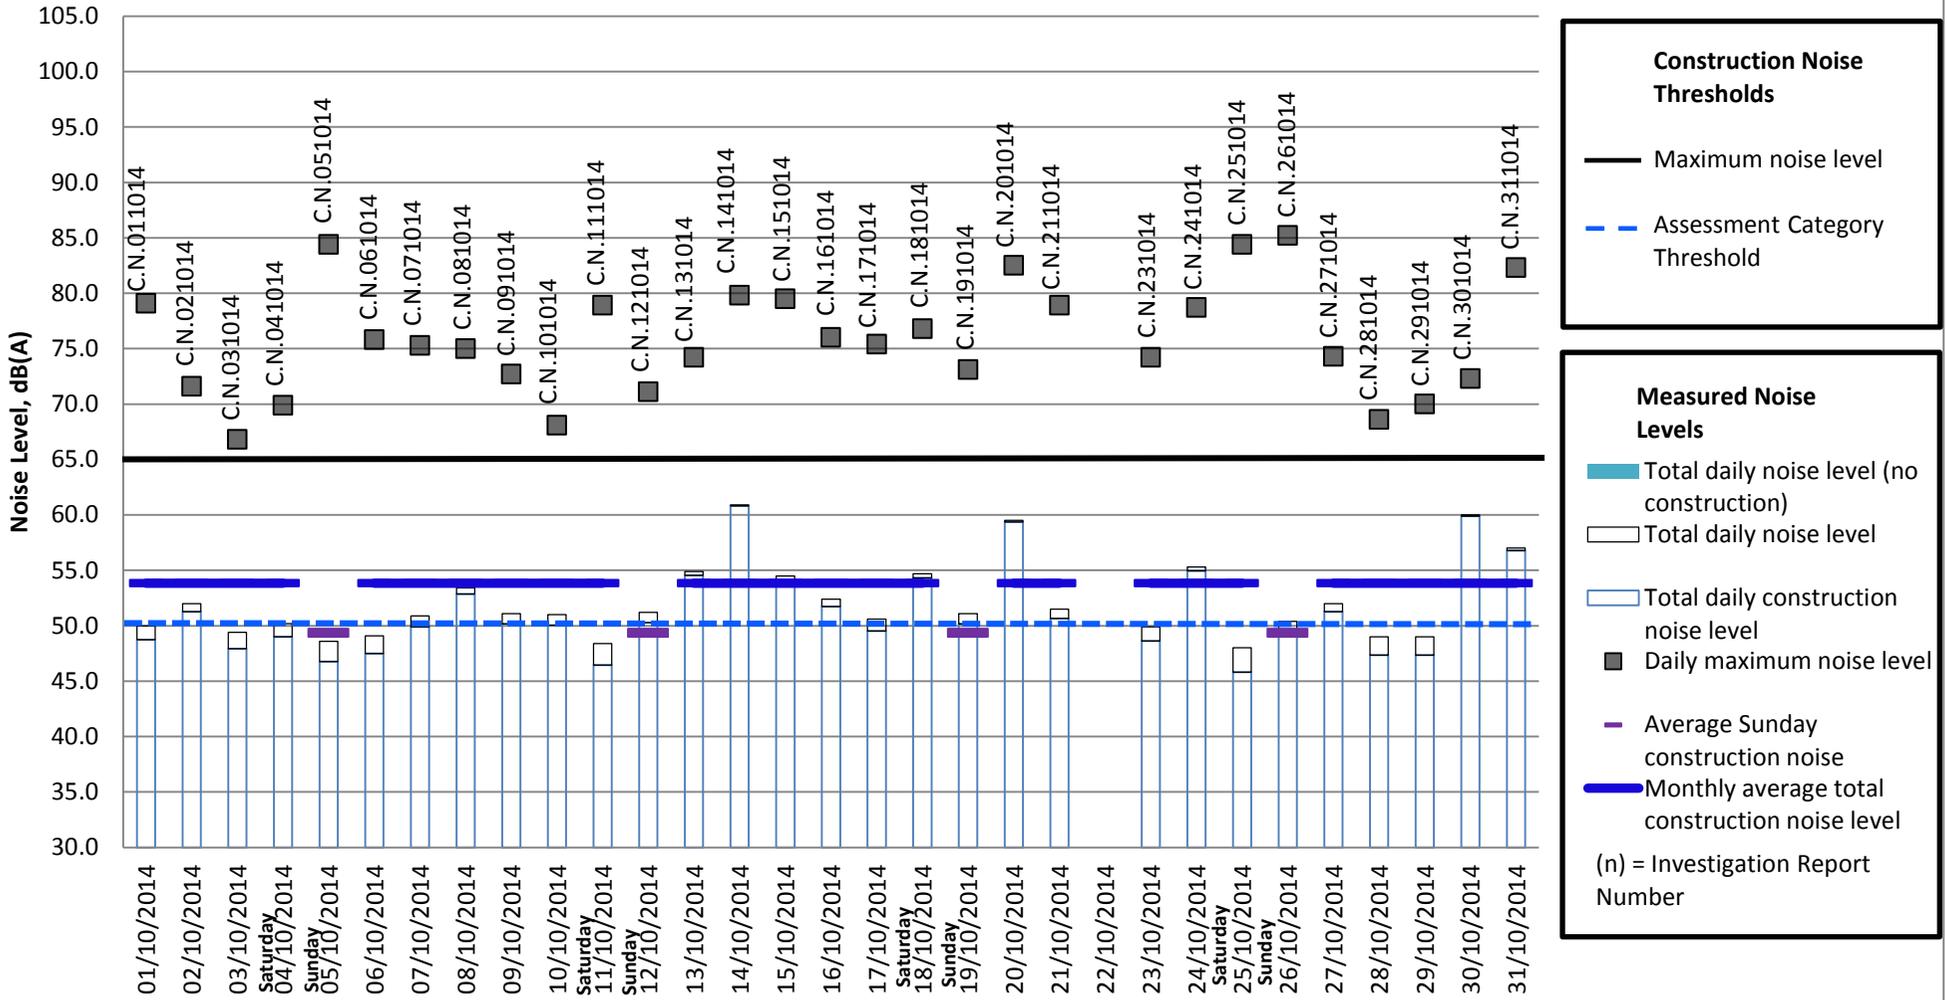
Measured Night-time Noise Levels at Clufflat Brae

Note: Data is missing from the 22/10/14 due to a device error.

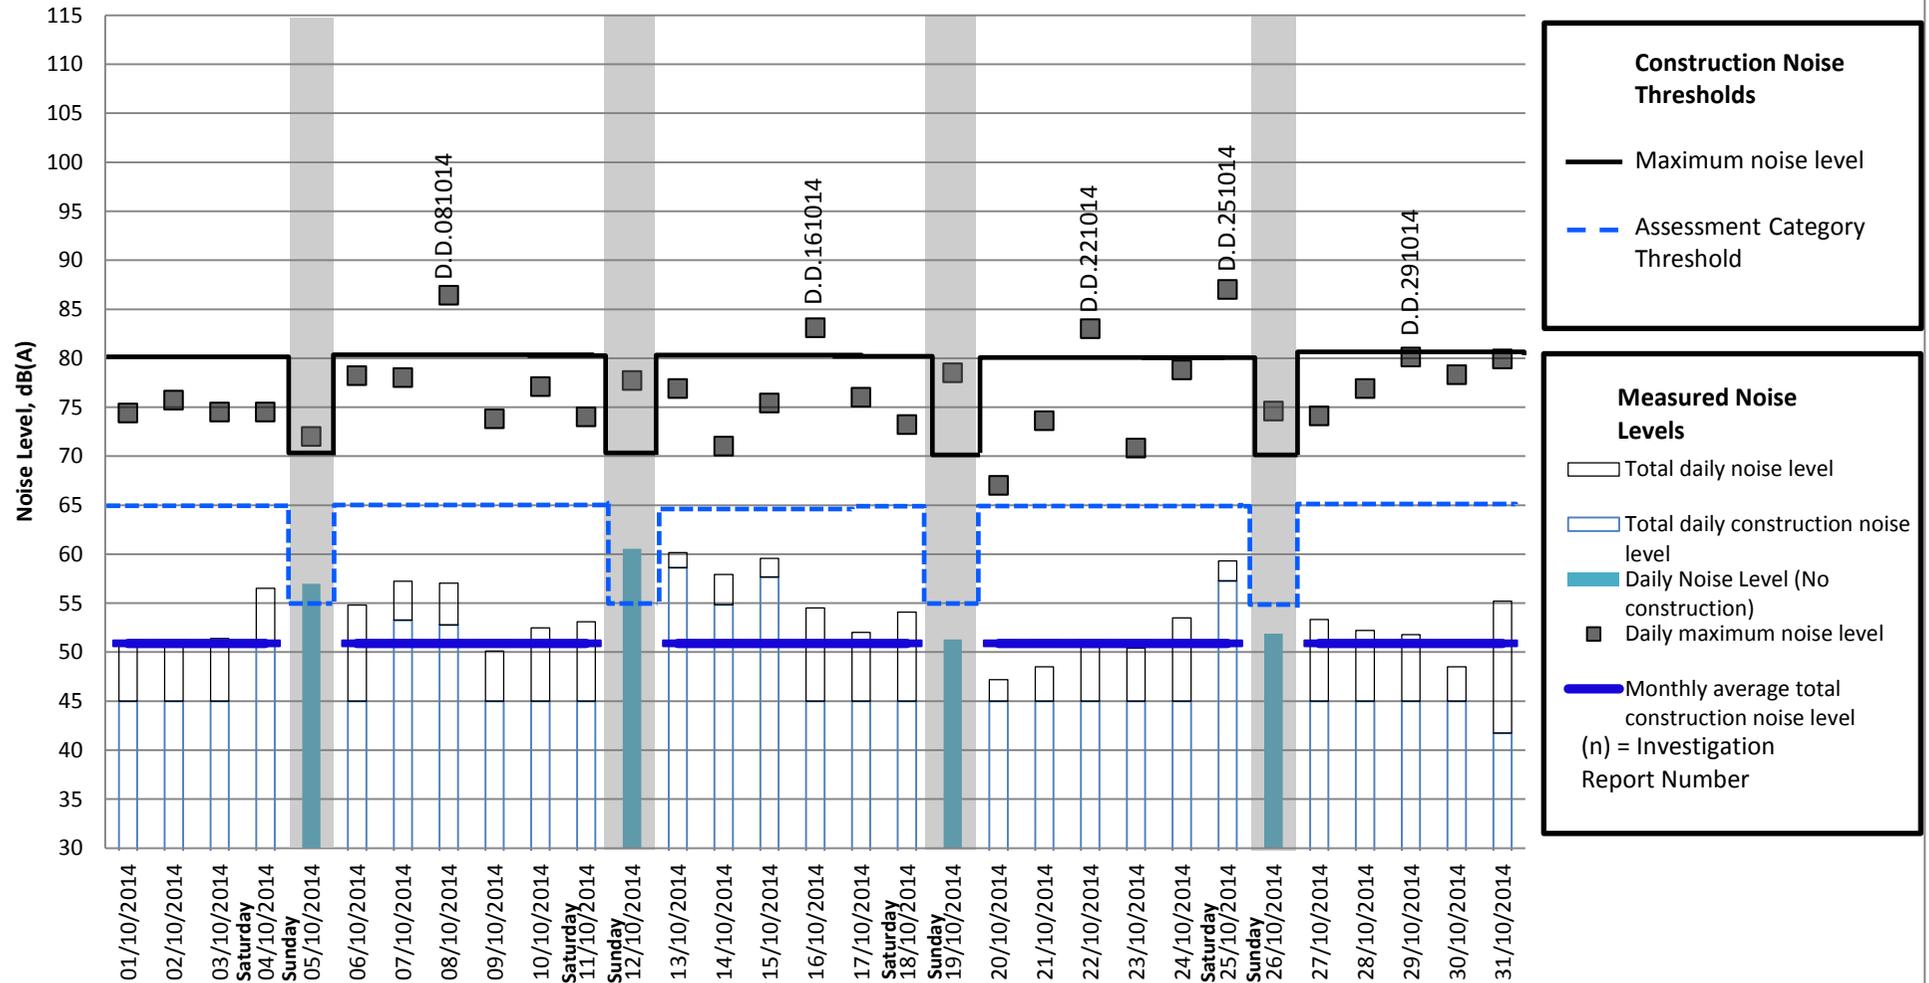
Measured Daytime Noise Levels at Dundas Home Farm Measurement period: October 2014

Note: The grey areas of the chart represent days on which no construction works have been conducted. The monthly average construction noise for Sunday has not been included as no Sunday works have been conducted at this location.

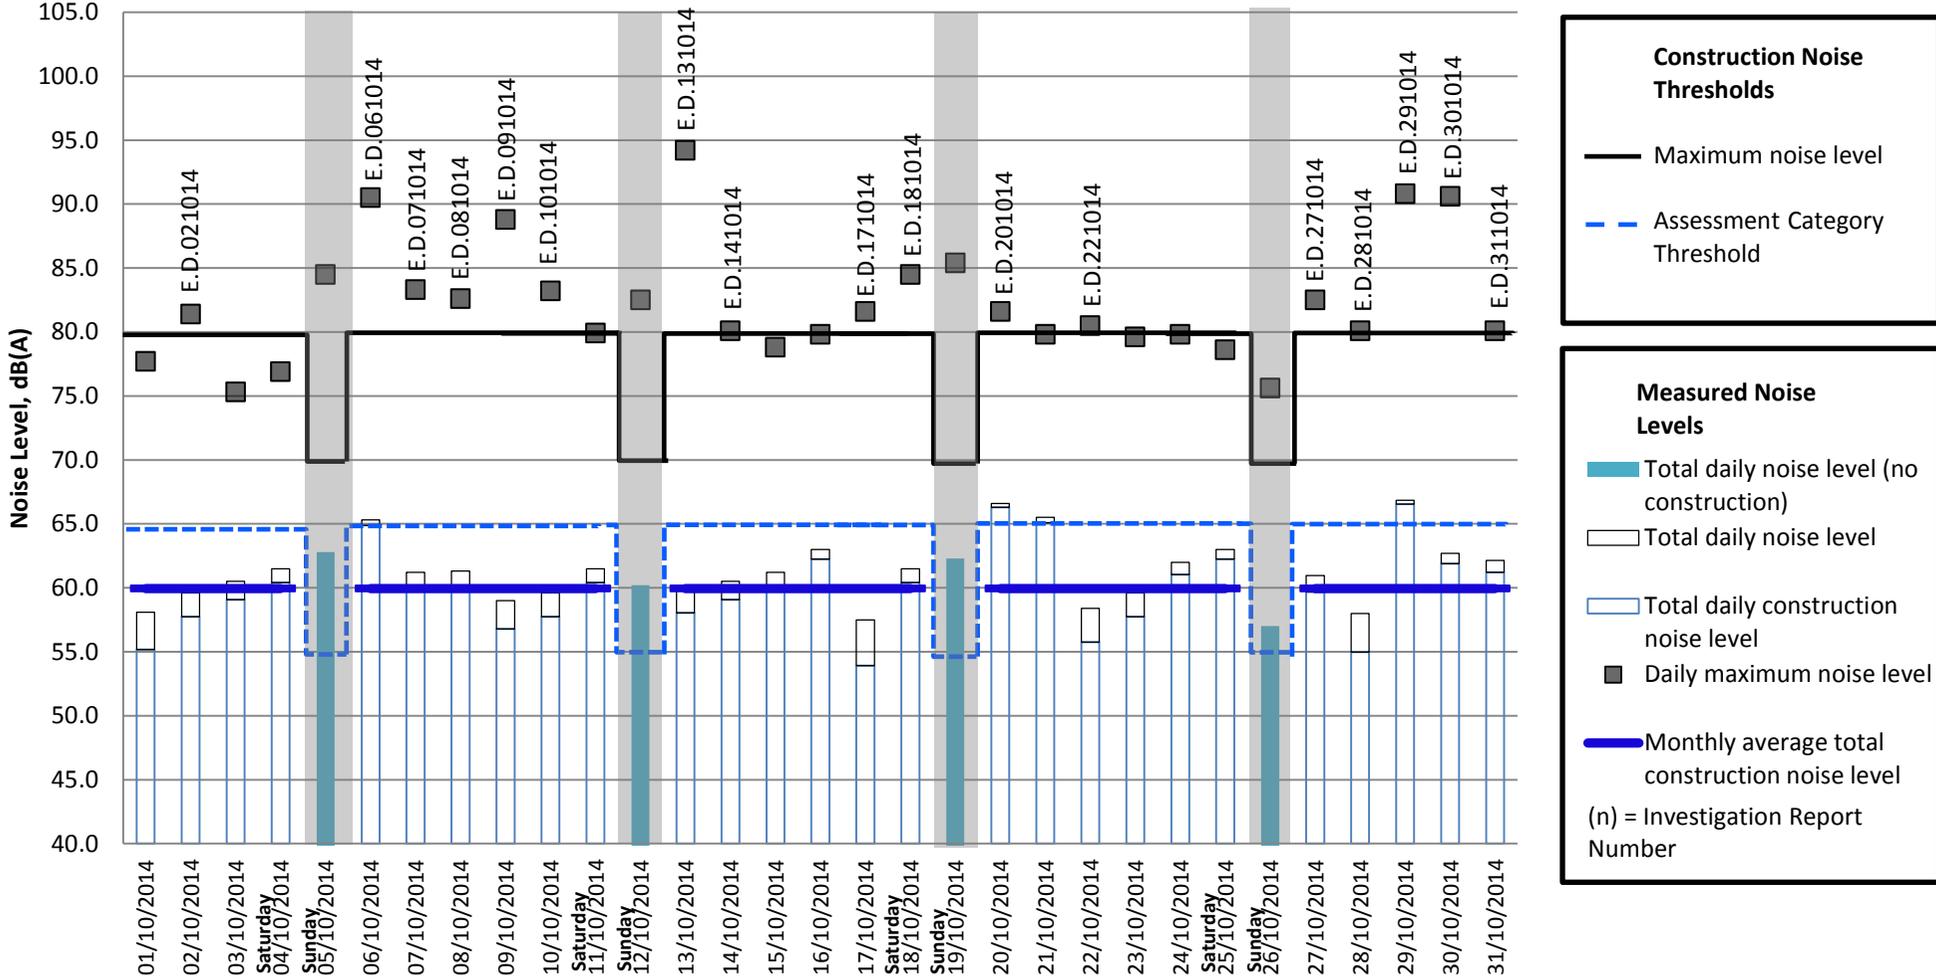
Measured Daytime Noise Levels at Echline Field

Note: The grey areas of the chart represent days on which no construction works have been conducted. A Sunday average has not been included on the graph as no Sunday works have been undertaken at this location.

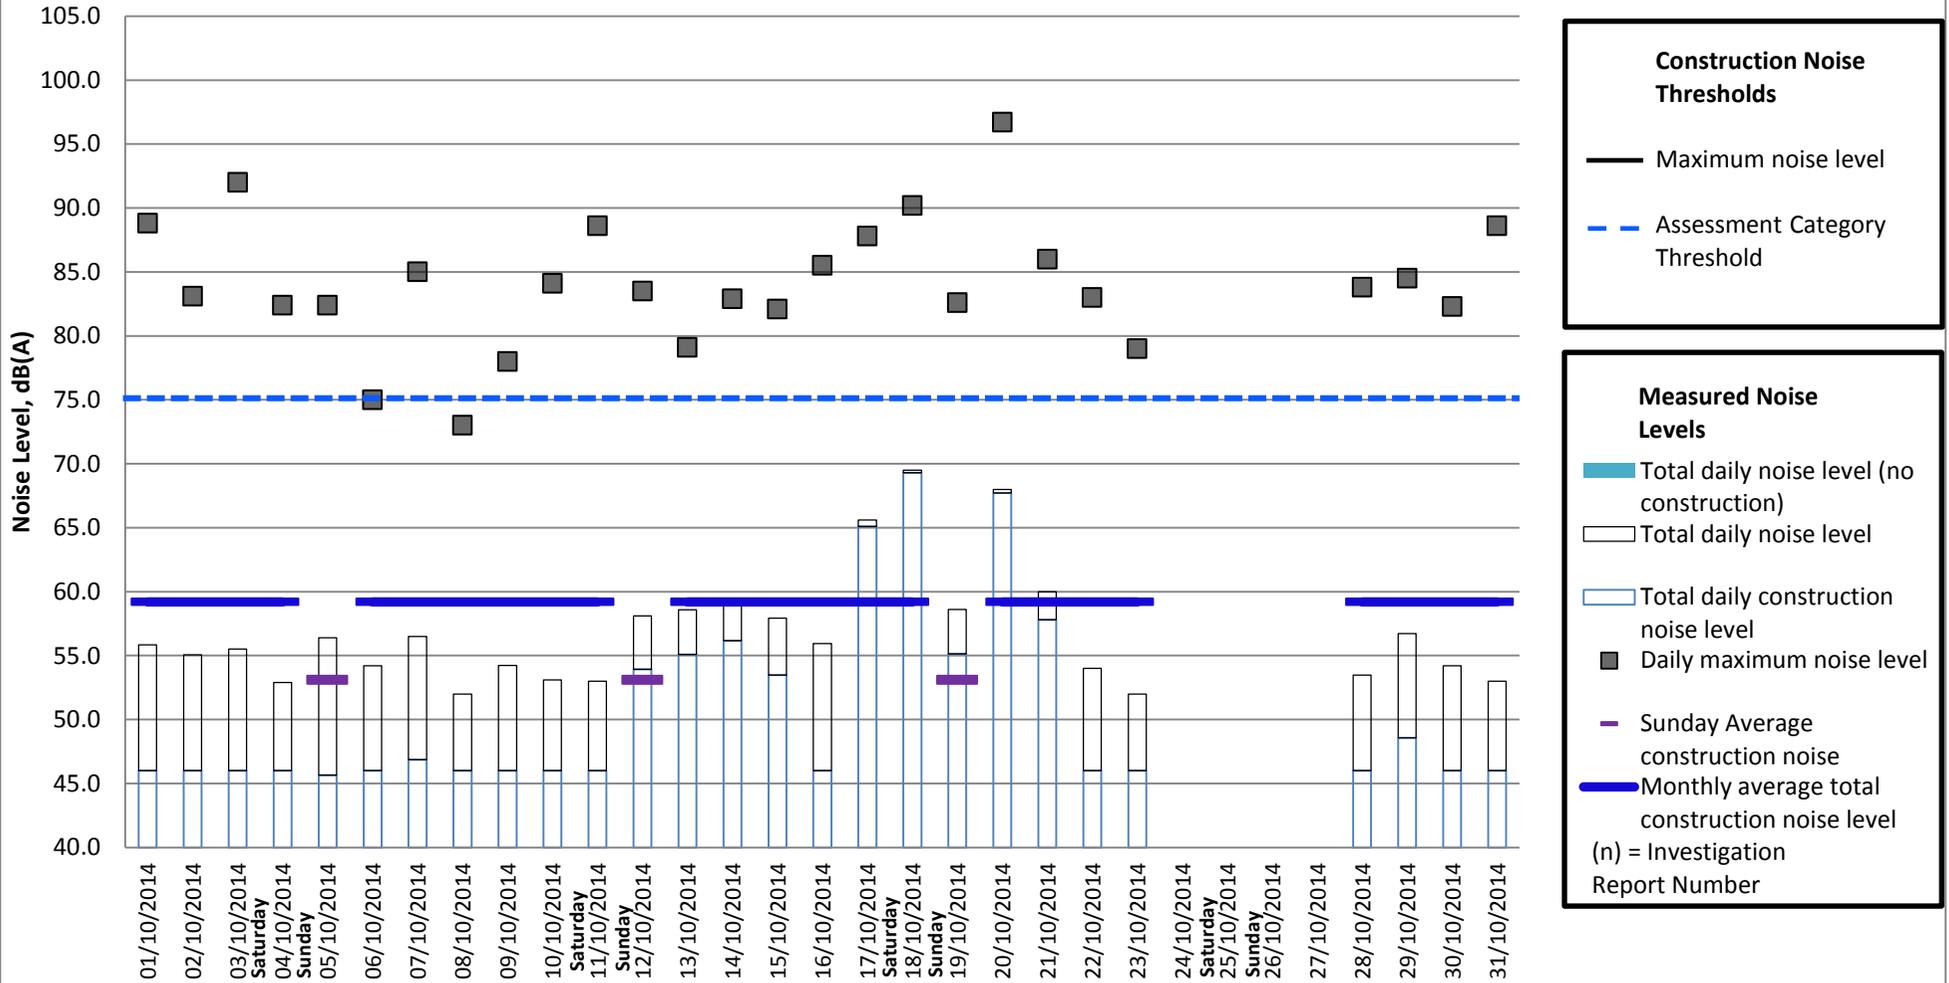
Measured Daytime Noise Levels at Port Edgar Measurement period: October 2014

Note: Data is missing for 24/10/14 to 27/10/14 due to a device error.

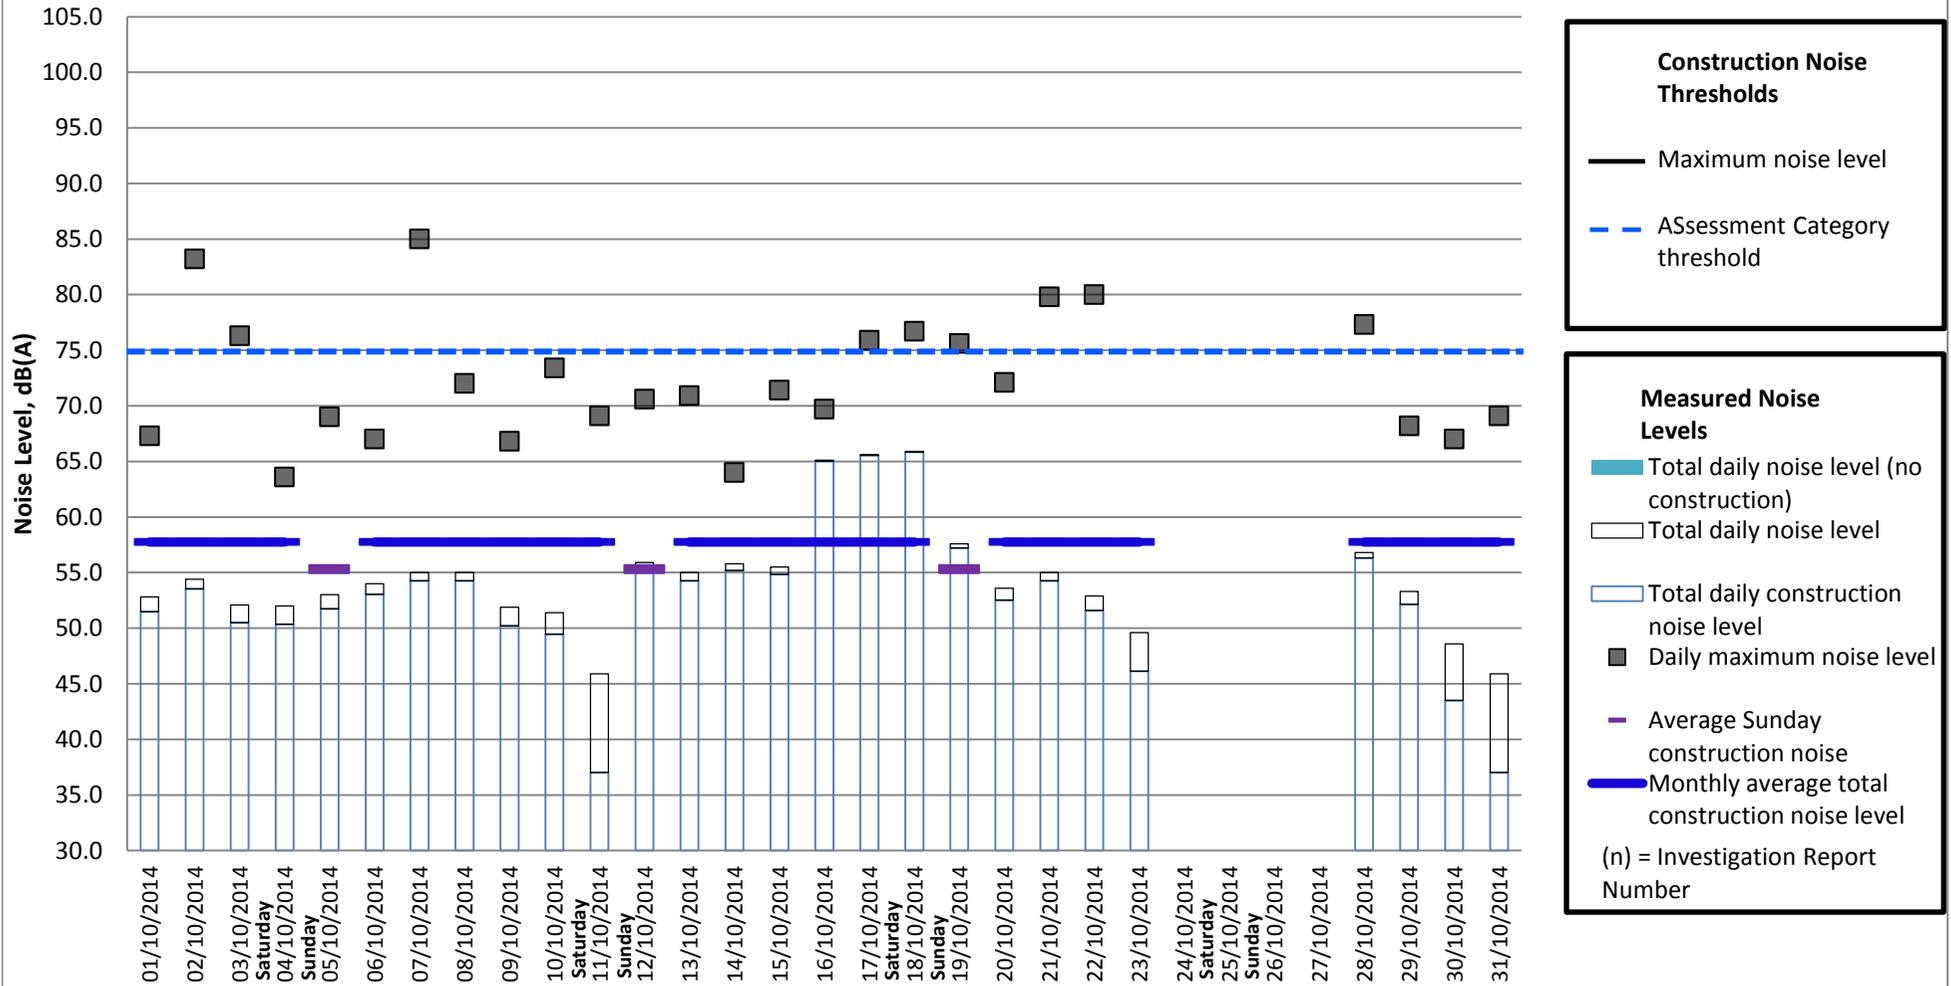
Measured Evening Noise Levels at Port Edgar Measurement period: October 2014

Note: Data is missing for 24/10/14 to 27/10/14 due to a device error.

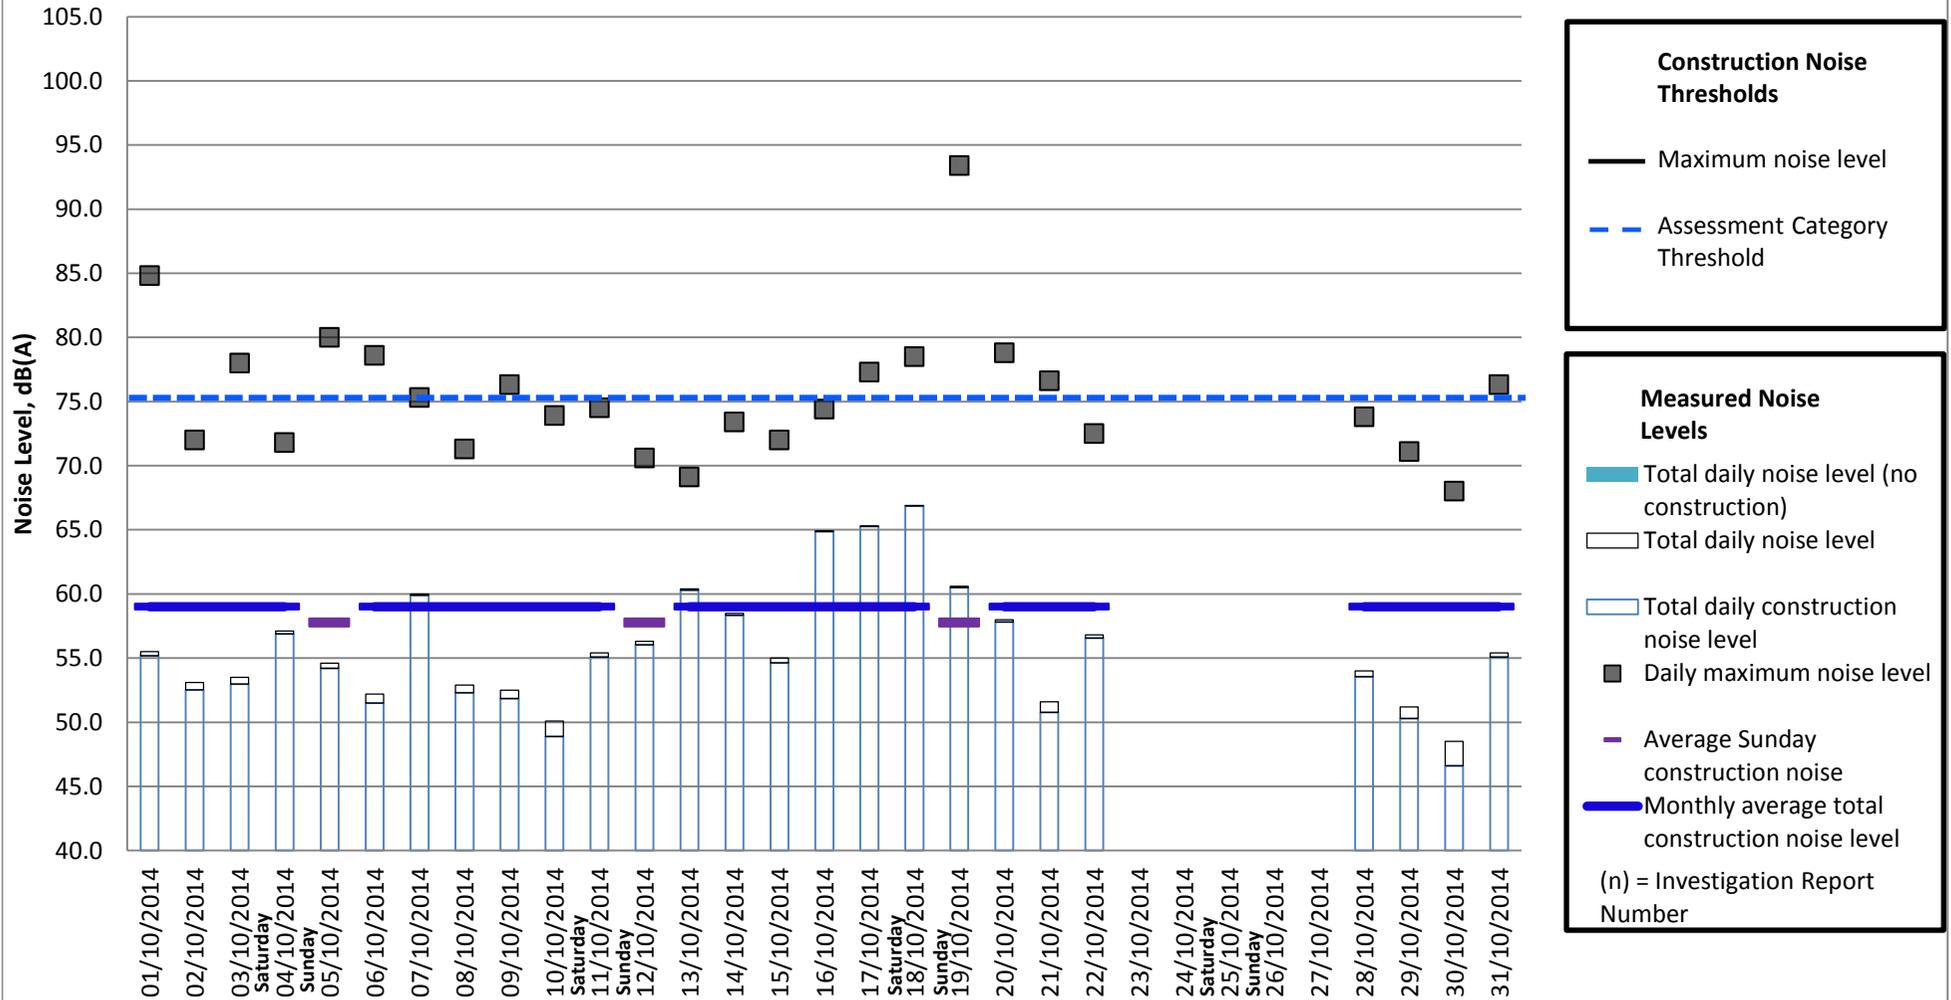
Measured Night-time Noise Levels at Port Edgar Measurement period: October 2014

Note: Data is missing for 23/10/14 to 27/10/14 due to a device error.

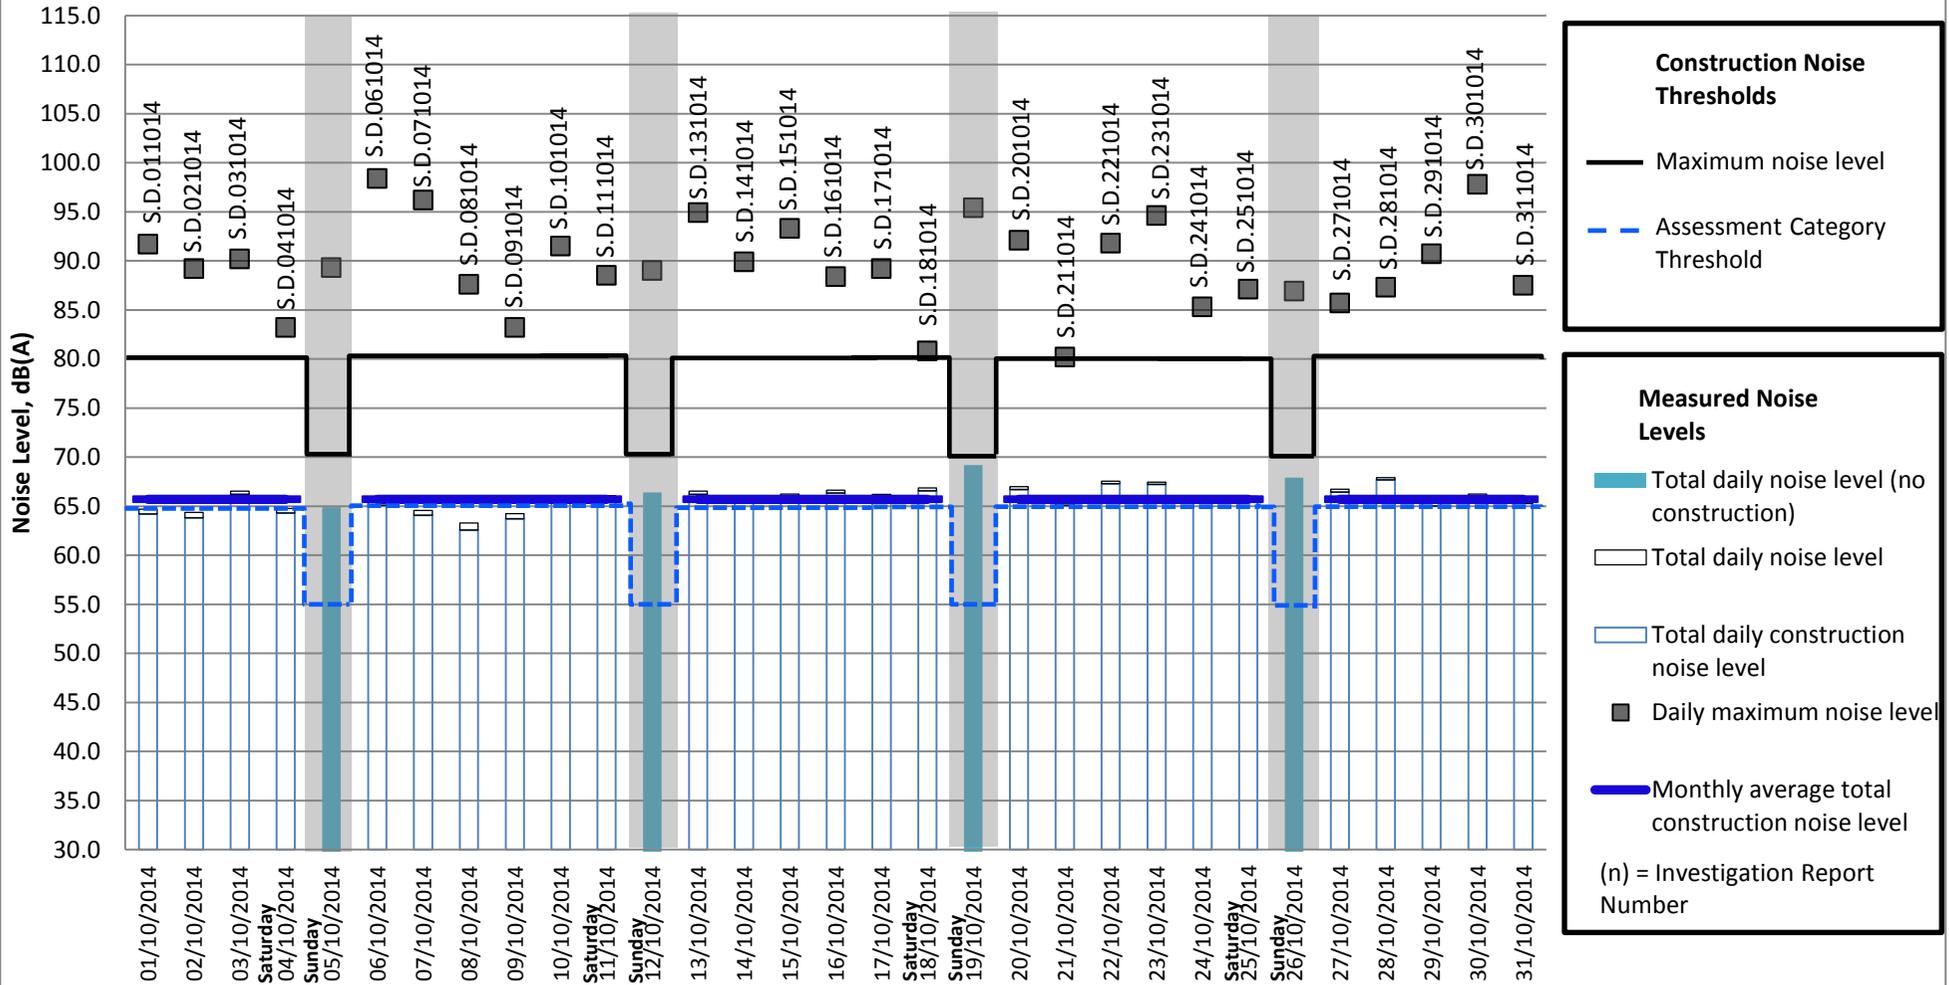
Measured Daytime Noise Levels at Scotstoun Measurement period: October 2014

- 3.5** The exceedance of the daytime average at Scotstoun is due to increased background noise levels due to the location of the meter directly adjacent to the road. The average for October is consistent with levels for previous months.

Note: The grey areas of the chart represent days on which no construction works have been conducted. The monthly average construction noise for Sunday has not been included as no Sunday works have been conducted at this location .

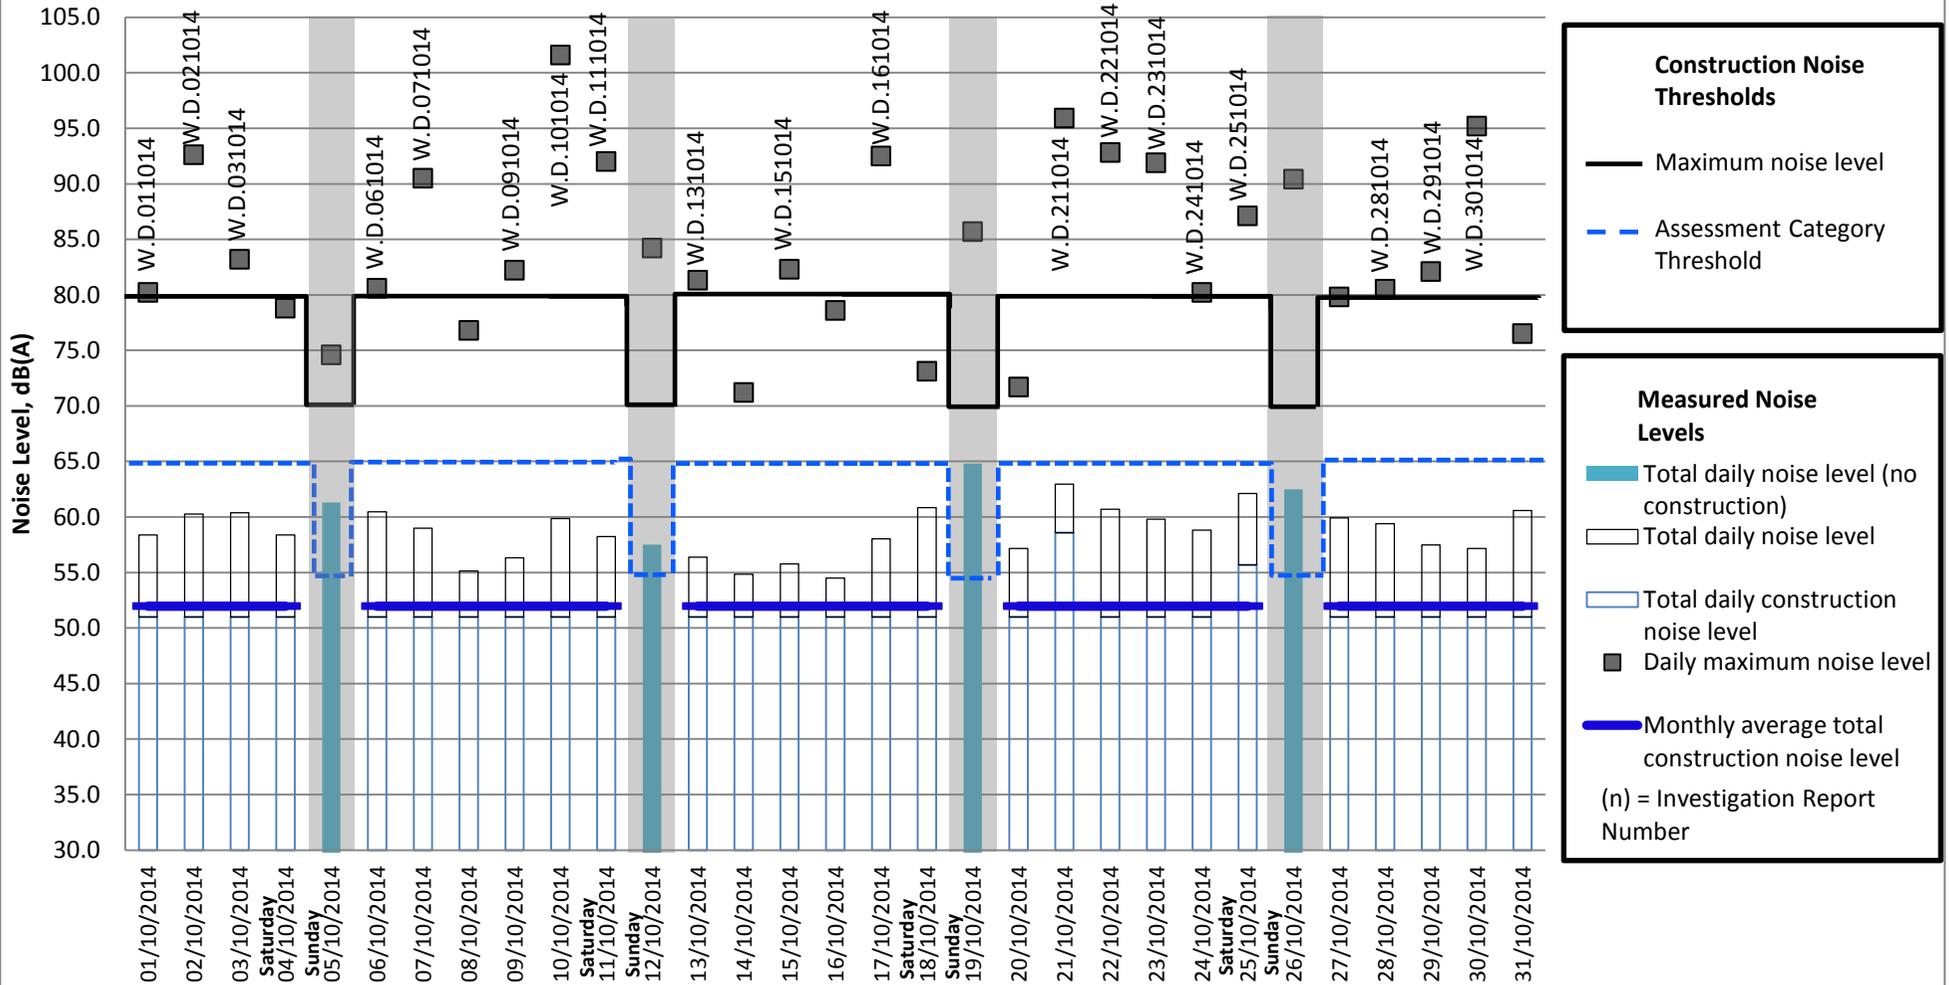
Measured Daytime Noise Levels at Whinny Hill

Note: The grey areas of the chart represent days on which no construction works have been conducted. The monthly average construction noise for Sunday has not been included as no Sunday works have been conducted at this location during this period.
