Project **FORTH REPLACEMENT CROSSING**

VIBRATION MONITORING REPORT
JUNE 2013

Document number	Rev
REP-00126	01

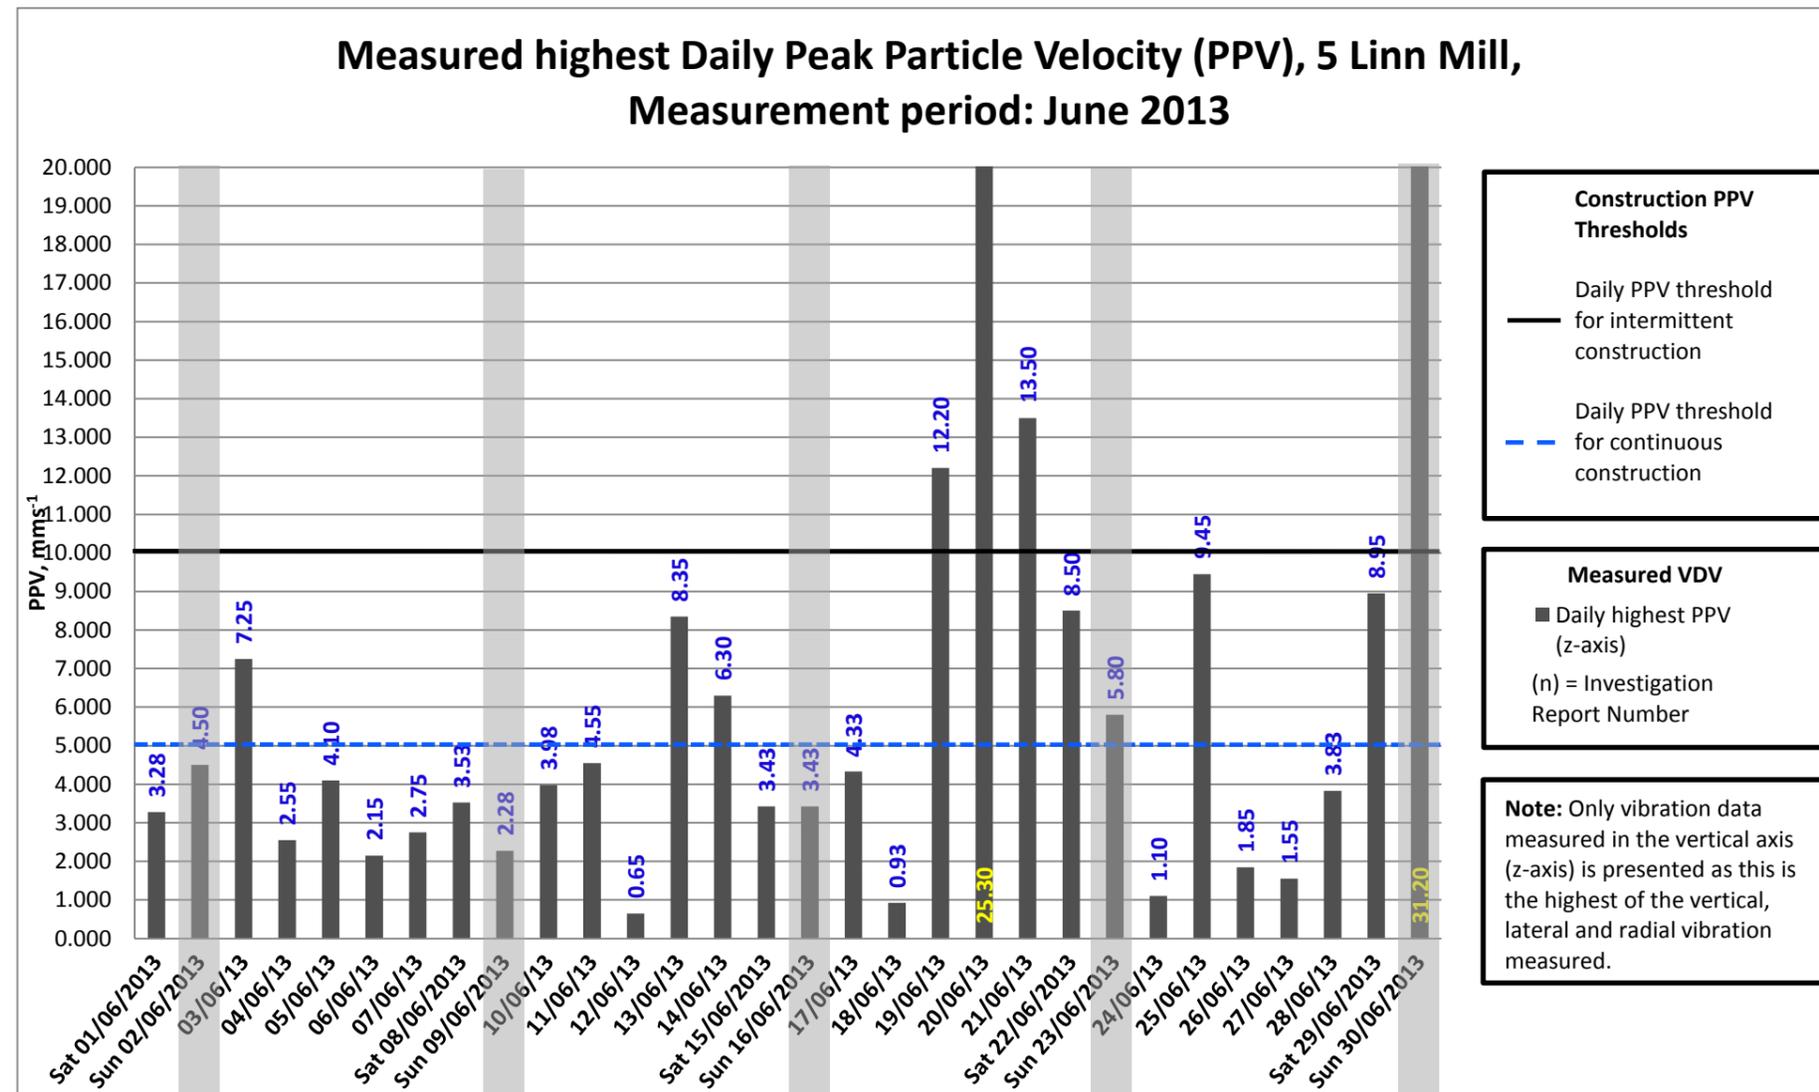
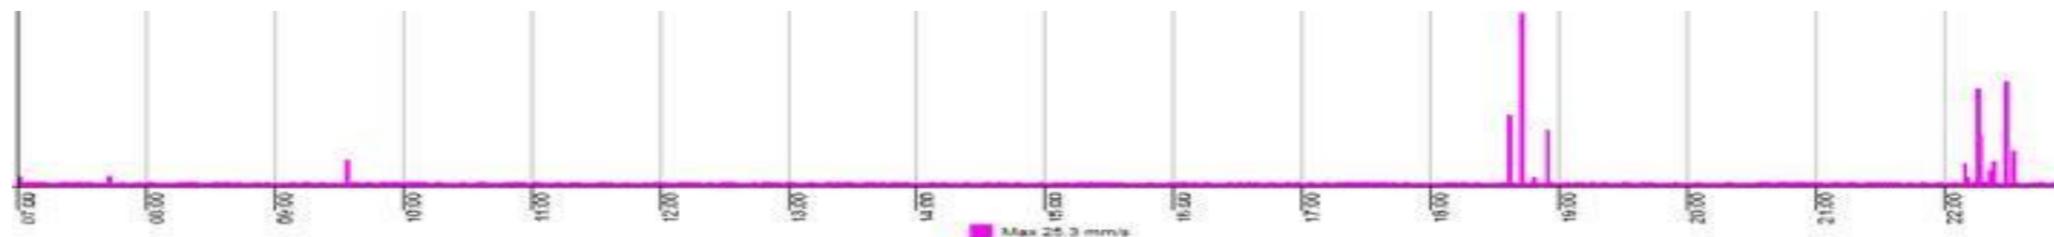
- The grey areas of the chart represent the days on which no construction works were undertaken; no works were conducted on Sundays.
- The PPV values on 03/06/13, 13/06/13, 14/06/13, 19/06/13, 20/06/13, 21/06/13, 22/06/13, 25/06/13, 29/06/13 and 30/06/13 have all been investigated, and have been seen to be individual, isolated events within each period (see Vibrock PPV graph below from 20/06/13), the majority of which are within the intermittent threshold of 10mm/s. Furthermore, it is extremely unlikely that these particular levels were generated as a result of FCBC construction, as the only works to be conducted on these dates in the vicinity of the monitor, involving vibration inducing plant were backfilling works at South Abutment, which involved the use of a vibratory roller for certain periods. A vibratory roller exhibits continuous levels vibration over the period of use, not intermittent, isolated levels as displayed in the above exceedances. In addition (as stated in Table 3), a vibratory roller was not operated within 50m of any occupied receptor.

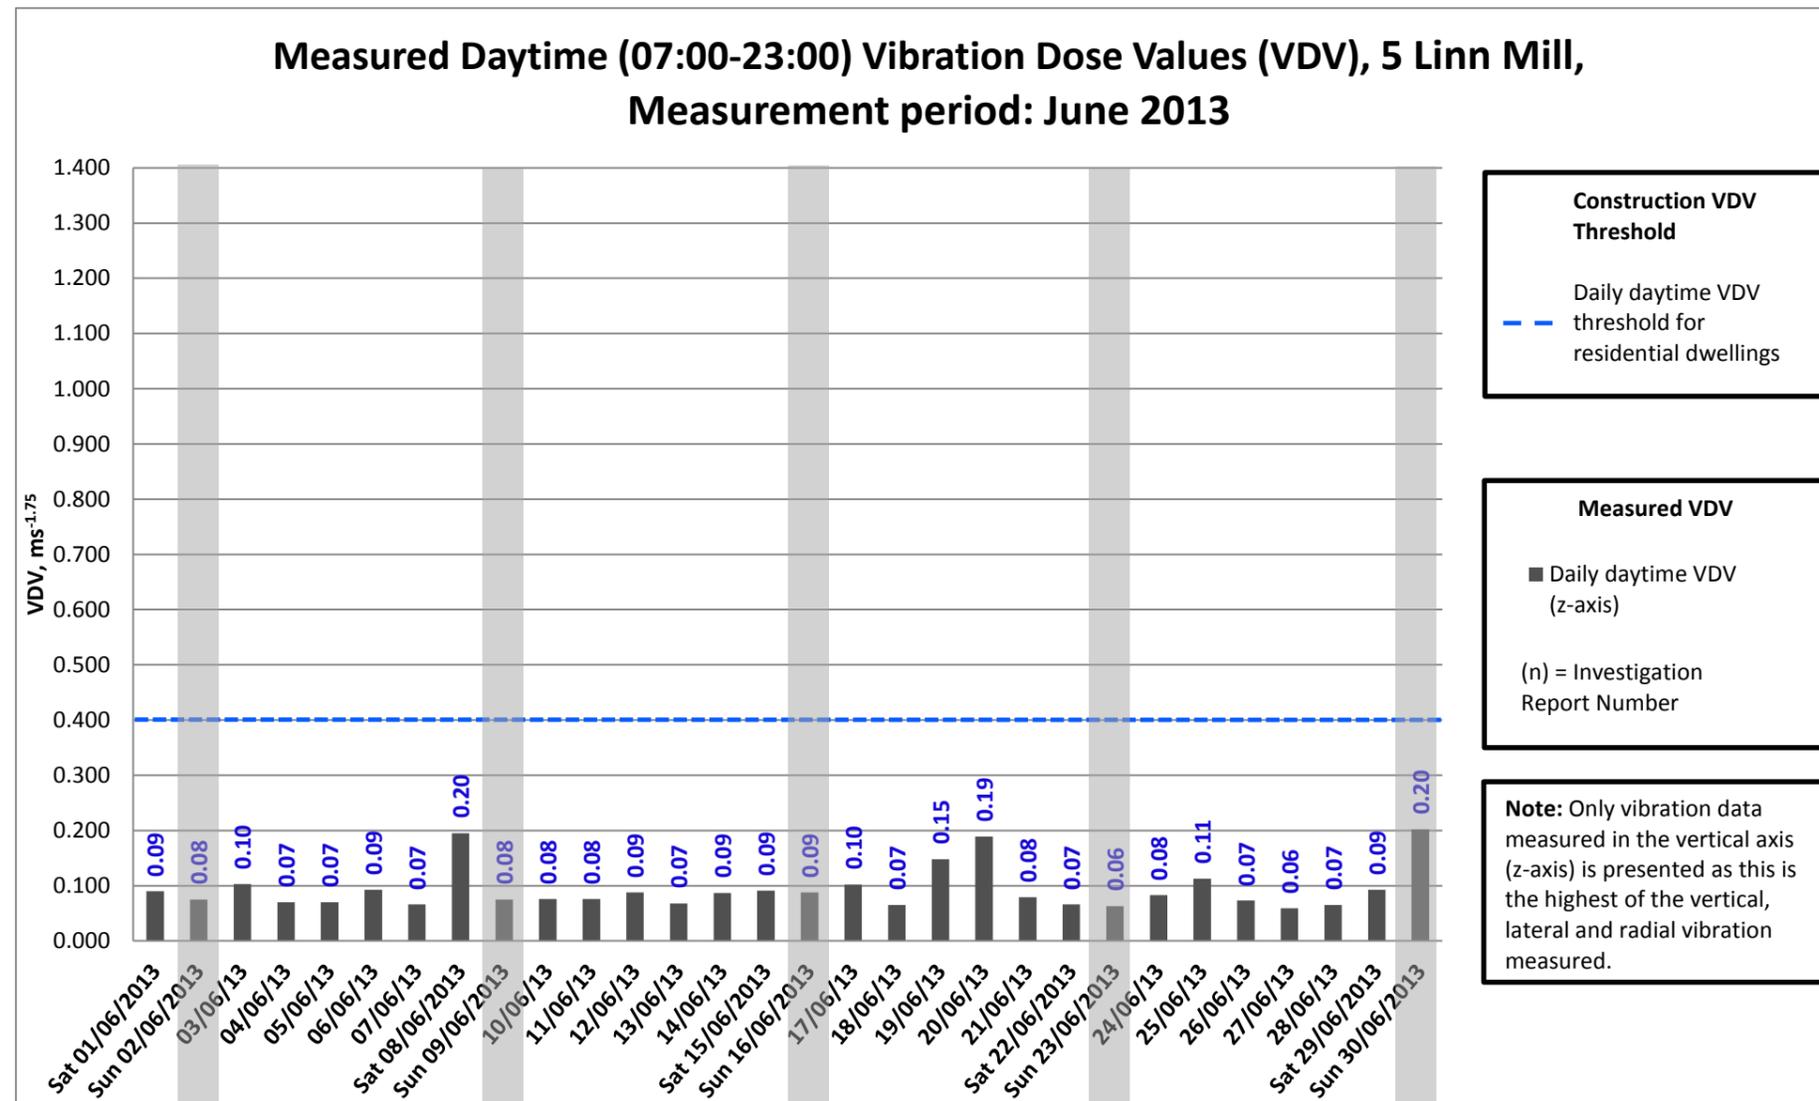
- The grey areas of the chart represent the days on which no construction works were undertaken; no works were conducted on Sundays.

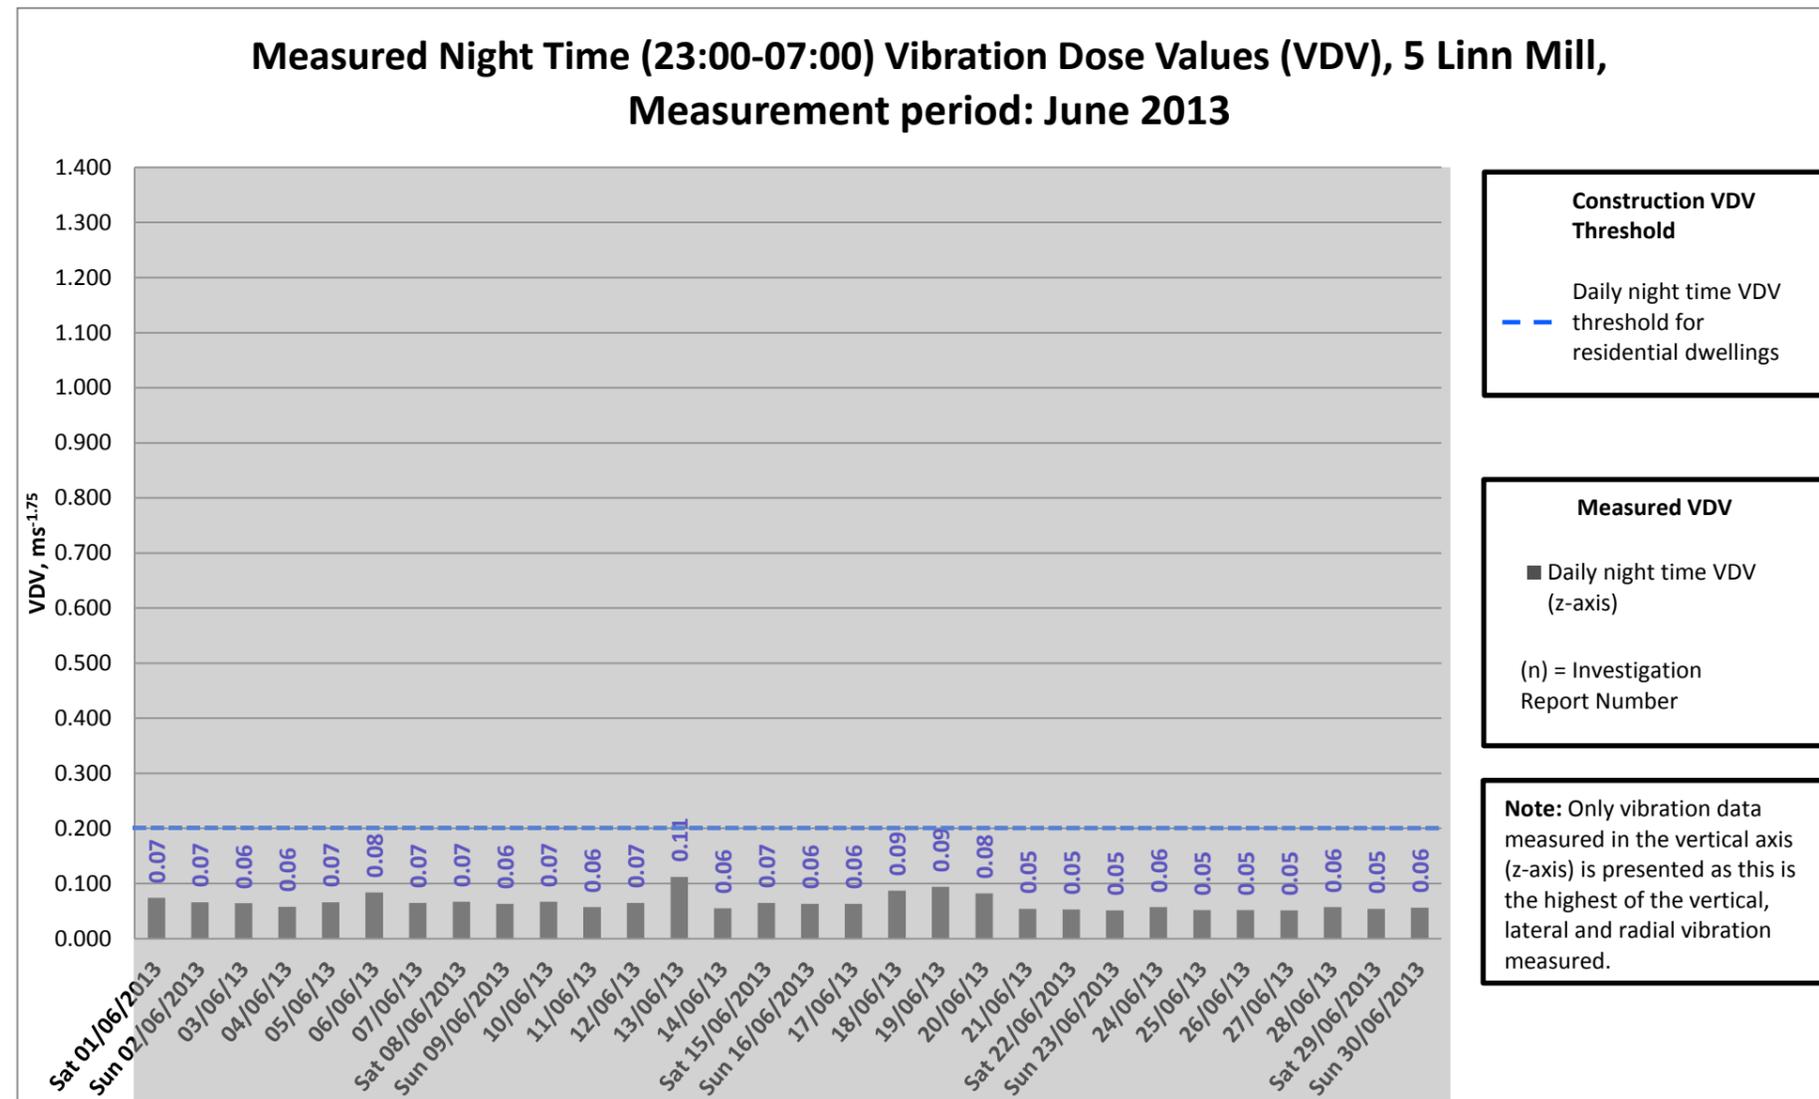
- The grey areas of the chart represent the days on which no construction works were undertaken; no night time works were conducted in the vicinity of the Linn Mill vibration monitor throughout the month of June 2013. This graph is included for illustrative purposes only.

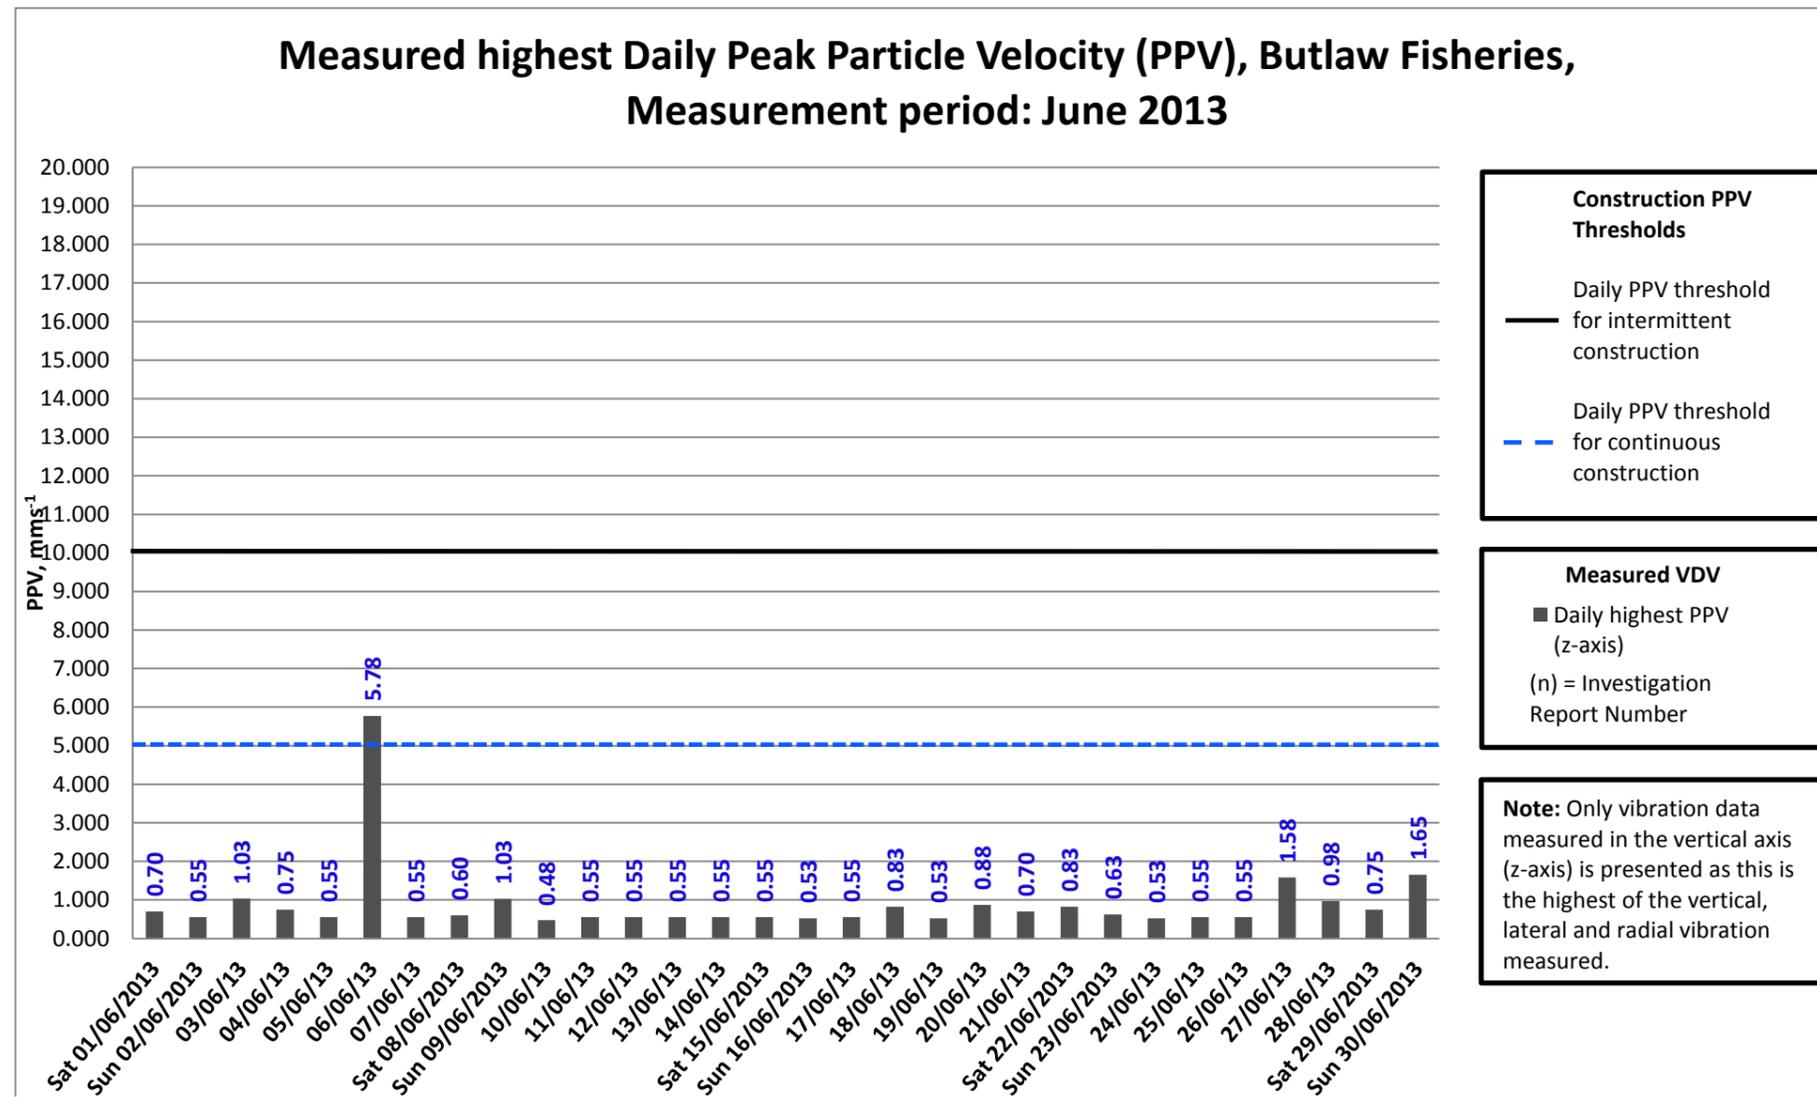
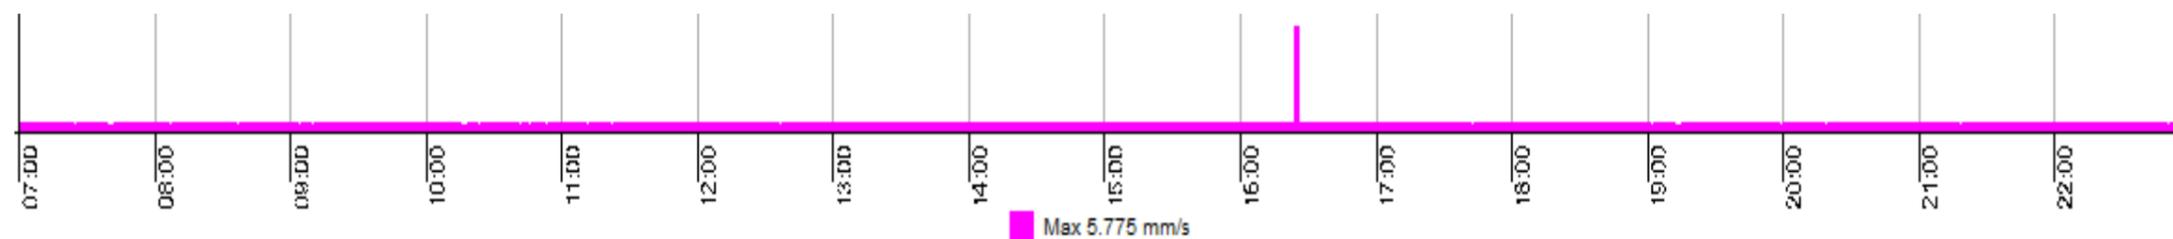
- The PPV value on 06/06/13 has been investigated, and has been seen to be an individual, isolated event within the intermittent threshold of 10mm/s construction (see Vibrock PPV graph below from 06/06/13).

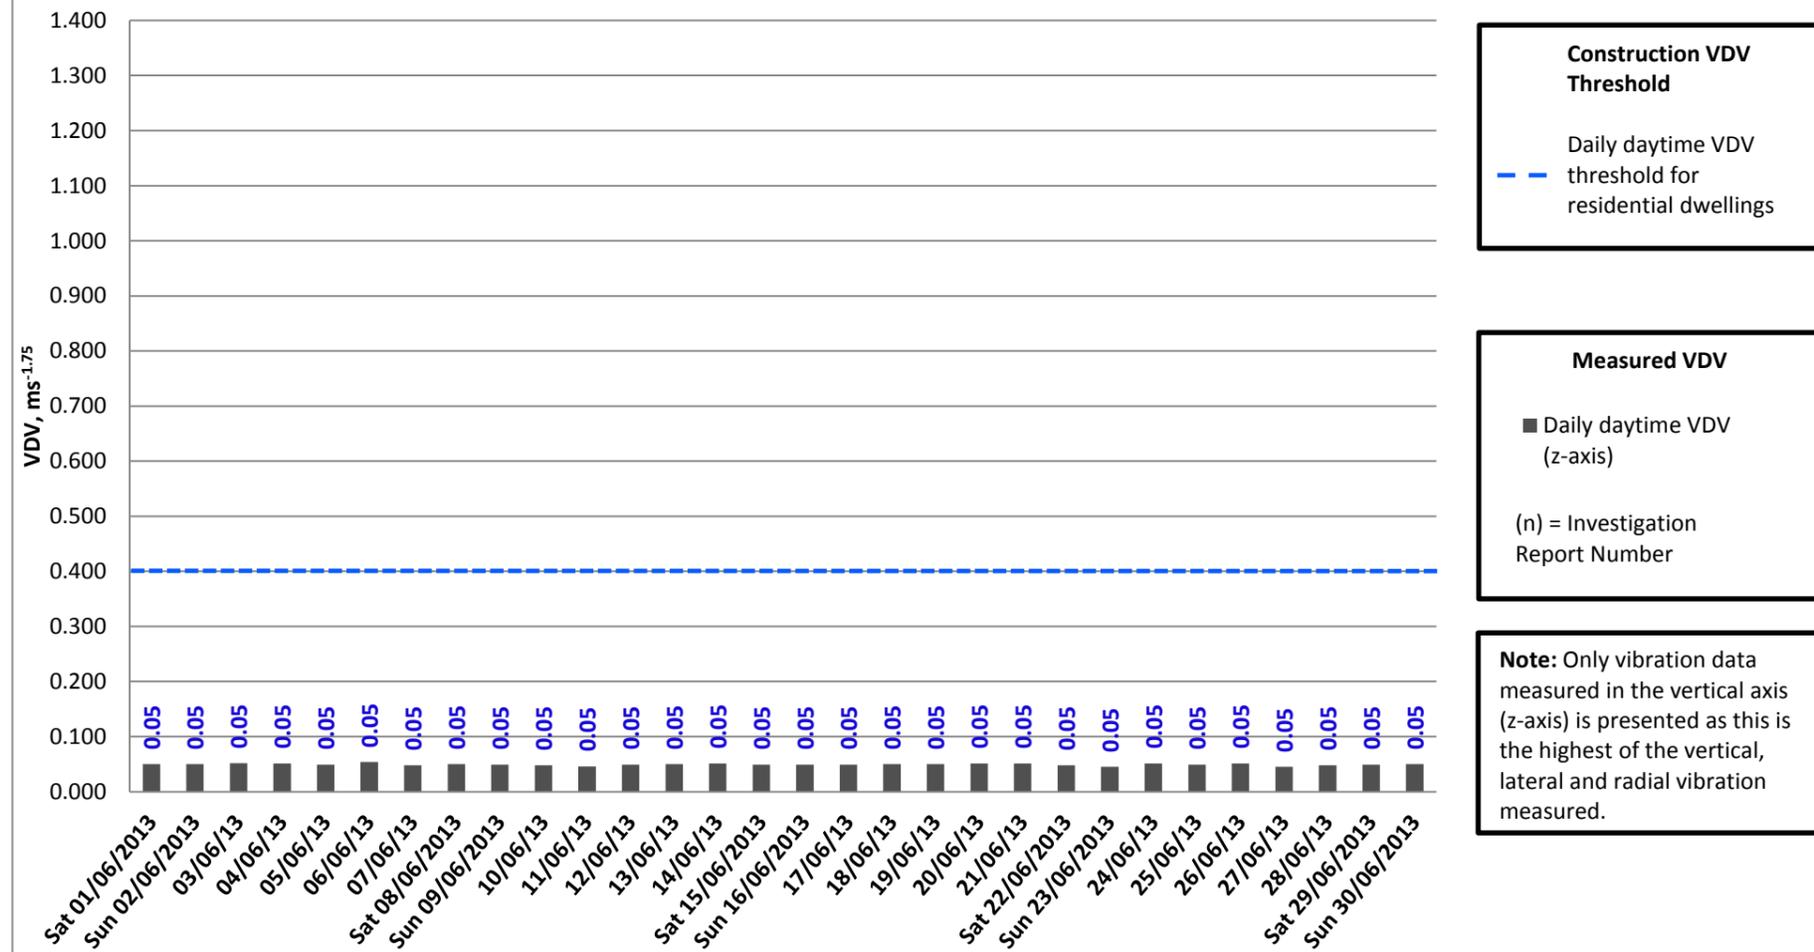
Measured Daytime (07:00-23:00) Vibration Dose Values (VDV), Butlaw Fisheries, Measurement period: June 2013

Note: Only vibration data measured in the vertical axis (z-axis) is presented as this is the highest of the vertical, lateral and radial vibration measured.

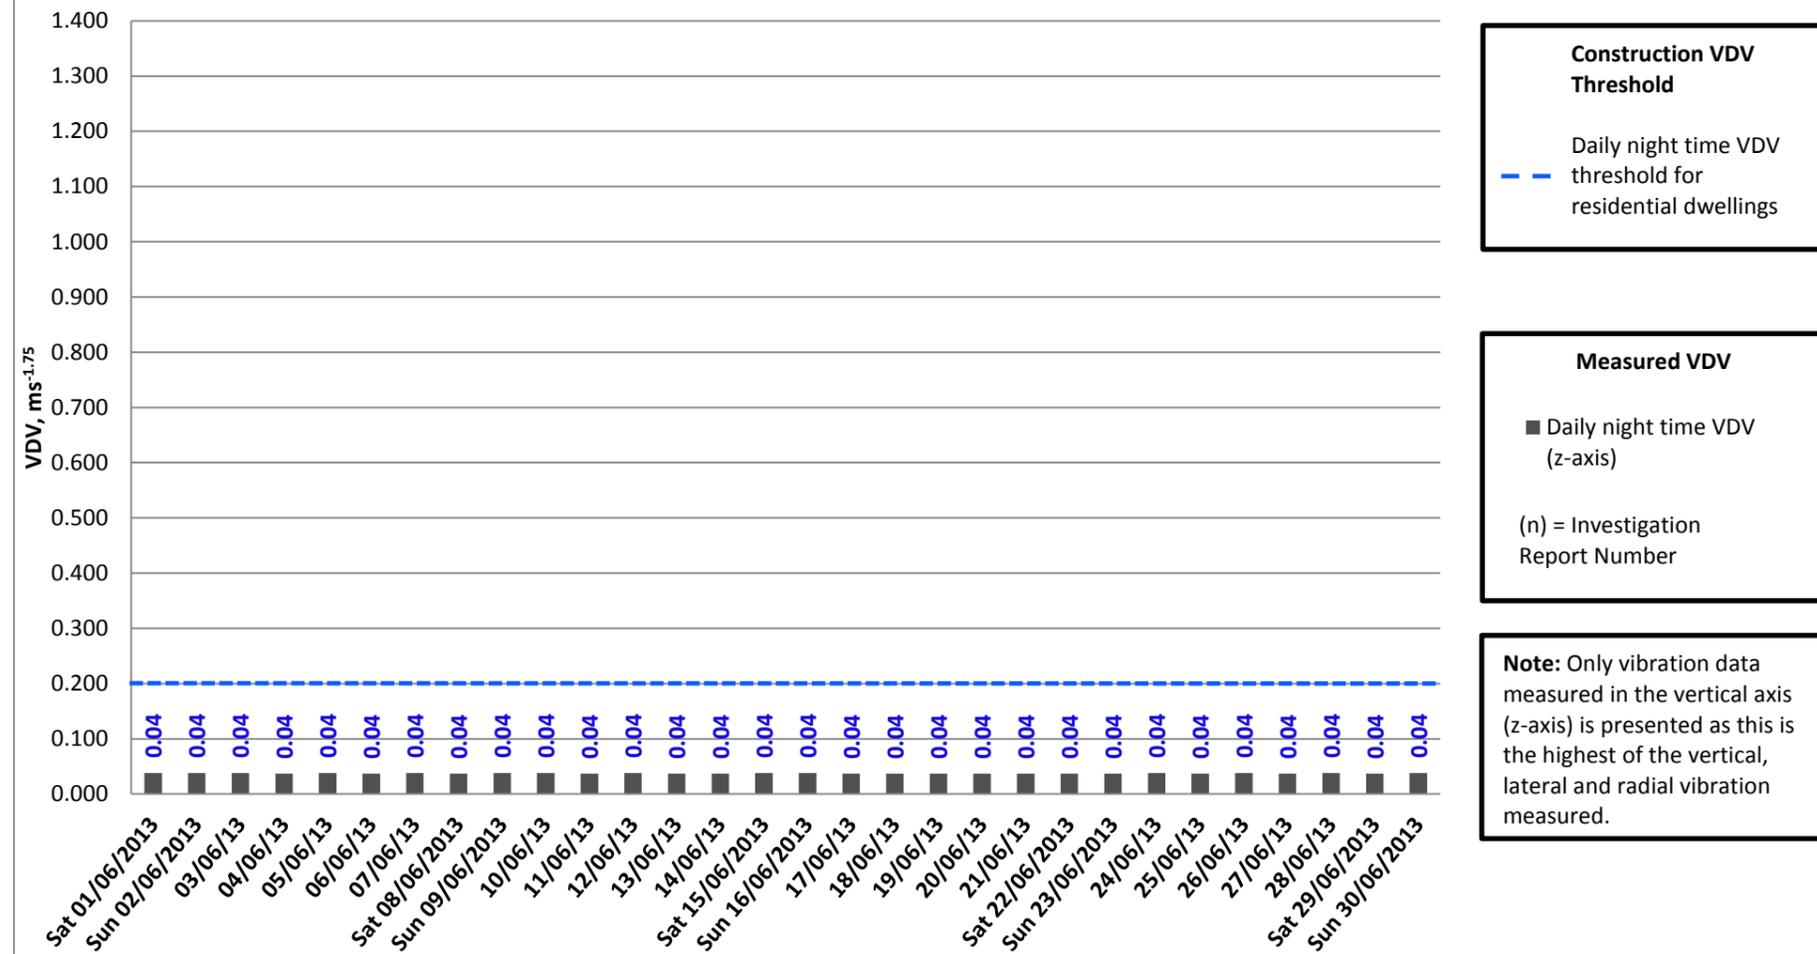
Measured Night Time (23:00-07:00) Vibration Dose Values (VDV), Butlaw Fisheries, Measurement period: June 2013

Note: Only vibration data measured in the vertical axis (z-axis) is presented as this is the highest of the vertical, lateral and radial vibration measured.

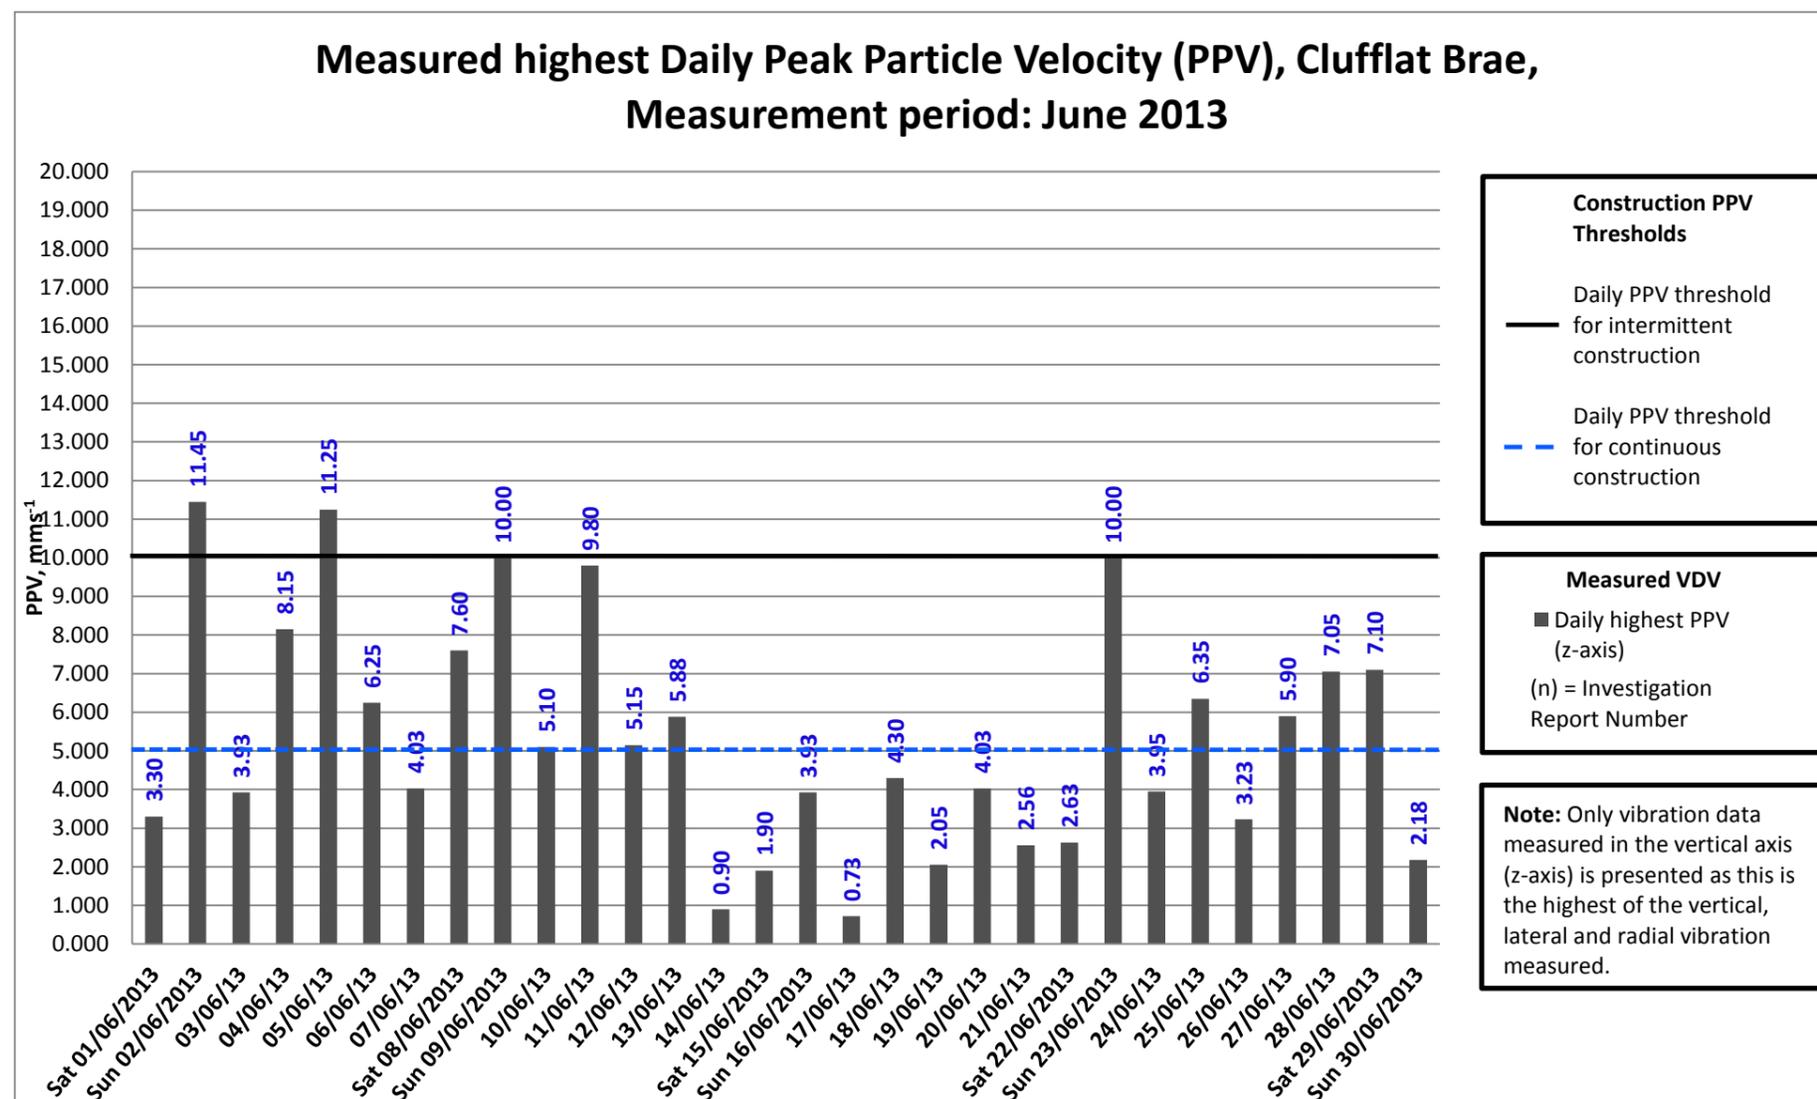
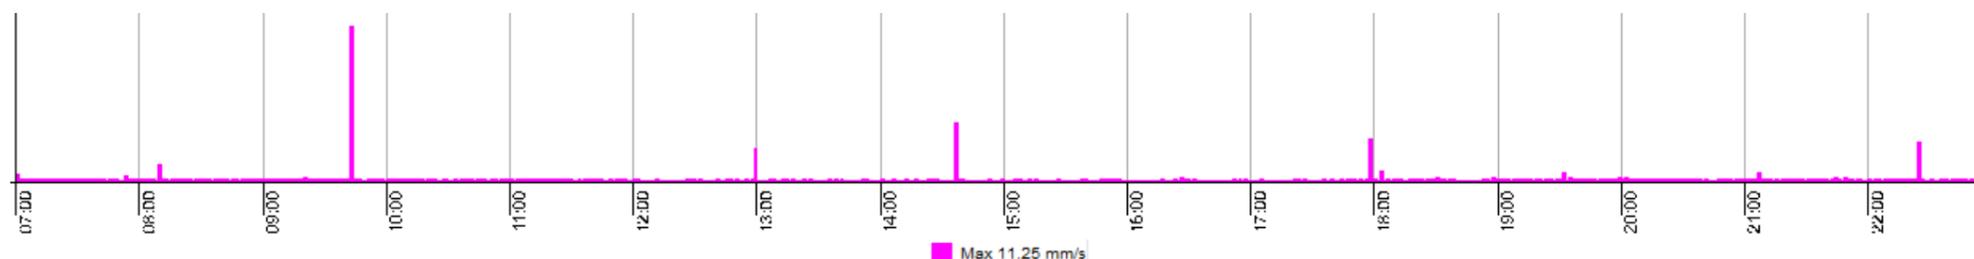
- The PPV values on 02/06/13, 04/06/13, 05/06/13, 06/06/13, 08/06/13, 09/06/13, 10/06/13, 11/06/13, 12/06/13, 23/06/13, 25/06/13, 27/06/13, 28/06/13 and 29/08/13 have been investigated, and have been seen to be individual, isolated events within each period (see Vibrock PPV graph below from 05/06/13), the majority of which are within the intermittent threshold of 10mm/s. Furthermore, it is extremely unlikely that these particular levels were generated as a result of FCBC construction, as the only works to be conducted on these dates in the vicinity of the monitor, involving vibration inducing plant were backfilling works at South Abutment, which involved the use of a vibratory roller for certain periods. A vibratory roller exhibits continuous levels of vibration over the period of use, not intermittent, isolated levels as displayed in the above exceedances. In addition (as stated in Table 3), a vibratory roller was not operated within 50m of any occupied receptor.

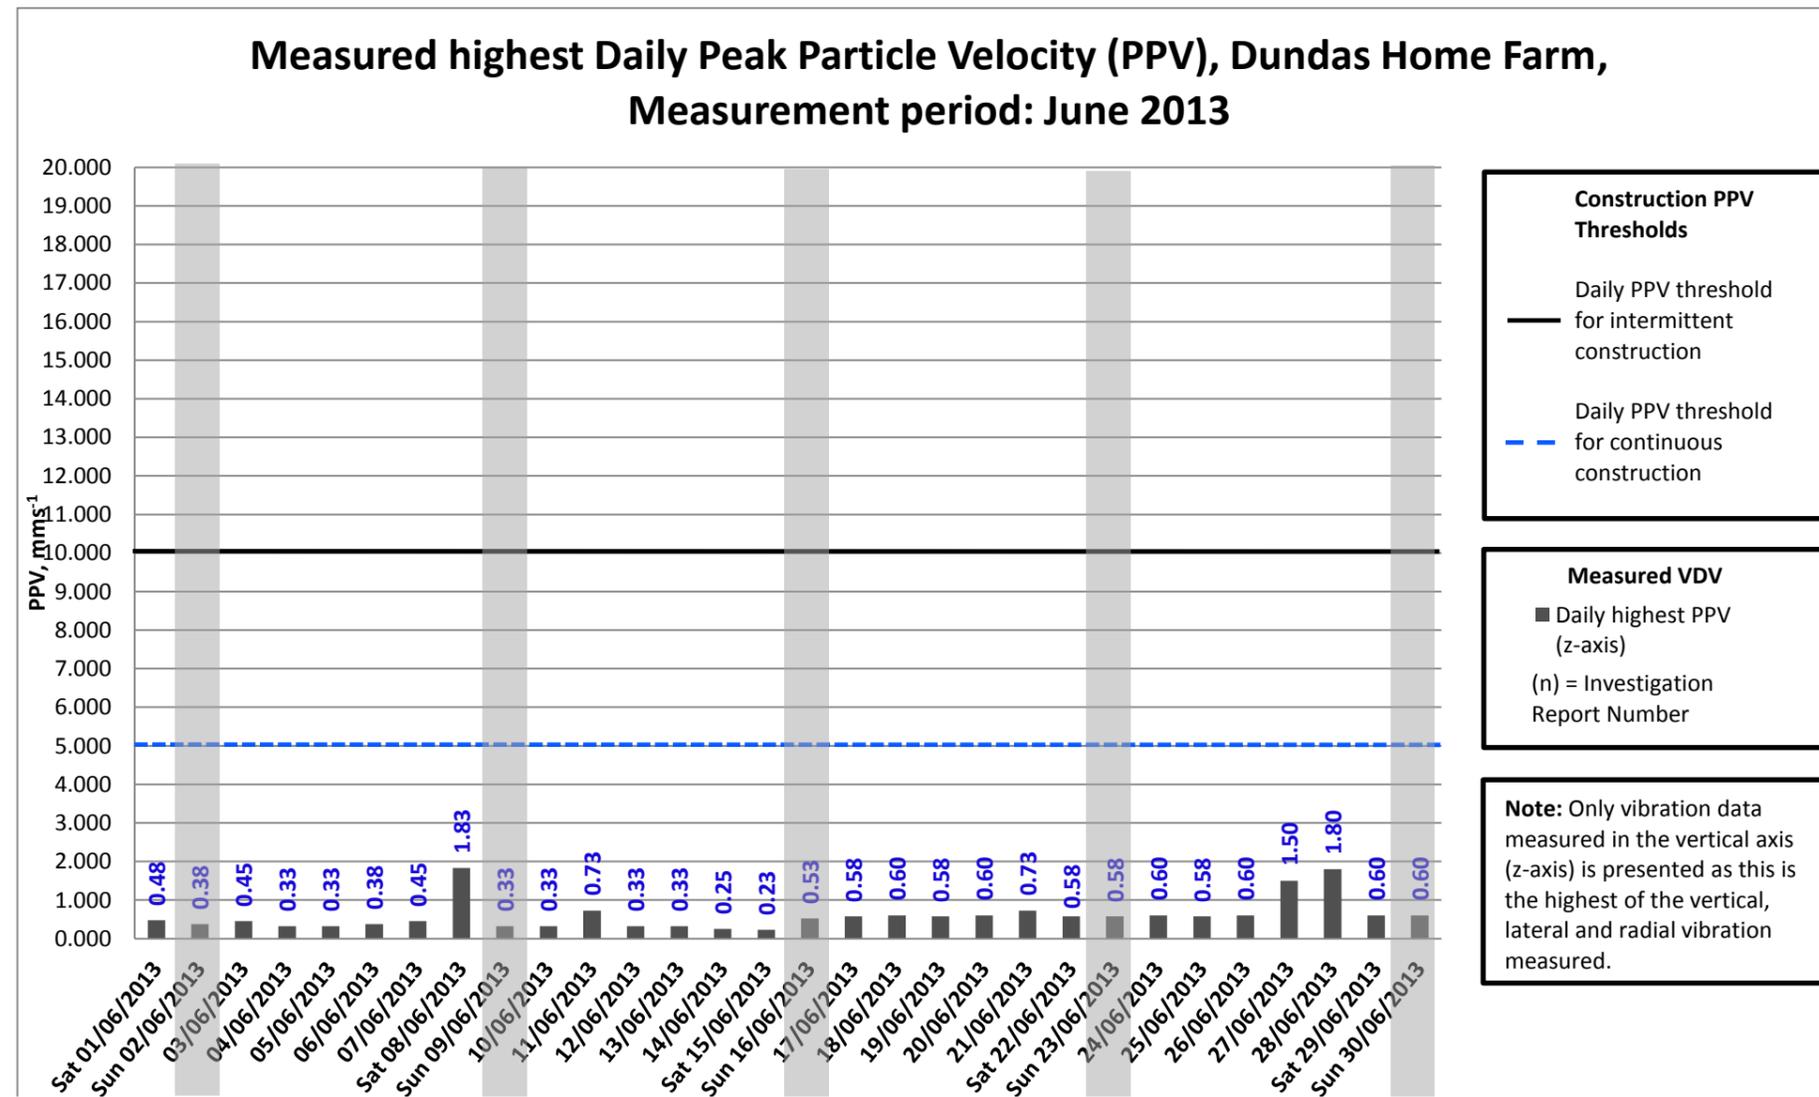
- The grey areas of the chart represent the days on which no construction works were undertaken; no works were conducted on Sundays.

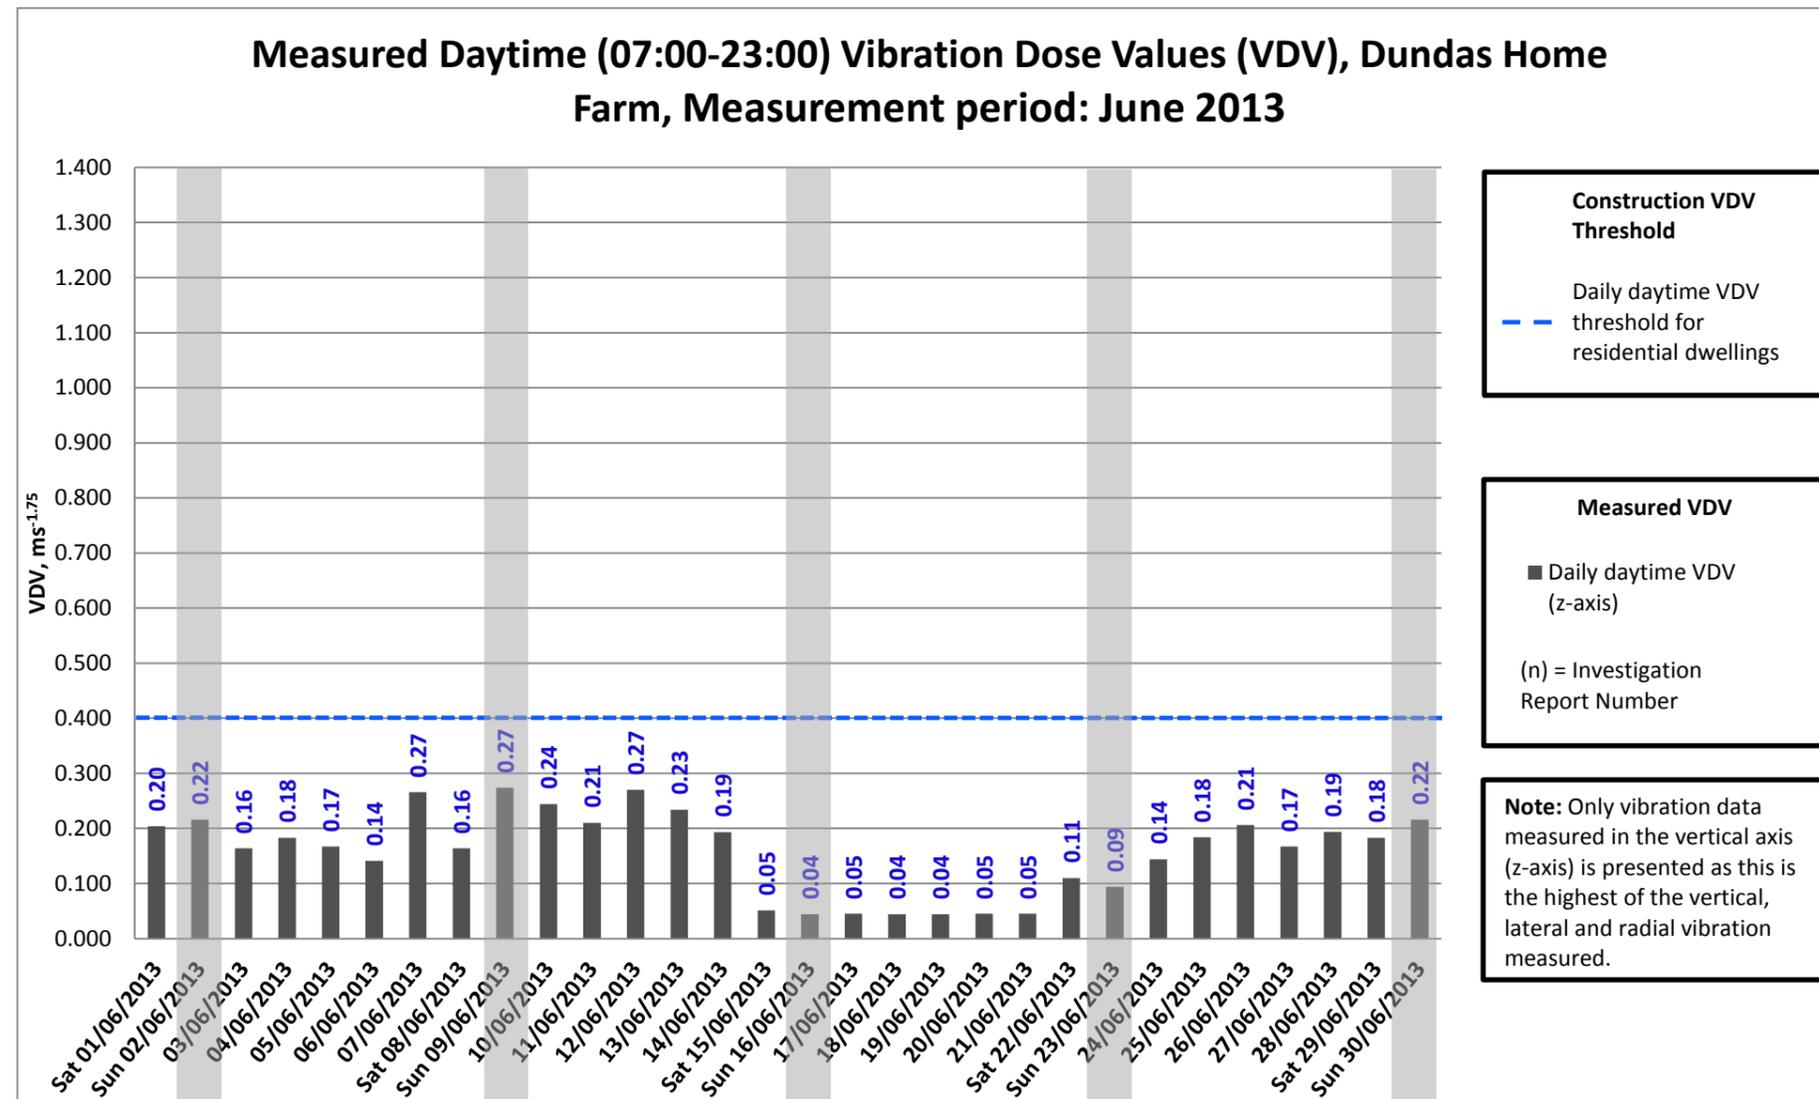
- The grey areas of the chart represent the days on which no construction works were undertaken; no works were conducted on Sundays.

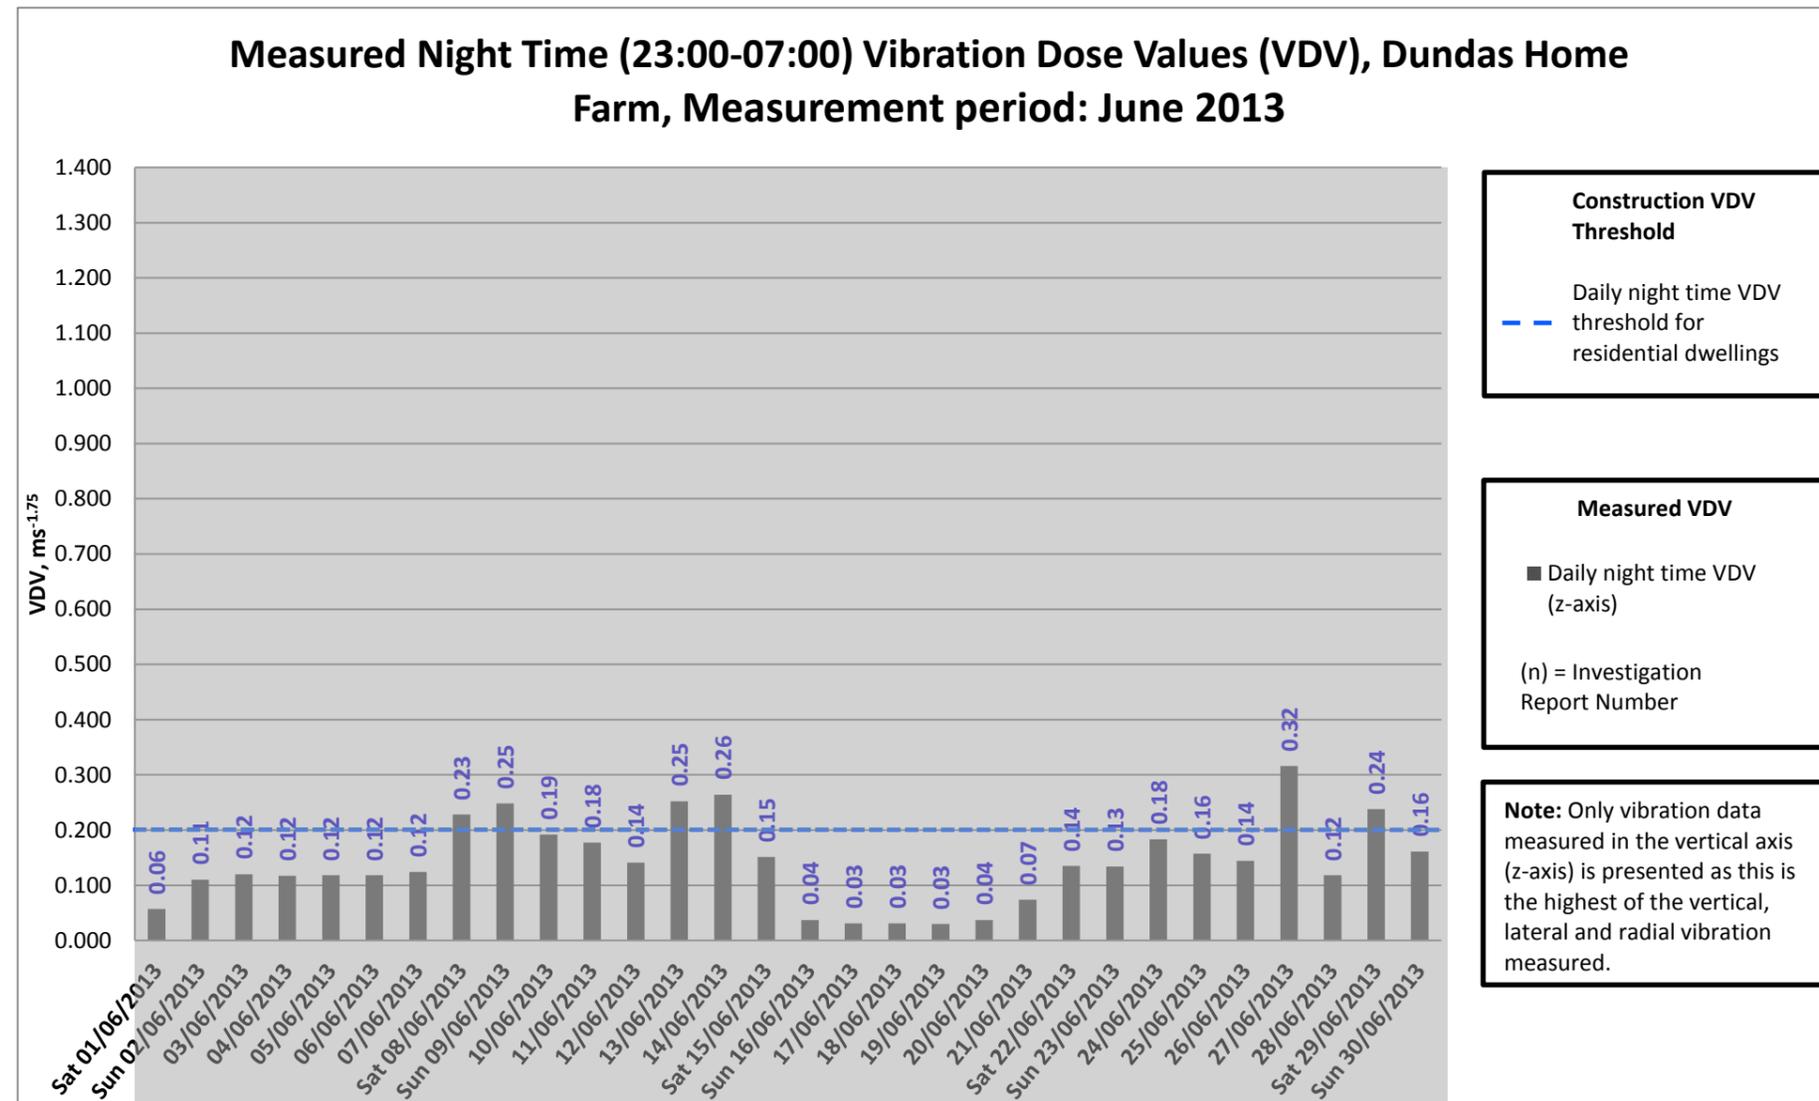
- Notes:**
- The grey areas of the chart represent the days on which no construction works were undertaken; no night time works were conducted in the vicinity of the Dundas vibration monitor throughout the month of June 2013. This graph is included for illustrative purposes only.
