Project **FORTH REPLACEMENT CROSSING**

VIBRATION MONITORING REPORT
JUNE 2013

Document number	Rev
REP-00126	01

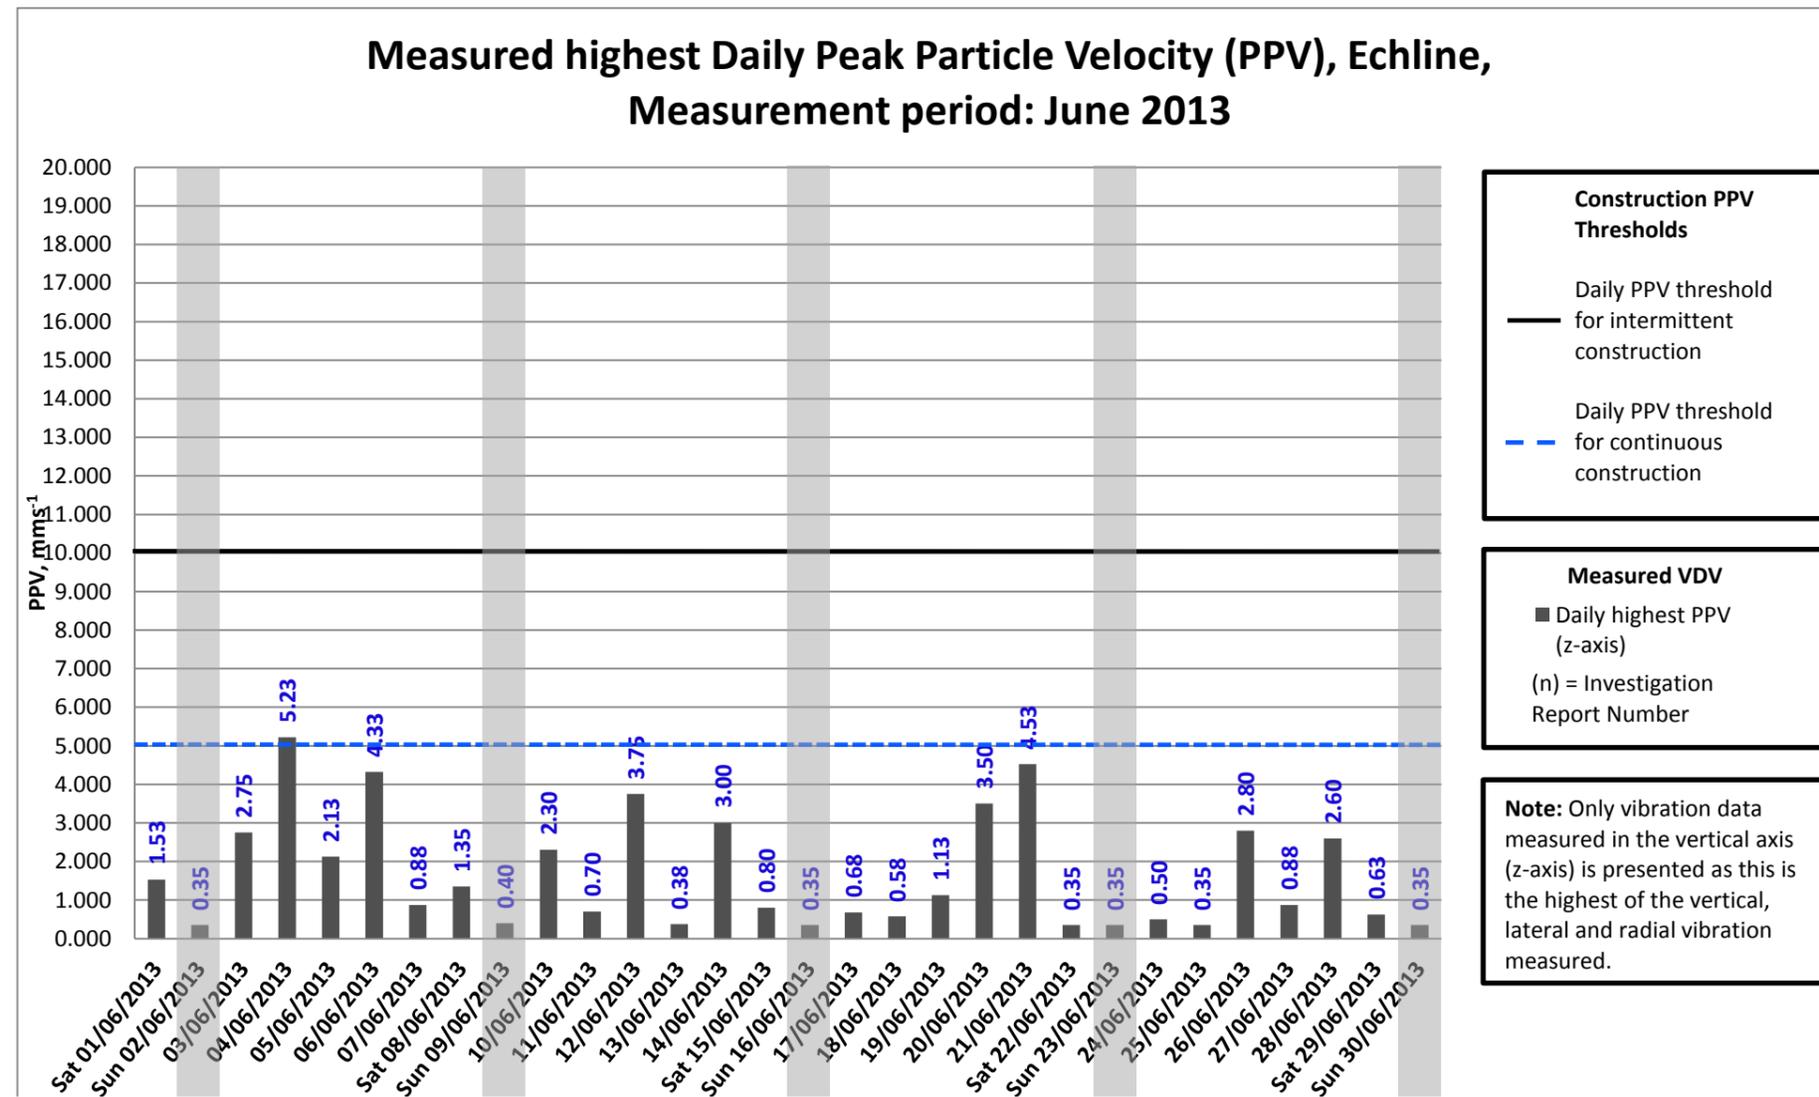
- The grey areas of the chart represent the days on which no construction works were undertaken; no works were conducted on Sundays.
- The PPV value on 04/06/13 has been investigated, and have cannot have been generated as a result of FCBC construction, as the only works to be conducted on this date in the vicinity of the monitor, was the structure works at gyratory, which did not involve any vibration inducing plant or equipment.

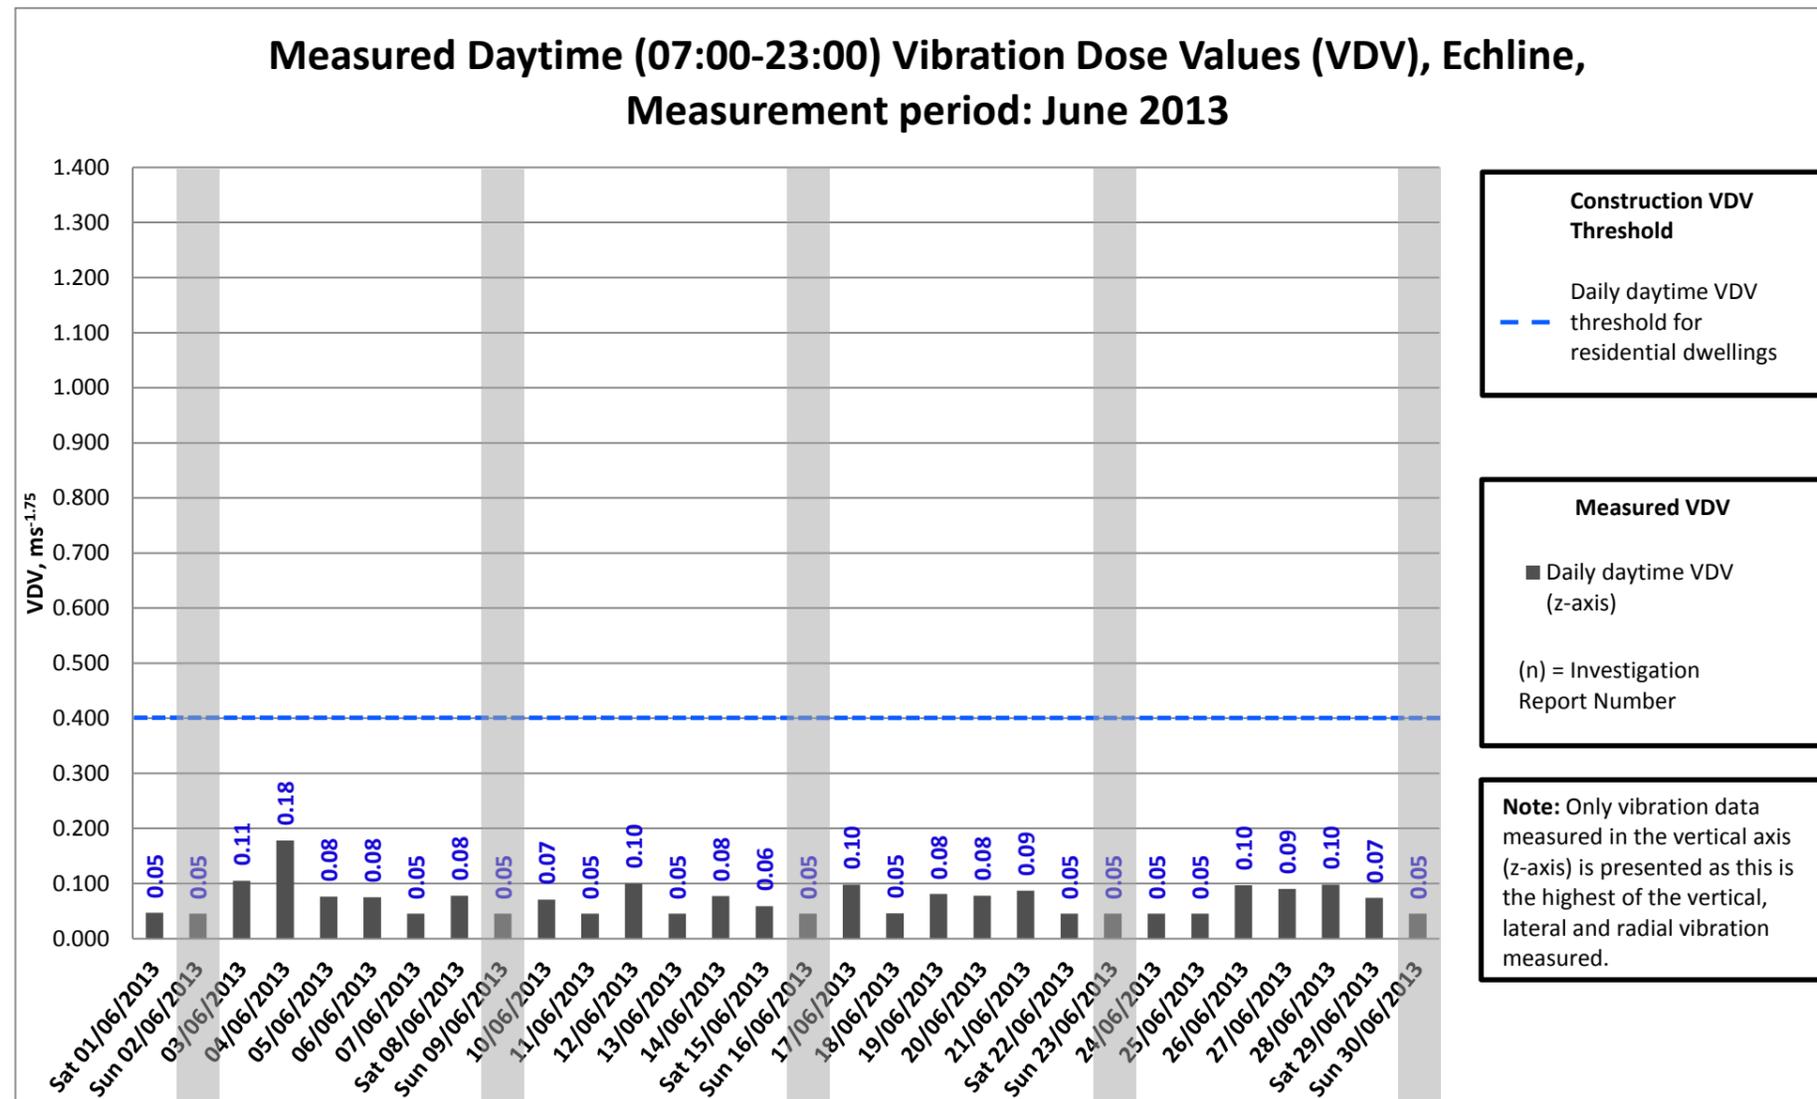
- The grey areas of the chart represent the days on which no construction works were undertaken; no works were conducted on Sundays.

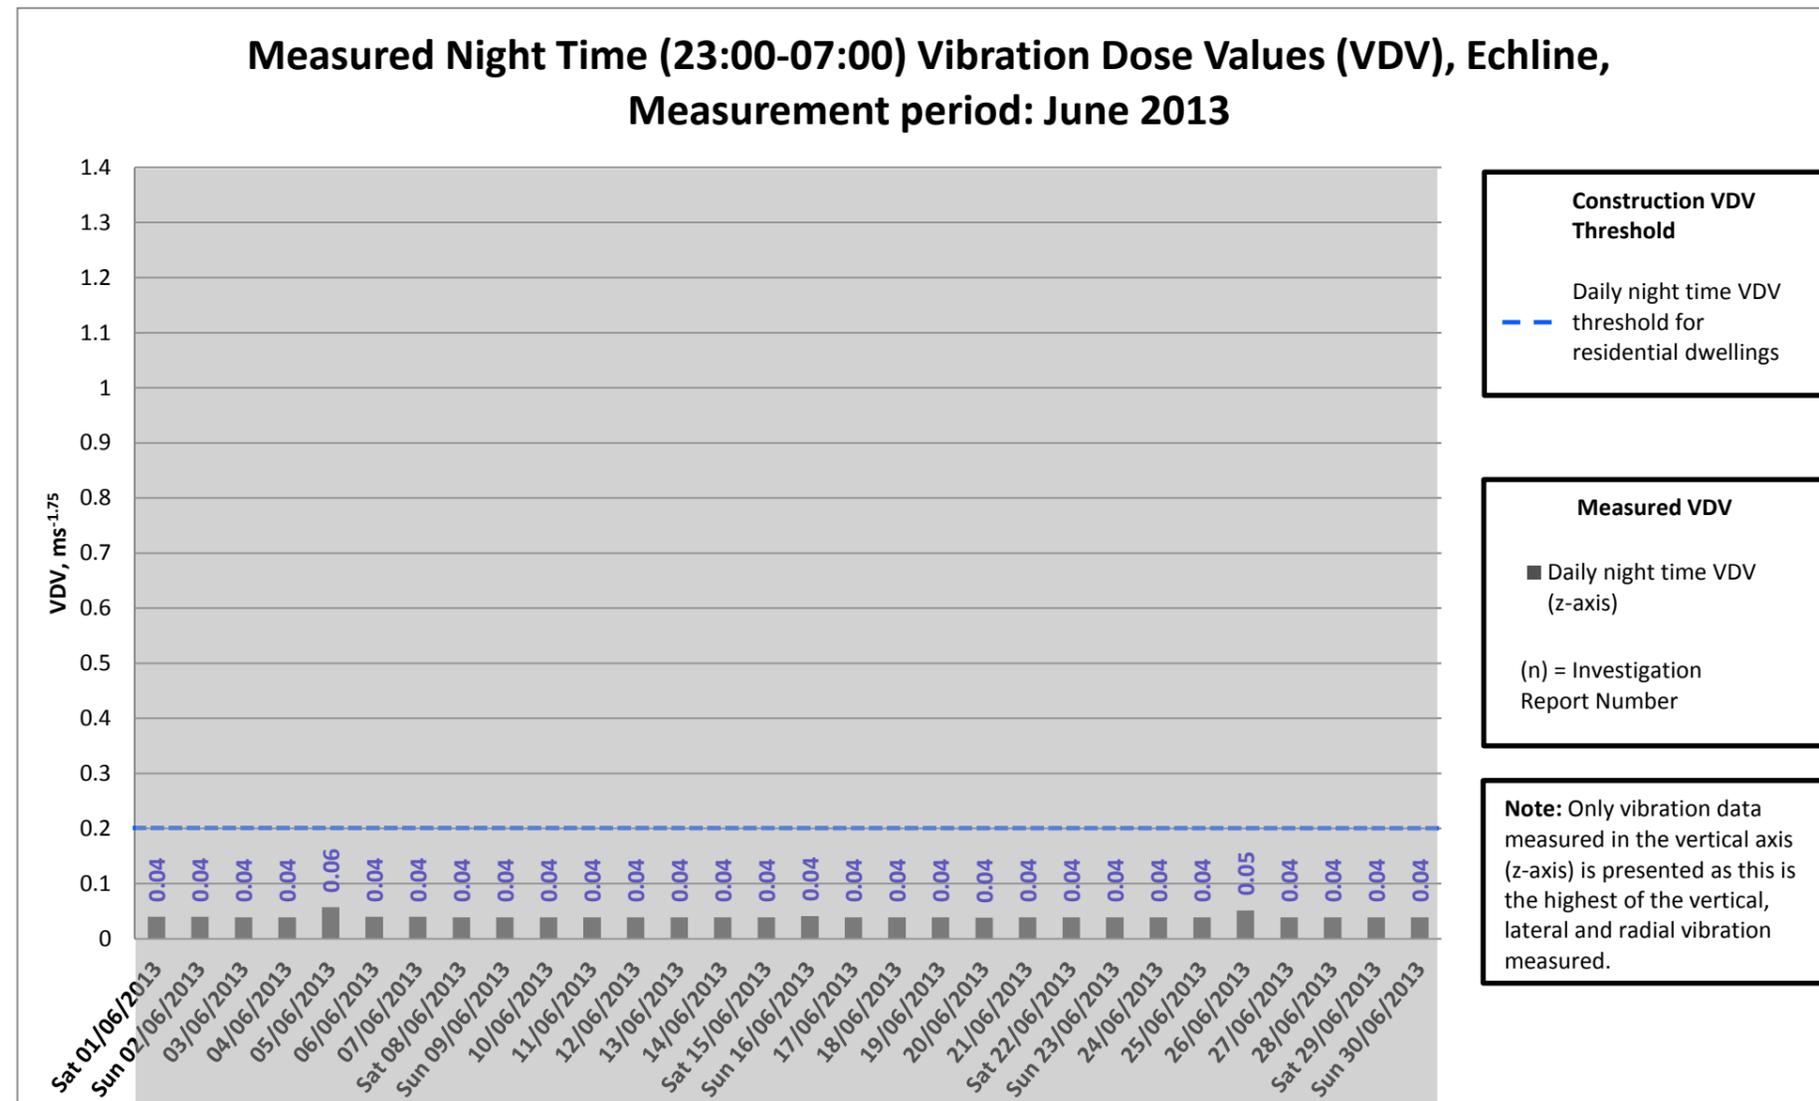
- The grey areas of the chart represent the days on which no construction works were undertaken; no night time works were conducted in the vicinity of the Echline vibration monitor throughout the month of June 2013. This graph is included for illustrative purposes only.

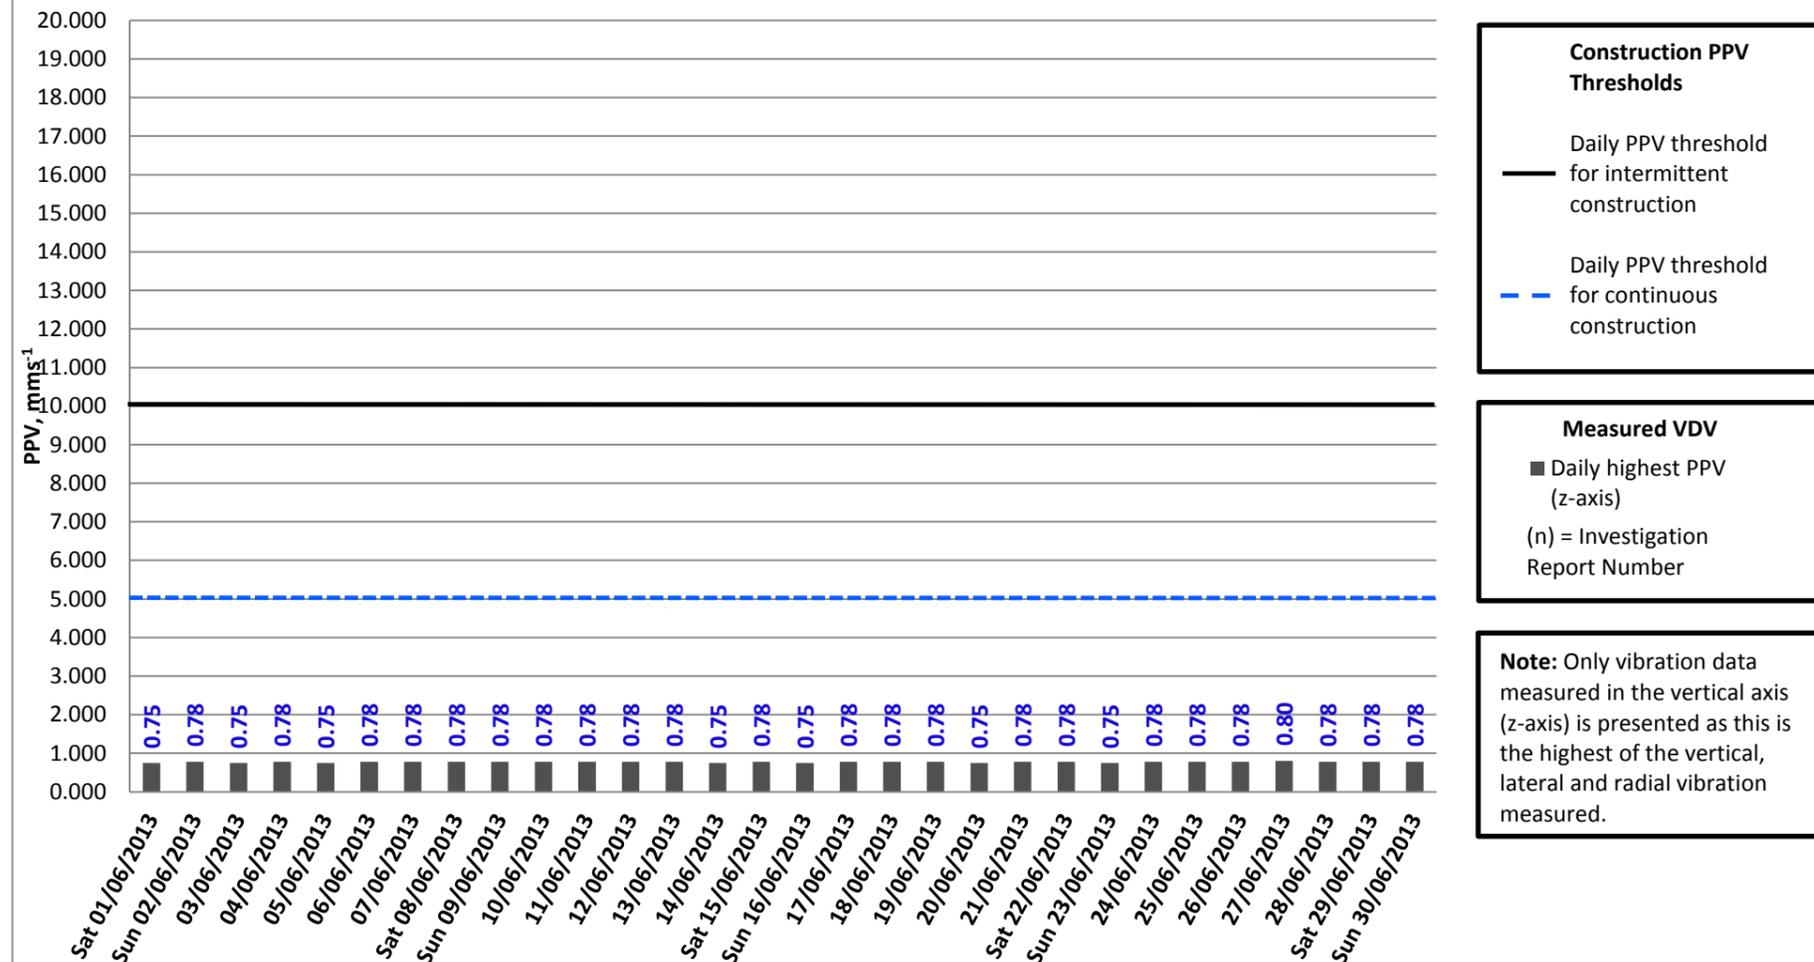
Measured highest Daily Peak Particle Velocity (PPV), Inchgarvie Lodge, Measurement period: June 2013

Note: Only vibration data measured in the vertical axis (z-axis) is presented as this is the highest of the vertical, lateral and radial vibration measured.

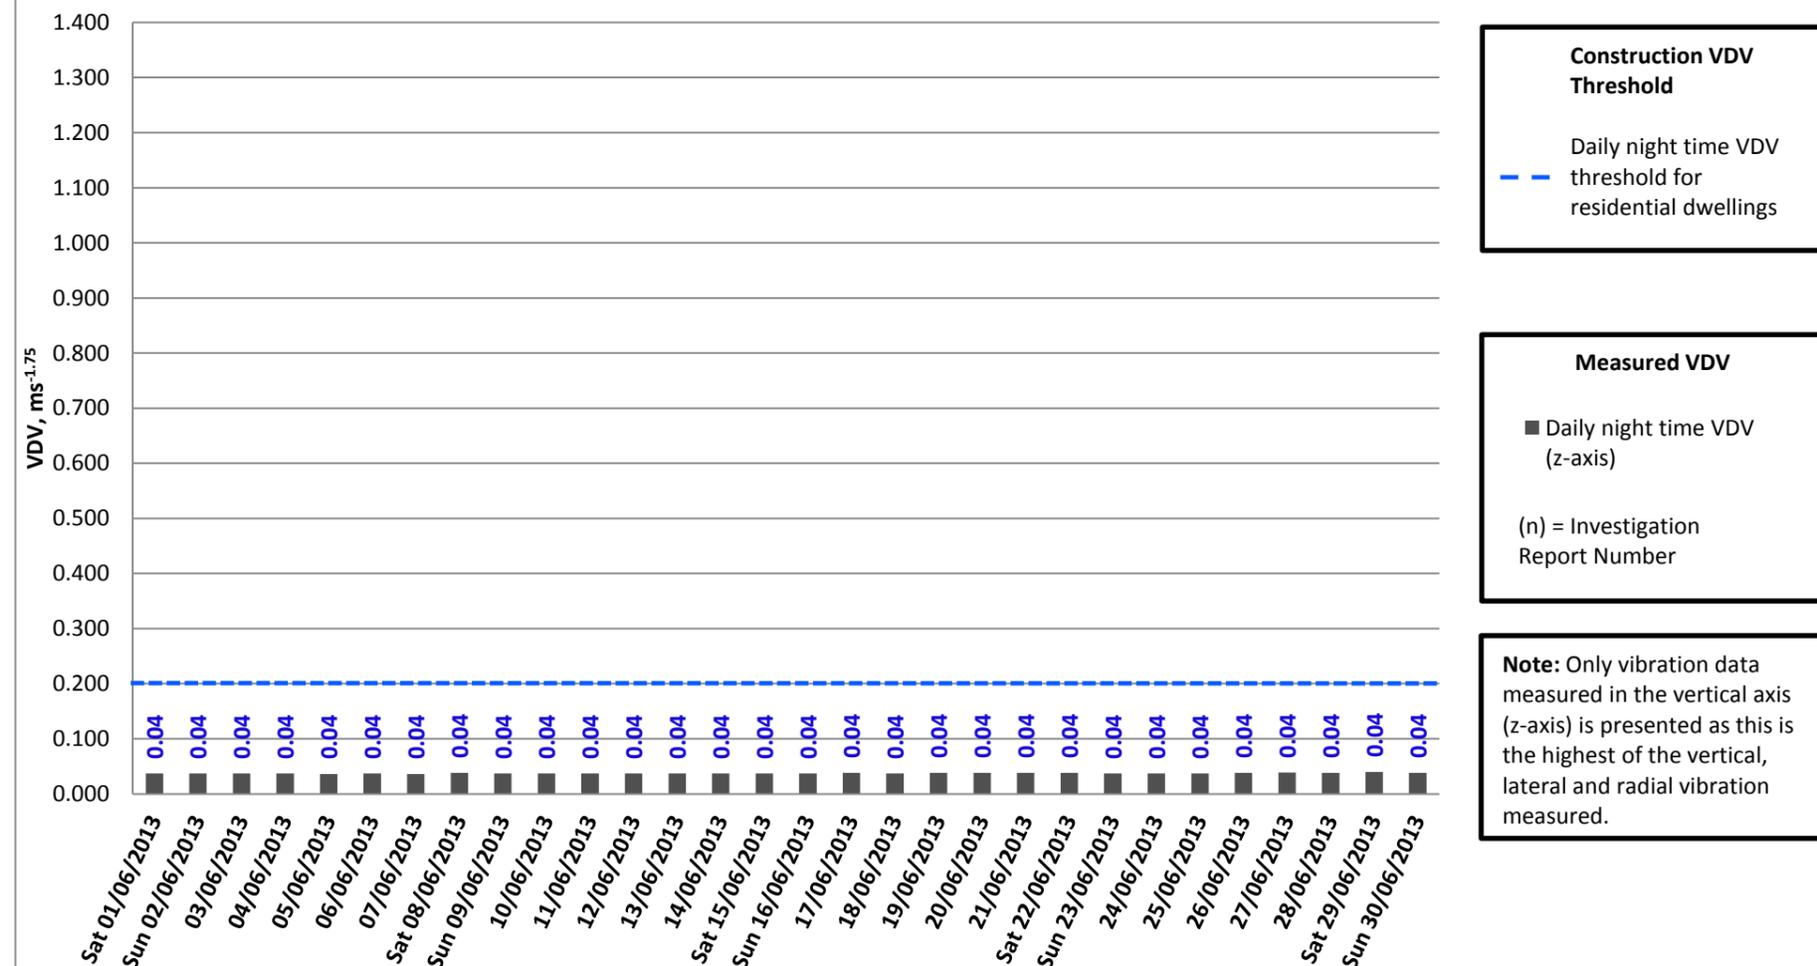
Measured Night Time (23:00-07:00) Vibration Dose Values (VDV), Inchgarvie Lodge, Measurement period: June 2013

Note: Only vibration data measured in the vertical axis (z-axis) is presented as this is the highest of the vertical, lateral and radial vibration measured.

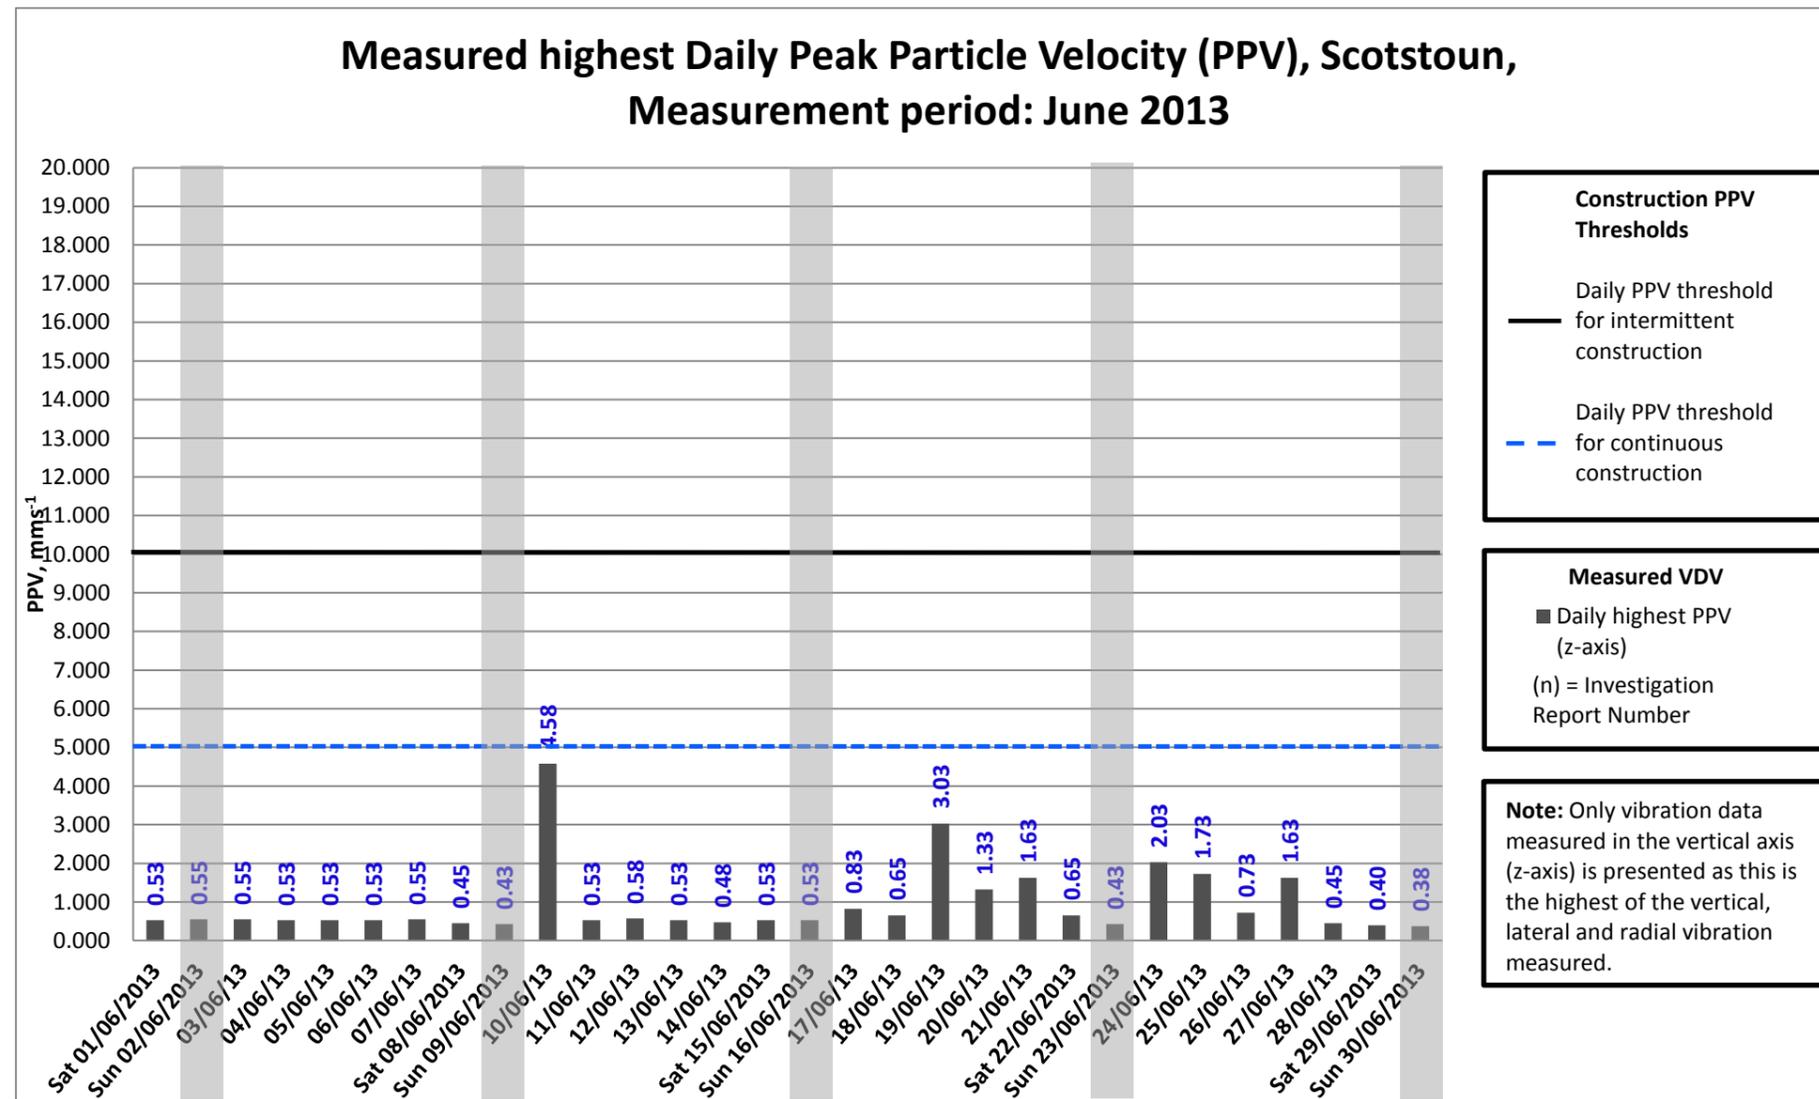
- The grey areas of the chart represent the days on which no construction works were undertaken; no works were conducted on Sundays.

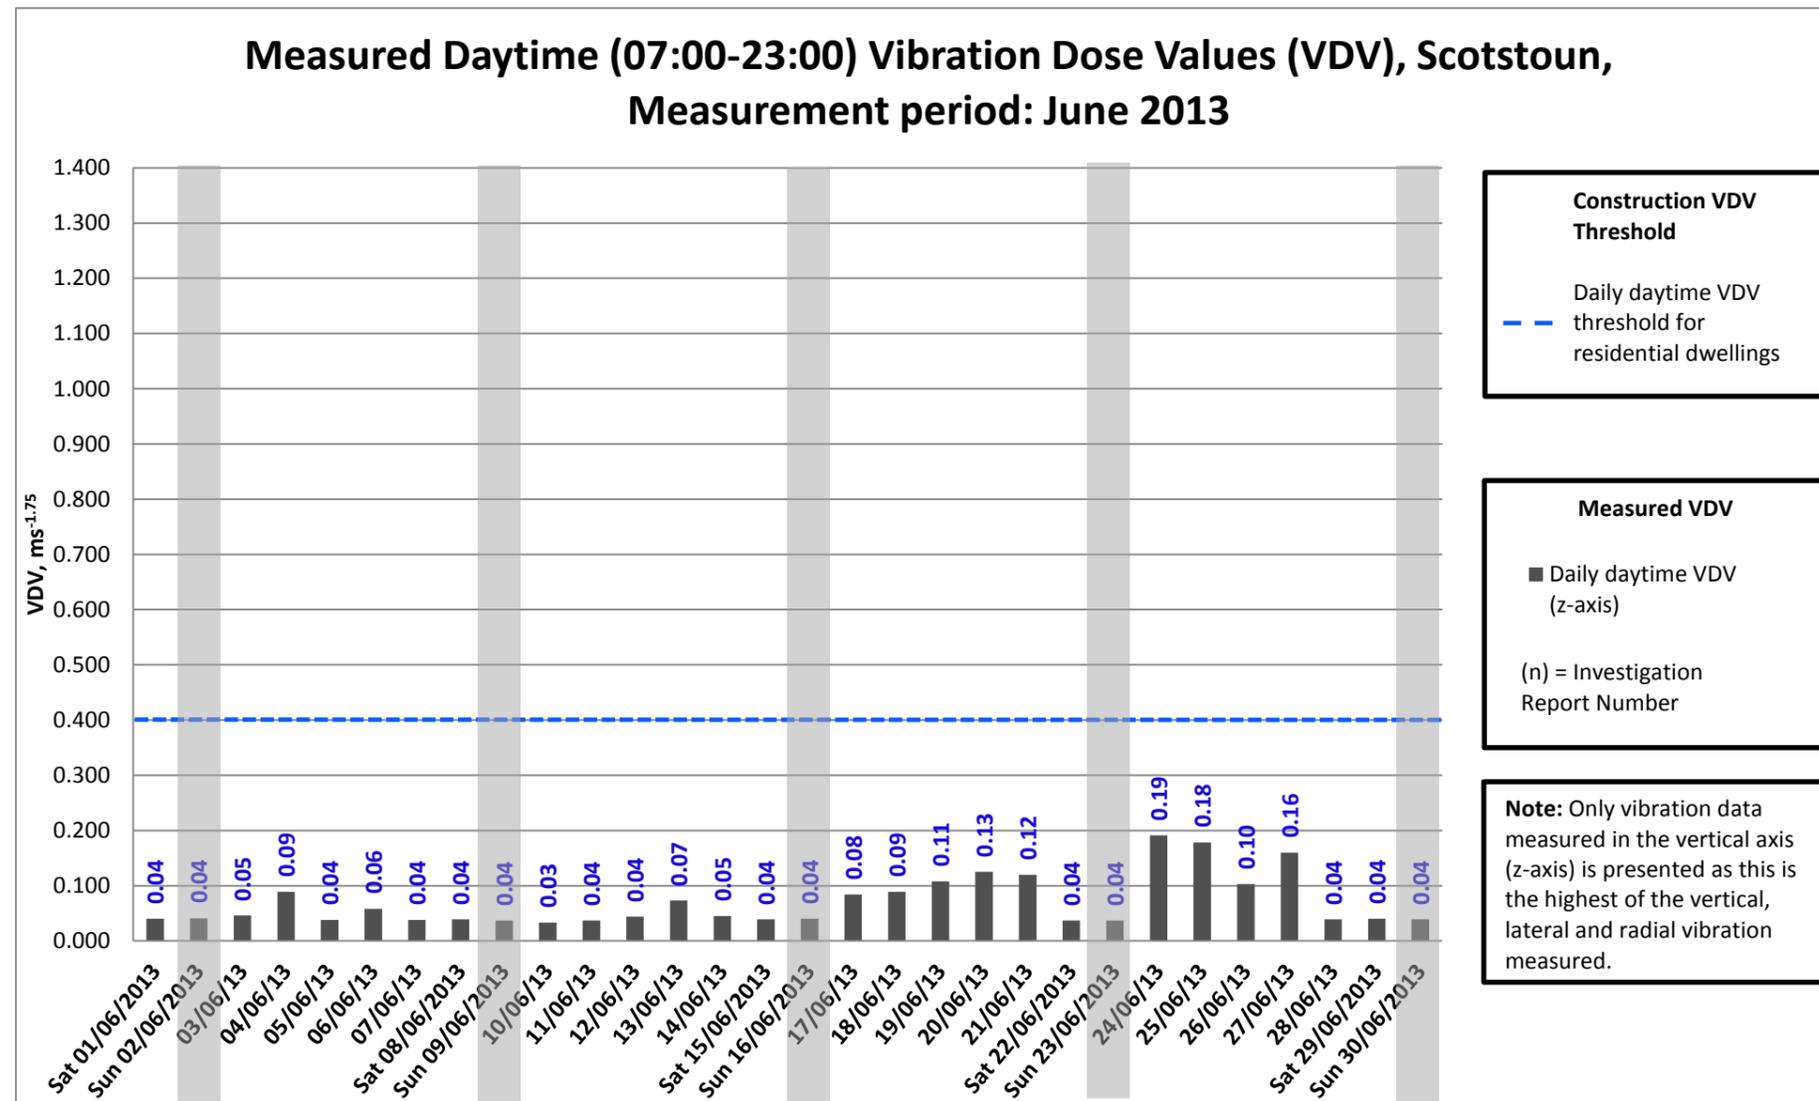
- The grey areas of the chart represent the days on which no construction works were undertaken; no works were conducted on Sundays.

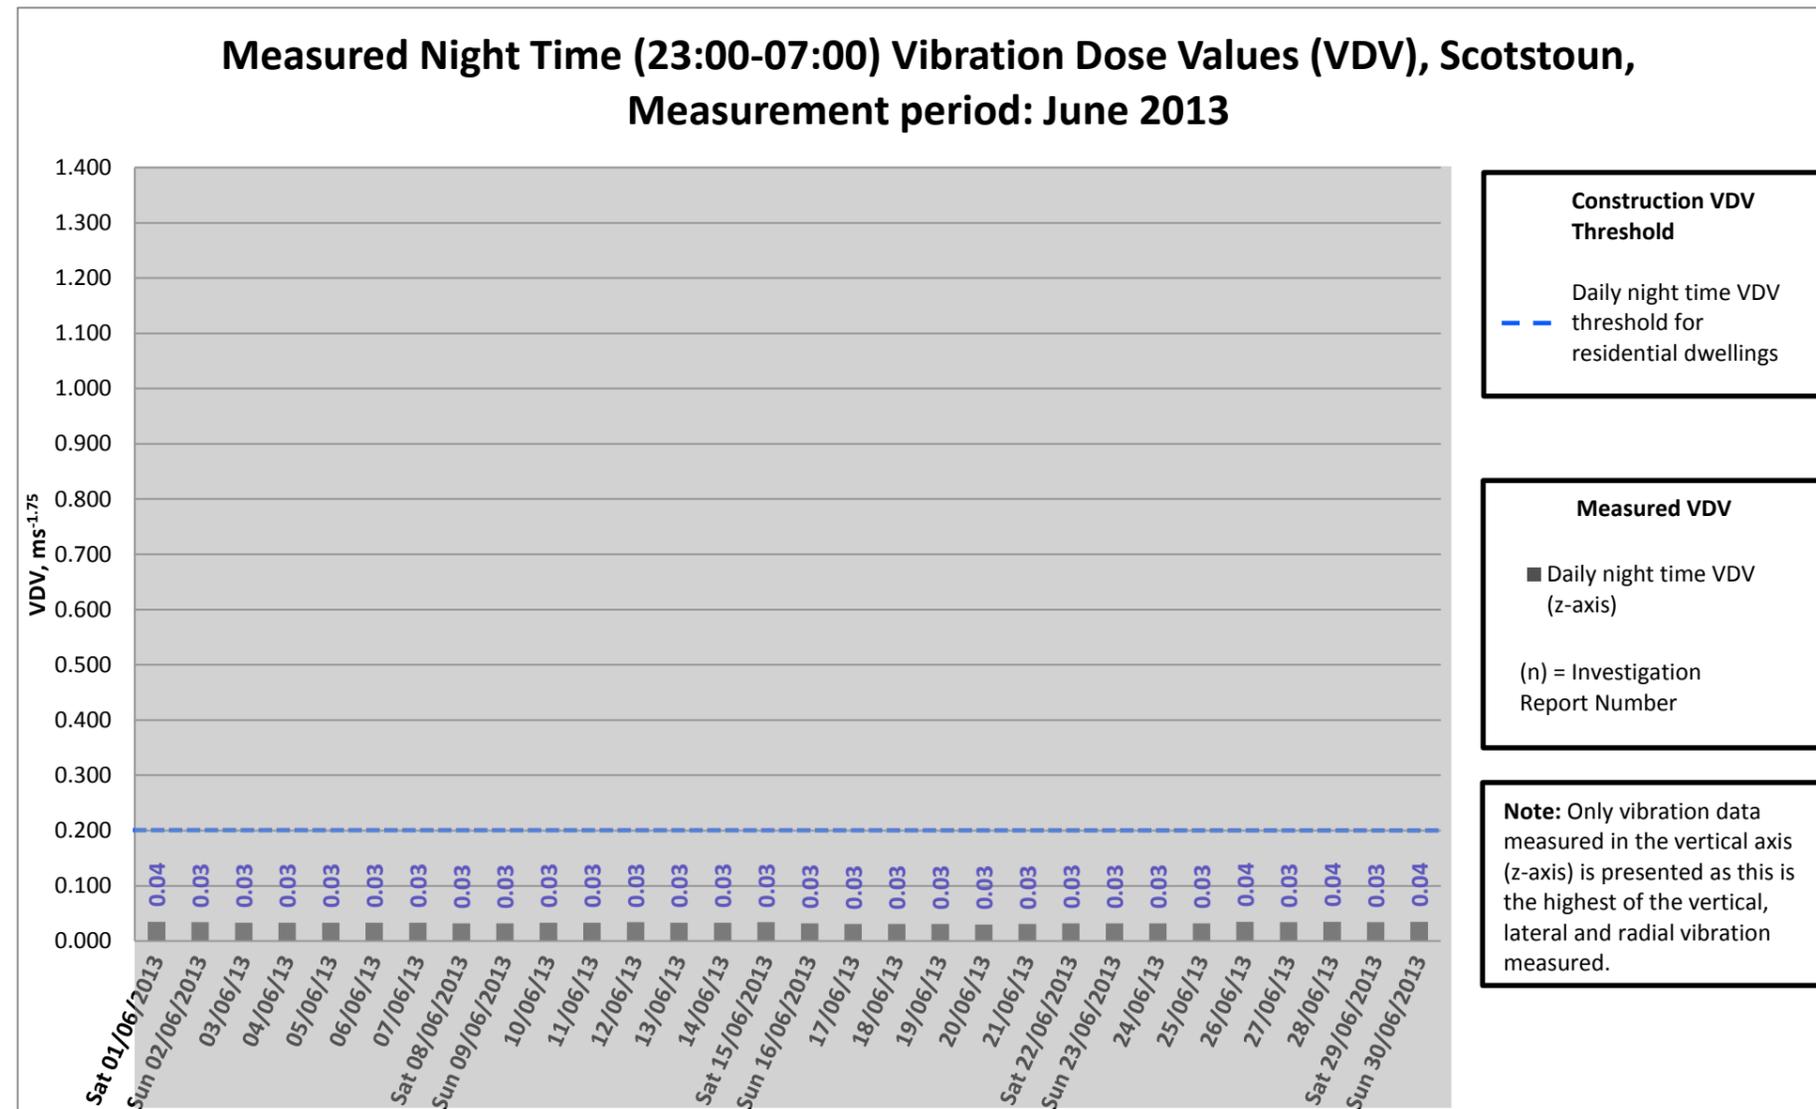
- The grey areas of the chart represent the days on which no construction works were undertaken; no night time works were conducted in the vicinity of the Scotstoun vibration monitor throughout the month of June 2013. This graph is included for illustrative purposes only.

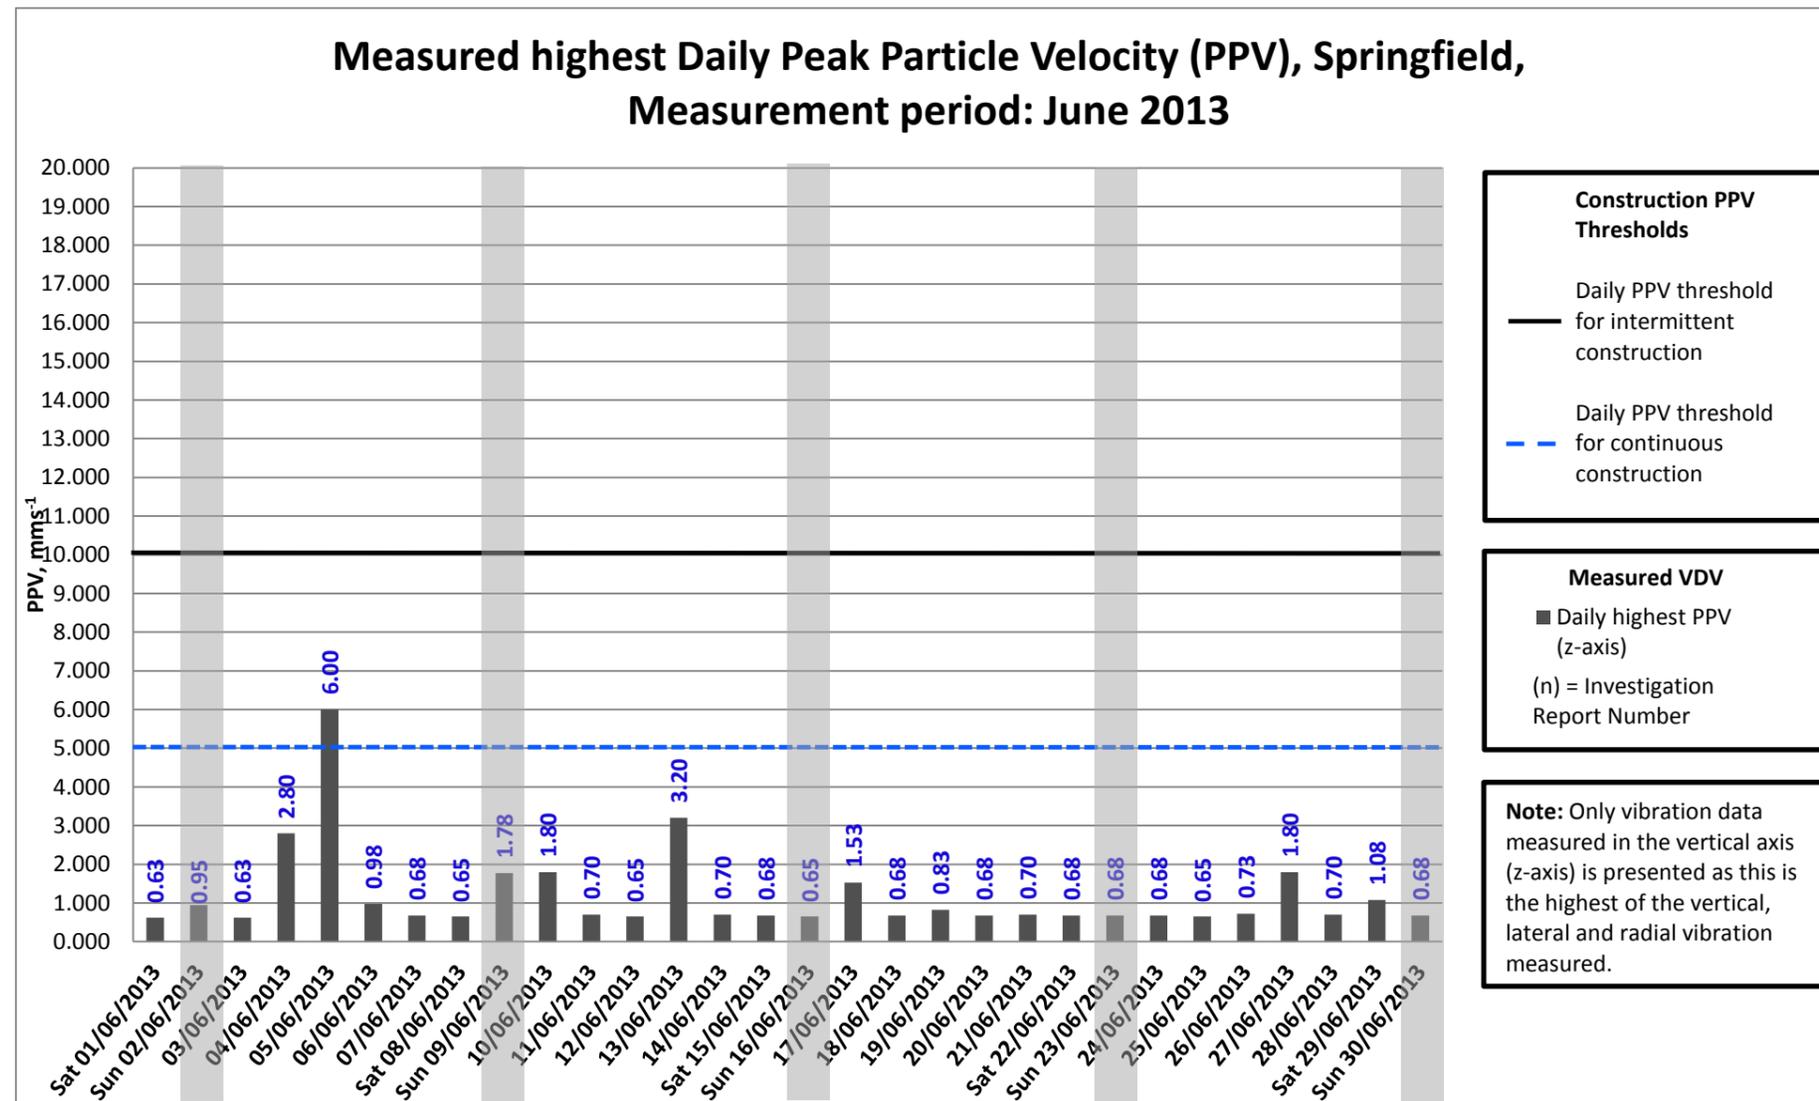
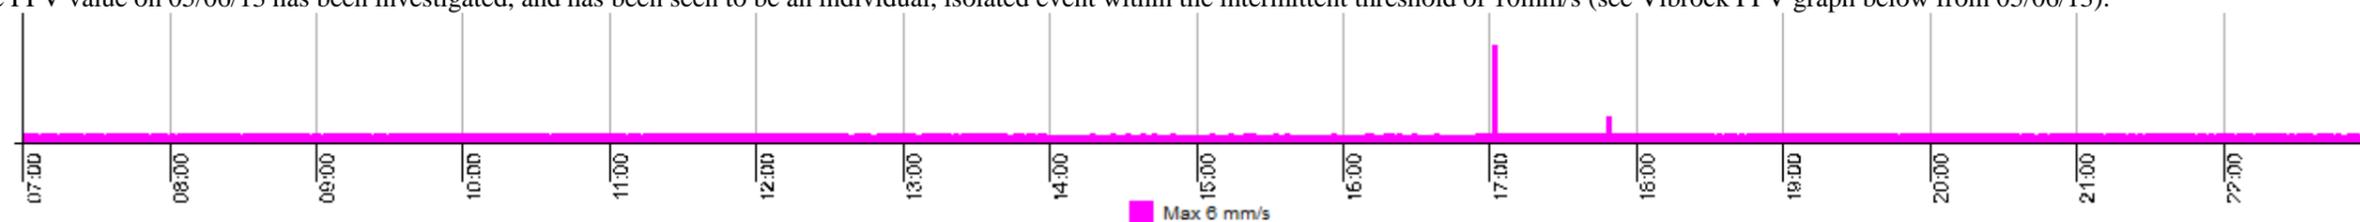
- The grey areas of the chart represent the days on which no construction works were undertaken; no works were conducted on Sundays.
- The PPV value on 05/06/13 has been investigated, and has been seen to be an individual, isolated event within the intermittent threshold of 10mm/s (see Vibrock PPV graph below from 05/06/13).

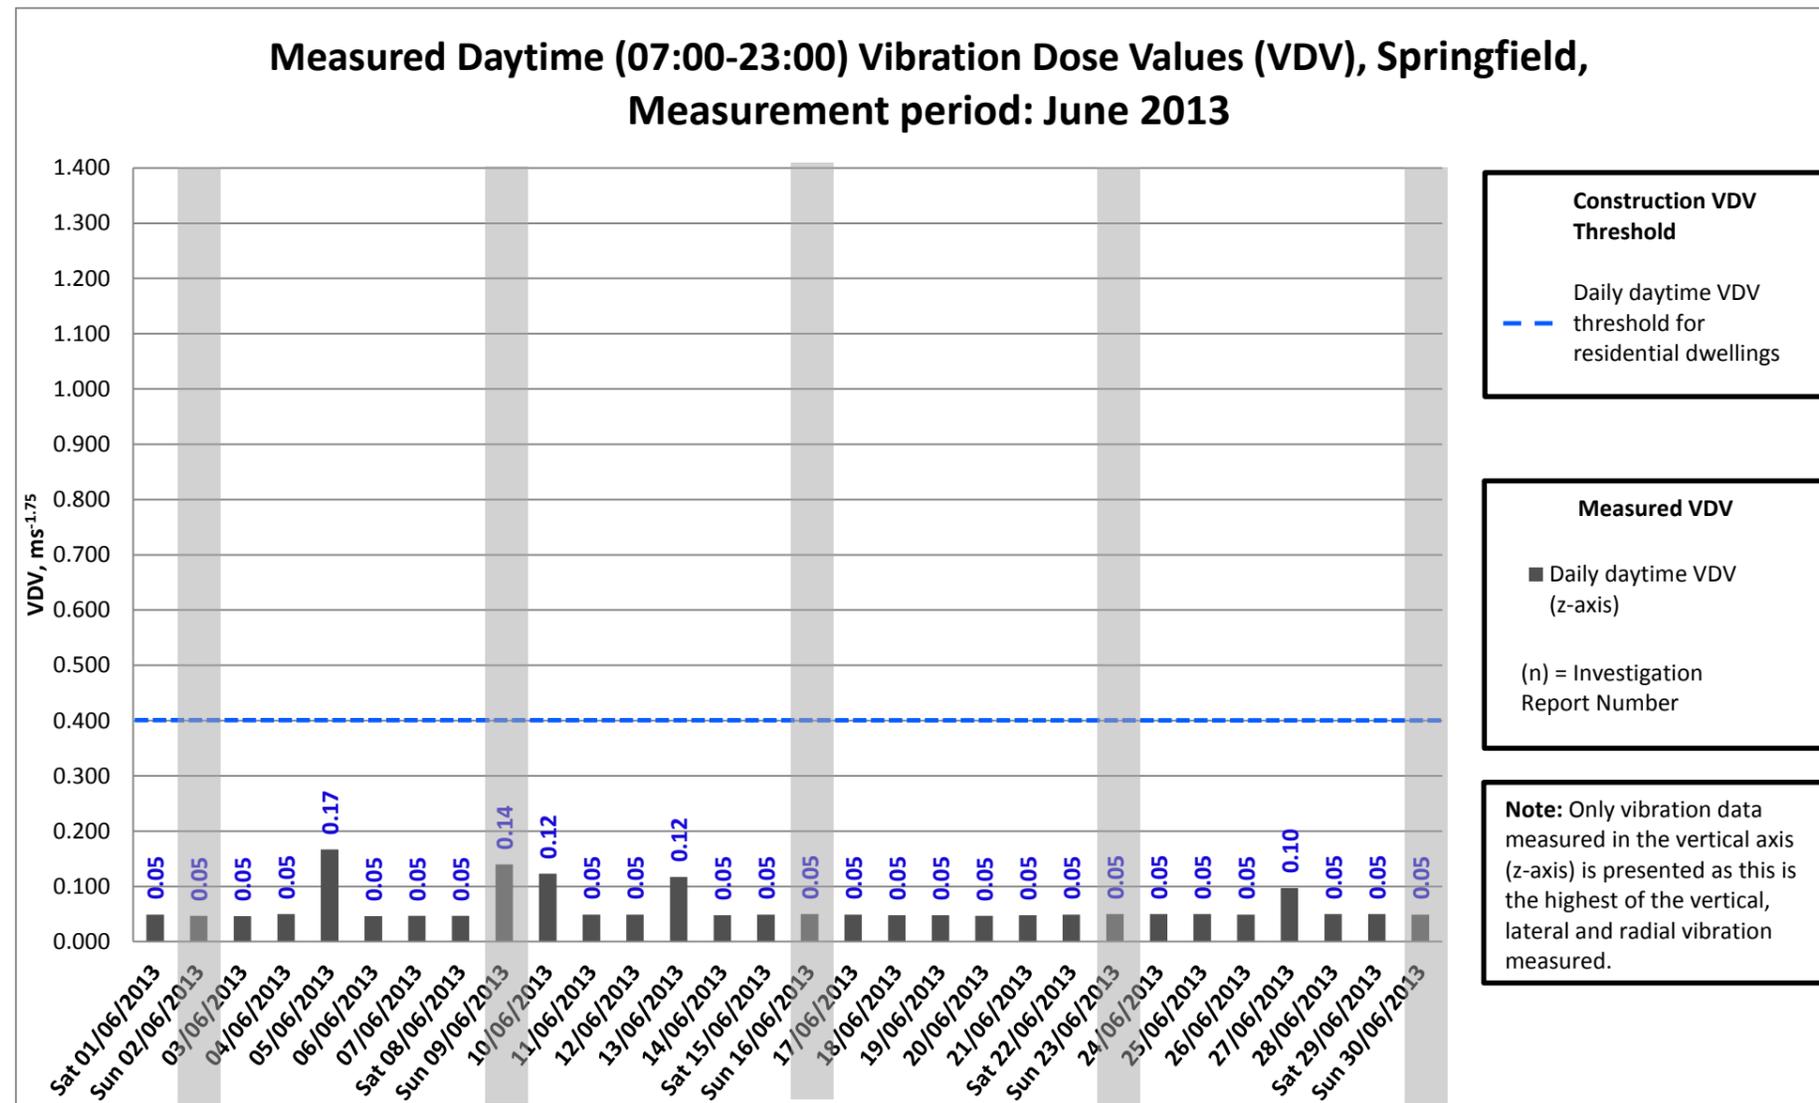
- The grey areas of the chart represent the days on which no construction works were undertaken; no works were conducted on Sunday.

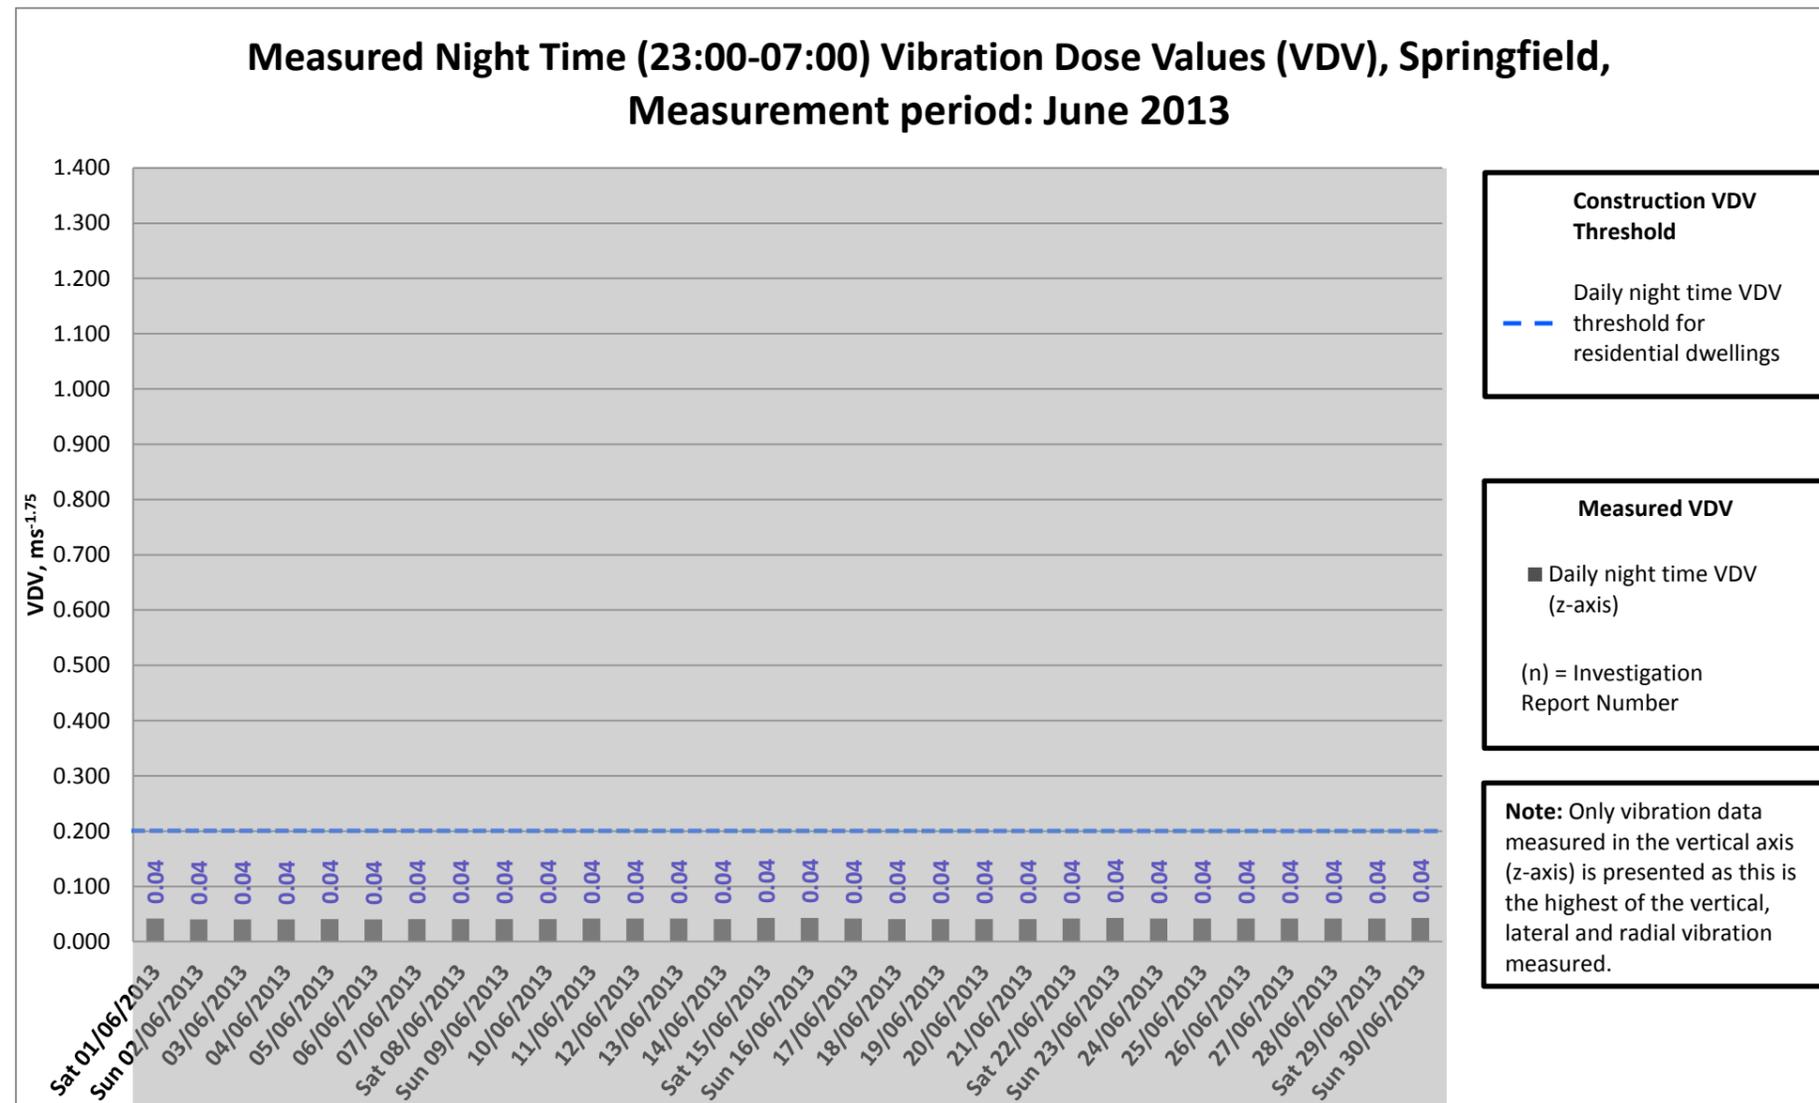
- The grey areas of the chart represent the days on which no construction works were undertaken; no night time works were conducted in the vicinity of the Springfield vibration monitor throughout the month of June 2013. This graph is included for illustrative purposes only.
