Project **FORTH REPLACEMENT CROSSING**

VIBRATION MONITORING REPORT
JUNE 2013

Document number	Rev
REP-00126	01

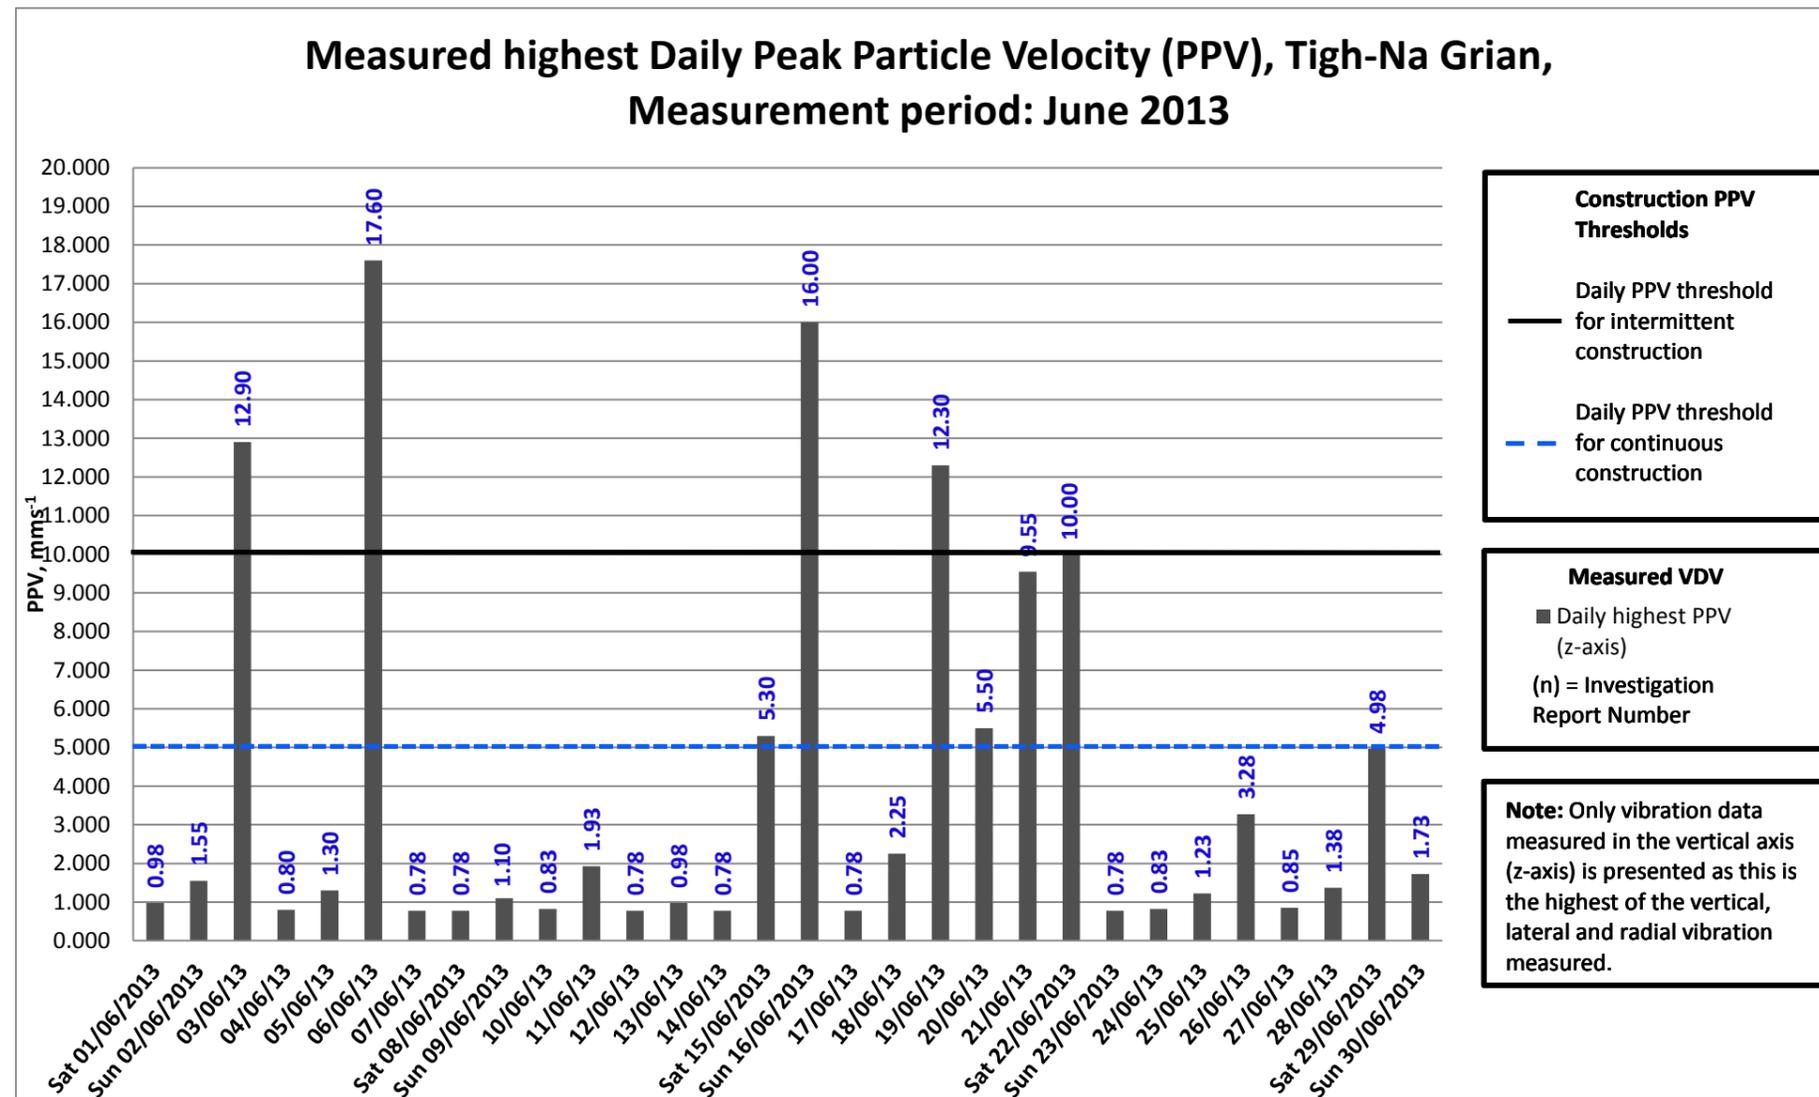
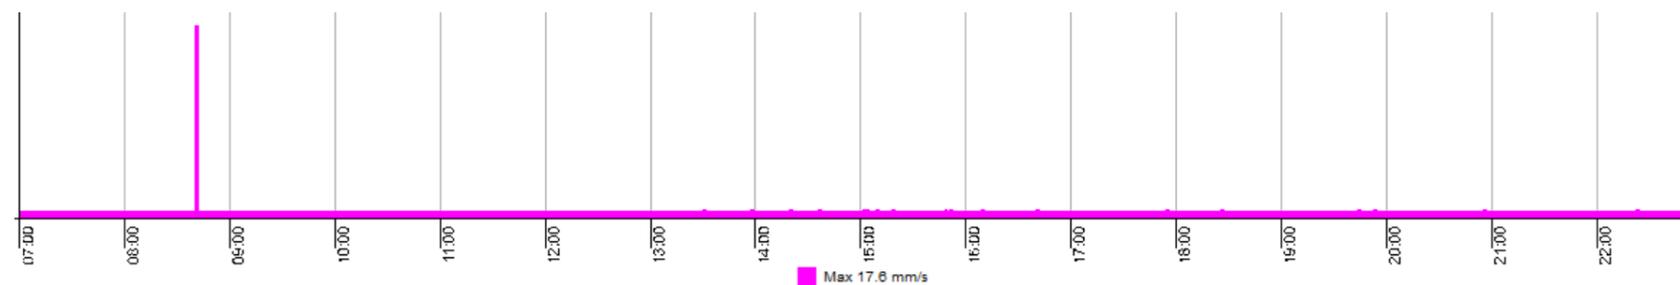
- The PPV values on 03/06/13, 06/06/13, 15/06/13, 16/06/13, 19/06/13, 20/06/13, 21/06/13 and 22/06/13 have been investigated, and have been seen to be individual, isolated events within each period (see Vibrock PPV graph below from 06/06/13). Furthermore, these particular levels cannot have been generated as a result of FCBC construction, as the only the works to be conducted throughout the month of June in vicinity of the monitor, was airlifting works at the North Tower, which is over 250m from the monitor, and did not involve the use of any vibration inducing plant or equipment.

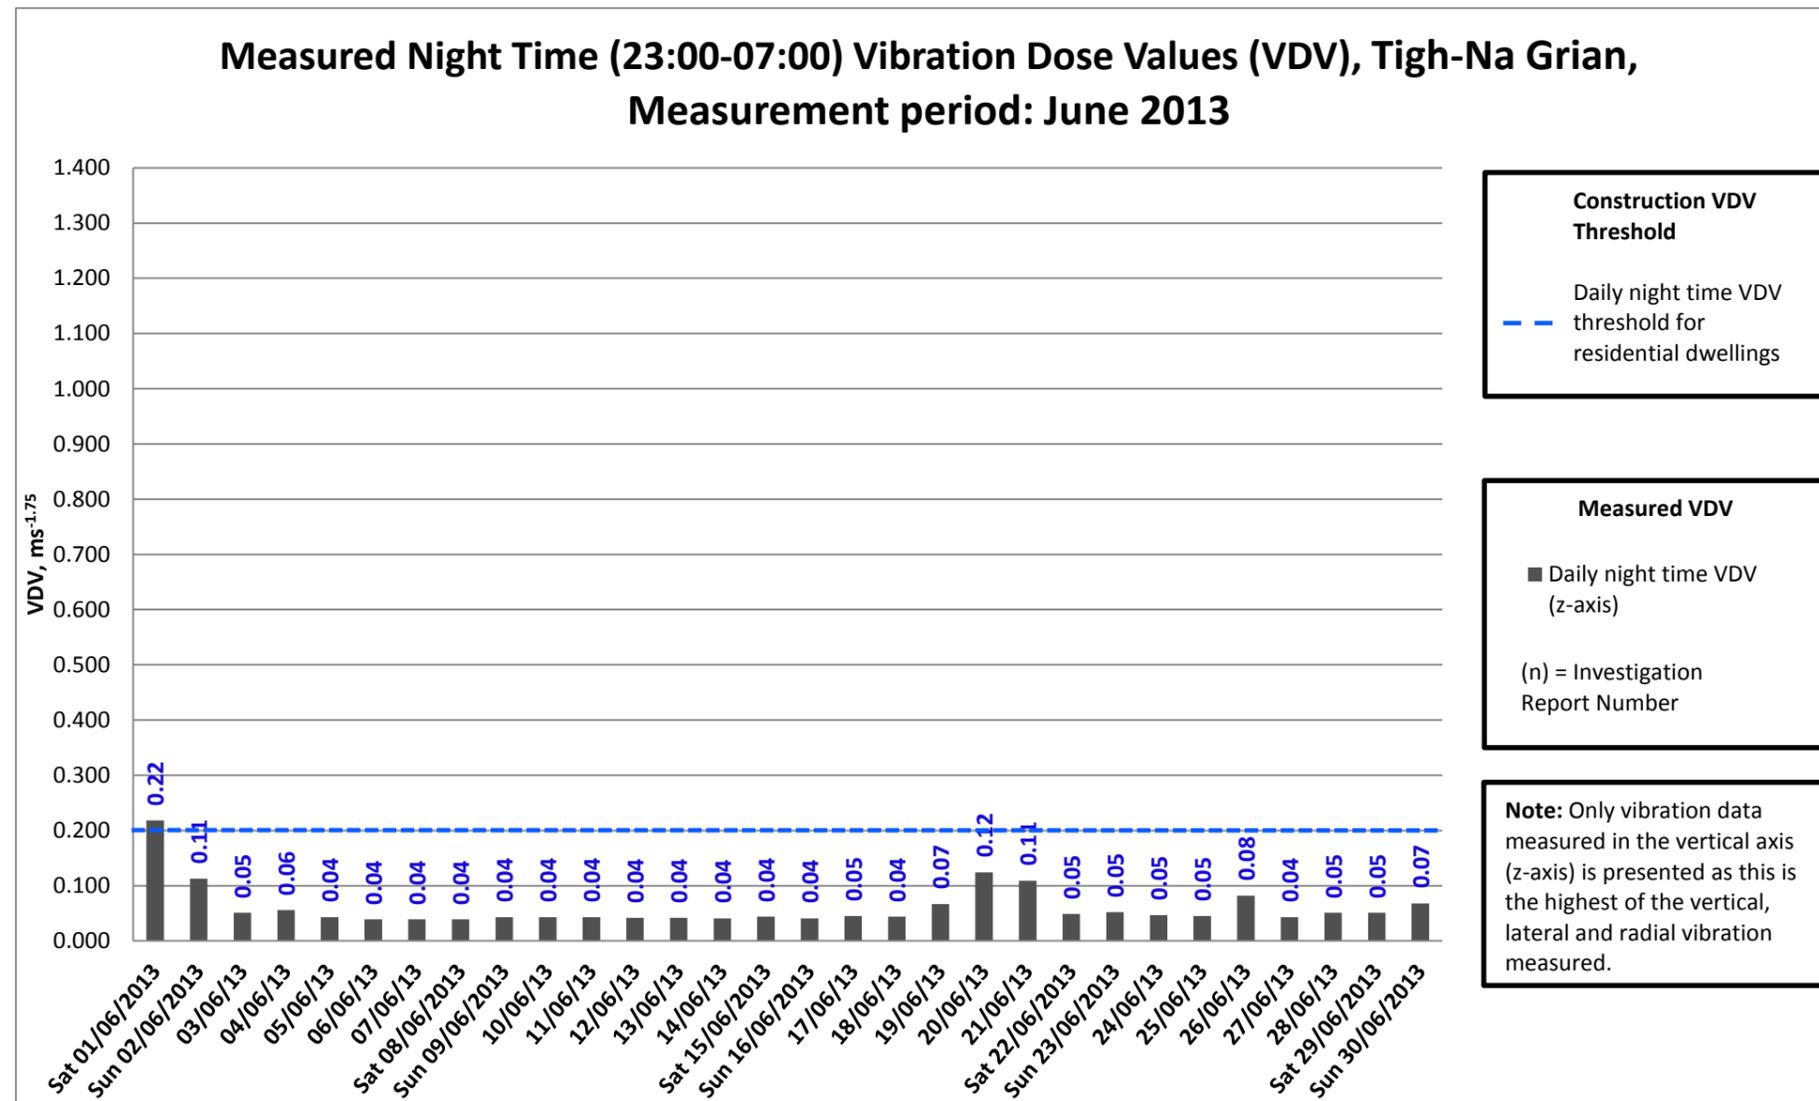
- The VDV exceedances recorded during June 2013 have been investigated, and cannot have been generated as a result of FCBC construction, as the only the works to be conducted throughout the month of June in vicinity of the monitor, was airlifting works at the North Tower, which is over 250m from the monitor, and did not involve the use of any vibration inducing plant or equipment.

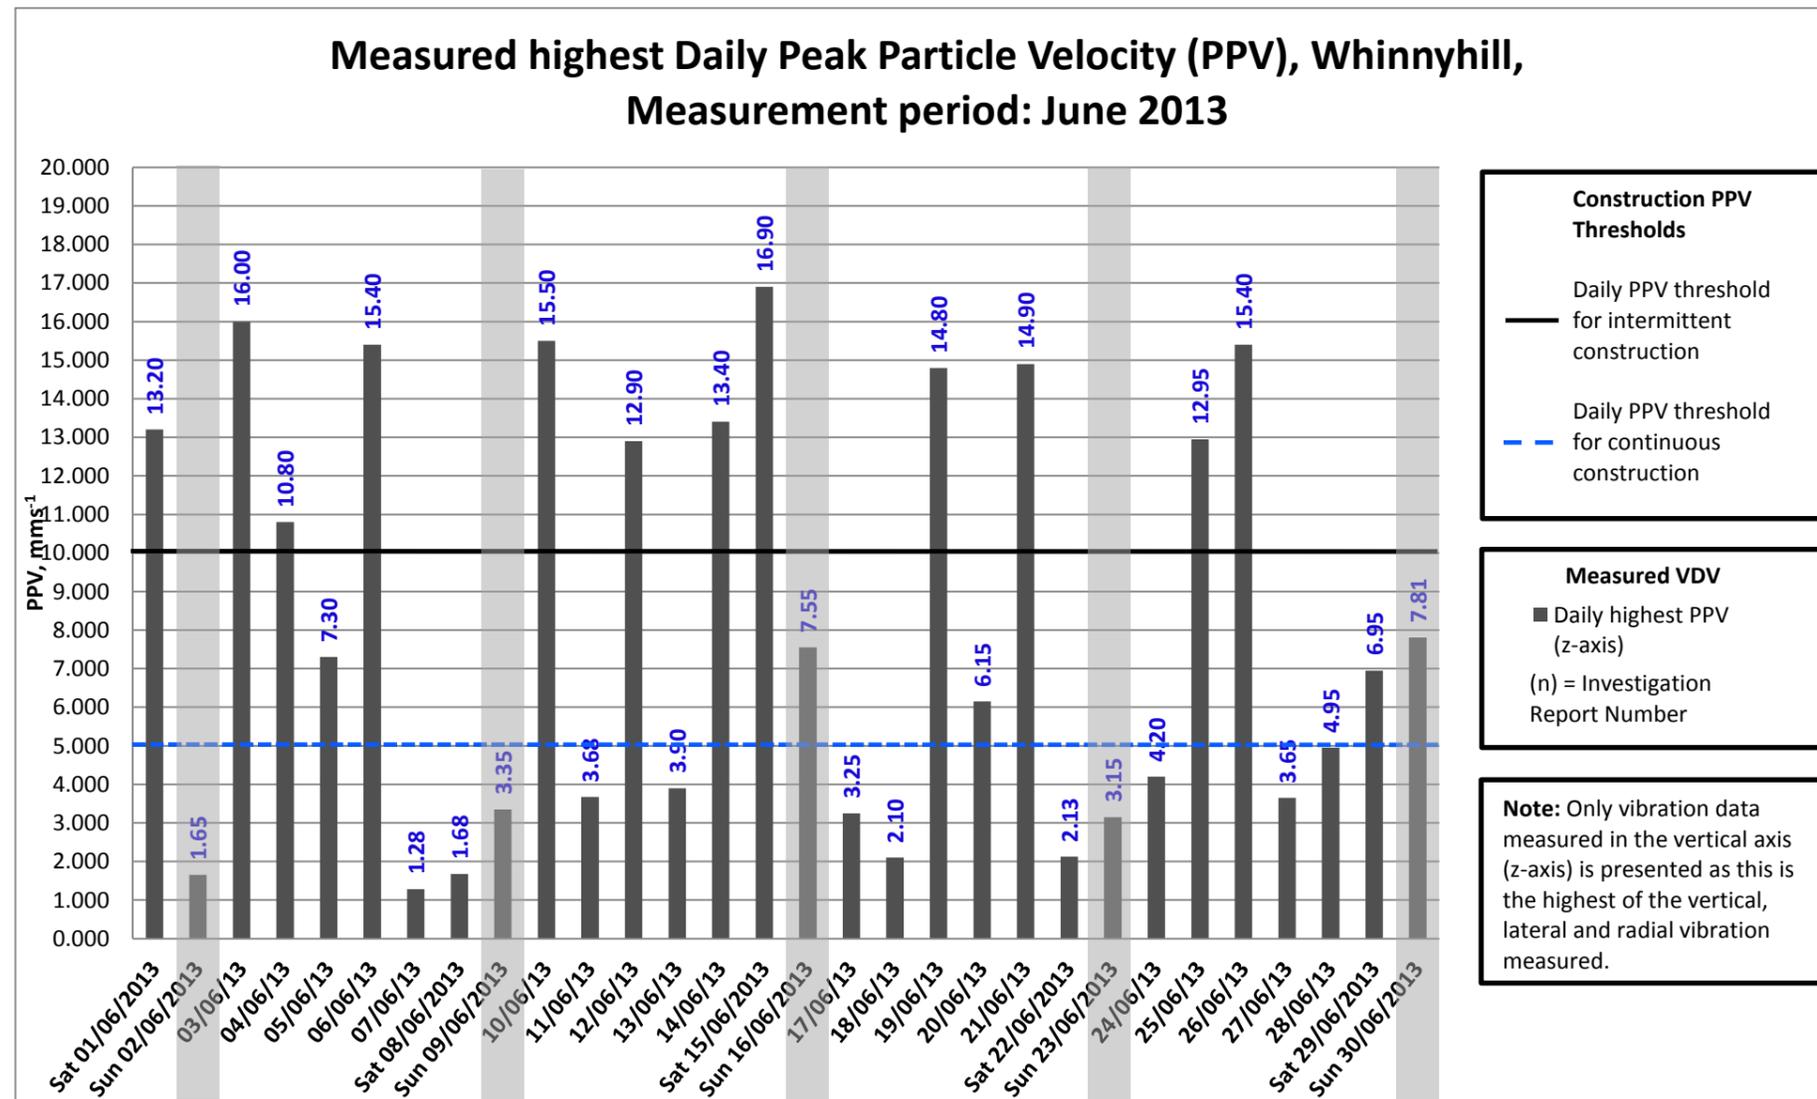
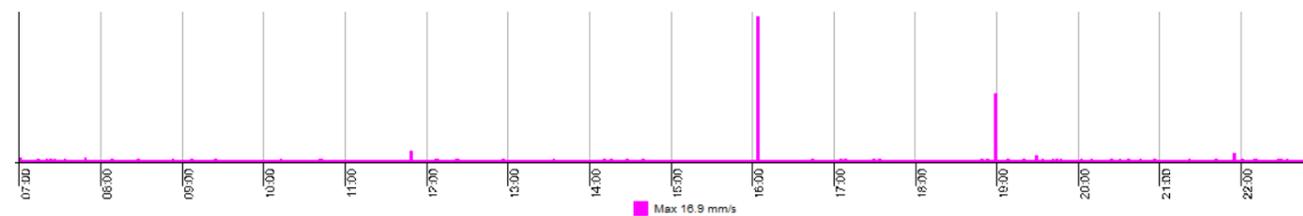
- The grey areas of the chart represent the days on which no construction works were undertaken; no works were conducted on Sundays.
- The PPV values on 01/06/13, 03/06/13, 04/06/13, 05/06/13, 06/06/13, 10/06/13, 12/06/13, 14/06/13, 15/06/13, 16/06/13, 19/06/13, 20/06/13, 21/06/13, 25/06/13, 26/06/13, 29/06/13 and 30/06/13 have been investigated, and have been seen to be individual, isolated events within each period (see Vibrock PPV graph below from 15/06/13). Furthermore, these particular levels cannot have been generated as a result of FCBC construction, as the only work to be conducted throughout the month of June in the vicinity of the monitor, were the band drains at King Malcolm Drive and the excavation works at Castlandhill Road, which are over 270m from the monitor, and did not involve the use of any vibration inducing plant or equipment.

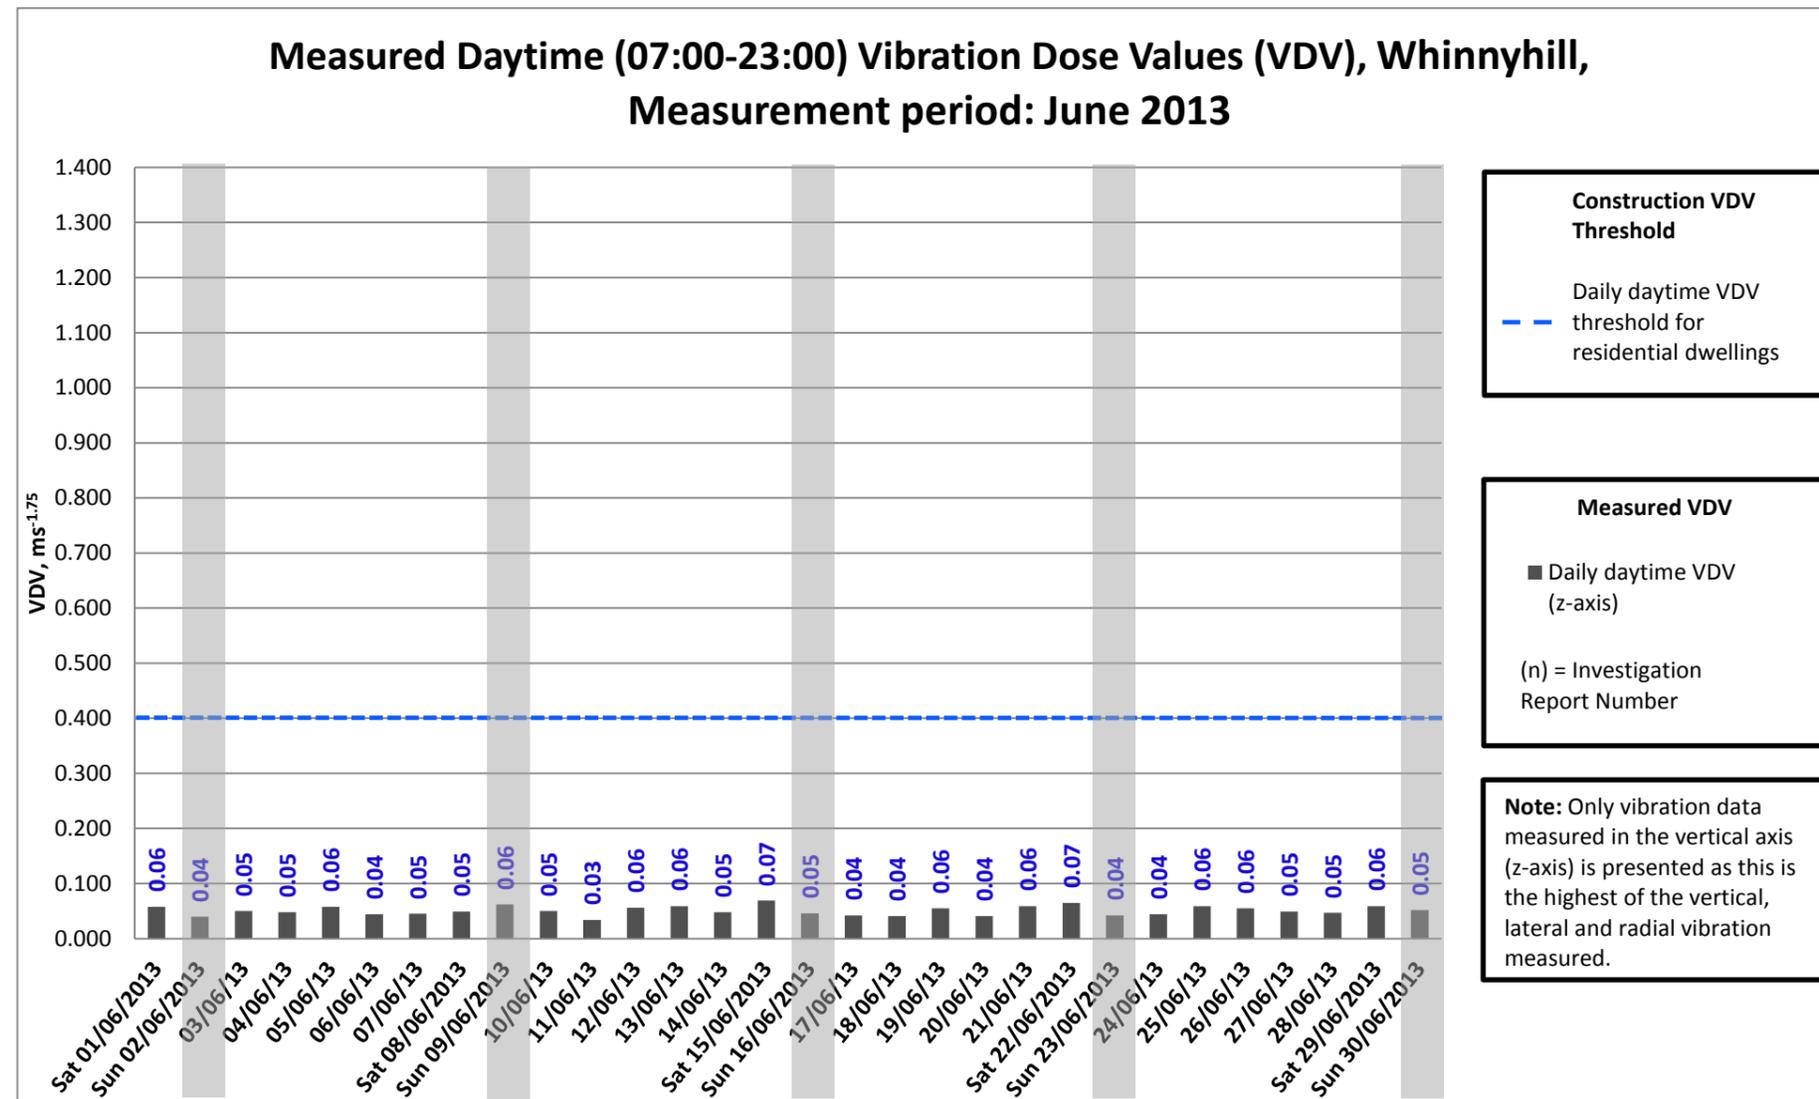
- The grey areas of the chart represent the days on which no construction works were undertaken; no works were conducted on Sundays.

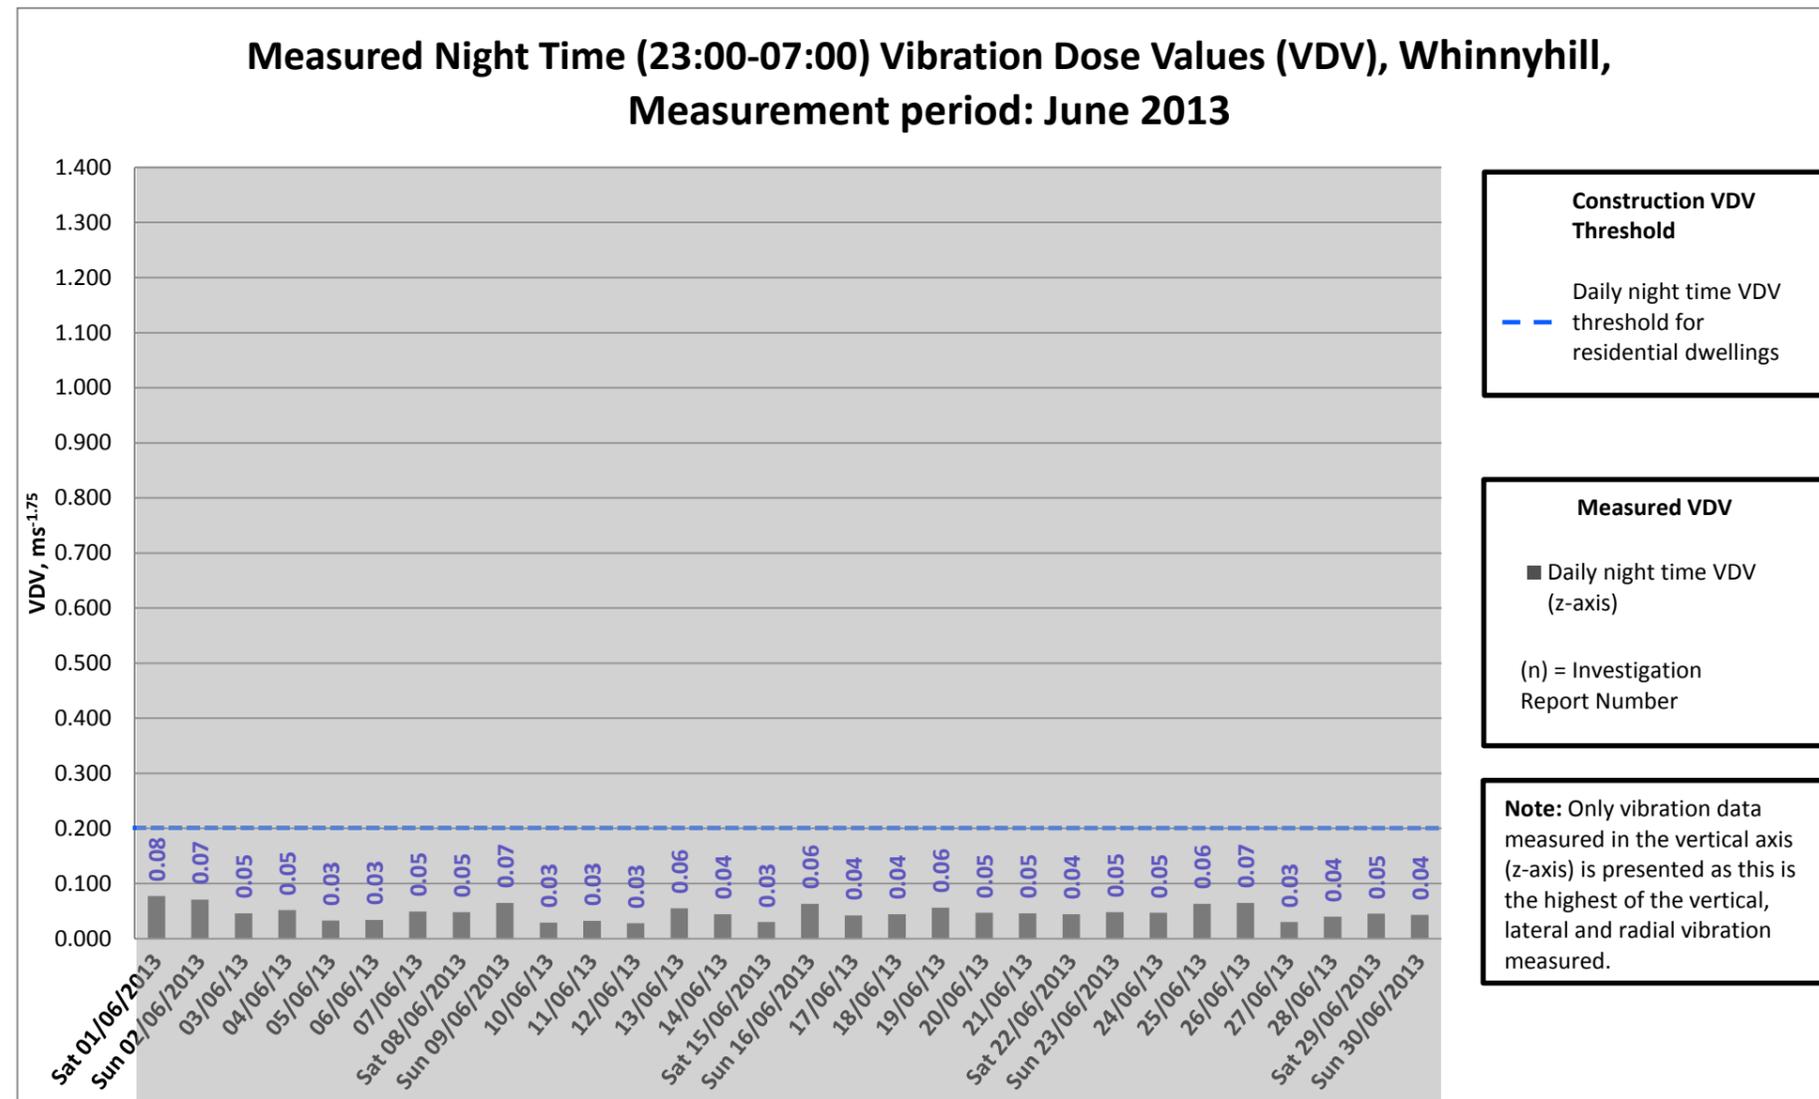
- The grey areas of the chart represent the days on which no construction works were undertaken; no night time works were conducted in the vicinity of the Whinnyhill vibration monitor throughout the month of June 2013. This graph is included for illustrative purposes only.
