Project **FORTH REPLACEMENT CROSSING**

**CONSTRUCTION NOISE MONITORING REPORT: FEBRUARY 2017**

**REP-00313**

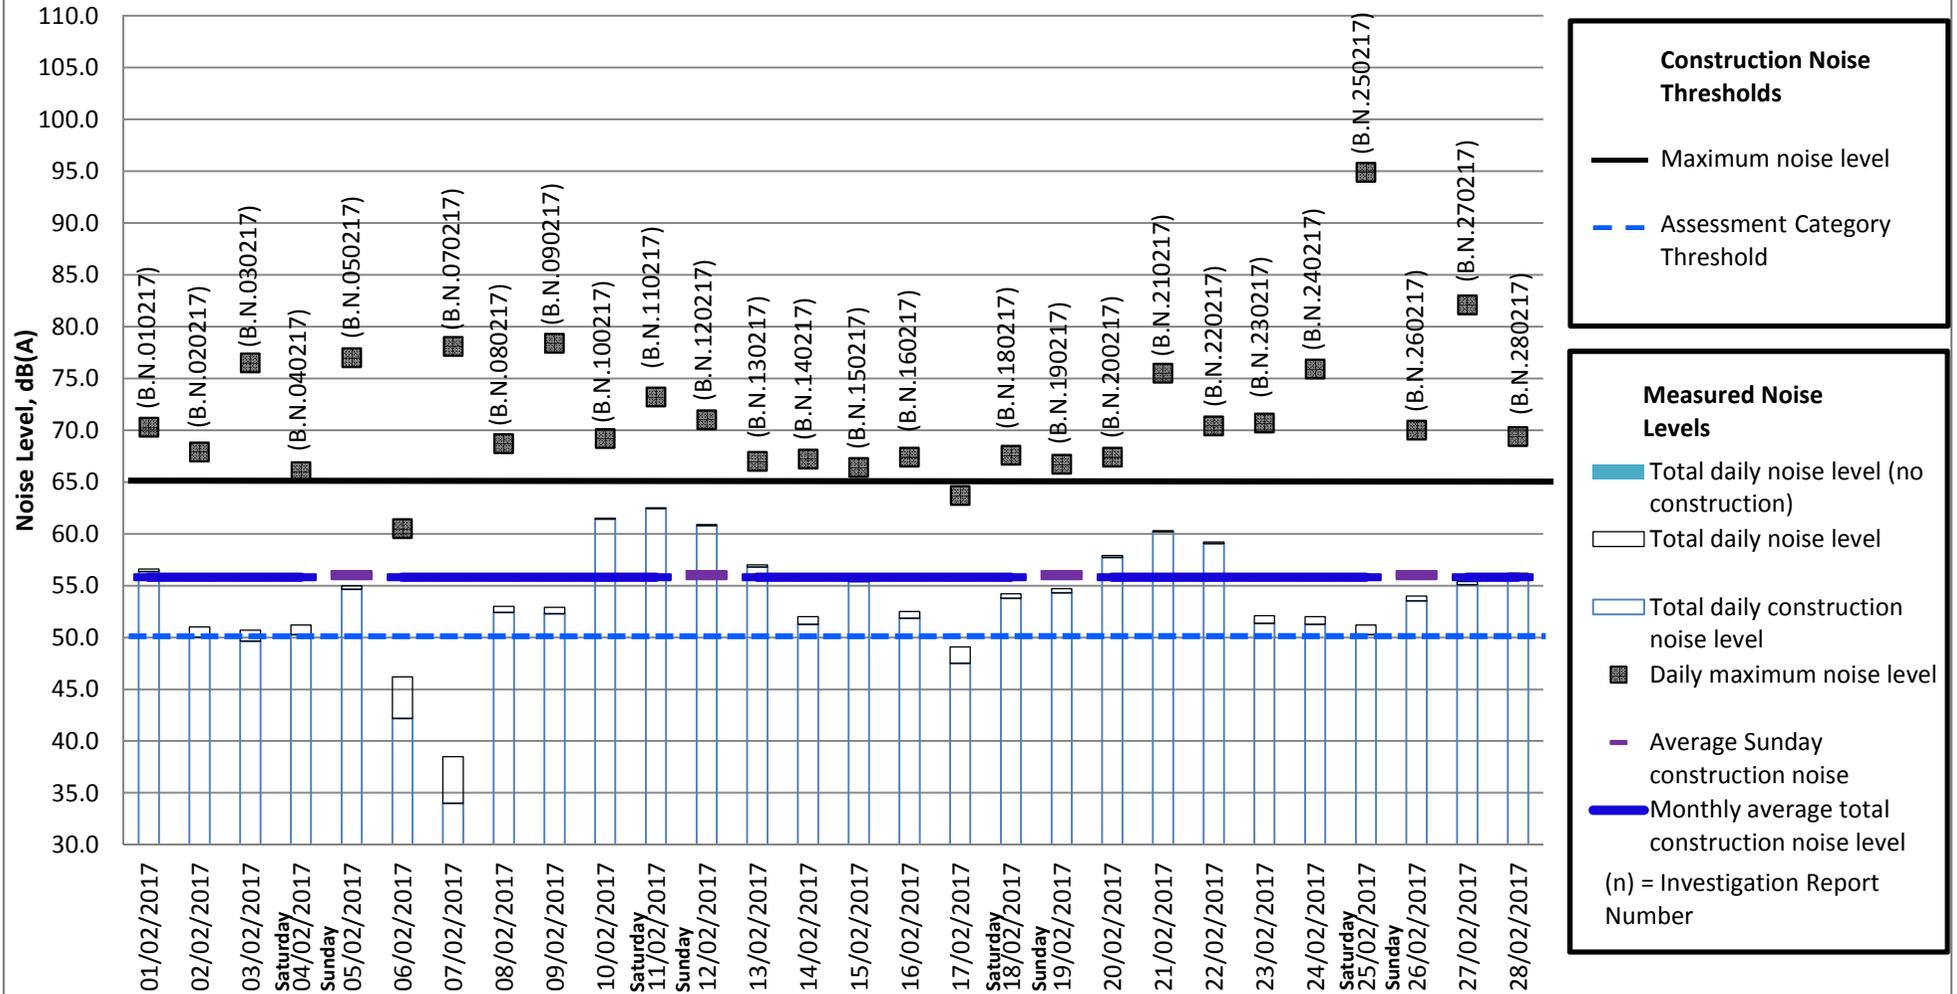
## Measured Night time Noise Levels at Butlaw Fisheries Measurement period: February 2017

**Note:** After investigation, it was concluded that the exceedance of the LAeq 'Total Daily Construction' throughout the month were caused by wind and waves

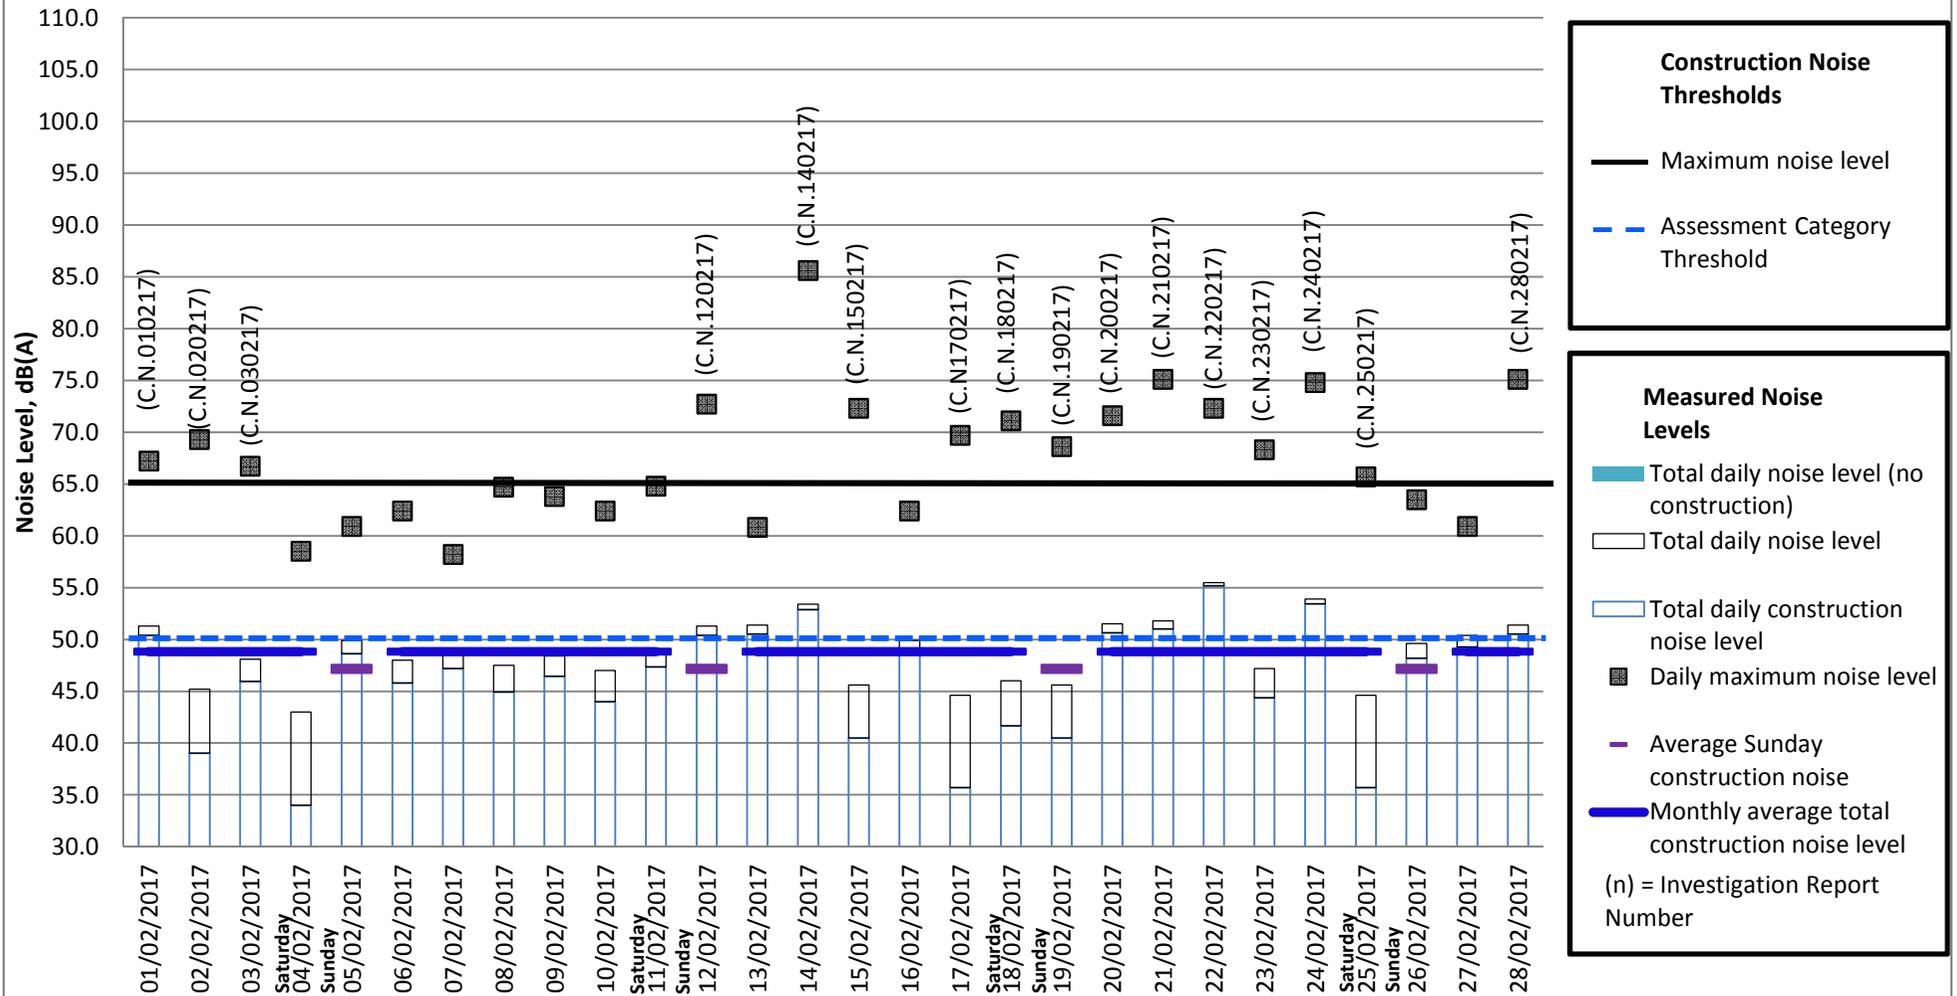
## Measured Night time Noise Levels at Clufflat Measurement period: February 2017

**Note:** After investigation, it was concluded that the exceedance of the LAeq 'Total Daily Construction' throughout the month were caused by wind

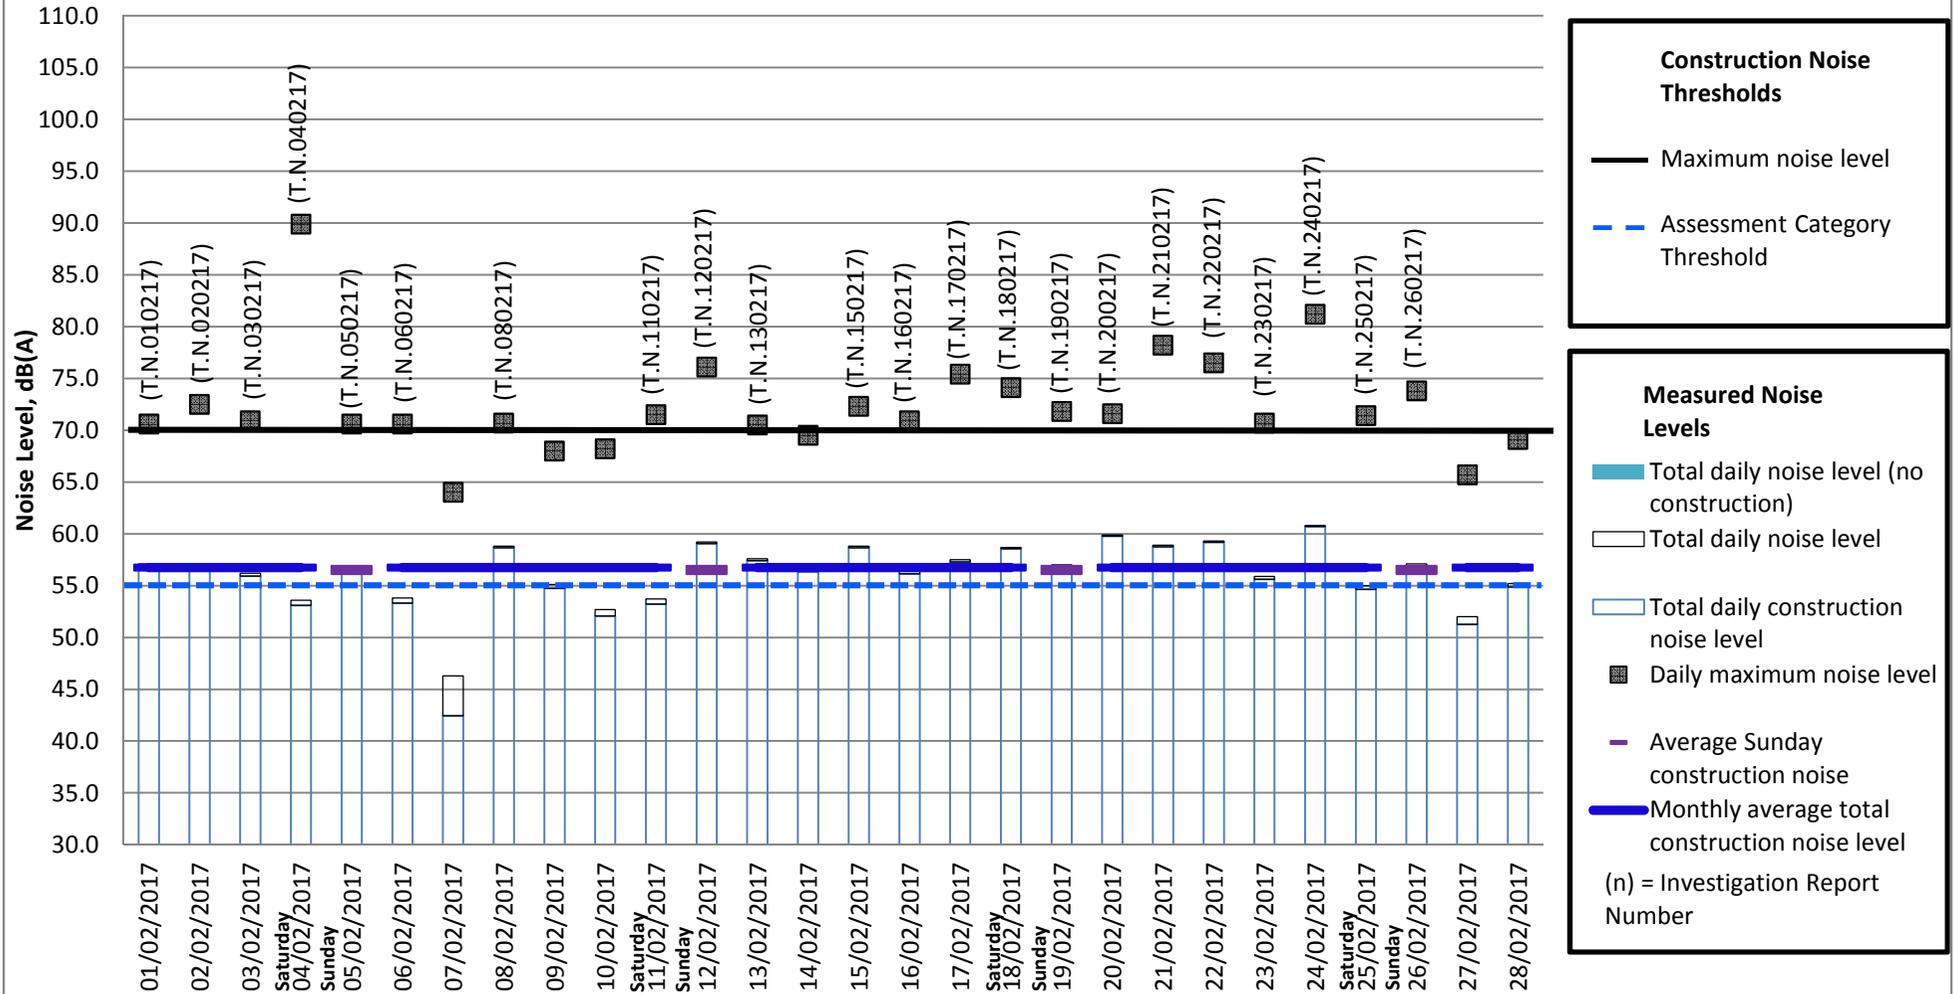
## Measured Night time Noise Levels at Tigh-Na-Grian Measurement period: February 2017

**Note:** After investigation, it was concluded that the exceedance of the LAeq 'Total Daily Construction' throughout the month were caused by wind.

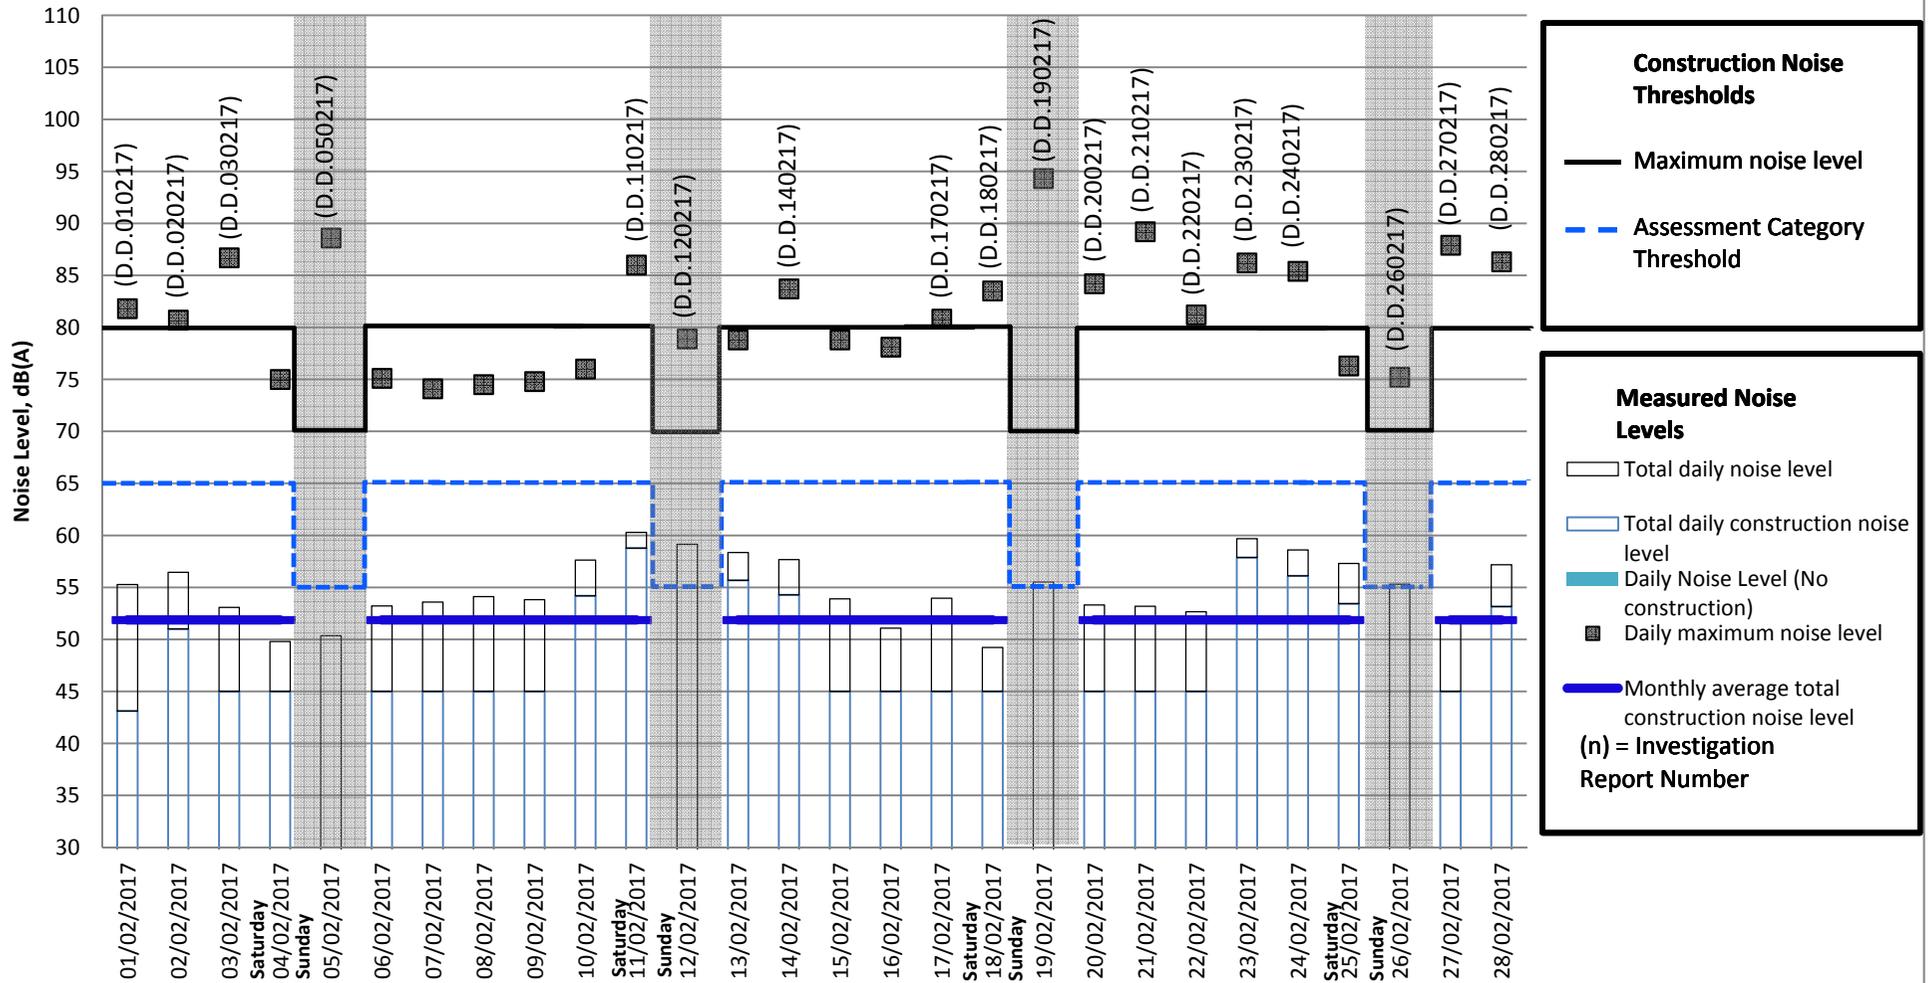
## Measured Daytime Noise Levels at Dundas Home Farm Measurement period: February 2017

**Note:** The grey areas of the chart represent days on which no construction works have been conducted;

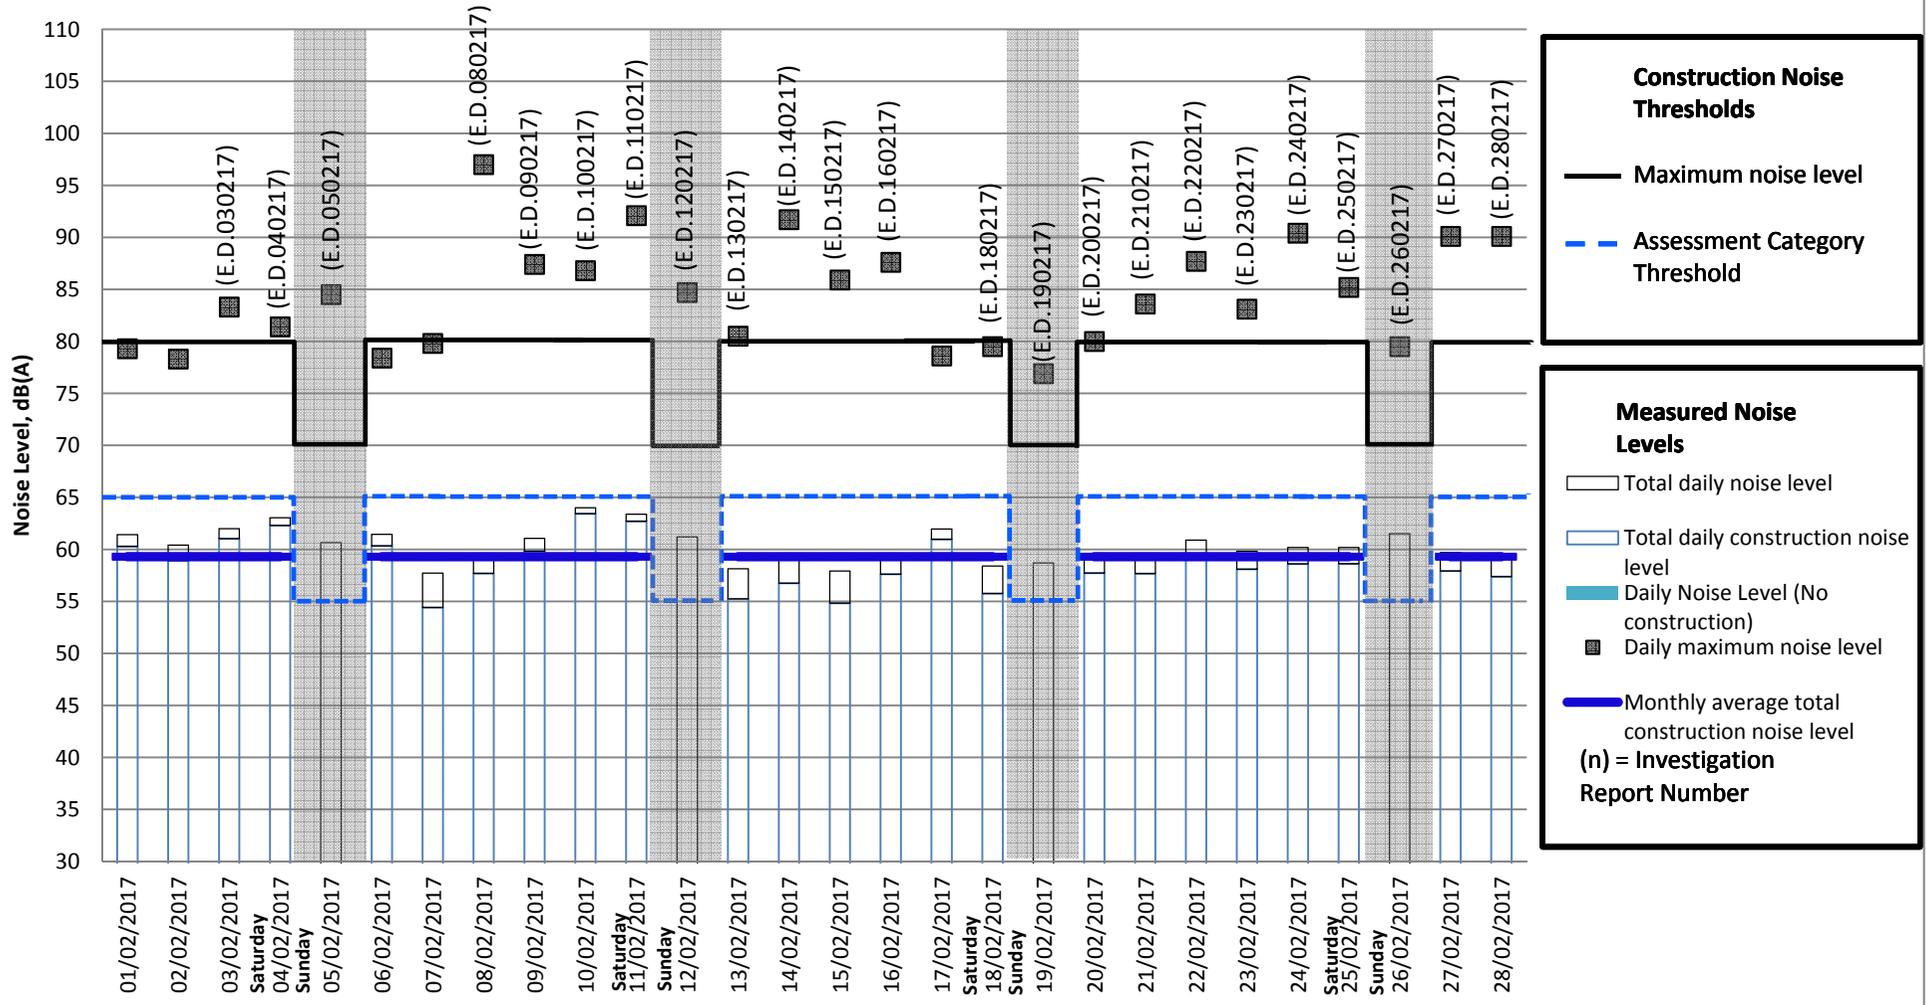
# Measured Daytime Noise Levels at Echline

**Note:** The grey areas of the chart represent days on which no construction works have been conducted;

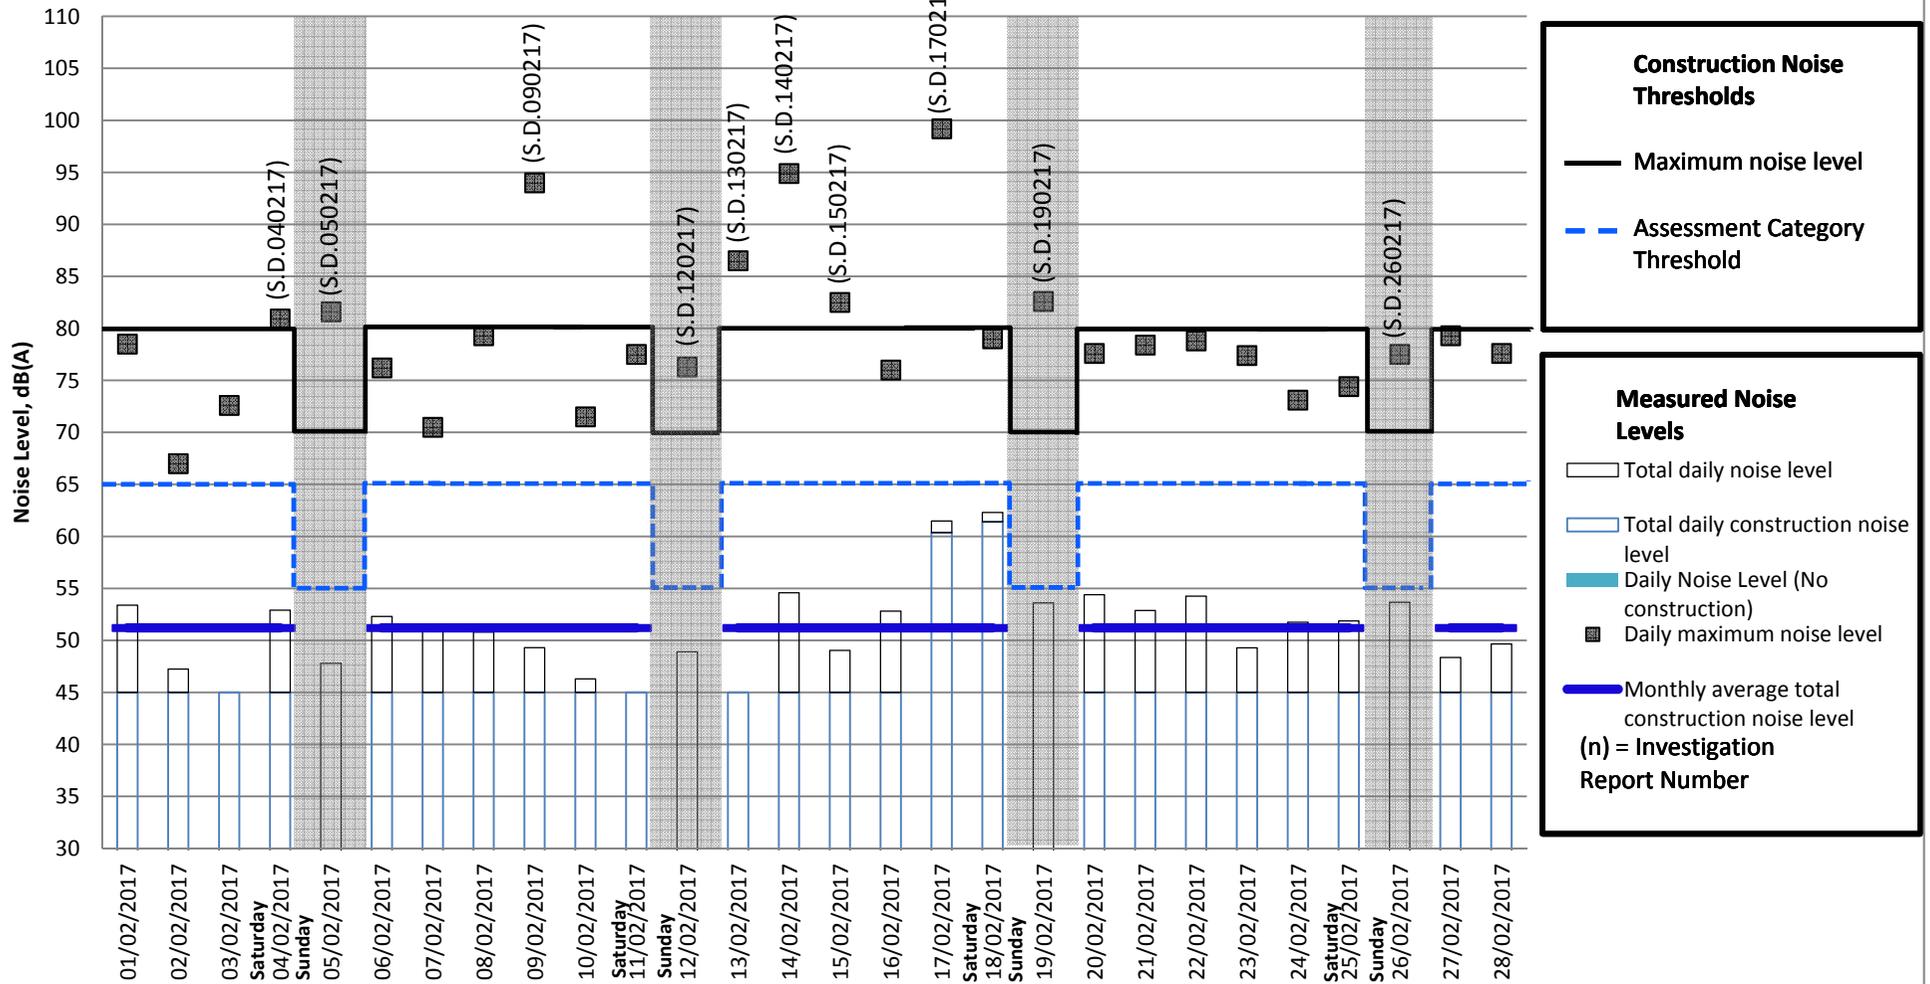
## Measured Daytime Noise Levels at Springfield Measurement period: February 2017

**Note:** The grey areas of the chart represent days on which no construction works have been conducted;

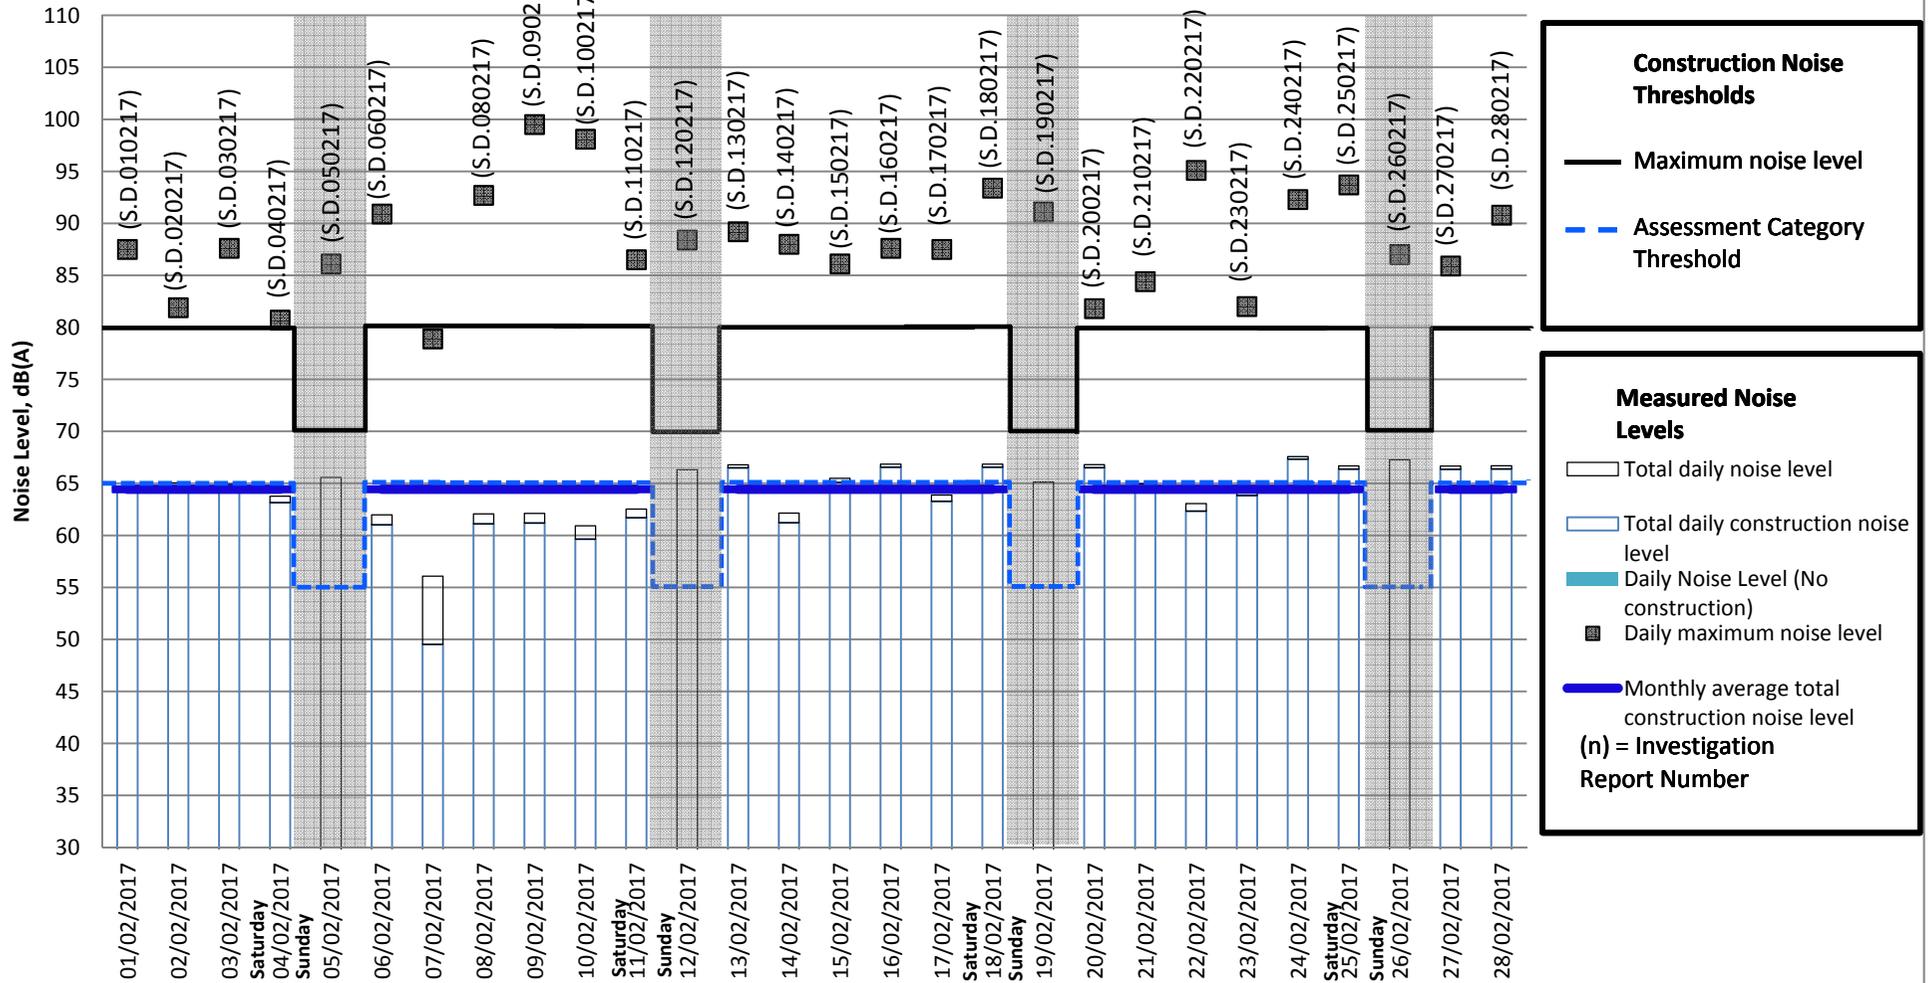
# Measured Daytime Noise Levels at Scotstoun

**Note:** The grey areas of the chart represent days on which no construction works have been conducted;

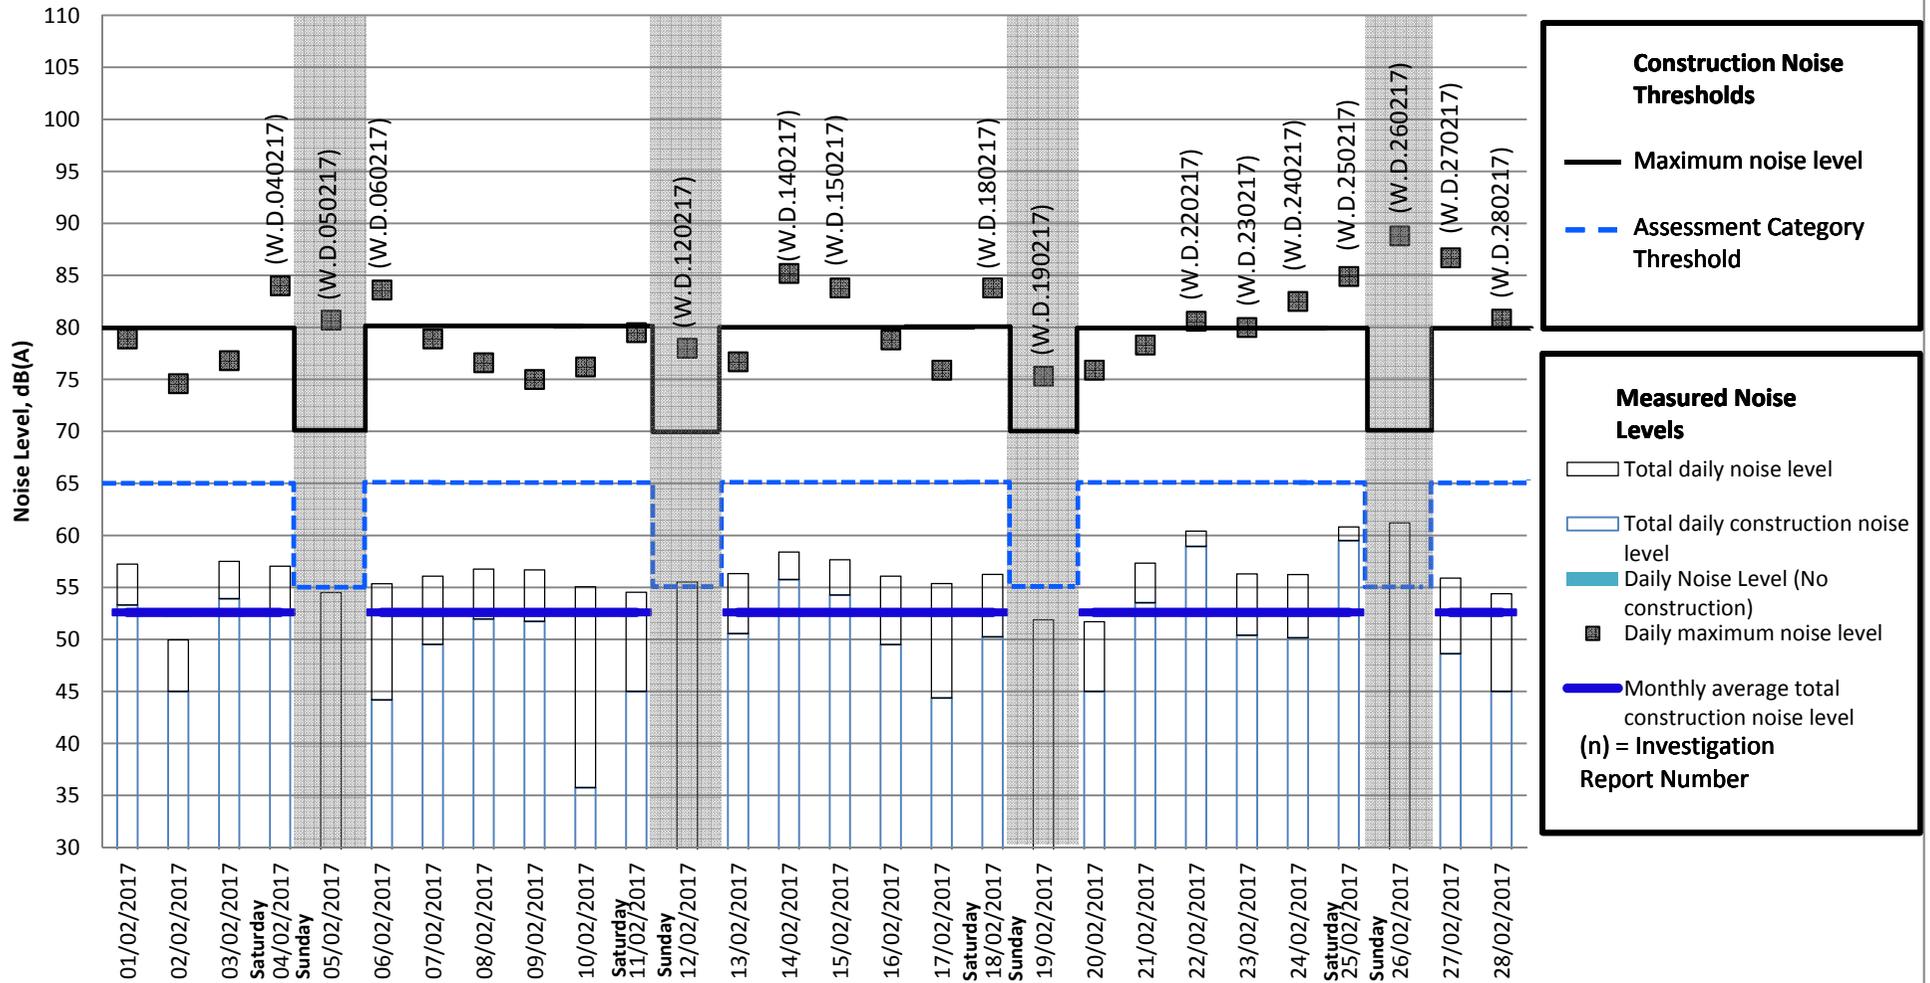
# Measured Daytime Noise Levels at Whinnyhill

**Note:** The grey areas of the chart represent days on which no construction works have been conducted;

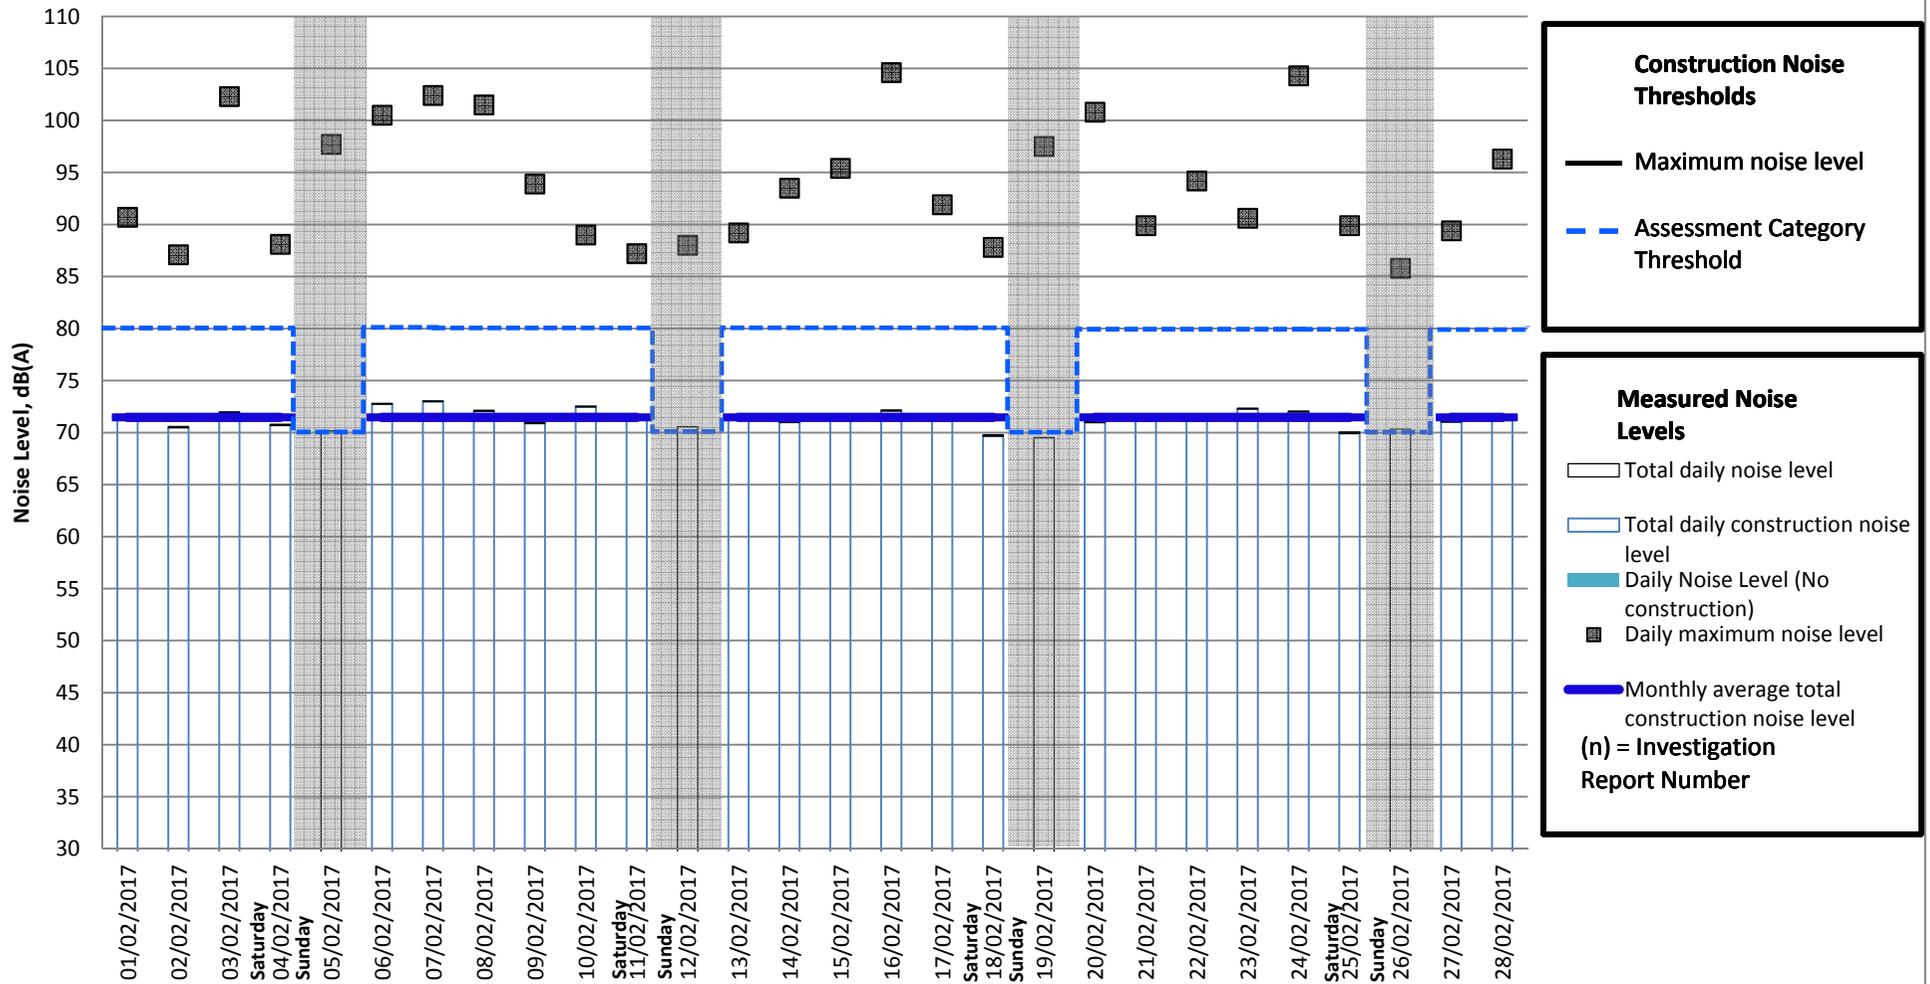
## Measured Daytime Noise Levels at Newton Measurement period: February 2017

**Note:** The grey areas of the chart represent days on which no construction works have been conducted;
