Project **FORTH REPLACEMENT CROSSING**

VIBRATION MONITORING REPORT
FEBRUARY 2013

Document number	Rev
REP-00102	00

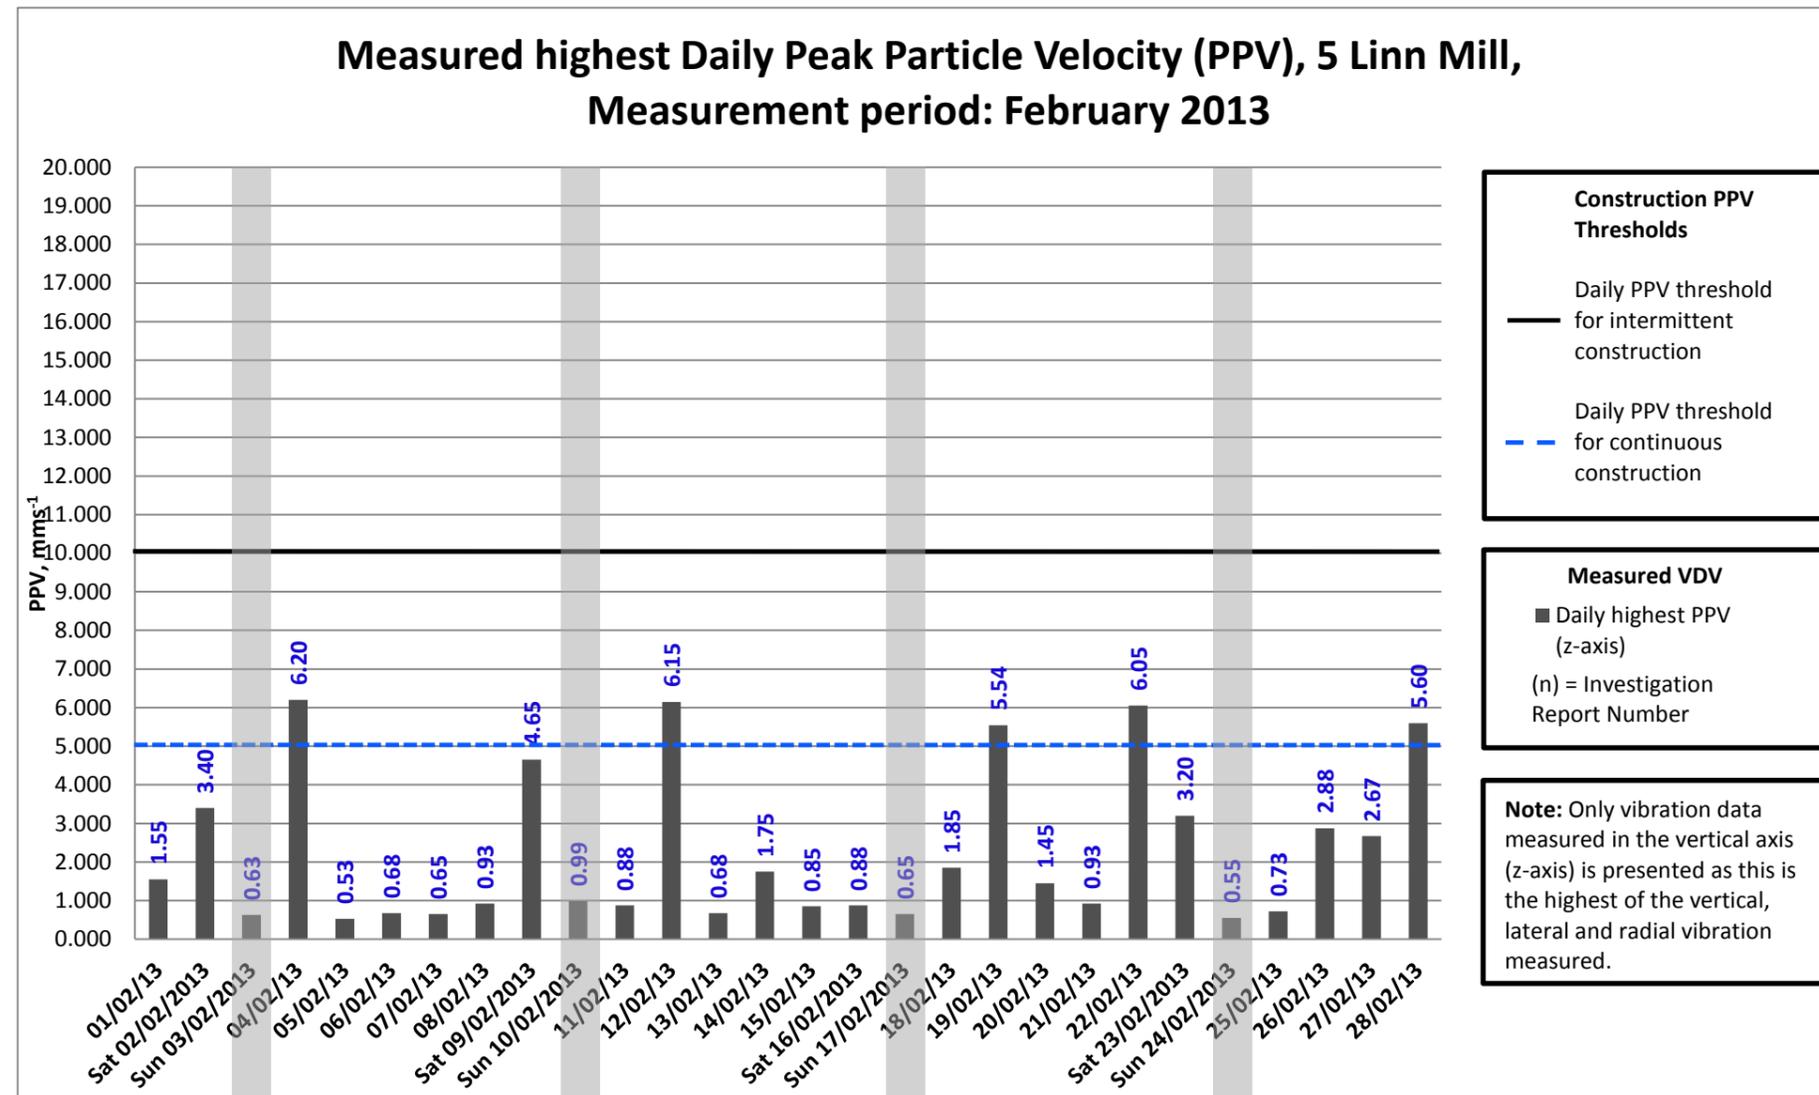
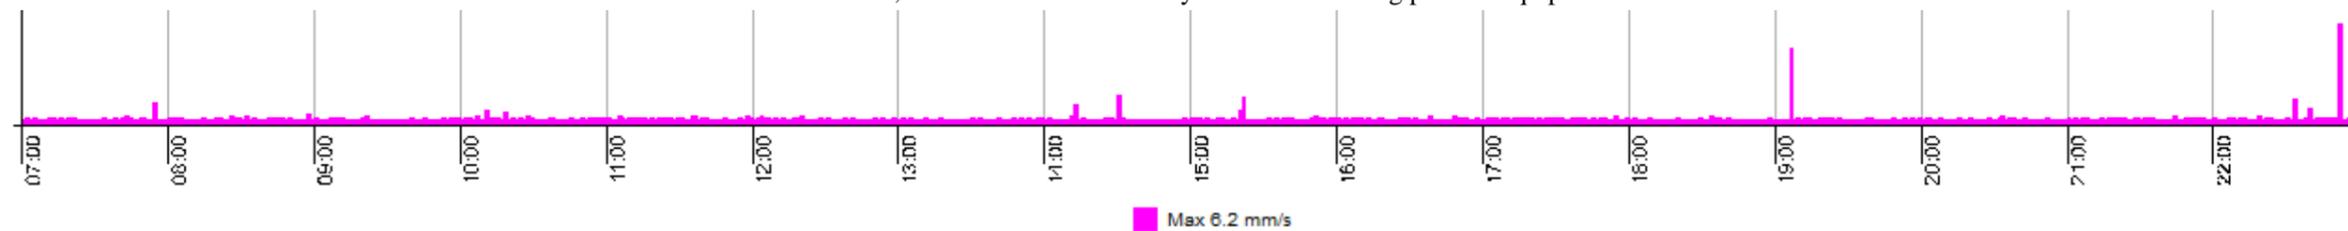
- The grey areas of the chart represent the days on which no construction works were undertaken; no works were conducted on Sundays.
- The PPV values on 04/02/13, 12/02/13, 19/02/13, 22/02/13 & 28/02/13 have been investigated, and have been seen to be individual, isolated events within each period (see Vibrock PPV graph below from 04/02/13), and are all within the intermittent threshold of 10mm/s. Furthermore, these particular levels cannot have been generated as a result of FCBC construction, as the only works to be conducted on these dates in the vicinity of the monitor, were excavation and backfill activities and erection of reinforcement at the South Abutment, which did not involve any vibration inducing plant or equipment.

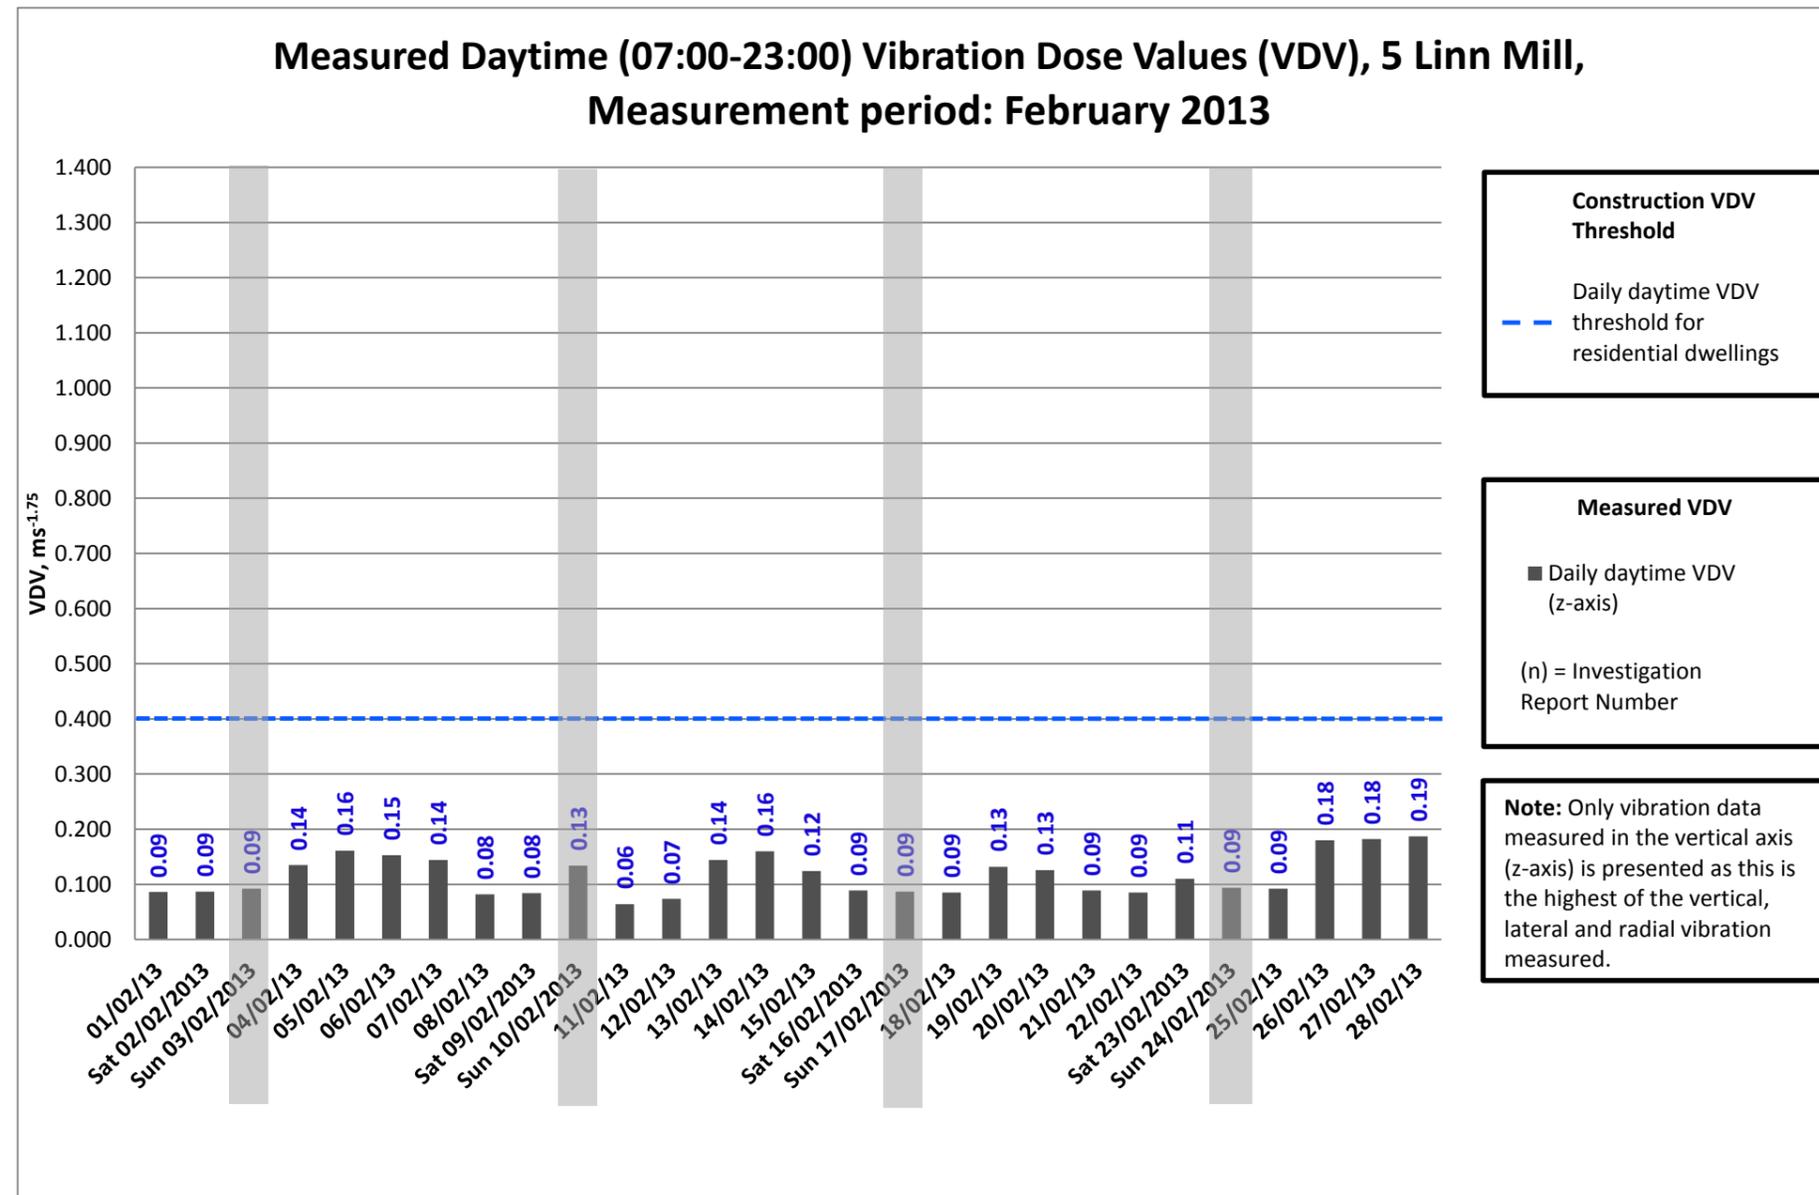
- The grey area of the chart represent the days on which no construction works were undertaken; no works were conducted on Sundays.

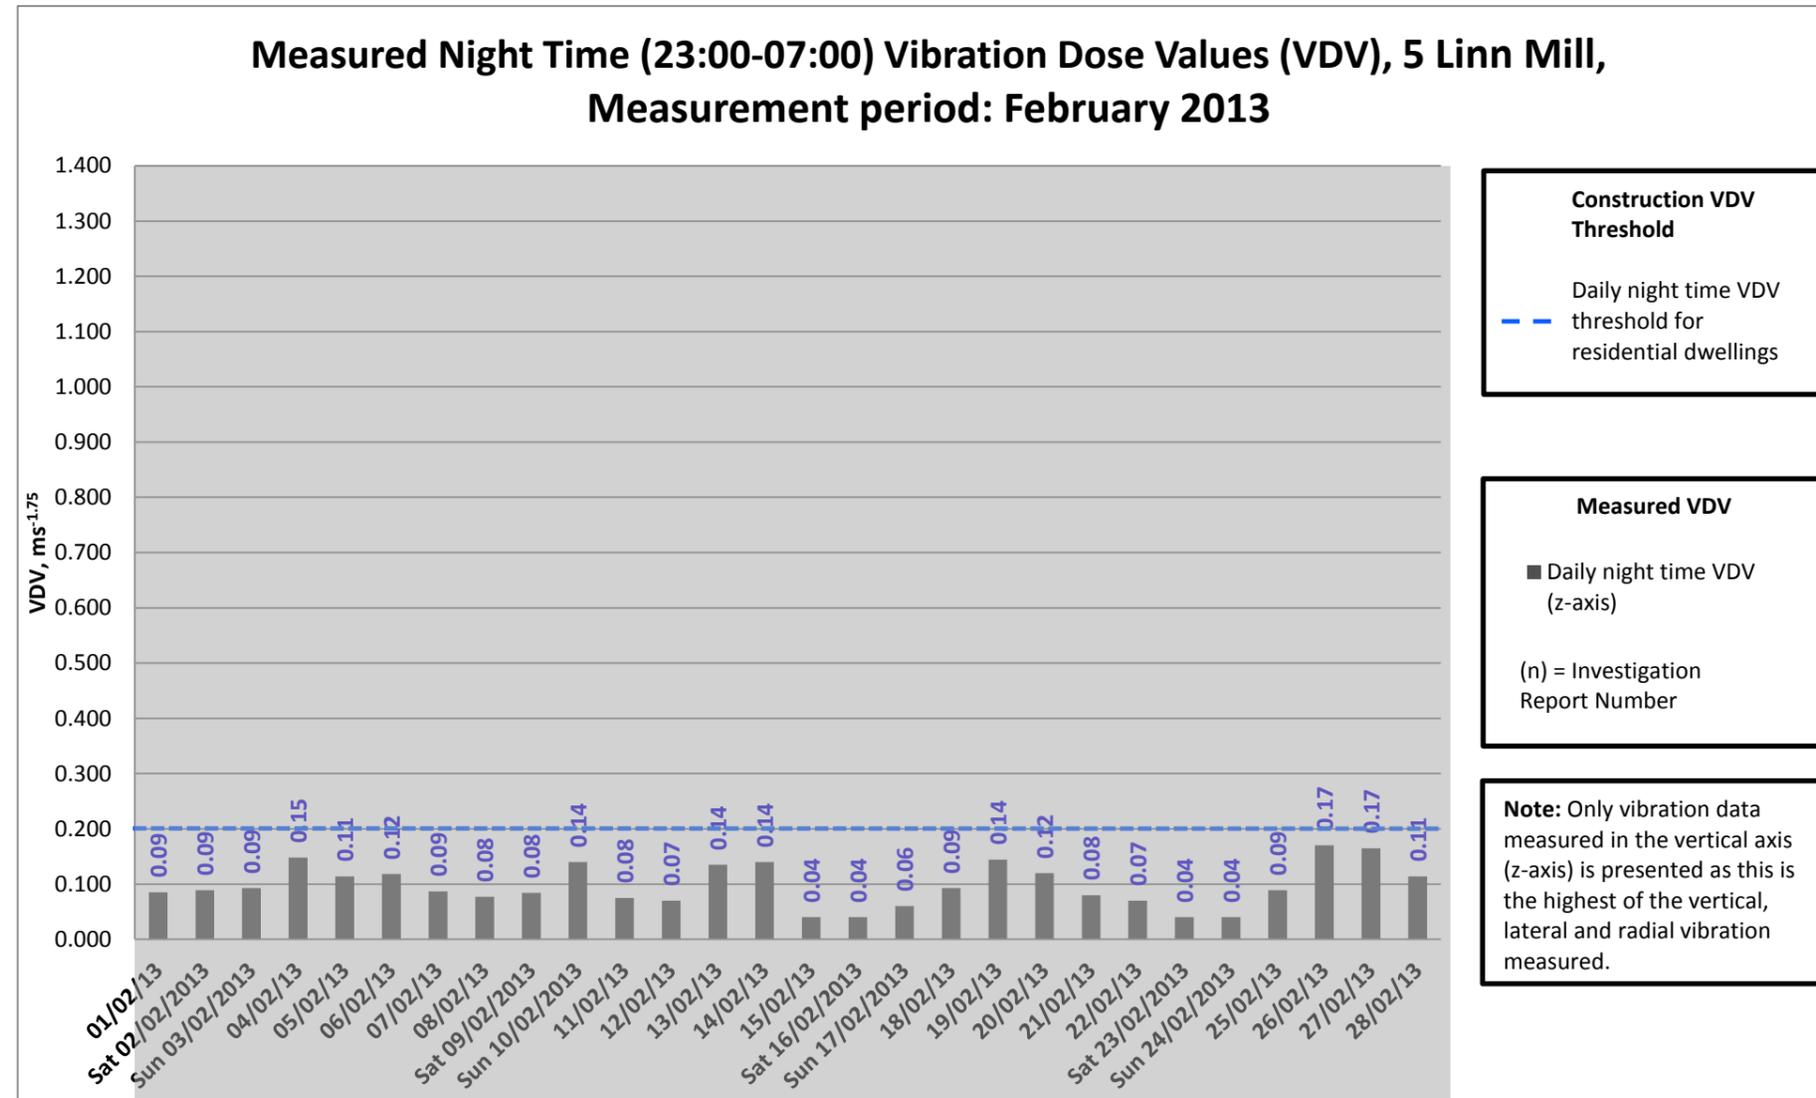
- The grey areas of the chart represent the days on which no construction works were undertaken; no night time works were conducted in the vicinity of the Linn Mill vibration monitor throughout the month of February 2013. This graph is included for illustrative purposes only.

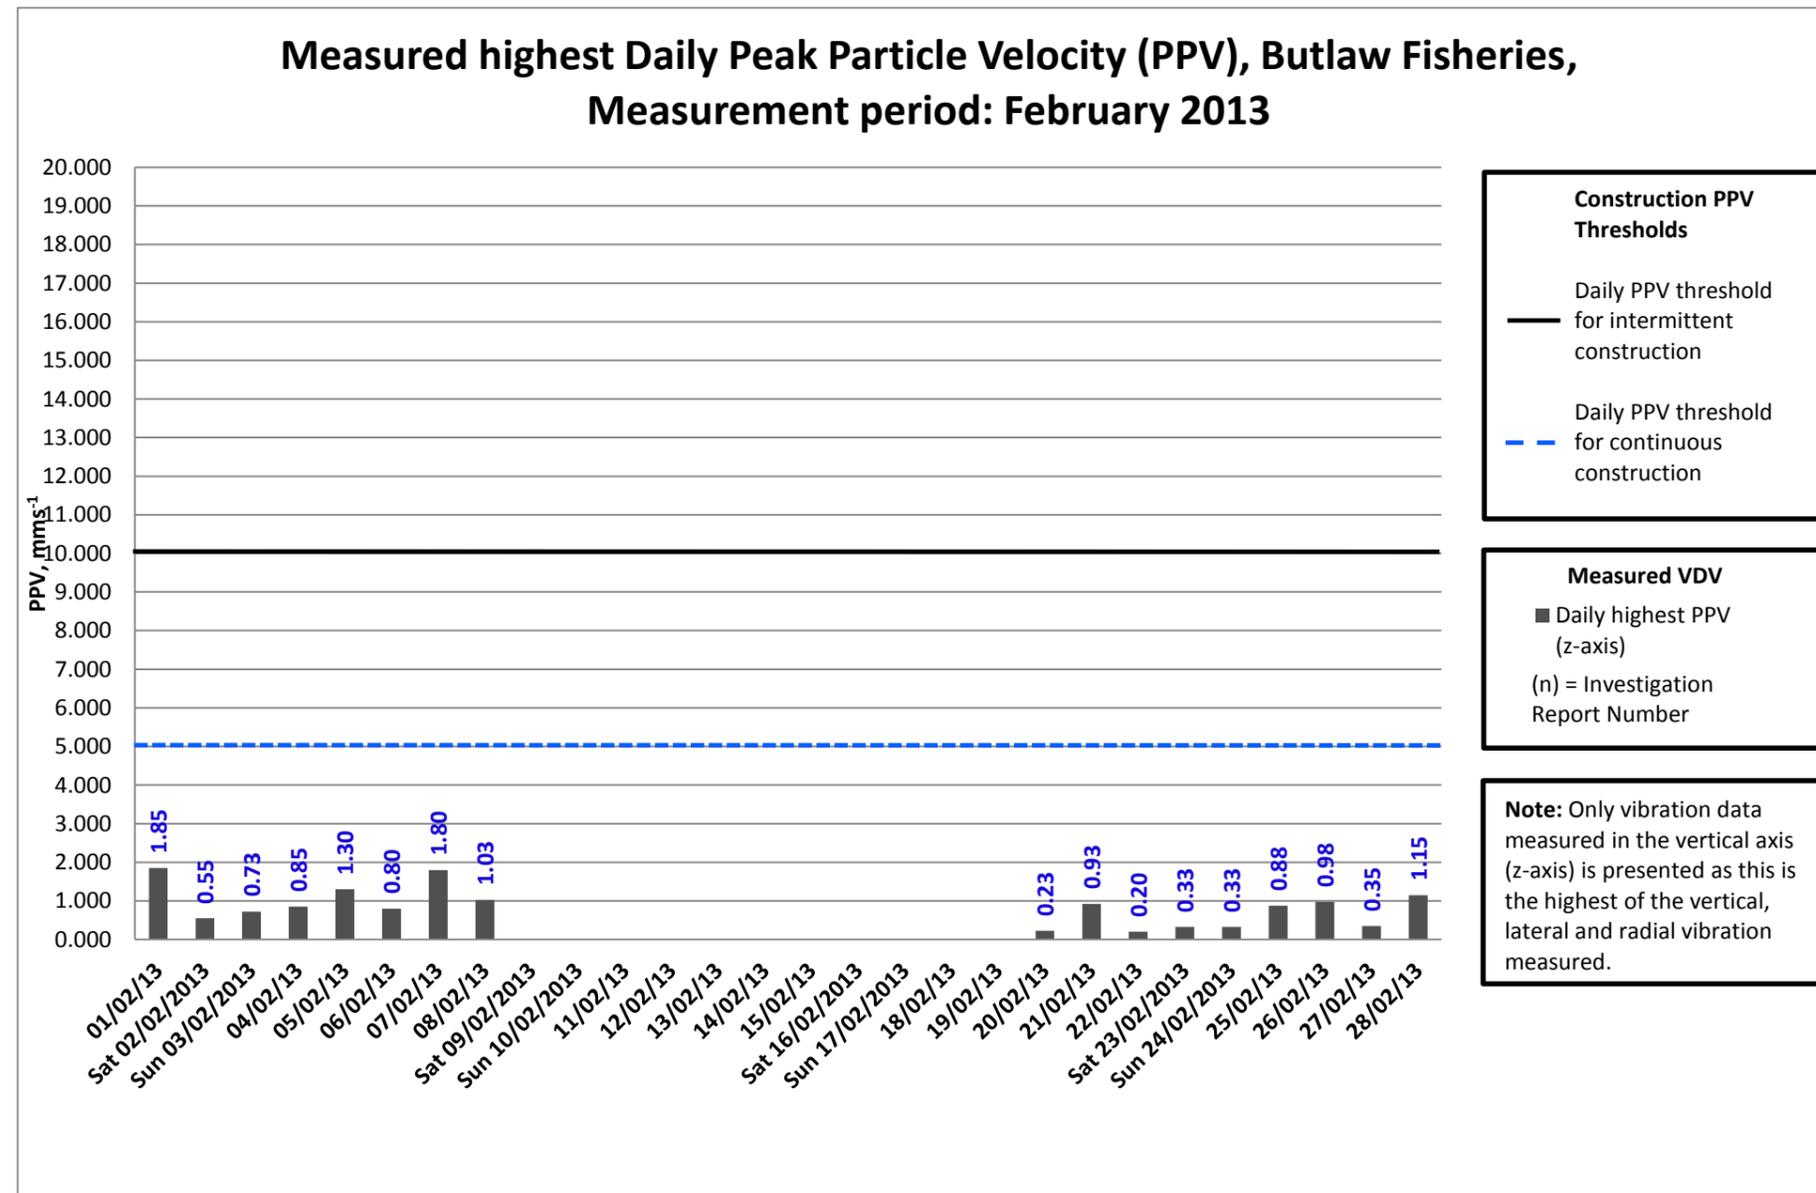
- Data is missing from 09/02/13 to 19/02/13 due to a power outage at the property whilst the resident was on holiday.

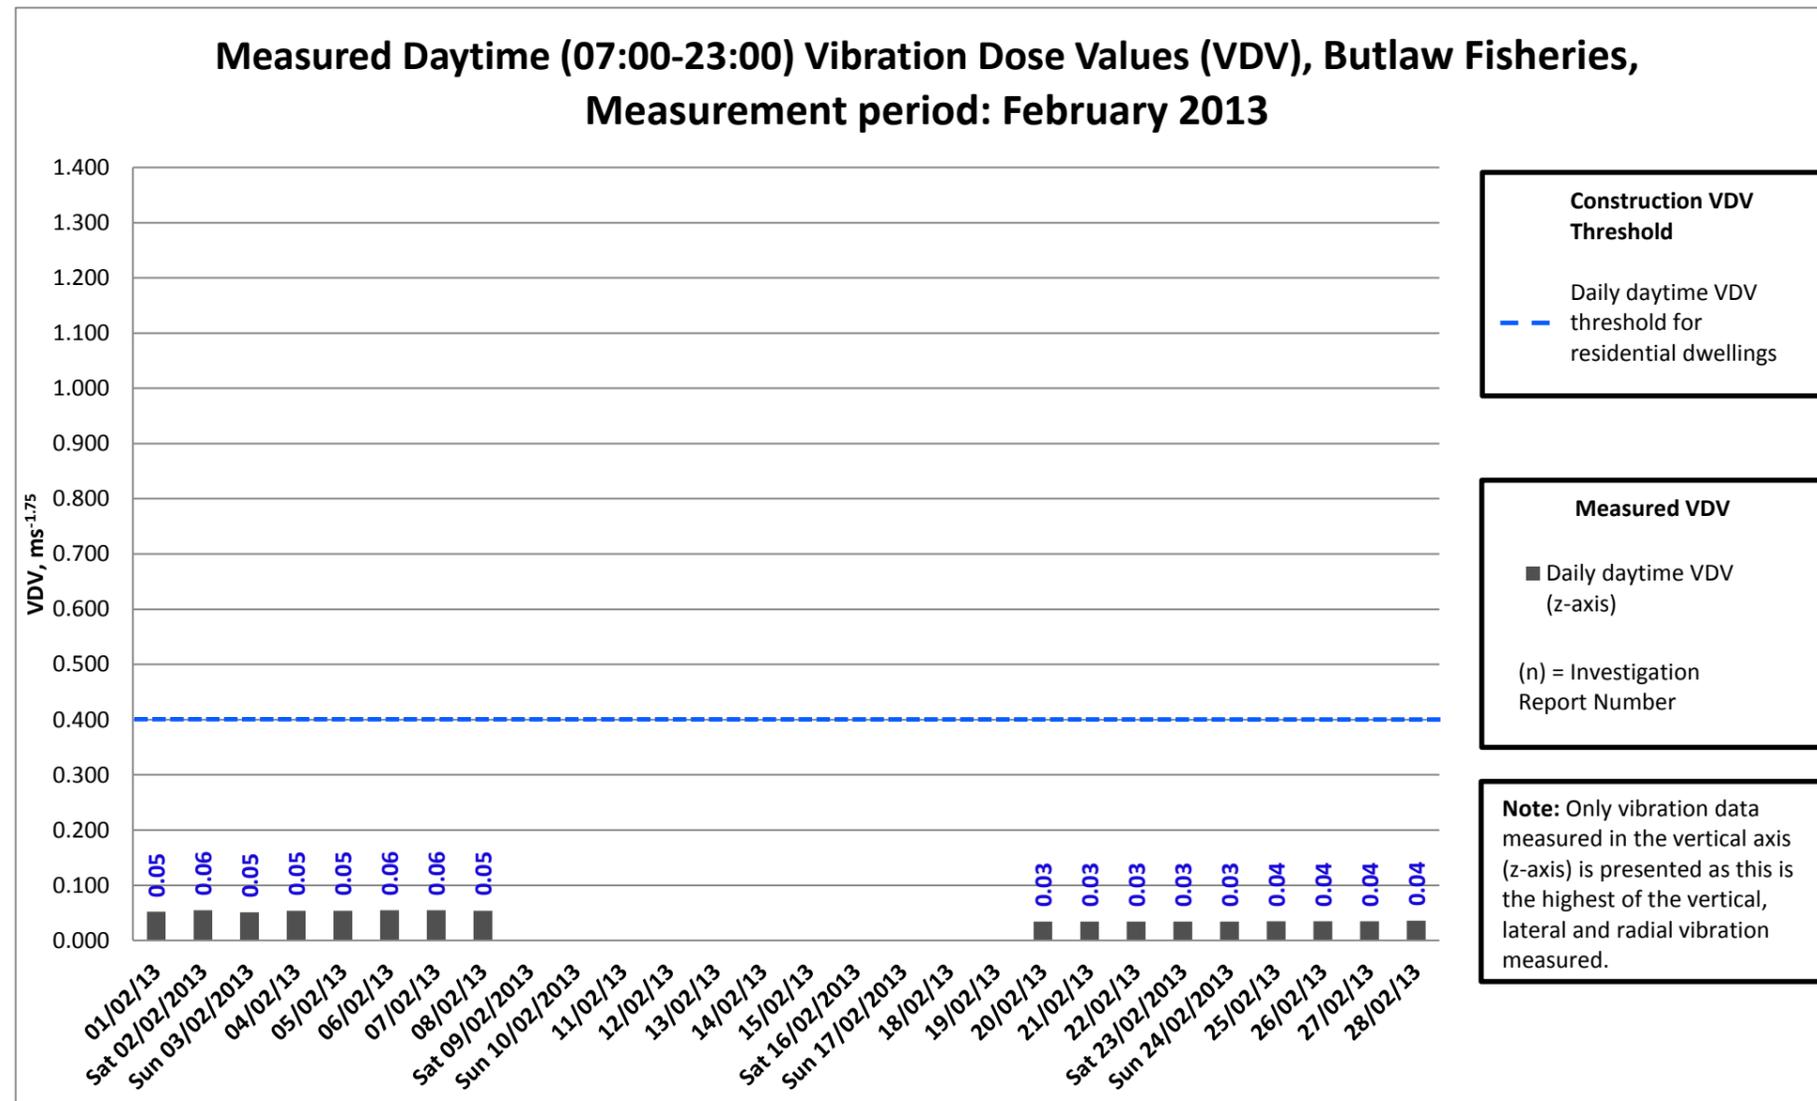
- Data is missing from 09/02/13 to 19/02/13 due to a power outage at the property whilst the resident was on holiday.

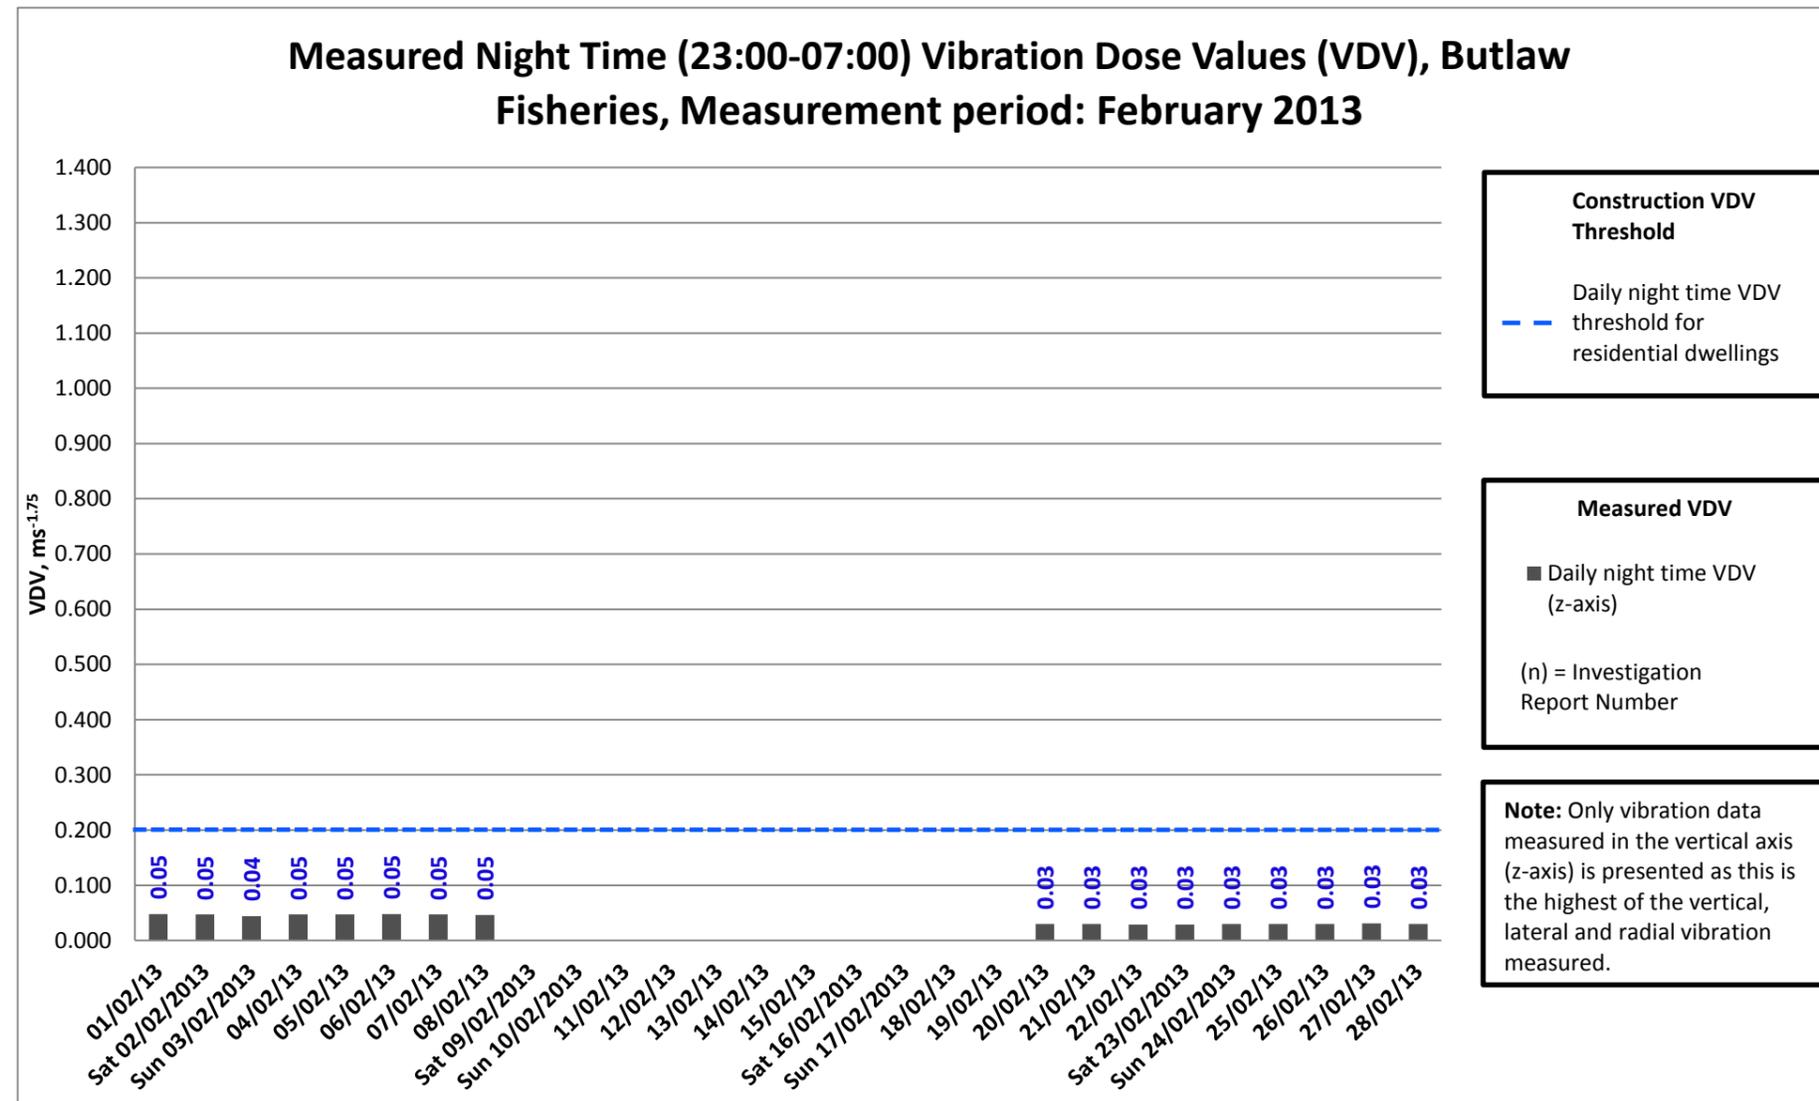
- Data is missing from 09/02/13 to 19/02/13 due to a power outage at the property whilst the resident was on holiday.

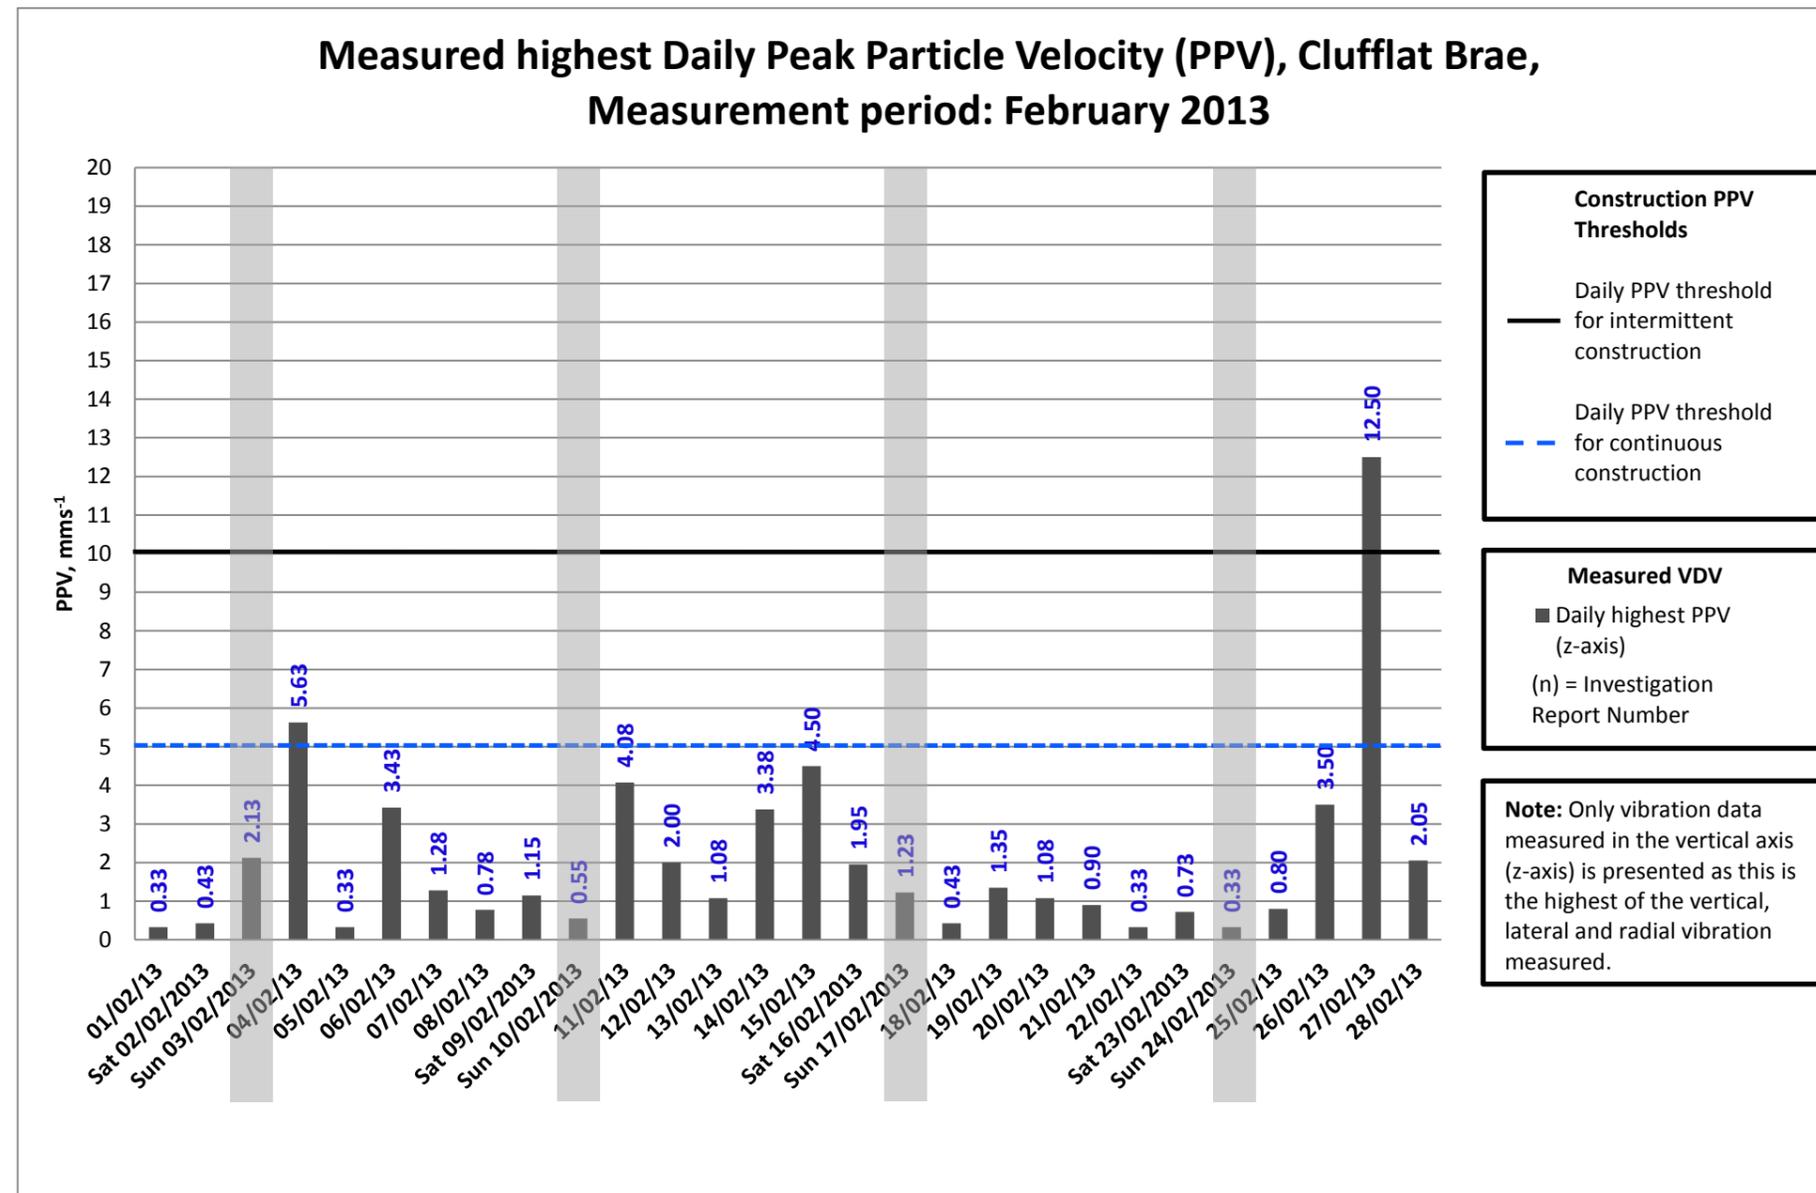
- The grey areas of the chart represent the days on which no construction works were undertaken; no works were conducted on Sundays.
- The PPV values on 04/02/13 & 27/02/13 cannot have been generated as a result of FCBC construction, as the only works to be conducted on these dates in the vicinity of the monitor, were excavation and backfill activities and erection of reinforcement at the South Abutment, which did not involve any vibration inducing plant or equipment.

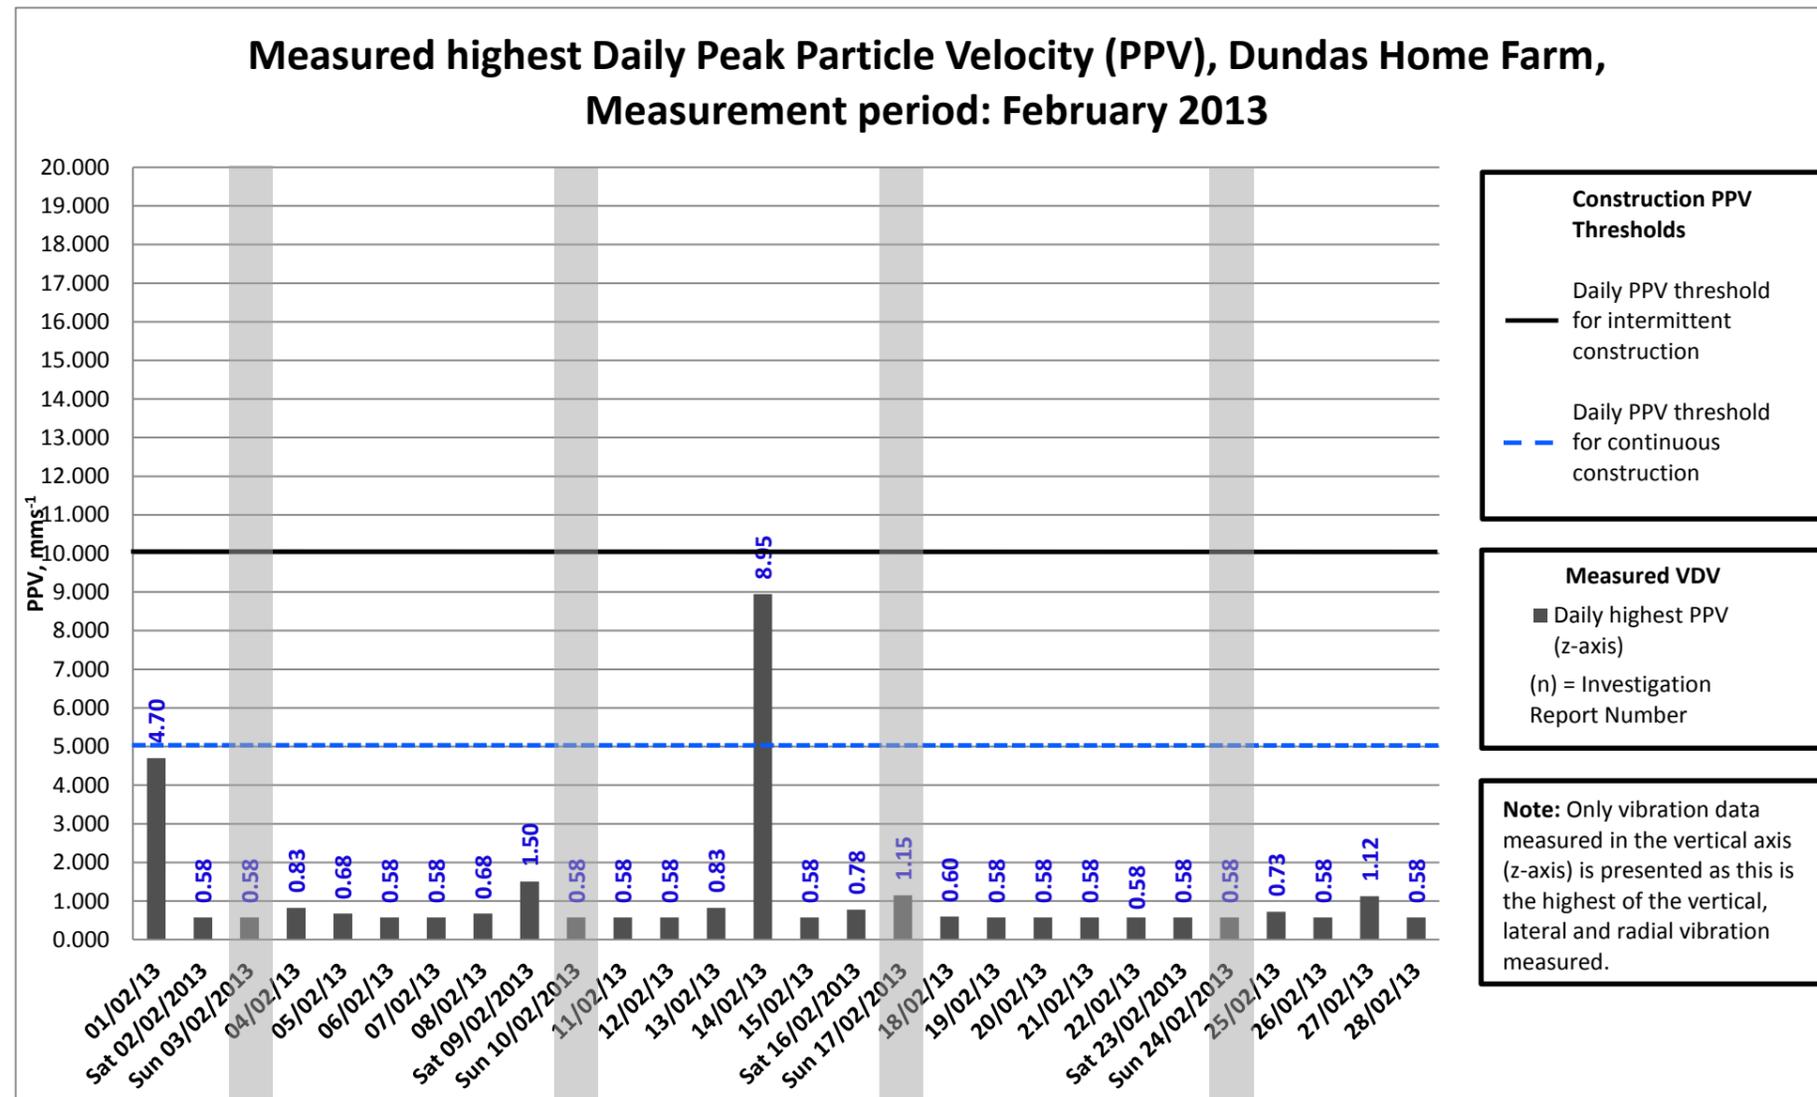
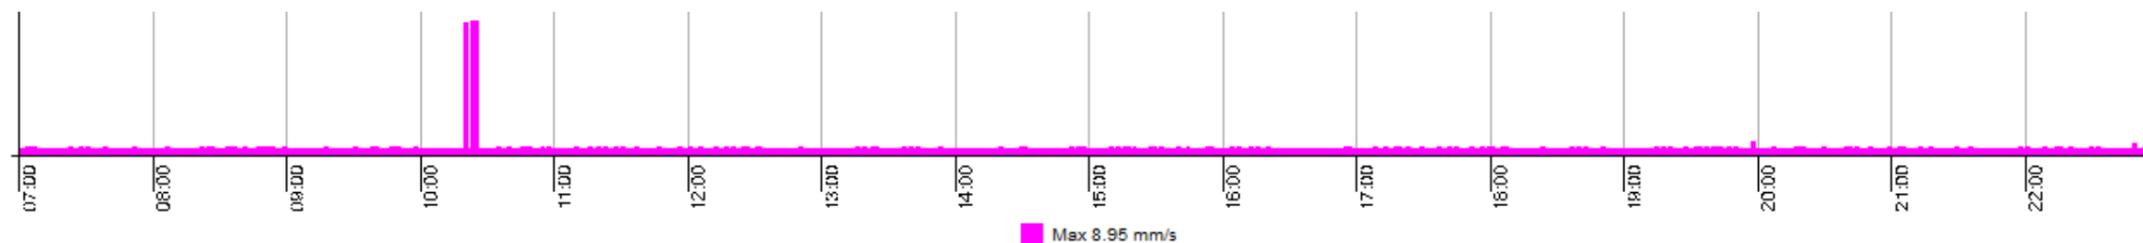
- The grey areas of the chart represent the days on which no construction works were undertaken; no works were conducted on Sundays.
- The PPV value on 14/02/13 has been investigated, and has been seen to be an individual, isolated event within the period (see Vibrock PPV graph below from 14/02/13), and is within the intermittent threshold of 10mm/s. Furthermore, this particular vibration cannot have been generated as a result of FCBC construction, as the only works to be conducted on this date in the vicinity of the monitor, were utility and soil stripping works, which did not involve any vibration inducing plant or equipment.

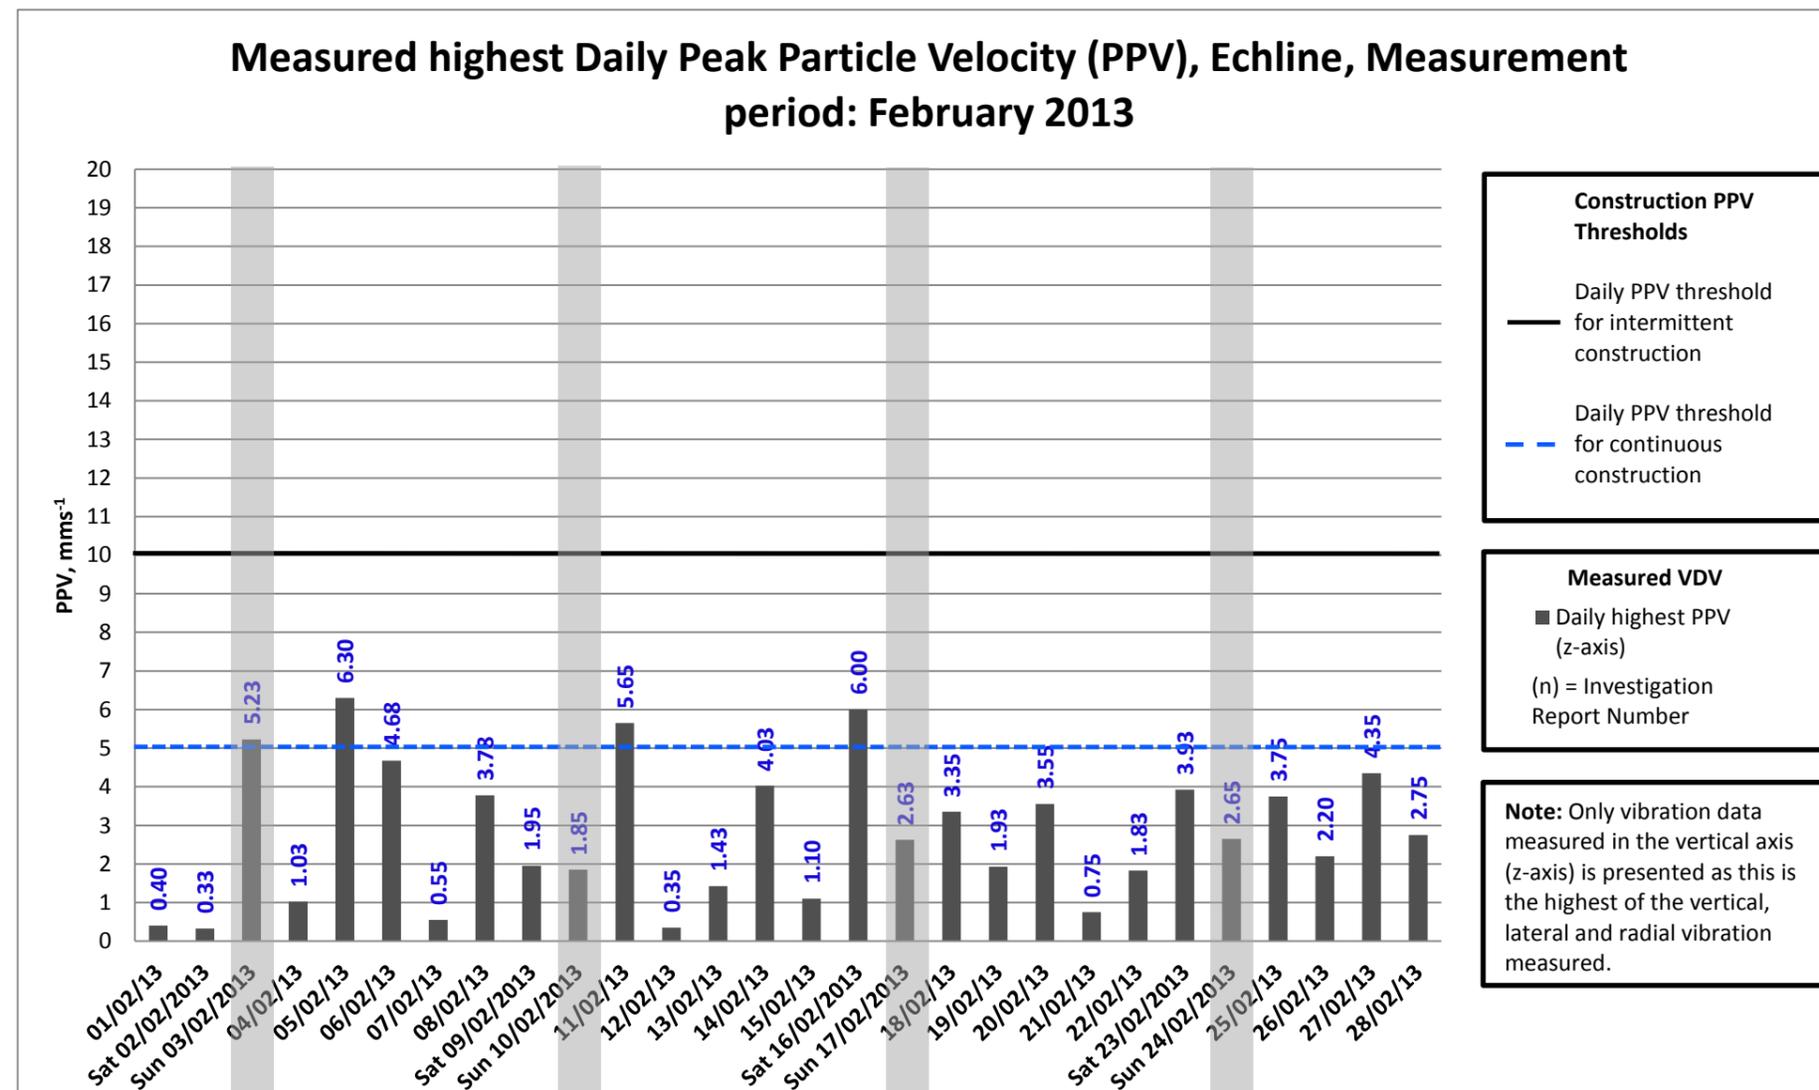
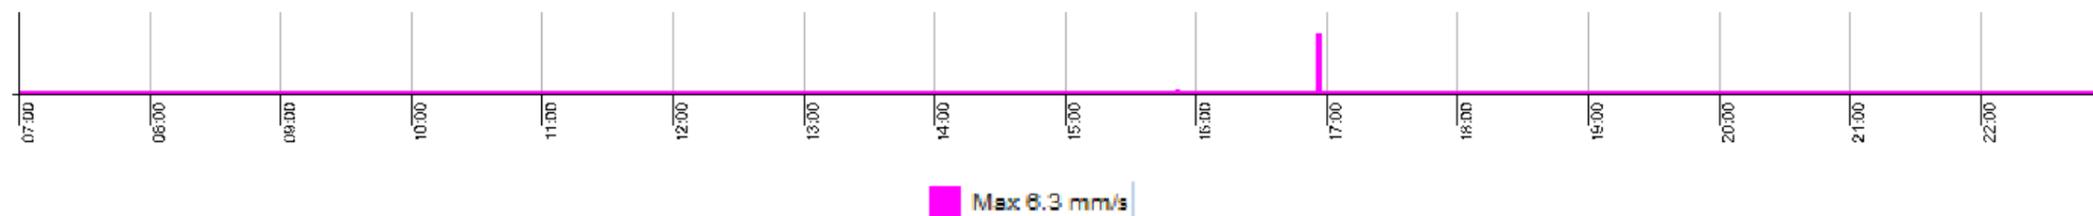
- The grey areas of the chart represent the days on which no construction works were undertaken; no works were conducted on Sundays.
- The PPV values on 05/02/13, 11/02/13 & 16/02/13 have all been investigated, and have been seen to be individual, isolated events within each period (see Vibrock PPV graph below from 05/02/13), and are all within the intermittent threshold of 10mm/s. Furthermore, these particular levels cannot have been generated as a result of FCBC construction, as the only works to be conducted on these dates in the vicinity of the monitor, were rock generation and backfill operations at the Queensferry gyratory and A904 verges respectively. The only vibration inducing plant or equipment involved in these activities were rock breakers, which were operated a minimum distance of 40m from the monitor (and nearest receptors), and can thus be discounted as the source of these particular PPVs. Considering the location of the monitor, these levels are likely due to road traffic (e.g. occasional HGVs passing by).

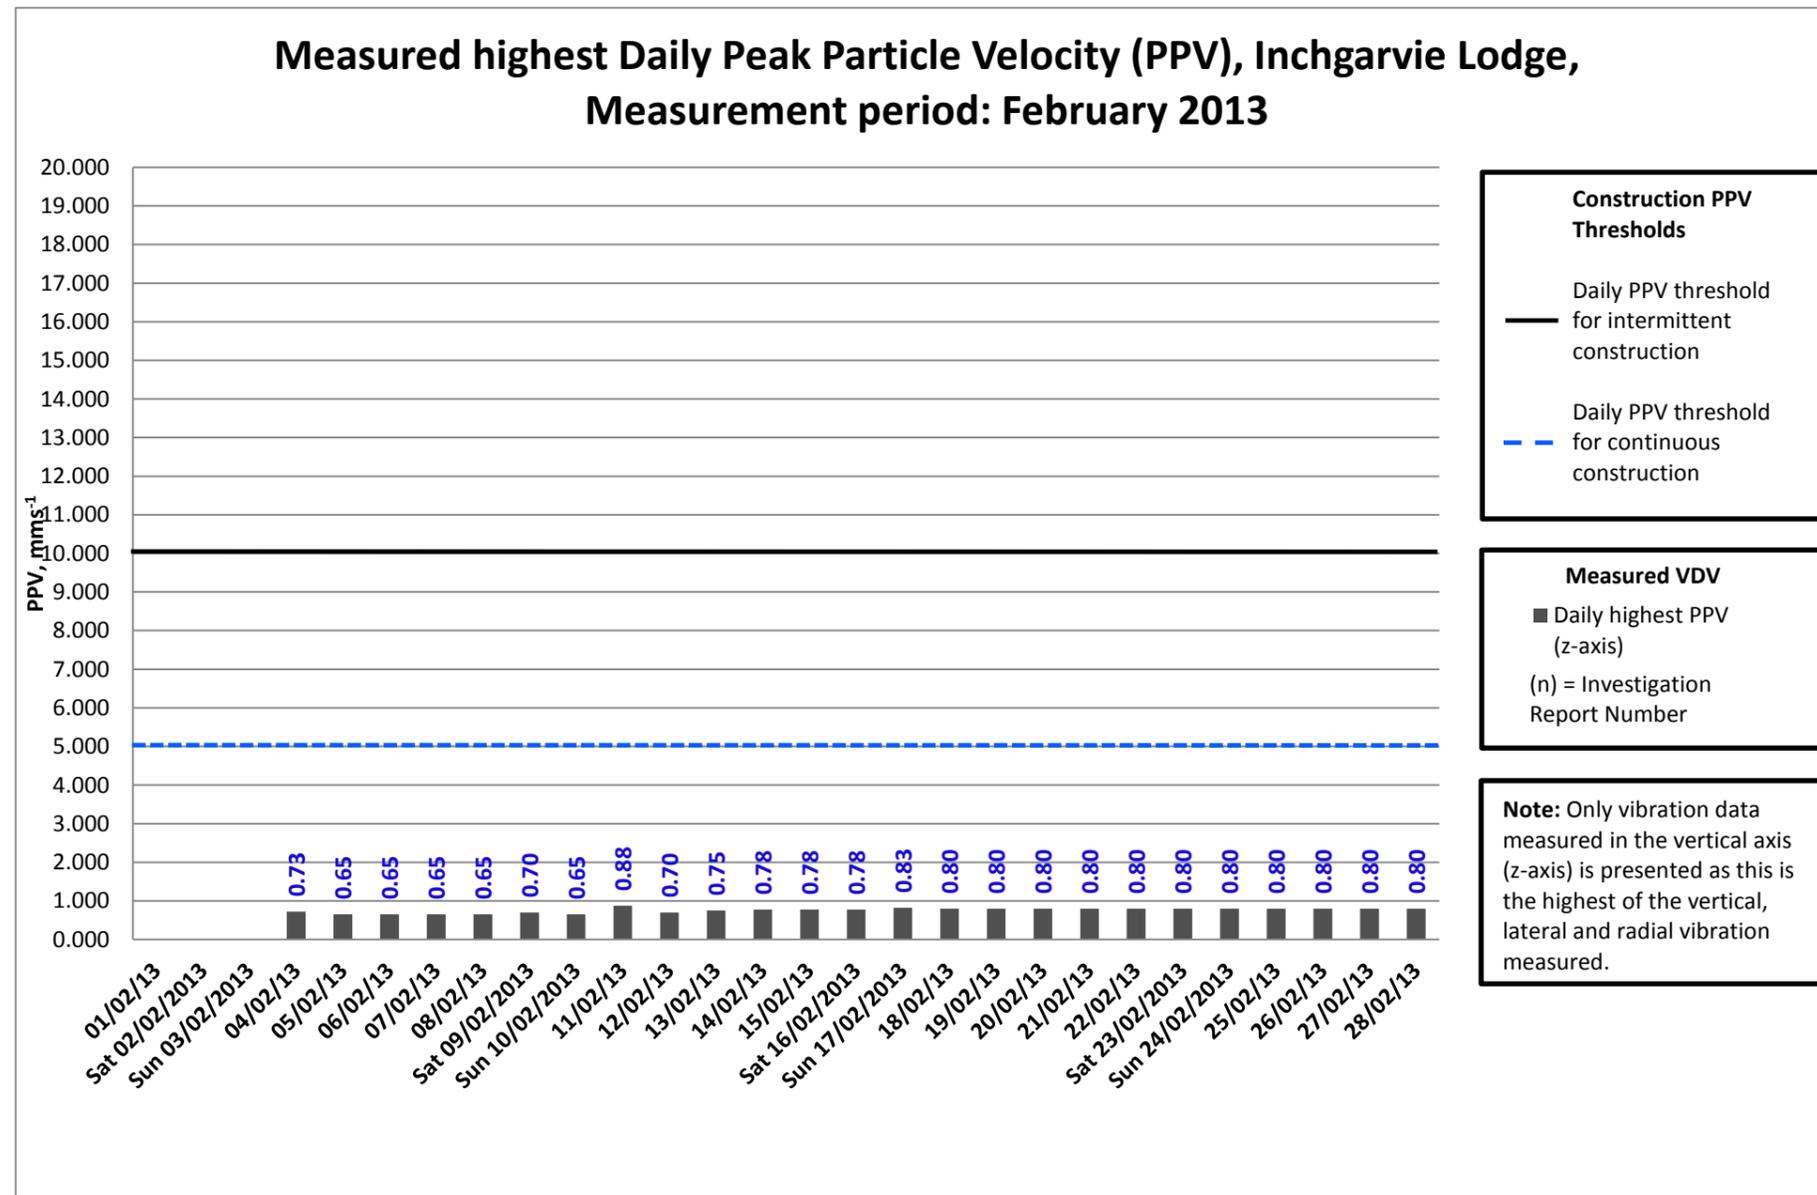
- Data is missing for 01/02/13 to 03/02/13 due to corrupt data files. Taking results manually and downloading results to avoid any more lost data.
