Project **FORTH REPLACEMENT CROSSING**

VIBRATION MONITORING REPORT
FEBRUARY 2013

Document number	Rev
REP-00102	00

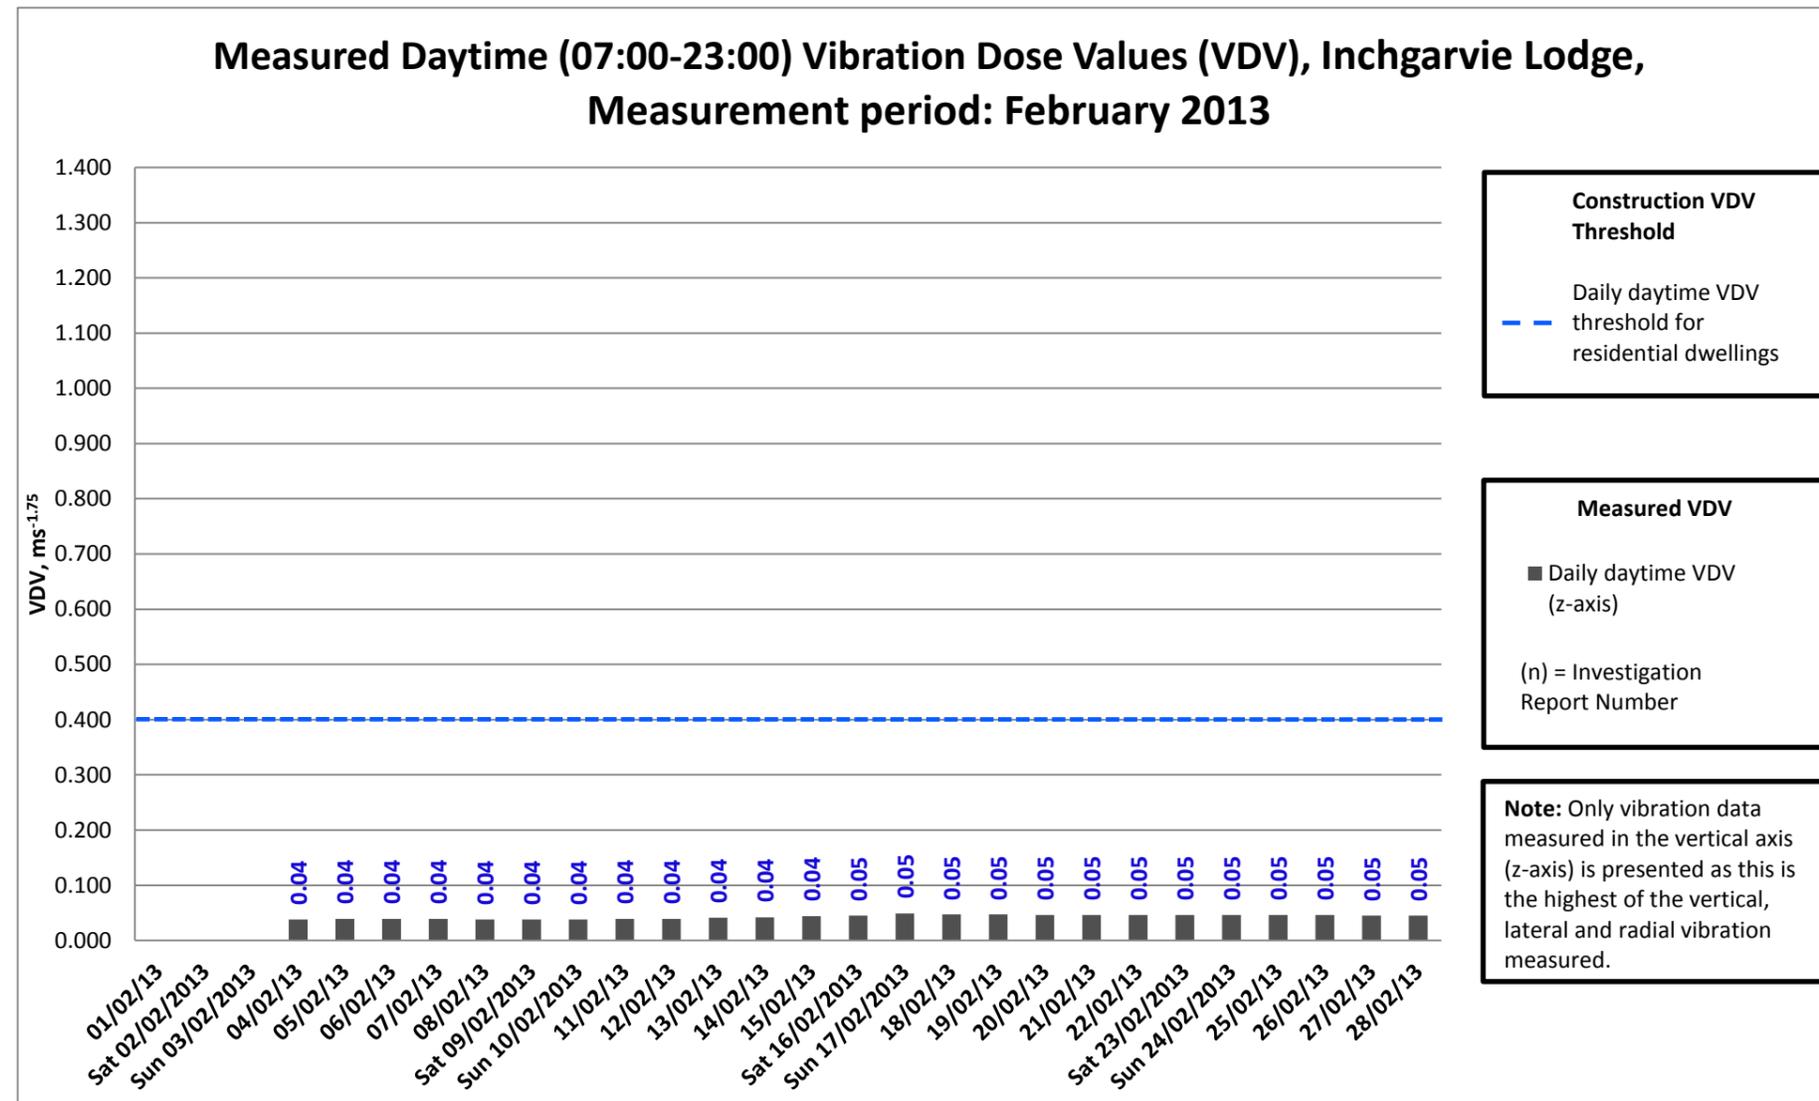
- Data is missing for 01/02/13 to 03/02/13 due to corrupt data files. Taking results manually and downloading results to avoid any more lost data.

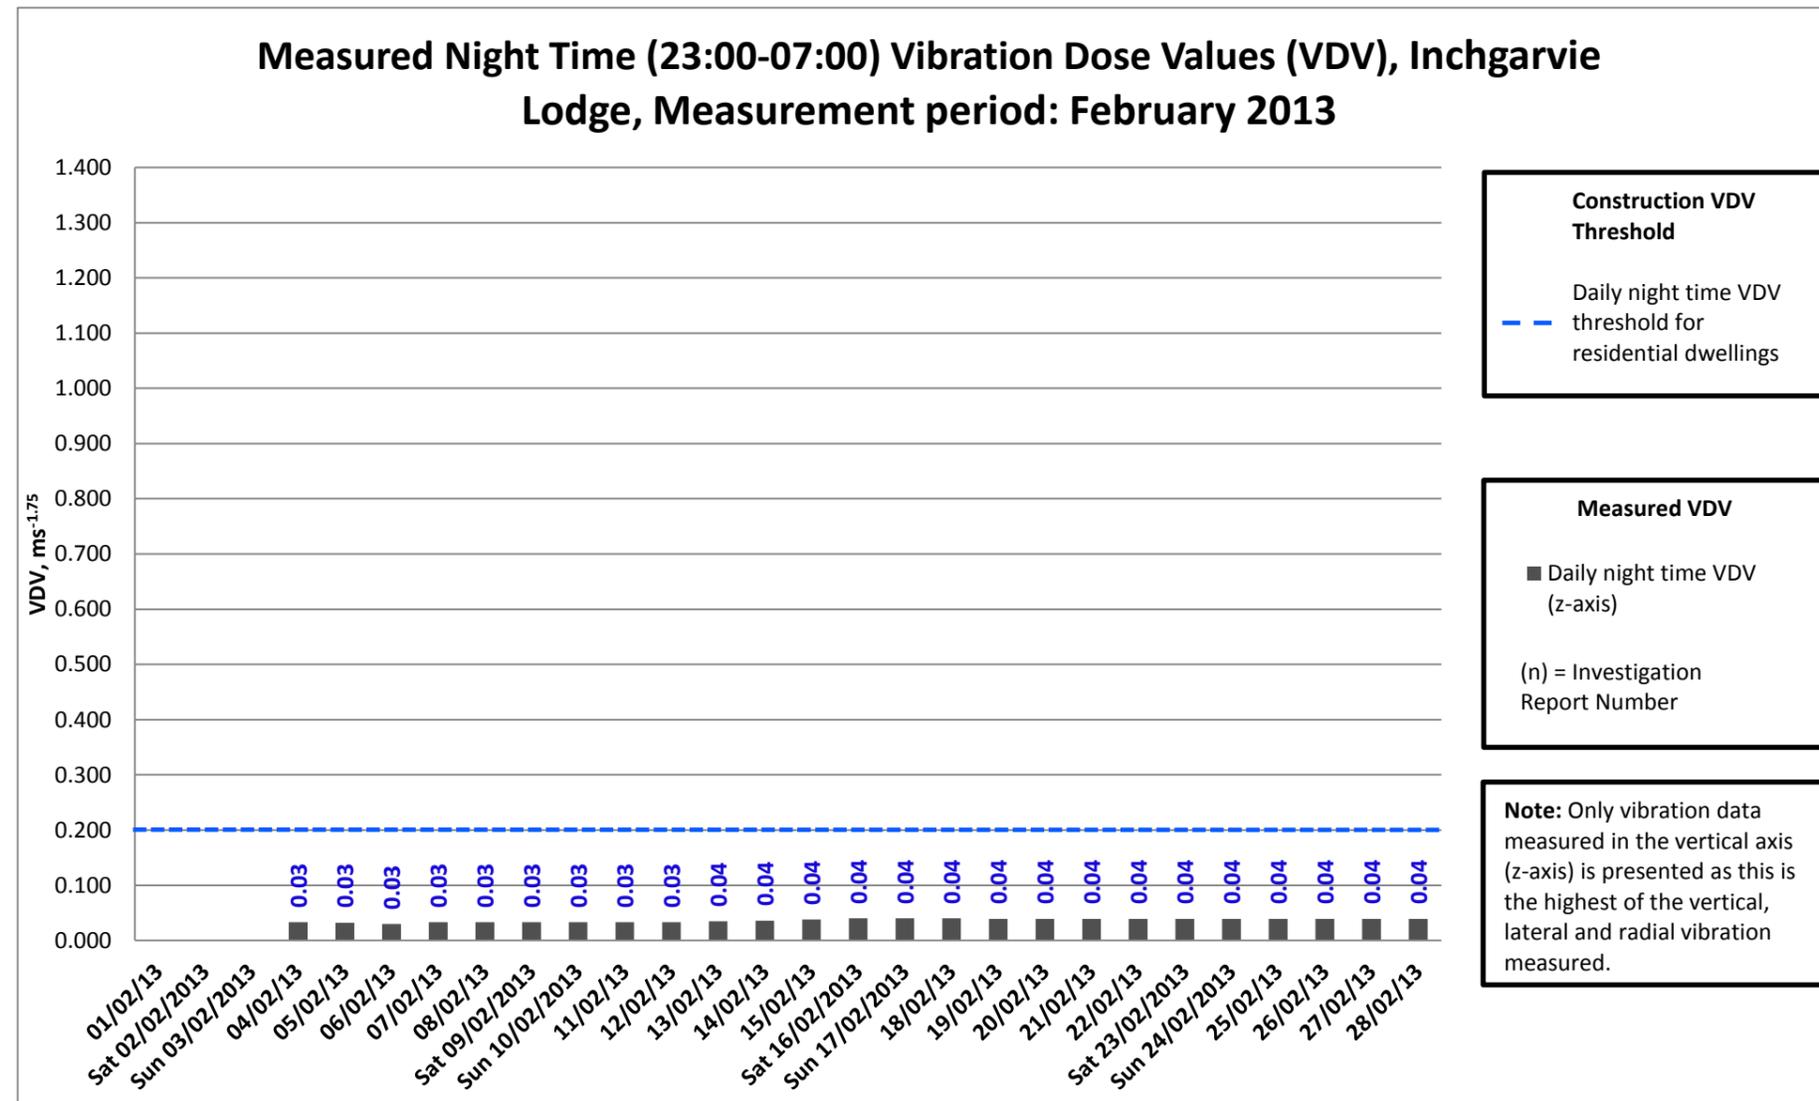
- Data is missing for 01/02/13 to 03/02/13 due to corrupt data files. Taking results manually and downloading results to avoid any more lost data.

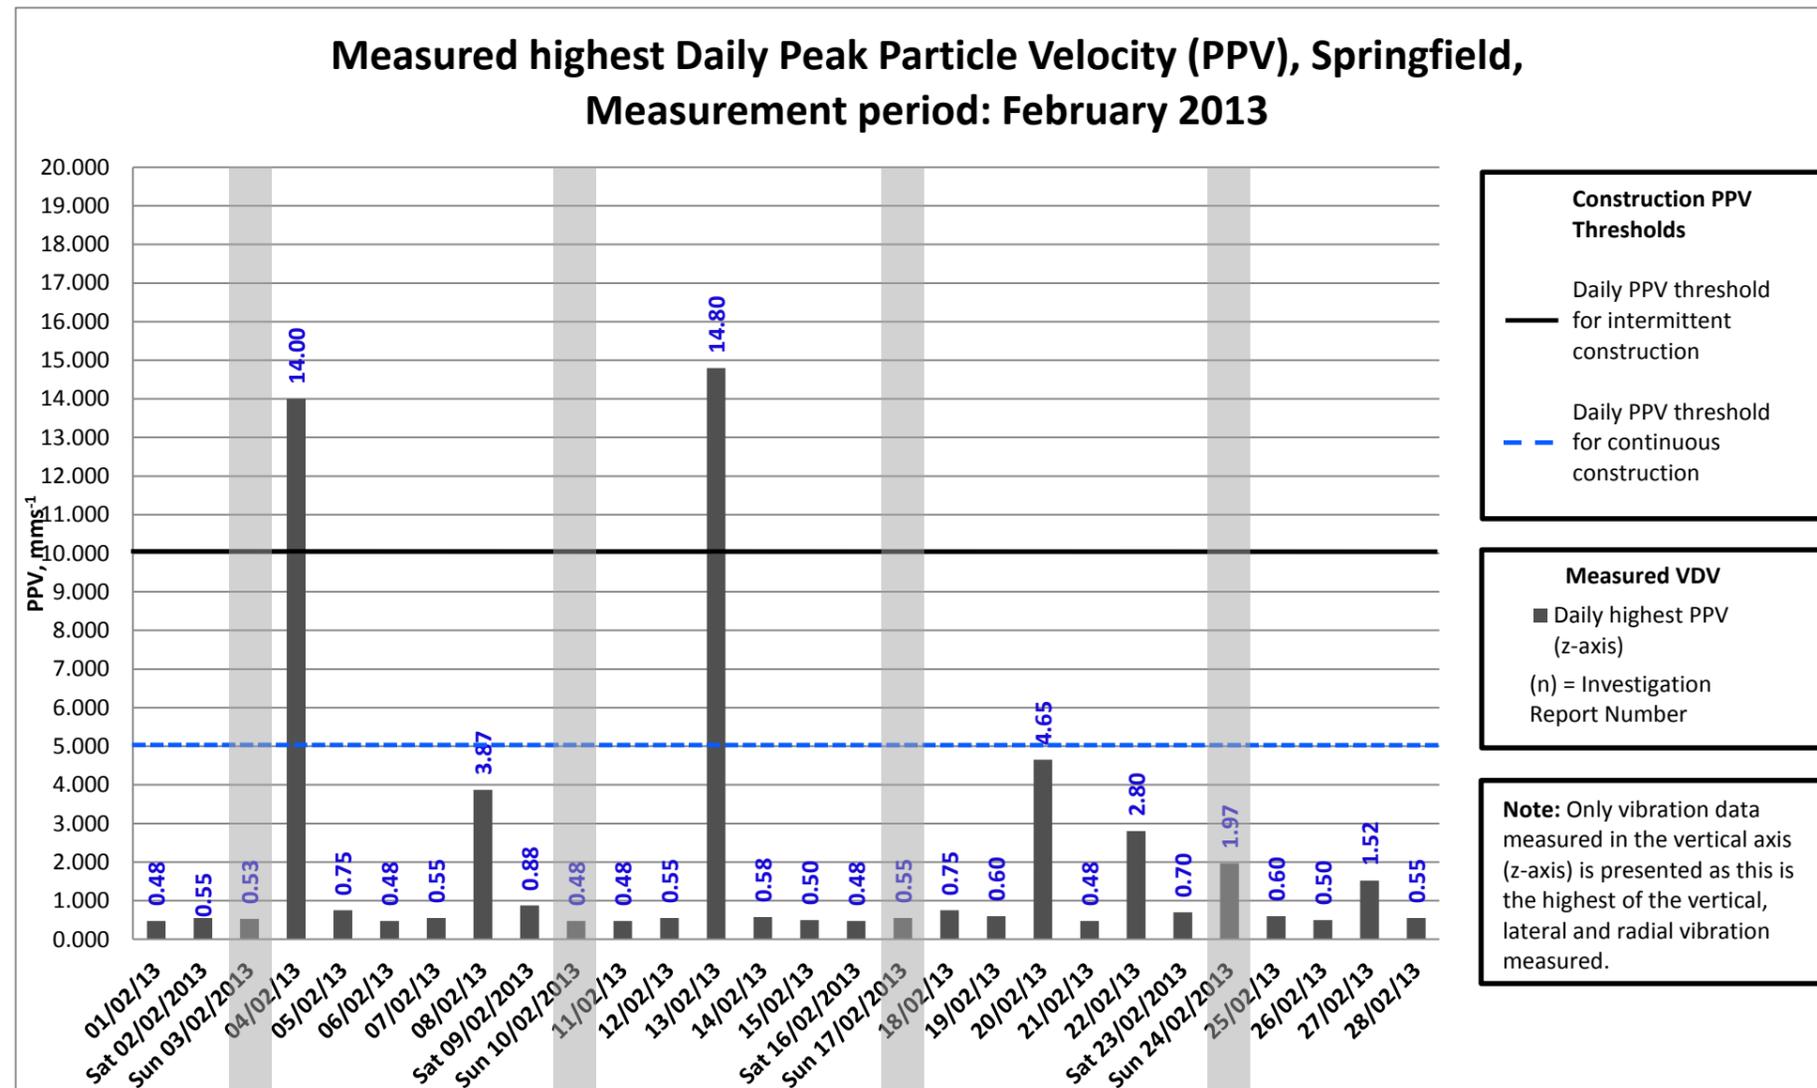
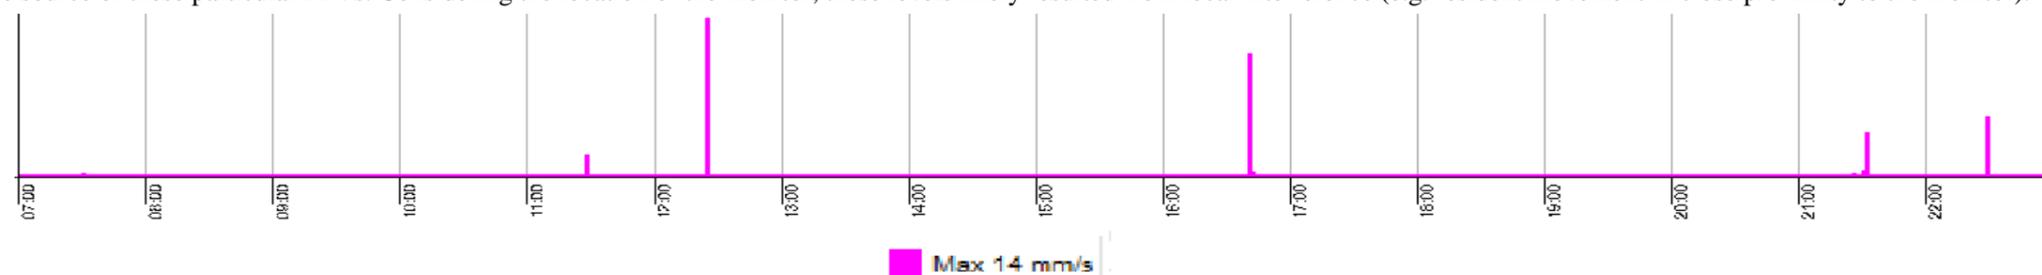
- The grey areas of the chart represent the days on which no construction works were undertaken; no works were conducted on Sundays.
- The PPV values on 04/02/13 & 13/02/13 have both been investigated, and have been seen to be individual, isolated events within each period (see Vibrock PPV graph below from 04/02/13). Furthermore, these particular levels cannot have been generated as a result of FCBC construction, as the only works to be conducted on these dates in the vicinity of the monitor, were rock generation and excavation operations at the Queensferry gyratory and Echline Field respectively. The only vibration inducing plant or equipment involved in these activities were rock breakers, which were operated a minimum distance of 50m from the monitor (and nearest receptors), and can thus be discounted as the source of these particular PPVs. Considering the location of the monitor, these levels likely resulted from local interference (e.g. resident movement in close proximity to the monitor).

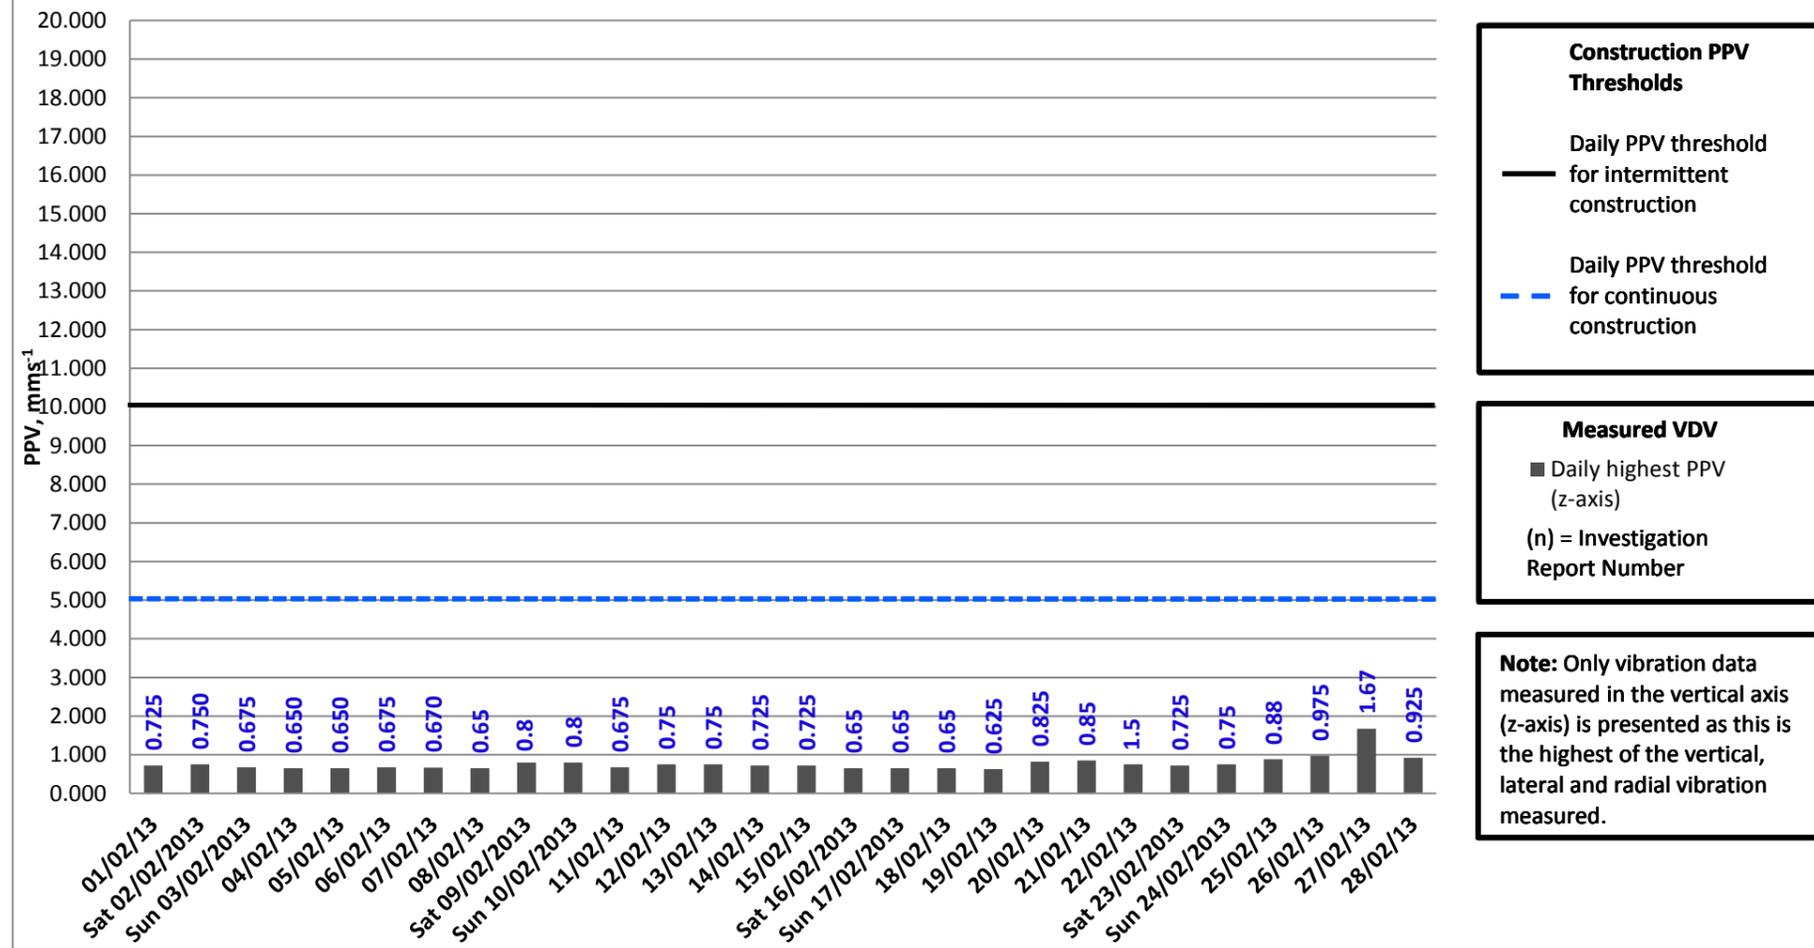
Measured highest Daily Peak Particle Velocity (PPV), Tigh-Na Grian, Measurement period: February 2013

Note: Only vibration data measured in the vertical axis (z-axis) is presented as this is the highest of the vertical, lateral and radial vibration measured.

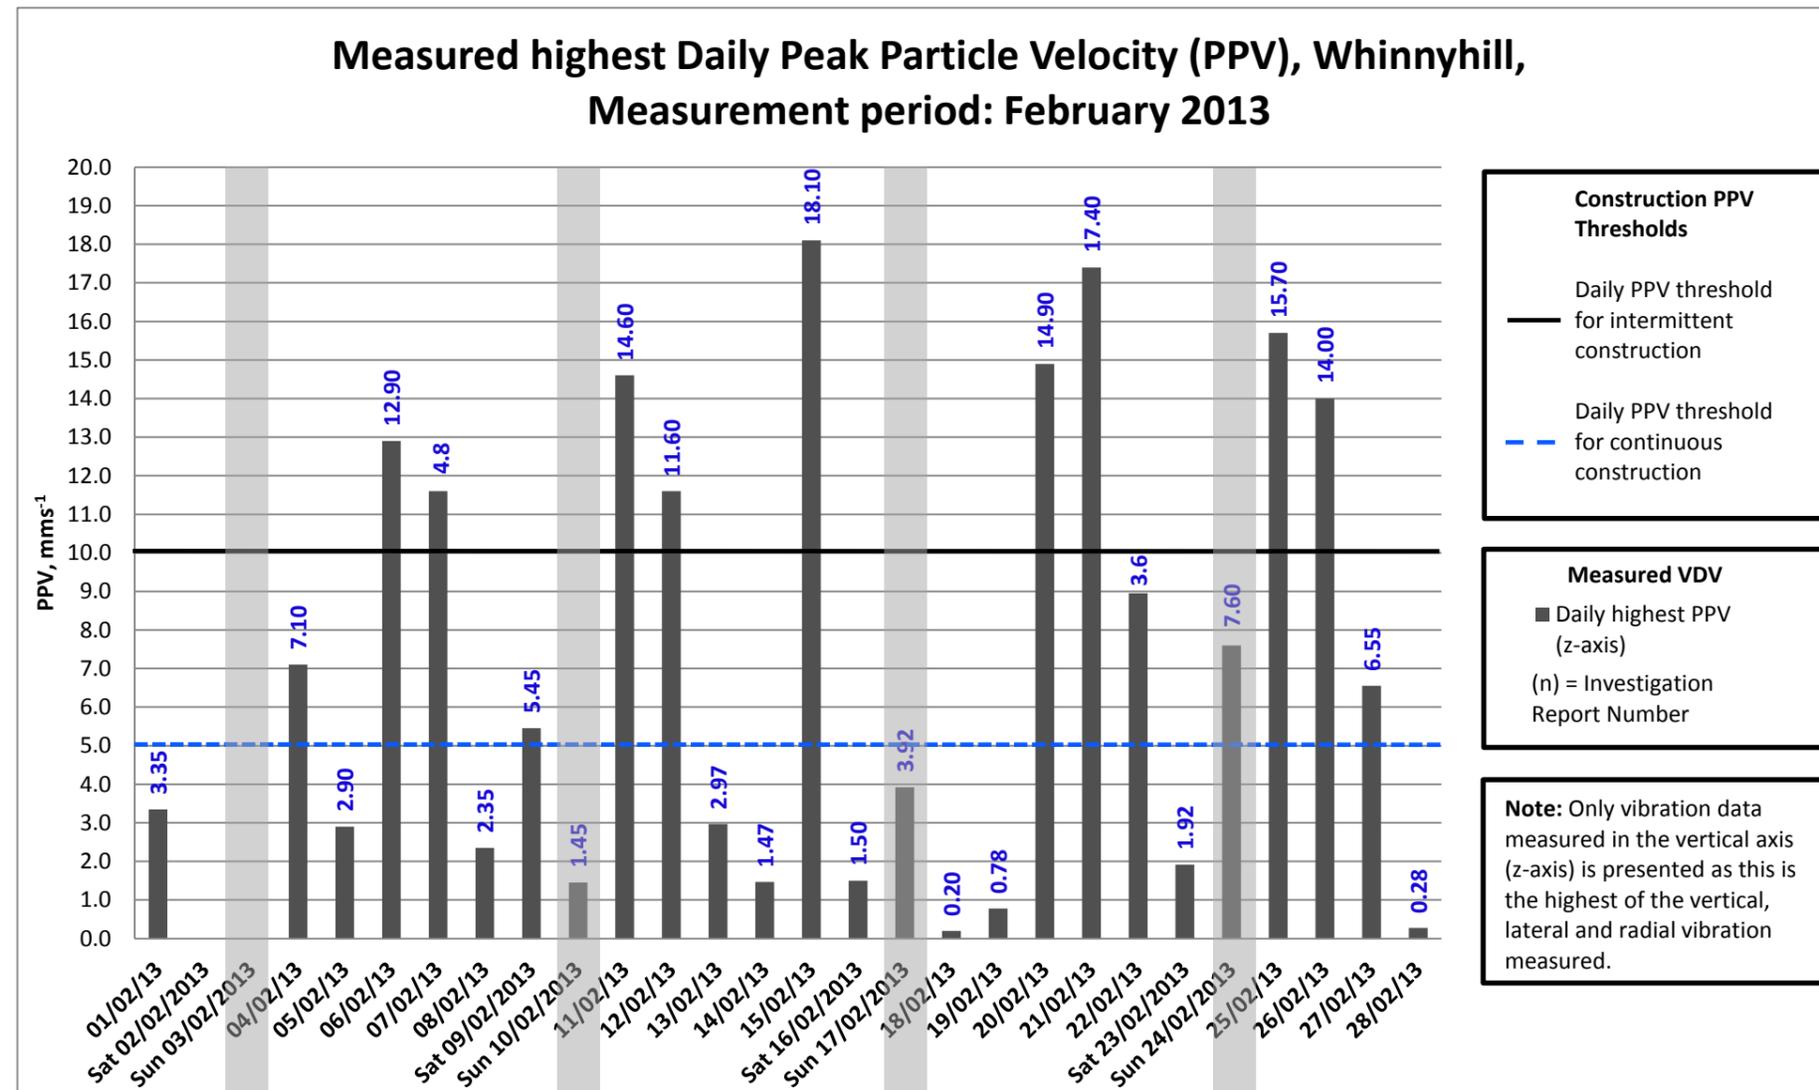
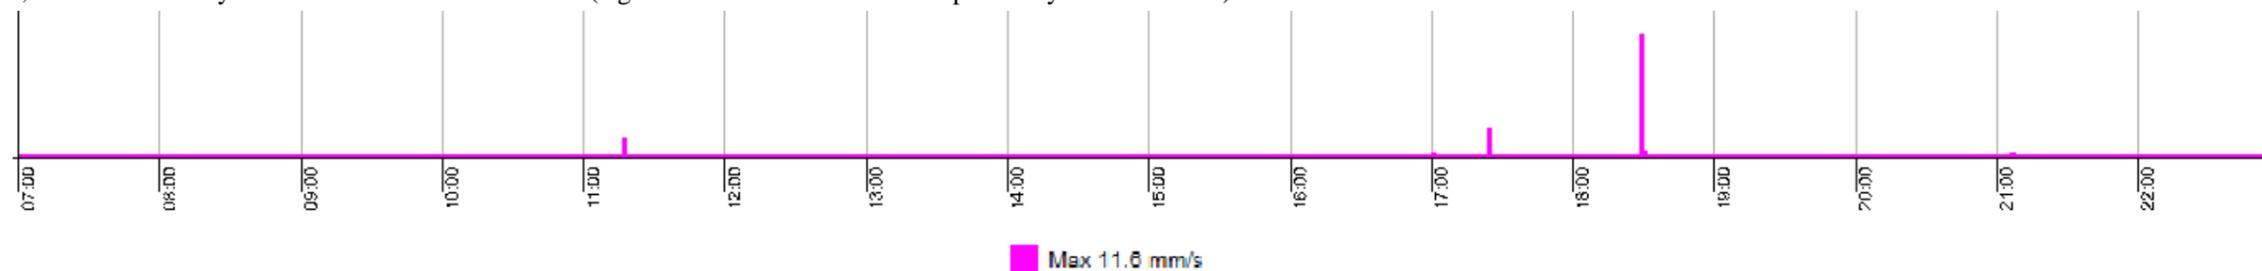
- The grey areas of the chart represent the days on which no construction works were undertaken; no works were conducted on Sundays.
- Data is missing for 02/02/2013 to 03/02/2013 due to device error.
- All PPV exceedances have been investigated, and have been seen to be individual, isolated events within each period (see Vibrock PPV graph below from 12/02/13). The only vibration inducing plant or equipment involved in these activities were rock breakers, which were operated a minimum distance of 270m from the monitor (and nearest receptors), and can thus be discounted as the source of these particular PPVs. Considering the location of the monitor, these levels likely resulted from local interference (e.g. resident movement in close proximity to the monitor).

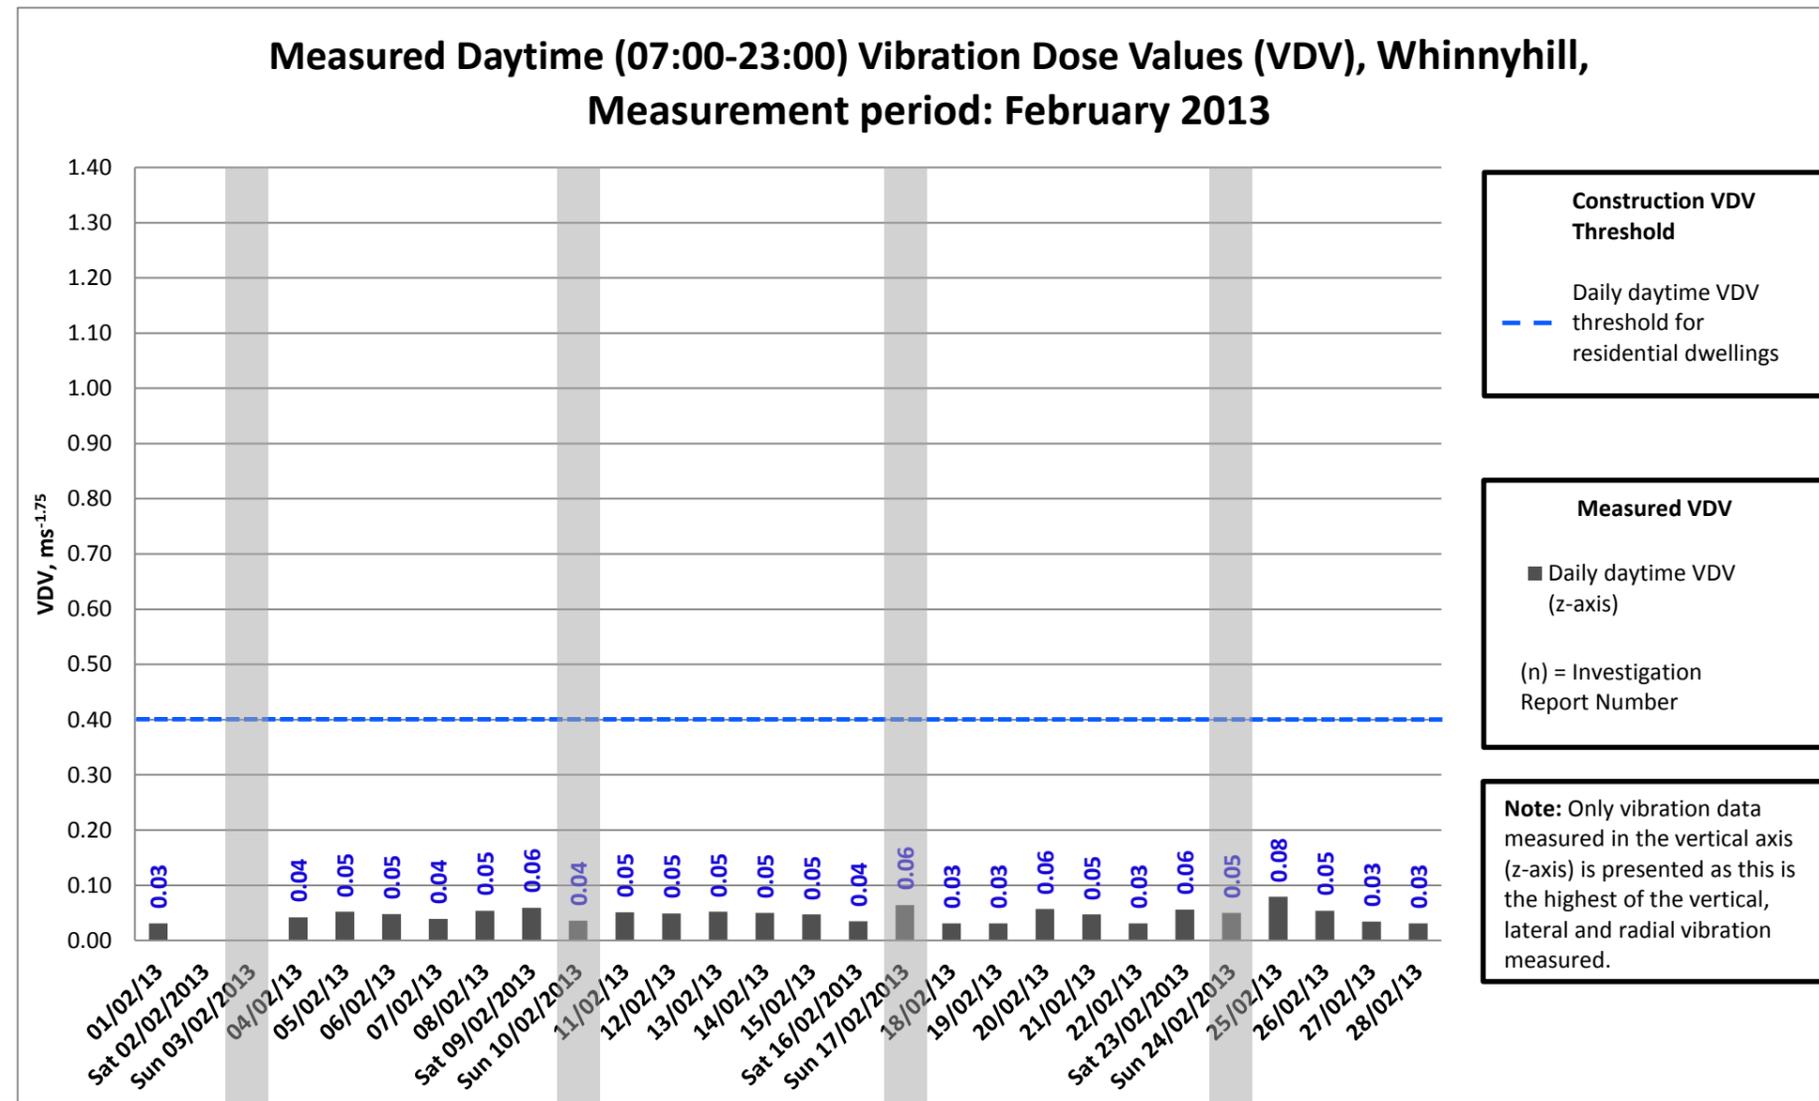
- The grey areas of the chart represent the days on which no construction works were undertaken; no works were conducted on Sundays.
- Data is missing for 02/02/2013 to 03/02/2013 due to device error.

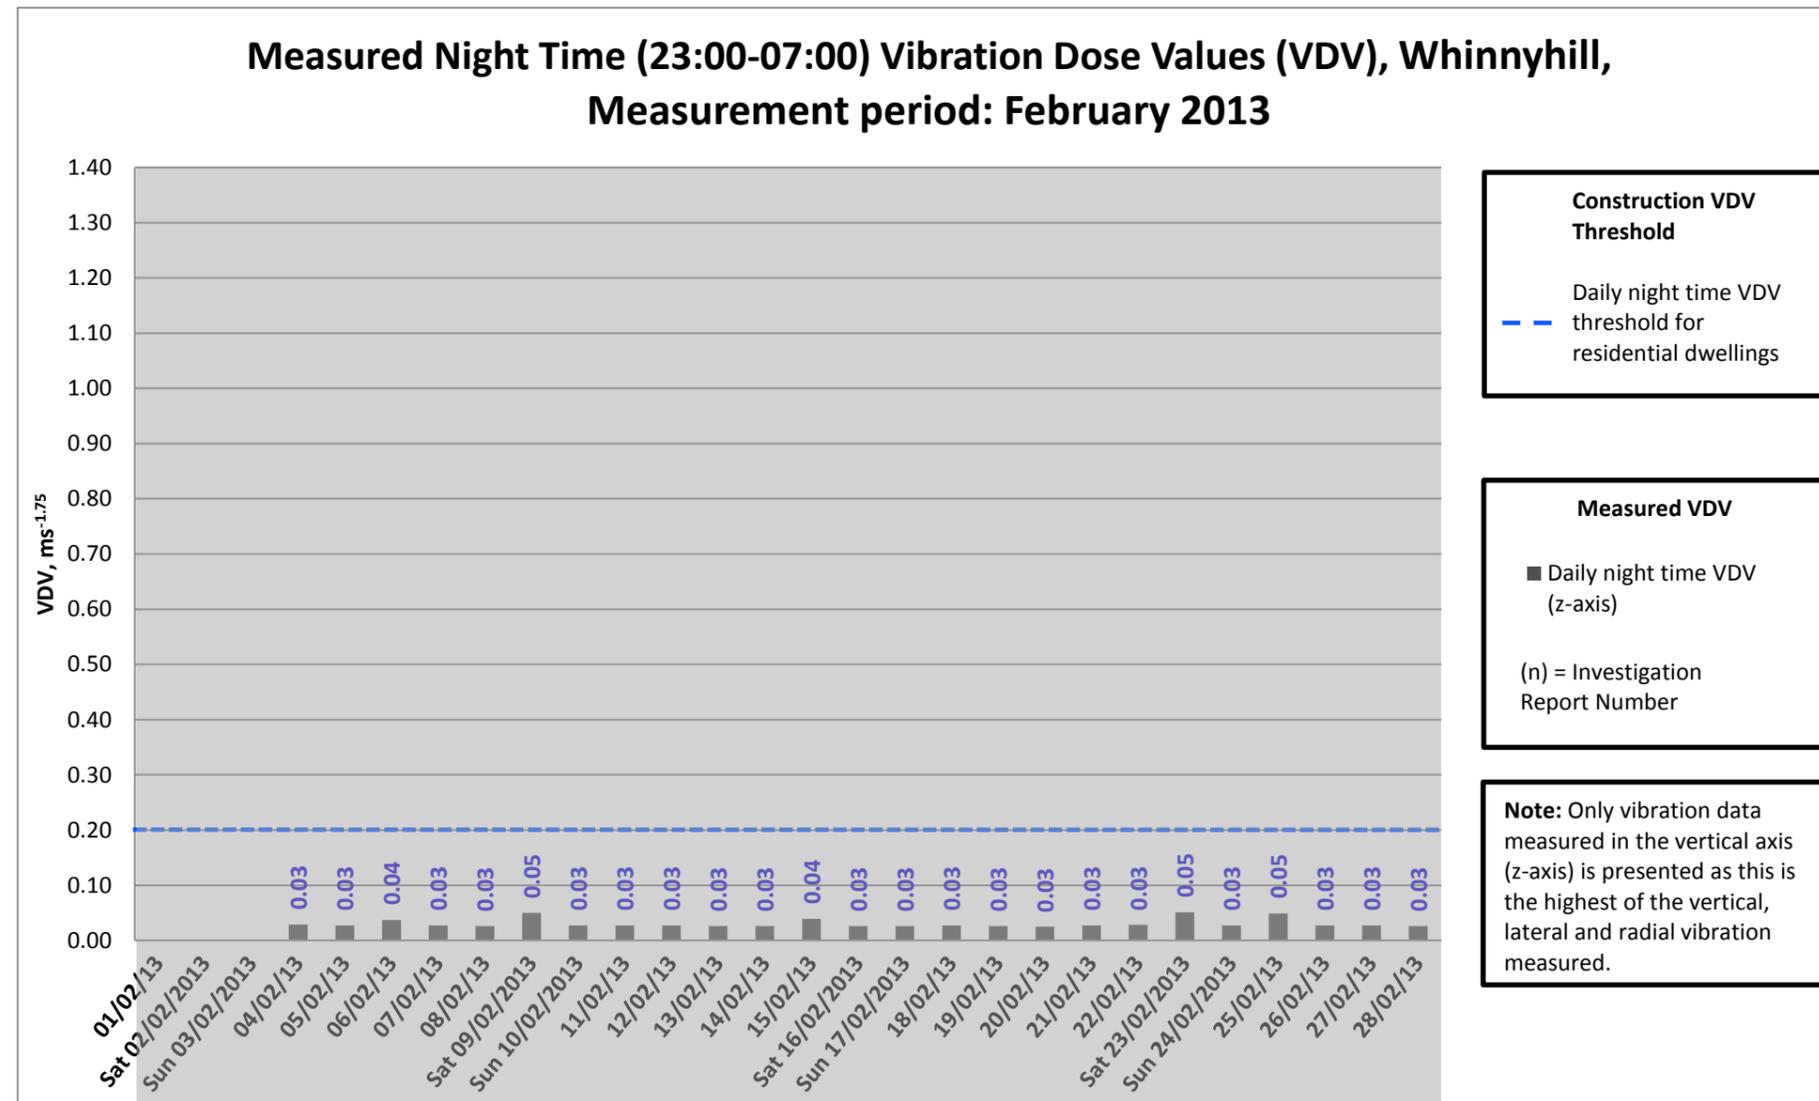
- The grey areas of the chart represent the days on which no construction works were undertaken; no night time works were conducted in the vicinity of the Whinnyhill vibration monitor throughout the month of February 2013. This graph is included for illustrative purposes only.
- Data is missing for 01/02/2013 to 03/02/2013 due to device error.
