TRANSPORT SCOTLAND
SCOTTISH TRUNK ROAD INFRASTRUCTURE
PROJECT EVALUATION

3YA Evaluation Report for A9(T) Bankfoot

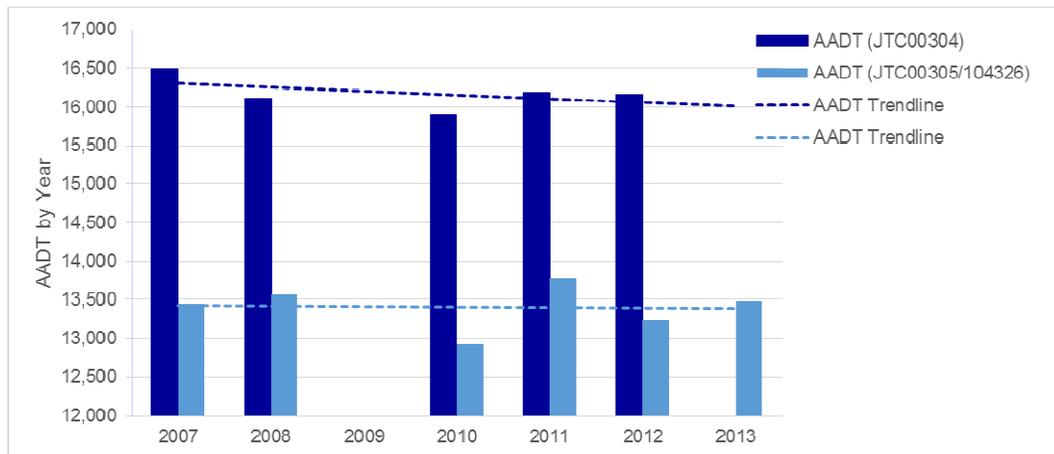
Figure 3.2: Long Term ATC Data

Notes: Incomplete data for counters JTC00304 & JTC00305 in 2012 – available data for neutral months (March, April & May) used
 Incomplete data for counter JTC00305 in 2013 – available data for neutral months (October & November) used

The **1YA Evaluation** indicated that traffic flows in 2010 were around 200 vehicles per day (approximately 1%) lower than 2008 flow levels. Flows in 2011 were marginally higher than 2008 levels. Traffic volumes on the A9(T) at Dunkeld have seen a reduction of around 600 vpd (approximately 4%) between 2008 and 2010 with flows in 2011 around 200 vpd (approximately 2%) higher than 2008 levels.

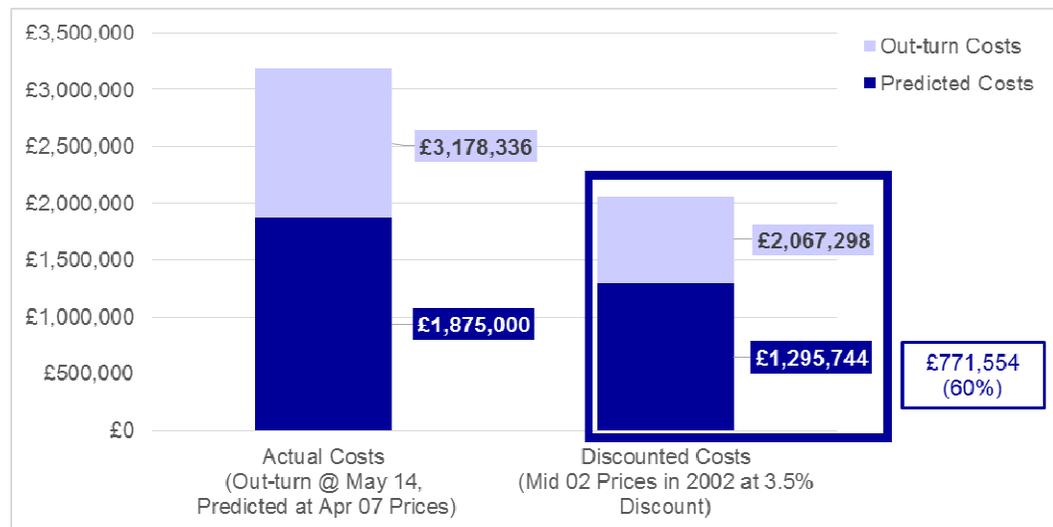
Figure 3.4: Project Cost Summary

The out-turn and predicted project costs are shown in Figure 3.4.

The latest comparison indicates that the current out-turn costs for the project are consistent with the out-turn costs at the time of the **1YA Evaluation**. The current out-turn costs are approximately £0.8m greater than was predicted at the time of assessment. It should be noted that the predicted costs used within the cost comparison are derived from the costs estimated at the project's pre-tender stage. As such, variations in actual and predicted project cost comparisons can occur due to issues identified during the tendering process.

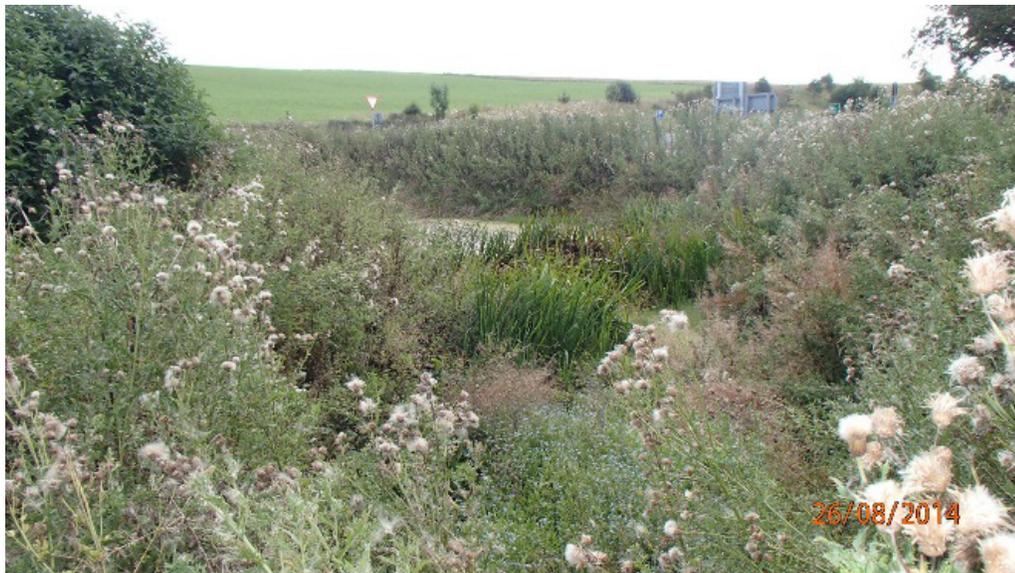
Wetland vegetation has become established within and around the pond to the south of the project and the marginal plants include reeds and rushes. However, the observation made in 1YA regarding the domination by weed species remains. There is a dominance of thistle around the upper banks of the pond, see Figure 1. The surface of the pond appeared covered in pond weeds, although it was not possible to confirm this by close inspection as a visual inspection could only be made from behind the pond fence, see Figure 2. It would be advisable to clear out the pond weed and cut back the dominant thistle to enhance the biodiversity of the pond and surroundings.

Figure 1: Dominance of thistle around pond

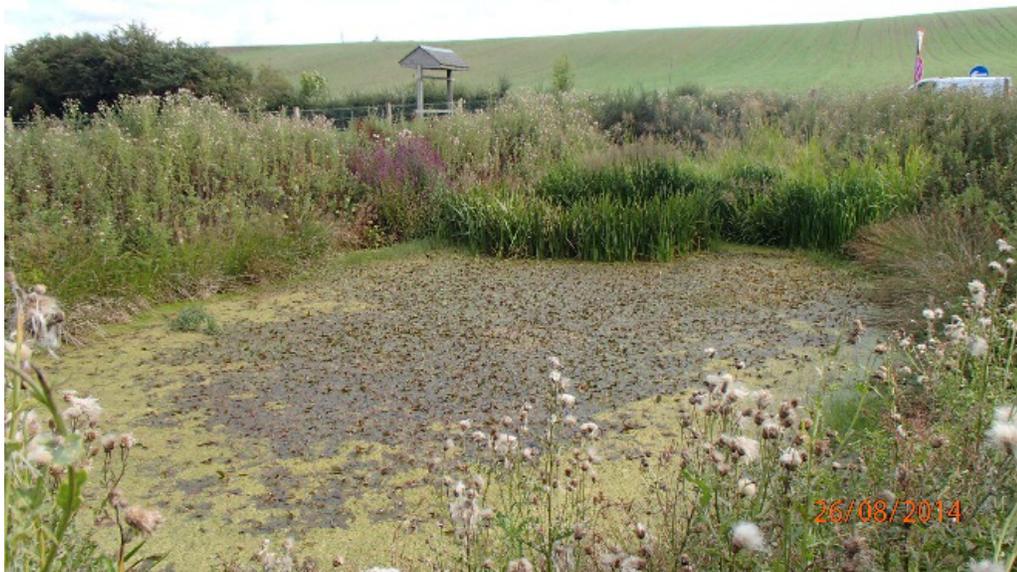
Figure 2: Pond weed covering surface

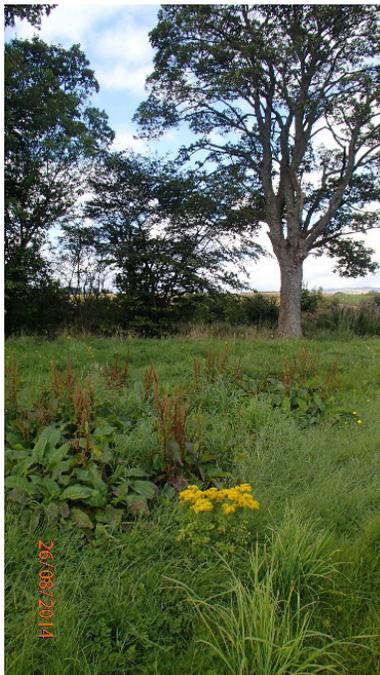
To the south of this pond, the verge on the west side of the carriageway is covered in a mix of wildflower, ruderal vegetation and grasses but there is also areas of dock weed and some ragwort, see Figure 3. Ragwort was found in small patches throughout the project. Ragwort poisoning can be fatal to horses and damaging to other livestock. If not already part of an injurious weed control programme, the area around the project should be considered for inclusion in future programming, to ensure against spread to neighbouring fields and farms where it could present a problem to livestock.

Figure 3: Ragwort and dock weed

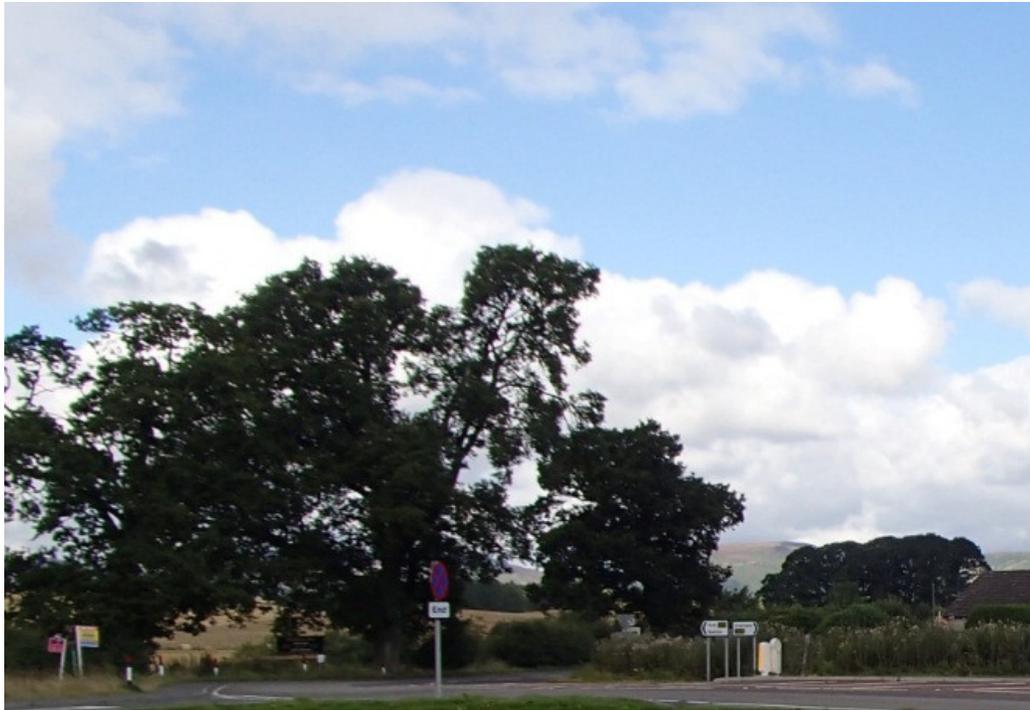
Figure 4: Mature trees by the southern pond

The RoD called for bat boxes to be positioned in mature trees on the side road opposite the pond. Similarly to the 1YA assessment, bat boxes could not be identified at this location. However, the trees themselves are mature enough that they will likely provide suitable roosting opportunities for bats, see Figure 4. Also, as in the 1YA assessment, boxes for birds, insects and hedgehogs could not be located.

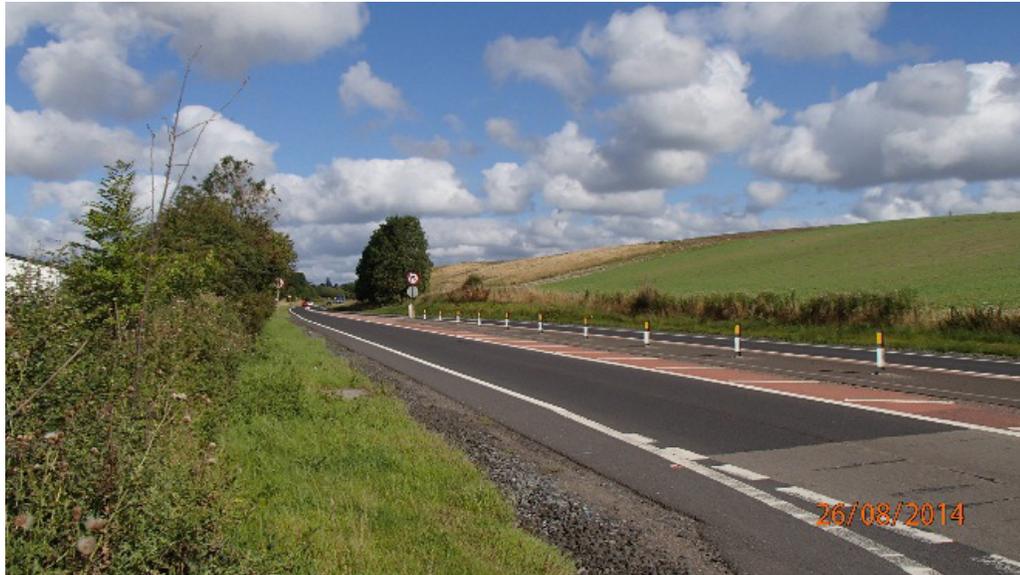
Figure 5: Looking north

On the eastern side of the carriageway, the vegetation on the verge is not as diverse but still comprises grassland and a variety of native trees, including ash, that are growing well. Going north from the pond there is a mix of ash, horse chestnut and hawthorn on the west side of the carriageway and more mature ash on the east side, which were protected in situ, see Figure 5 and Figure 6. All of this new planting is establishing well and together with the mature trees helps integrate the scheme effectively into the existing landscape of the carriageway and fields beyond.

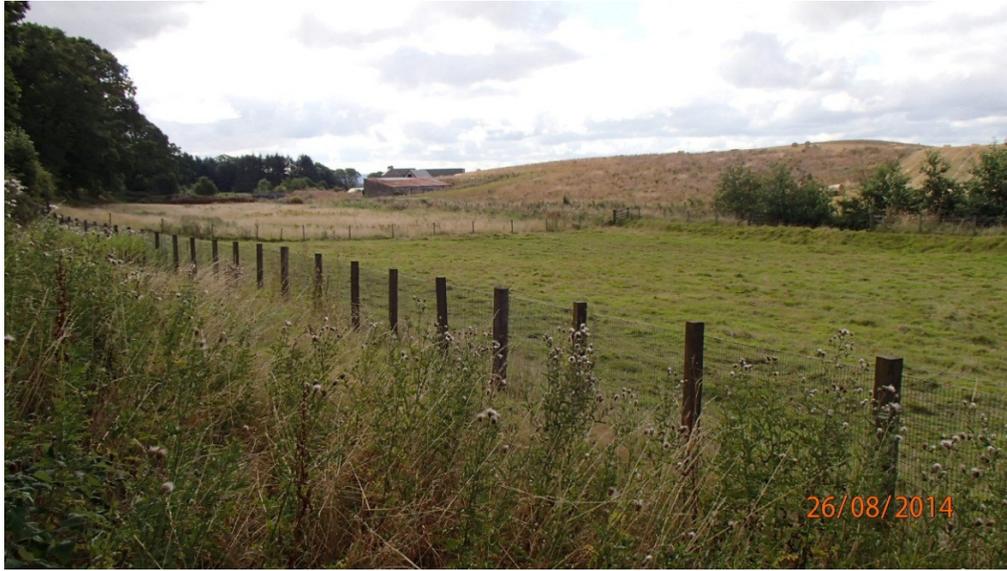
The otter fence adjacent to the Garry Burn at the south side of the project was located and inspected. It was found to be in good condition, but does not satisfy the DMRB specification² as it does not have an overhang at the top (to stop otters climbing over it) although this is not a requirement of SNH guidance³ see Figure 7.

Figure 7: Mammal fence

- The effectiveness of the otter fencing at Garry Burn at preventing otters from entering the carriageway should be investigated given that it does not follow DMRB design specification (for length and overhang required, although SNH guidance does not require an overhang), and improvements to the fencing should be considered if needed. The investigation could start with an otter activity survey and review of the roadkill data.

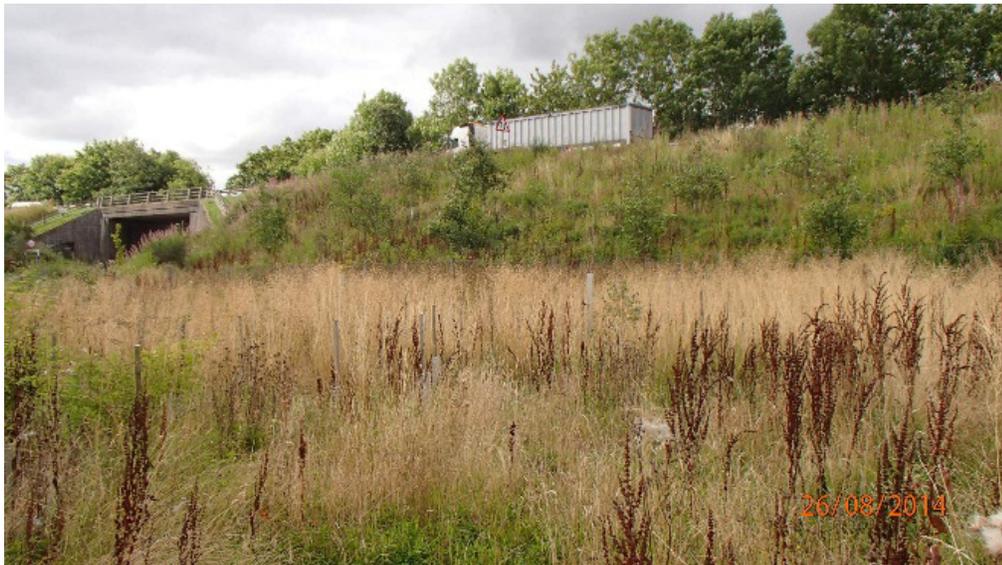
The planting of the embankment and areas near the northern SUD pond has been less successful and is dominated by ruderal vegetation, see Figure 8 and Figure 9. There are a number of failed trees and empty tubes and posts remain, see Figure 10. Some of the trees towards the embankment, closer to the carriageway, have been more successful but these successful species appear mainly to be the alder, see Figure 11.

Figure 8: Dominance of ruderal vegetation

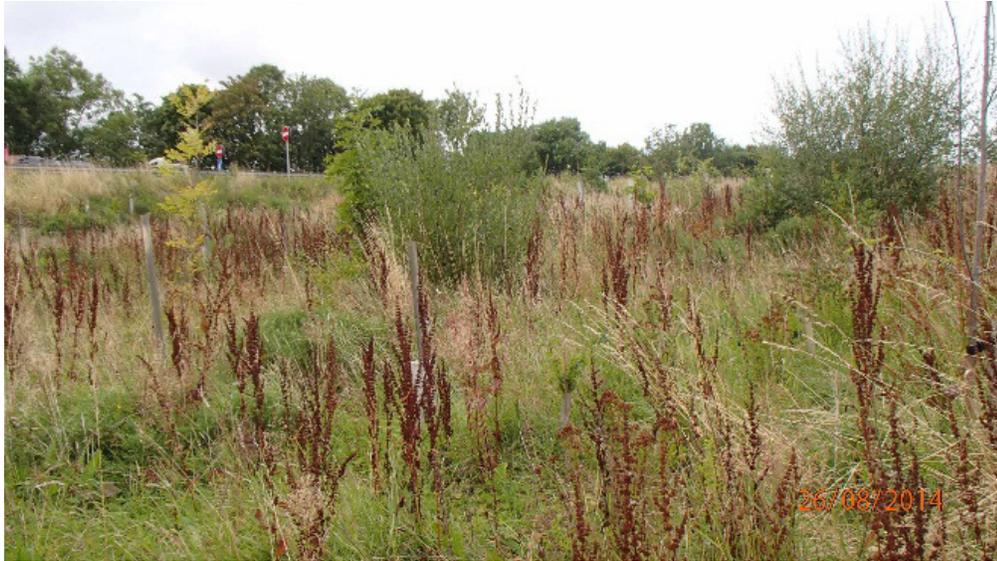
Figure 9: Dominance of ruderal vegetation & failed planting

- Where tree planting has failed, empty tubes and redundant posts should be removed and consideration should be given to replacing the lost trees.

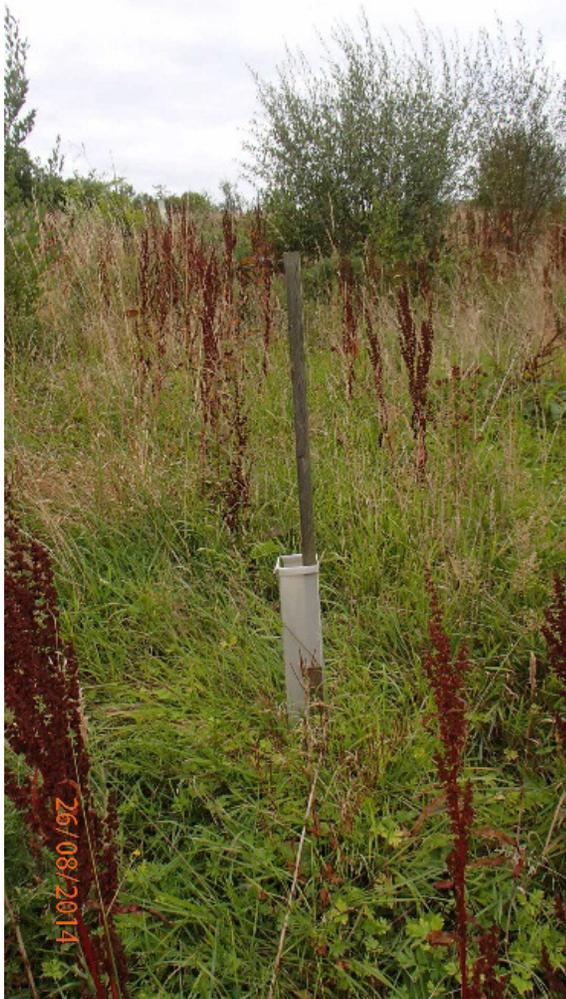
Figure 10: Failed planting. Empty tube & post remain

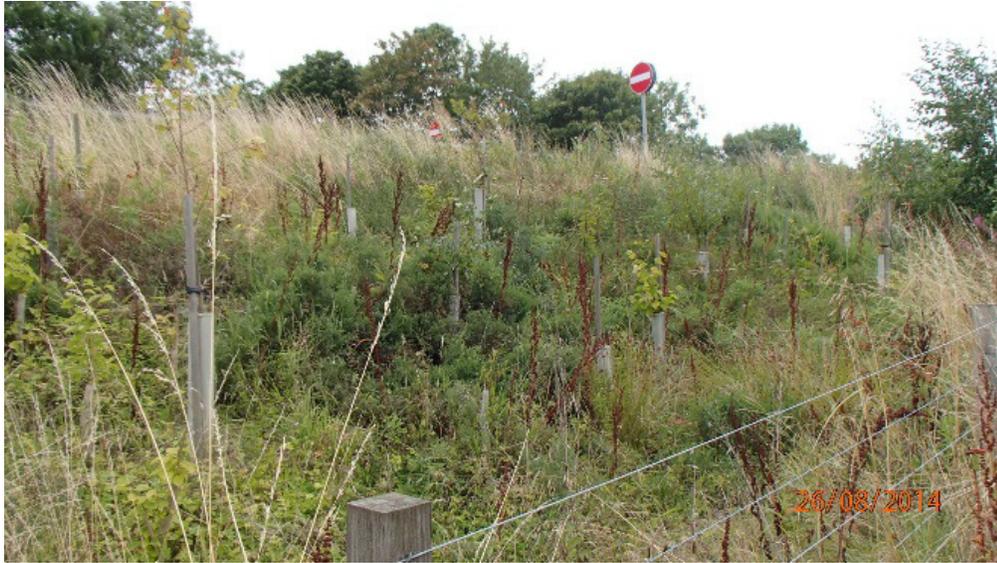
Figure 11: Some planting on embankment, some of which failed to establish

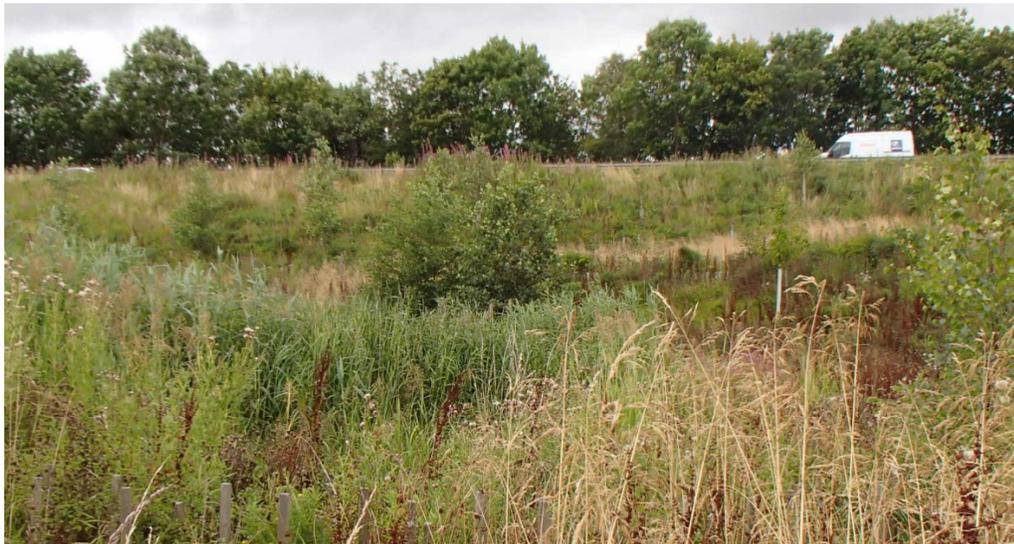
The vegetation within the northern SUDS pond has established well, comprising reeds and rushes, including common reed *Phragmites australis*, leaving no open water visible (Figure 12). The pond banks comprise alder and ruderal vegetation. The reeds may crowd out other native plants if not managed sensitively, and along with the ruderal vegetation in and around the area, could reduce the capacity of the pond. As with the southern pond, all of the vegetation in this area require more maintenance and the failed tree planting needs to be reviewed, removing redundant tubes and posts and replanting where required.

Figure 122: Northern pond dominated by common reed (centre) and surround by ruderal vegetation

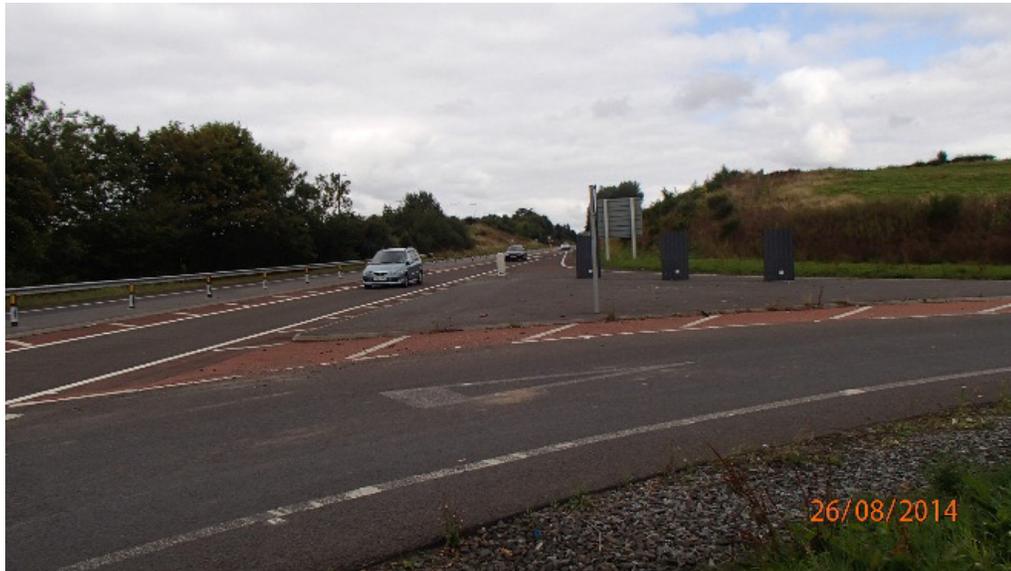
Figure 133: Northern extent of the project

Overall, the project now sits well within the wider landscape, particularly with regards the view from the road. As reported above, however, further maintenance is required to both SUDS ponds and to the areas overgrown by weeds, and the failed tree planting should be reviewed so as to improve the effectiveness of the biodiversity and landscape mitigation implemented.
