# FORTH REPLACEMENT CROSSING

# AIR QUALITY MONITORING REPORT AUGUST 2017

REP-00342		00	
Document number		Rev	
Initials: SWR	Initials: David Clark		
Made by Steven Westwater	Checked By: David Clark

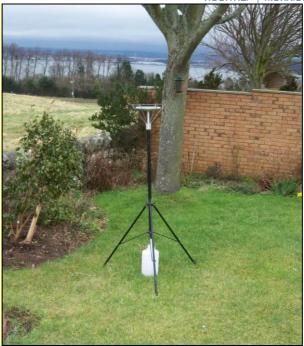
Figure 1: Example of an Installed Frisbee Gauge Meter

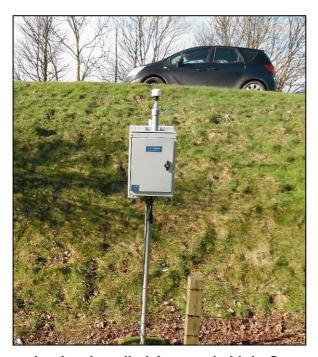
Figure 2: Example of an installed Automatic Light Scatter Dust Meter

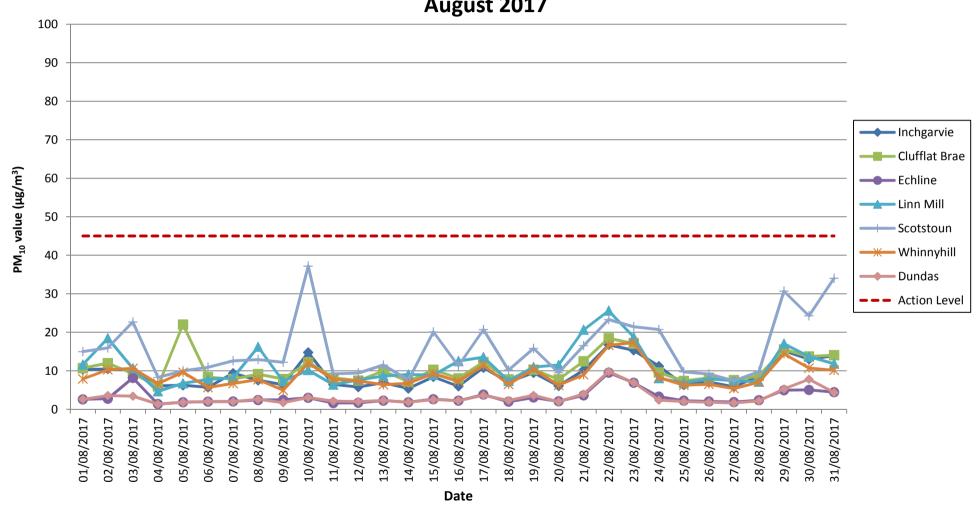
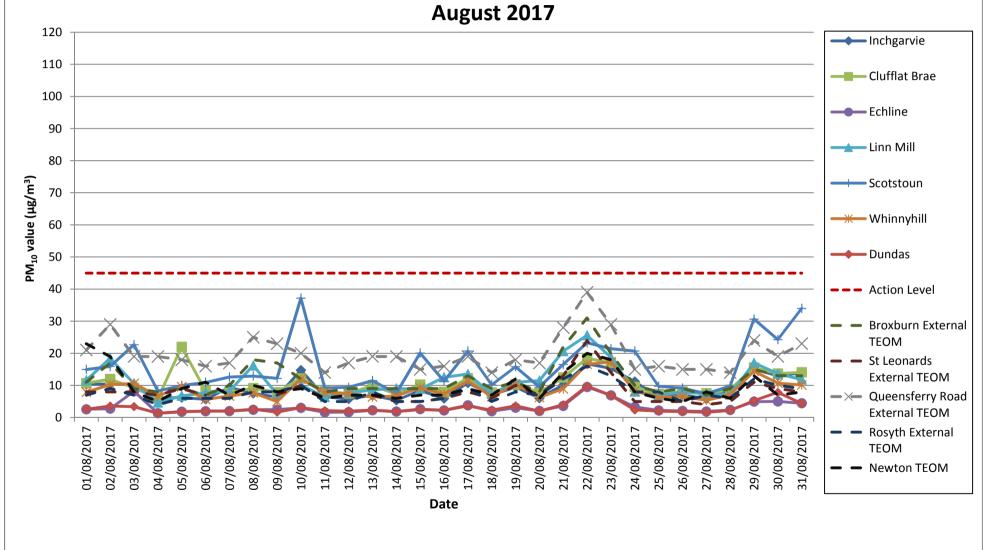
**APPENDIX A: LIGHT SCATTER METER RESULTS**

- 3.1.1. Light scatter meter results for August 2017 have been presented in a monthly chart; this can be found in Appendix A. Results for the month are generally low and all are below the action level. PM<sub>10</sub> levels generally follow a similar pattern throughout the month with the exception of higher results recorded at Scotstoun on the 10<sup>th</sup>, 29<sup>th</sup> and 31<sup>st</sup> August. At the time of these higher results there were no project related activities being undertaken which would give rise to dust as FCBC construction works were complete in this area.

# Air Quality Monitoring Particulate Matter (PM10) Results for all Monitoring Locations August 2017

- 3.1.2. The PM<sub>10</sub> results have also been compared to the daily mean results obtained from the TEOM air quality monitoring stations located in Newton, Rosyth, and Broxburn, and from the TEOM FDMS station located at Queensferry Road and St Leonards, Edinburgh (an urban background site). The TEOM at Newton was installed by West Lothian Council, facilitated by FCBC, during January 2012. The comparison between the light scatter and TEOM results demonstrates that both sets

of results generally follow the same pattern throughout the month, with the exception of the result recorded at Scotstoun on 10<sup>th</sup> August.

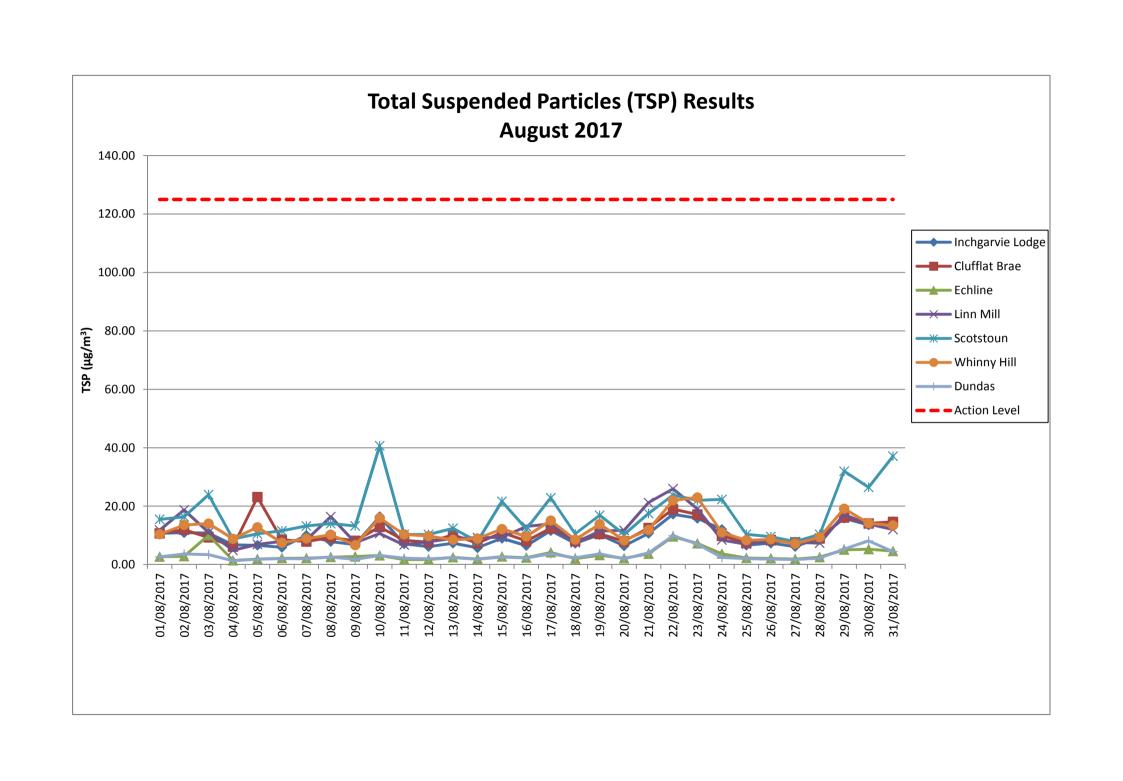
**APPENDIX B: TOTAL SUSPENDED PARTICLES**

3.2.1. The TSP results for August 2017 have been presented in a monthly chart; this can be found in Appendix B. The TSP levels at monitoring locations during August were found to be generally low and all within the threshold level. All locations across the site were found to follow a similar pattern to that observed for PM<sub>10</sub> levels, as described in 3.1.1.

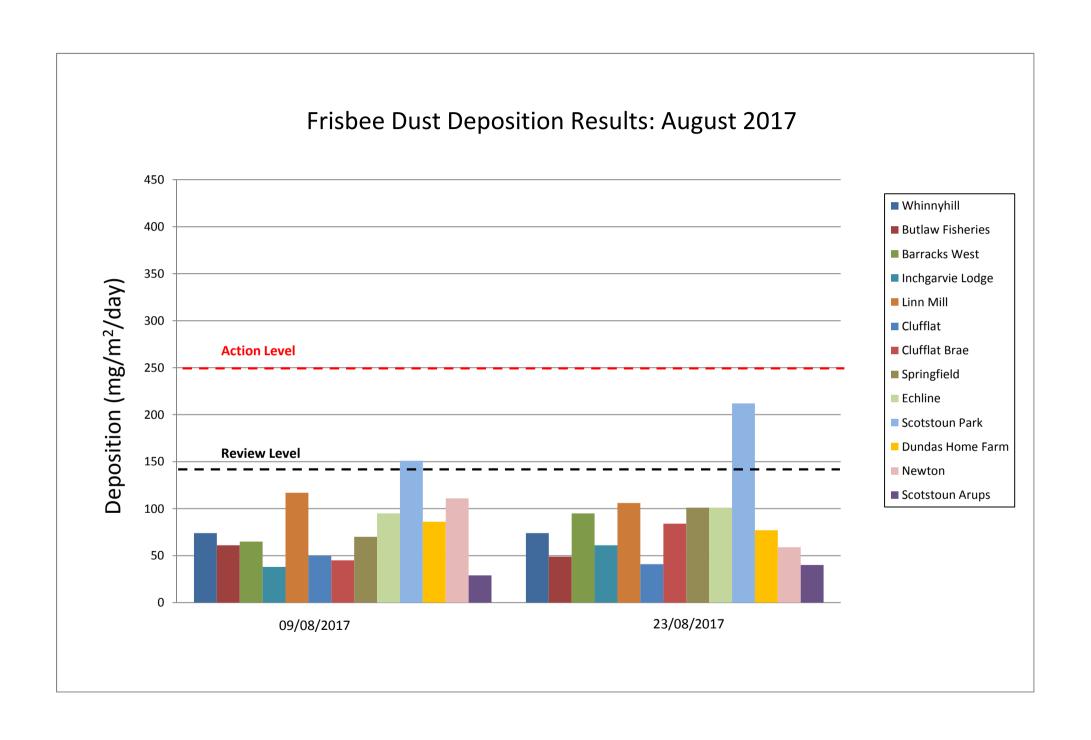
**APPENDIX C: FRISBEE GAUGE RESULTS**

- **3.3.1.** The Frisbee dust deposition results for August 2017 have been presented in a chart and can be found in Appendix C. Two collections were made in August; these occurred on the 9<sup>th</sup> and 23<sup>rd</sup> August 2017.

- **3.3.2.** The site action level for the dust deposition rate has been set at 250 mg/m²/day. Exceedances of this level are treated as a potential incident and a review of the works in the vicinity of the site is instigated. A lower site review level has been set at 140 mg/m²/day. Where concentrations exceed the lower review threshold the site works are reviewed to ensure good practice is implemented; it is essentially a warning that additional controls may be required.

- 3.3.3. During August there were exceedances of the site review level at Scotstoun Park for both monitoring periods. With regards to these exceedances, the temporary Frisbee at Scotstoun Arups, which is located closer to the FCBC works area, indicates a significantly lower result than for the permanent Frisbee during this period. In addition, there were no project related activities being undertaken in this area during August which would give rise to dust. This suggests that the higher results obtained at the permanent monitoring location are not due to FCBC activities.
