Appendix 10.5

Preliminary Peat Landslide Risk Assessment

- 1.1.1 In support of **Chapter 10 (Volume 1)** of the Design Manual for Roads and Bridges (DMRB) Stage 3 Environmental Impact Assessment (EIA) report, this technical appendix presents a Preliminary Peat Landslide Risk Assessment for Project 8 – Dalwhinnie to Crubenmore of the A9 Dualling Programme (hereafter referred to as the Proposed Scheme).

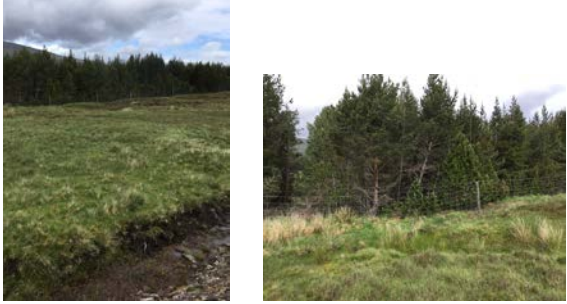
Not all directly observed. No evidence of instability where observed at between ch. 21,000 and 21,050. Potential instability in models created by steeper cutting slope.	Undertake quantitative stability analysis prior to construction and mitigate as required if risk confirmed. If risk is disproved, follow general guidance measures in Section 6 on how to reduce peat landslide risks.
ch. 21,950	Moderate	Relatively extensive areas of indicated instability throughout the Dalwhinnie junction on both sides of the proposed infrastructure	Relatively extensive area ca. 70m upslope (east of the existing A9)

No instability observed.	Undertake quantitative stability analysis prior to construction and mitigate as required if risk confirmed. If risk is disproved, follow general guidance measures in Section 6 on how to reduce peat landslide risks. Trees to remain. Sheep pen to be added in this area. Recommend no additional water is introduced into this area from construction of the pen.

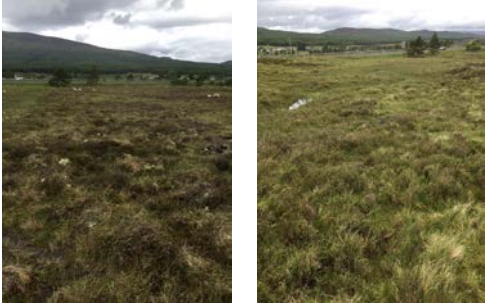
Area of deep peat, but generally very flat with no evidence of instability so likely false positive.	Undertake quantitative stability analysis prior to construction and mitigate as required if risk confirmed. If risk is disproved, follow general guidance measures in Section 6 on how to reduce peat landslide risks. Excavations should be avoided if possible and appropriately supported where not.
ch. 22,550 to 22,850	-	Multiple small areas of indicated instability indicated predominantly east of existing A9 (with two small areas to west). Predominantly within the footprint of the proposed works, and all within the proposed temporary and permanent works boundaries	-

No evidence of instability observed. These areas are unlikely to be problematic. Area within proposed eastern junction loop has slight slope and natural drainage line. Area to west of existing A9 at ch. 22,700 is likely a false positive.	Undertake quantitative stability analysis prior to construction and mitigate as required if risk confirmed. If risk is disproved, follow general guidance measures in Section 6 on how to reduce peat landslide risks.

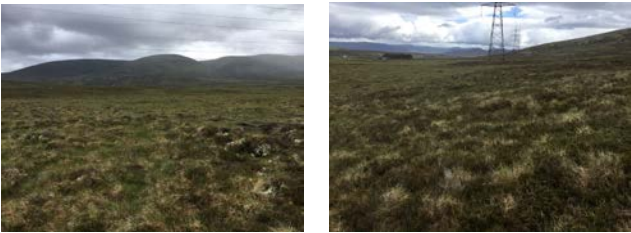
ch. 22,650 to ch. 22,800	-	Extensive areas of indicated instability ca. 160m east of the existing A9 Dalwhinnie predominantly outside of the permanent and temporary works boundaries.	-

No evidence of instability. Deeper peat and slight slope in west, steeper slope in east (but with less peat) likely generating possibility of instability in model in extreme conditions in quantitative model.	Undertake quantitative stability analysis prior to construction and mitigate as required if risk confirmed. If risk is disproved, follow general guidance measures in Section 6 on how to reduce peat landslide risks. Avoid surcharges and excavation in the identified area.

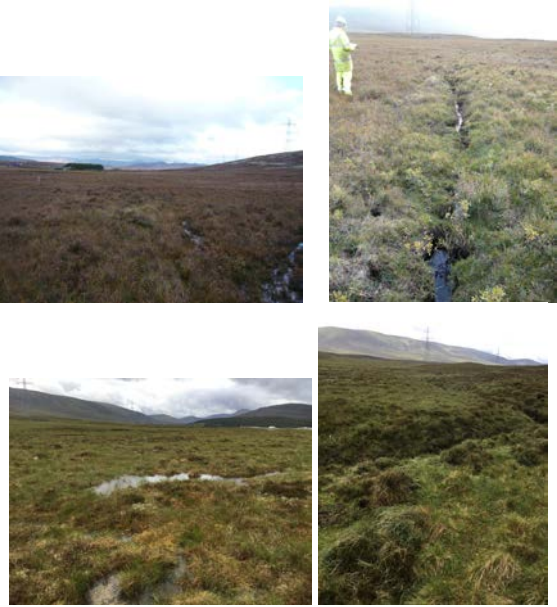
Slightly sloping low angle area crossed with artificial drainage. Deep peat.	Undertake quantitative stability analysis prior to construction and mitigate as required if risk confirmed. If risk is disproved, follow general guidance measures in Section 6 on how to reduce peat landslide risks. Avoid surcharges and excavation in the identified areas. Protect drainage channels to prevent minor runouts into watercourses.

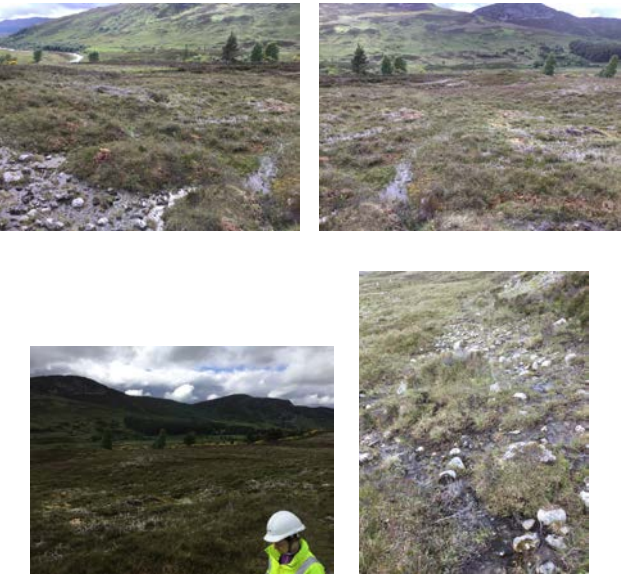
No instability evident.	Undertake quantitative stability analysis prior to construction and mitigate as required if risk confirmed. If risk is disproved, follow general guidance measures in Section 6 on how to reduce peat landslide risks. Consider protection of existing A9 and natural watercourse with catch fences during construction.
ch. 29,850 to ch. 30,000	Moderate	Two large areas of indicated instability located ca. 80m east of the existing A9 above the existing cutting. These intersect with proposed watercourse diversions and temporary works areas.	East (upslope) of the existing A9. Linear areas associated with existing cut off drains above the existing cutting and further upslope partly intersecting with a proposed watercourse and temporary works area.

No obvious evidence of recent instability and slopes are gentle. However, surface water is plentiful and there is an area of exposed substrate at the margins of the area of deeper peat. Topography is also undulating. Unlikely to indicate major peat instability but advise treat area with caution, protecting existing A9 and works below from possible runouts during construction.	Undertake quantitative stability analysis prior to construction and mitigate as required if risk confirmed. If risk is disproved, follow general guidance measures in Section 6 on how to reduce peat landslide risks. Consider protection of existing A9 and natural watercourse with catch fences during construction.

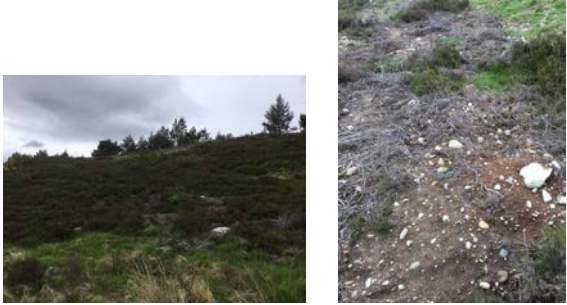
ch. 30,300 to ch. 30,350	-	Discrete area of indicated instability fringed by moderate instability between ch. 30,300 and 30,400, intersecting with proposed embankment slope	-

No peat present on the slope. Mineral soil present. Probably false positive.	Undertake quantitative stability analysis prior to construction and mitigate as required if risk confirmed. If risk is disproved, follow general guidance measures in Section 6 on how to reduce peat landslide risks.
ch. 30,650 to ch. 31,850	Moderate	-	East (upslope) and west (downslope) of the existing A9, partly within the footprint of proposed scheme, picking out areas of forestry, drainage and steeper slopes.	-	Not directly observed.	Undertake quantitative stability analysis prior to construction and mitigate as required if risk confirmed. If risk is disproved, follow general guidance measures in Section 6 on how to reduce peat landslide risks.
