# Appendix 12.5

## Protected Vertebrate Survey

## **A9 Dualling - Project 8 Dalwhinnie to Crubenmore**

### Protected Terrestrial Vertebrate Species Survey

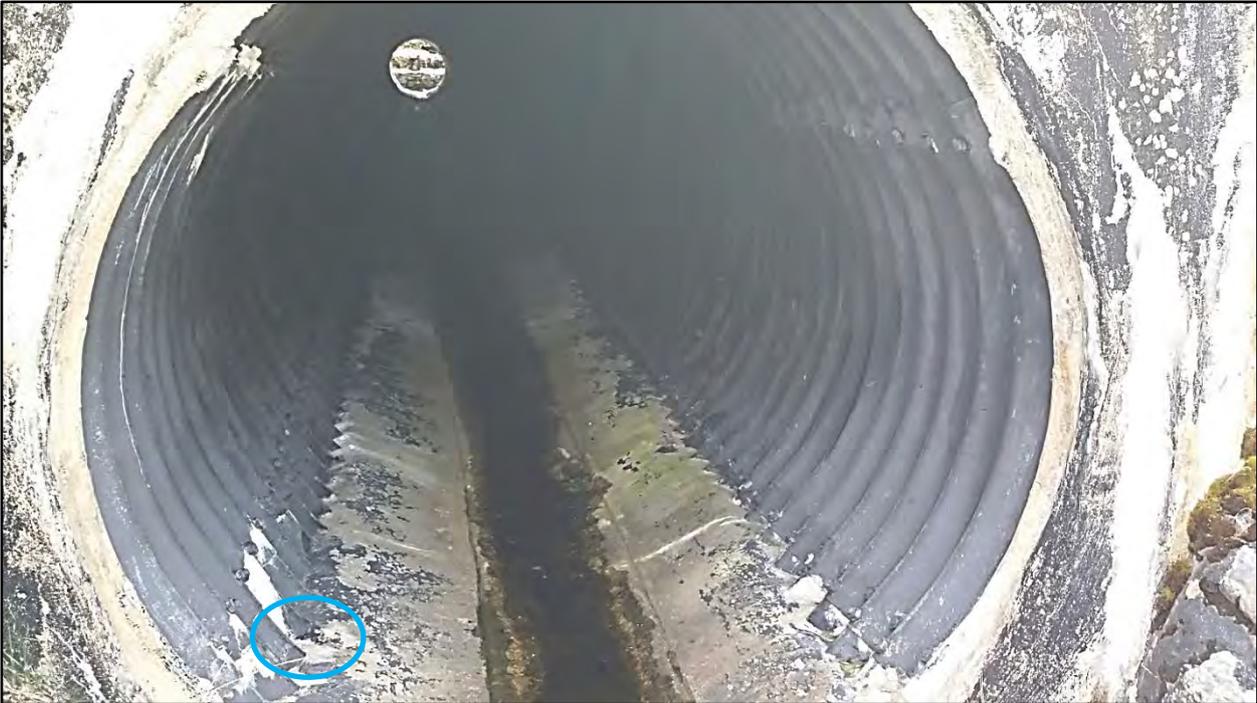
8\_05\_1

the other two at the north end of the survey area, near Crubenmore Bridge at the bankside of the River Truim (O7) and under a small wooden footbridge near the river (O8); these were recent spraints. No signs of otter shelter, either holt, hover or couch, were recorded. More details on the target notes recorded can be found in Appendix 1 and their locations can be found on the Figures in Appendix 2.

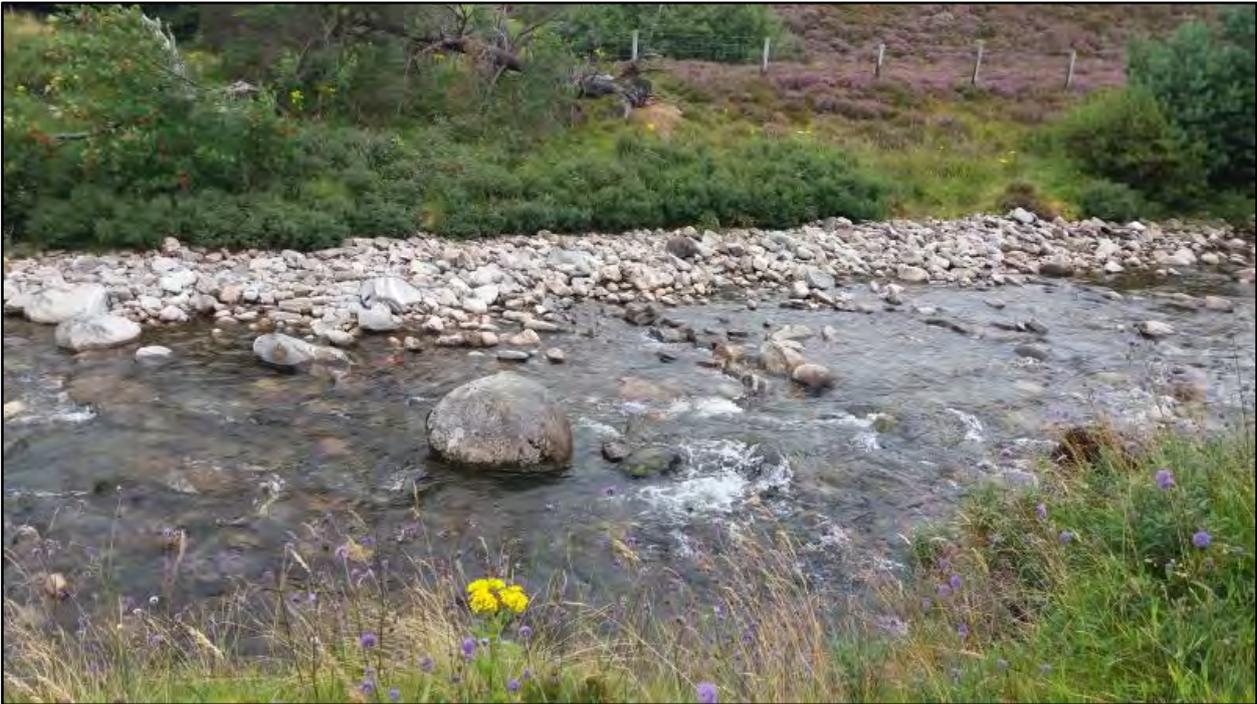
8\_WV1\_11

- 4.10 A number of burrows were observed along the grassy bank adjacent to the aquaduct footbridge (WV1). Some very old, degraded droppings, consistent with water vole, were noted nearby. This reach of the River Truim is not generally suitable for water vole due to shallow riffles and fast flow.

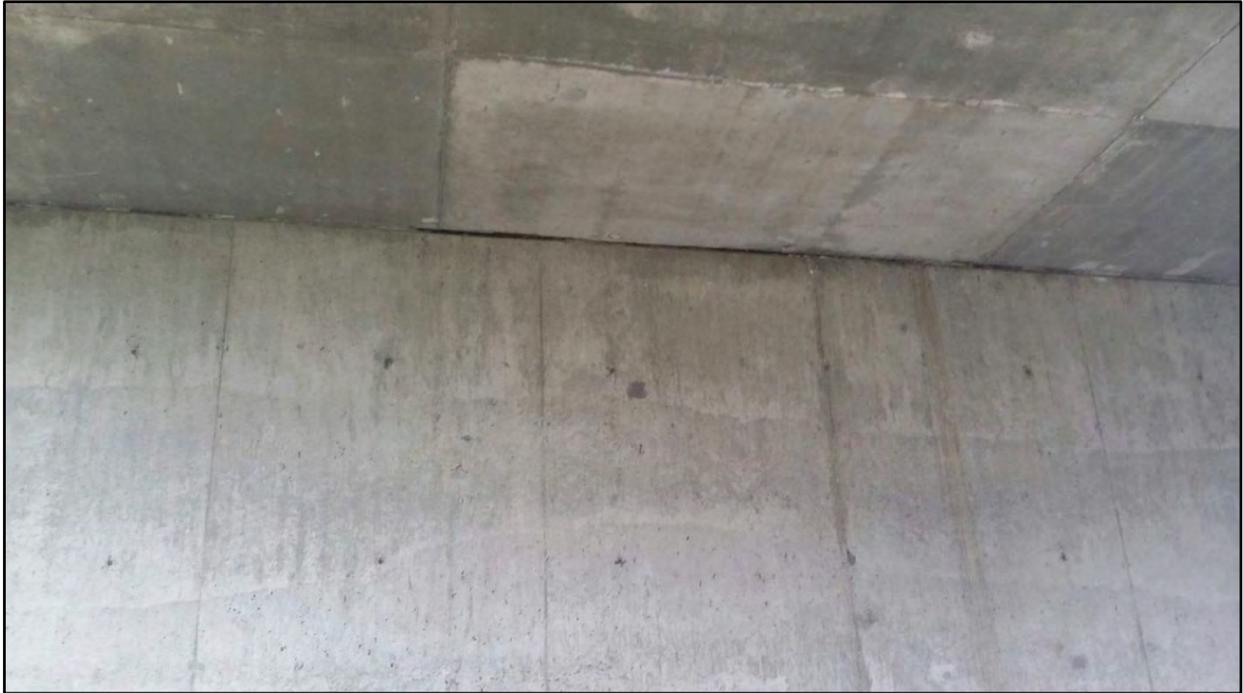
**8\_BT2\_1**

- 4.22 Five other bridge structures and trees with limited BRP were identified during the survey and details on these can be found in Appendices 1 and 2. These other structures are classified as BRP 2 or 3.
