Appendix 10.5

Preliminary Peat Landslide Risk Assessment

- 1.1.1 In support of **Chapter 10 (Volume 1)** of the Design Manual for Roads and Bridges (DMRB) Stage 3 Environmental Impact Assessment (EIA) report, this technical appendix presents a Preliminary Peat Landslide Risk Assessment for Project 7 – Glen Garry to Dalwhinnie of the A9 Dualling Programme, hereafter referred to as the Proposed Scheme.

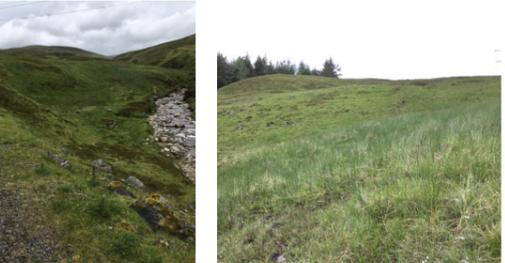
Slope visible in area photograph has an apparent overlap with area of interpolated deep peat, from measurements in basin to right. However, additional on-site measurements indicate peaty soil only therefore	
ch. 450 to ch. 500	Substantial	Approximately 120m east of existing A9 carriageway on right bank of Allt Coire Mhic-Sith, within a more extensive area of moderate risk. Risk driven by presence of shallow and deep peat, steep slopes and proximity to Allt Coire Mhic-Sith.	-

Limited peat cover, but very wet and located upstream of Private Water Supply infrastructure for The Old Schoolhouse, Station Cottages and other properties at Dalnaspidal. Instability due to over steepened slopes caused by fluvial cutting on far bank indicate possibility of failures into channel in area of construction.	The location is mostly within the permanent and temporary works boundaries but mostly outwith the footprint of the proposed earthworks, except for a drainage channel which crosses the area. The slope falls away from the proposed earthworks, so the risk is primarily related to Allt Coire Mhic-Sith. Either the drainage channel should be re-routed around the highest risk area or Allt Coire Mhic-Sith protected with catch fences. However, mitigation measures from potential failure should be considered and re-assessment may be required if forestry is removed. No materials should be stored in this area.

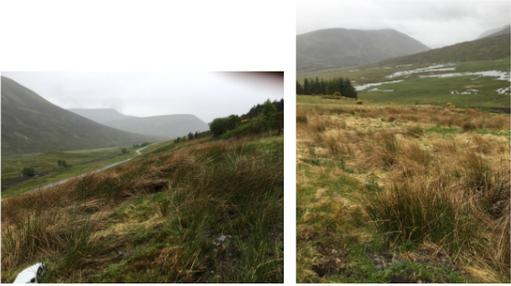
Extensive area between ch. 950 and ch. 1,050. Probing during walkover indicated peat up to 1.65m deep on sloping ground, therefore not a false positive.	Follow general guidance measures in Section 6 on how to reduce peat landslide risks and protect working areas with catch fences.
ch.1,050 to ch.1,100	-	-	Between existing and NCN7 route, falling within footprints of proposed earthworks so will be removed.

Variable peat depths from 0 to 0.88m – treat with caution during construction.	Follow general guidance measures in Section 6 on how to reduce peat landslide risks and consider protection of NCN7 route and watercourse with catch fences during construction.

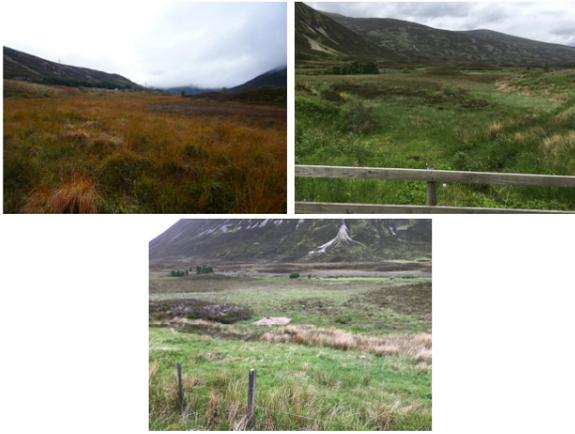
Approx. Chainage	Pre-Mitigation Risk	Semi-Quantitative Assessment	Quantitative Assessment	Area Photographs (CFJV, 2017)	Area Observations (CFJV, 2017)	Risk Mitigation
ch.4,150 to ch. 4,500	-	-	Northwards extension of area identified between ch. 3,900 and ch. 4,150, associated with areas of deep peat. Possible 'false positive' due to behaviour of infinite slope equation where peat is deep, slope angles are shallow and unit weight of material is low.

Very low slope angles but very deep peat. The area of potential in stability picks out basins between elevated ground. Excavation in these areas best avoided/ minimised and watercourses protected from any runout or debris laden run-off.	Follow general guidance measures in Section 6 on how to reduce peat landslide risks. Quantitatively assess stability of specific Proposed Scheme elements in this area for peat stability during detailed design.

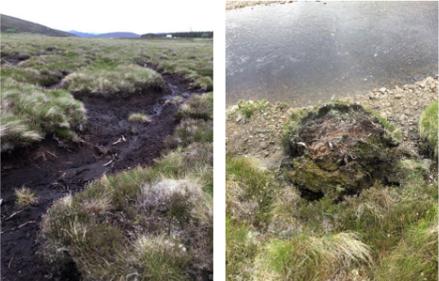
ch. 7,400 to ch. 7,600	Moderate	Multiple, very small in extent areas in the vicinity of the proposed Balsporran-Drumochter Junction. More extensive area nearer to the River Truim, mostly outside of permanent and temporary works.	Multiple, very small areas of potential instability and marginal stability in the vicinity of the proposed Balsporran-Drumochter Junction. More extensive area adjacent to River Truim, mostly outside of the permanent and temporary works boundaries.

Most areas not directly observed. However, photographs show area adjacent to River Truim where erosion on the outside of the meander apex has caused undercutting and toppling of peat blocks. Gullying has also occurred on the upper surface.	Undertake quantitative stability analysis prior to construction and mitigate as required if risk confirmed. If risk is disproved, follow general guidance measures in Section 6 on how to reduce peat landslide risks. If risk proven, protect River Truim from potential runoff and topples of peat blocks at river edge when constructing drainage channels west of the existing A9.

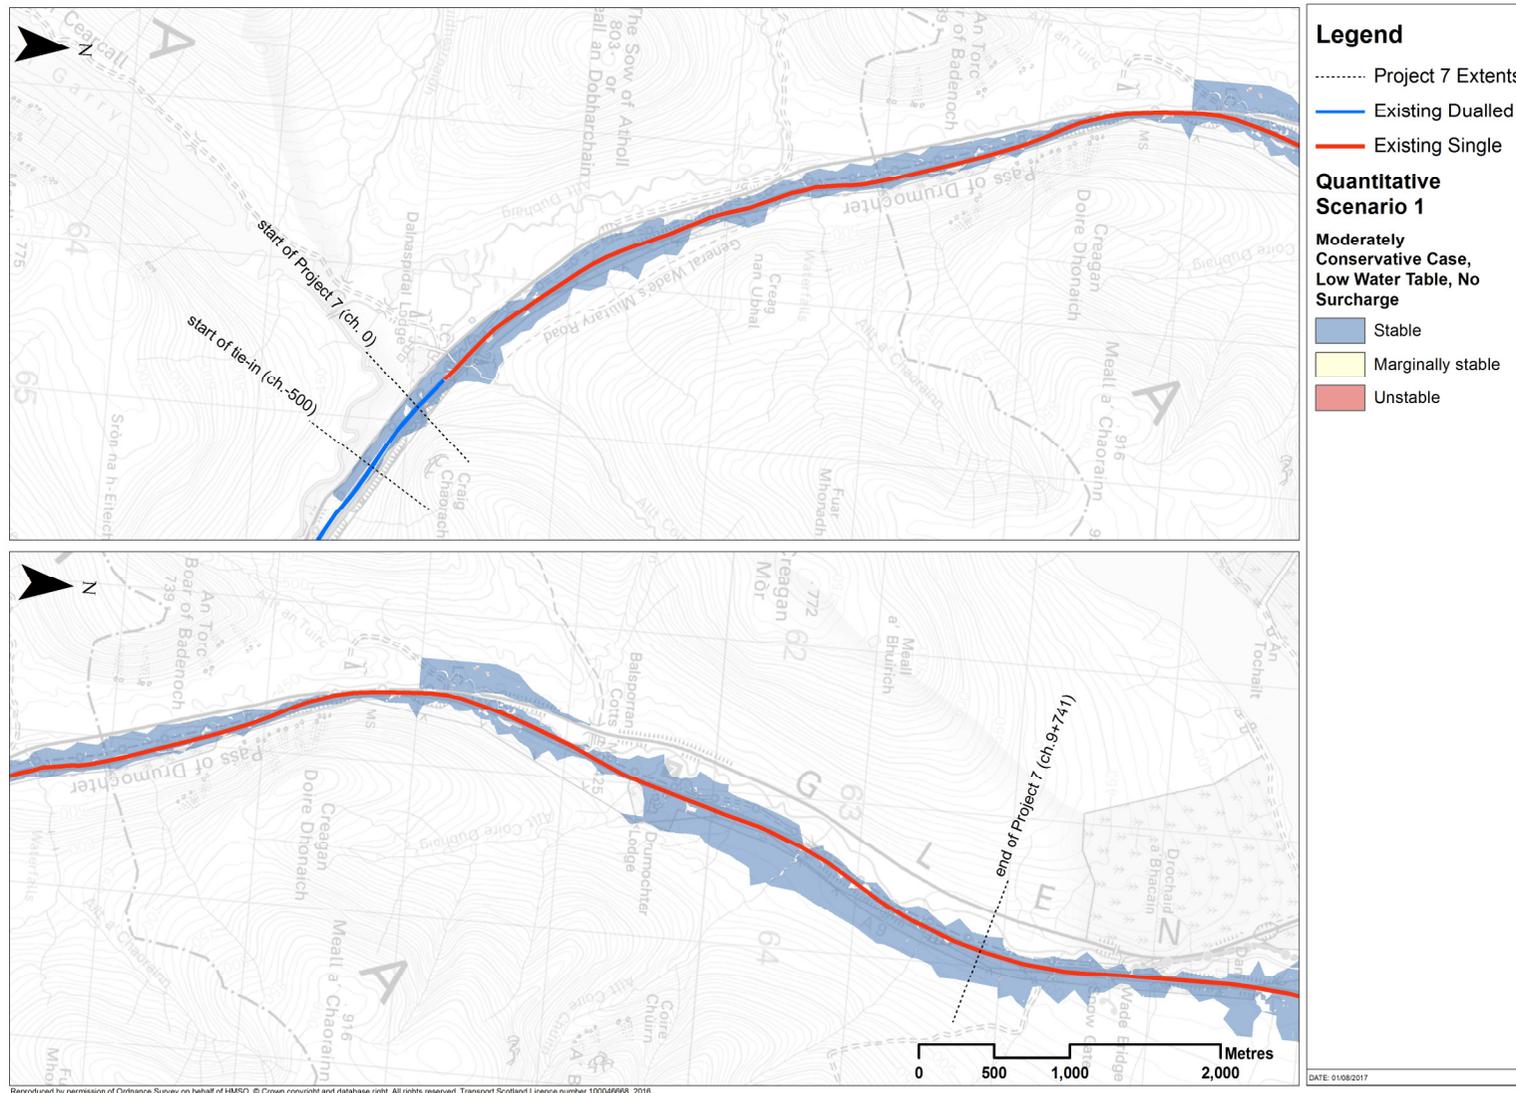
Figure 1: Quantitative Stability Assessment Scenario 1; Moderately Conservative Case, Low Water Table, No Surcharge

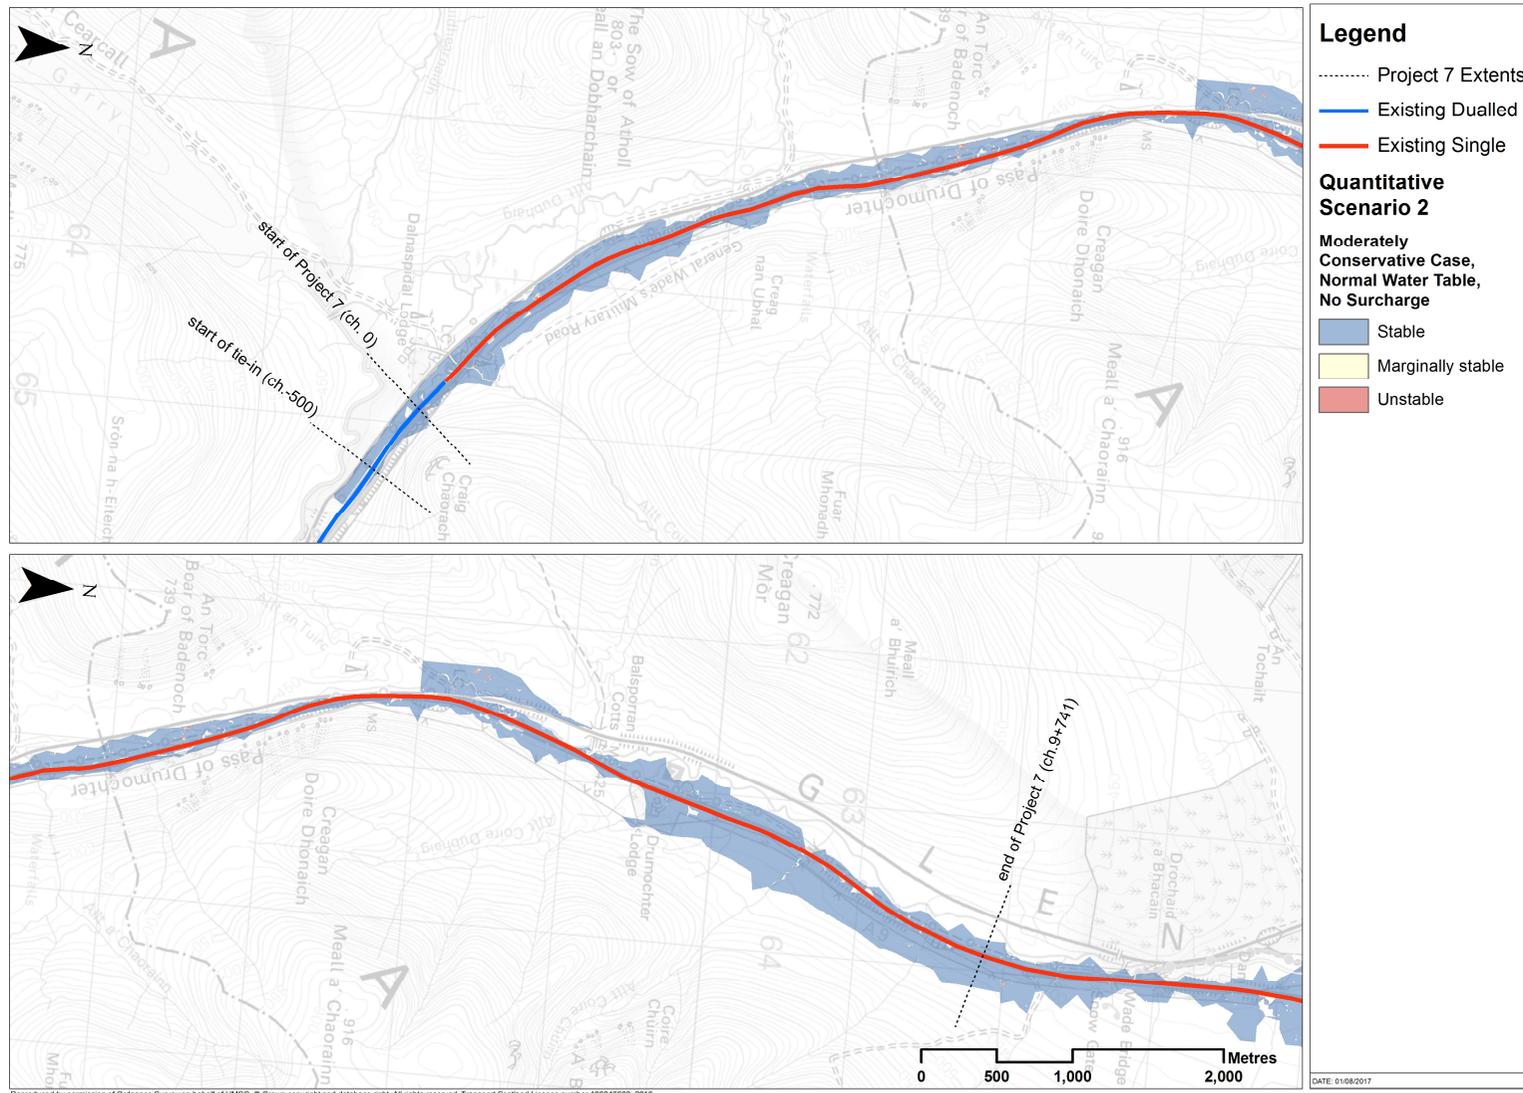
Figure 2: Quantitative Stability Assessment Scenario 2; Moderately Conservative Case, Normal Water Table, No Surcharge

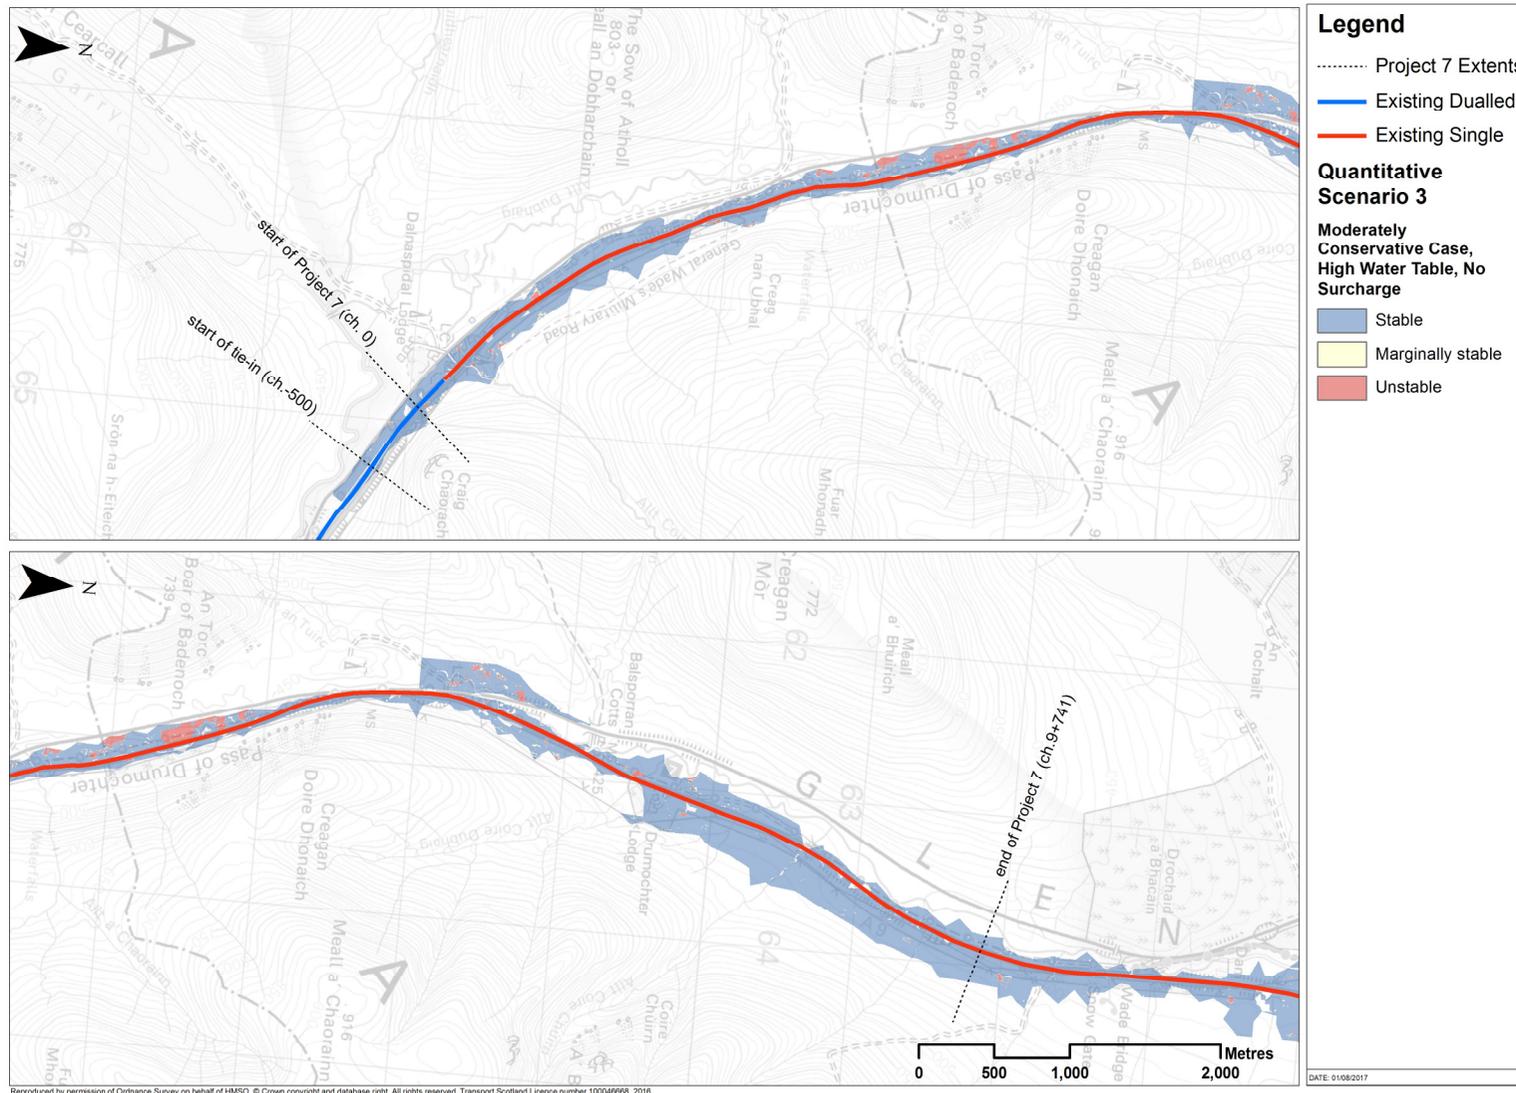
Figure 3: Quantitative Stability Assessment Scenario 2; Moderately Conservative Case, High Water Table, No Surcharge

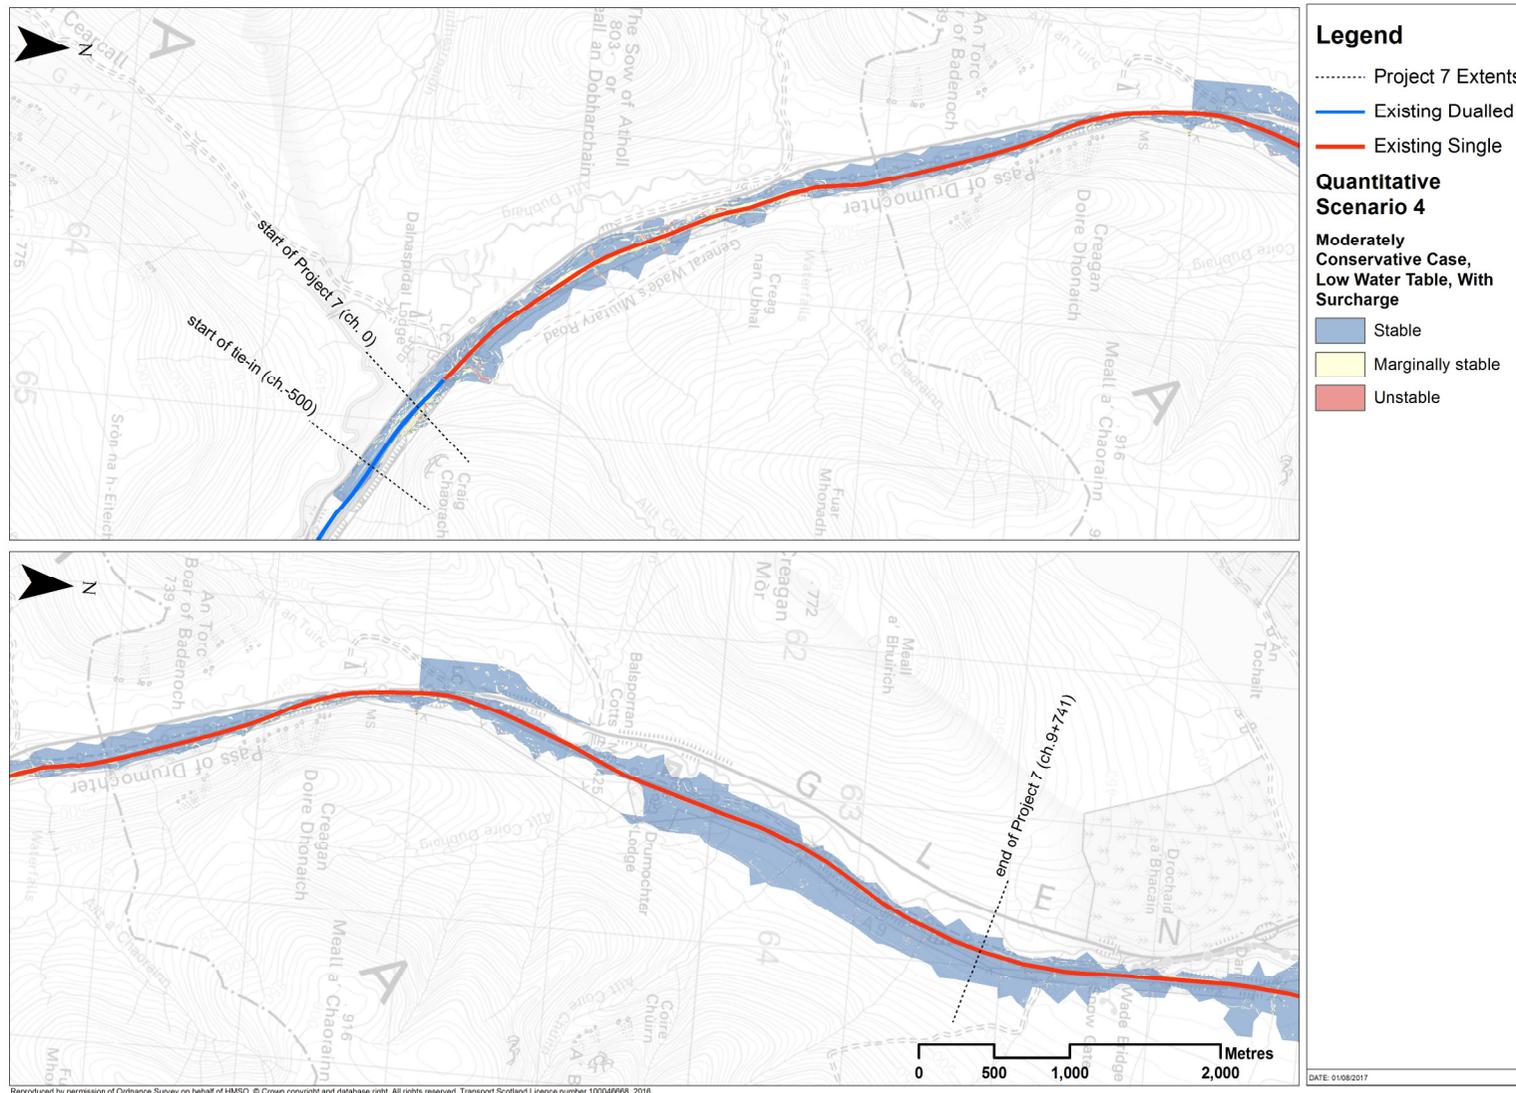
Figure 4: Quantitative Stability Assessment Scenario 4; Moderately Conservative Case, Low Water Table, With Surcharge

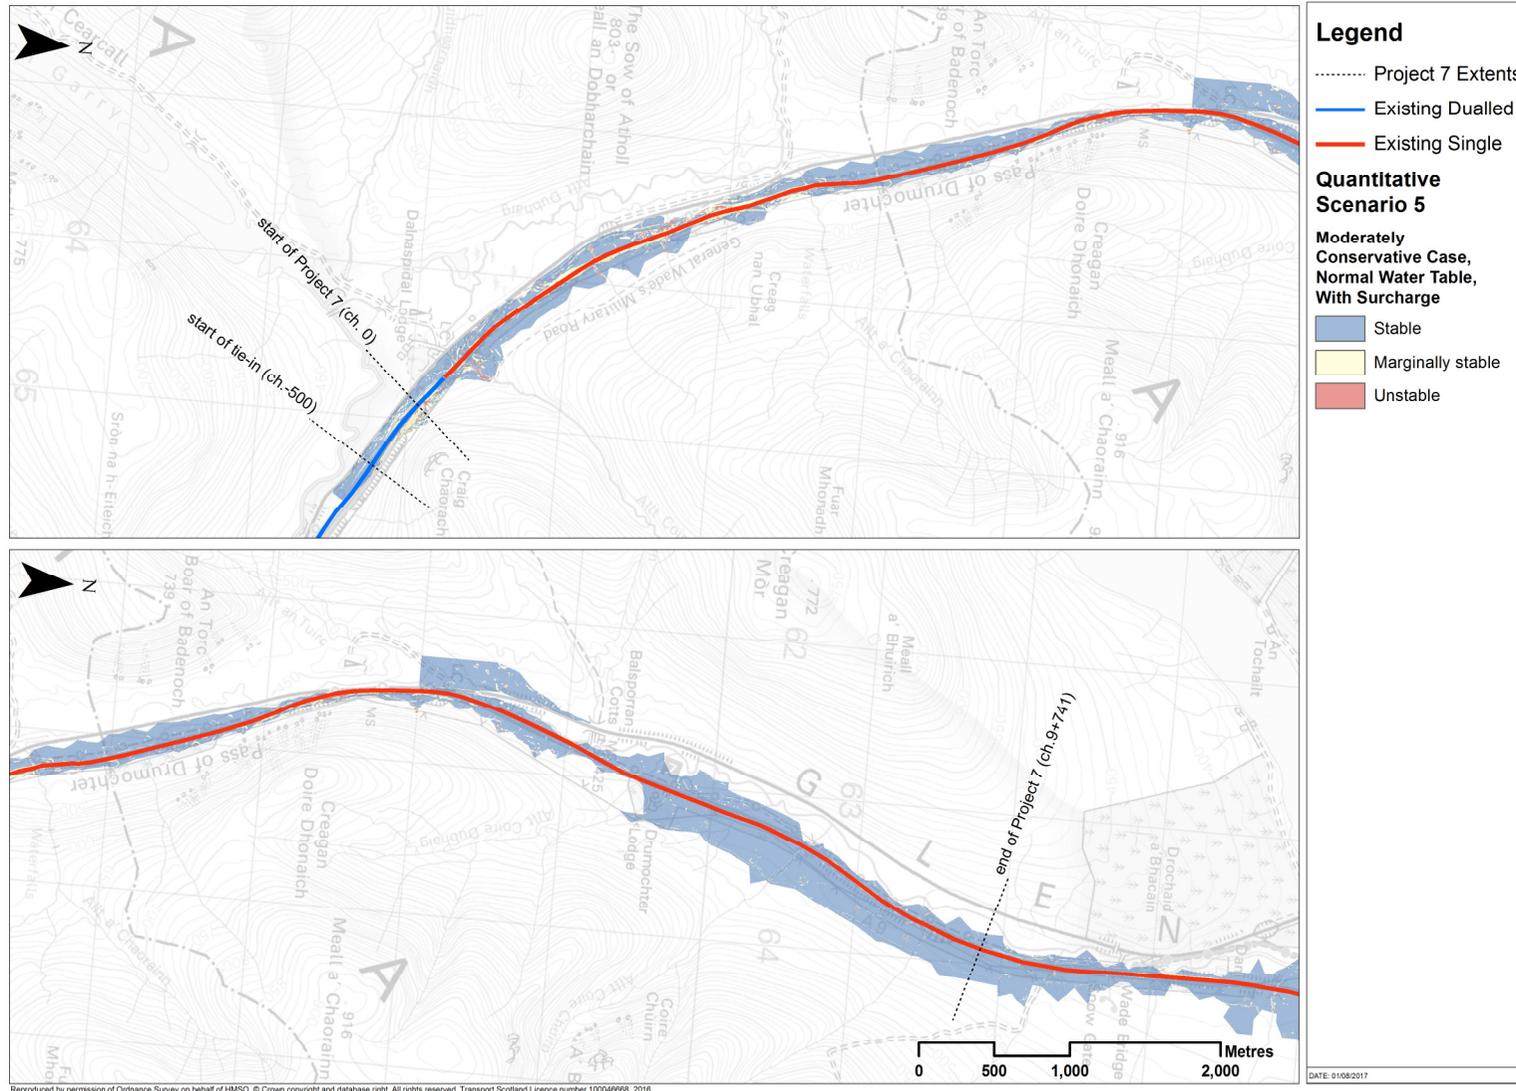
Figure 5: Quantitative Stability Assessment Scenario 5; Moderately Conservative Case, Normal Water Table, With Surcharge

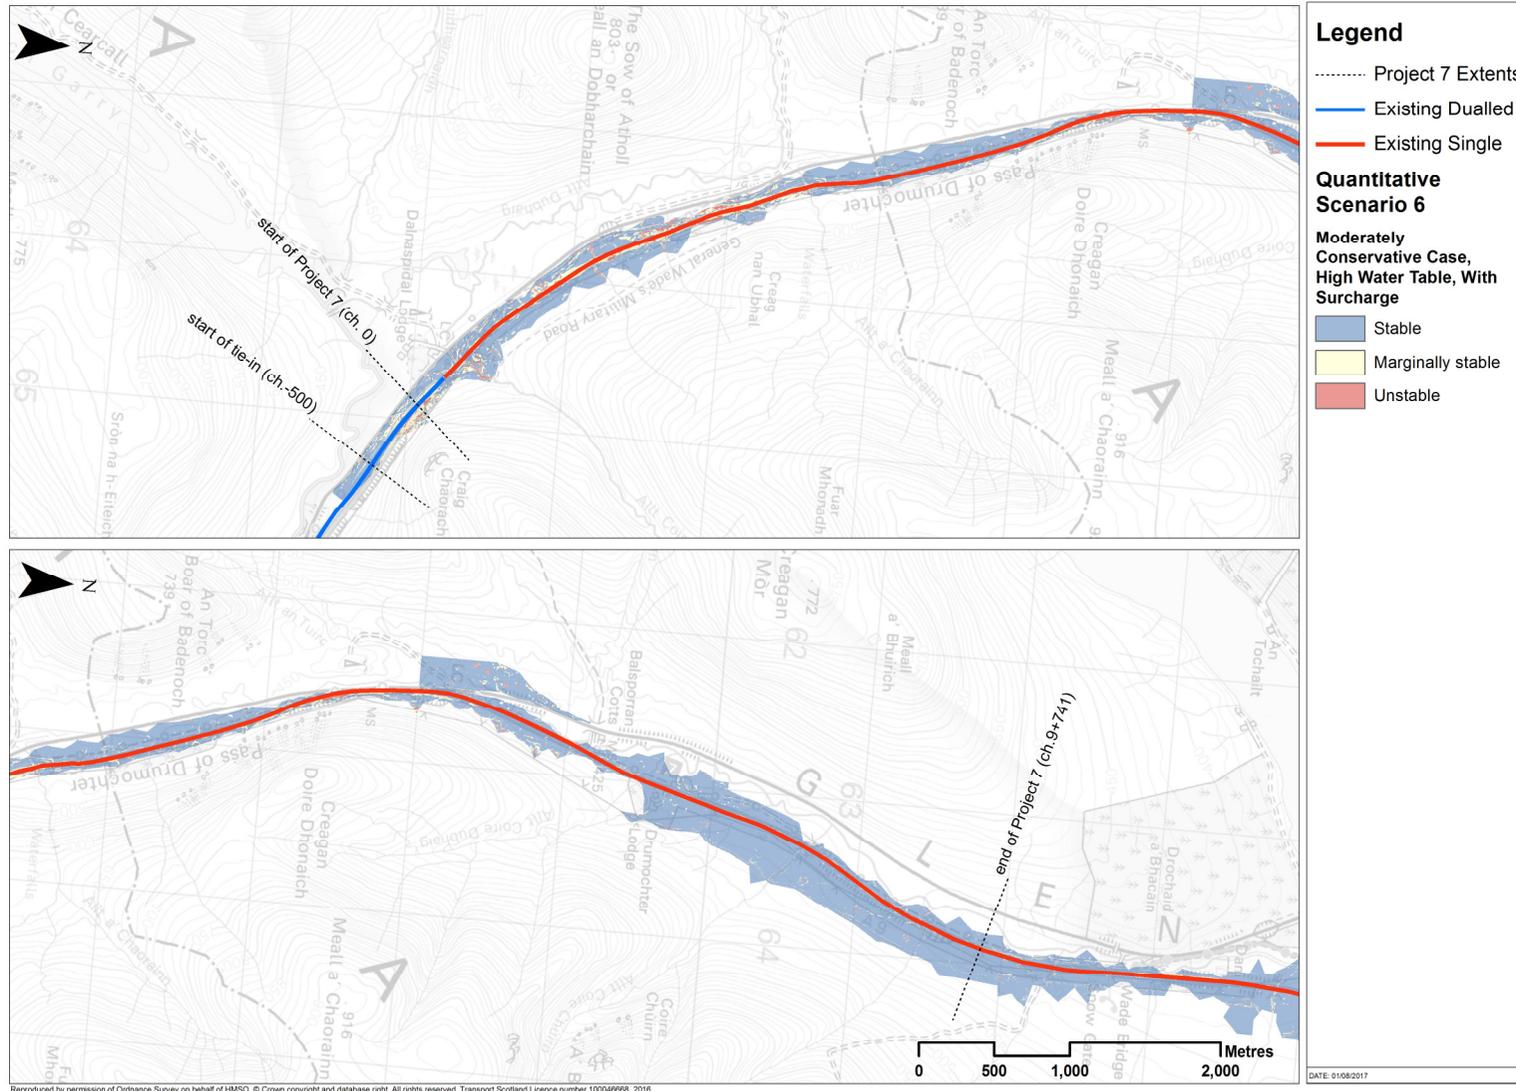
Figure 6: Quantitative Stability Assessment Scenario 6; Moderately Conservative Case, High Water Table, With Surcharge

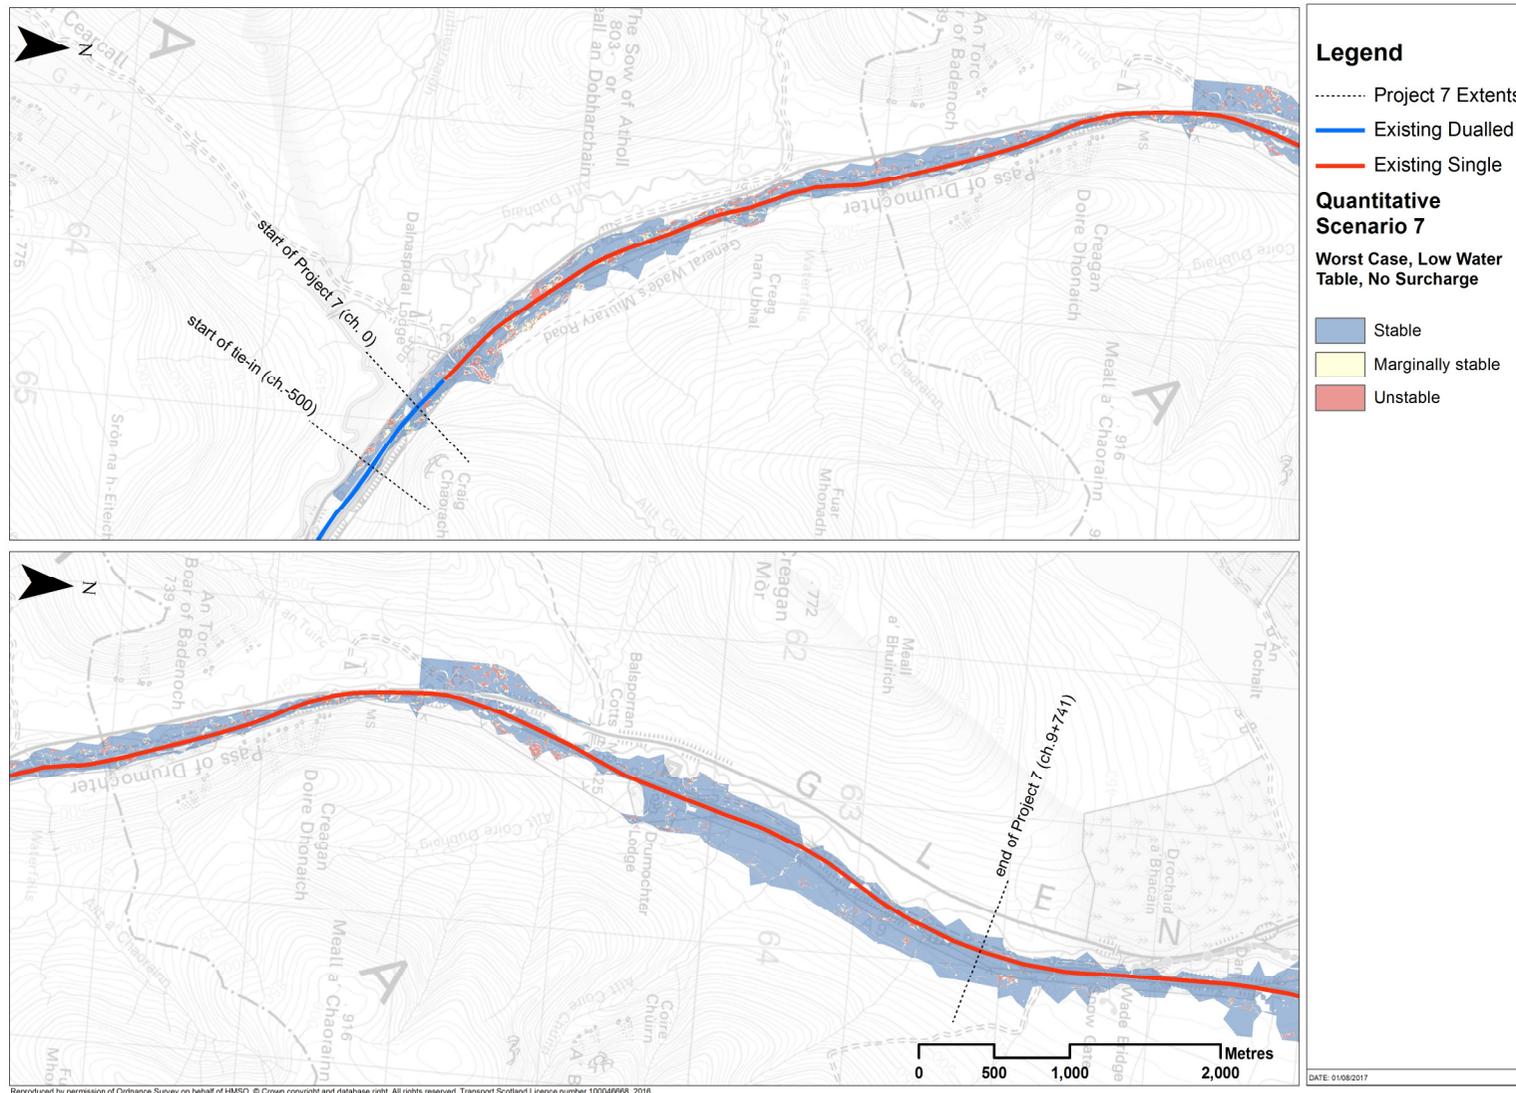
Figure 7: Quantitative Stability Assessment Scenario 7; Worst Case, Low Water Table, No Surcharge

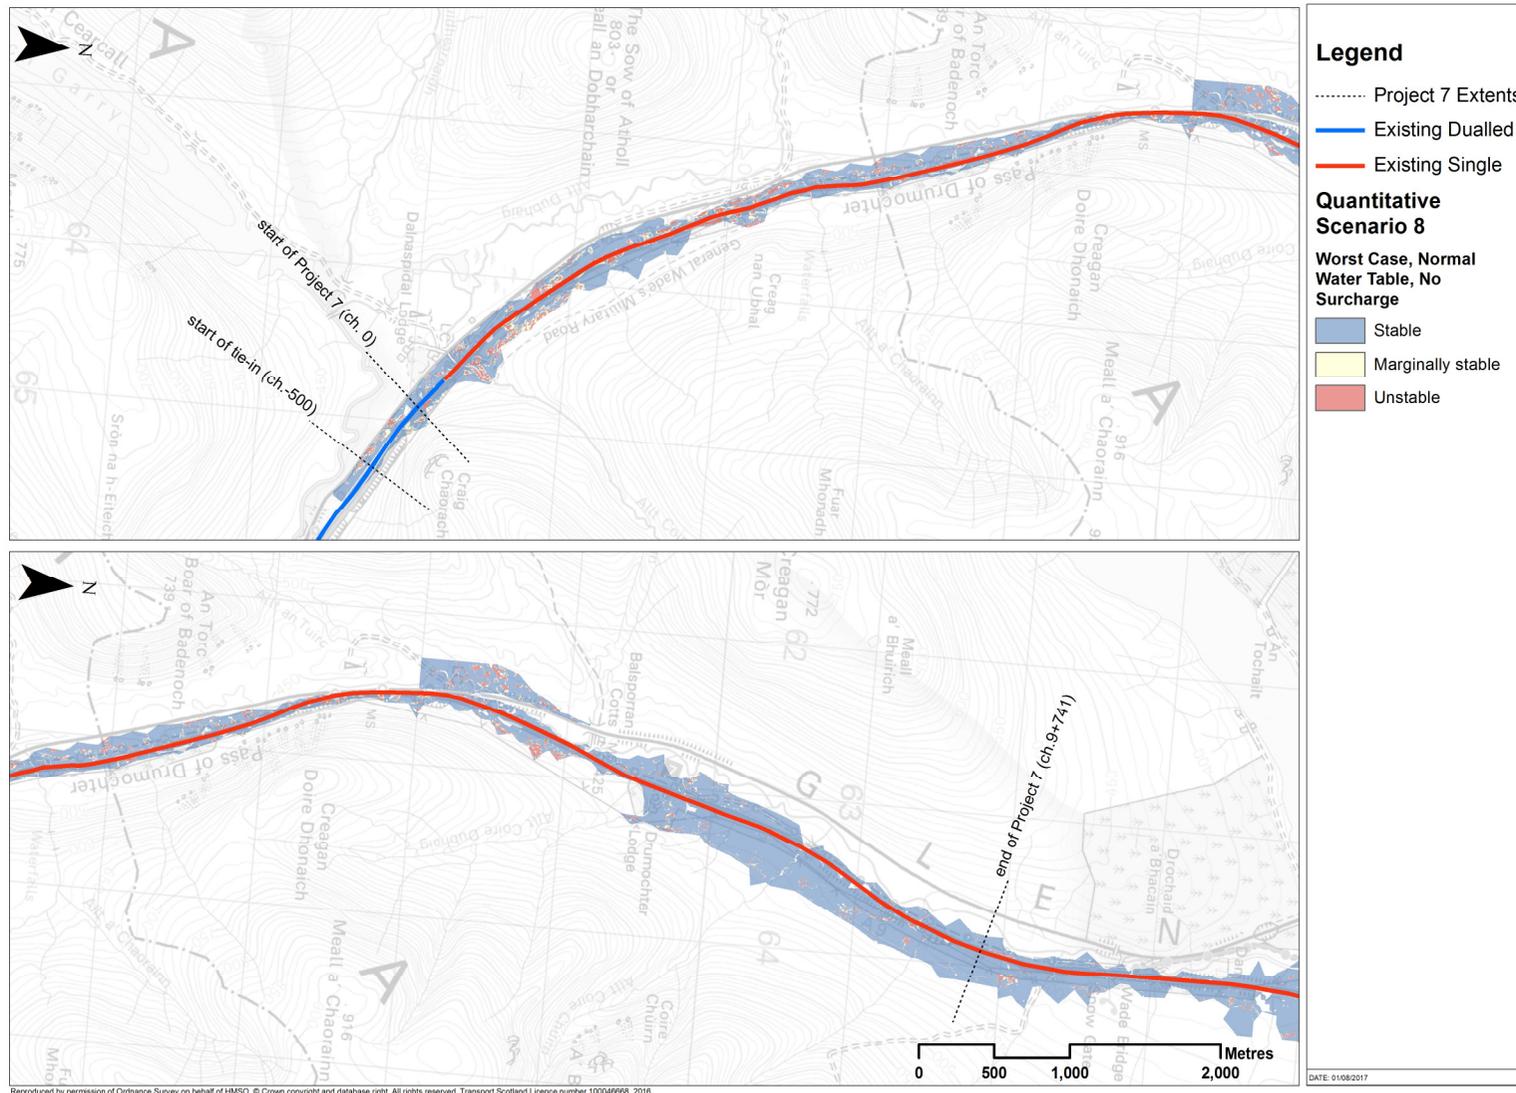
Figure 8: Quantitative Stability Assessment Scenario 8; Worst Case, Normal Water Table, No Surcharge

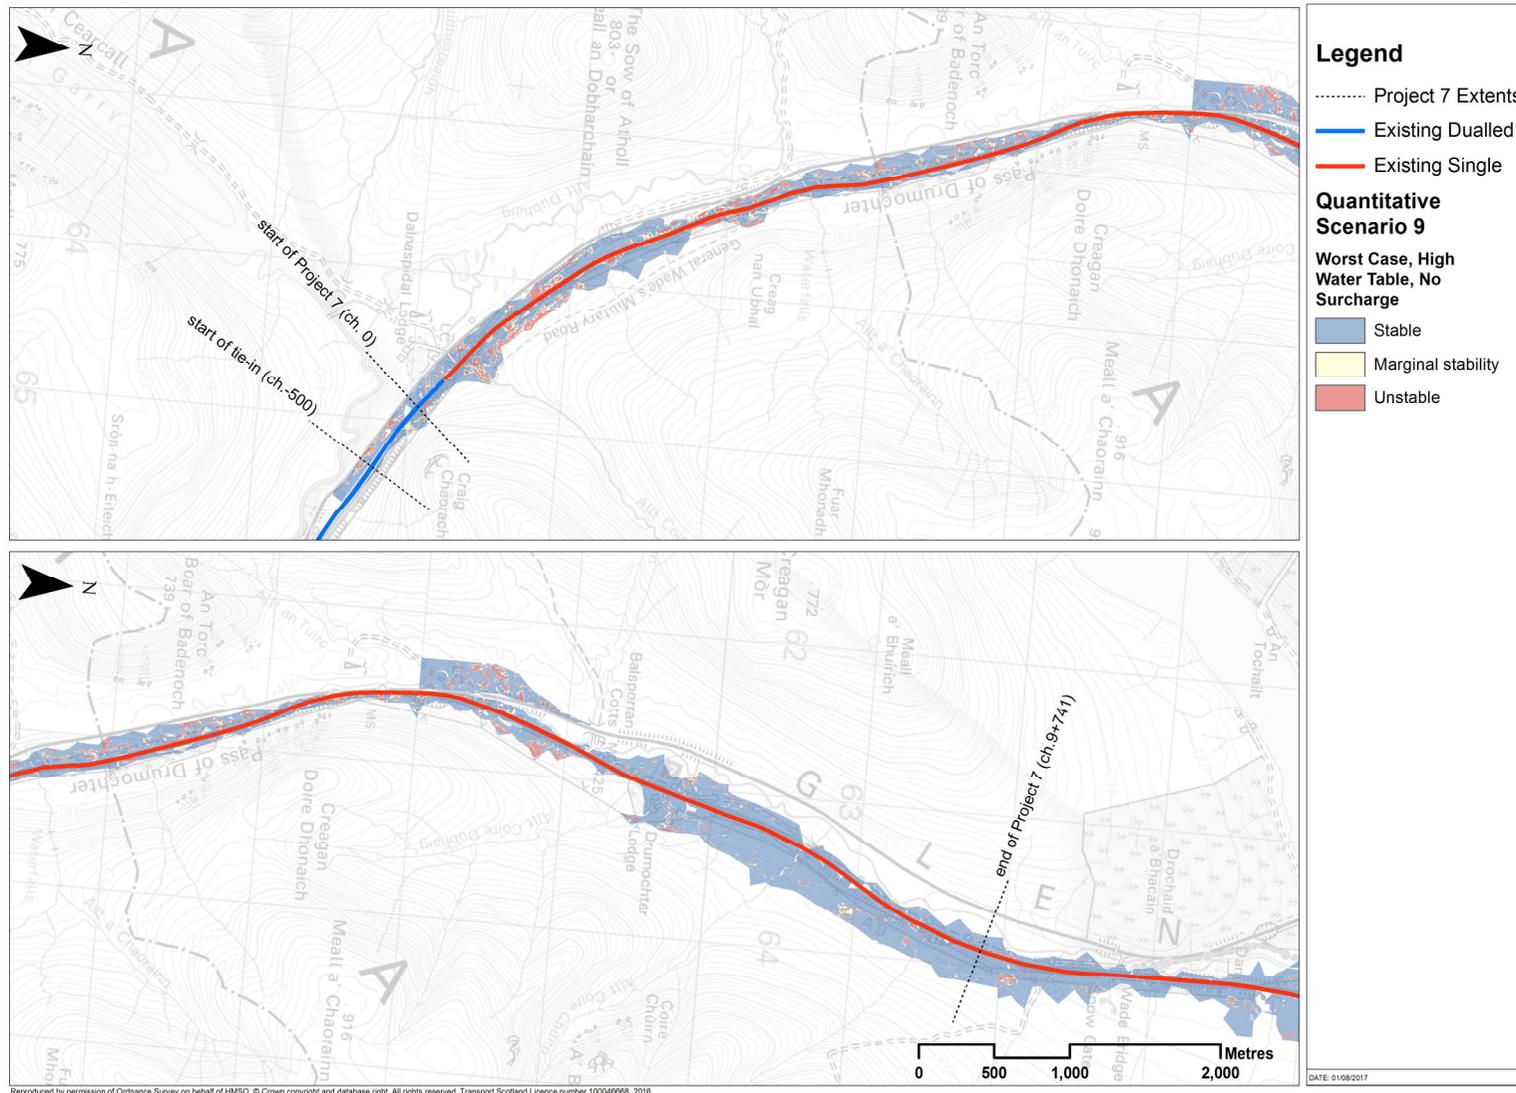
Figure 9: Quantitative Stability Assessment Scenario 9; Worst Case, High Water Table, No Surcharge

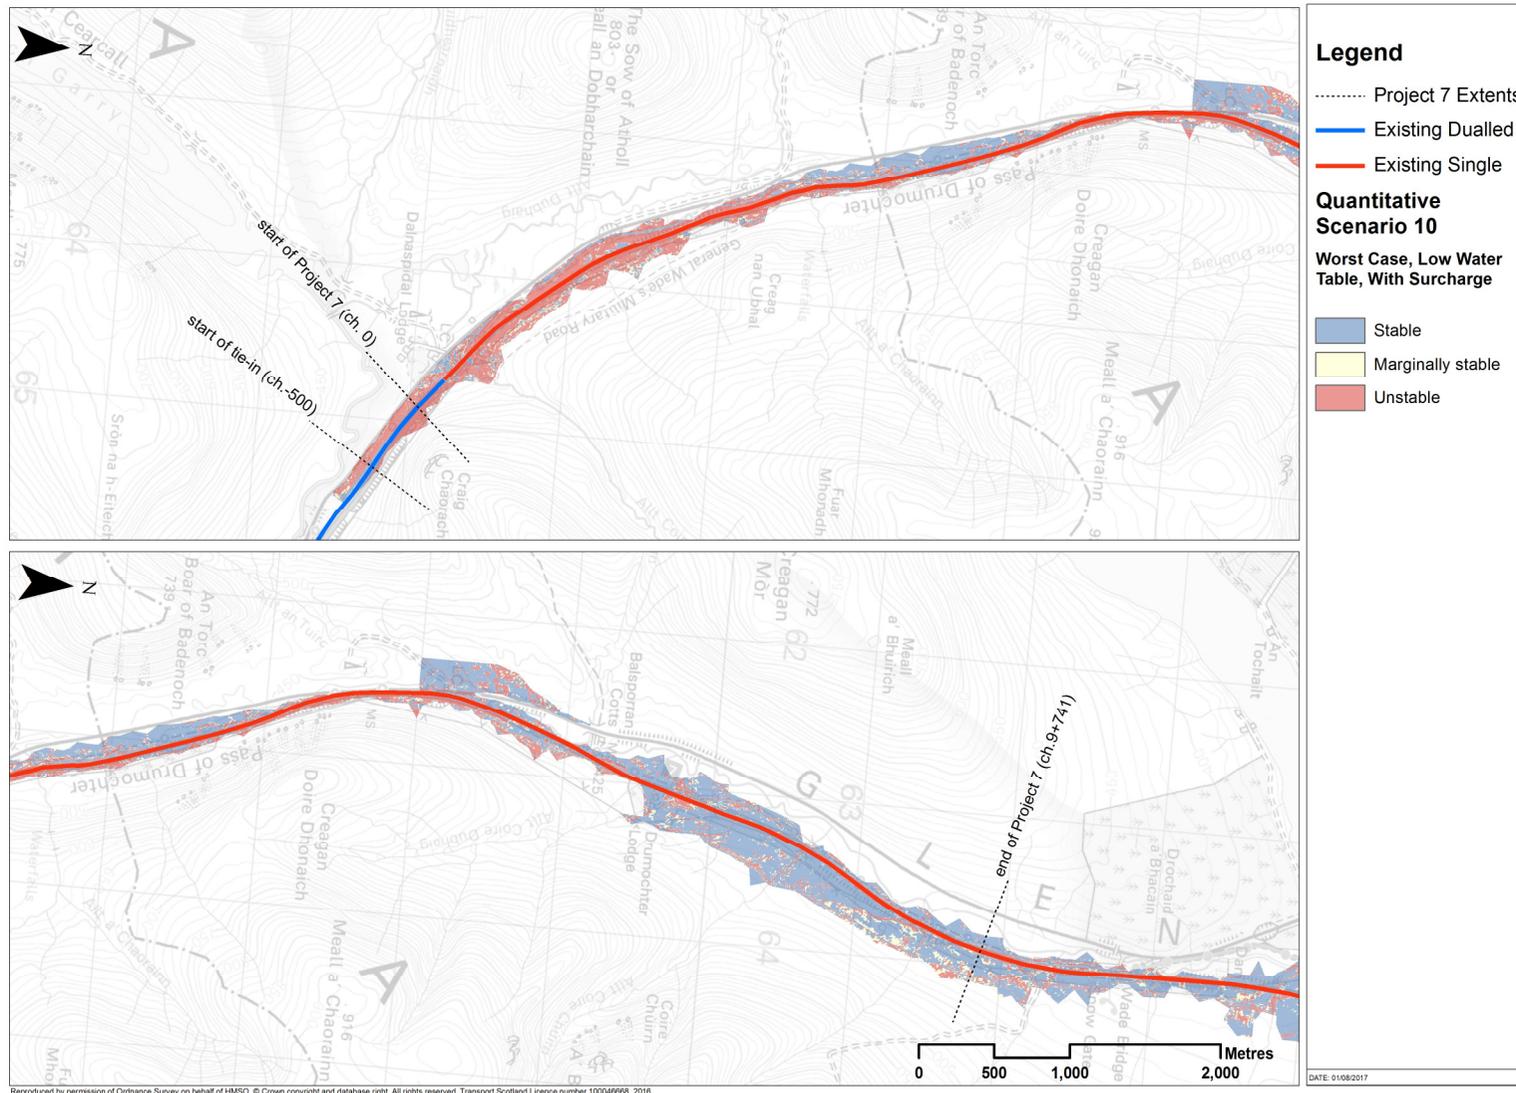
Figure 10: Quantitative Stability Assessment Scenario 10; Worst Case, Low Water Table, With Surcharge

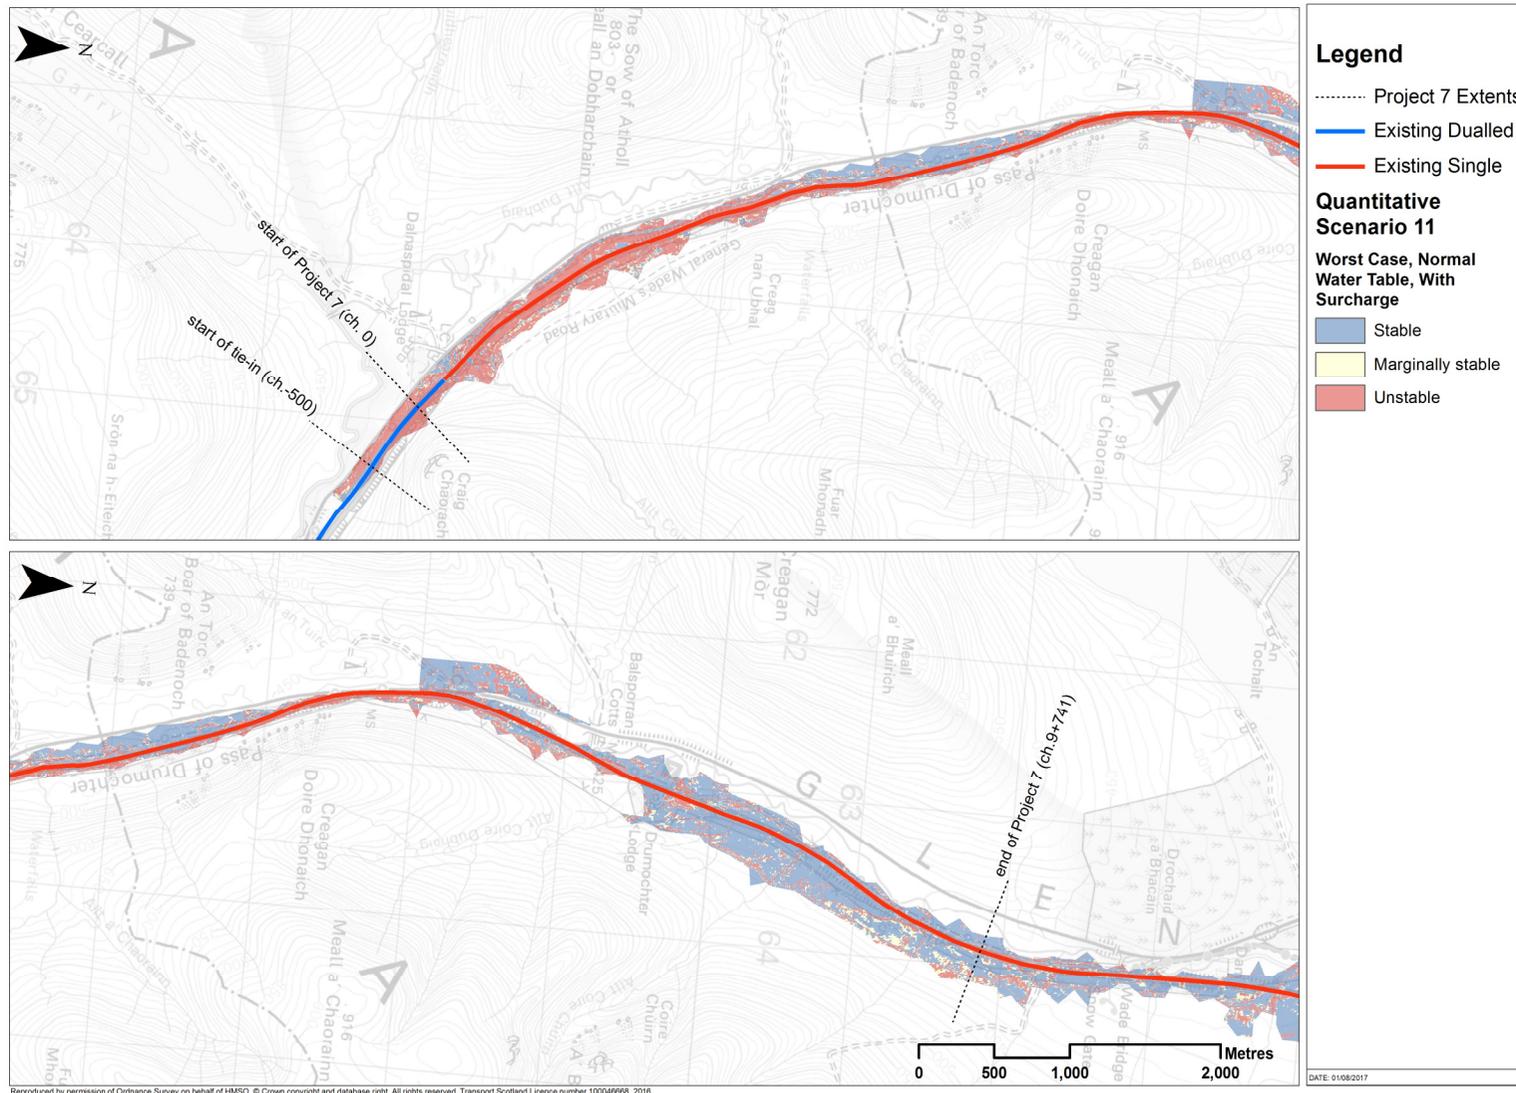
Figure 11: Quantitative Stability Assessment Scenario 11; Worst Case, Normal Water Table, With Surcharge

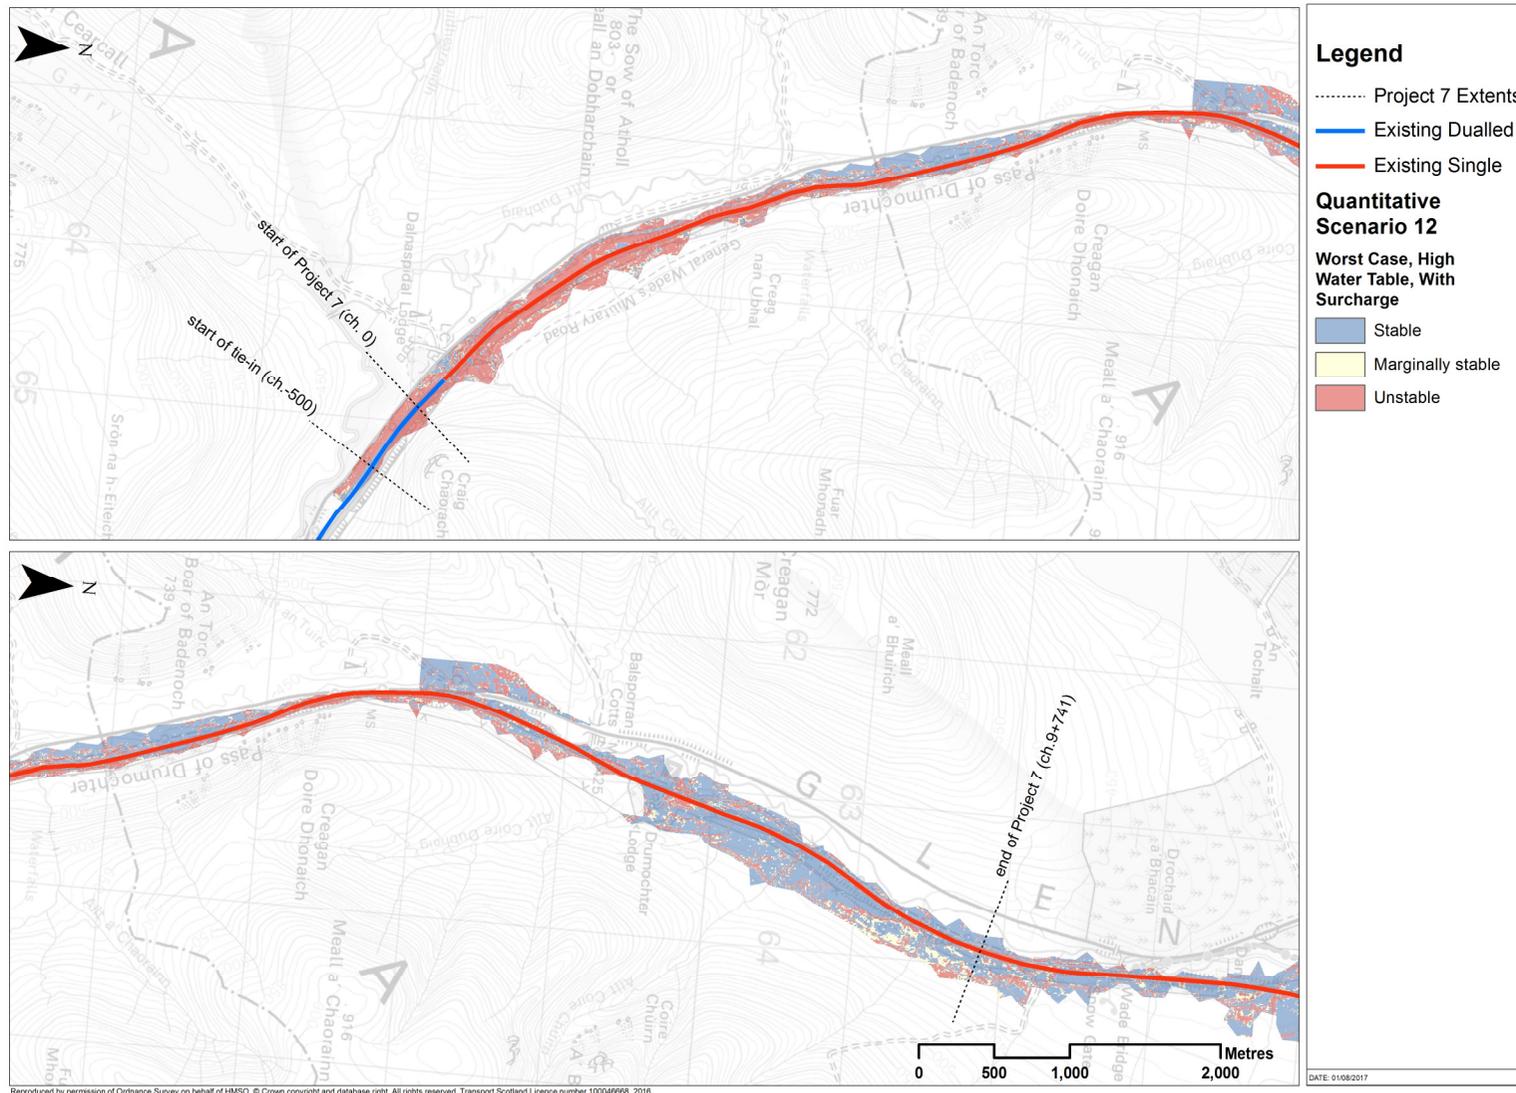
Figure 12: Quantitative Stability Assessment Scenario 12; Worst Case, High Water Table, With Surcharge
