Appendix 12.7

Fish Habitat Assessment

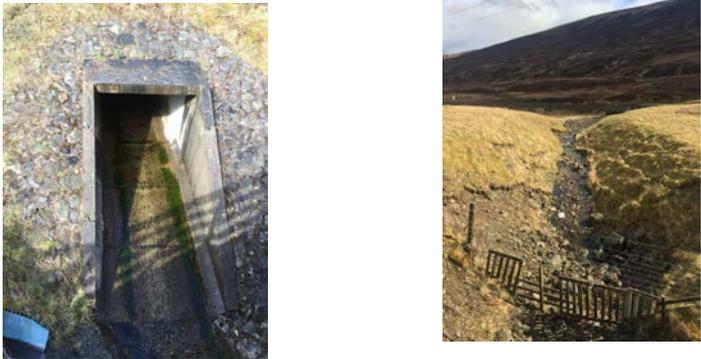
Table 4-1: Allt Chaorach Beag fish habitat assessment

Watercourse: Allt Chaorach Beag		Hydro ID: N/A Southern tie in	Chainage: N/A -800	Catchment: Tay	
Upstream		Comments	Downstream		Comments
Channel width		No upstream assessment undertaken due to extensive box culvert considered prohibitive to upstream fish movement and no works noted to crossing or upstream sections.	Channel width	1-2m	Watercourse flows through steep box culvert for 70m. Opportunities for upstream fish migration are limited. Some evidence of erosion on channel sides Plane bed morphology Shallow glide
Channel depth:			Channel depth:	100 – 150mm	
Substrate:			Substrate:	Cobble dominant with boulders, coarse gravel present	
Gradient:			Gradient:	5-10°	
Bank structure/vegetation:			Bank structure/vegetation:	Steep banksides (30°) dominated by gramminoids	
Barriers Y/ N			Barriers Y/ N	Y	
No Upstream assessment

<p>Overview of suitability for fish</p> <p>The upstream section is separated from downstream by an existing culvert 70m in length where water flows are spread in a shallow current across a flat concrete invert and is considered to represent a barrier to fish access. Downstream the channel appears that it may have been straightened previously and lacks pool/riffle structure, although does support suitable substrates for spawning fish. Discharge of road drainage into downstream section may mean that the watercourse is suboptimal due to water quality. During high flows, there is a risk of wash out as water will accelerate through existing culvert.</p>

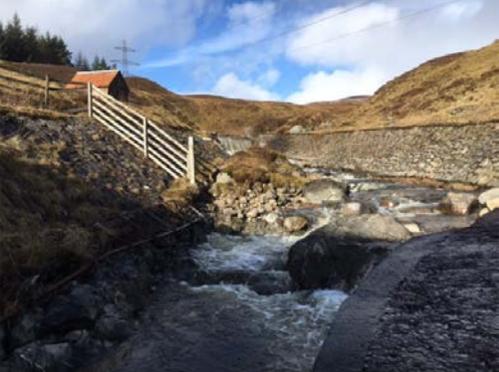
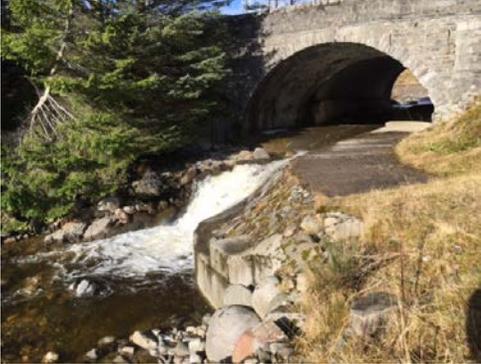
Table 4-2: Allt Coire Mhic-sith fish habitat assessment

Watercourse: Allt Coire Mhic-sith		Hydro ID: 2	Chainage: 400	Catchment: Tay	
Upstream		Comments	Downstream		Comments
Channel width	3-4m	High velocity watercourse heavily modified upstream of culvert structure including a weir >2m in height c 40 upstream of the crossing. Cascade morphology. No fish of any age observed	Channel width	3-4m	Channel appears to have been modified previously. Large step feature downstream of existing arch culvert. Through the culvert, water depth is low <100mm and fast flowing across flat concrete invert, in normal flows may prohibit fish passage. Plane bed/ morphology – deep glide downstream.
Channel depth:	Max 500mm typically 150 – 300mm		Channel depth:	500mm+ deep pool downstream of existing structure	
Substrate:	Bedrock and boulders/ isolated gravel deposits		Substrate:	Boulders dominant boulders – cobbles further downstream	
Gradient:	>10°		Gradient:	Gradient: <10°

Bank structure/ vegetation:	Engineered banks		Bank structure/ vegetation:	Coniferous plantation to north grassland and scrub to south	
Barriers Y/ N	Y		Barriers Y/ N	Y	
Photograph Upstream:			Photograph Downstream:

<p>Overview of suitability for fish:</p> <p>The Allt Coire Mhic-sith falls off steep ground to the east and generally supports good flows of water at relatively high velocity. Substrates are generally unsuitable for spawning fish comprising of bedrock and boulders, though more cobbles are present further downstream. Barriers to fish movement are present at the downstream end of the culvert and the shallow rapid flow across the culvert base may inhibit movement. A significant weir is also present c 40m upstream of the existing structure. Some deeper pools are present downstream which may present opportunities for rest/ shelter of adult or juvenile fish.</p>

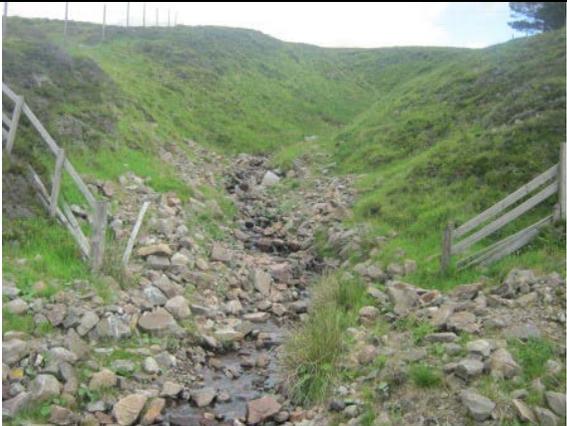
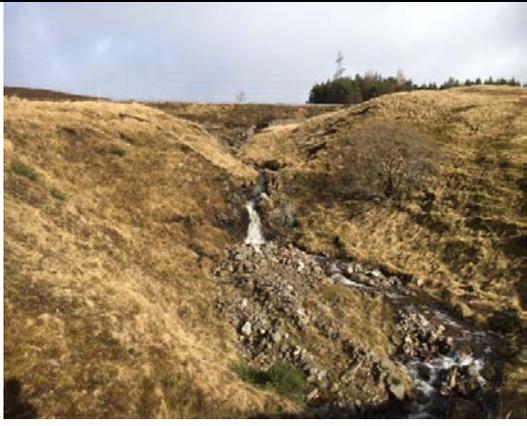
Table 4-3: Allt Ruidh nan Sgoilearan fish habitat assessment

Watercourse: Allt Ruidh nan Sgoilearan		Hydro ID:8	Chainage: 1,500	Catchment: Tay	
Upstream		Comments	Downstream		Comments
Channel width	1m	Watercourse descends under existing road through a steep pipe culvert (30°) which is considered impassable to fish. Cascade morphology No fish of any age observed	Channel width	1m	Downstream of culvert is a small weir and control structure. At and downstream of the control are significant areas of construction debris. Cascade morphology No fish of any age observed
Channel depth:	100 – 200mm		Channel depth:	100 – 200mm	
Substrate:	Mix of bedrock boulders and cobbles		Substrate:	Bedrock and cobbles dominant. Step features present around bedrock outcrops.	
Gradient:	15°		Gradient:	>15° with further vertical step features	
Bank structure/vegetation:	Steep 45° banksides vegetated with acid grassland and dry heath.		Bank structure/vegetation:	Steep banksides (45°). Acid grassland.

Barriers Y/ N	Y		Barriers Y/ N	Y	
Photograph Upstream:			Photograph Downstream:

<p>Overview of suitability for fish: Lack of pool/ riffle structure and steep gradient both upstream and downstream makes the watercourse largely unsuitable for fish spawning. Upstream is generally inaccessible due to the steep and stepped nature of the downstream course and the steep set pipe culvert under the existing road. The watercourse is highly unlikely to support spawning salmon or lamprey or other lifestages for those species.</p>

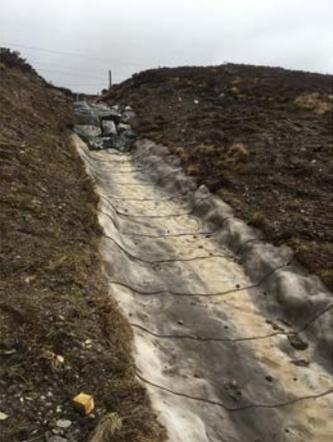
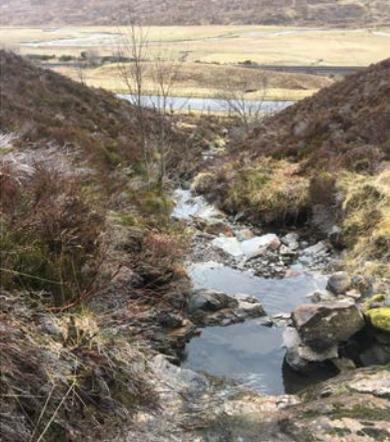
Table 4-4: Unnamed watercourse Hydro ID 12 fish habitat assessment

Watercourse: Unnamed watercourse		Hydro ID: 12	Chainage: 1,875	Catchment: Tay	
Upstream		Comments	Downstream		Comments
Channel width	1.5m	Recently restored lined channel with geotextile panels on a steep section leading down to the existing road. At the base of the lined channel is a vertical drop of 1.5m before the watercourse enters a concrete pipe culvert. Fine sediment build up following recent restoration works.	Channel width	1 m	20m downstream is a 3m vertical drop over a bedrock outcrop, further cascade features continue downstream to NCN7 route. Presence of steep vertical outcrops and absence of 'rest pools' are considered to mean the watercourse is not accessible to salmon or lamprey. Cascade morphology
Channel depth:	>50mm		Channel depth:	Typically, less than 150mm	
Substrate:	Geotextile lined channel		Substrate:	Bedrock with cobbles and occasional boulder	
Gradient:	>15°		Gradient:	>15°

Bank structure/vegetation:	Lined channel recently disturbed grassland outside main channel		Bank structure/vegetation:	Steep banksides vegetated with dry heath	
Barriers Y/ N	Y		Barriers Y/ N	Y	
Photograph Upstream:			Photograph Downstream:

<p>Overview of suitability for fish: Substrate and watercourse structure (steep cascade) are considered unsuitable spawning salmon or sea lamprey and other life stages.</p>

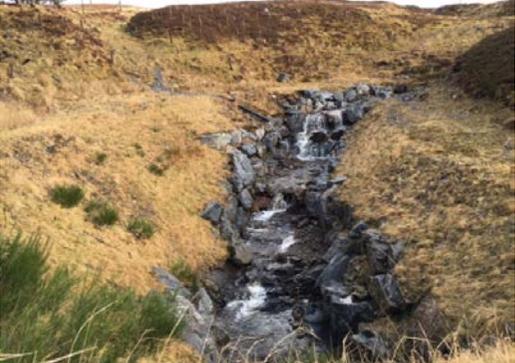
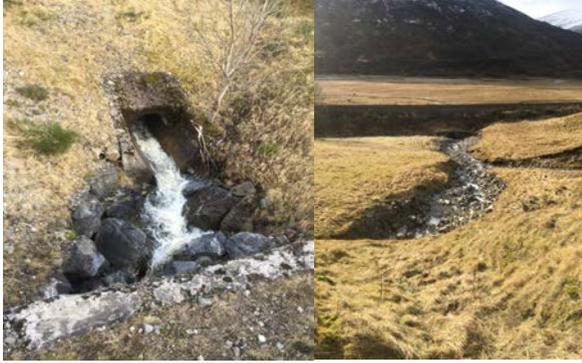
Table 4-5: Allt Fuar Bheann fish habitat assessment

Watercourse: Allt Fuar Bheann		Hydro ID: 13	Chainage: 2,000	Catchment: Tay	
Upstream		Comments	Downstream		Comments
Channel width	1-2m	Recently engineered (naturalised channel). Series of step features though no significant pools. Cascade morphology No fish of any species/ age observed	Channel width	1-2m	Steep section of culverted watercourse which it emerges for a short time between A9 and NCN7 Absence of any notable deep pools Cascade morphology No fish of any species/ age observed
Channel depth:	100 – 250mm		Channel depth:	100-200mm	
Substrate:	Bedrock (artificial) cobbles/ gravels.		Substrate:	Bedrock dominated with some cobble/ gravel.	
Gradient:	15° some steep vertical sections present.		Gradient:	>10°	
Bank structure/ vegetation:	Near vertical rock walls, re-establishing grassland		Bank structure/ vegetation:	Banksides eroded, acid grassland present where vegetated.	
Barriers Y/ N	Y		Barriers Y/ N	Y

Photograph Upstream:			Photographs Downstream:

<p>Overview of suitability for fish: Lack of pool/riffle structure and steep gradient both upstream and downstream makes the watercourse largely unsuitable for fish spawning. Upstream is generally inaccessible due to the steep and stepped nature of the downstream course and the steep set pipe culvert under the existing road, similarly the upstream section is inaccessible due to the stepped nature of the watercourse which lacks rest/ acceleration pools to enable passage. The watercourse is highly unlikely to support spawning salmon or lamprey or other lifestages for those species.</p>

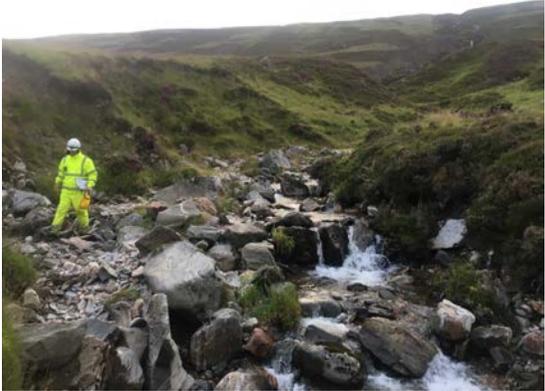
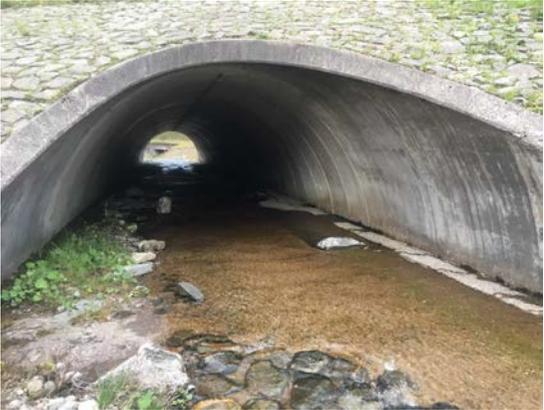
Table 4-6: Allt a' Chaorainn fish habitat assessment

Watercourse: Allt a' Chaorainn		Hydro ID: 23	Chainage: 3,000	Catchment: Tay	
Upstream		Comments	Downstream		Comments
Channel width	1.5 – 2m	Rises to very steep ground 200m upstream of crossing. Otter use noted. Cascade morphology – number of minor step features present Solid invert in culvert structure creates shallow rapid flow which will limit permeability.	Channel width	4-5m narrowing	Solid invert in culvert structure extends 21m downstream of culvert creates shallow rapid flow which will limit permeability. Plane bed morphology downstream of NCN7.
Channel depth:	25 cm max in minor pools		Channel depth:	10cm max over solid invert 15cm further downstream	
Substrate:	Bedrock, boulders, cobbles/ gravels		Substrate:	Solid invert to 21m d/ s then cobbles/ gravels	
Gradient:	>10° increasing upstream		Gradient:	<5°	
Bank structure/ vegetation:	Dry heath		Bank structure/ vegetation:	Engineered banks

Barriers Y/ N	Y minor		Barriers Y/ N	Y minor	
Photograph Upstream:			Photograph Downstream:

<p>Overview of suitability for fish: Little of no suitability for fish spawning where solid invert is present. Upstream channel gradient increases to a point where it is of limited value to spawning fish of any species considered, some minor pools are present between step features. Dowsntream no suitable habitat for any lifestage is present upstream of NCN7 crossing. Shallow glide with cobbles/ gravels downstream of NCN7 may provide some spawning potential for lamprey or salmon and juvenile habitat for salmon.</p>

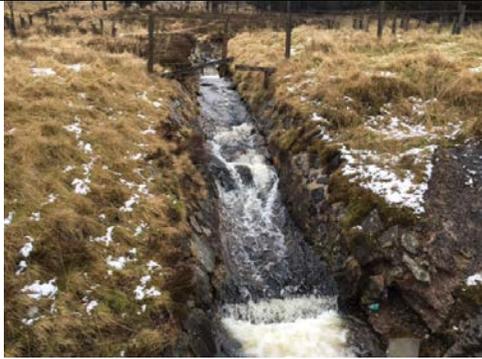
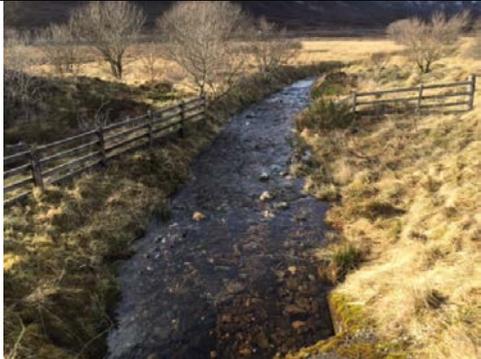
Table 4-7: Allt an Creagach fish habitat assessment

Watercourse: Allt an Creagach		Hydro ID: 31	Chainage: 3,750	Catchment: Spey	
Upstream		Comments	Downstream		Comments
Channel width	>1m	Upstream of existing pipe culvert crossing is a concrete lined channel for 20m. Water depth is lower in concrete channel.	Channel width	1.5m reducing to 0.3m	One of few watercourses where shade provided by willow scrub and in places undercut banks in peat.
Channel depth:	<150mm		Channel depth:	100- 200mm to 500mm in peat areas	
Substrate:	Cobble – gravel some fine gravels and sand	Steep ground present <200m upstream	Substrate:	Gravel - cobble	Plane bed morphology
Gradient:	10° slope in concrete channel		Gradient:	<5°	
Bank structure/vegetation:	Low level banks. Plantation woodland upstream dry heath		Bank structure/vegetation:	Bank vegetated with wet heath/ mire occasional willow scrub	No observations of fish of any age group.
Barriers Y/ N	Y		Barriers Y/ N	N	
Photograph Upstream:			Photograph Downstream:

<p>Overview of suitability for fish: Substrate and watercourse gradient downstream are suitable for spawning salmon/ lamprey and are suitable for juvenile life stages of salmon. Presence of pipe culvert and steep concrete lined channel upstream limits likelihood of upstream migration, channel structure and substrate is of low suitability for spawning upstream. Approximately 100m downstream watercourse cuts through and sometimes underneath peat in a narrow (300mm) but deeper (500mm) with the channel dropping below peat in some locations.</p>

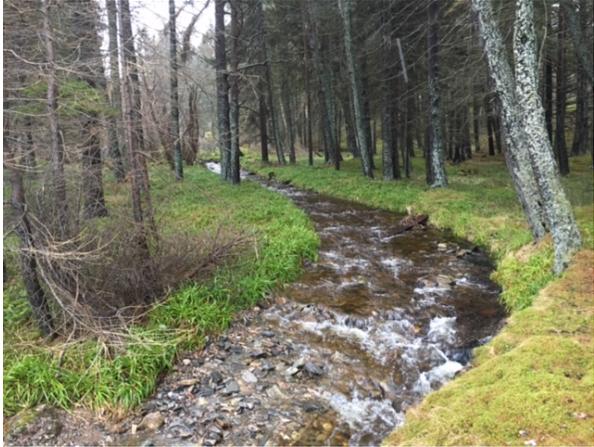
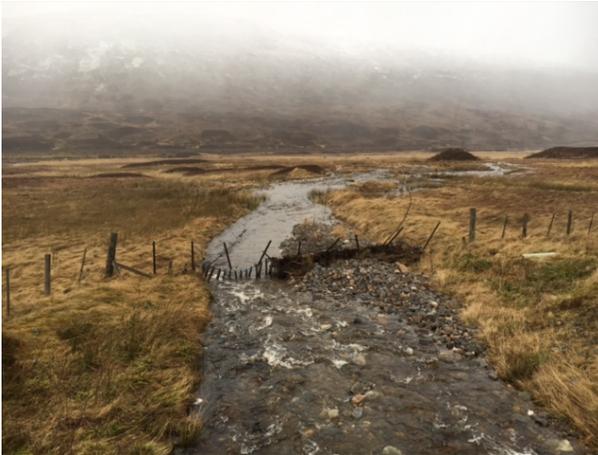
Table 4-8: All Coire Dubhaig fish habitat assessment

Watercourse: Allt Coire Dubhaig		Hydro ID: 52	Chainage: 7,200	Catchment: Spey	
Upstream		Comments	Downstream		Comments
Channel width	2-3m	Watercourse meanders through plantation woodland near Drumochter lodge. Bed plane morphology Shallow glide No fish of any age observed	Channel width	2m	Downstream flow through mire. Very little bank structure. Morphologically active channel with braded channels through mire before confluence with Truim. Plane – riffle morphology
Channel depth:	150-300mm		Channel depth:	150- 300mm	
Substrate:	Cobble –dominated		Substrate:	Cobble – gravel	
Gradient:	<5°		Gradient:	<5°	
Bank structure/vegetation:	Low banks at 45 within conifer plantation		Bank structure/vegetation:	Very low banks through marshy grassland/ mire	
Barriers Y/ N	N		Barriers Y/ N	N	
Photograph Upstream:			Photograph Downstream:

<p>Overview of suitability for fish: Substrate and gradient both downstream and upstream support suitable substrates for spawning salmon, limited presence of sand particulates limit suitability for lamprey. Suitable for juvenile life stages of Atlantic salmon, though have no suitability as lamprey nursery areas. Absence of deep pools and pool/riffle structure limits overall value.</p>

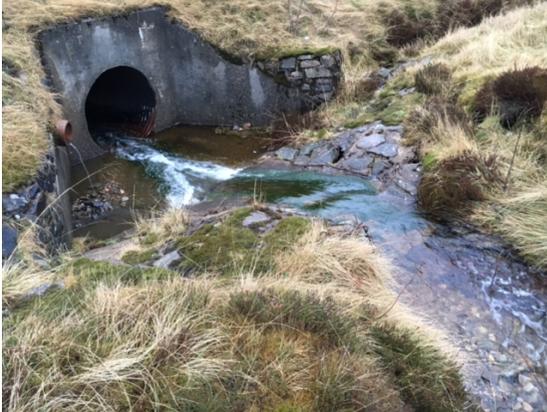
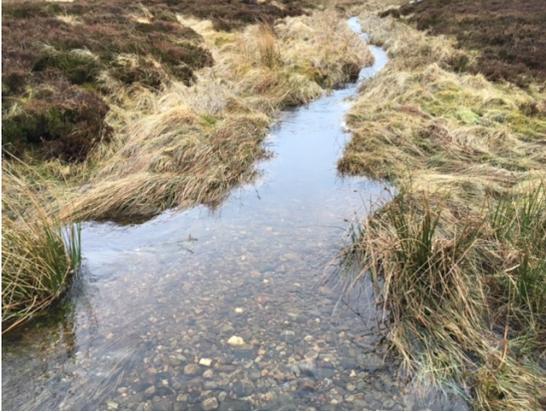
Table 4-9: Hydro ID 57 fish habitat assessment

Watercourse: Unnamed		Hydro ID: 57	Chainage: 7,900	Catchment: Spey	
Upstream		Comments	Downstream		Comments
Channel width:	1.5m	Lined concrete channel on upstream section on steep gradient likely to restrict upstream movement of fish immediately upstream of pipe culvert (120mm water depth through culvert during survey). Plane – bed morphology.	Channel width:	Narrow channel (<300mm)	Narrow and sometimes shallow channel is likely to prohibit adult upstream migration. Presence of finer sediment downstream may be suitable for juvenile lamprey in some locations. Minor barrier where fence line has trapped debris. Plane bed morphology.
Channel depth:	100 – 300mm		Channel depth:	Variable up to 500mm with shallow (>100mm) sections around gravel deposits	
Substrate:	Cobble – dominant, some gravel deposits		Substrate:	Finer gravels/ pebbles	
Gradient:	<5°		Gradient:	<5°	
Bank structure/vegetation:	heath mire – low banks overhung by heather (both banks)		Bank structure/vegetation:	Channel cuts through peatland habitats including mire and wet earth

Barriers Y/ N	Y - minor		Barriers Y/ N	Y	
Photograph Upstream:			Photograph Downstream:

<p>Overview of suitability for fish: Hydro ID 57 supports sediment types upstream and downstream which are suitable for spawning. The narrow nature of the watercourse and in some areas shallow depth are likely to limit value to both salmon and lamprey, though some use is possible.</p>

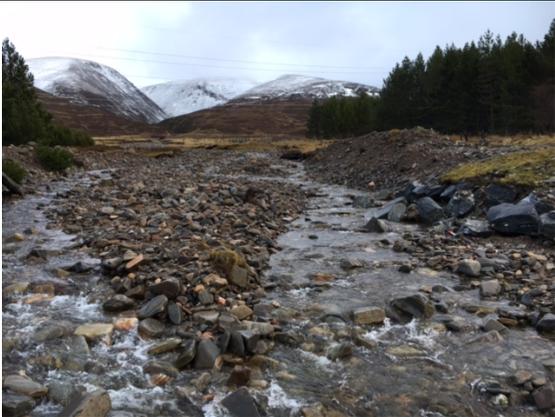
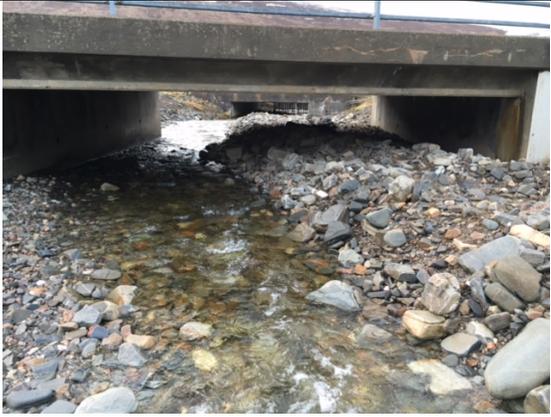
Table 4-10: Allt Coire Chuirn fish habitat assessment

Watercourse: Allt Coire Chuirn		Hydro ID: 59	Chainage: 8400	Catchment: Spey	
Upstream		Comments	Downstream		Comments
Channel width	5m	Highly active channel – some management (removal of cobbles) to prevent bridge obstruction evident upstream.	Channel width	5m	Downstream section designated as part of River Spey SAC.
Channel depth:	200 – 500mm		Channel depth:	200 – 400mm	
Substrate:	Cobble – boulder (some pebble - gravel)	Wandering morphology and braided channels	Substrate:	Cobble – boulder (some pebble - gravels)	Engineered banks between existing A9 and NCN7 crossing short distance downstream
Gradient:	<5°		Gradient:	<5°	
Bank structure/vegetation:	Heavily disturbed banksides upstream	Otter spraint under crossing.	Bank structure/vegetation:	Acid grassland/ heathland.	Plane – bed morphology
Barriers Y/ N	N		Barriers Y/ N	N	
Photograph Upstream:			Photograph Downstream:

<p>Overview of suitability for fish:</p> <p>The Allt Coire Chuirn at the existing crossing is dominated by larger cobbles and boulders, this may be a result of management to prevent sediment build up upstream of the bridge. Further downstream and upstream are habitats present which are likely to form habitat suitable for spawning Atlantic salmon. The absence of sand particles limits the value to sea lamprey spawning. Watercourse appears to be of high velocity so significant risk of washout of spawning areas. Absence of pools in channel or overhanging vegetation limit the value of the watercourse to adult or parr salmon. No habitat suitable for lamprey nursery areas is present.</p>

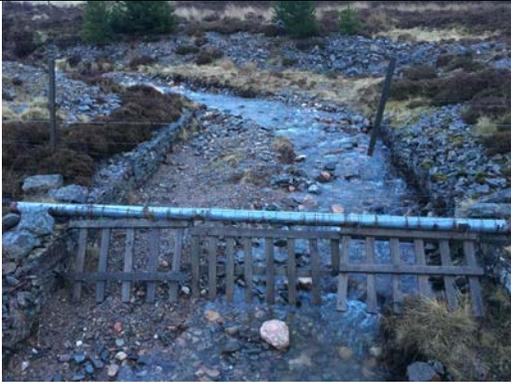
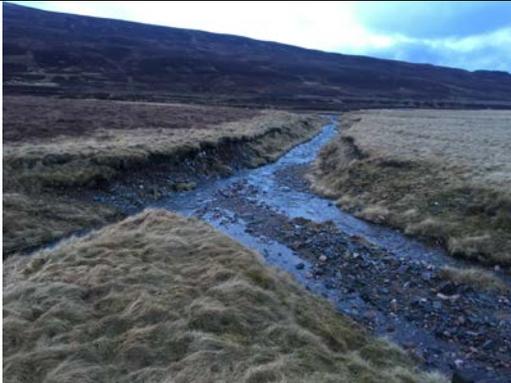
Table 4-11: Allt Coire Bhotie fish habitat assessment

Watercourse: Allt Coire Bhotie		Hydro ID: 64	Chainage: 8400	Catchment: Spey	
Upstream		Comments	Downstream		Comments
Channel width	2-3m	Historical realignment. Gabion baskets on both banks to control flow through A9 bridge upstream Some possible management of sediment build up No aquatic macrophytes Plane bed morphology Shallow glide/ riffle structure, absence of pools	Channel width	2-3m	Straight channel from previous realignment Joined by second watercourse (ID 63) No aquatic macrophytes Erosion on south bank close to confluence with Hydro ID 63 Plane bed morphology Shallow glide/ riffle structure, absence of pools
Channel depth:	100 – 300mm		Channel depth:	100 – 400mm	
Substrate:	Cobble – boulder (some pebble - gravel)		Substrate:	Cobble – boulder (some pebble - gravels)	
Gradient:	>5°		Gradient:	<5°	
Bank structure/vegetation:	Low banks vegetated with dry/ wet heath		Bank structure/vegetation:	Acid grassland on steep banks

Barriers Y/ N	N		Barriers Y/ N	N	
Photograph Upstream:			Photograph Downstream:

<p>Overview of suitability for fish:</p> <p>The Allt Coire Bhotie at the existing crossing is dominated by larger cobbles and boulders, this may be a result of management to prevent sediment build up upstream of the bridge. Further downstream and upstream are habitats present which have some potential to form habitat suitable for spawning atlantic salmon. Straight realigned channel has no notable pool features limiting spawning habitat potential. The absence of sand particles limits the value to sea lamprey spawning. Absence of pools in channel or overhanging vegetation limit the value of the watercourse to adult or parr salmon. No habitat suitable for lamprey nursery areas is present.</p>
