Appendix 12.9

Deer Vehicle Collision Study

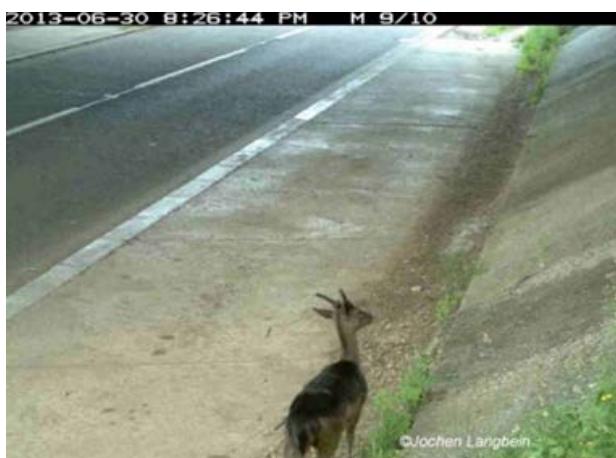
Photograph 3-3-1: Fallow deer at slip road underpass beneath dual A38 trunk, Devon

- 3.5.6 The extent of use by deer of joint use underpasses has to date not been widely documented in the UK, but a number of recent published and unpublished projects have highlighted that small as well as large species of deer are increasingly making use of a wide variety of structures beneath trunk roads (Langbein 2010; Muttock 2013, Langbein 2015). Two examples among many structures that are now known to be used by deer as safe passages on trunk roads in England are shown in Photograph 1 and 2 below; including even a culvert with a diameter of less than 2.5 m that extends for more than 100 m beneath a six lane wide section of the M25.

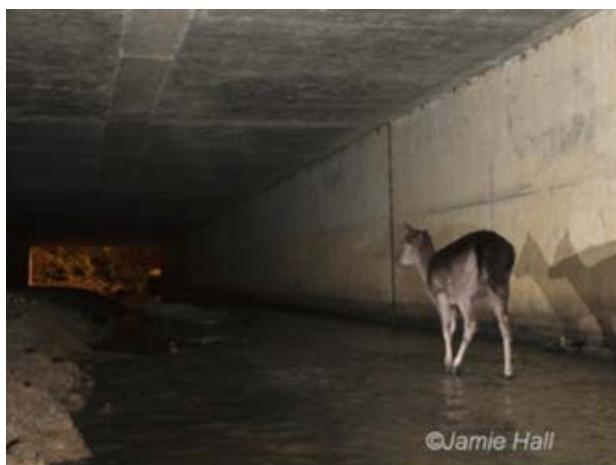
Photograph 3-3-4: Fallow deer crossing box culvert underpass beneath 6-lane M25 Essex

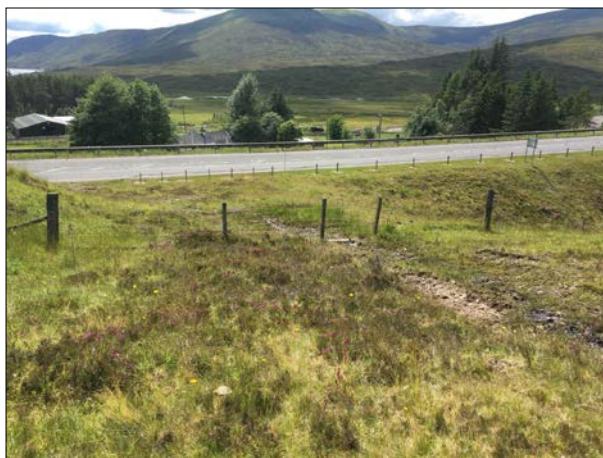
Photograph 5-1: Deer Target Note 1 - potential crossing point and damaged fence

- 5.1.3 The survey results found two areas which could be at risk of deer crossing in the survey area:
- Deer Target Note 1 – Area of disturbed ground east of the A9 (likely from construction of the Beauly Denny Line). No obvious mammal tracks are present but multiple slots, most likely to be red deer, are present (Grid Ref. NN 6466 7327). The standard stock fence in this location is damaged and low, which is unlikely to serve as a barrier to deer movement. Slots were found next to this location indicating a potential crossing point and a potential DVC area (see **Photograph 5-1**).

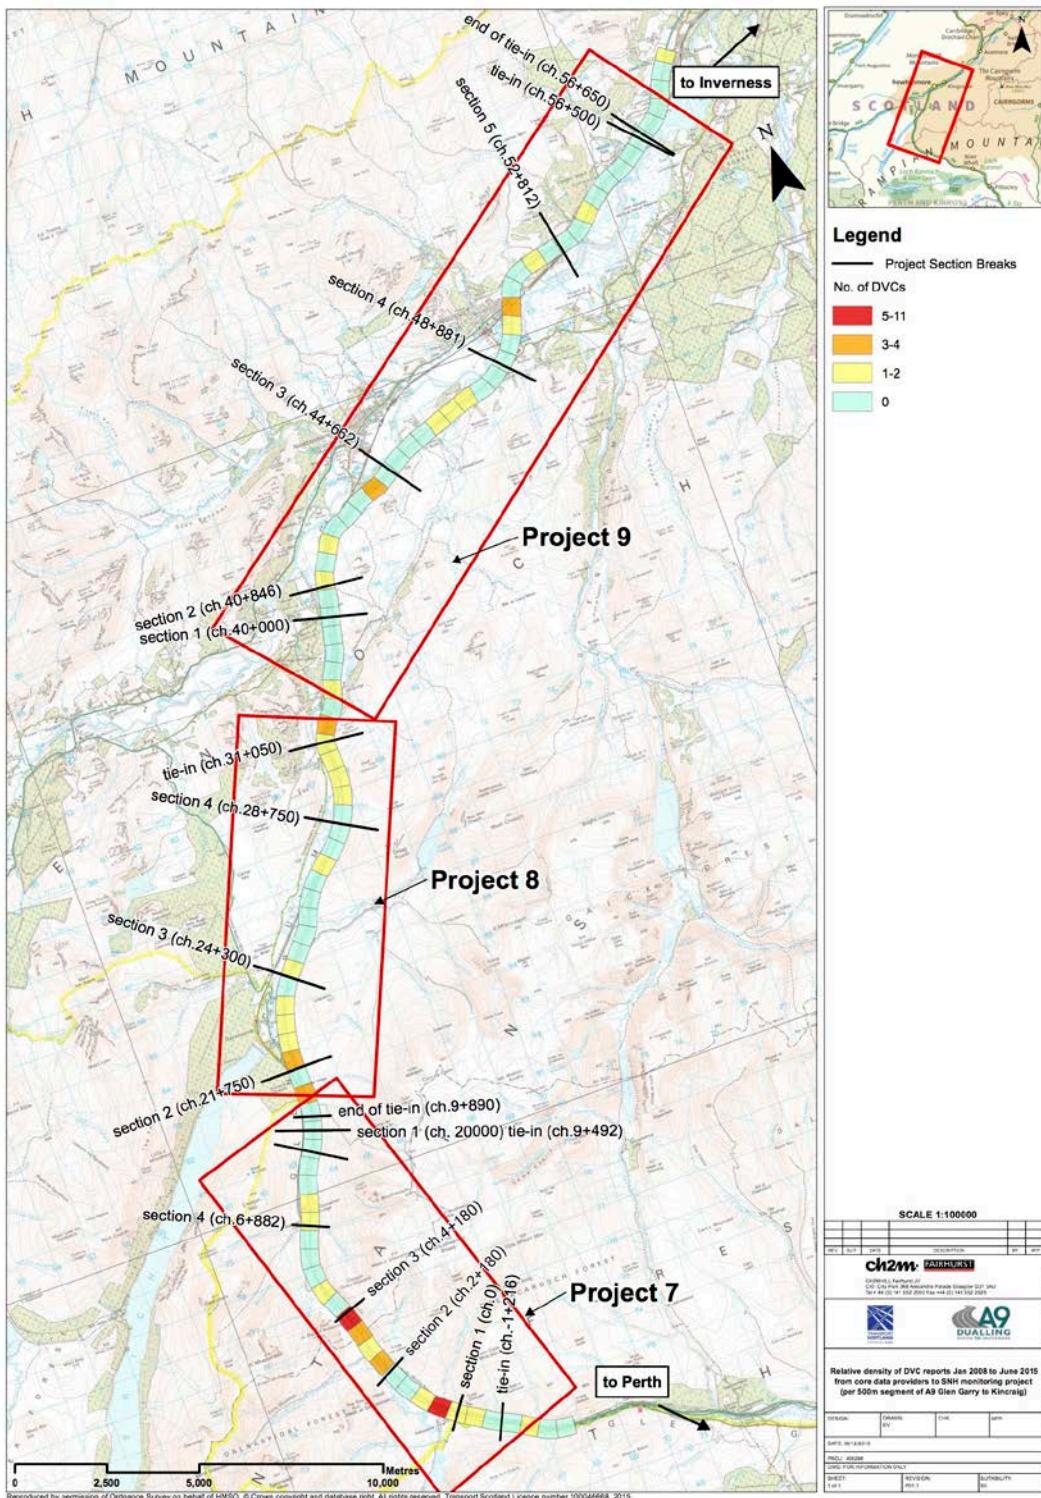
Appendix 1- DVC Heat Map – Glen Garry - Dalraddy

Figure 3.2 (pre 2008). As discussed previously (see 2.1 above) the more recent data in **Figure 3.1** will be the most reliable in terms of direct comparability of recording between different subsections. A larger scale scheme plan showing the post 2008 DVC Heat map overlaid onto detail of the Central Section Project areas and subsections is provided separately as Appendix 1 with this report.
