Appendix 10.2

Peat Stability Risk

Assessment

- 1.1.1. This report forms a Technical Appendix to Chapter 10 Geology, Soils and Groundwater of the A9 Dualling Dalraddy to Slochd Stage 3 Environmental Statement (ES), and should be read with reference to this chapter.

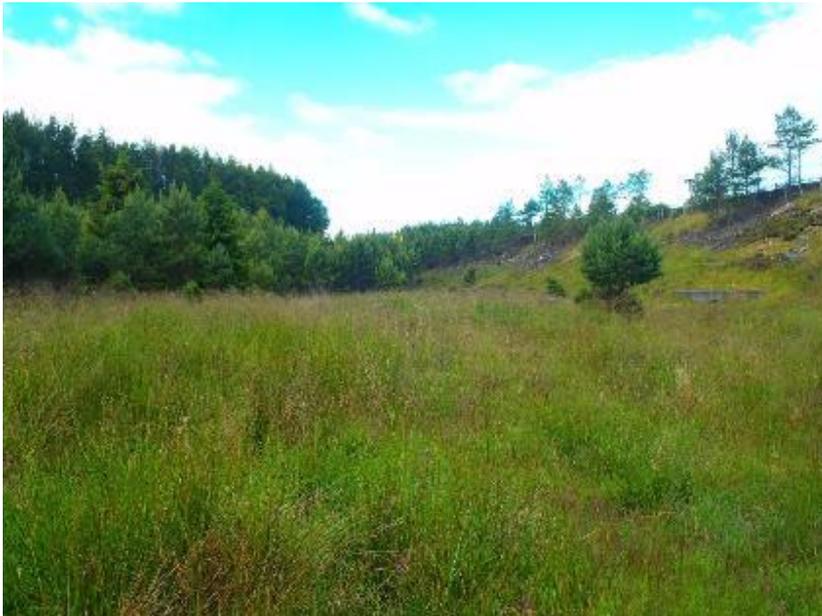
Illustration 1: Blanket bog habitat at Crannaich, low gradient with areas of deep peat (NH 905 211)

Illustration 3.1 shows an area of swamp and blanket bog at Crannaich at 269mAOD, looking north adjacent to the existing A9. The area features primarily deciduous woodland which is boggy underfoot. There are isolated areas of deeper peat of up to 4.3m depth. Typical slope angles are less than 6° with the exception of the existing road embankment.

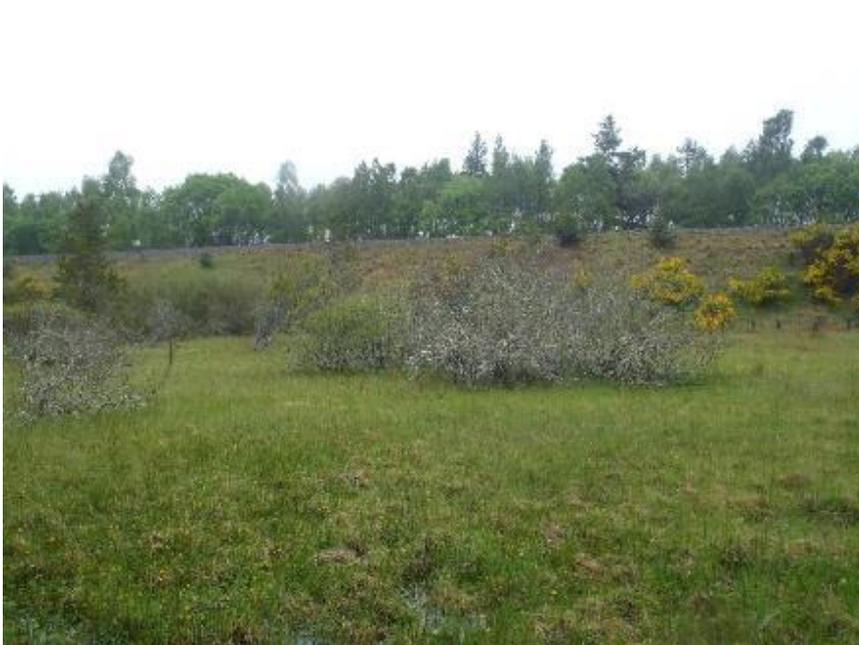
Illustration 2: Swamp habitat facing north towards Highland Railway line, underlain by peat (NH 792 319)

Illustration 2 shows swamp habitat adjacent to A938 at 274mAOD, looking north towards the Highland Mainline. The area features a swamp surrounded by grassland and woodland to the south. Peat depths vary with a maximum depth of 2.55m measured in the centre of the swamp. The area is flat, with artificial embankments along the existing A9 and railway line containing this feature.

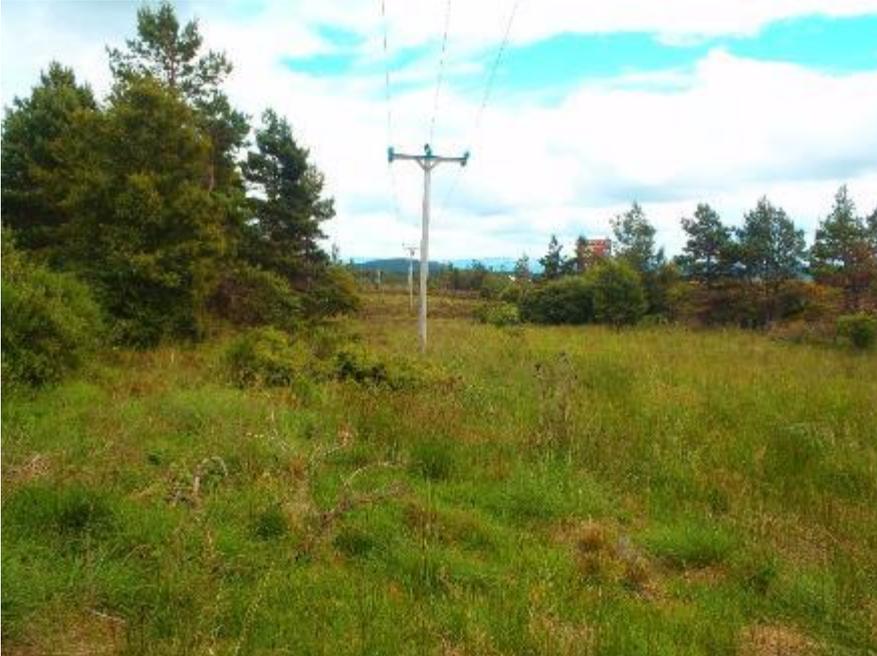
Illustration 3: Looking east towards Black Mount junction along southbound carriageway (NH 862 238)

Illustration 3 shows marshy grassland in the foreground, facing east towards Black Mount junction, with mire habitats including Class 3 Priority Peatland area located in the background adjacent to the existing A9 at 360m AOD. This area of blanket bog features peat depths of up to 2.8m in the centre of the area. Typical slope angles are less than 6°, with the exception of the existing road embankment.

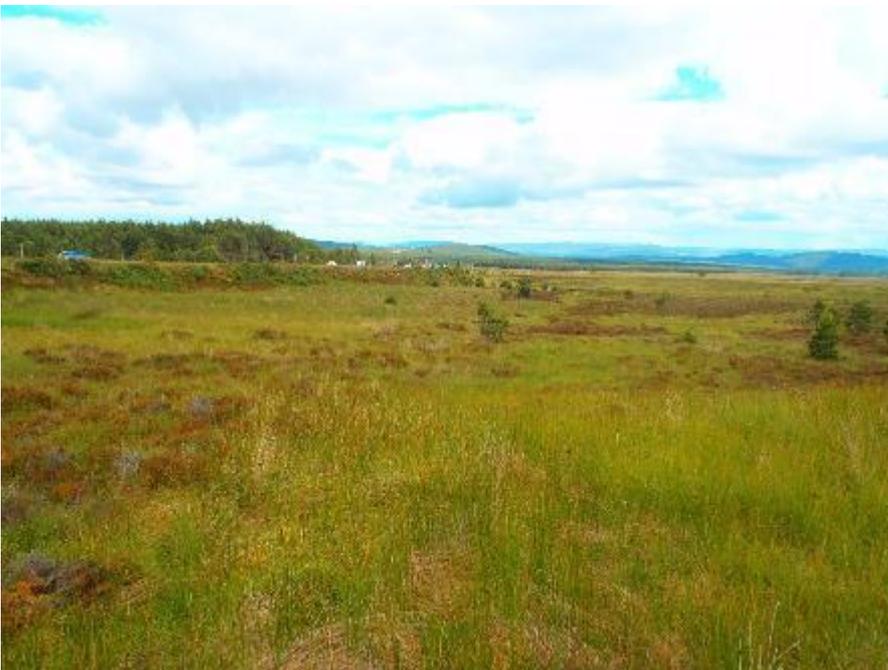
Illustration 4: Class 1 peatland west of Black Mount, facing east and downslope of existing A9 (NGR NH 861 238)

Illustration 4 shows an extensive area of Class 1 priority peatland blanket bog, looking east along the existing A9. This area features an average peat depth of 3m, with a maximum depth of 5.3m. Slope angles are typically less than 6° and relatively flat across the peatland, with the existing A9 on a raised embankment.

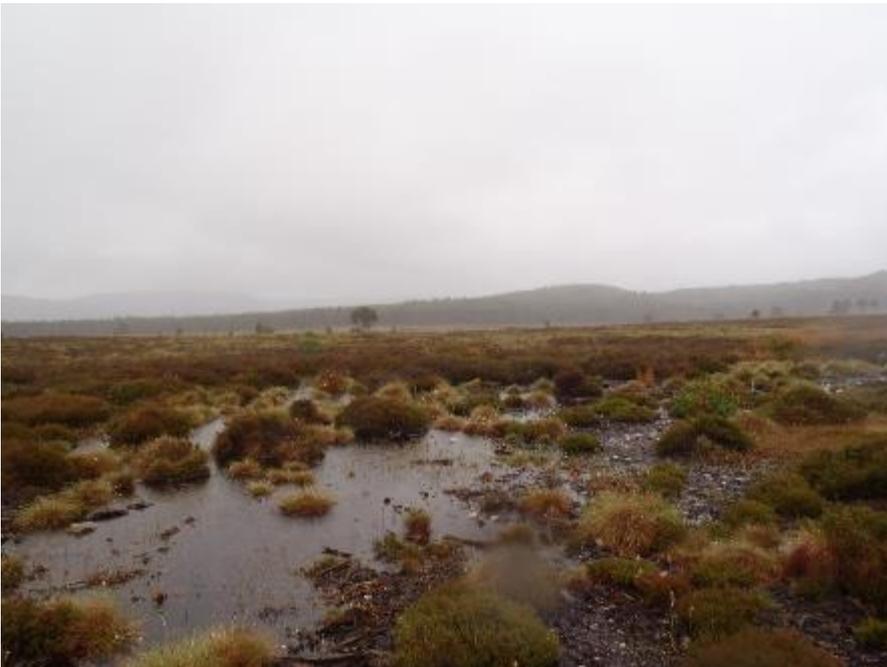
Illustration 5: Area of degraded peat adjacent to existing northbound A9 (NGR NH 867 238)

Illustration 5 shows an area of degraded peatland adjacent and south of the existing A9, facing south-west. The peatland habitat adjacent and parallel to the existing A9 was noted to be in a poor condition, with large areas of exposed and eroded peat with low levels of vegetation cover, numerous drains and high levels of superficial deposits mixed into the peat.

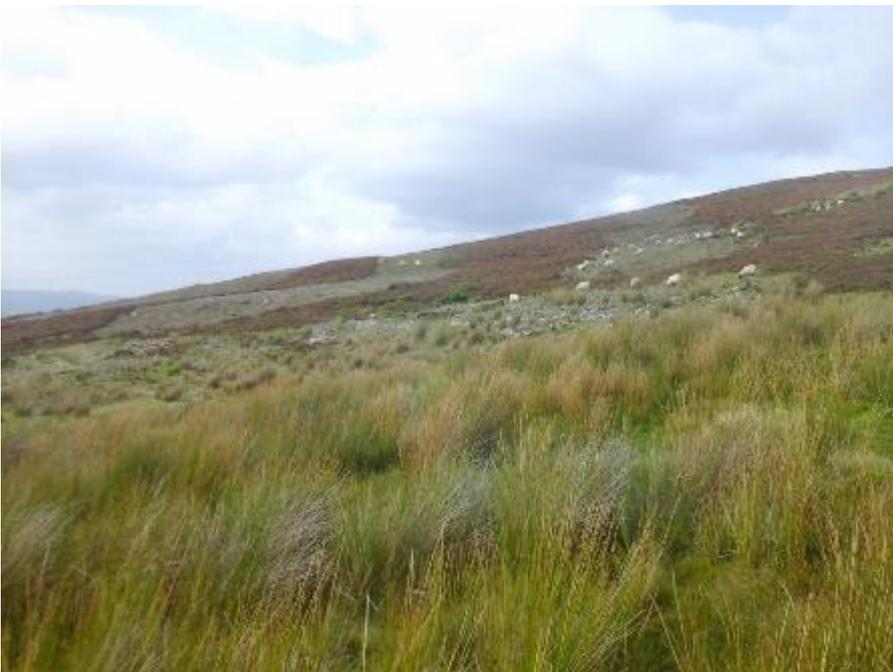
Illustration 6: Hill slopes at Slochd Summit facing north-west (NGR NH 823 255)

Illustration 6 shows steeper slopes at Slochd Summit, often exceeding 30°. The A9 runs north-west to south-east through this valley. The slopes feature thin peaty podzols with rocky outcrops, featuring a combination of mire and heath habitats.

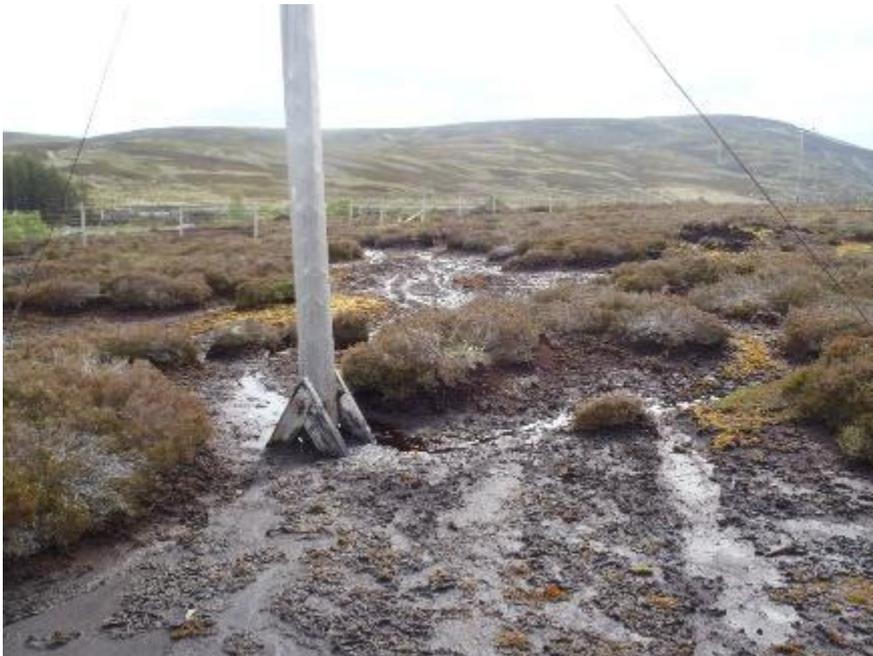
Illustration 7: Exposed peat facing south-east from the slopes of Carn a' Gharbh-choire towards Slochd (NGR NH 828 260)

Illustration 7 shows eroded peat with limited vegetation cover north of Slochd, west of the existing A9. Maximum peat depths of 7.6m were recorded within the scheme footprint, with slope angles are typically less than 60, with steeper slopes located upslope and downslope towards the A9. The Highland Mainline Railway is located within a cutting between this area and the existing A9.

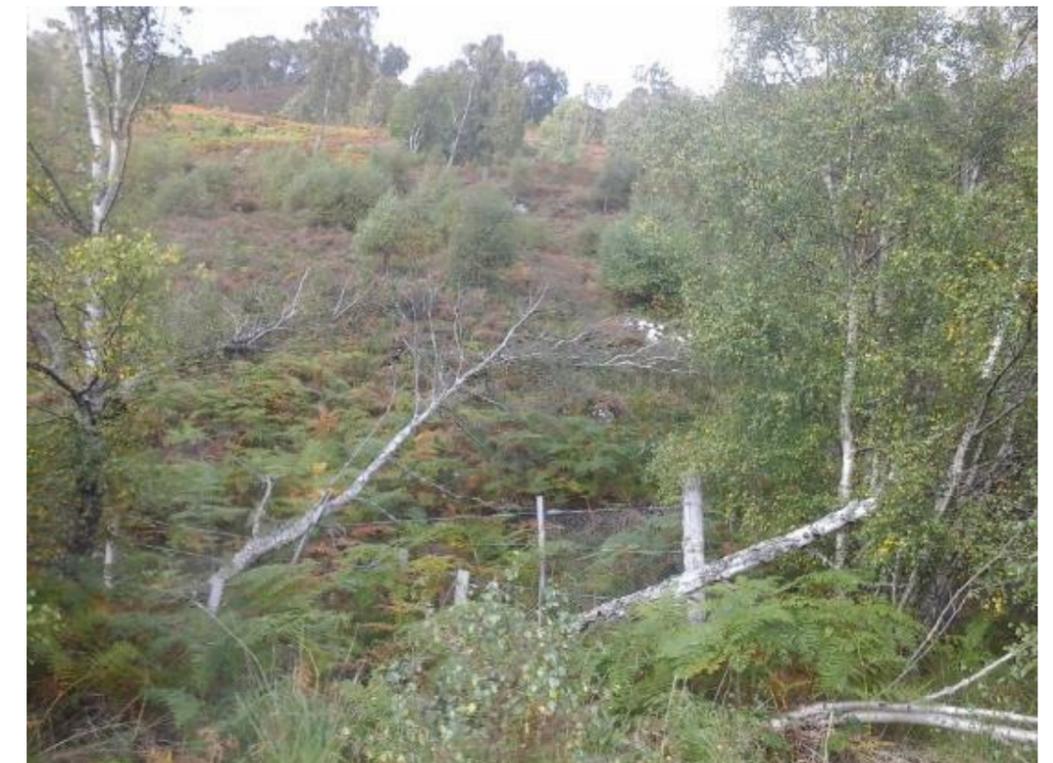
However, NVC surveys indicate these areas do not feature peatland habitats and both GI locations record topsoil and sand present, therefore no peat core was obtained in this area.

Photograph at NGR NH 888 110, looking north-west along the bank from the existing northbound carriageway.

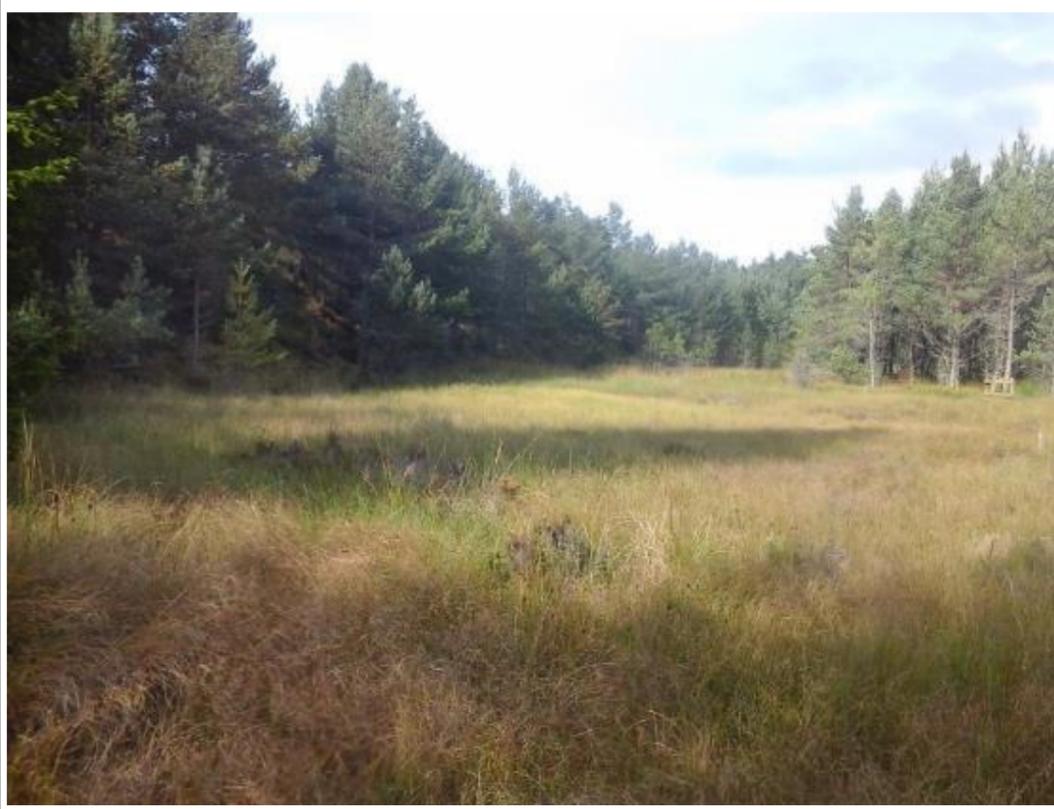
Photograph taken from NGR NH 907 208 looking north over swamp area, with existing A9 embankment to the west.

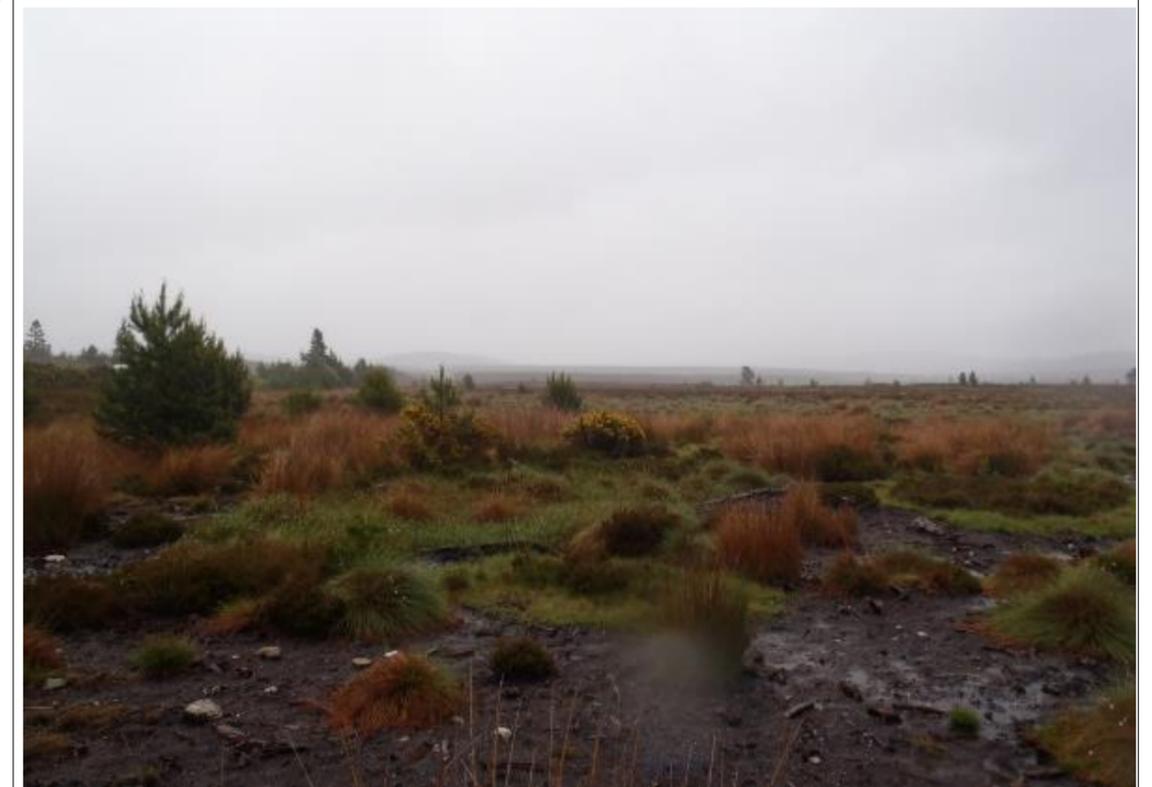
Photograph from NGR NH 864 238 facing east looking over Class 1 Priority Peatland, with the existing A9 carriageway to the north, and existing Black Mount Junction in the background.

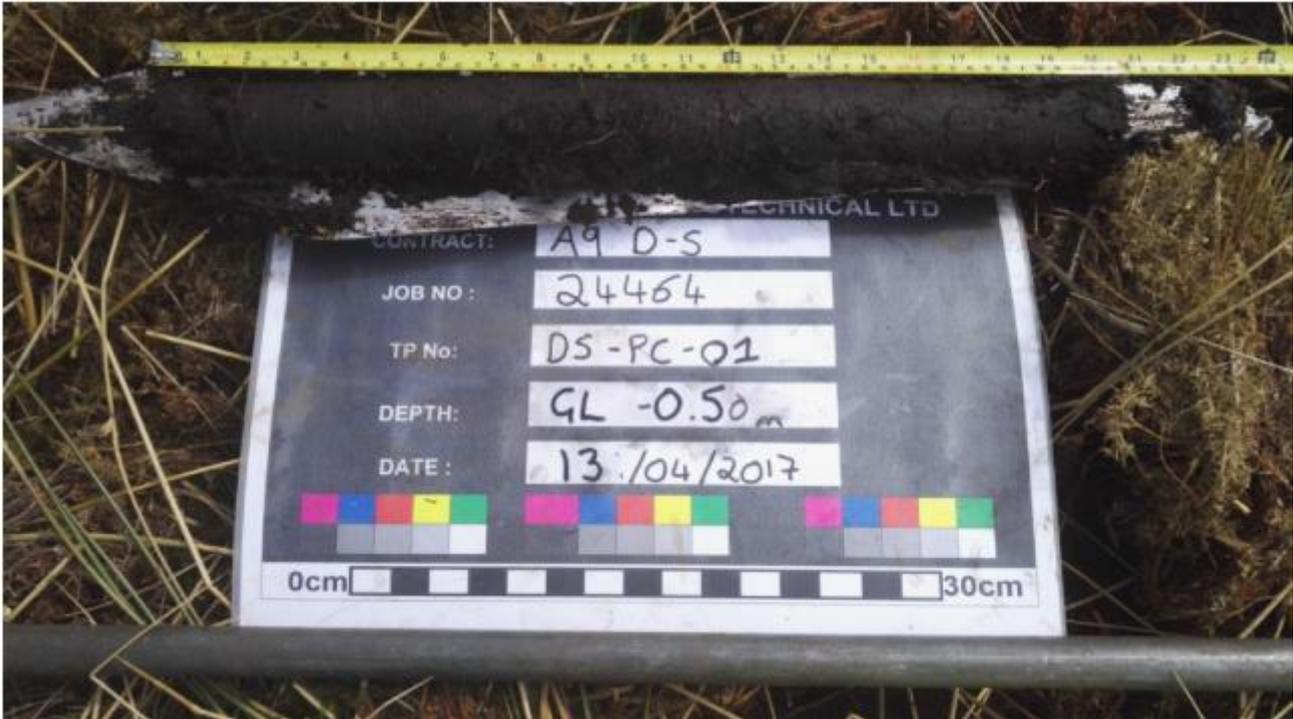
Figure 7. Peat Core DS-PC-01 taken at depth 0 – 0.5m

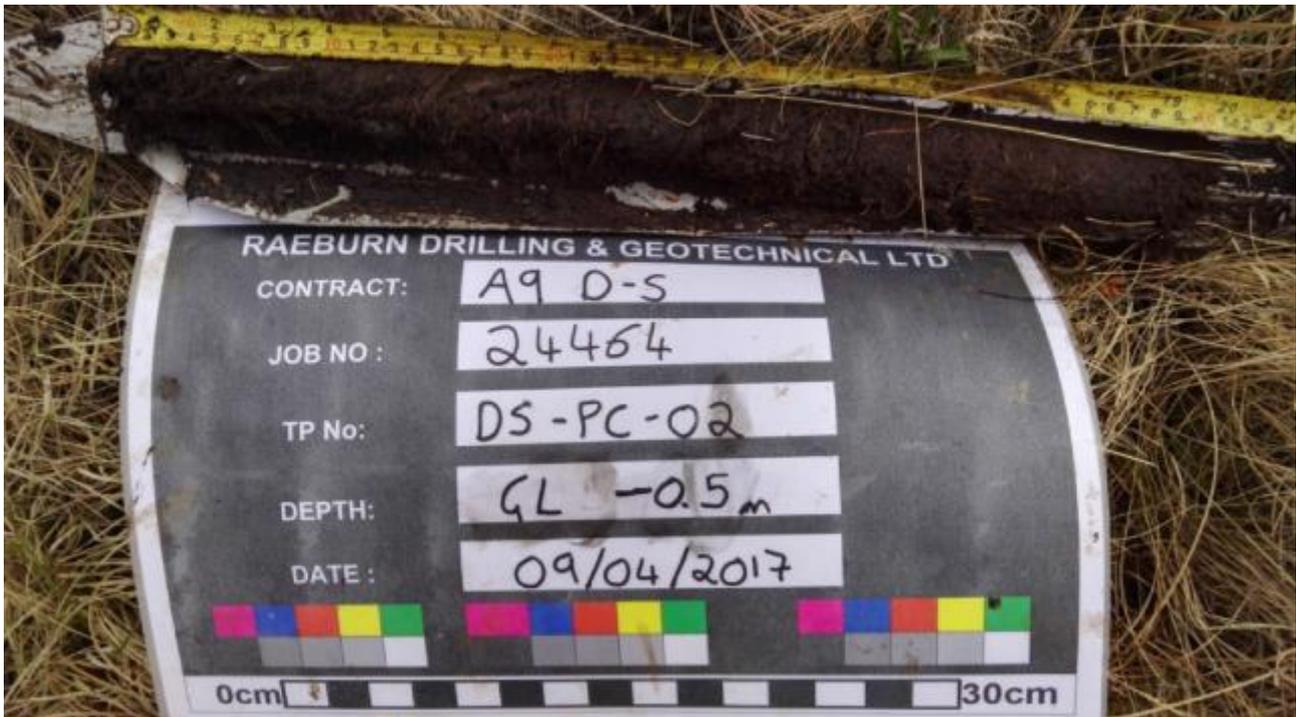
Figure 8. Peat Core DS-PC-02 taken at depth 0 – 0.5m

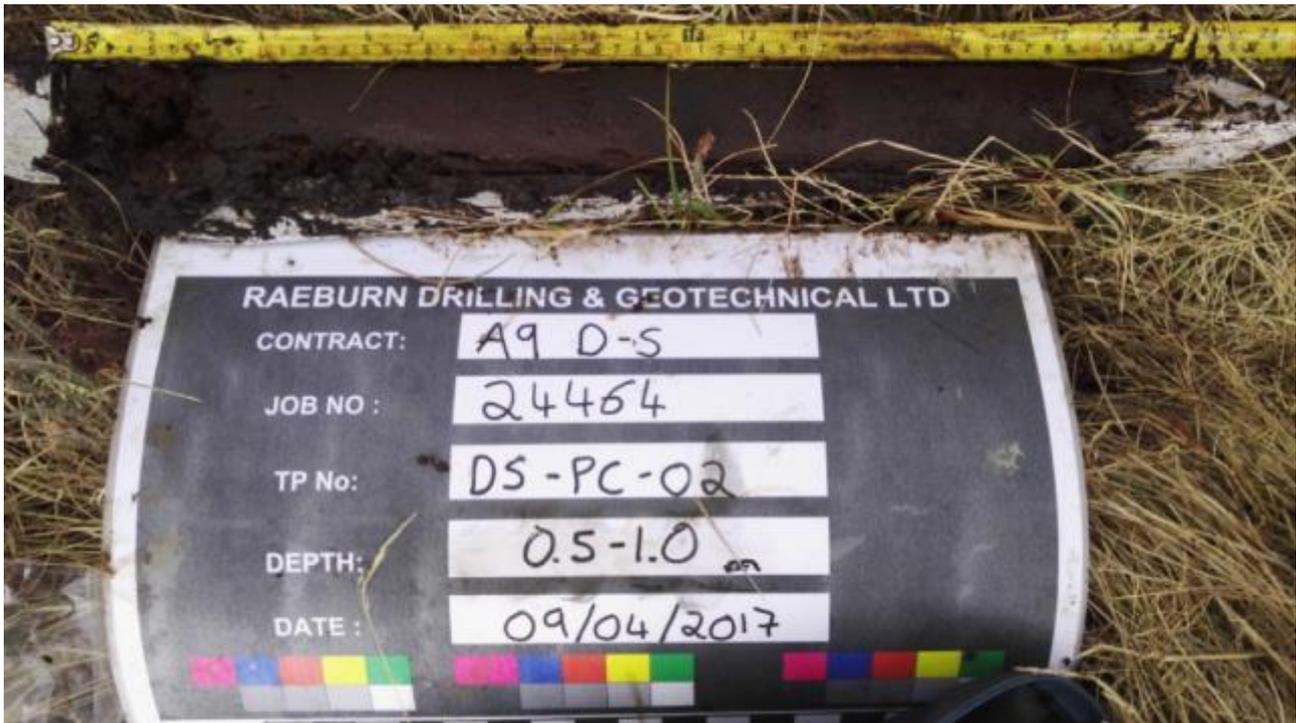
Figure 9. Peat core DS-PC-02 taken at depth 0.5 – 1.0m

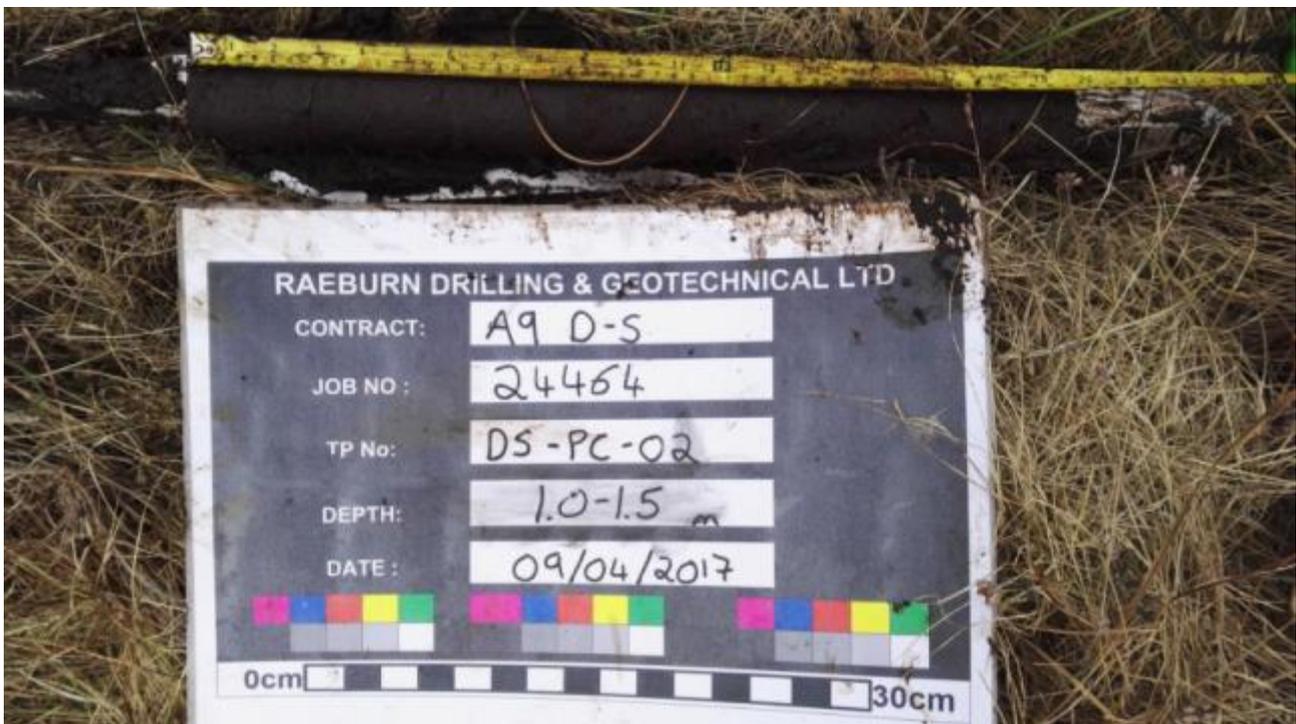
Figure 10. Peat Core DS-PC-02 taken at depth 1.0 – 1.5m

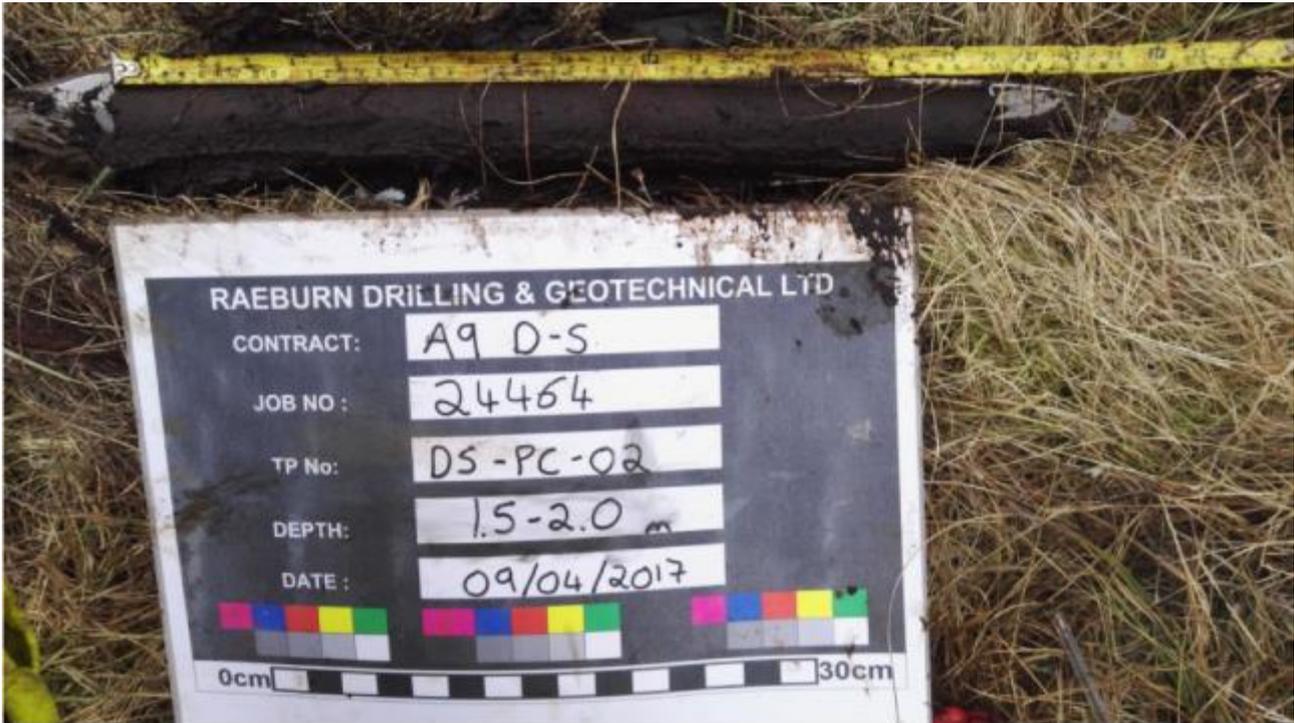
Figure 11. Peat Core DS-PC-02 taken at depth 1.5 – 2.0m

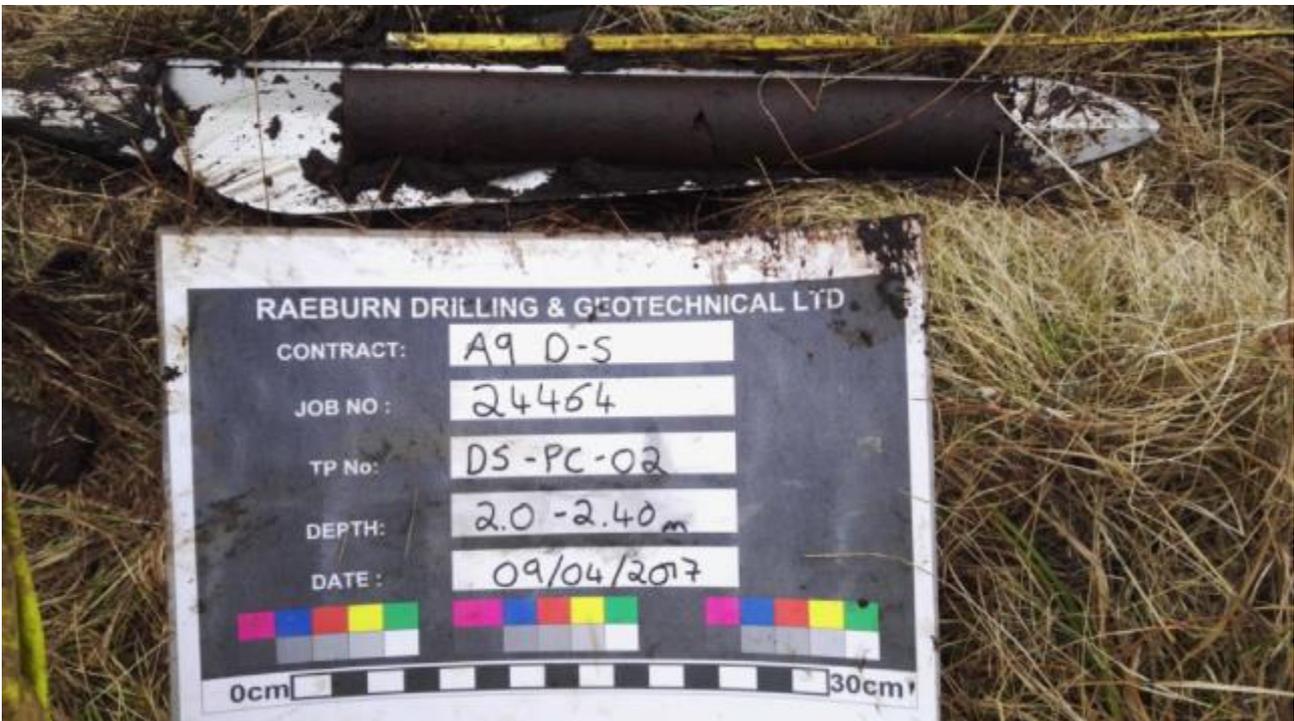
Figure 12. Peat Core DS-PC-02 taken at depth 2.0 – 2.4m

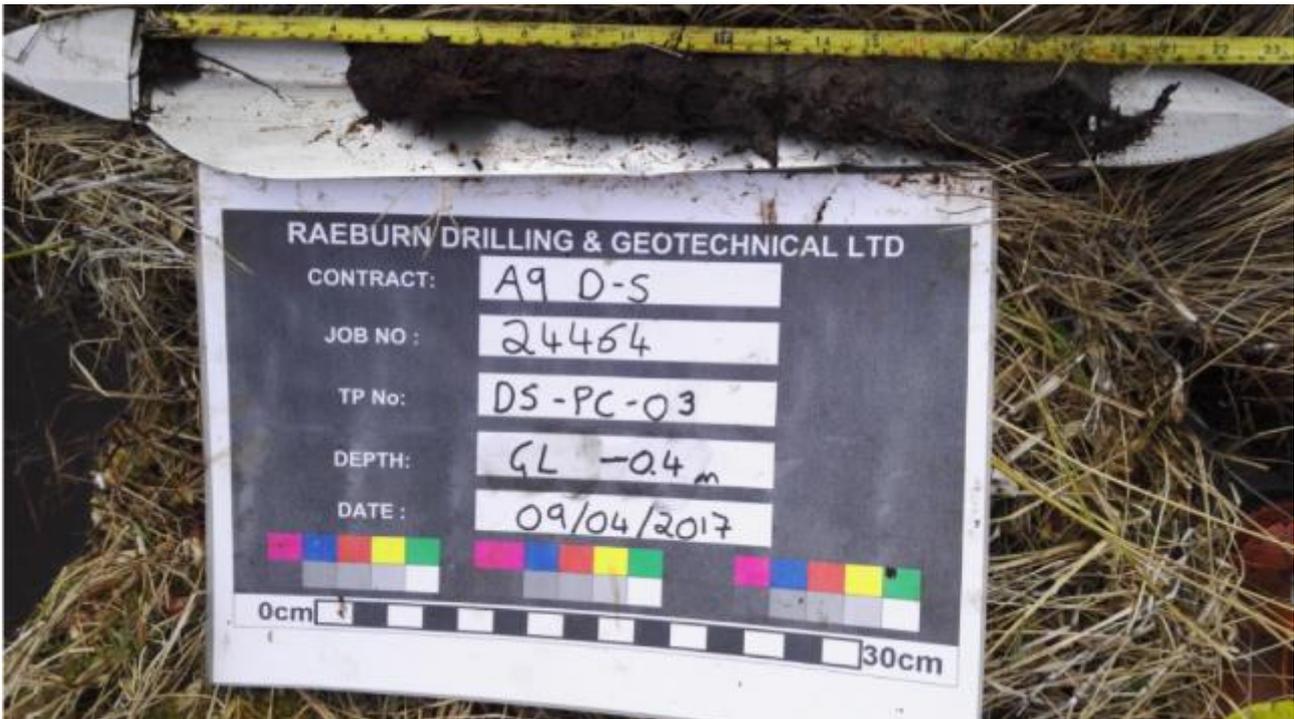
Figure 13. Peat Core DS-PC-03 taken at depth 0 – 0.4m

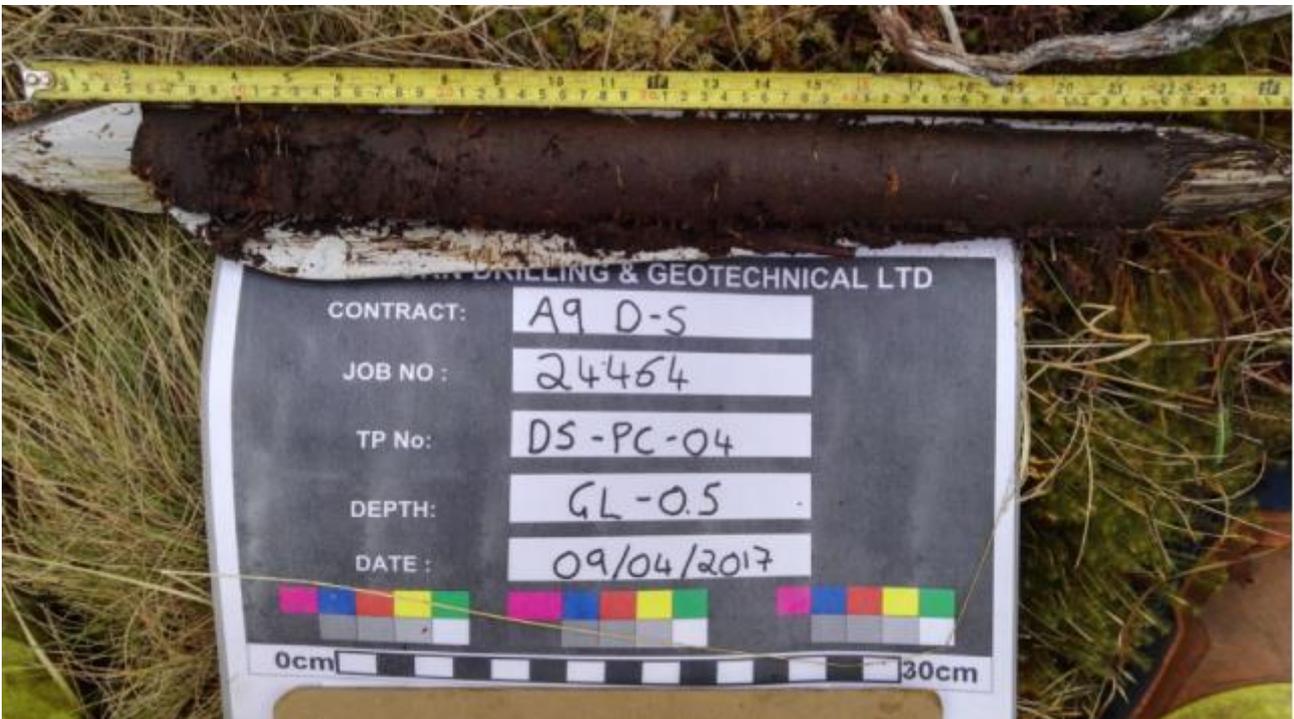
Figure 14. Peat Core DS-PC-04 taken at depth 0 – 0.5m

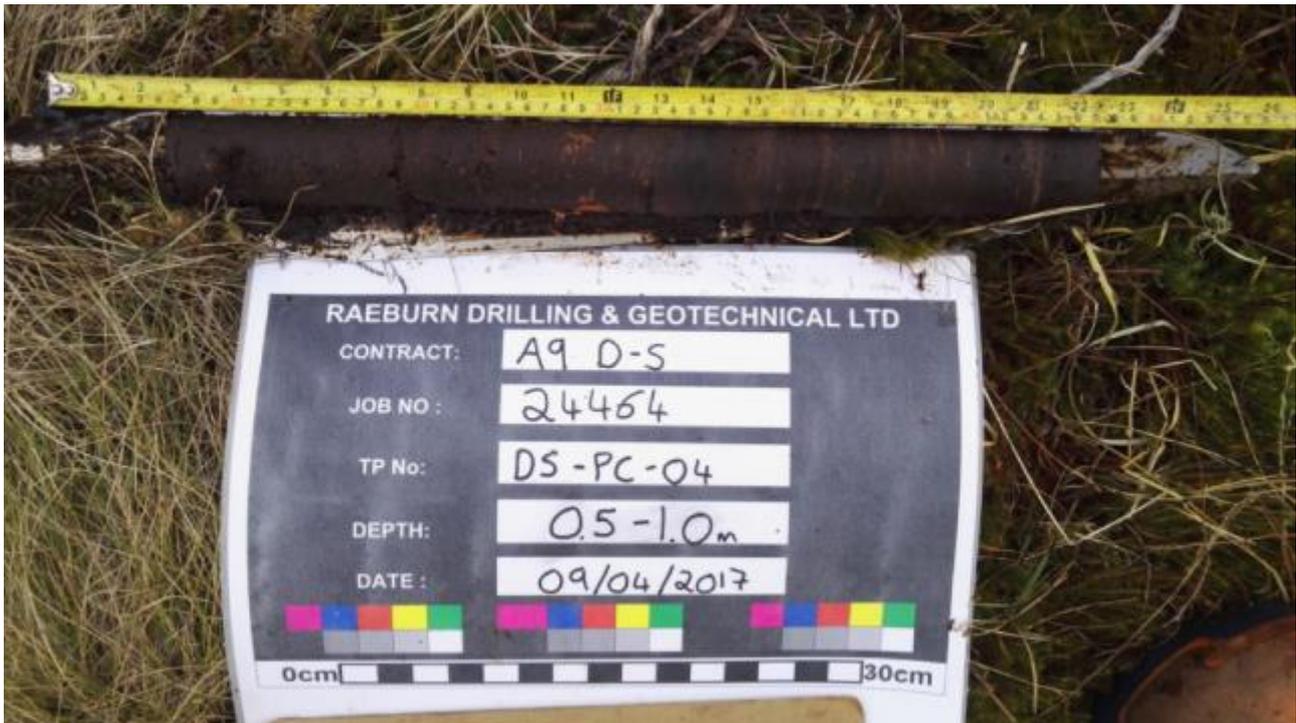
Figure 15. Peat Core DS-PC-04 taken at depth 0.5 – 1.0m
