14 Cultural Heritage

- 14.1.1 This chapter presents the Design Manual for Roads and Bridges (DMRB) Stage 3 Environmental Impact Assessment Report (EIAR) cultural heritage assessment for the A9/A96 Inshes to Smithton scheme (hereafter referred to as the proposed scheme).

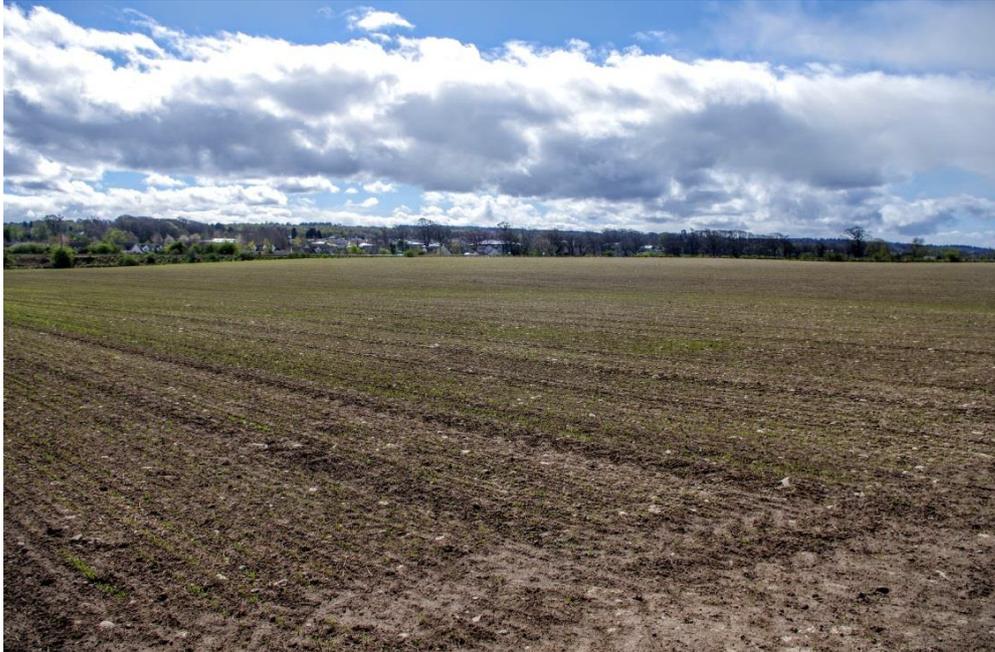
14.4.7 The Scheduled Monument (Asset 14; SM11535; Photograph 14.1) comprises a penannular ring ditch and three pit circles identified from aerial photographs and interpreted as the remains of an unenclosed prehistoric settlement. Pit circles may have held a ritual or ceremonial function representing the remains of Neolithic timber circles, with the pits dug to erect large timber uprights in a circle arrangement (Scottish Archaeological Research Framework (ScARF 2012a; Millican 2007). However, the pit circles forming the Scheduled Monument appear to be characteristic of prehistoric roundhouses. They lie within a settlement context (with an associated ring ditch) are less than 15m in diameter, and comprise regularly spaced pits (for structural integrity) with detached pits that may represent a porch structure attached to the roundhouse (Millican 2007). Additionally, the presence of a double line of pits associated with one of the pit circles may suggest more than one phase of construction, resulting from the replacement of posts over time (Millican 2007).

Photograph 14.1: Location of the Scheduled Monument (Asset 14), Looking South.

14.4.9 The setting of the Scheduled Monument (Asset 14) is characterised by its semi-rural location on a slight topographic rise in the landscape with views in all directions which may have influenced the choice of the location of the settlement (Photograph 14.1). The spatial and temporal relationship of Asset 14 with similar prehistoric archaeology within the study area contributes to our understanding, appreciation and experience of Asset 14 (Table 2 of Appendix A14.1: Cultural Heritage Baseline Report). Distant traffic, aeroplane and train noise form part of this asset's setting; however, this does not contribute to our understanding, appreciation or experience of it. The value of Asset 14 is derived primarily from its archaeological remains.

- 14.6.10 To mitigate any potential for accidental damage to the Scheduled Monument (Asset 14), Asset 14 will be securely fenced off for the duration of construction (**Mitigation Item CH-08**). This will comprise a permanent post and rail fence, appropriate signage, and a toolbox talk for contactors. The proposed fenced area will be located on the edge of the Draft CPO boundary. Contractors will not be permitted to use land outwith the Draft CPO Boundary without prior agreement.

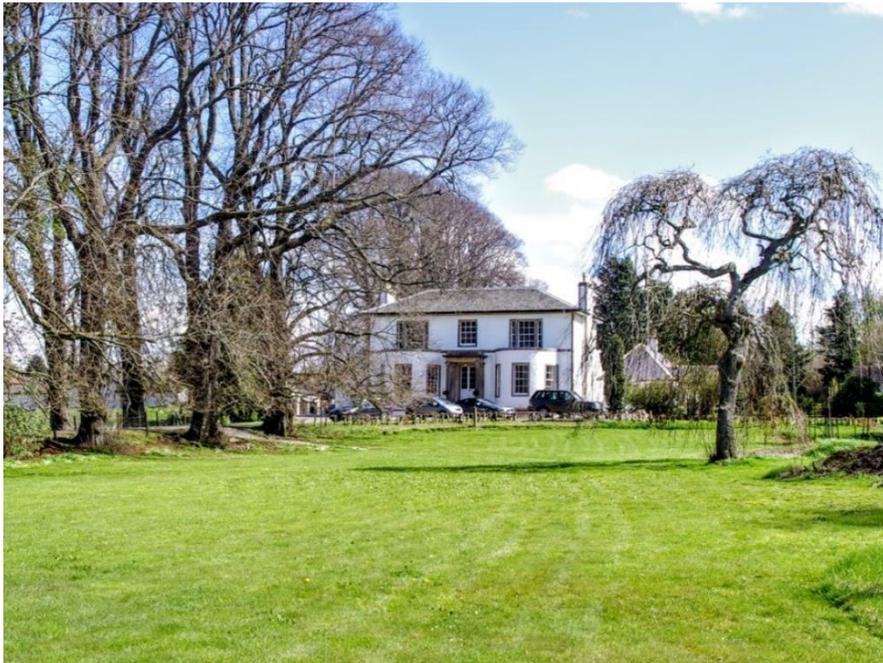
Photograph 14.2: North Facing Elevation of Castlehill House (Asset 9), Showing Avenue of Trees to the Left

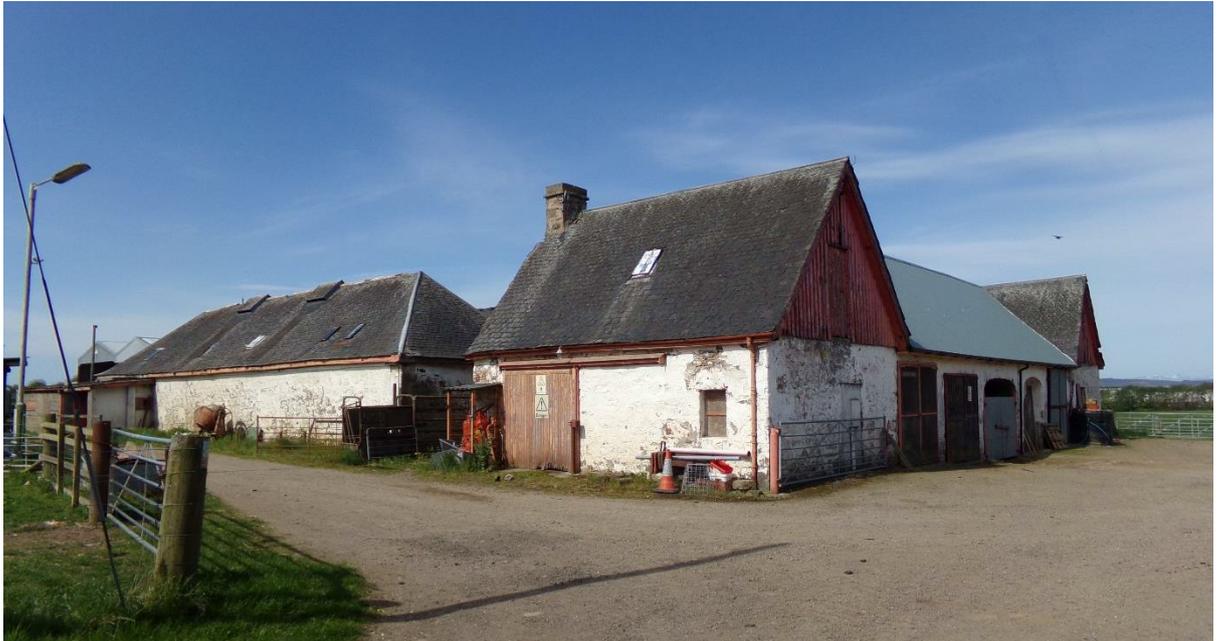
- 14.4.41 Ashton Farm Cottages (Asset 17) and Ashton Farm (Asset 18; Photograph 14.3) form a single farm complex with 19th century origins. Ashton Farm Cottages (Asset 17) are depicted on 1st Edition Ordnance Survey mapping as a small square building associated with the farmsteading. The cottages are similar in architectural style to small cottage types within the Highlands. The current building has been substantially altered and modernised. Ashton Farm (Asset 18), a single-storey range of rendered rubble stone construction, reflects the vernacular architecture of the agricultural improvement era (Maudlin 2009) and is characteristic of the farm steadings of the surrounding historic landscape - Rectilinear Fields and Farms (HLT 2) (Paragraph 14.4.65). However, this architectural type is not rare and represents 73% of rural farmsteads still extant in the Scottish Highlands today (Maudlin 2009). A pair of decorative carved red sandstone corunnells (stones or boards forming the top of a door opening (Pride 1996)) of unknown origin have been reused and now form part of a rubble stone garden wall at Ashton Farm.

Photograph 14.3: Single-storey Agricultural Ranges Forming part of Ashton Farm (Asset 18), Facing West

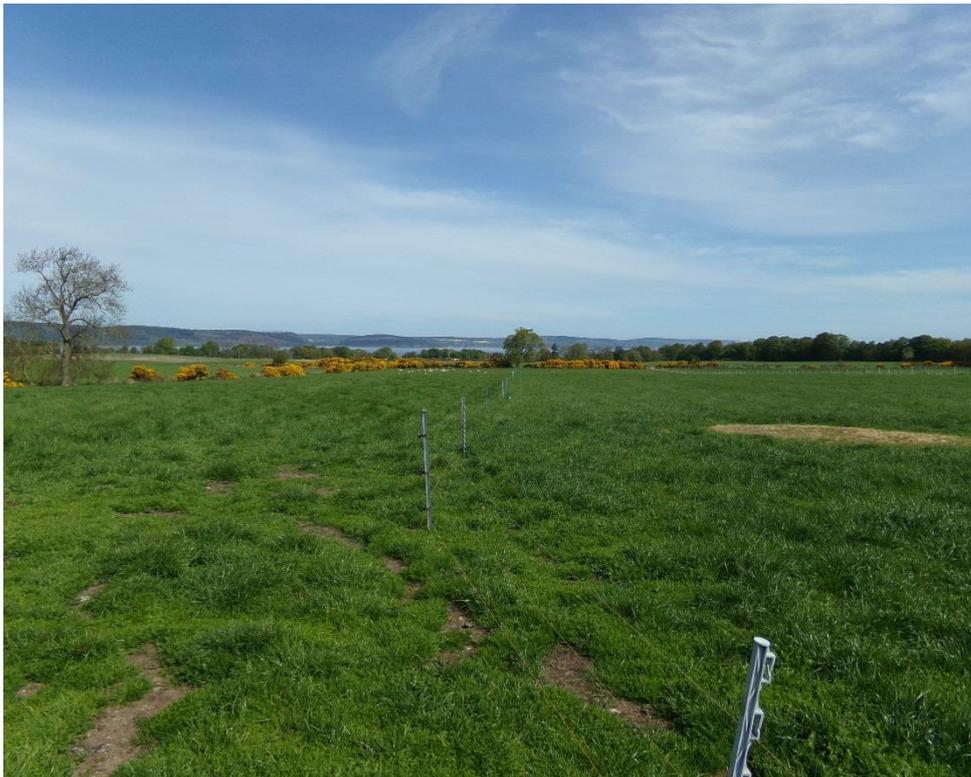
Photograph 14.4: Rectilinear Fields and Farms (HLT 2), Looking North

- 14.6.13 Photographic surveys will be undertaken prior to construction to record the current condition of Rectilinear Fields and Farms (HLT 2). The photographic surveys will be undertaken in accordance with the guidance provided in Understanding the Archaeology of Landscapes: A Guide to Good Recording Practice (Second Edition) (Historic England 2017) (**Mitigation Item CH-11**).
