Project **FORTH REPLACEMENT CROSSING**

**AIR QUALITY MONITORING REPORT**  
**FEBRUARY 2012**

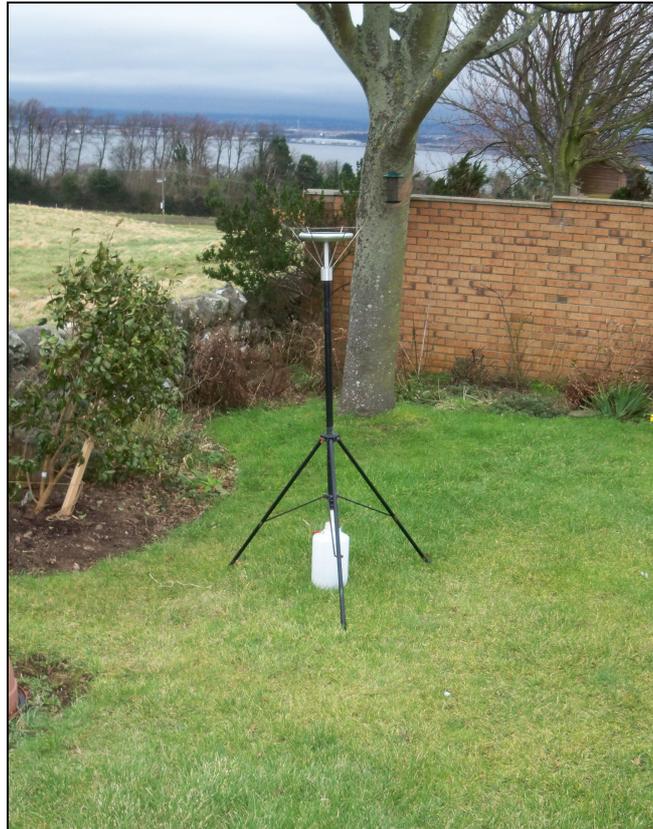
**Figure 1: Example of an Installed Frisbee Gauge Meters**

- 2.1.** Air quality is being monitored on site using both automatic light scatter dust meters and Frisbee gauge dust deposition monitoring. Twelve Frisbee gauges are set up at sensitive locations across the site to measure dust deposition rates (Figure 1). Seven automatic light scatter meters have also been installed at various sensitive locations to measure real time particulate matter (PM<sub>10</sub>) concentrations (Figure 2). Table 1 lists the air quality monitoring equipment present at each monitoring location.

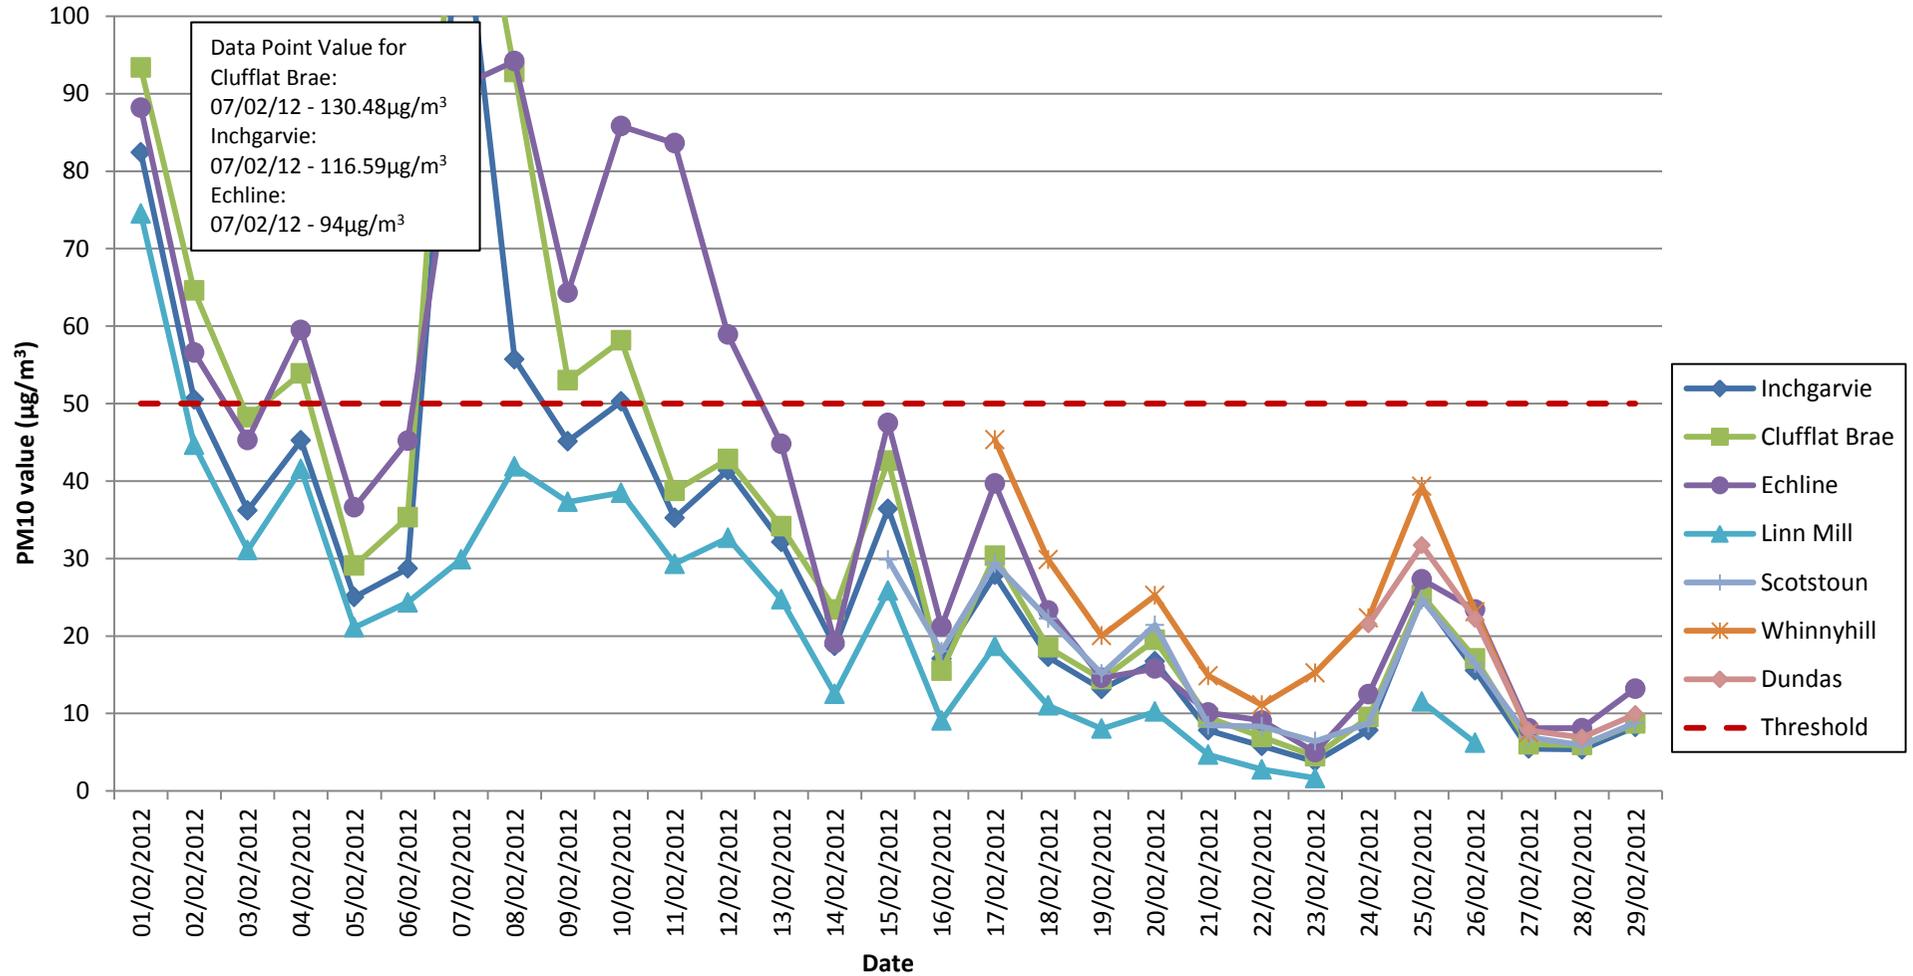
## PM10 Results February 2012: All Locations

**Note:** Monitoring began at the following locations during February; Scotstoun (14/02/12), Whinnyhill (16/02/12) and Dundas (23/02/12). Data is missing for Linn Mill: 24/02/12, 27/02/12, 28/02/12 and 29/02/12 and for Whinnyhill: 28/02/12 to 29/02/12 due to device error. The results for Echline and Dundas have been multiplied by 10.

**3.1.1.** Light scatter results for February 2012 have been presented in a monthly chart. This can be found in Appendix A. Results show that, for the majority of the period, the PM<sub>10</sub> concentrations were below the threshold for each location. From the 13 February 2012 onwards all locations were within the threshold value of 50µg/m<sup>3</sup>. Additionally, the results were compared to the daily mean results from the TEOM air quality monitoring stations located in Rosyth, Broxburn and Queensferry Road, Edinburgh (Appendix A). This demonstrated that the results obtained using the light scatter meters follow the same pattern as those collected from the TEOMs; this indicates that the pattern observed throughout February was due to regional changes in air quality, rather than due to construction works.

**3.1.2.** Readings at Echline and Dundas both appeared to be low in comparison to the other meters on site. As meters across the site would be expected to read similarly, with the exception of during a localised air pollution incident, these low readings were investigated in consultation with the supplier. The supplier confirmed that the meters were reading low by a factor of approximately 10, thus the results have been updated to reflect this.

**3.1.3.** Some exceedances of the PM<sub>10</sub> threshold did occur within the period. These exceedances generally occurred as single daily peaks rather than continued periods. Table 2 lists the dates and locations of all February exceedances of the PM<sub>10</sub> threshold. Echline experienced the greatest number of exceedances (9 exceedances in total). However, no exceedances during the period were found to be attributable to construction; real time triggers were received to inform of any exceedances, initiating investigations into the causes during working

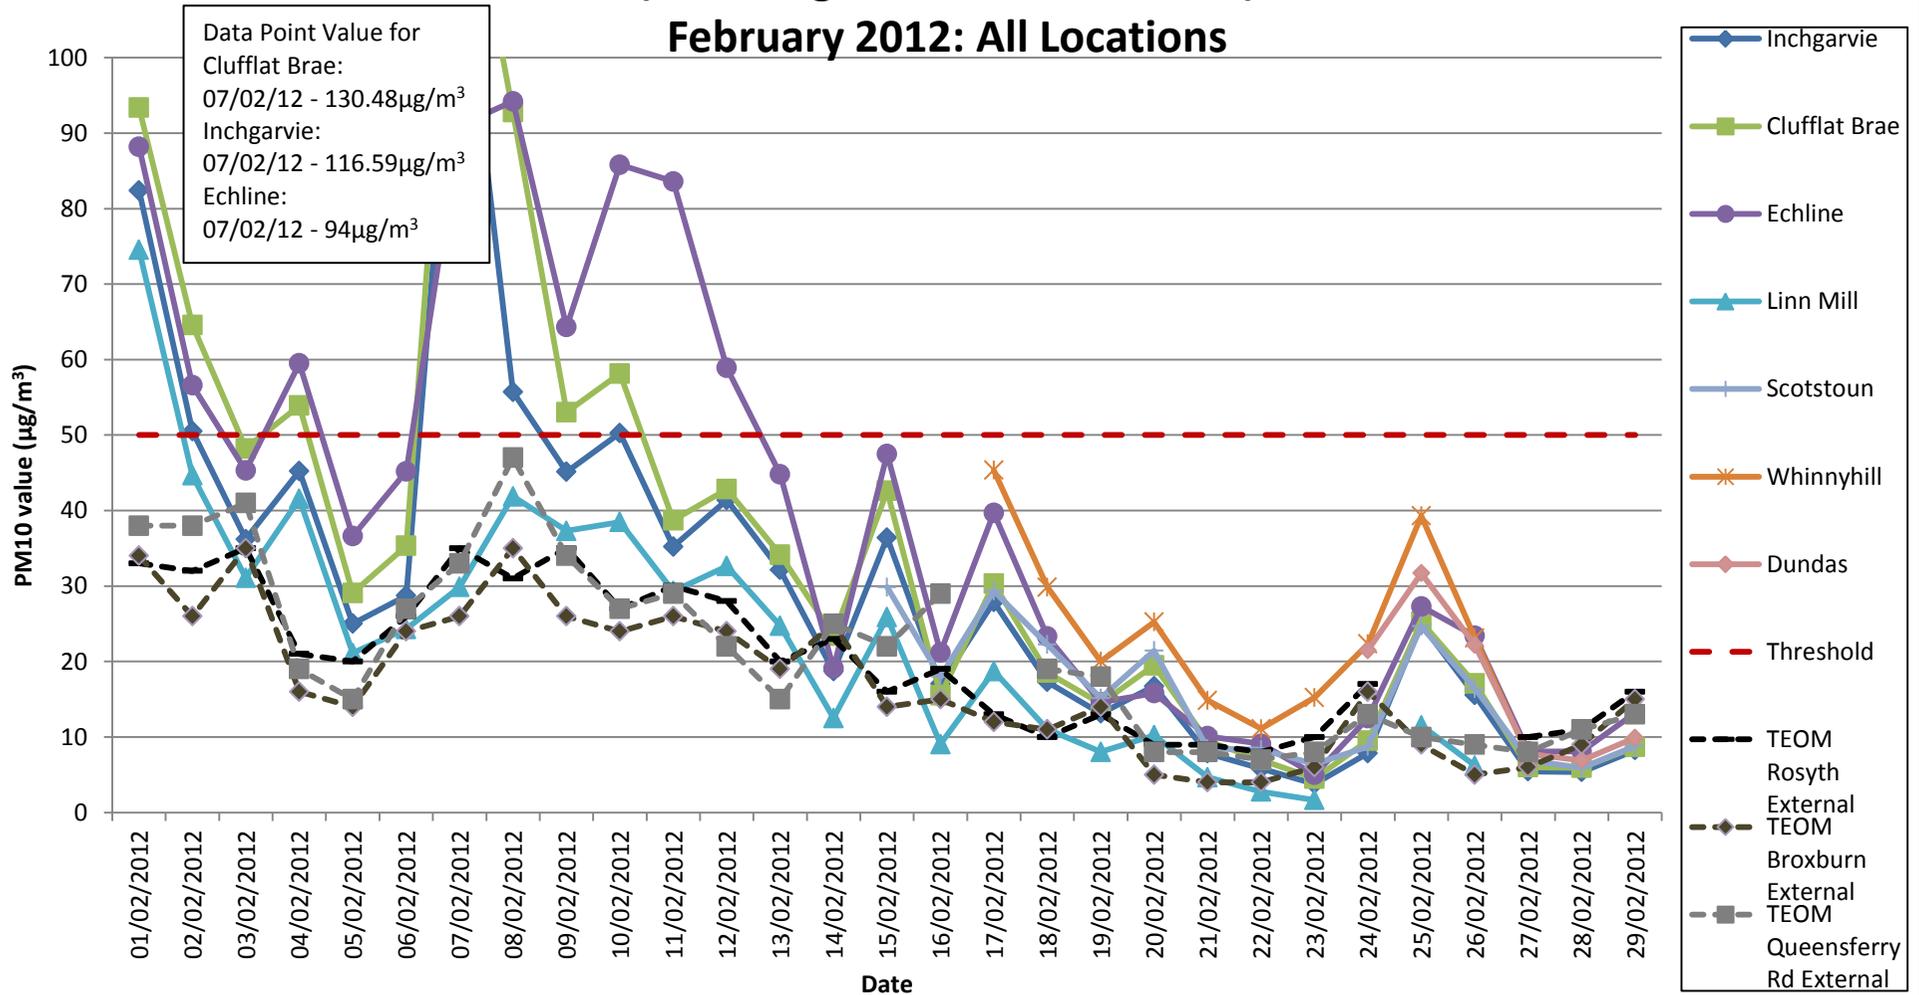
## PM10 Results (Including External TEOM Data) February 2012: All Locations

**Note:** Monitoring began at the following locations during February; Scotstoun (14/02/12), Whinnyhill (16/02/12) and Dundas (23/02/12). Data is missing for Linn Mill: 24/02/12, 27/02/12, 28/02/12 and 29/02/12 and for Whinnyhill: 28/02/12 to 29/02/12 due to device error. The results for Echline and Dundas have been multiplied by 10 following consultation with the supplier.
