Project **FORTH REPLACEMENT CROSSING**

**AIR QUALITY MONITORING REPORT**  
**APRIL 2013**

Document number  
**REP-000-00113-00**

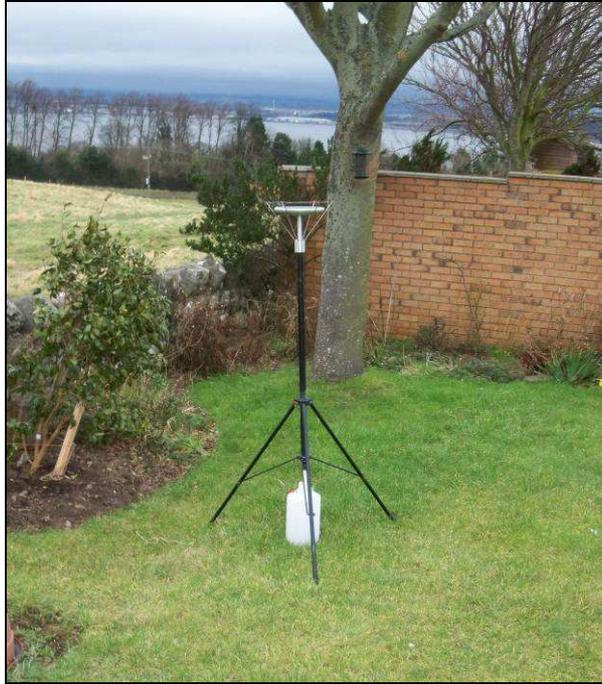
**2.1.** Air quality is being monitored on site using both automatic light scatter dust meters and Frisbee gauge dust deposition monitoring. Thirteen Frisbee gauges are set up at sensitive locations across the site to measure dust deposition rates (Figure 1). Seven automatic light scatter meters have also been installed at various sensitive locations to measure real time particulate matter (PM<sub>10</sub>) concentrations and the Total Suspended Particle (TSP) concentrations (Figure 2). Table 1 lists the air quality monitoring equipment present at each monitoring location. The installation of the air quality monitoring equipment was not simultaneous across the site, thus installation dates are also given in Table 1.

**Figure 1: Example of an Installed Frisbee Gauge Meters**
