Fish Barriers on Scottish Major Roads

Scottish Road Research Board

Document Title: Fish Barriers on Scottish Major Roads

Client Name: Transport Scotland

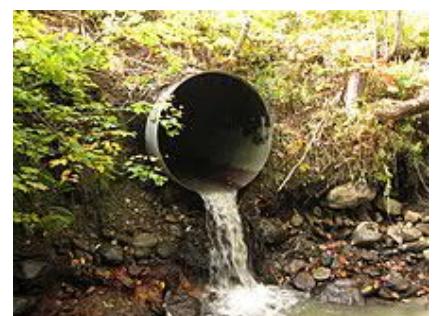
Figure 2. Example culvert.

Culverts are used to allow a river channel to flow underneath civil engineering infrastructure. They take the place of the natural river channel and thus alter the flow characteristics and hinder natural river connectivity. As a result, culverts are known to contribute to a decline of fish populations.

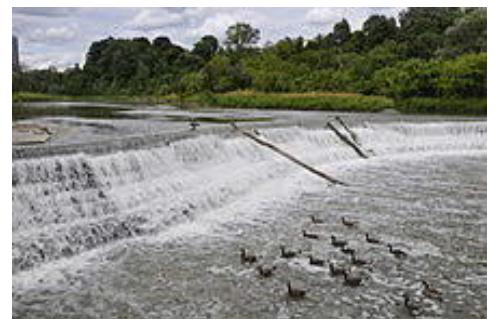
Figure 3. Example weir.

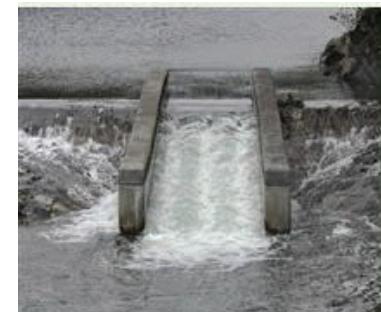
- Baffled Passes – water is redirected down a rectangular channel by a series of 'baffles' placed within a sloping channel. This results in a continual dissipation of energy and controlled water velocities. The four main types of Baffle Passes are: Larinier Baffle Fish Pass, Plane Baffle Pass (Denil), Alaskan and Chevron. An example of a Larinier Baffle Fish Pass is shown in Figure 4.

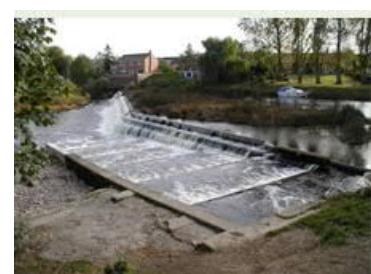
- Pool & Weir Passes – consist of a number of pools which are organised as a series of steps and are separated by cross walls. Resting areas for migrating fish are provided to dissipate energy, either in large eddies or by turbulent mixing and a hydraulic jump. These passes can be used by the majority of fish species. An example Pool Pass is shown in Figure 5.

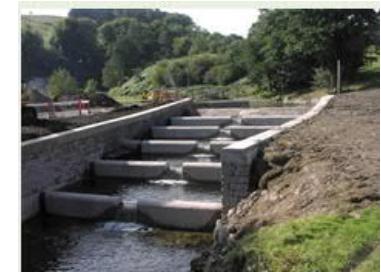
- Pre-Barrages – a small weir that is placed downstream of the structure to cause water to back up and flood the downstream end of a potential obstruction, thus improving hydraulic conditions and acting to facilitate entry into and passage through a structure. An example of Pre-Barrages is shown in Figure 6.

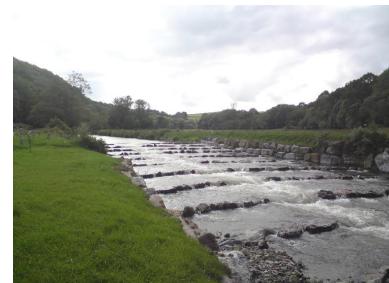
- Rock-Ramp Passes – involve the direct integration of a ramp of bedrock or concrete-embedded boulders spanning the entire width of the obstruction. These are used extensively worldwide and often considered as the form of fish pass that best replicates natural rapids. An example Rock-Ramp Pass is shown in Figure 7.

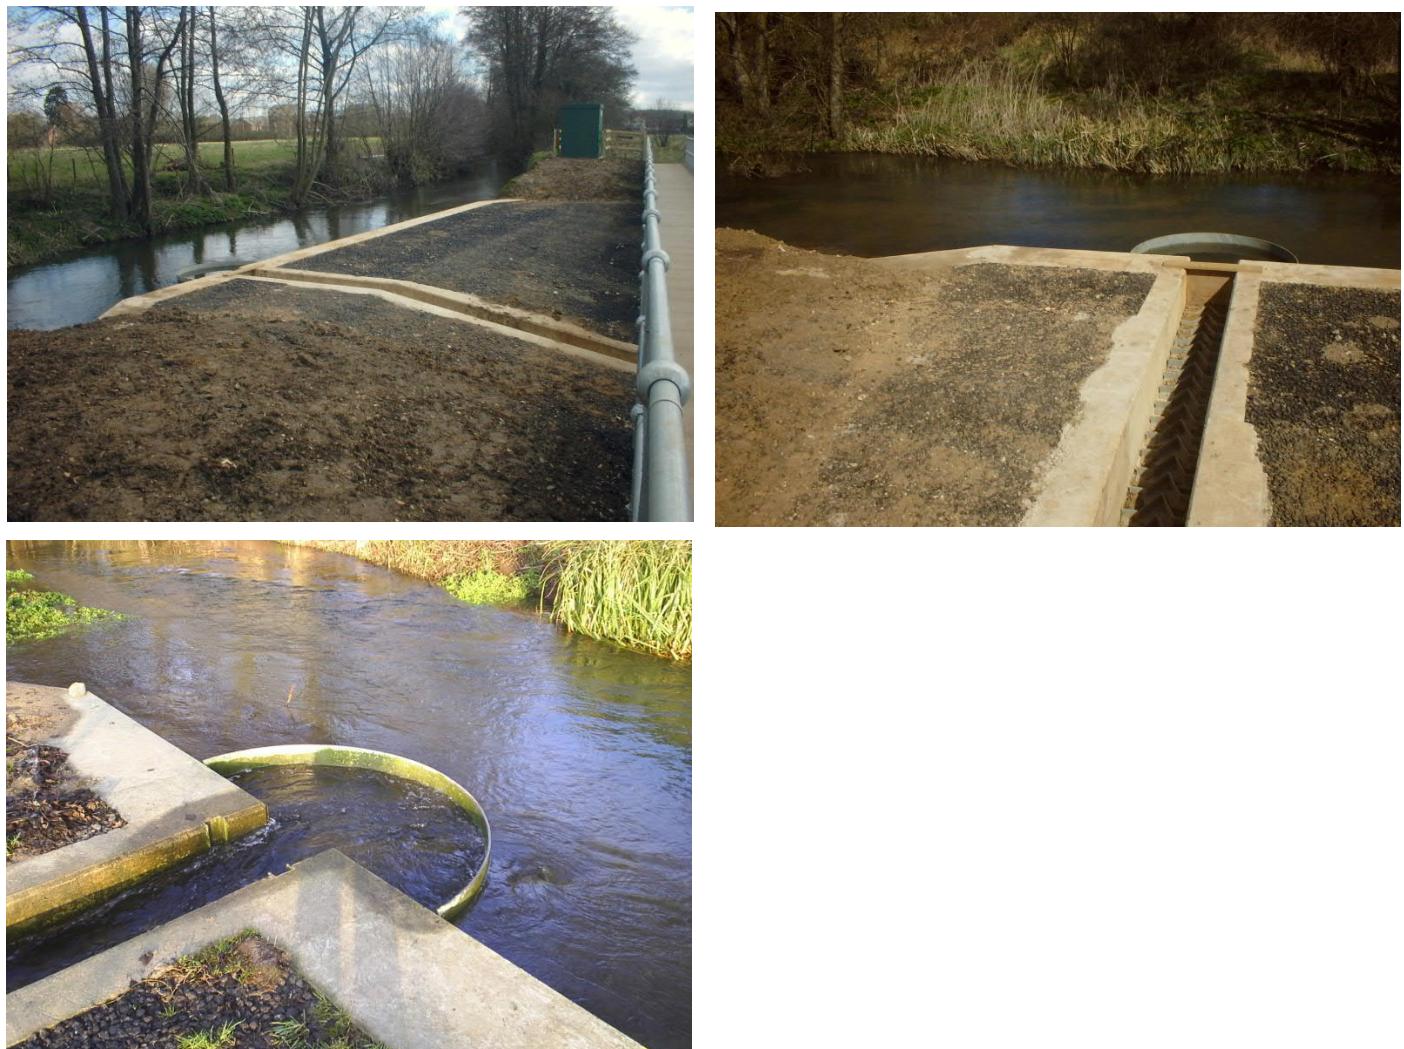
Figure 11. Photographs of the fish pass.

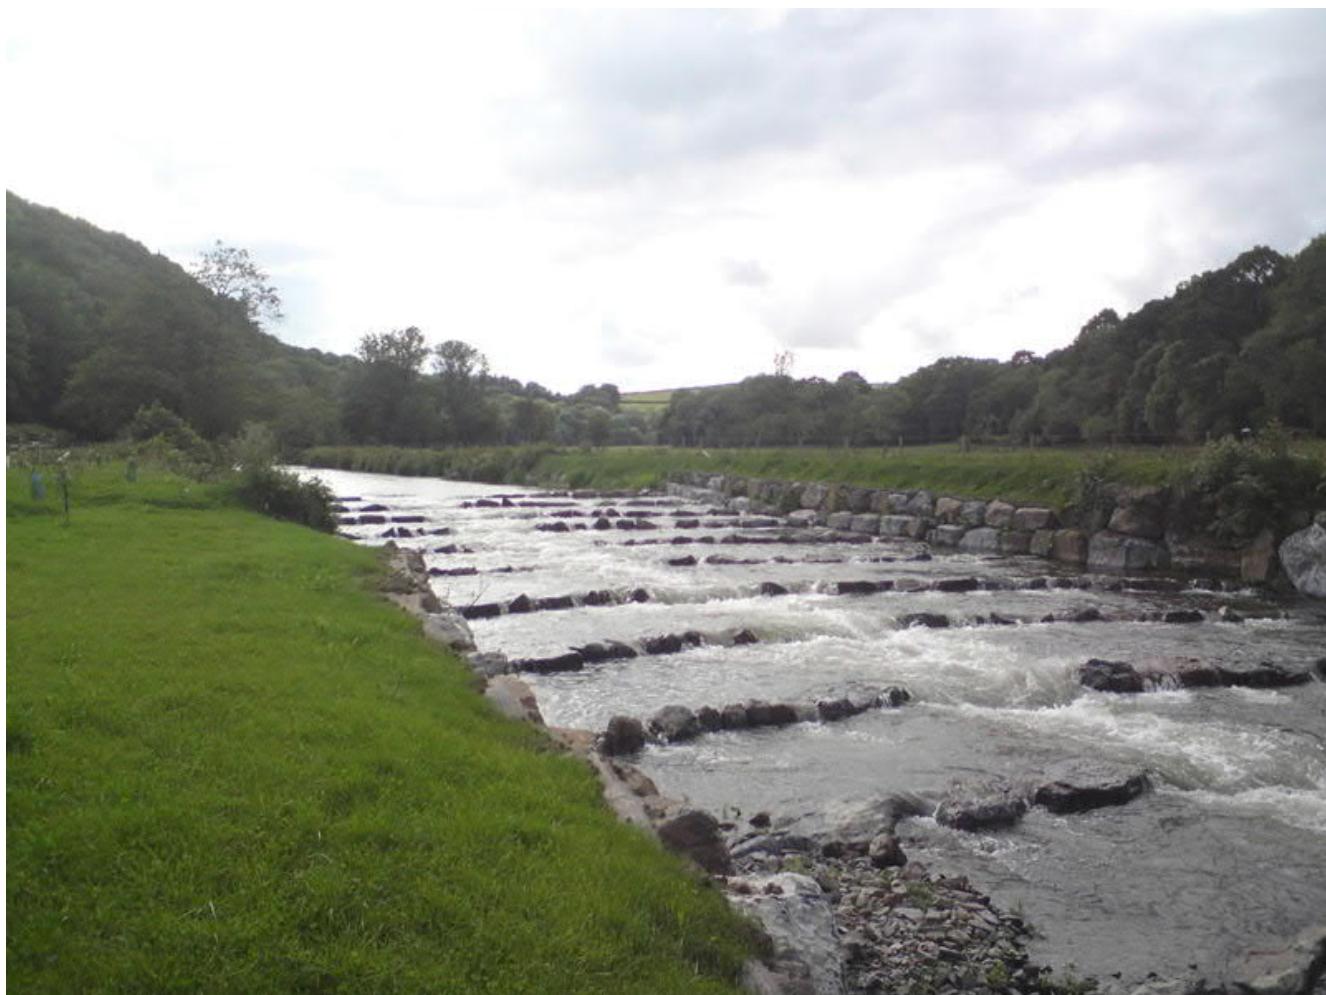
Figure 15. Photograph of the finished fish pass.

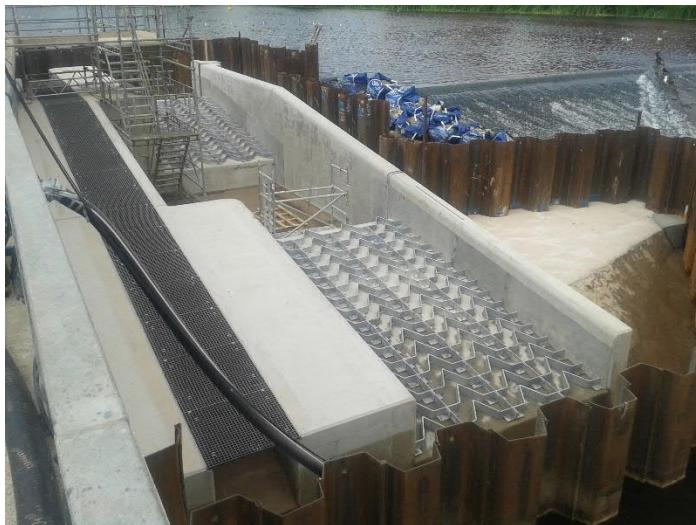
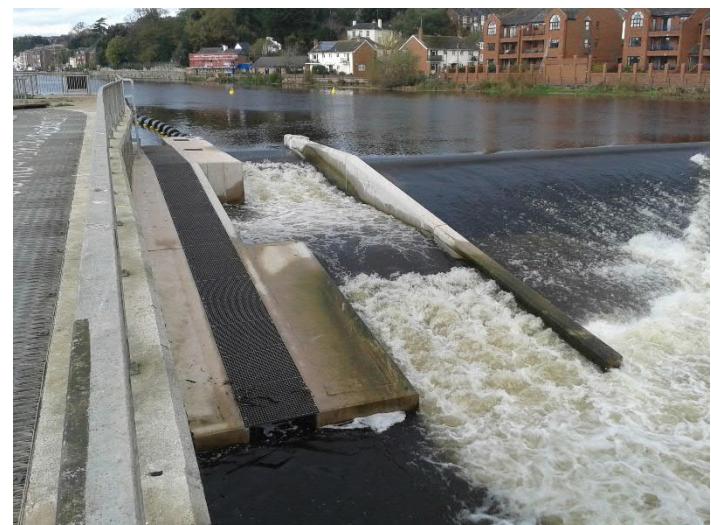
A secondary Larinier Baffle Fish Pass has been provided in the side spill inlet weir to the Flood Relief Channel. To minimise construction costs and overall footprint, the pass was constructed in a galvanised steel channel. Again, to meet the technical requirements of the EA fish pass group, a central rest pool was constructed on an elevated platform midway along the pass. Photographs of the fish pass can be found in Figure 18.

Figure 18. Photographs of the fish pass.

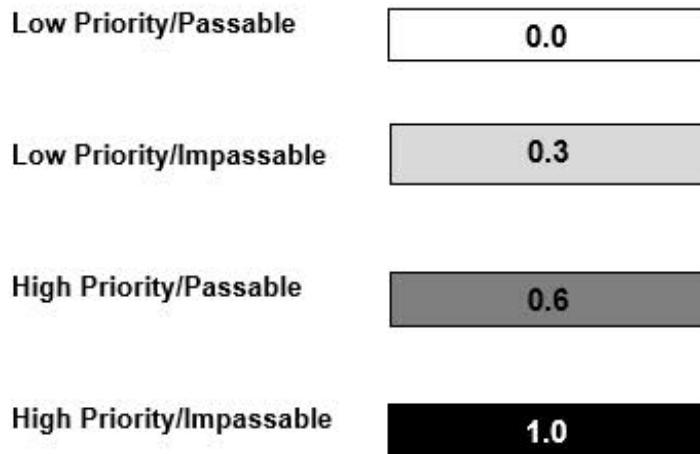
The scoring system is placed at the bottom of the checklist with a request to score the culvert from 0.0 (low priority and passable) to 1.0 (high priority and impassable). The scoring system is shown in Figure 24.

Figure 24. The scoring system.

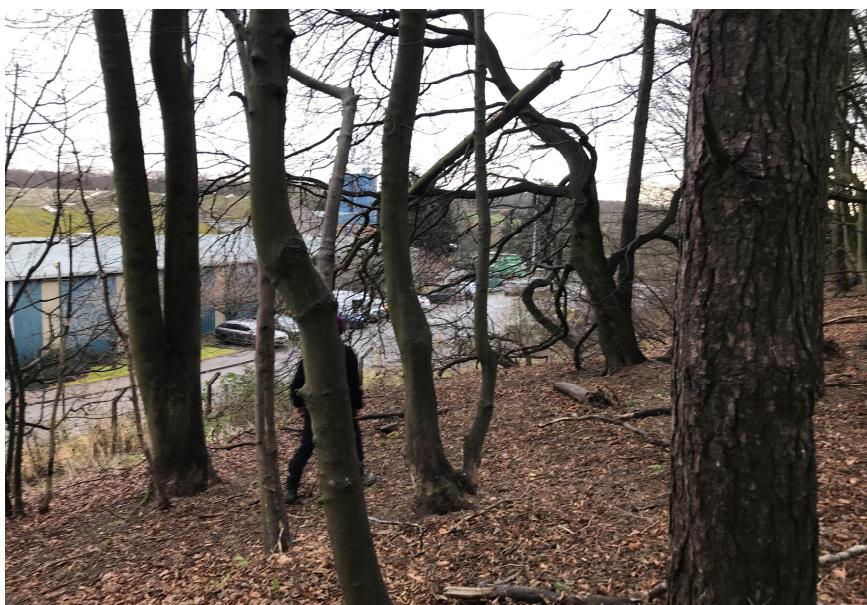
Figure 25. The sloping valley side leading down to the car park of Stoneywood Mill.

FB20689 and FB20690 are in close proximity to one another in Aberdeen City. Ownership of FB20689 is unknown. FB20690 is privately owned by Stoneywood Mill. The culvert runs under the car park of the mill (Figure 25) with an outlet into the River Don.

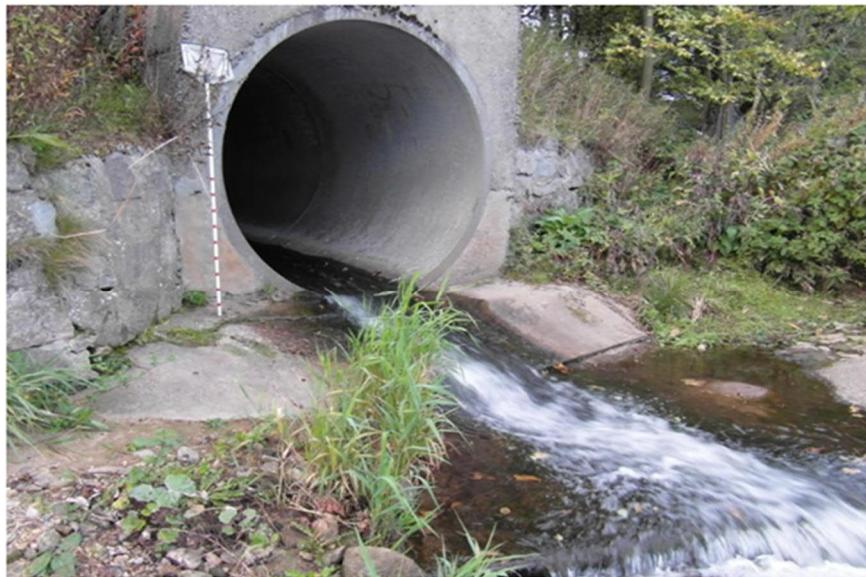
Figure 26. The downstream outlet of FB20689.

Two options for improvement can be considered here. The first is to build a weir or Pre-Barrage downstream of the culvert outlet to increase the water depth in the downstream pool and throughout the culvert and to reduce the velocity. However, with such a long and dark culvert, it is still unlikely that this would attract fish.

The second option, which is preferred by SEPA, is to either divert the channel from the car park or to open the culvert from underneath the car park to introduce light. This would involve a major operation as a full diversion and restoration project. If the channel were to be diverted, it would be necessary to find a channel gradient suitable to the steep sloping land at the side of the channel. Given the length and lack of light in the culvert, diverting the channel or opening the culvert would be the recommended option. For both options, large rocks will be required upstream to produce eddies and provide a resting place for fish.

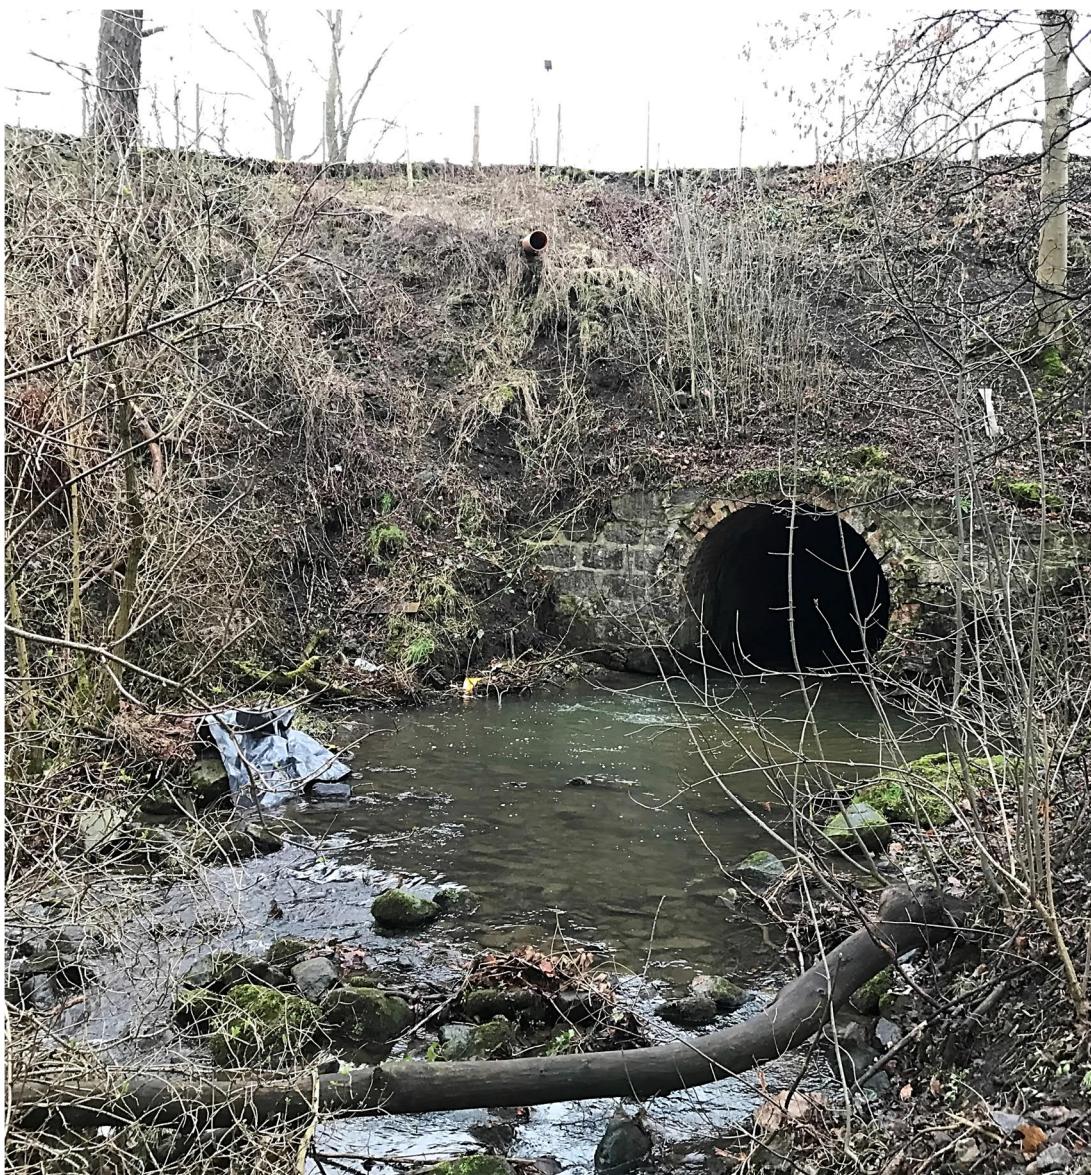
Around 60m upstream of FB20689 is FB20690. This is an extremely long and dark culvert. The depth through the culvert looks adequate, whereas the river bed downstream of the culvert outlet is shallow and is only passable at high flows (Figure 27). Making this culvert passable could be a major highway project if the culvert is opened with a bridge to introduce light. Whilst this is the recommended solution, a cheaper alternative to be considered would be using artificial lighting, preferably with a solar panel and battery, along with a Pre-Barrage downstream.

Figure 27. The downstream outlet of FB20690.

Improvements should only be considered to FB20690 if it is confirmed that work is possible at FB20689, and vice versa. In cases such as this where a large amount of work would be involved to improve the structures, consultation is required with SEPA to determine if the upstream habitat is in good enough condition to merit the level of work.

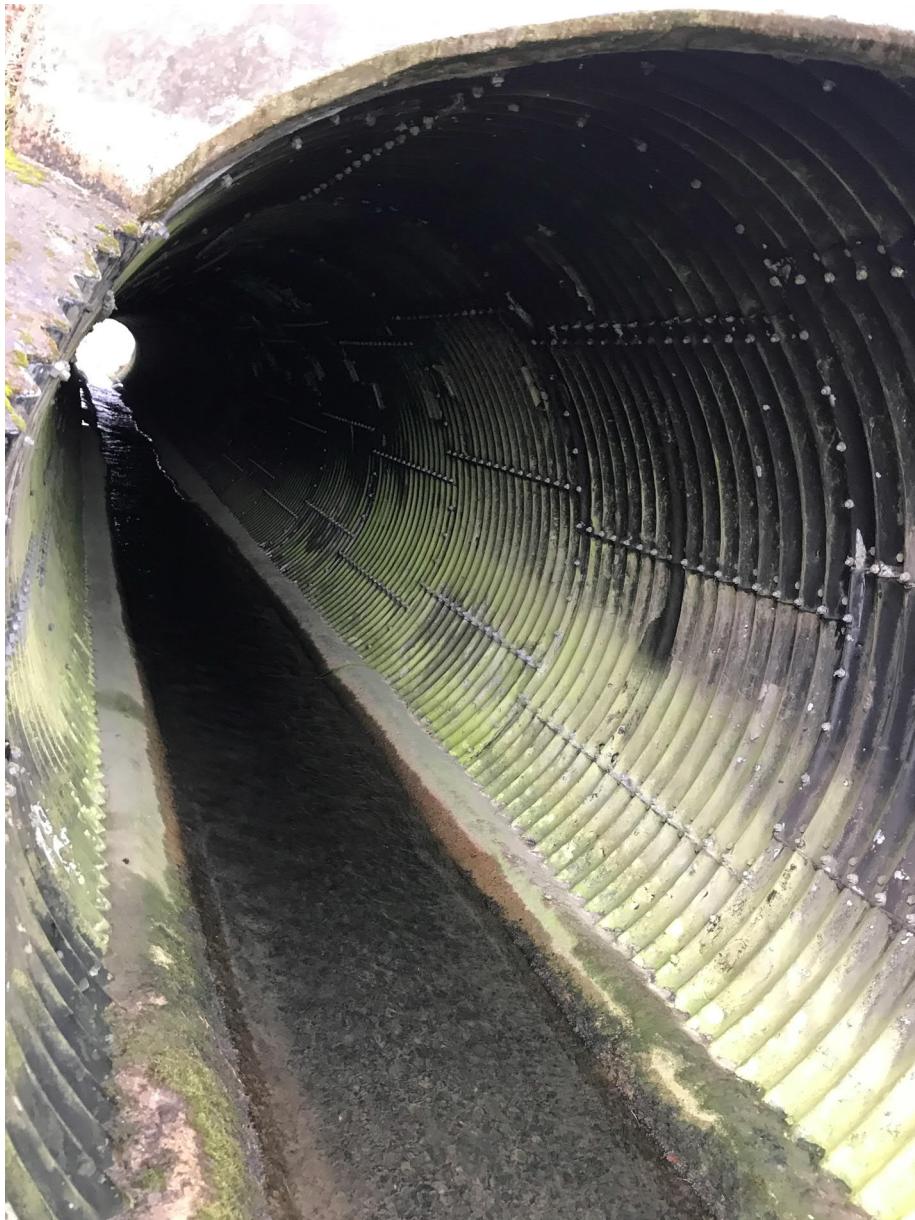
FB3176 runs under the A96. The channel is shallow throughout the culvert with a very high velocity making it impassable to fish (Figure 28). The SEPA ecologist on site advised sea trout have been found in the channel.

Figure 28. View from the outlet facing upstream (FB3176).

A Pre-Barrage or small weir structure is required downstream of the culvert to back up water, thus reducing water velocity and increasing the depth throughout. A low flow notch should be included in the middle of the Pre-Barrage to concentrate flows and ensure passage in low flows. The channel upstream of the culvert is a suitable habitat (Figure 29).

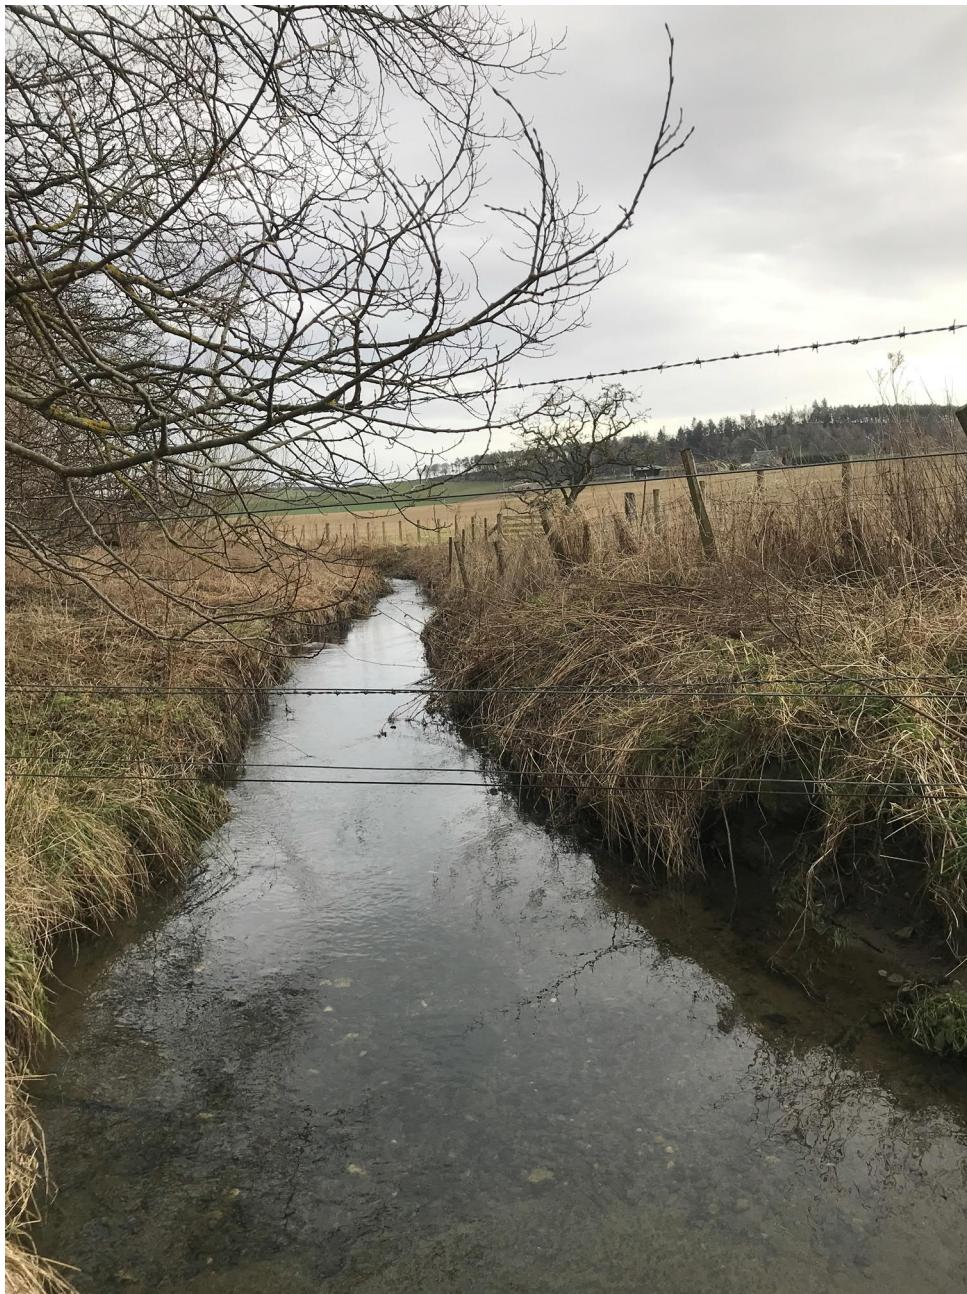
Figure 29. Upstream channel at FB3176.

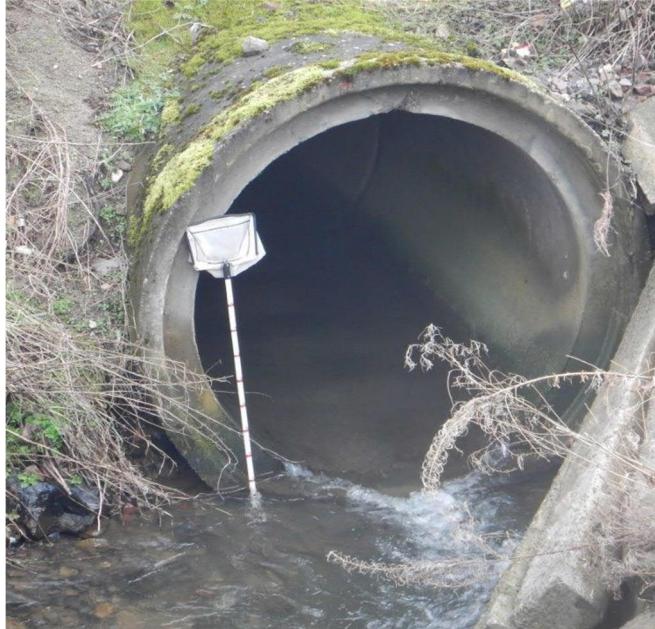
Downstream of FB3176 is another impassable culvert running under an industrial site (Figure 30). SEPA consider this to be possibly passable at medium flows. While the water in the culvert is relatively deep, a Pre-Barrage is required downstream to hold water depth throughout during low flows. Large rocks are required in the channel upstream of the inlet to create eddies.

Figure 30. The downstream outlet on the left and the upstream inlet on the right (Culvert 2).

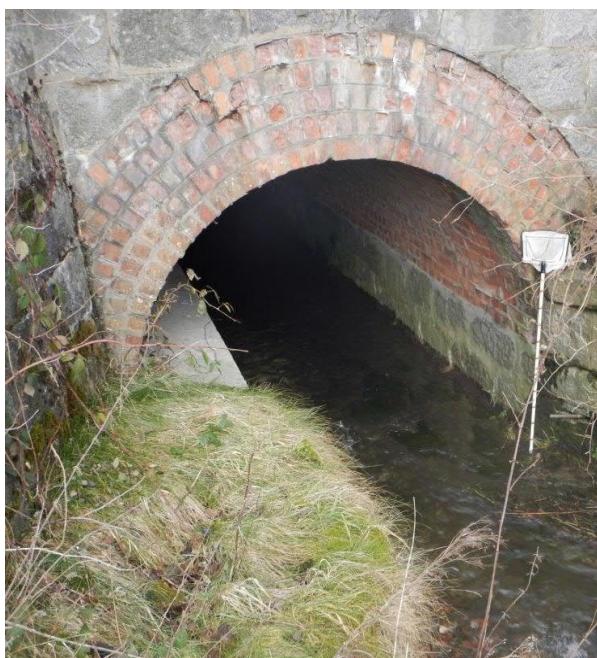
A third culvert is found slightly further downstream which runs under a disused Network Rail line (Figure 31). The culvert is unattractive to fish due to its length and lack of light. Only the upstream inlet of the culvert could be viewed due to access issues, and large rocks are required here to create eddies. A Pre-Barrage may be necessary downstream, but it was not possible to confirm this.

Figure 31. Upstream inlet of Culvert 3.

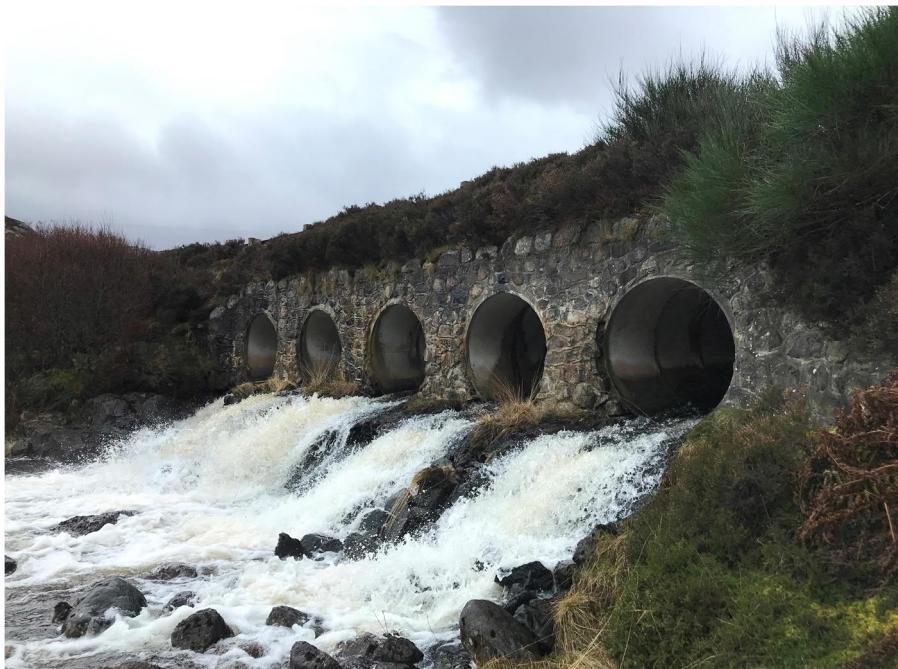
FB602 can be found North of Poolewe. It is a five-pipe culvert and weir running under the A832 road, managed and maintained by Highland Council (Figure 32). There is a lack of flow concentration with the channel flowing through all five pipes. The weir at the downstream outlet is large with an insufficient depth in the pools below. Due to the slope and lack of friction within the culvert pipes the water velocity is extremely high as it approaches the crest of the downstream weir, making fish passage impossible at this site.

Figure 32. Downstream outlet of FB602.

Water depth is greater on the left bank (facing downstream), and so flow should be concentrated to the culvert on this side of the channel. Stop logs can be placed in the remaining four culverts to create this concentration. However, this could result in a reduced capacity through the culverts and so the resulting flood risk must be considered. Another method of concentrating flows is to lower the base of the culvert inlet which could potentially damage the bottom of the culvert.

There are two options for improvement here. First is for a Larinier Baffle Fish Pass with a plunge pool in the left-hand bank culvert. Larinier fish passes have lower maintenance requirements than other types and have good flow attraction. The second option is to use natural material found in the surrounding area to create a Rock-Ramp Fish Pass downstream leading up to the culvert. The rock pools should be of significant size to allow dissipation of energy. Whilst this is a lower cost option, and is possible given the availability of material, it will involve moving a large amount of rock and may require some imported material. A natural Rock-Ramp Pass at this site is also at a high risk of being washed away during a large flood due to the steep gradient and high water velocity. For these reasons, the Larinier Baffle Fish Pass is recommended.

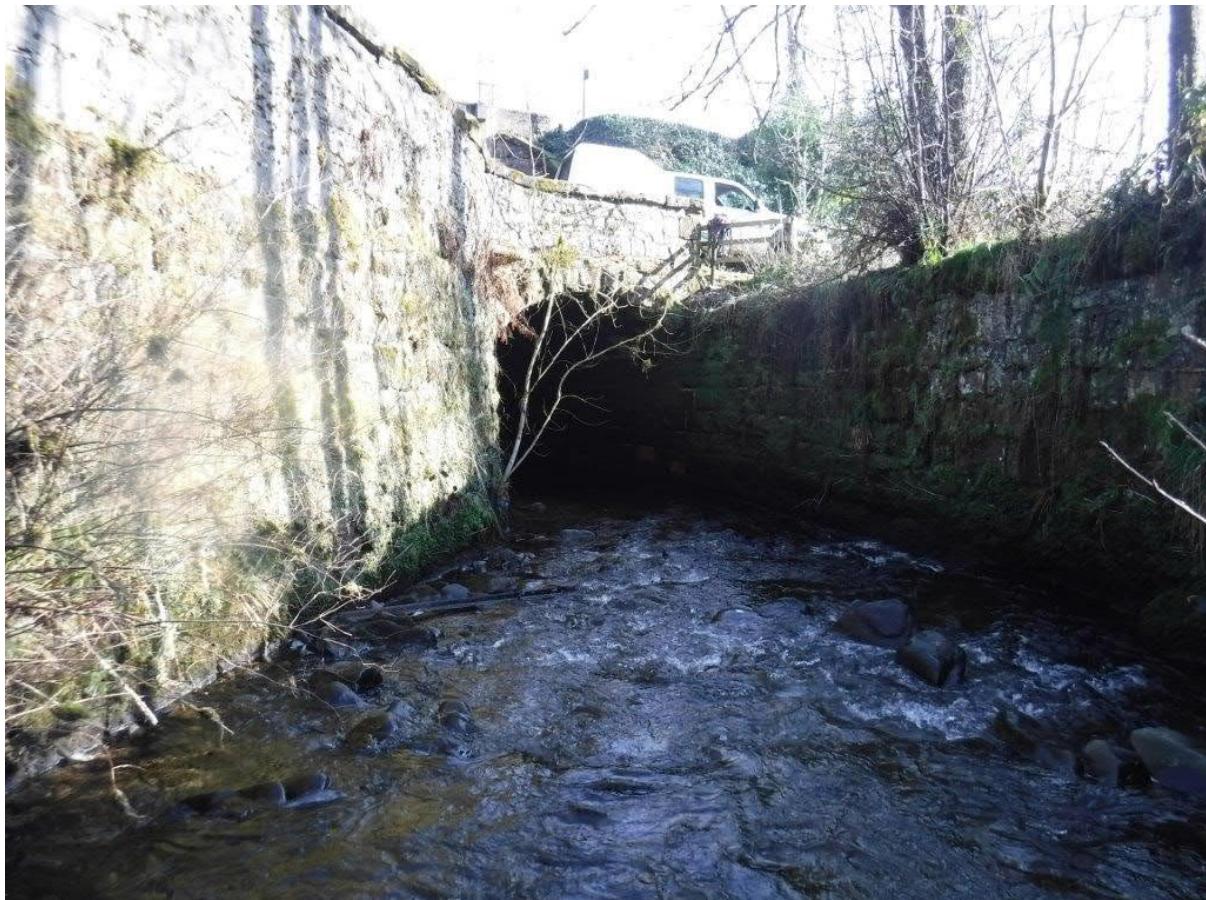
FB1423 is a culvert owned by Network Rail. The culvert is narrow downstream and widens as it moves upstream (Figure 33 and Figure 34). The channel is deep throughout the culvert but is very fast flowing. The main issue with this culvert is the length and lack of light. SEPA had concerns that there may be an impassable waterfall upstream of the culvert. This was checked during the site visit by conducting a walkover, but no impassable features were found upstream. There was a large log blocking some flow upstream of the culvert in an area of private land, however this can be easily removed and should not impact the decision on whether improvements can be made to the culvert.

Figure 33. Upstream inlet of FB1423.

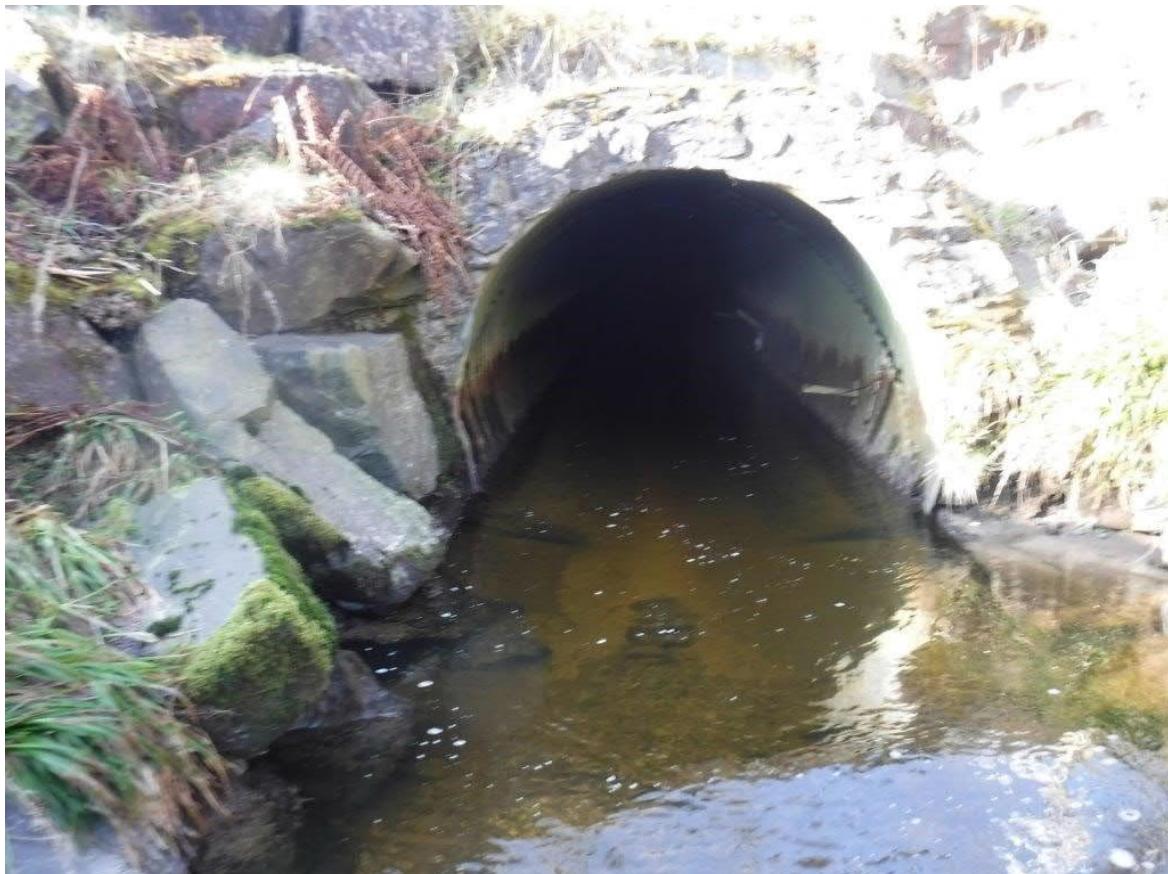
Figure 34. Downstream outlet of FB1423.

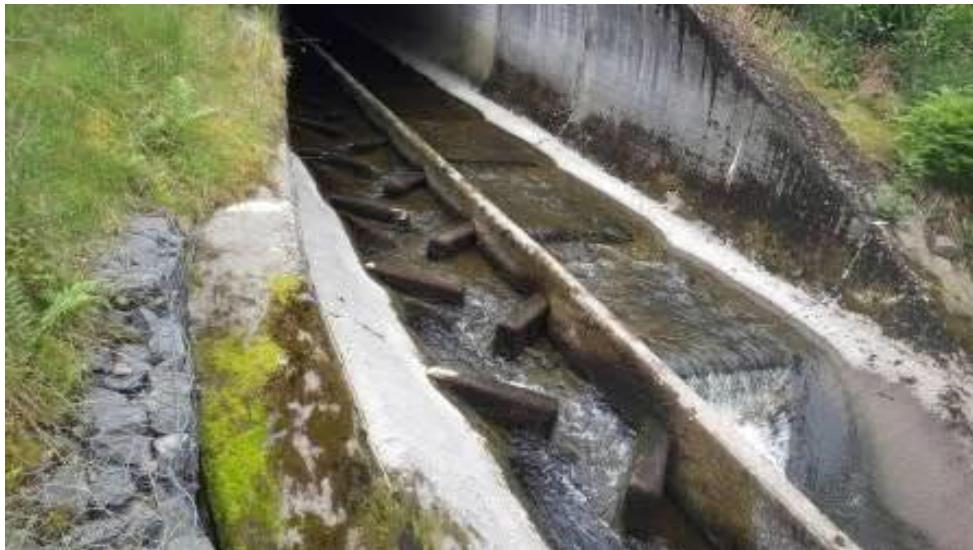
FB21394 has been deemed passable by SEPA and already has baffles within the culvert (Figure 36), which is likely to have been chosen as the solution here due to the steeper gradient. This barrier was included in the site visit to check the structural integrity. No modifications are required to FB21394. It should be noted, however, that there will be maintenance requirements at this site due to the potential for blockages in the baffles.

Figure 36. Downstream outlet of FB21394.

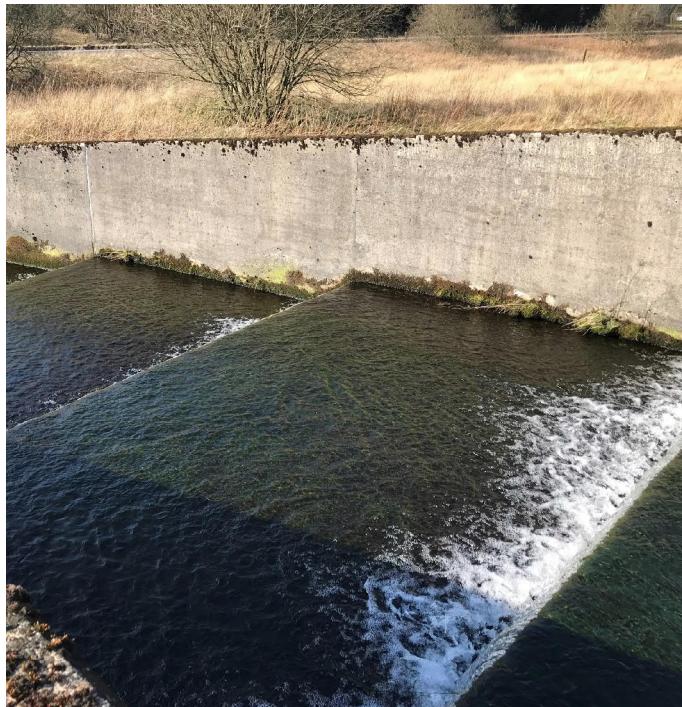
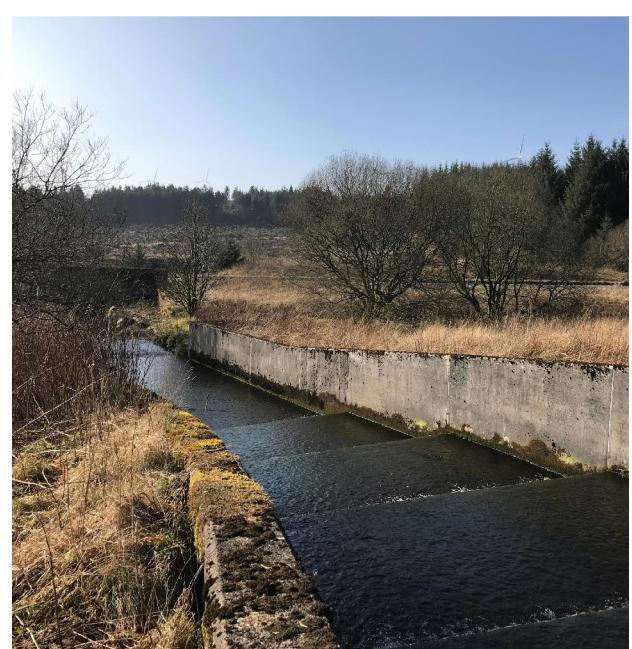
FB91 is an aqueduct over a National Rail line. There are currently a series of steps at the downstream end of the crossing over which the water depth is too shallow and channel slope too steep for migrating fish (Figure 37). The vertical sides to the channel prevent the formation of natural rest pools and eddies.

Figure 37. Series of steps downstream at FB91.

It is possible to work with the weir steps already in place by raising the height of the crests to create a deeper pool, allowing fish adequate depth for jumping. Low flow notches should be created in the middle of the crests to concentrate flow during low flows and to create eddies at either side. It should be noted that the walls surrounding the aqueduct are in poor condition (Figure 38) and may require structural support during any improvement works.

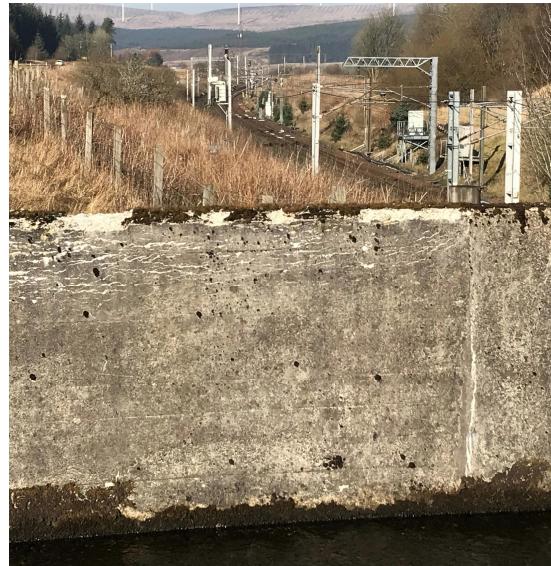
Figure 38. The surrounding walls of the aqueduct are in poor condition.
