FORTH REPLACEMENT CROSSING

**AIR QUALITY MONITORING REPORT
 DECEMBER 2012**

REP-00080-00

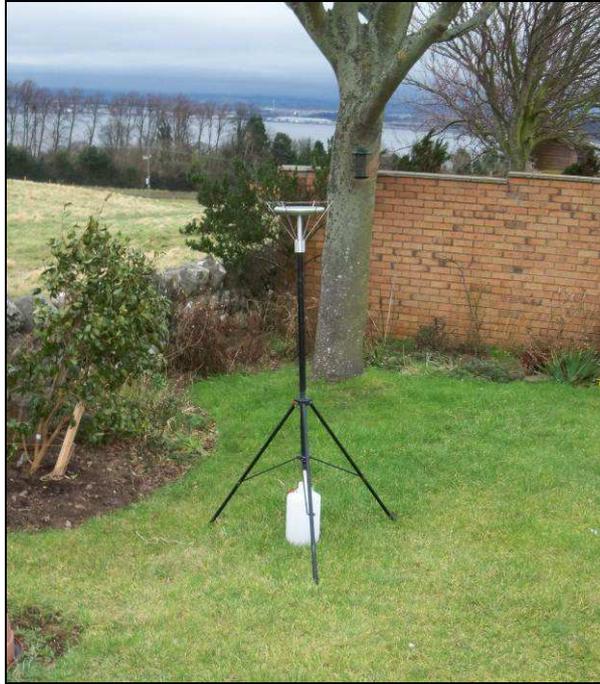
Figure 1: Example of an Installed Frisbee Gauge Meters

2.1. Air quality is being monitored on site using both automatic light scatter dust meters and Frisbee gauge dust deposition monitoring. Thirteen Frisbee gauges are set up at sensitive locations across the site to measure dust deposition rates (Figure 1). Seven automatic light scatter meters have also been installed at various sensitive locations to measure real time particulate matter (PM₁₀) concentrations and the Total Suspended Particle (TSP) concentrations (Figure 2). Table 1 lists the air quality monitoring equipment present at each monitoring location. The installation of the air quality monitoring equipment has not been simultaneous across the site, thus installation dates are also given in Table 1.

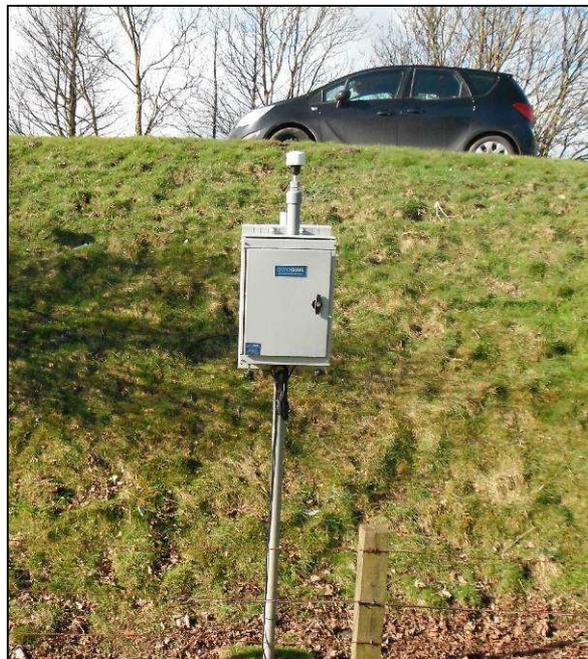
Figure 2: Example of an installed Automatic Light Scatter Dust Meter

2.2. Light scatter type monitoring equipment have been selected as a site monitoring tool to create a live network which assesses the levels of fugitive particulate matter, principally airborne dust. These monitors require less space, maintenance and power than other real time monitors such as a Tapered Element Oscillating Microbalance (TEOM) which is used and designed to measure particulate levels to exceedingly high standards, including measuring long-term compliance to statutory limits. Light scatter meters are more practicable to deploy. However, the meters do generally record levels higher than those measured by the TEOM. The meters can also be affected by atmospheric moisture content which further increases reported levels. Accordingly, any elevations of statutory limits should be treated as precautionary exceedances. The monitors are reliable for on-site monitoring and the establishment of action thresholds to ensure unforeseen activities generating significant dust are identified and suitably controlled. Light scatter meters are becoming the construction and waste industries norm for particulate dust monitoring.

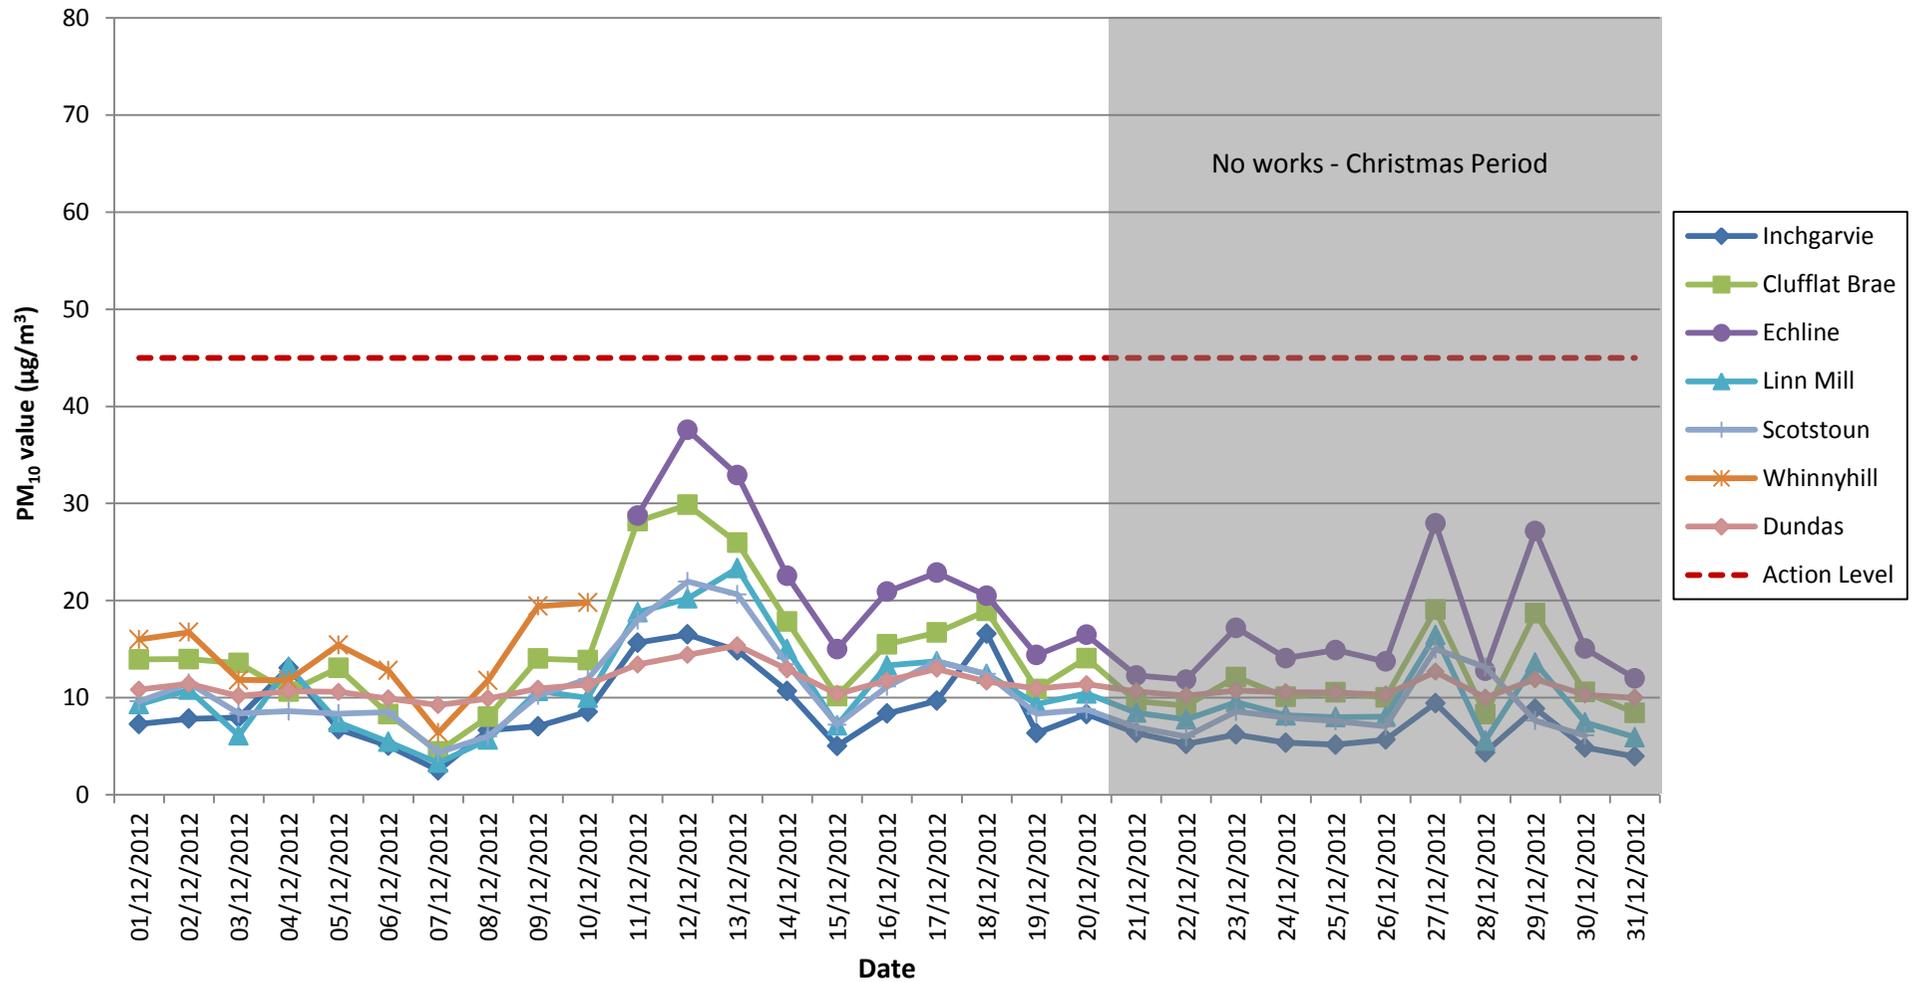
Air Quality Monitoring Particulate Matter (PM10) Results for all Monitoring Locations December 2012

3.1.1. Light scatter results for December 2012 have been presented in a monthly chart; this can be found in Appendix A. Results show that the PM₁₀ levels were low and largely followed the same pattern across the site. There were no exceedances of the threshold throughout December. It should be noted that no land-based works were undertaken over the Christmas period (21/12/12 to 07/01/13), indicating that changes in the particulate matter results during this period were not likely to be associated with construction works but were rather due to non-construction related factors. Damp weather conditions over this time would also restrict any dust arising from the site.

- 3.1.3.** Due to a pump failure with the Echline meter, data is missing for this monitoring location between 1 and 10 December. Whilst the Echline meter was sent for repair, the Whinny Hill device was relocated to Echline as a temporary measure. As a result, data is missing at Whinny Hill between 11 and 31 December. During site operating times over this period, there were increased visual inspections by the FCBC environmental team at Whinny Hill. However, it should be noted that works at Whinny Hill were demobilised for the Christmas period on 14 December, with no blasting or drilling occurring between the 10 and 14 December. Therefore, it was considered that the meter would be better placed at Echline.

Note: The greyed out area of the graphs represents the Christmas period over which no works were undertaken (21/12/12 to 07/01/12). Due to a pump error with the Echline meter, there is no data for this location between 01/12/12 and 10/12/12. Whilst the Echline meter was away for servicing, the Whinny Hill meter was stationed at Echline as a temporary measure. Visual inspections were increased at Whinny Hill during the period for which data is missing for this location (10/12/12 to 20/12/12).

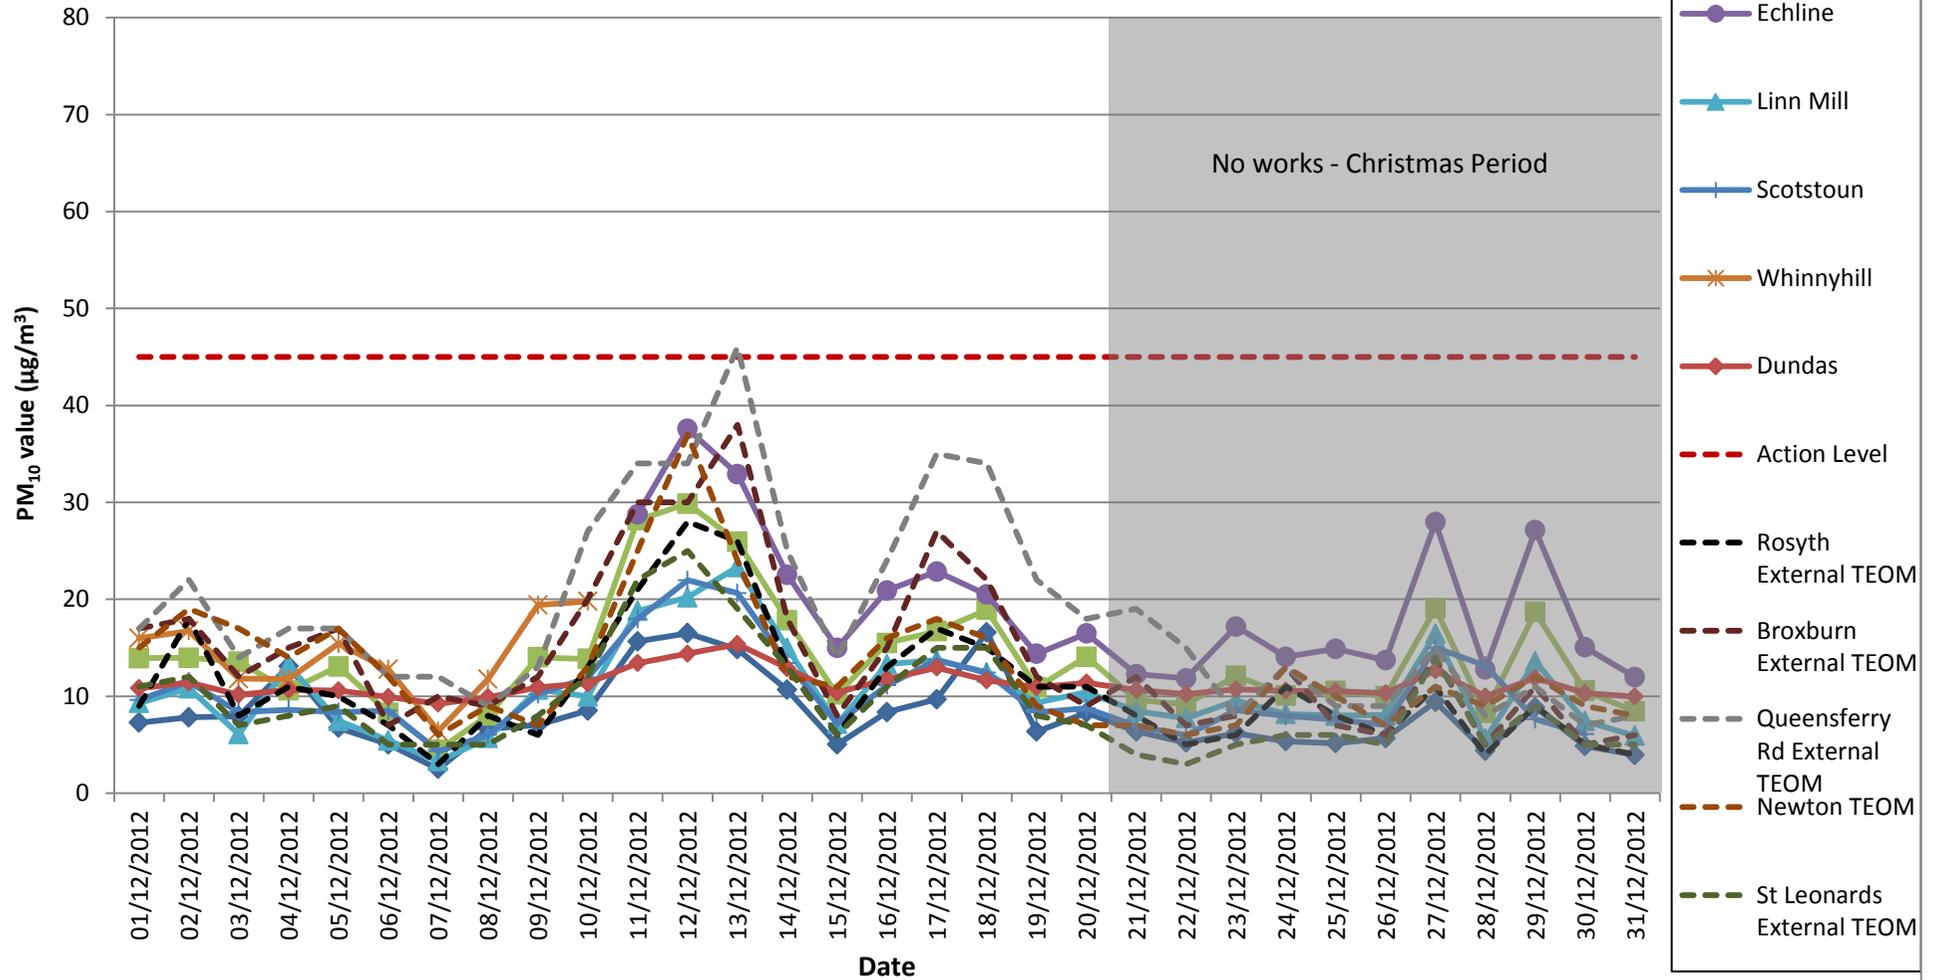
Air Quality Monitoring Particulate Matter (PM10) Results for all Monitoring Locations December 2012

3.1.2. The PM₁₀ results have also been compared to the daily mean results obtained from the TEOM air quality monitoring stations located in Newton, Rosyth, Broxburn, Queensferry Road, Edinburgh and St Leonards, Edinburgh (an urban background site). The TEOM at Newton was installed by West Lothian Council, facilitated by FCBC,

during May. The comparison between the light scatter and TEOM results demonstrates that both sets of results generally follow the same pattern at similar levels, indicating that the pattern observed throughout December was largely due to regional changes in air quality.

Note: The greyed out area of the graphs represents the Christmas period over which no works were undertaken (21/12/12 to 07/01/12). Due to a pump error with the Echline meter, there is no data for this location between 01/12/12 and 10/12/12. Whilst the Echline meter was away for servicing, the Whinny Hill meter was stationed at Echline as a temporary measure. Visual inspections were increased at Whinny Hill during the period for which data is missing for this location (10/12/12 to 20/12/12).

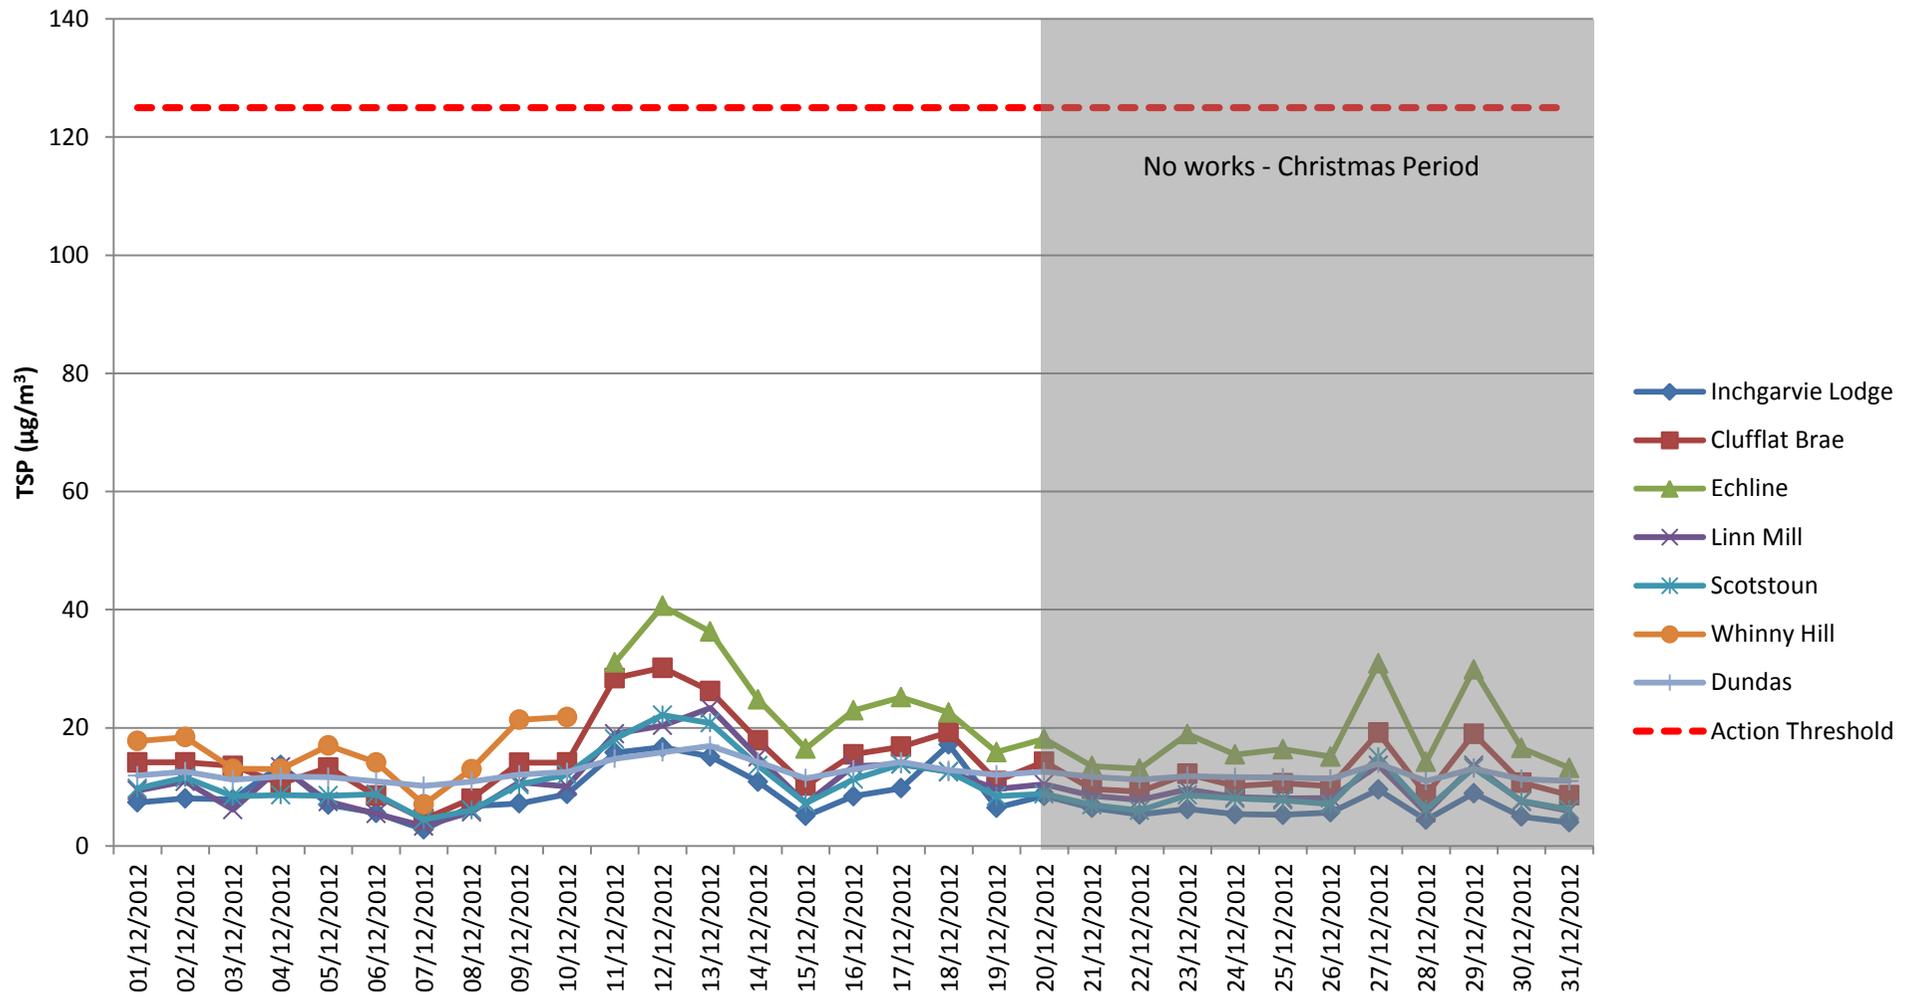
Total Suspended Particles (TSP) Results December 2012

- 3.2.1.** The TSP results for December 2012 have been presented in a monthly chart; this can be found in Appendix B. The TSP levels at all monitoring locations throughout December were within the threshold level and largely found to follow a similar pattern across the site, demonstrating that in general the levels are influenced by regional changes in TSP levels, rather than construction works.
- 3.2.2.** Data is missing for Echline between the 1 and 10 December due to a pump failure with this device. Data is also missing from Whinny Hill between 11 and 31 December as the Whinny Hill meter was temporarily relocated to Echline. Please refer to paragraph 3.1.3 for further information.

Note: The greyed out area of the graphs represents the Christmas period over which no works were undertaken (21/12/12 to 07/01/12). Due to a pump error with the Echline meter, there is no data for this location between 01/12/12 and 10/12/12. Whilst the Echline meter was away for servicing, the Whinny Hill meter was stationed at Echline as a temporary measure. Visual inspections were increased at Whinny Hill during the period for which data is missing for this location (10/12/12 to 20/12/12).

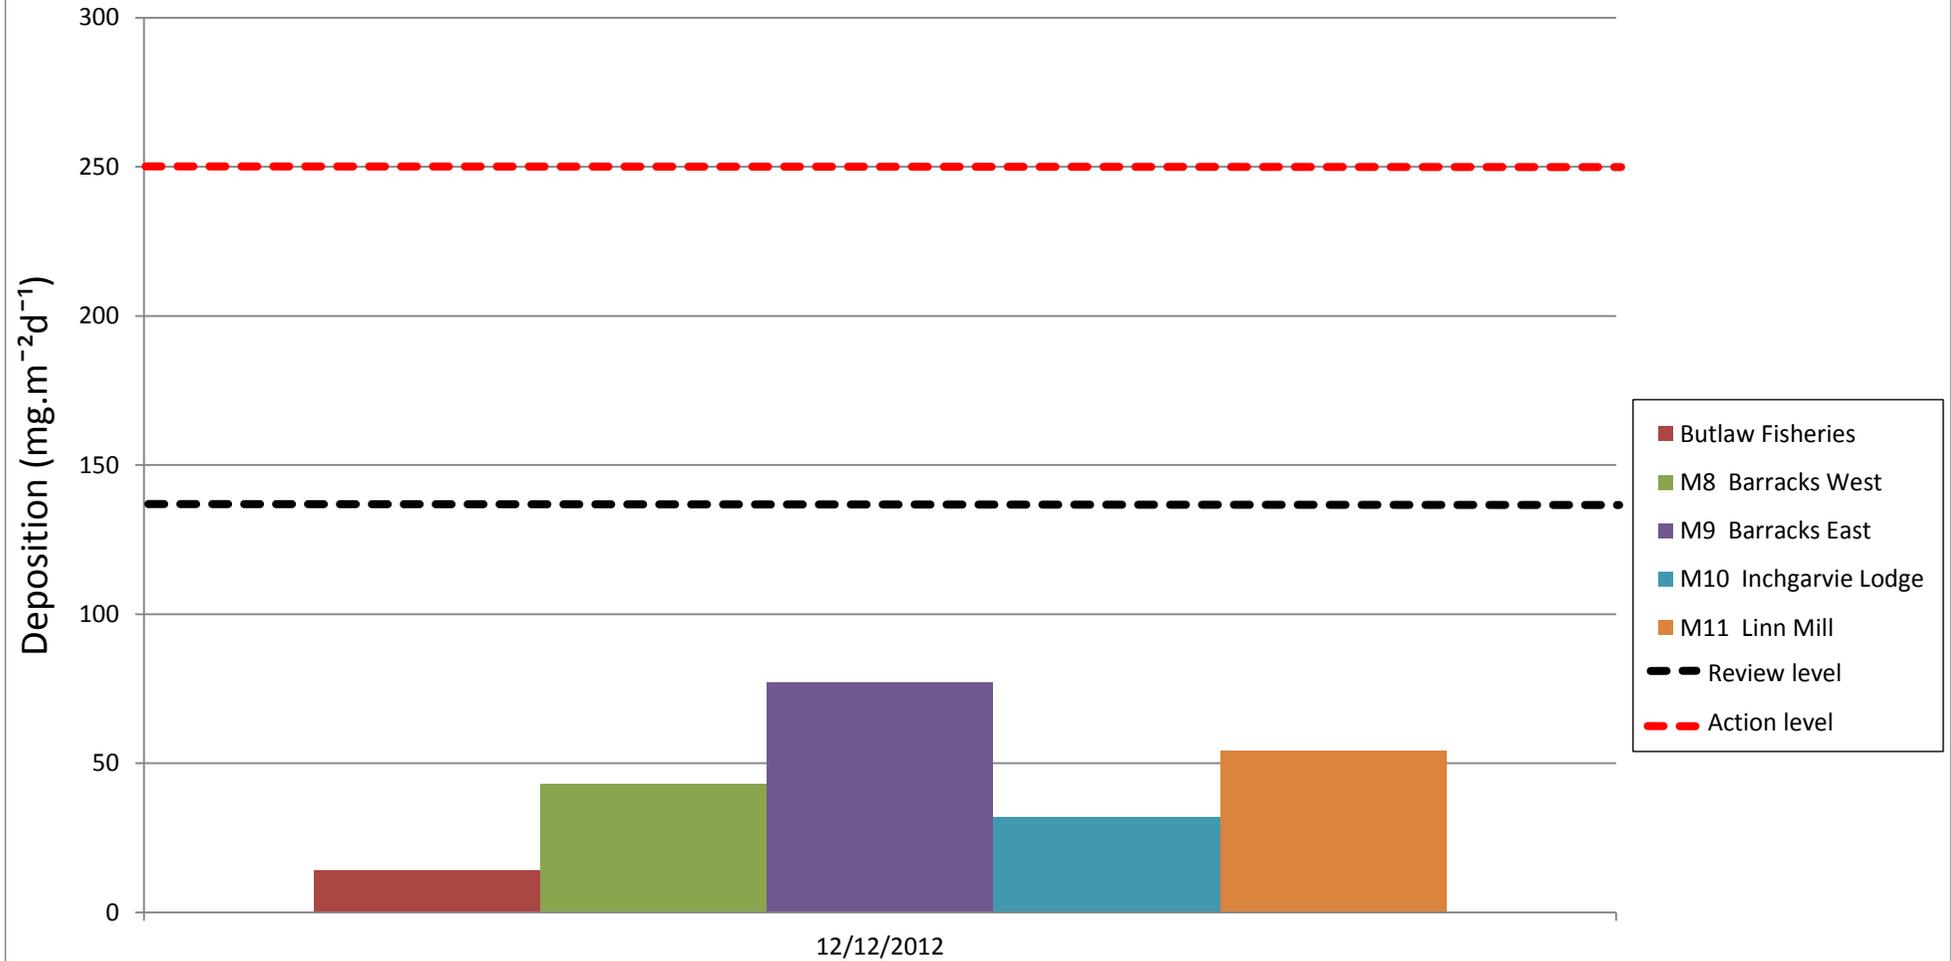
Frisbee Dust Deposition Results: Group 1
Locations: M7 Butlaw Fisheries, M8 Barracks West, M9 Barracks East,
M10 Inchgarvie Lodge and M11 Linn Mill

3.3.2. Frisbee dust data deposition results are collected fortnightly, and the results averaged over this fortnight period to give a daily dust deposition rate. Due to the Christmas break (21/12/12 to 07/01/13) only one collection date fell during December on 12 December 2012. The next collection date is due on the 9 January 2013. During December there were no exceedances of either the site review level or the site action level across the site and all results were found to be low.

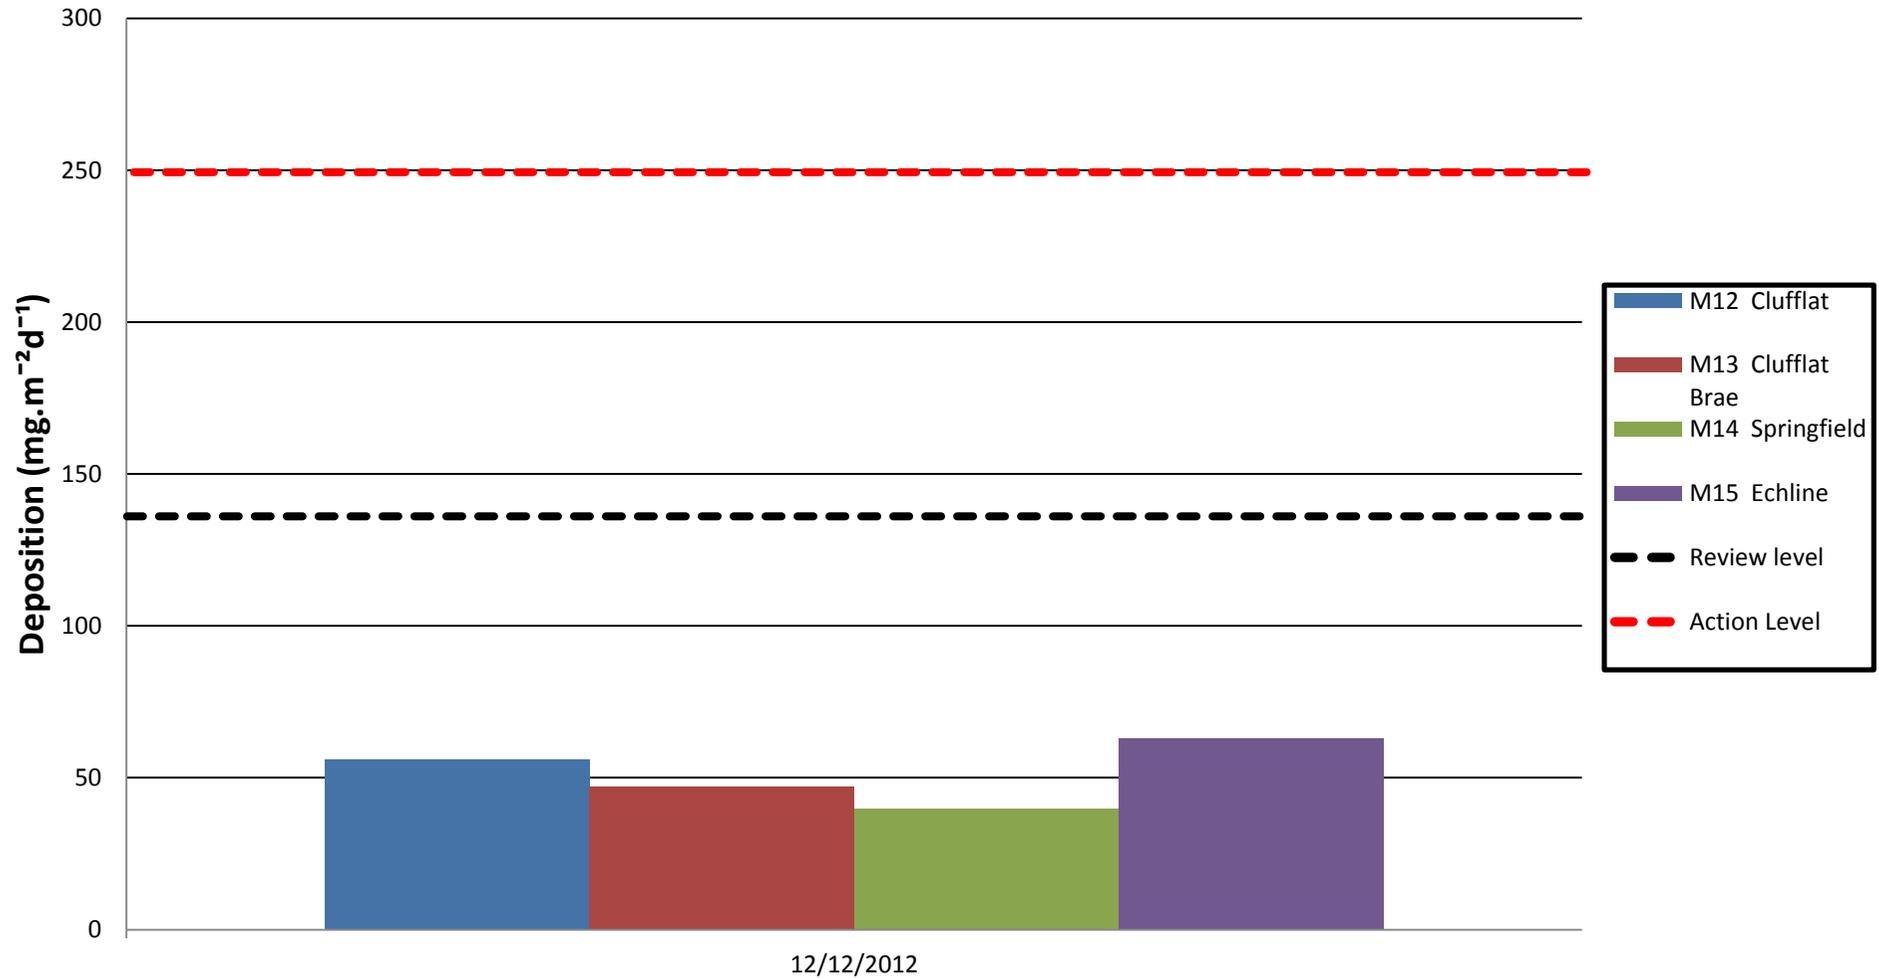
Frisbee Dust Deposition Results: Group 2

Locations: M12 Clufflat, M13 Clufflat Brae, M14 Springfield and M15 Echline

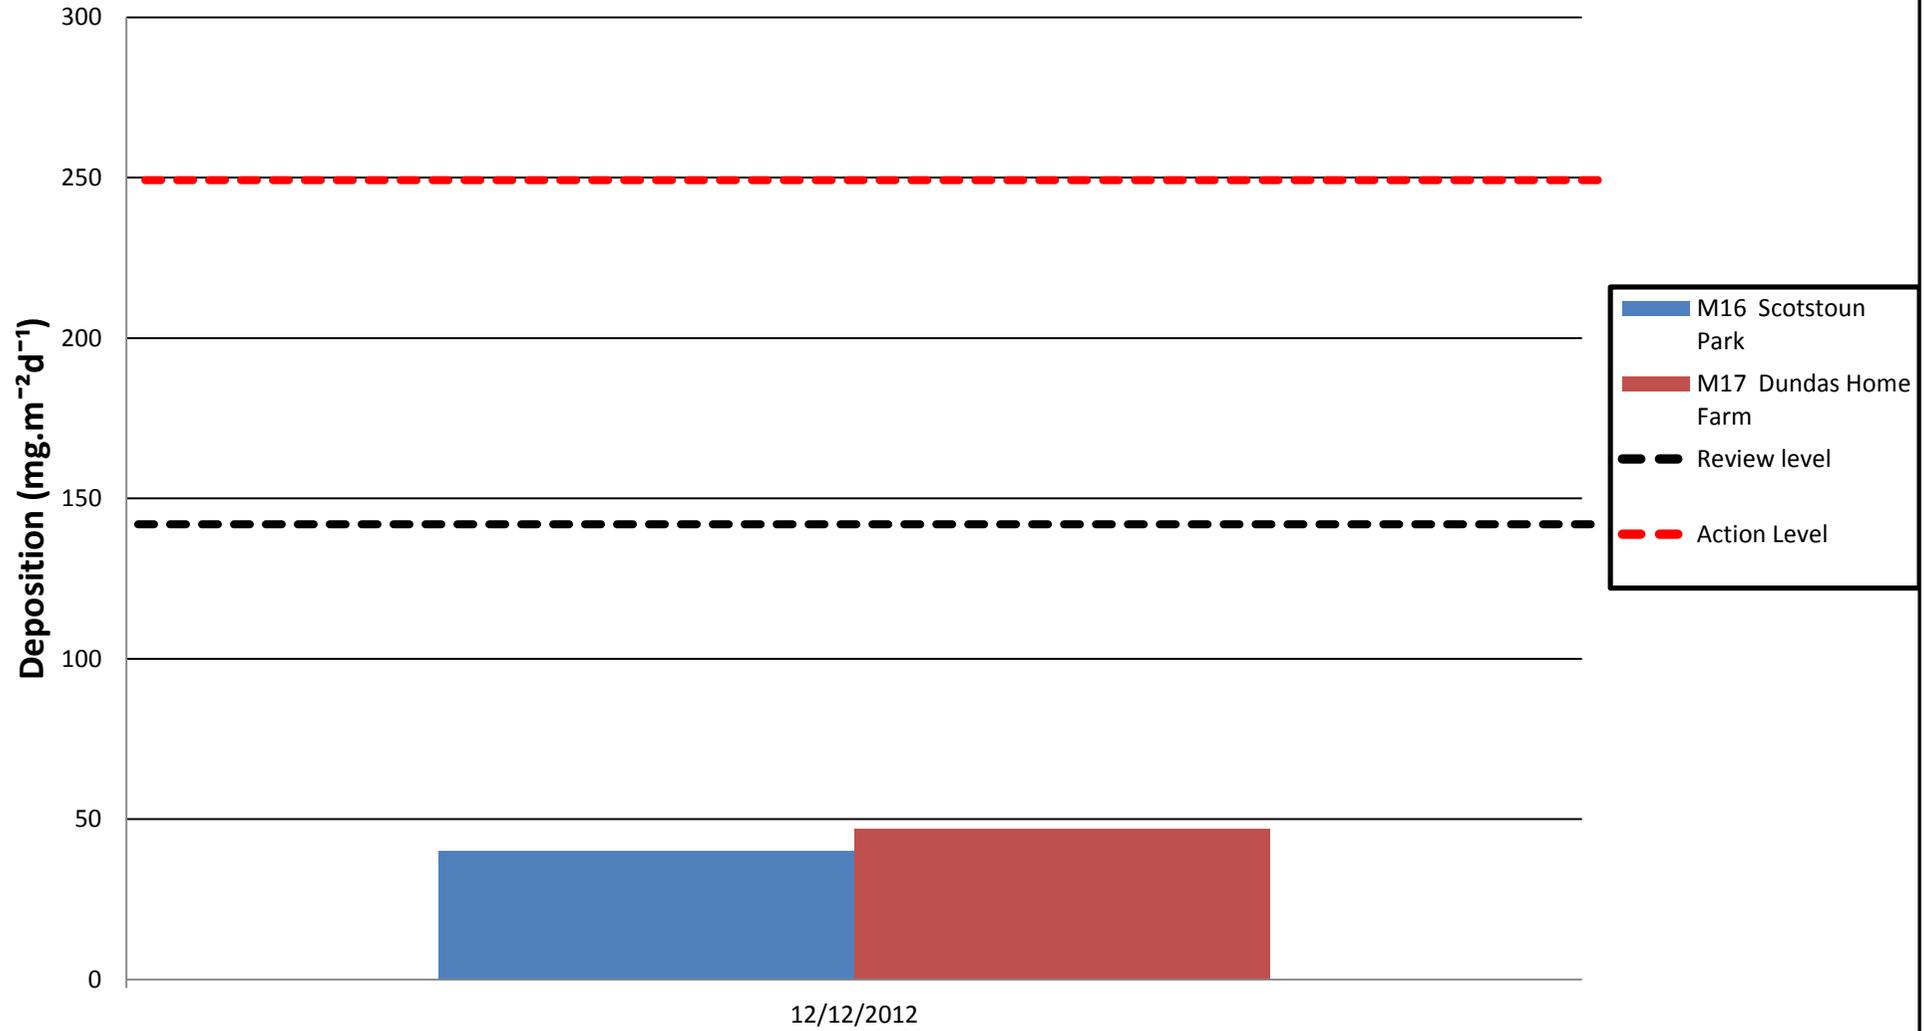
Frisbee Dust Deposition Results: Group 3

Locations: M16 Scotstoun Park and M17 Dundas Home Farm

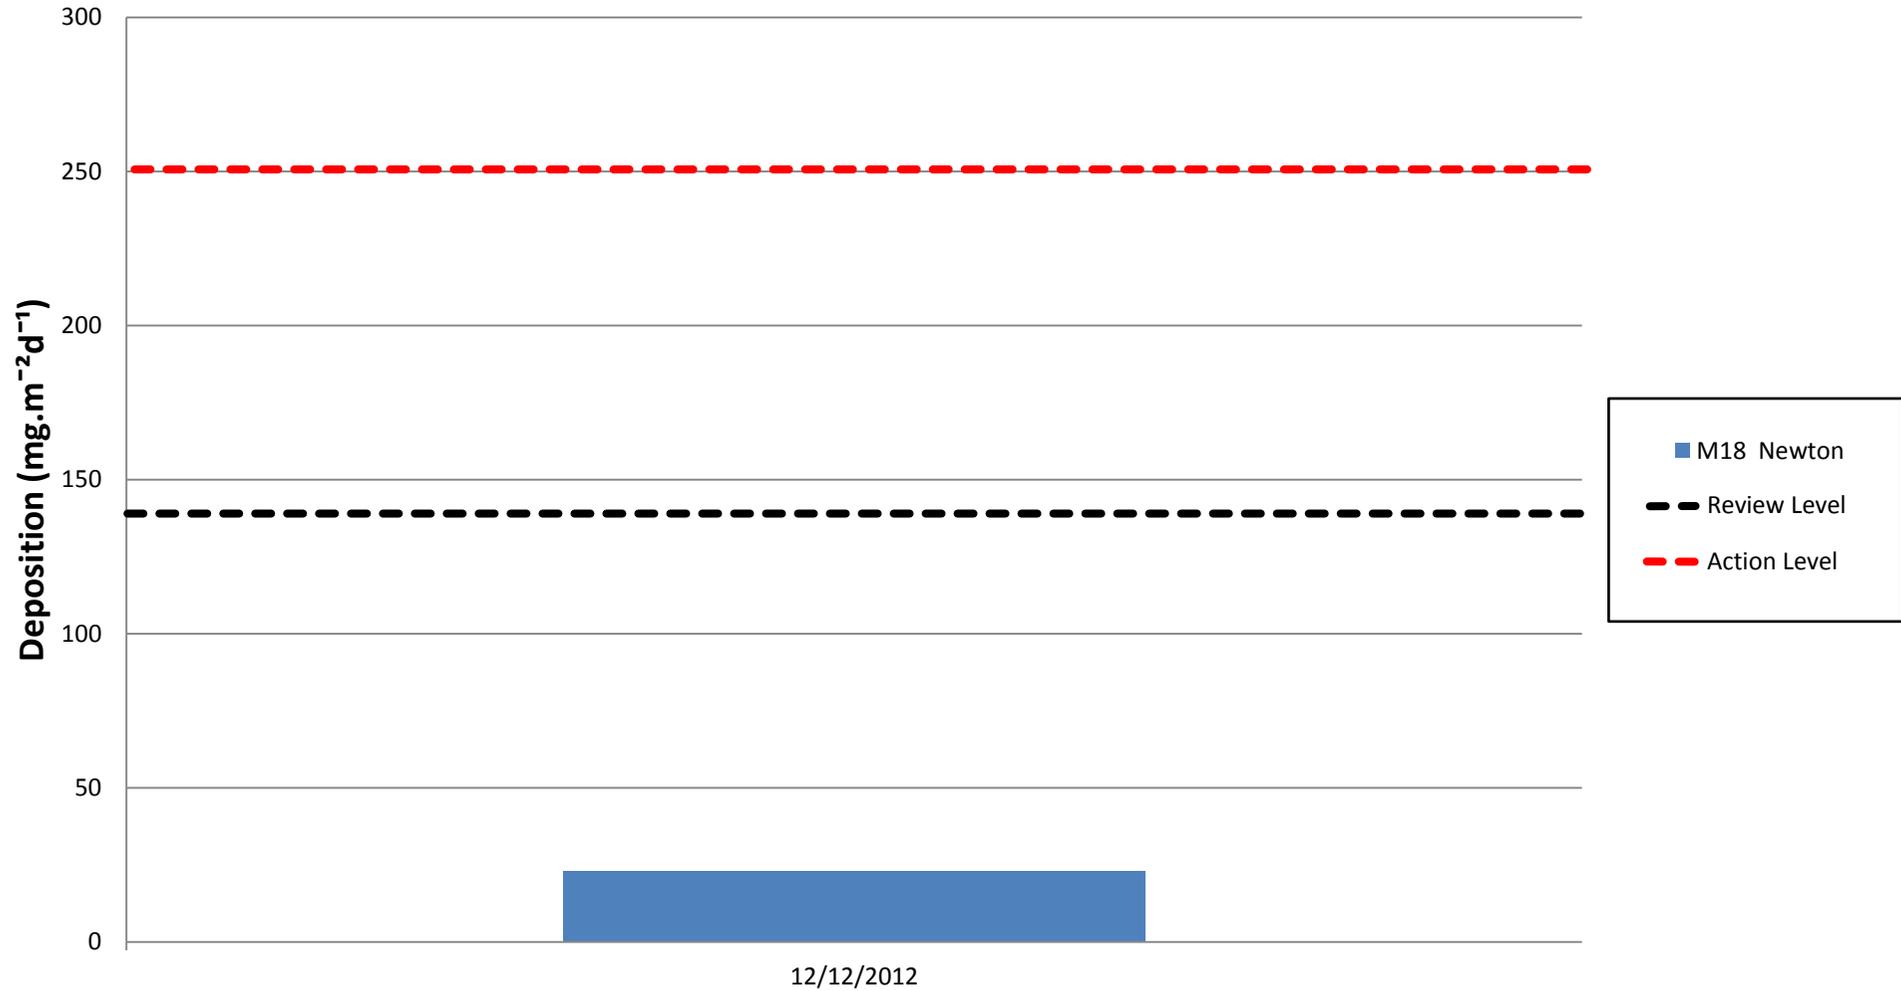
Frisbee Dust Deposition Results: Group 4

Location: M18 Newton

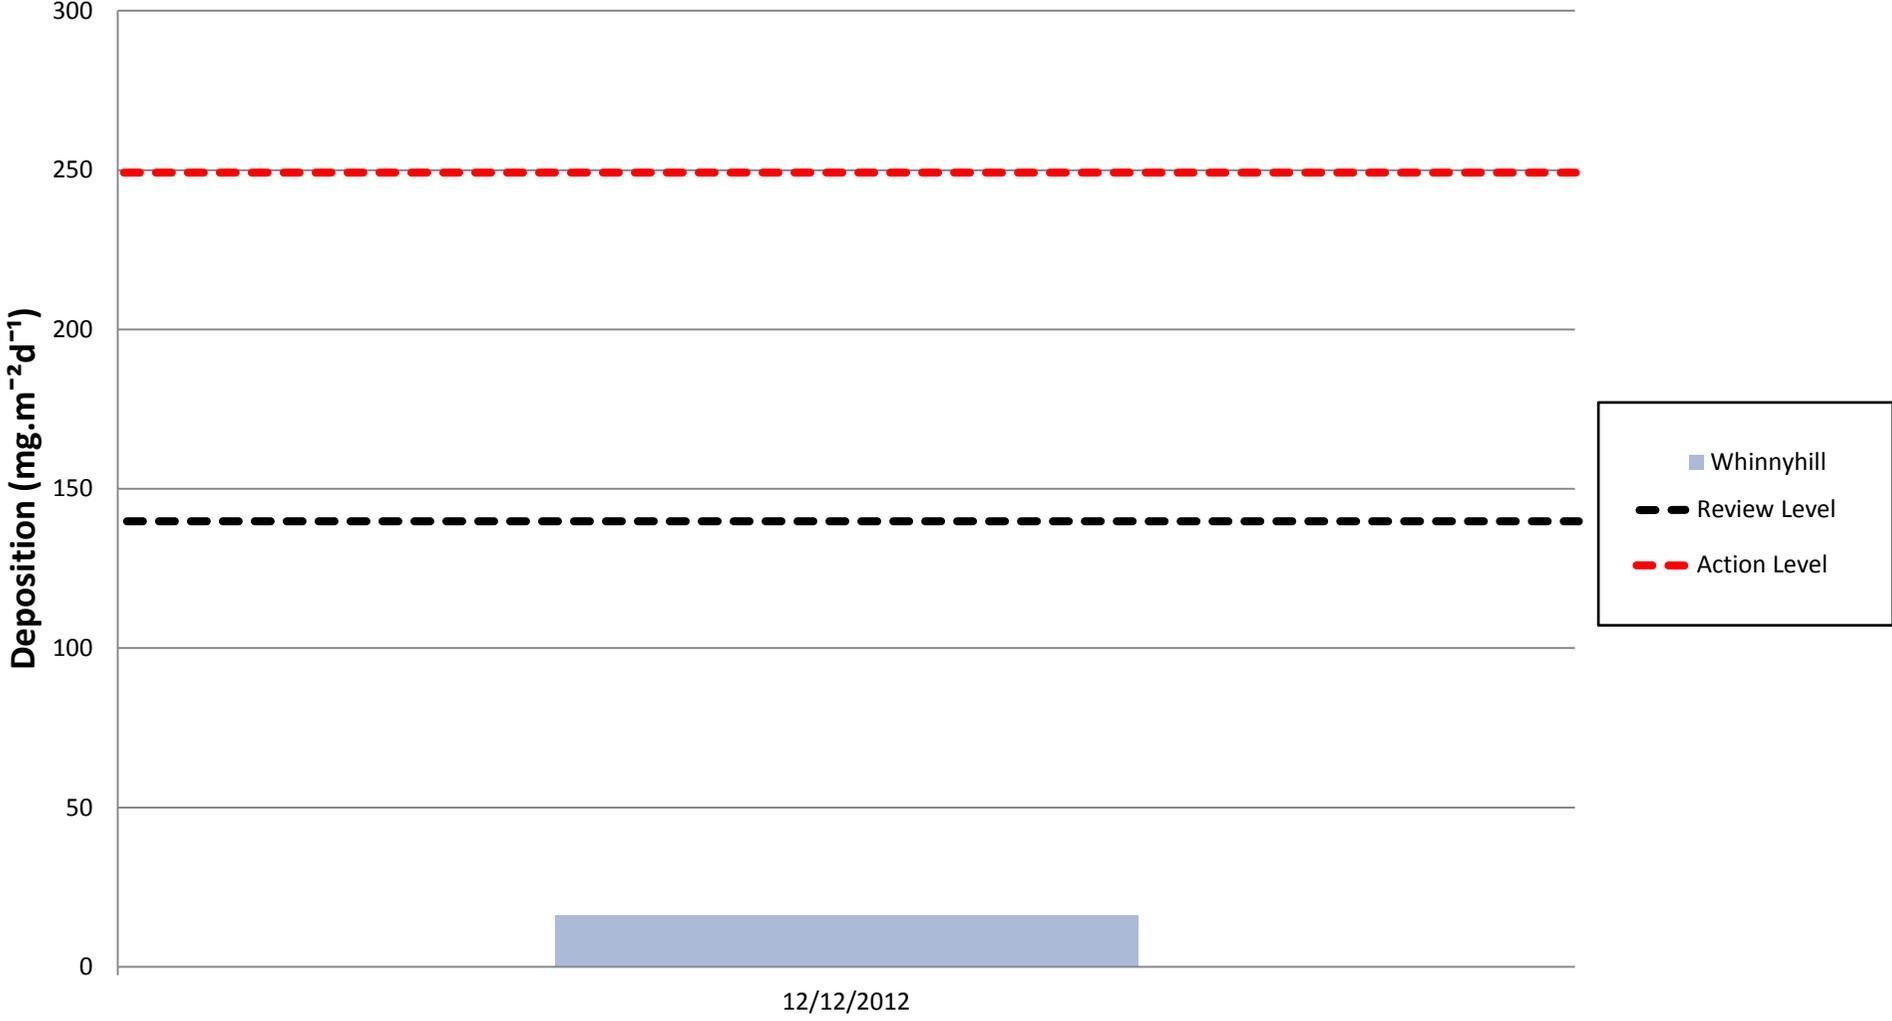
Frisbee Dust Deposition Results: Group 5

Location: M1 Whinny Hill
