Project **FORTH REPLACEMENT CROSSING**

VIBRATION MONITORING REPORT
NOV 2012 TO DEC 2012

REP-00082-

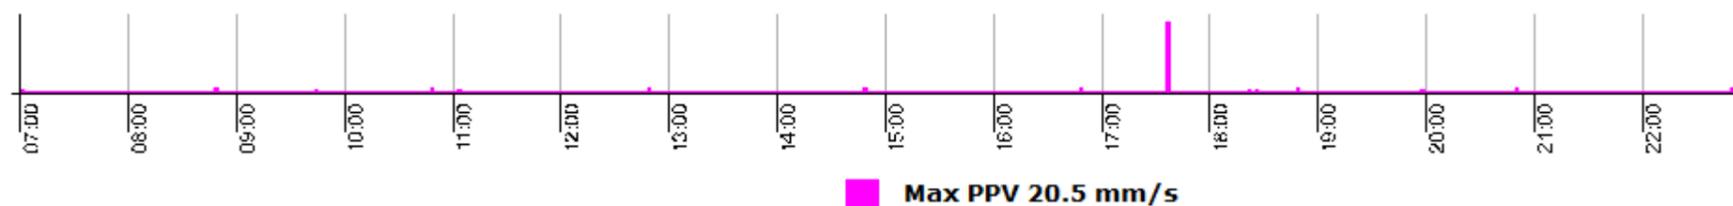
Measured highest Daily Peak Particle Velocity (PPV), Springfield, Measurement period: December 2012

- Exceedances have been investigated and are all isolated events due to local interferences rather than any continuous construction activities (please see an example below for (13/12/12)).
